| | | <p style="text-align: center;"> <b>CBRT NB NORTH CHANNEL</b><br/> <b>BRIDGE REPAIRS</b><br/> <b>REPAIR TYPE I - I</b> </p> | |

| <p align="center"> <b>CBBT NB NORTH CHANNEL</b><br/> <b>BRIDGE REPAIRS</b><br/> <b>REPAIR TYPE I - II</b> </p> | | | |

COMMONWEALTH OF VIRGINIA  
DEPARTMENT OF TRANSPORTATION  
STRUCTURE AND BRIDGE DIVISION  
**CBBT NB NORTH CHANNEL  
BRIDGE REPAIRS  
REPAIR TYPE 3 - 1**

| PROJECT: STEEL BRIDGE REPAIRS | | | |

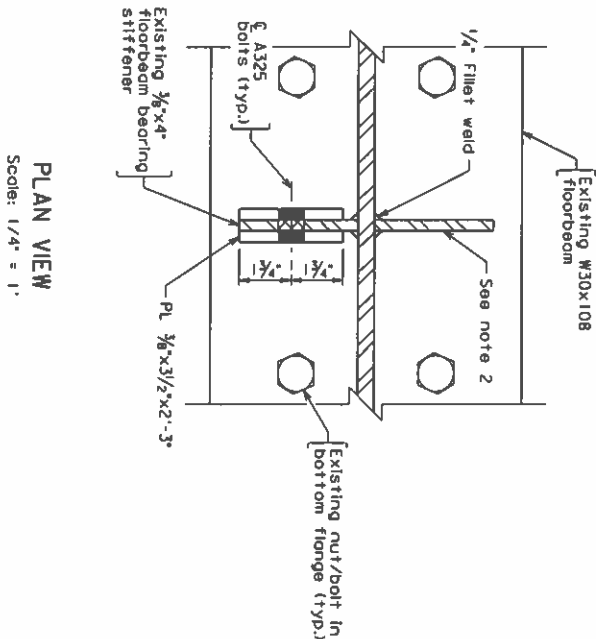
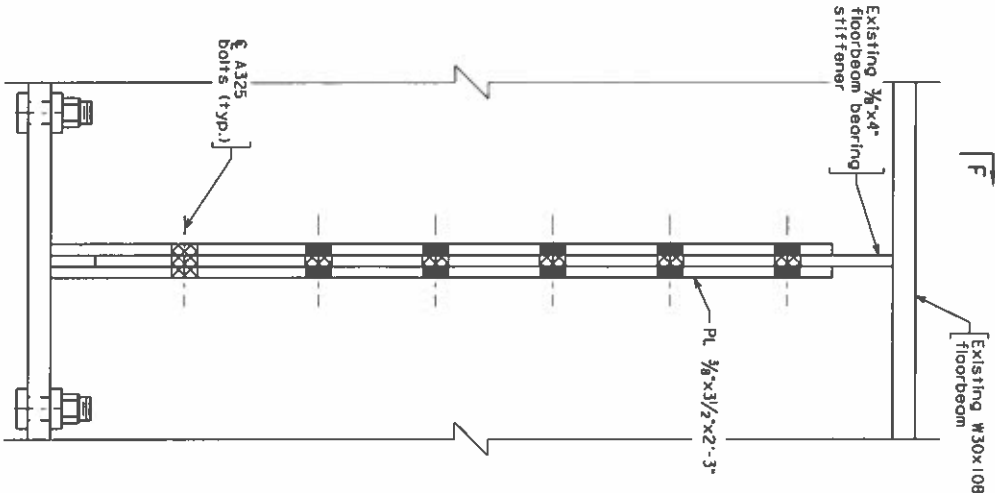
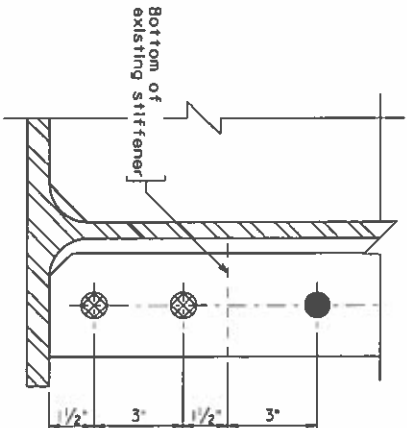
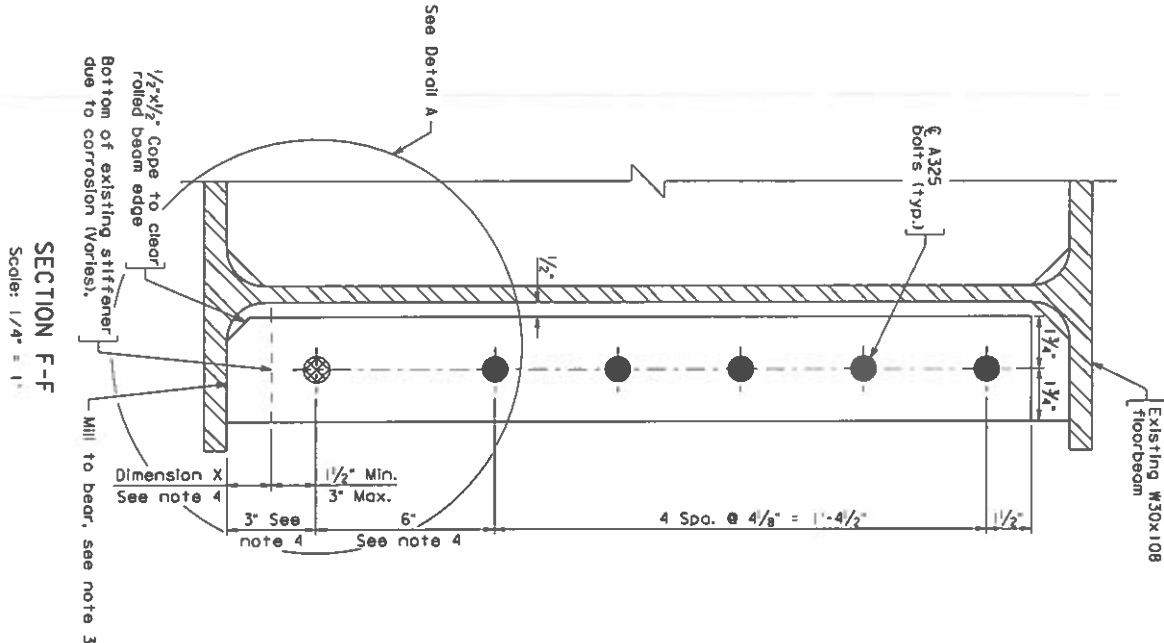
1. Match drill opposing splice plates in the shop.
2. Back to back repair condition will exist. Refer to table.
3. Restore mill to bear contact due to corrosion of existing bearing stiffener.
4. When Dimension X is  $1\frac{1}{2}$ " or less, use single field drilled hole as shown. When Dimension X is  $1\frac{1}{2}$ " and 6", cut out existing stiffener to a height of 6", above the top of bottom flange, grind fillet weld flush with web, add  $\frac{3}{8}$ "x4"x6" fill plate with a 1"x1" cope to clear rolled beam edge, and use two drilled holes as shown in Detail A. The fill plate need not be welded to the web.

- A. Clean and grind corroded areas as required. As part of cleaning and preparing the top of the bottom flange, up to  $\frac{1}{8}$  section loss for the bottom flange is acceptable. For bottom flange section loss greater than  $\frac{1}{8}$ , the contractor shall notify the owner prior to proceeding with the repair. Determine if Section F or Detail A is necessary.

- B. Achieve mill to bear condition for the first splice plate and temporarily clamp it in place. Ensure alignment of the clamped position will provide proper edge distance ( $1\frac{1}{2}$ ) for the field drilled holes. Using the shop drilled holes as a template, field drill splices for the floorbeam stiffener. Achieve a mill to bear condition for the second splice plate. The second splice plate shall be drilled to match the first splice plate. Insert field plate if required. Holes shall be filled with a field stiffener splice plate to match existing surface. Temporarily clamp the second stiffener splice plate in place and field drill the bottom most one or two bolt holes as determined in the field.

- C. Remove the temporarily clamped splice plates. Clean the galvanized splice/fill plates and clean the entire existing steel area to be plated. Paint any bare steel using the three coat system. Repair any damages to galvanized surfaces.

- D. Bolt the splice/fill plates to both sides of the floorbeam stiffener and remove clamps.

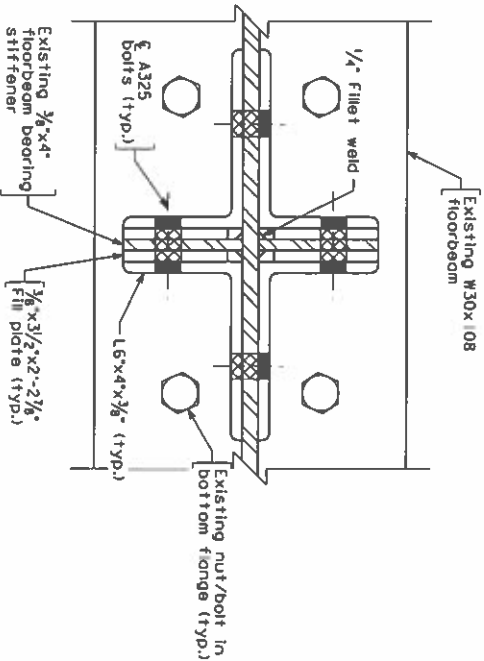
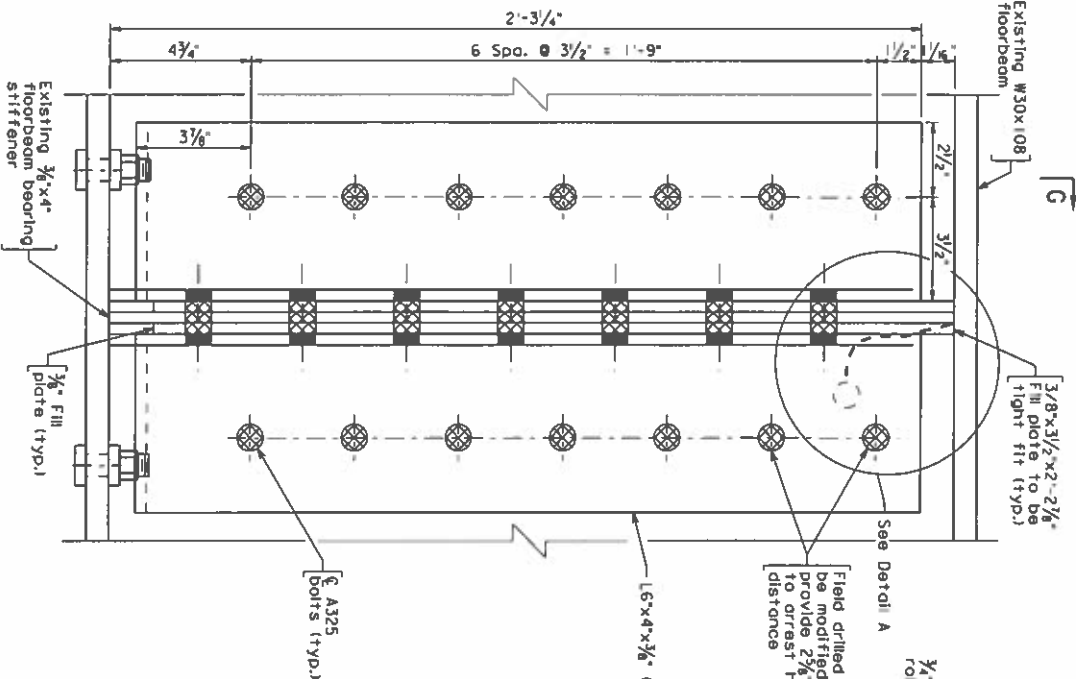
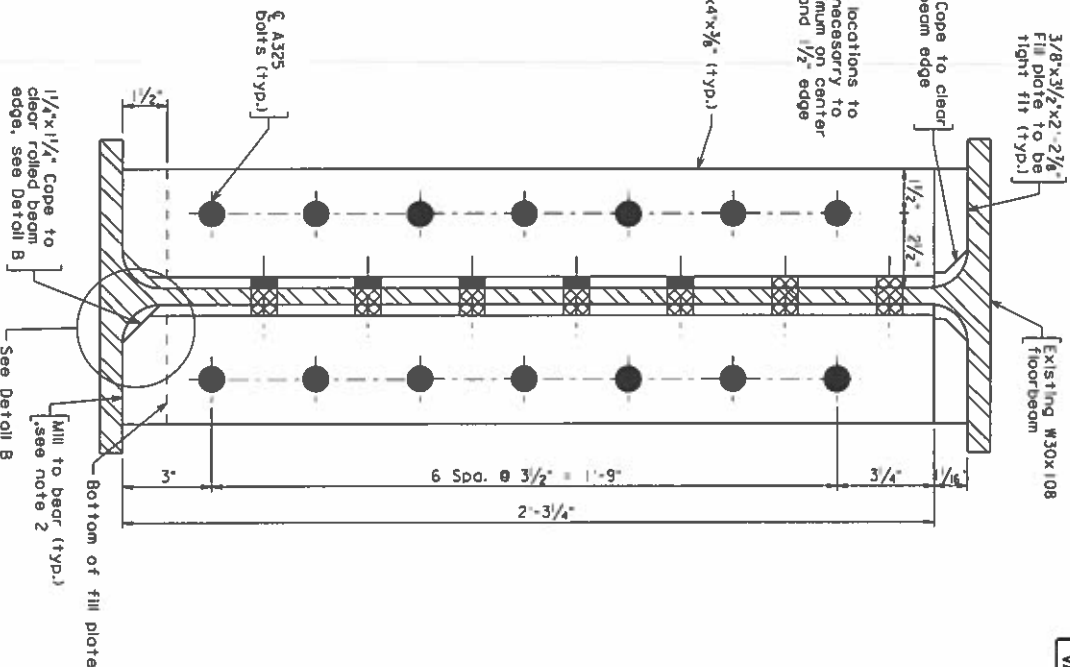
**FLOORBEAM BEARING STIFFENER REPAIR OVER LONGITUDINAL GIRDERS**

- Near top flange, locate fillet weld crack along bearing stiffener and grind out affected weld flush to base metal. Base metal shall not be removed during grinding. Check weld area with dye penetrant or magnetic particle testing to ensure the crack has been removed. All ground out weld areas are to be the same length on both sides of the stiffener.

- If the crack has propagated into the base metal, locate the ends of the crack(s) using some non-destructive testing methods and arrest the crack tip as shown in Detail A. Clean and grind corroded areas as required.

- Achieve tight fit condition for two opposing fill plates and mill to bear condition for the first angle and temporarily clamp all in place. Ensure alignment of the clamped shop drilled holes as a template, field drill through the fill plates and the floorbeam web. Achieve a mill to bear condition for the second angle on this same side of the floorbeam web. Also align with the field drilled holes in the fill plate. Repeat process for the opposite side of the floorbeam web. With all four angles clamped in place and using the shop drilled holes as a template, field drill through the floorbeam web and the opposite side angle.

- Remove the temporarily clamped angles and fill plates. Clean the galvanized steel elements and clean the entire existing steel area to be plated. Paint any bare steel surfaces.

- Bolt the angles and fill plates to both sides of the floorbeam stiffener and remove clamps.

- Match drill opposing angle legs in the shop.
- Angles shall be mill to bear at the bottom flange connection.
- Fill plates shall be tight fit at the top flange.
