## FY2023 Annual Inspection and Underwater Inspection, Trestle CSB

### FY2023 Facility Annual Inspection Report FINAL

December 30, 2022

Chesapeake Bay Bridge and Tunnel District

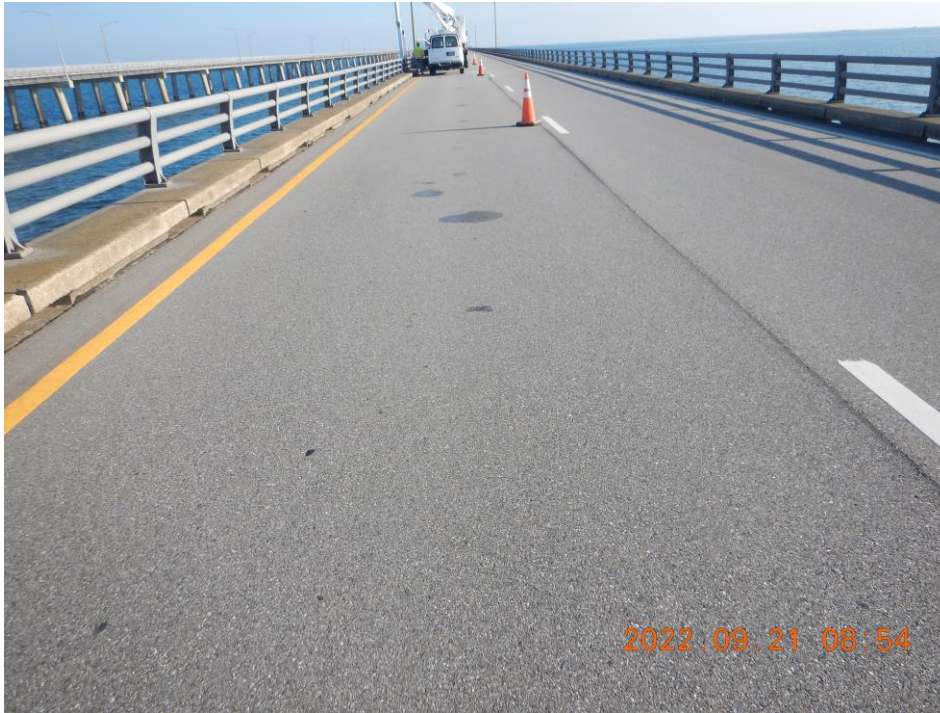
Photo 1: ANB90 Asphalt Wearing Surface – Typical Good Condition of Wearing Surface (Looking North)

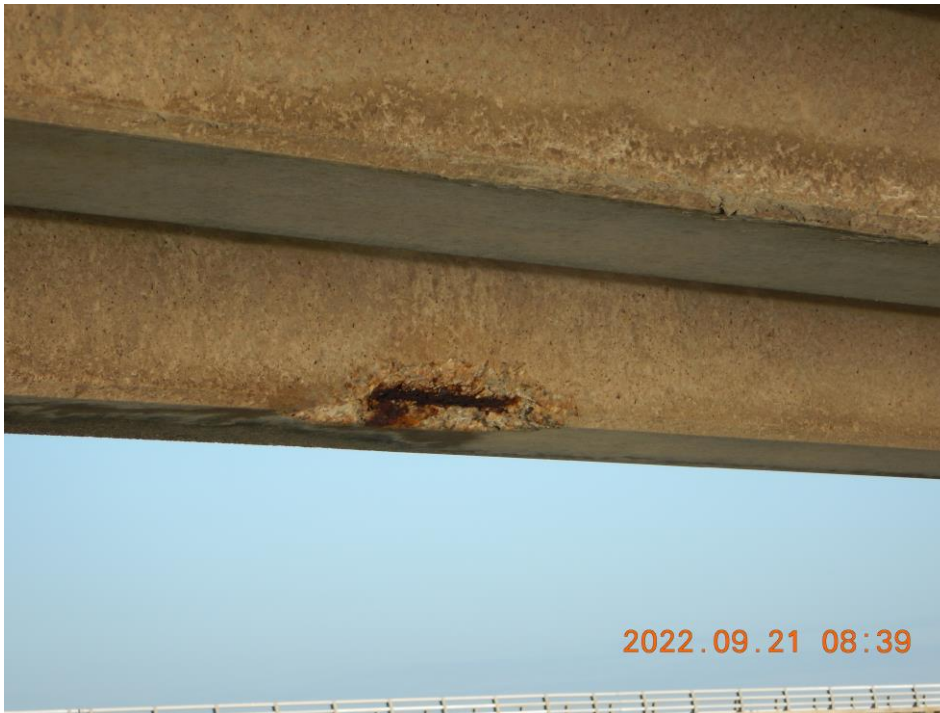
Photo 2: ANB91 Prestressed Concrete Girder – Spall with Exposed Strand, Girder 8, Defect represents <0.1% of Total Quantity (Looking Southeast)

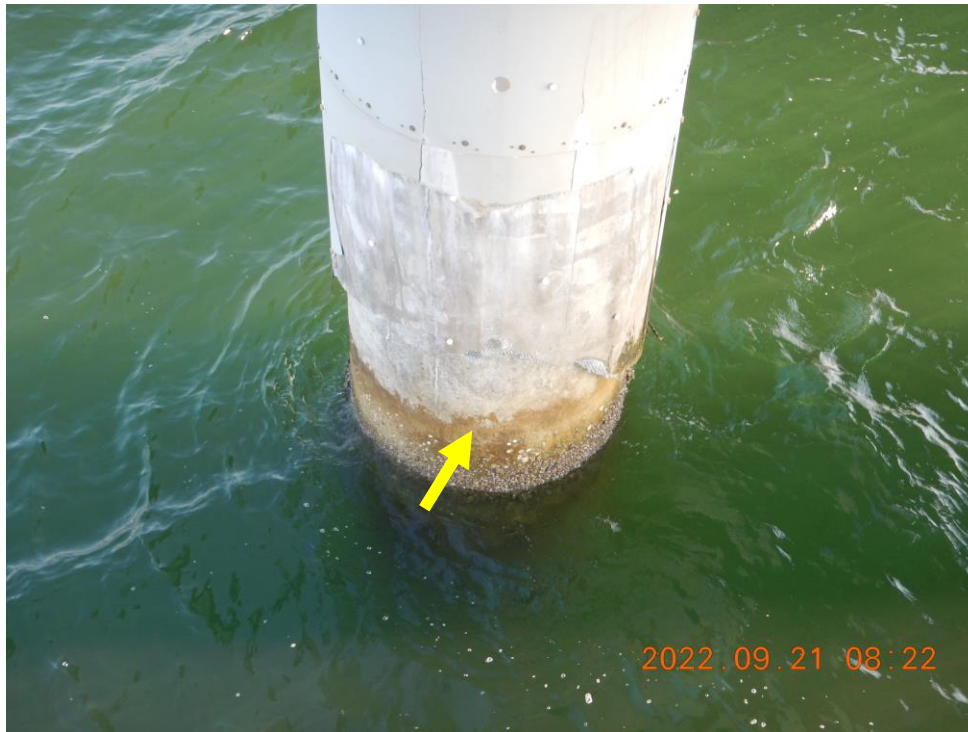
Photo 3: ANB89 Prestressed Concrete Piles – Missing Annulus Grout at Pile A (Looking Southeast)

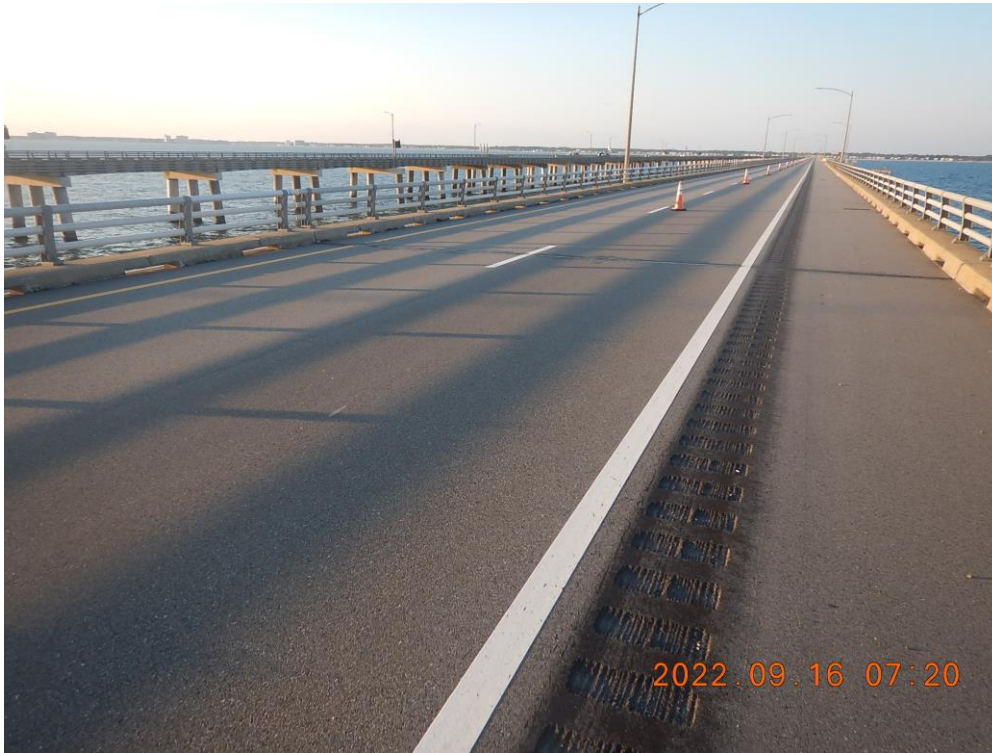
Photo 4: ASB163 Asphalt Wearing Surface – Typical Good Condition of Wearing Surface (Looking South)

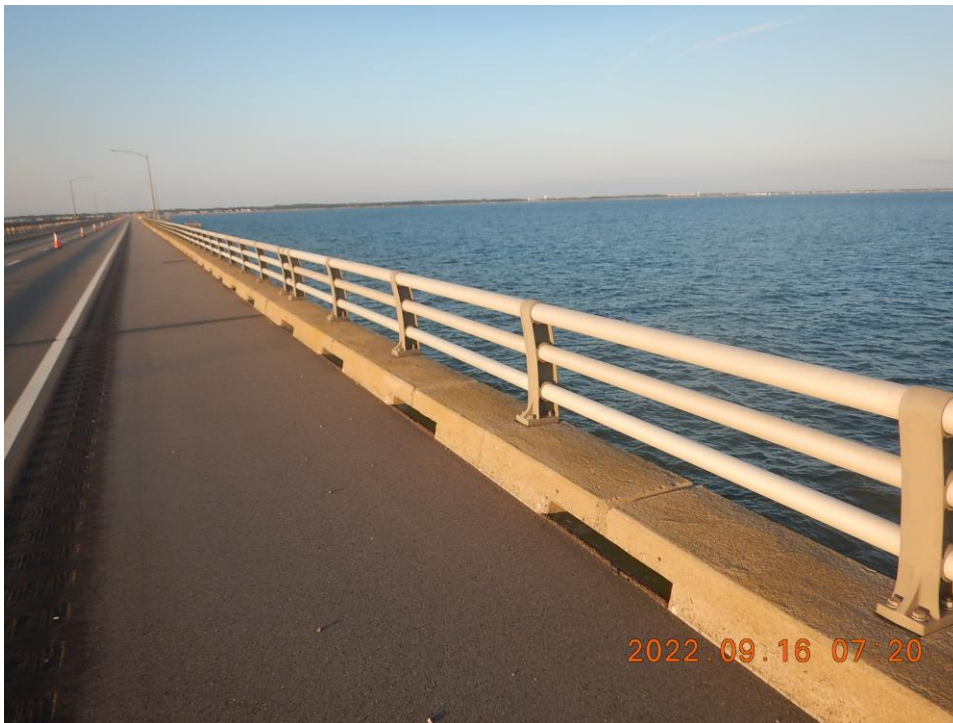
Photo 5: ASB163 Metal Bridge Railing – Typical Good Condition of Bridge Railing and Curb (Looking Southwest)

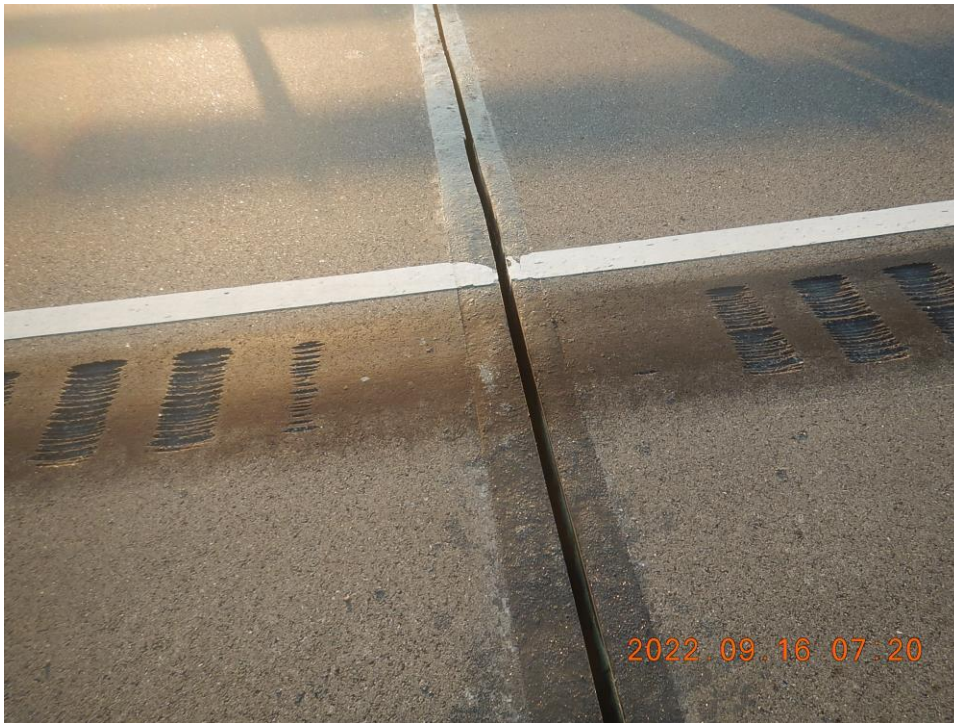
Photo 6: ASB162 Open Expansion Joint – Typical Good Condition of Joint (Looking East)

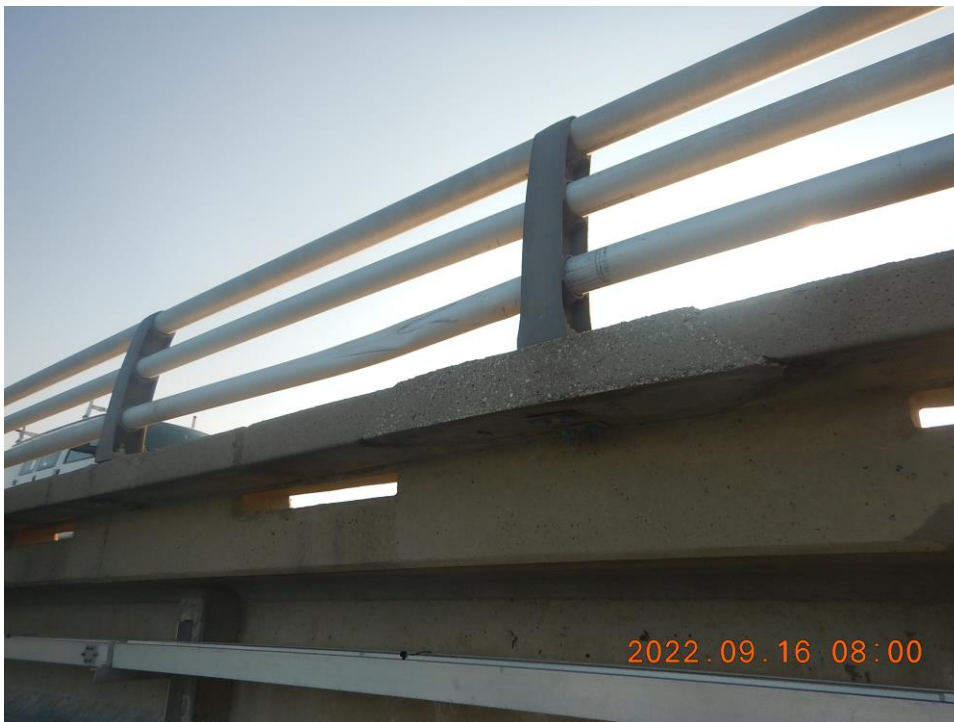
Photo 7: ASB160 Concrete Curb & Metal Bridge Railing – Good Repair Patch in West Curb with Minor Impact Damage to Bridge Rail at Midspan (Looking East)

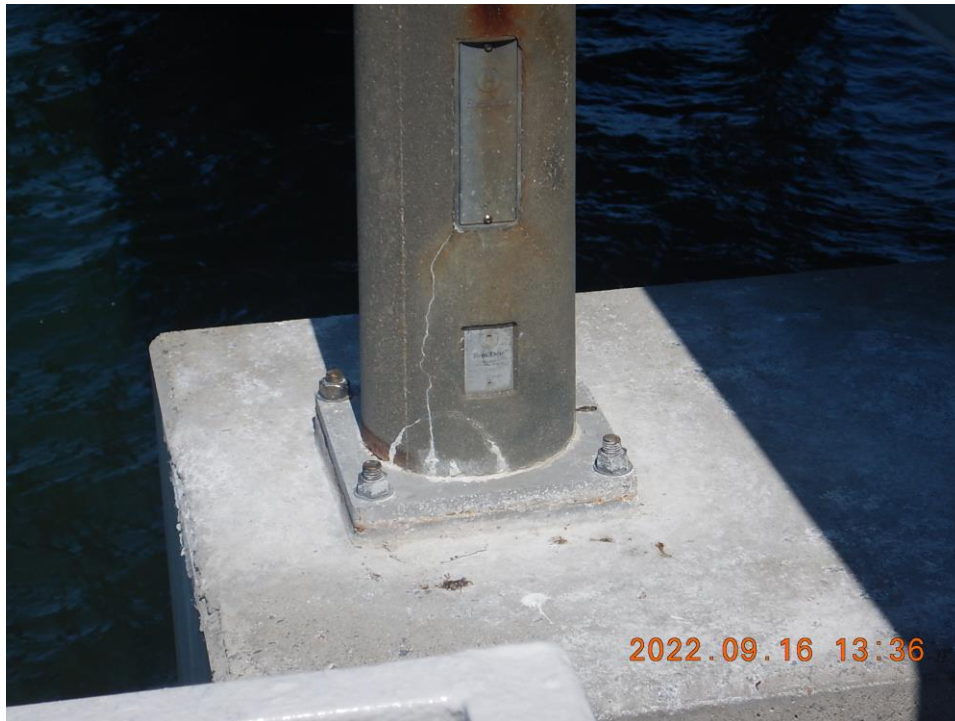
Photo 8: ASB129 – Cracking with Efflorescence at Base of Light Pole (Looking West)

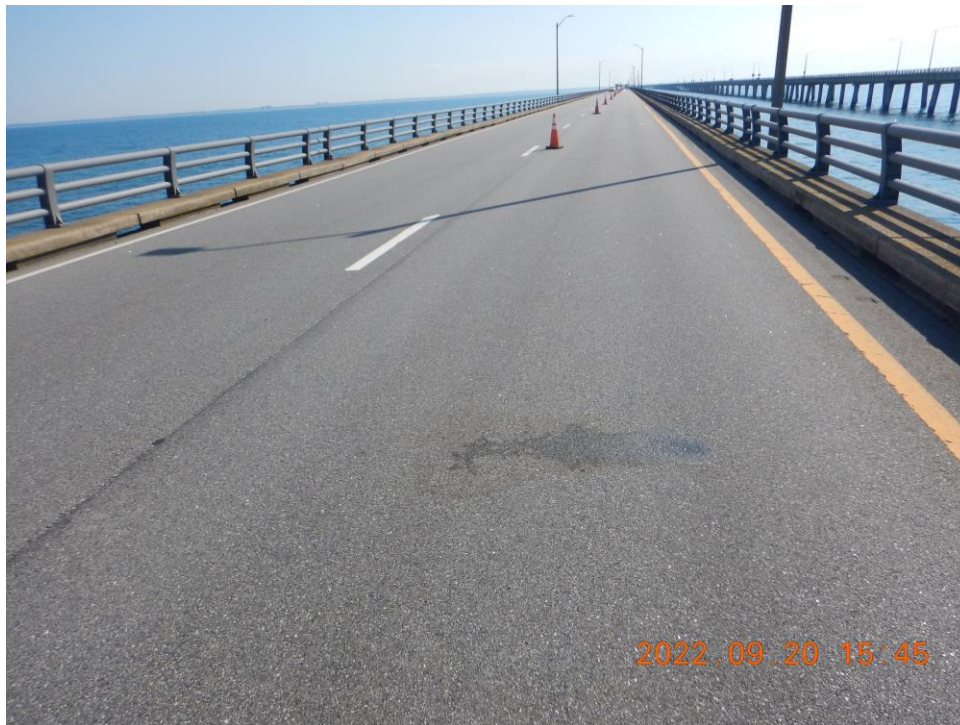
Photo 9: BNB99 Wearing Surface and Metal Bridge Railing – Typical Good Condition (Looking South)

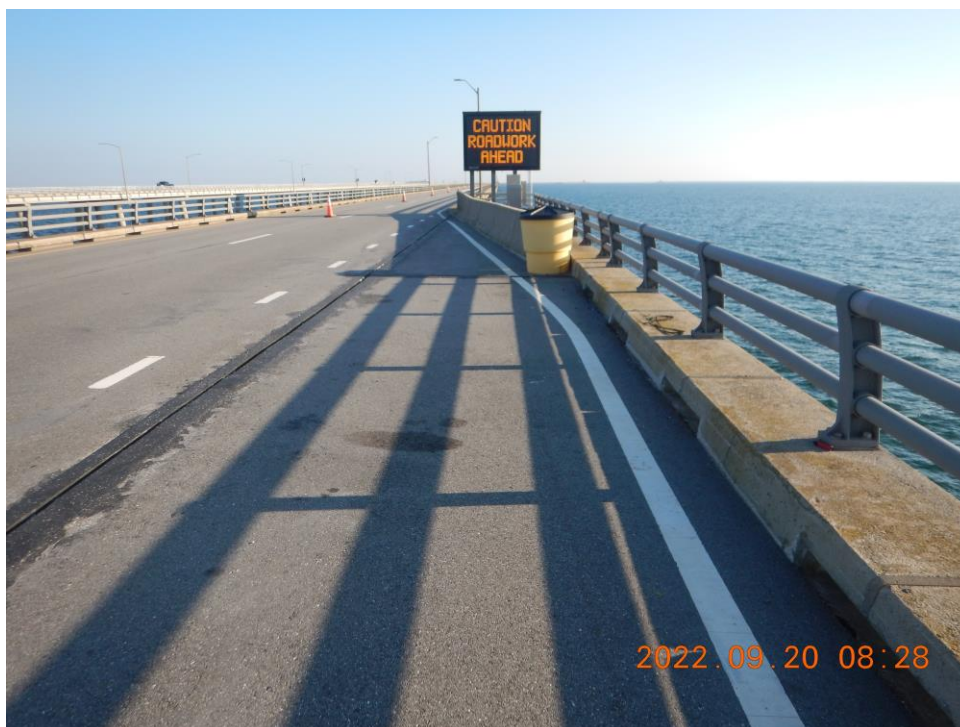
Photo 10: BNB61 Wearing Surface – Typical Condition of EPO (Looking North)

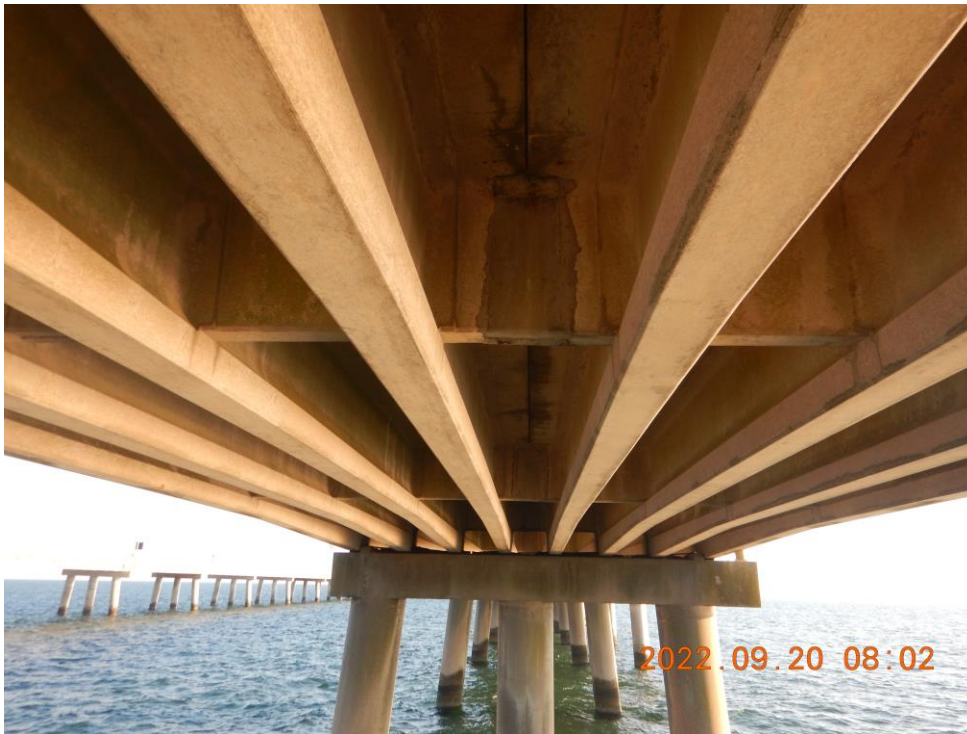
Photo 11: BNB59 Prestressed Concrete Girders – Typical Good Condition of Superstructure (Looking North)

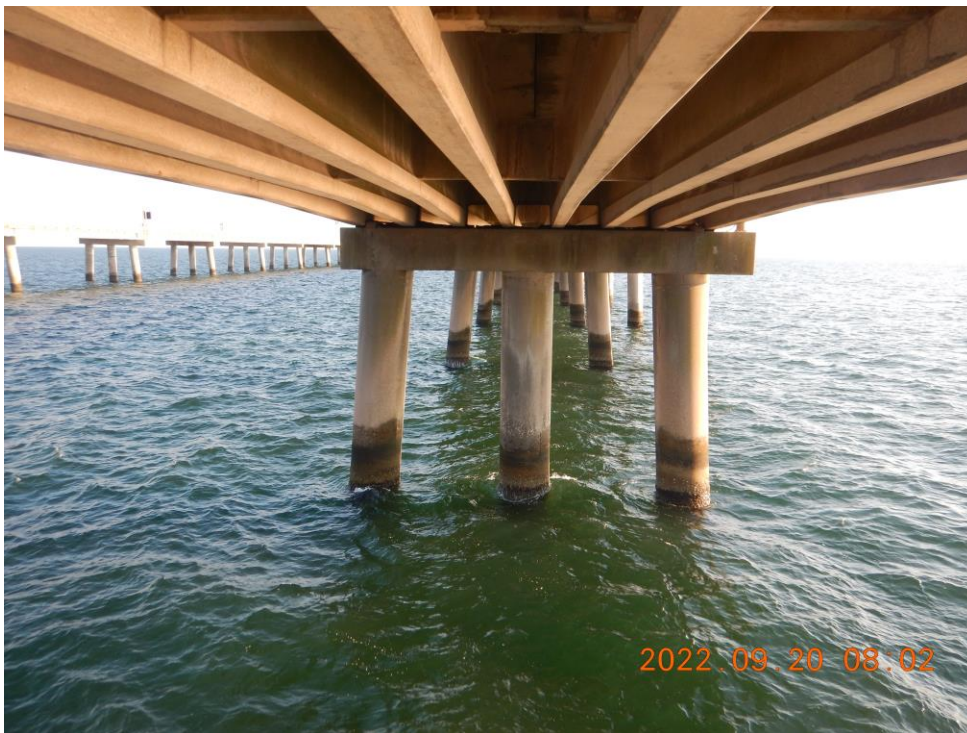
Photo 12: BNB60 – General Good Condition of Bent Cap and Piles (Looking North)

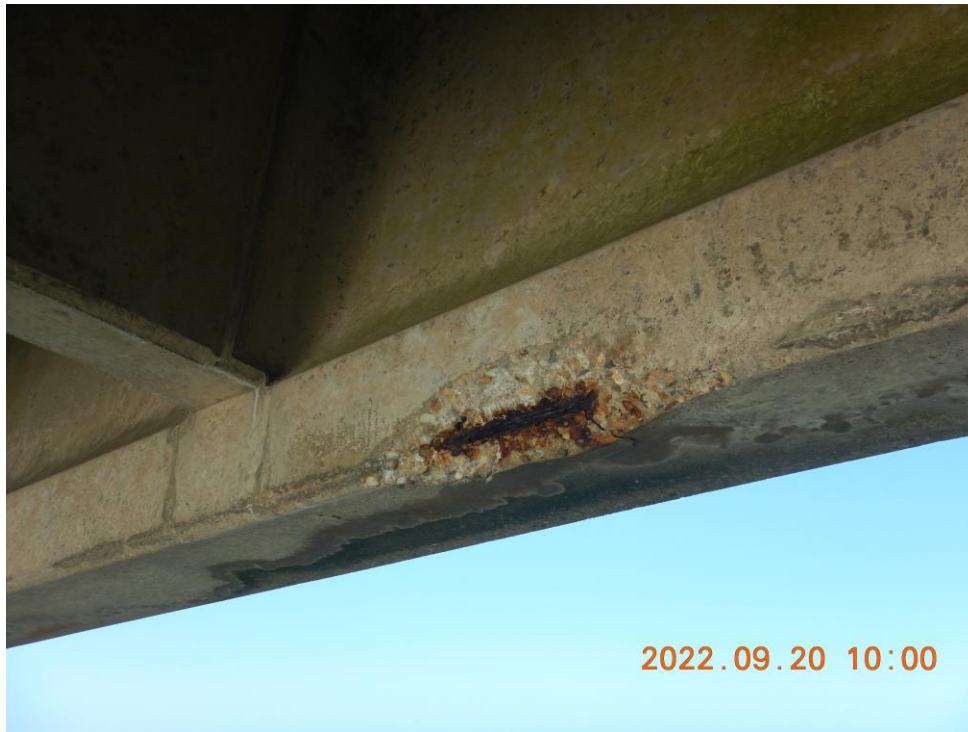
Photo 13: BNB72 Prestressed Concrete Girders – Spall with Exposed and Corroded Strand, Girder 8 (Looking Southwest)

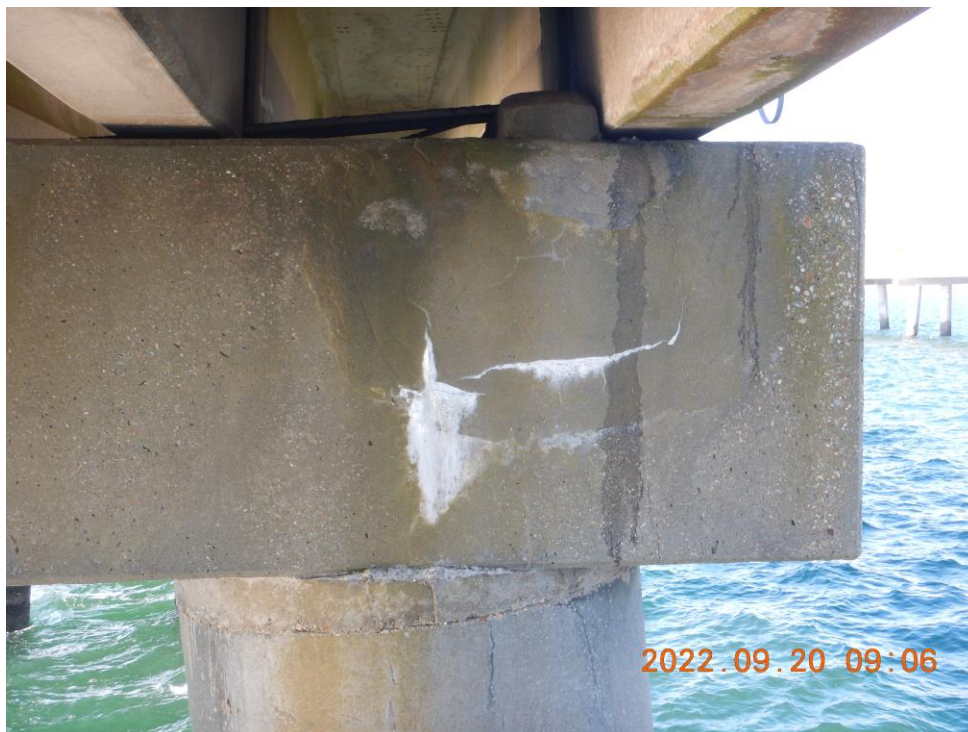
Photo 14: BNB66 Reinforced Concrete Cap – Patch with Heavy Efflorescence over Pile A (Looking South)

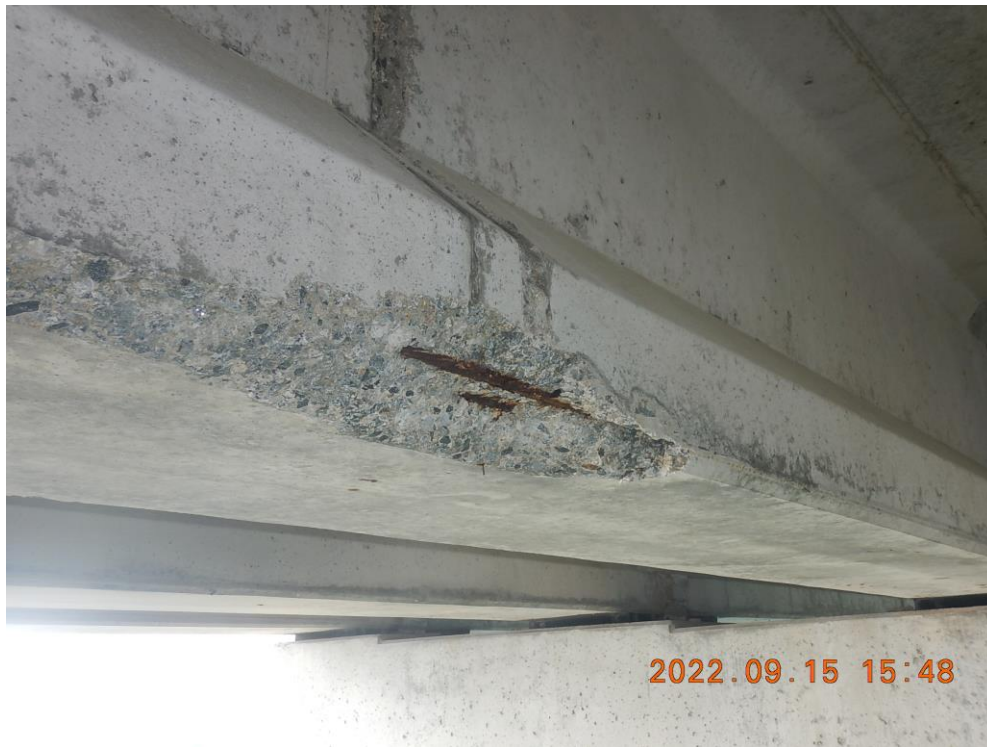
Photo 15: BSB165 Prestressed Concrete Girders – Spall with 2 Exposed Strands, Girder 3 (Looking Southeast)

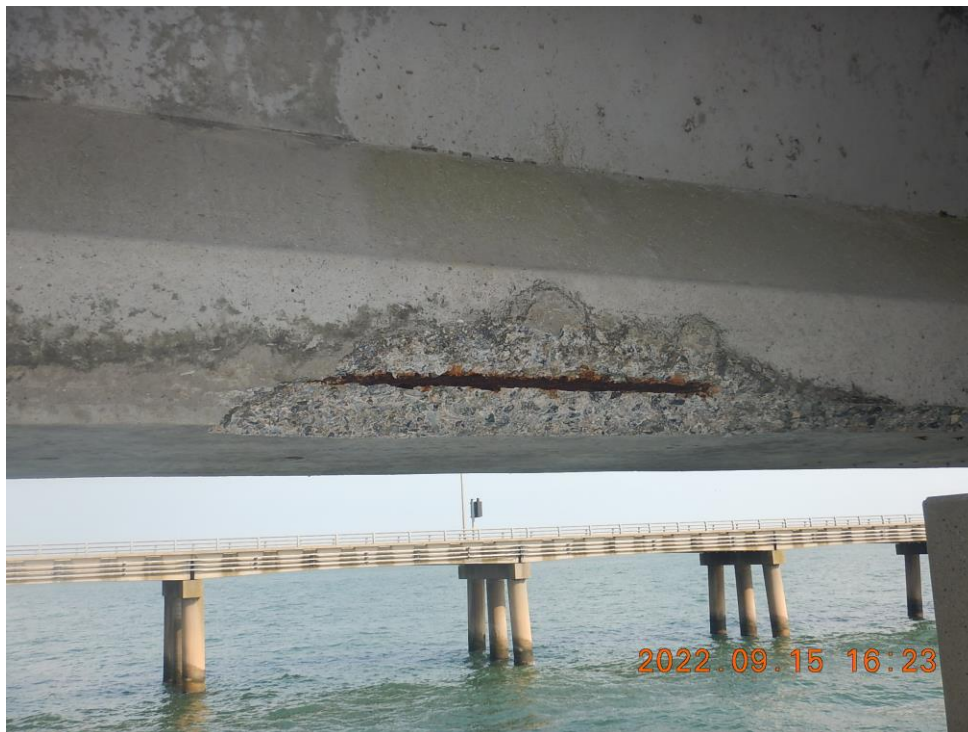
Photo 16: BSB160 Prestressed Concrete Girders – Spall with Exposed Strand (Looking Southeast)

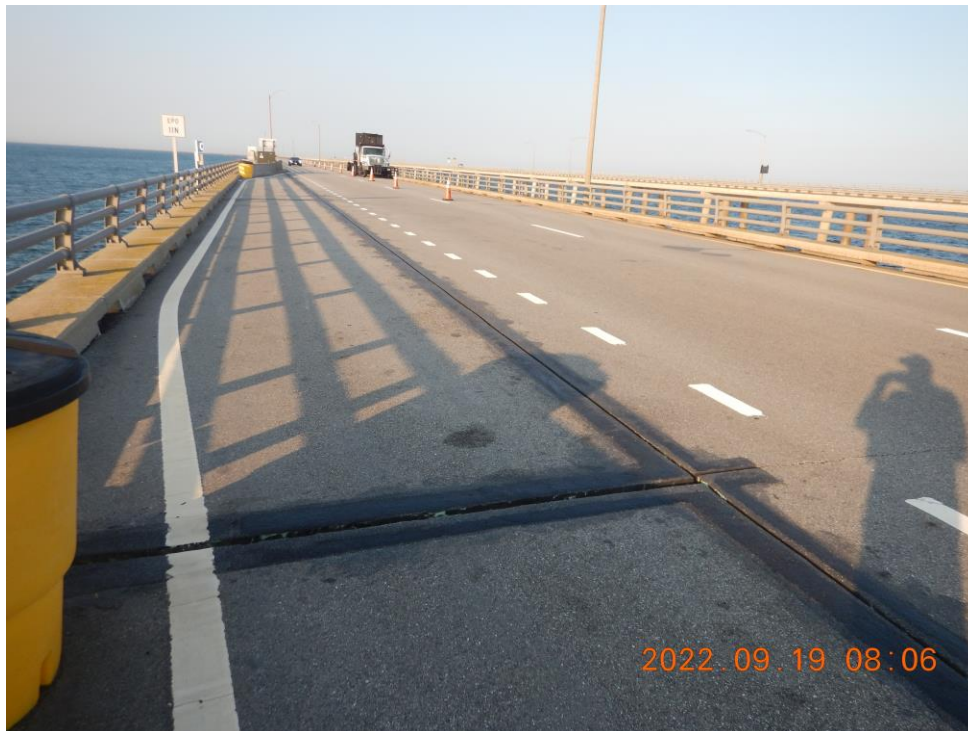
Photo 17: CNB66 Wearing Surface – Typical Condition of Wearing Surface and Bridge Railing (Looking Southwest)

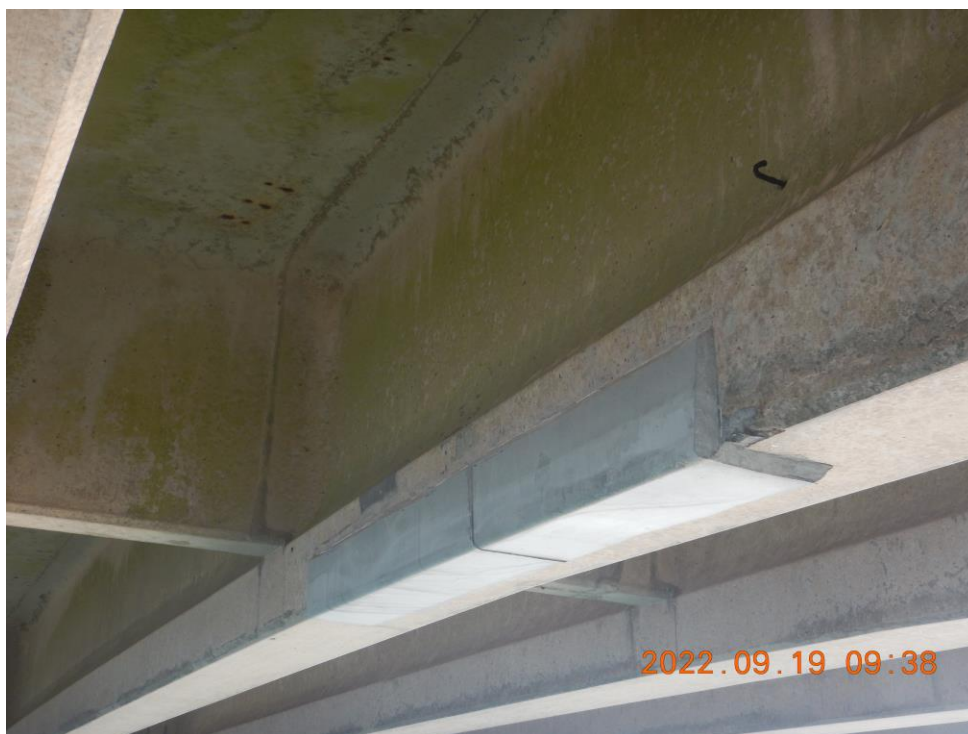
Photo 18: CNB81 Prestressed Concrete Girder – Typical Good Repair Patch, Girder 5 Shown (Looking Northeast)

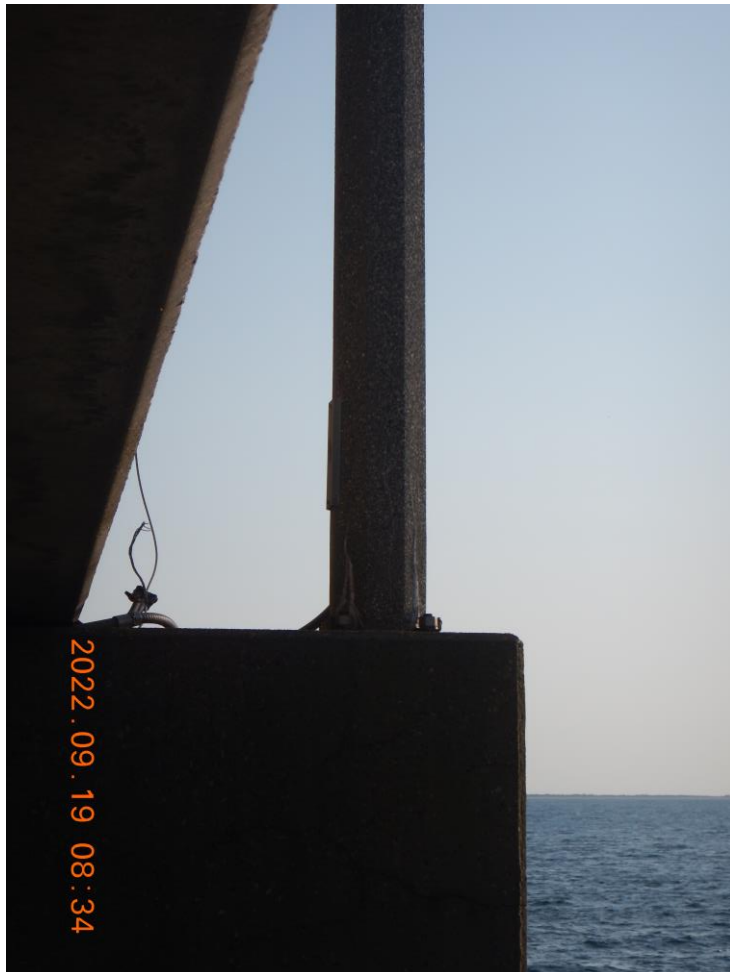
Photo 19: CNB74 Light Pole – Cracking with Efflorescence (Looking Northeast)

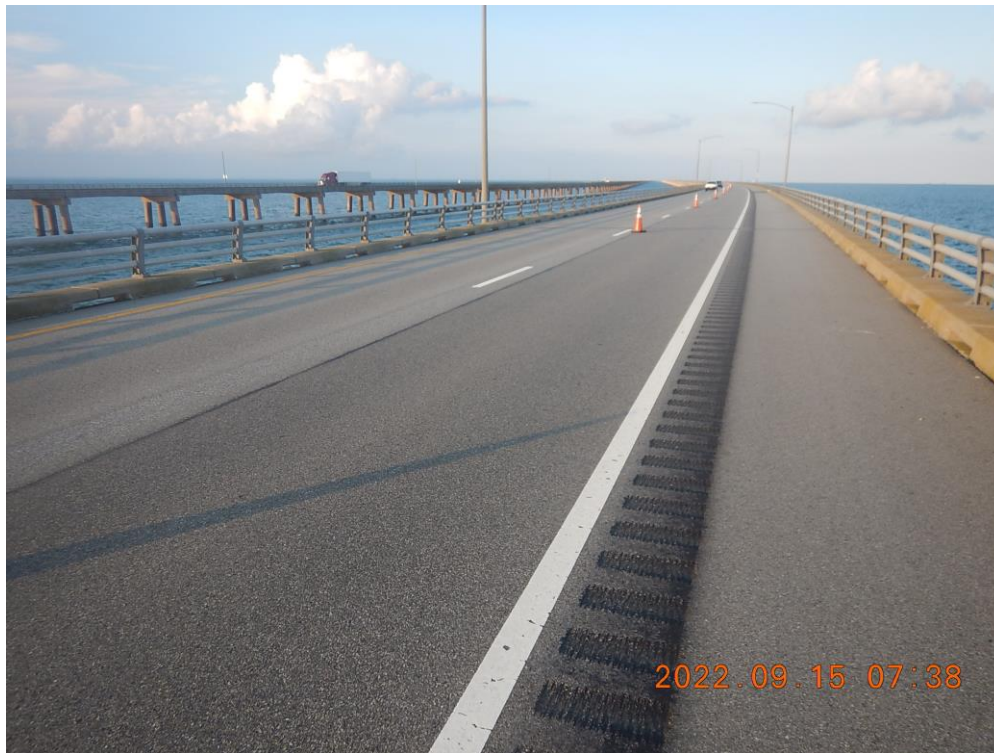
Photo 20: CSB200 Wearing Surface – Typical Good Condition of Deck and Bridge Railing (Looking South)

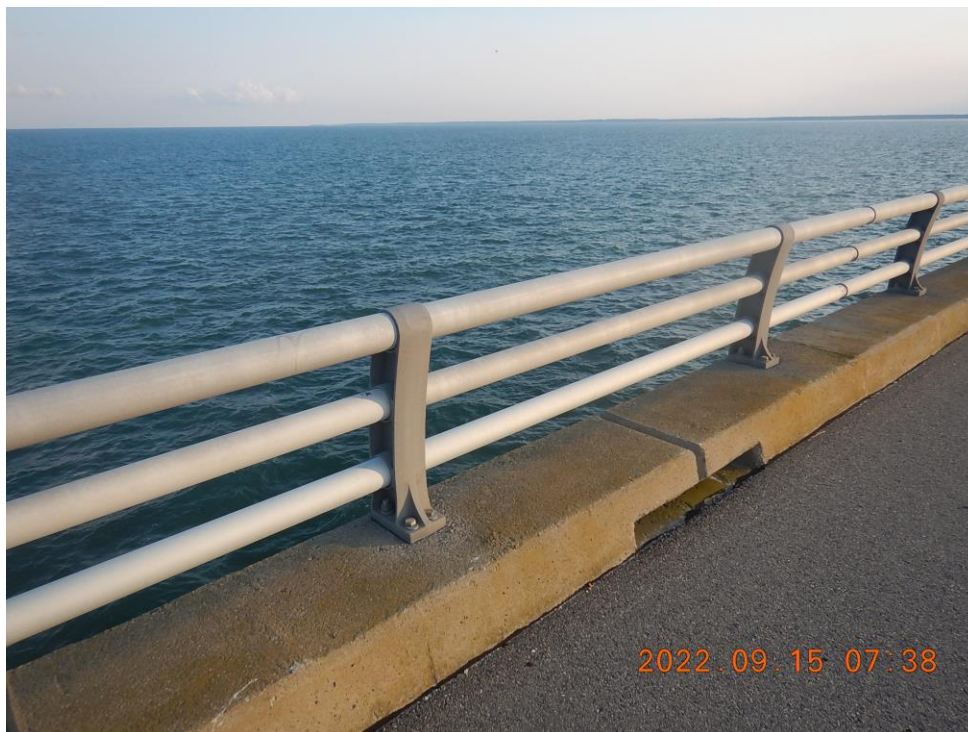
Photo 21: CSB199 Metal Bridge Railing– Typical Good Condition of Bridge Railing (Looking Northwest)

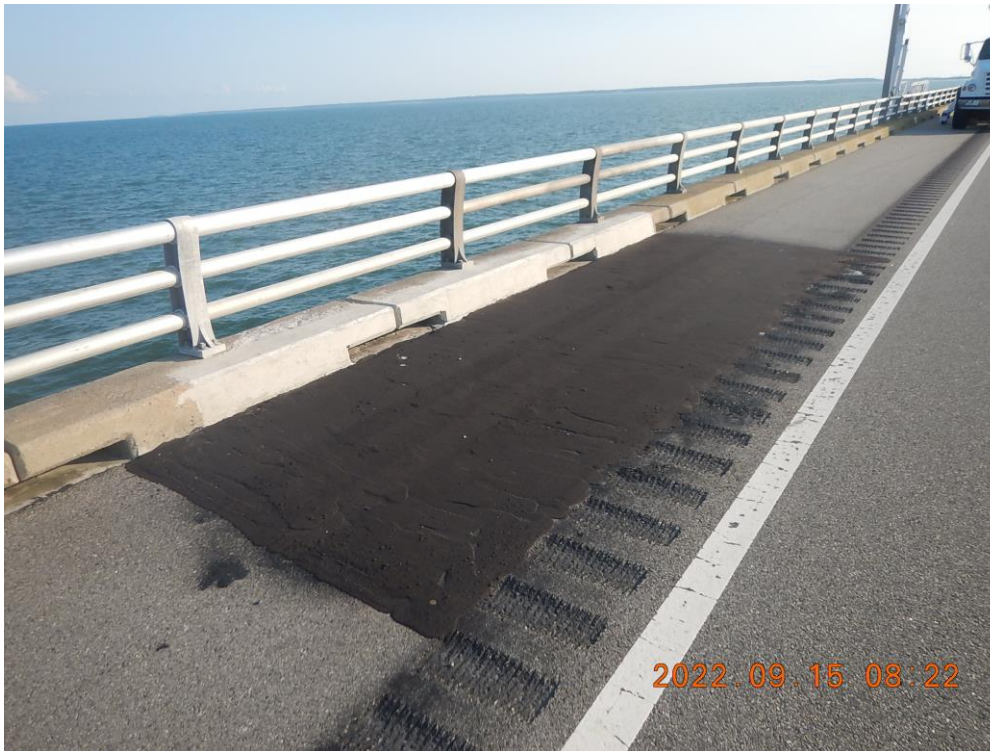
Photo 22: CSB190 Wearing Surface – Good Pavement Patch and Patch in West Shoulder (Looking Northwest)

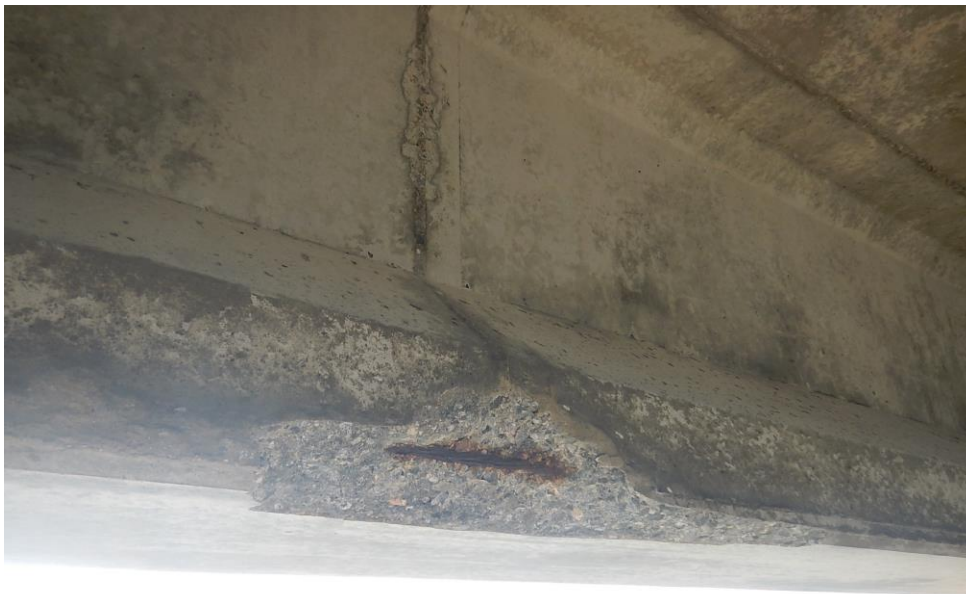
Photo 23: CSB 188 Prestressed Girder 1– Spall with Exposed Prestressing Strand (Looking Southwest)

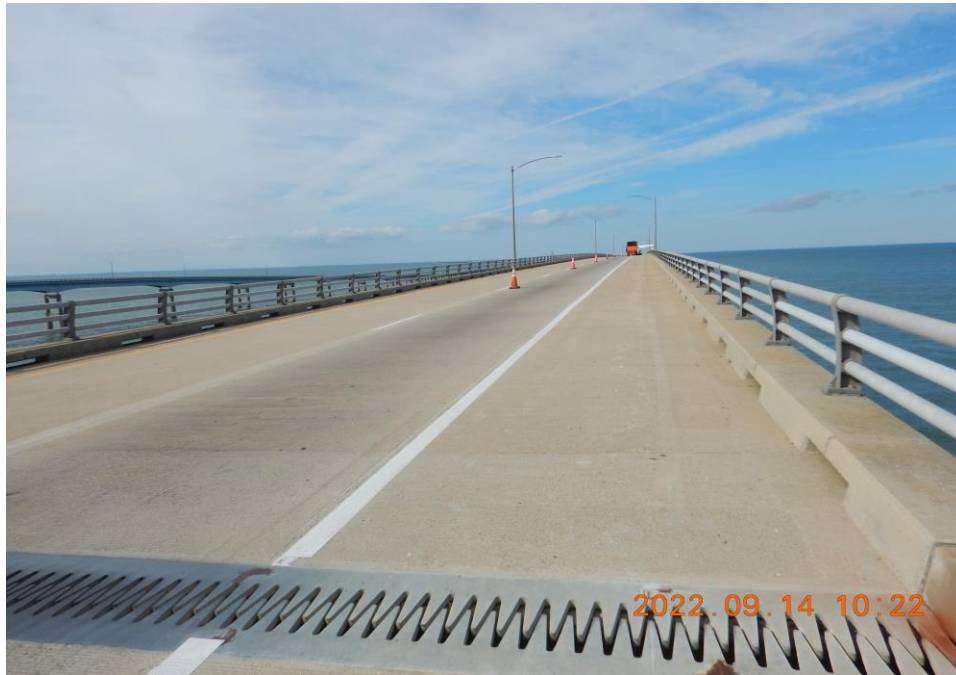
Photo 24: NCB-SB 18 Deck and Wearing Surface – General Good Condition (Looking South)

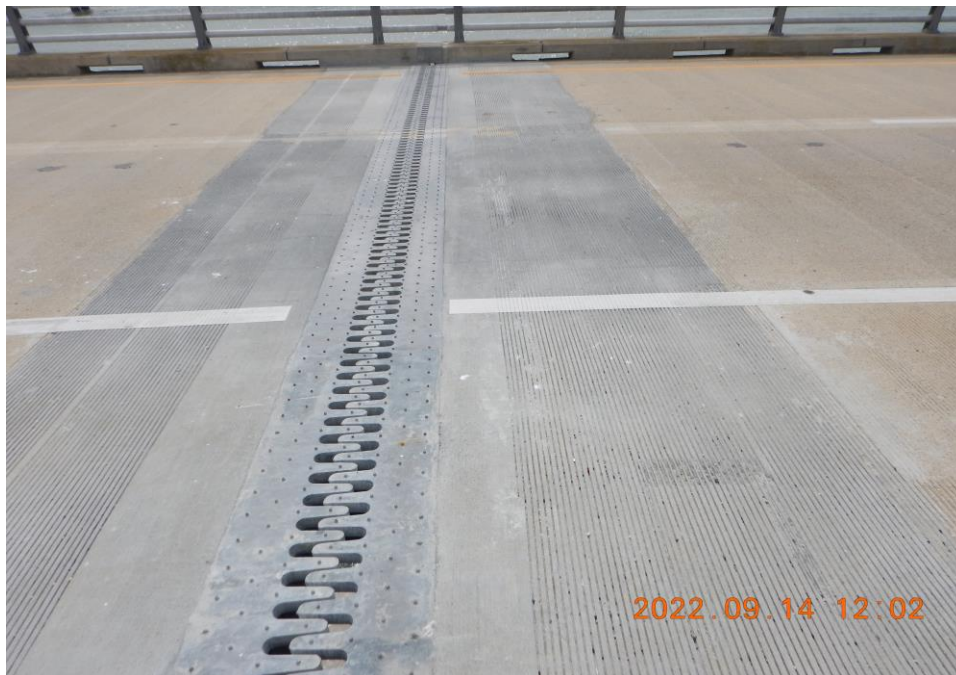
Photo 25: Modular Joint Seal – Typical Good Condition of Joint and Adjacent Deck Header, Pier 10 Shown (Looking East)

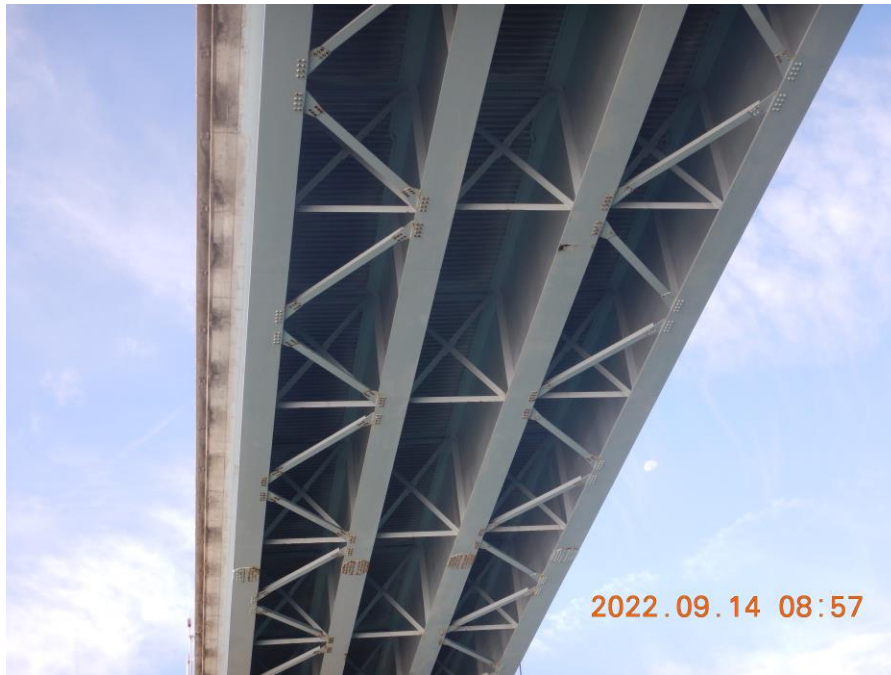
Photo 26: Superstructure – General Condition of Steel Superstructure, Span 9 (Looking South)

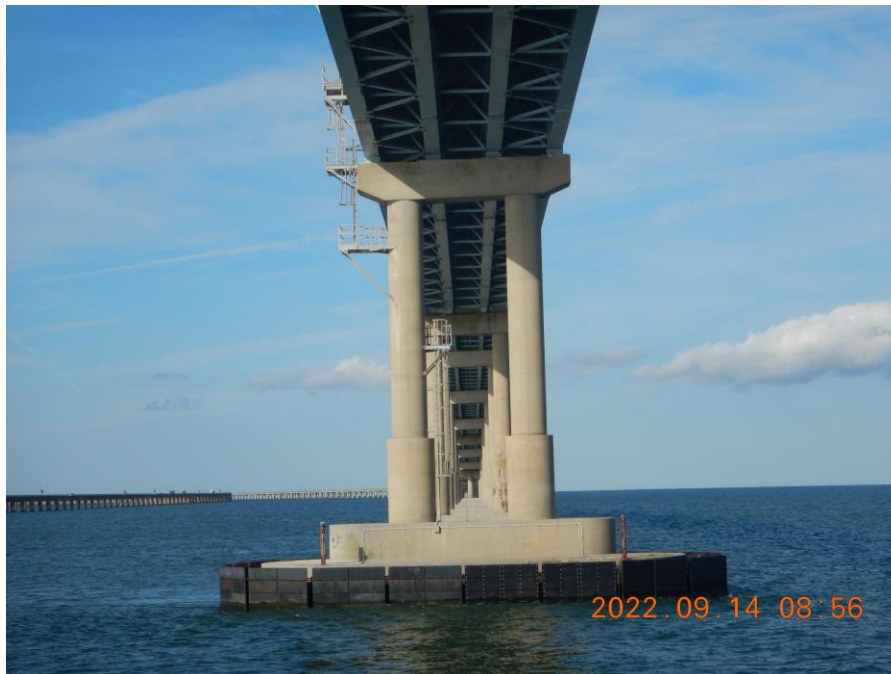
Photo 27: Substructure – General Condition of Pier Substructure, Pier 9 Shown (Looking Shown)

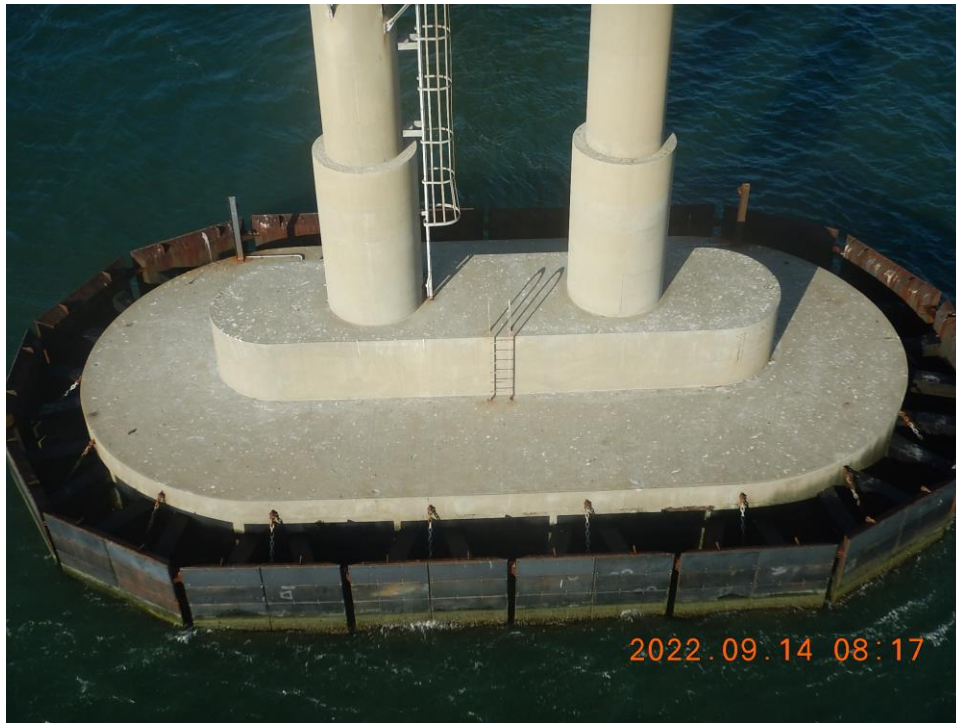
Photo 28: Fender System – Typical Condition of Pier 10 Footing and Fender System (Looking South)

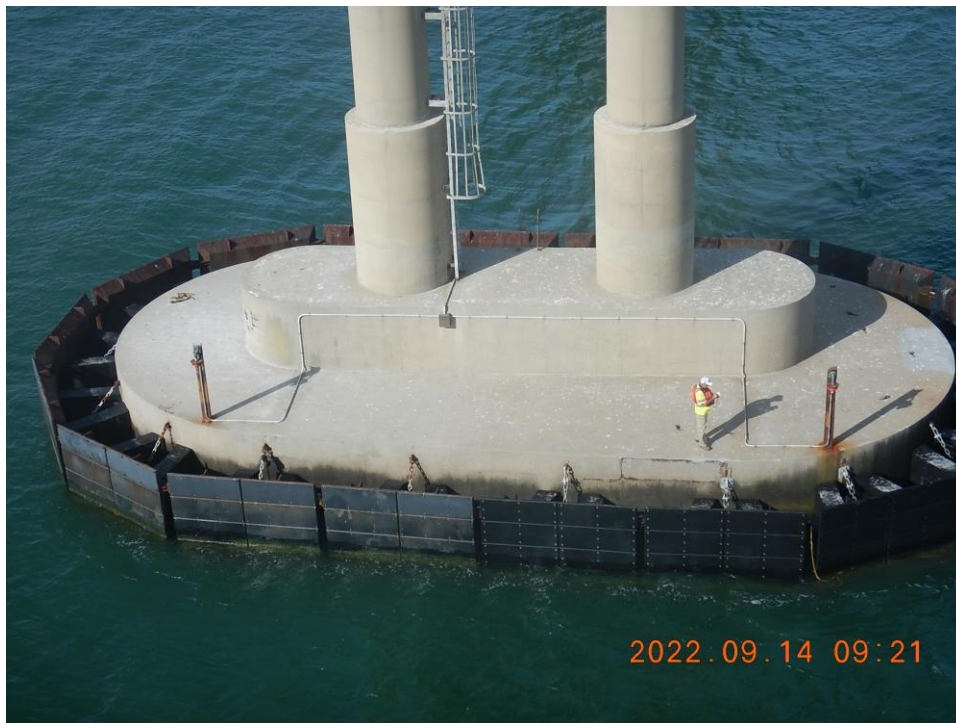
Photo 29: Fender System – Typical Condition of Pier 9 Footing and Fender System (Looking South)

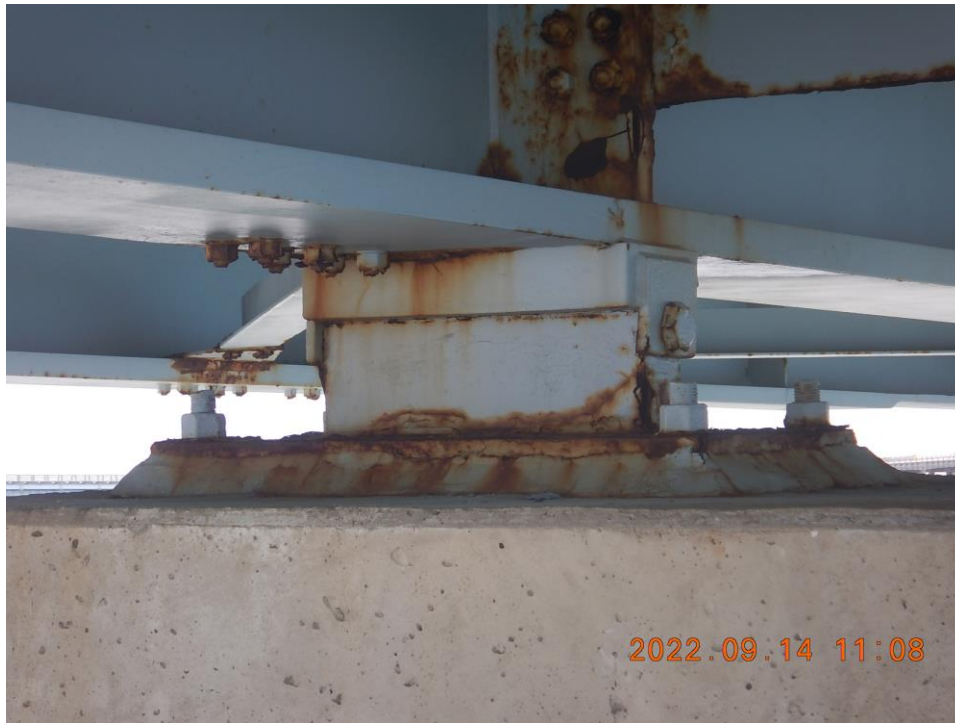
Photo 30: NCB-SB5 Bearings – Typical Peeling Paint with Surface Corrosion at Bearings (Looking Southeast)

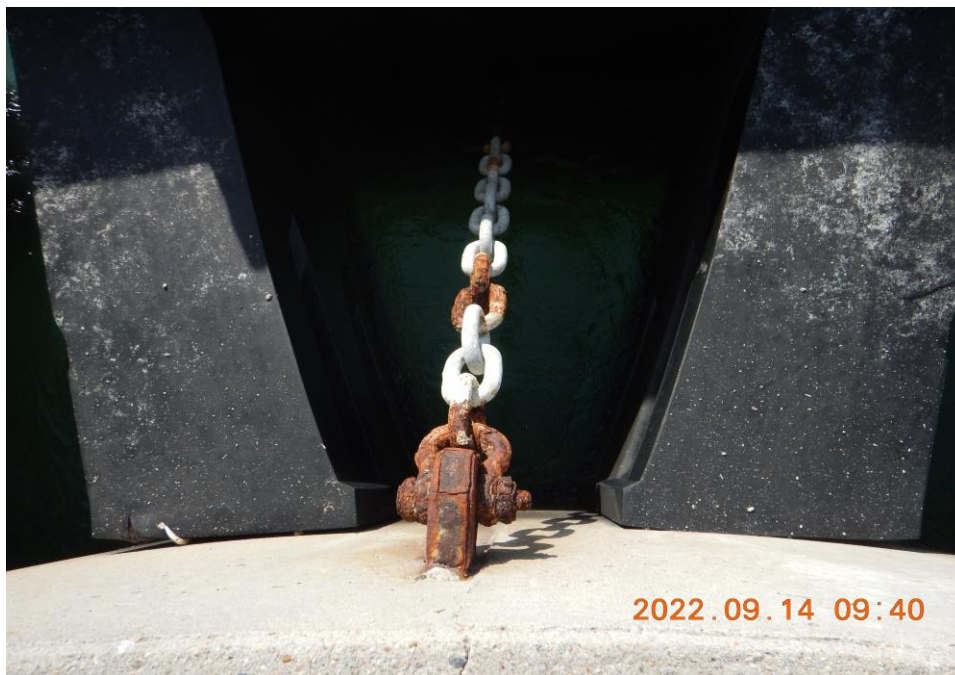
Photo 31: Fender System – Typical Minor Corrosion of Chain between Pier 9 Footing and Fender System (Looking South)

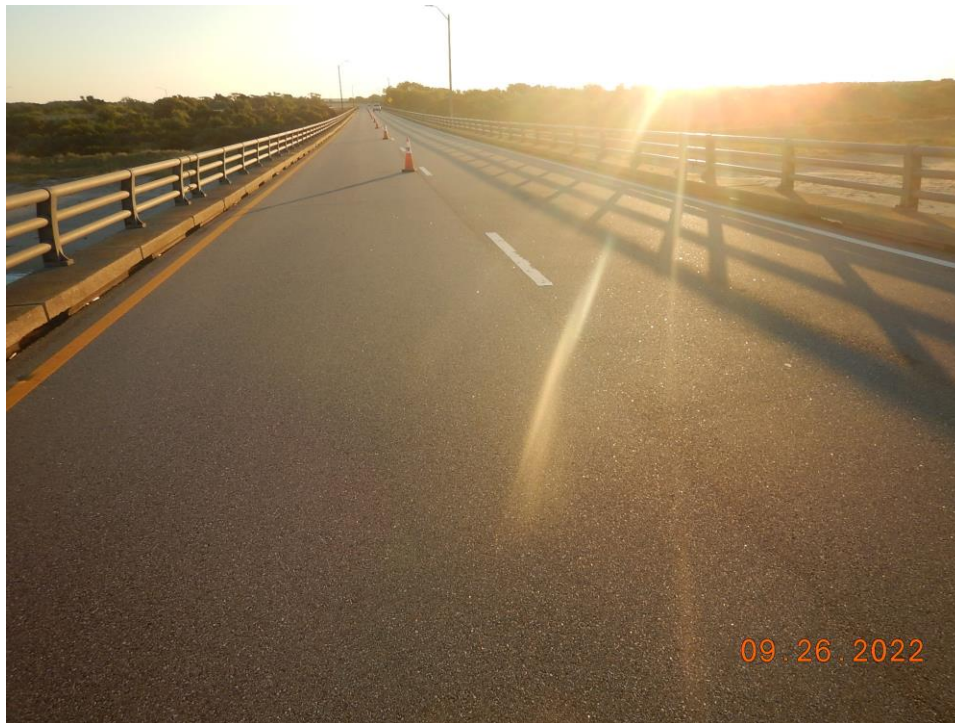
Photo 32: DNB1 Wearing Surface - General Good Condition of Deck and Wearing Surface (Looking North)
