## FY2023 Annual Inspection and Underwater Inspection, Trestle CSB

### FY2023 Facility Annual Inspection Report FINAL

December 30, 2022

Chesapeake Bay Bridge and Tunnel District

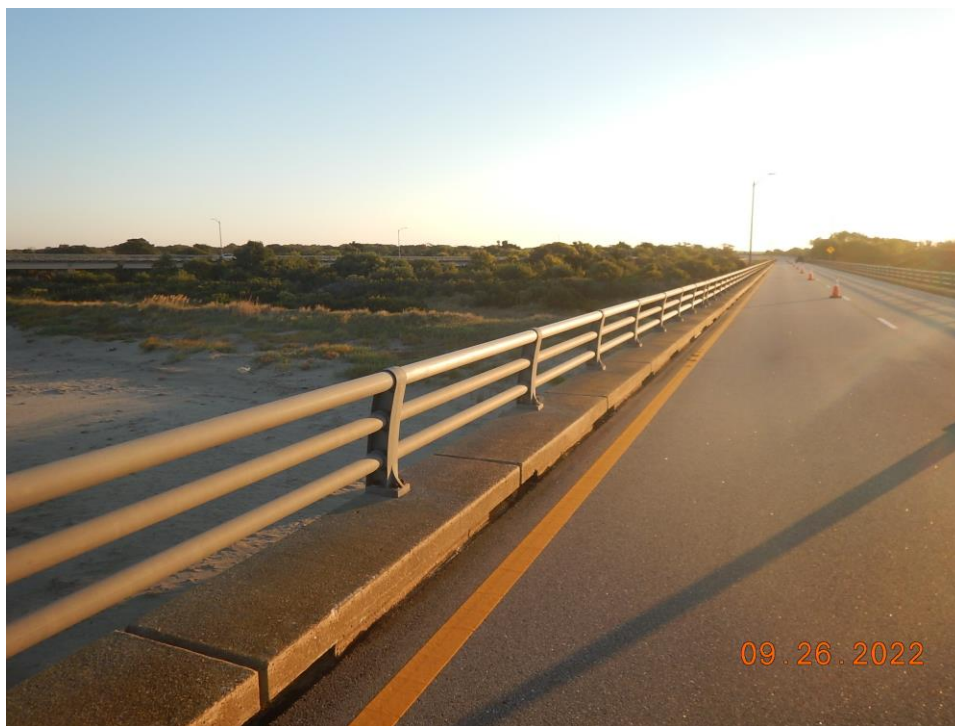
Photo 33: DNB2 Metal Bridge Railing - General Good Condition of Railing(Looking Northwest)

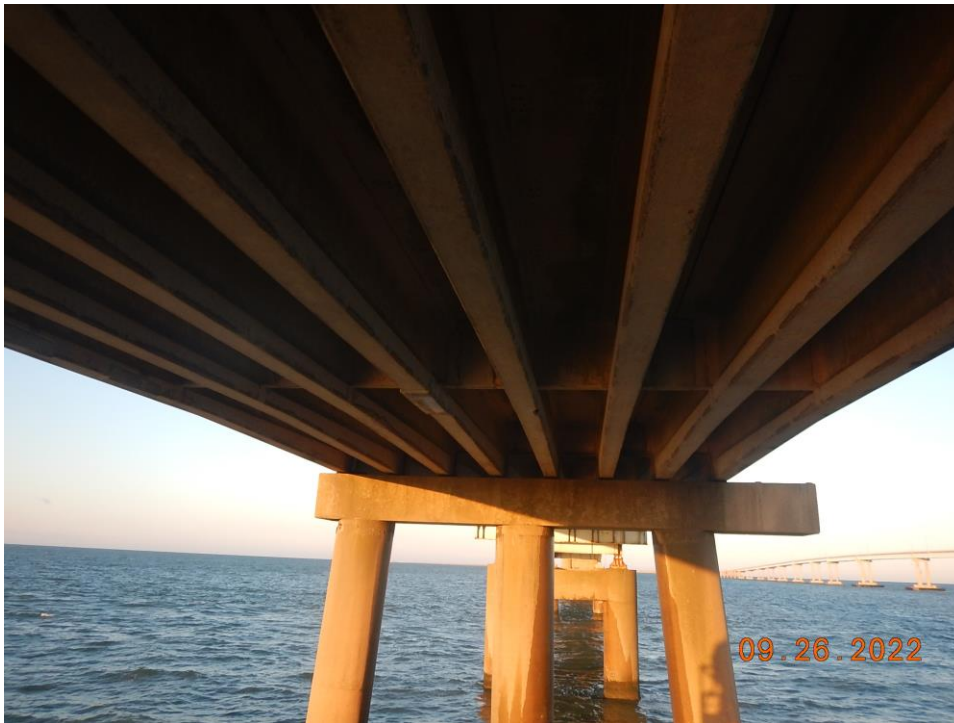
Photo 34: Superstructure – Typical Good Condition of Girder Superstructure (Span 2 Looking South)

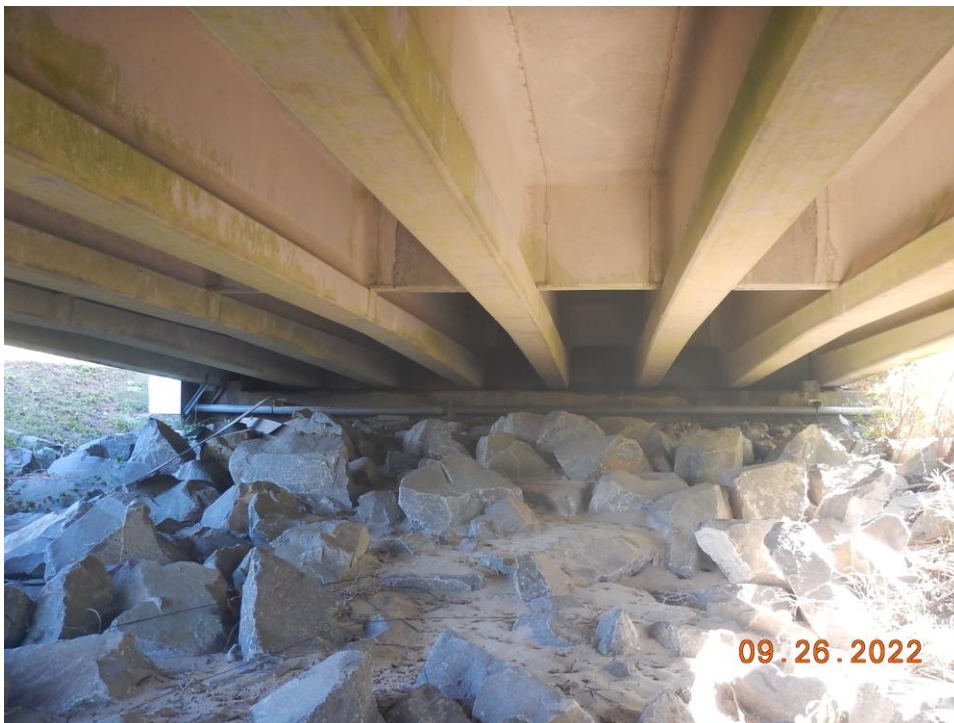
Photo 35: Abutment – Typical Good Condition of Abutment and Slope Protection (Looking North)

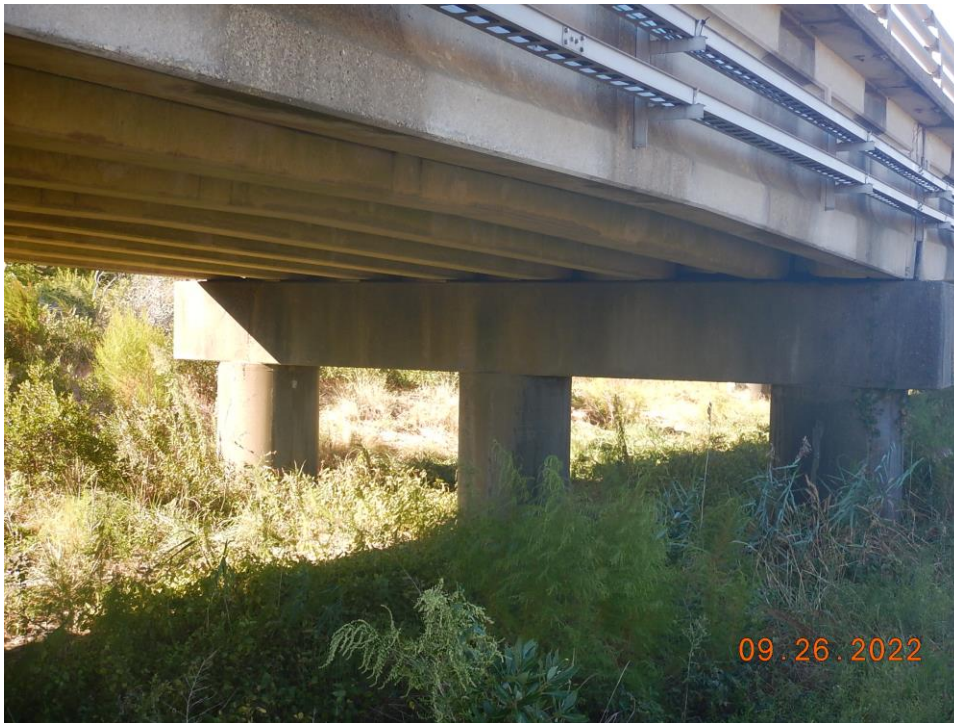
Photo 36: Substructure – Typical Good Condition of Piers (Pier 13 Shown, Looking Shown)

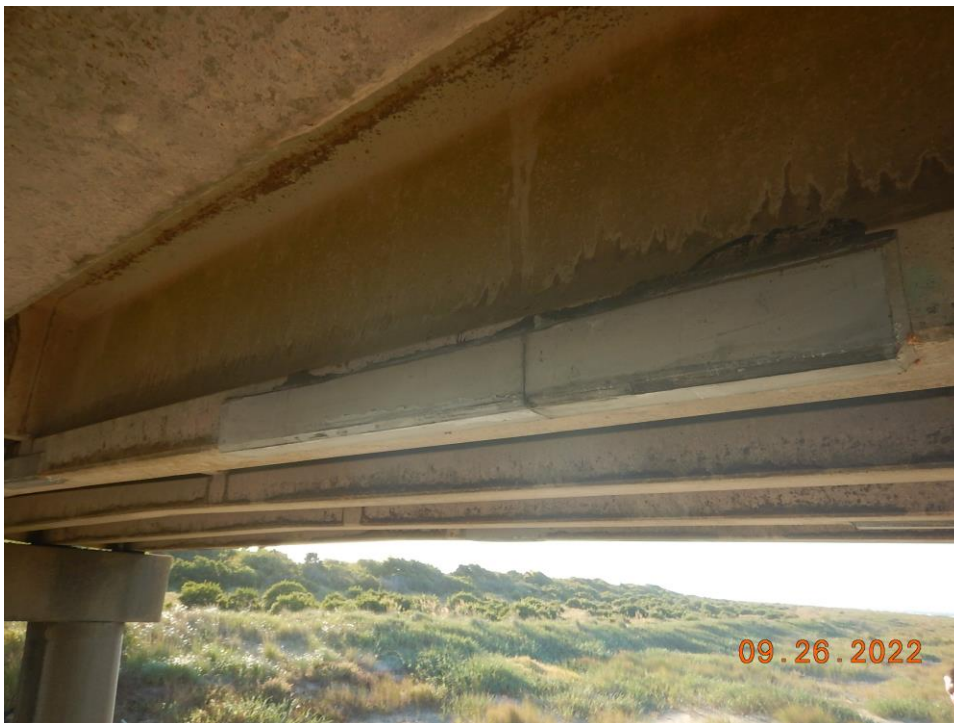
Photo 37 – Typical Good Repair Patch (Girder 4 in Span 7 at Midspan Shown, Looking East)

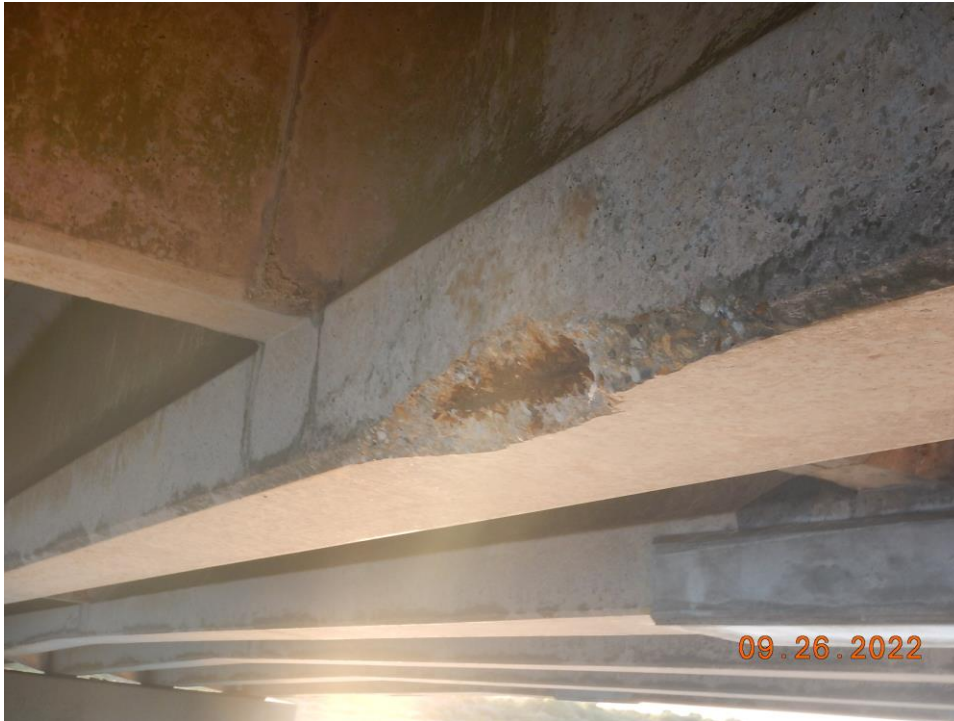
Photo 38: Prestressed Concrete Girders, Girder 5 – Spall with Exposed Strand at Pier 9 (Looking East)

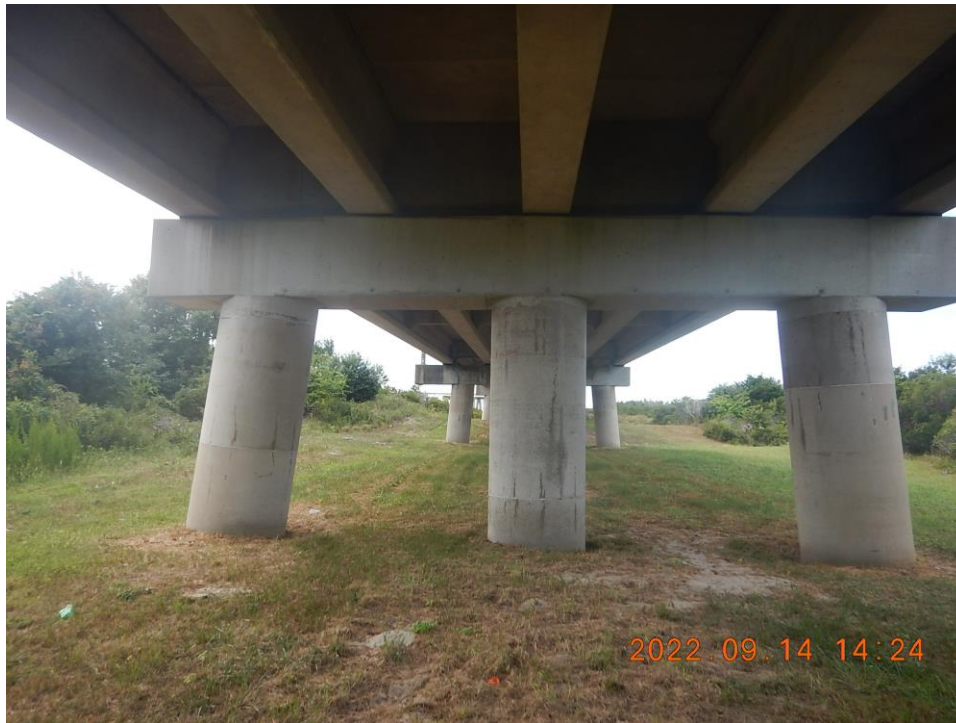
Photo 41 – Typical Condition of Bents (Bent 13 Shown Looking South)

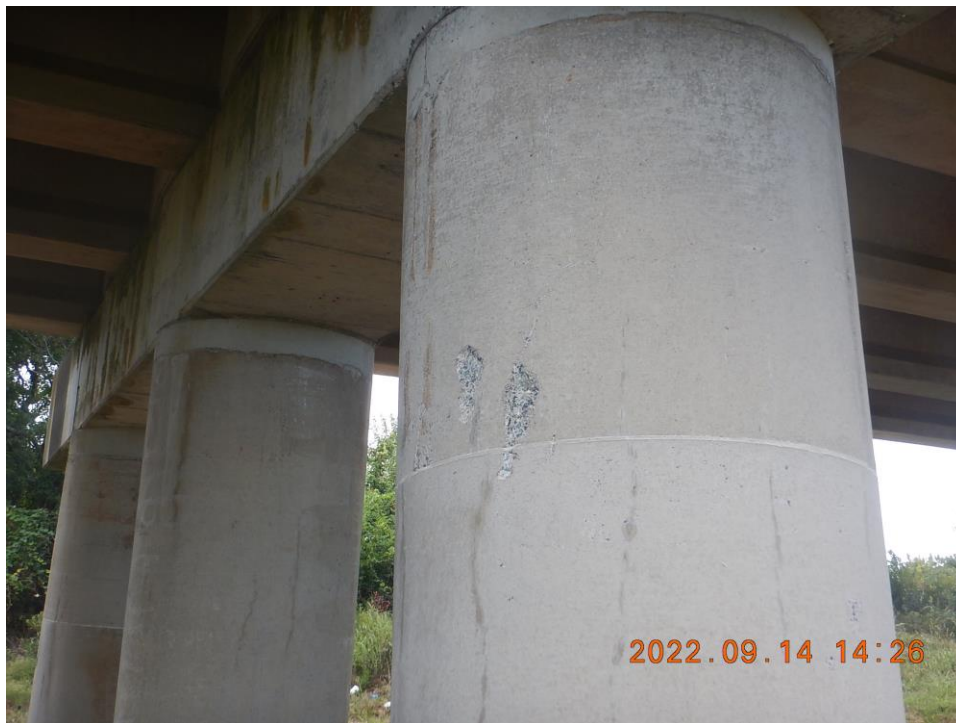
Photo 42: Substructure – Random Shallow Spalls in Pile A at Bent 12 (Looking Southeast)

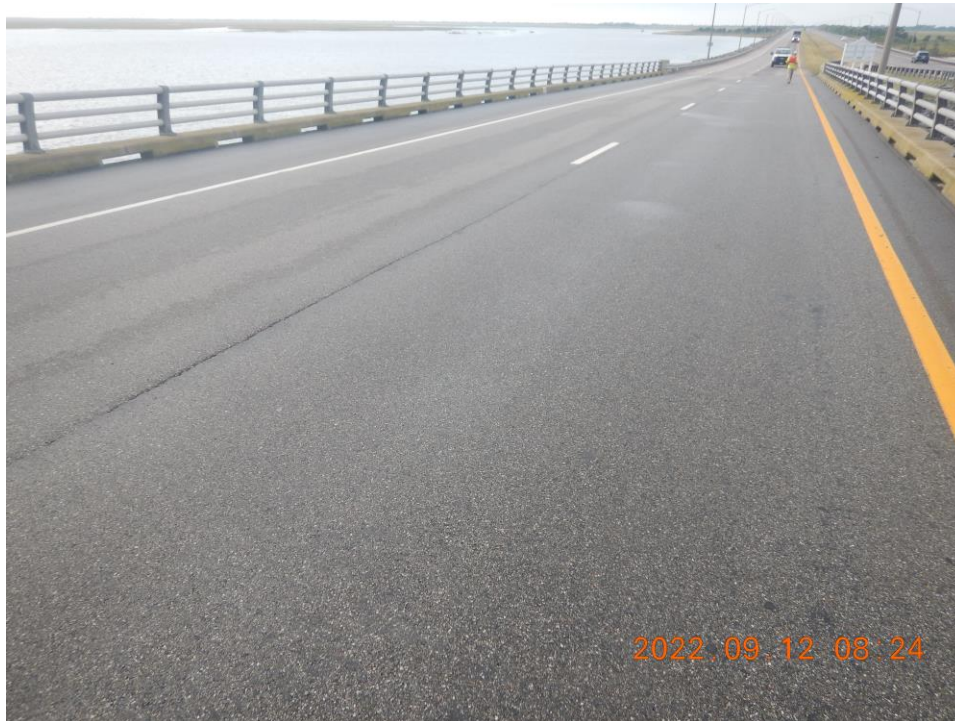
Photo 43: Wearing Surface - General Good Condition of Deck and Wearing Surface of Trestle ENB (Looking South)

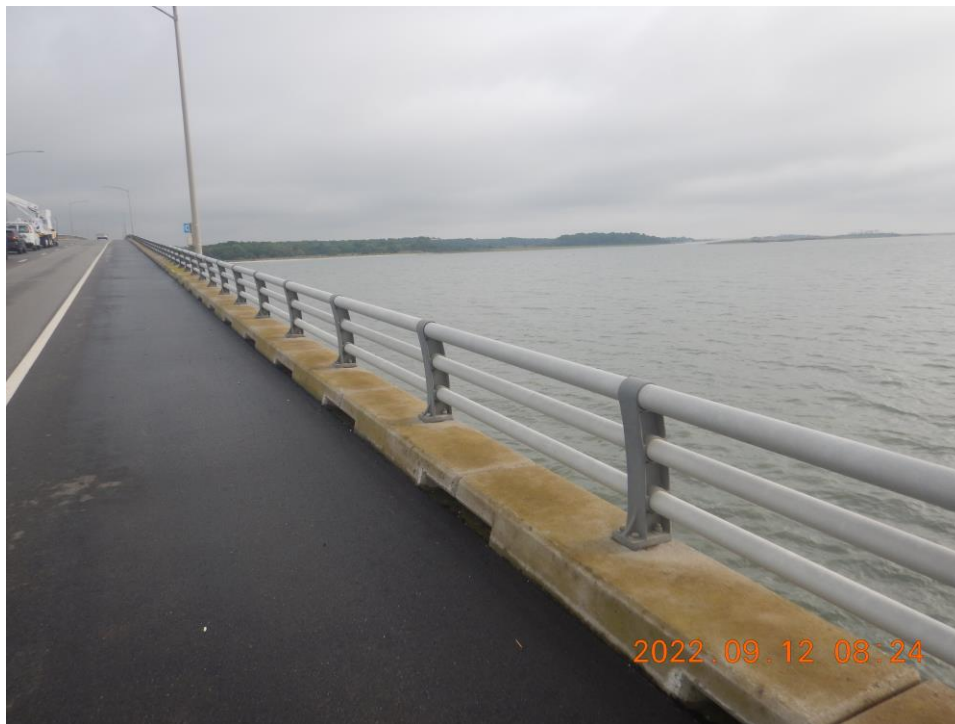
Photo 44: Metal Bridge Railing -Typical Good Condition of Railing in Trestle ENB (Looking Northeast)

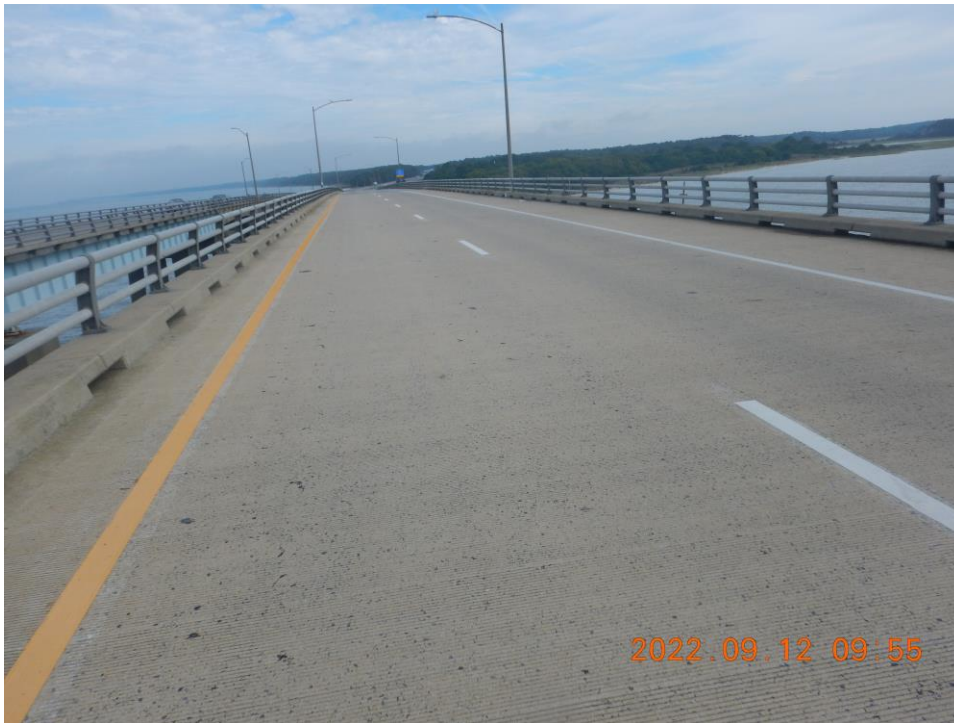
Photo 45: Deck and Wearing Surface – Typical Good Condition at FIB-NB (Looking North)

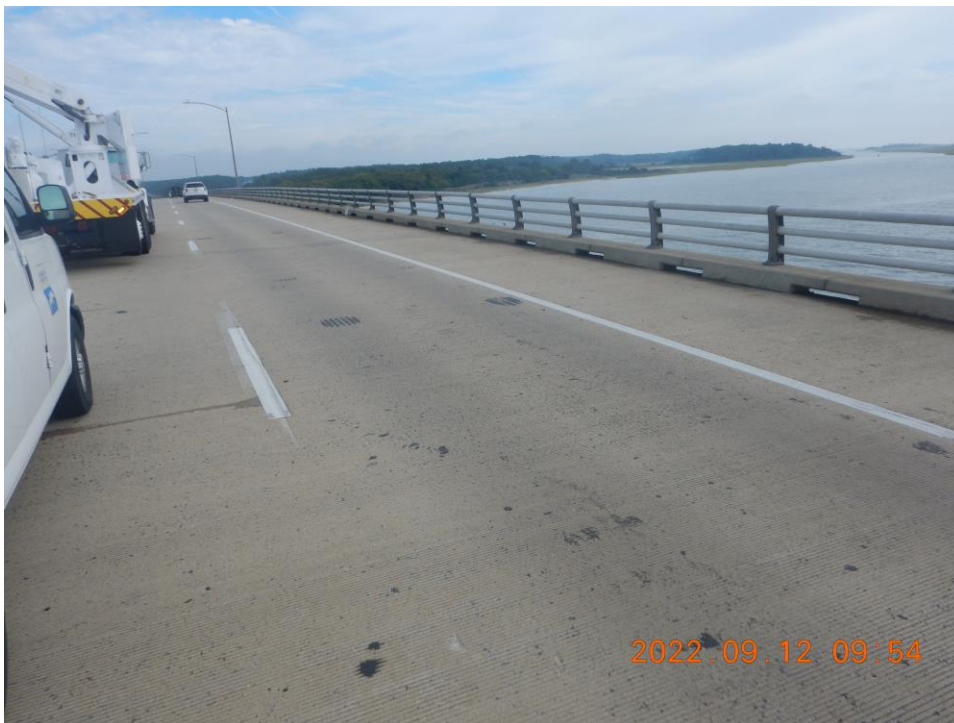
Photo 46: Metal Bridge Railings – Typical Good Condition of Railings at FIB-NB (Looking Northeast)

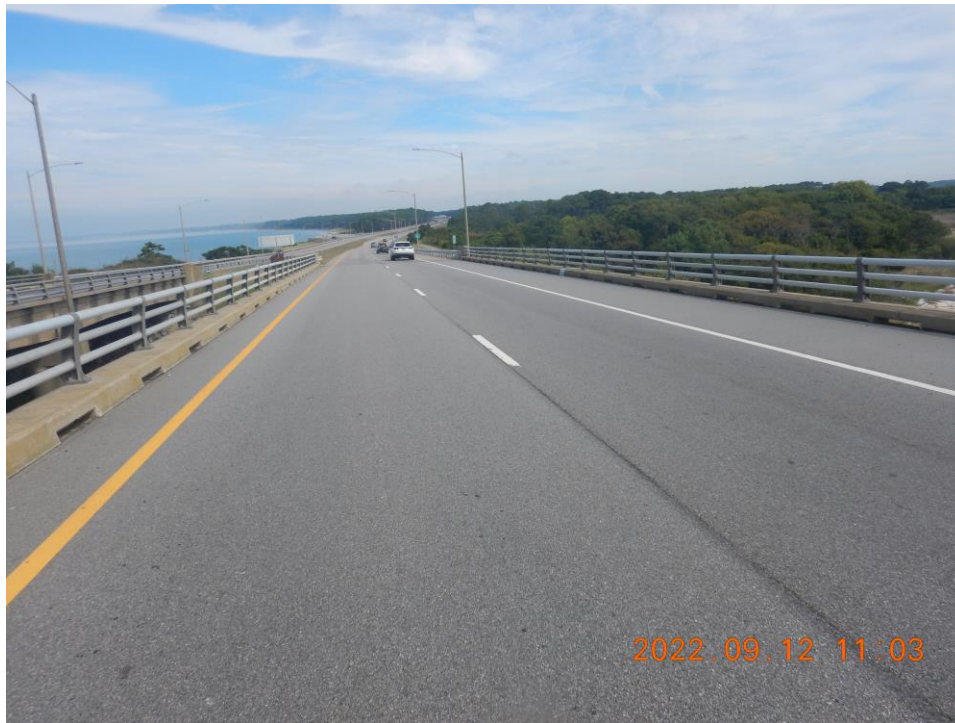
Photo 47: Deck and Wearing Surface – Typical Good Condition of the Deck and Wearing Surface at Trestle FNB

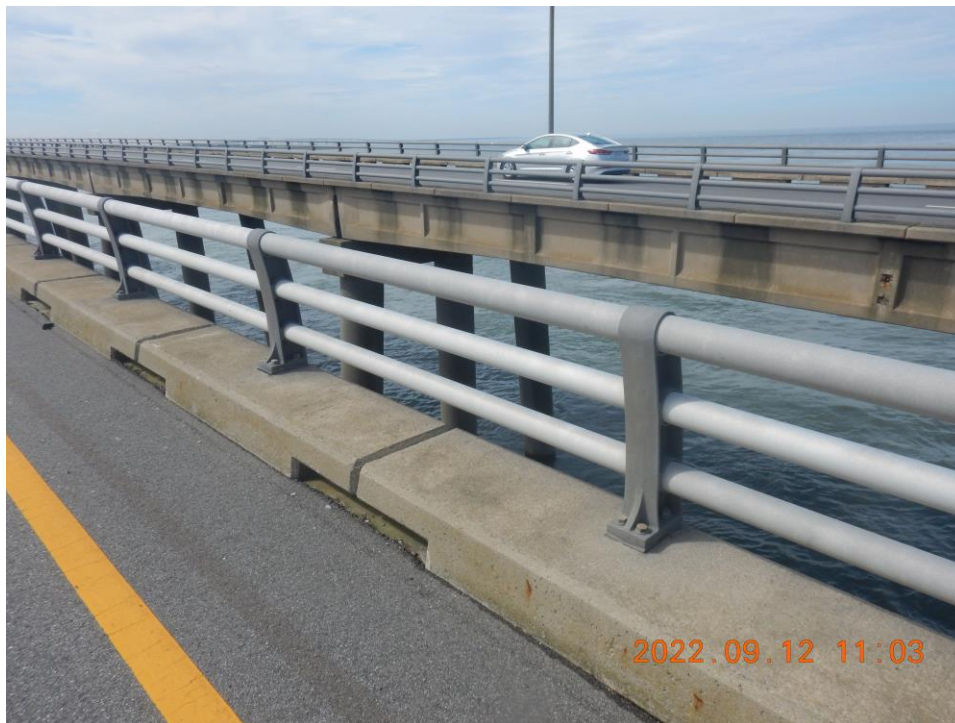
Photo 48: Metal Bridge Railing – Typical Good Condition of Railing at Trestle FNB

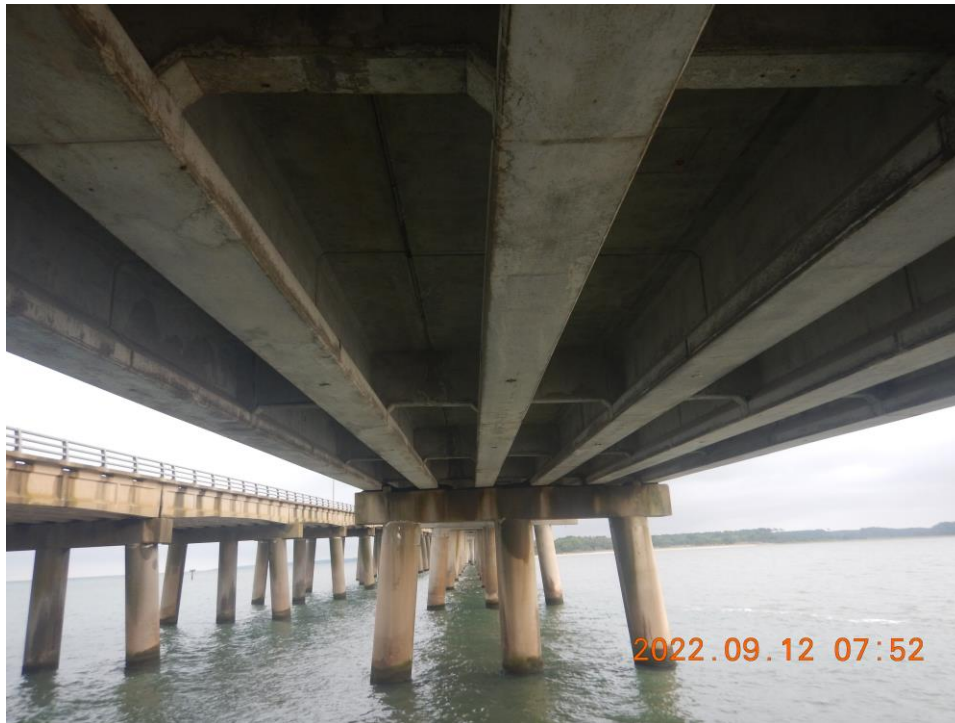
Photo 49: Superstructure – Typical Good Condition of Superstructure of Trestle ENB

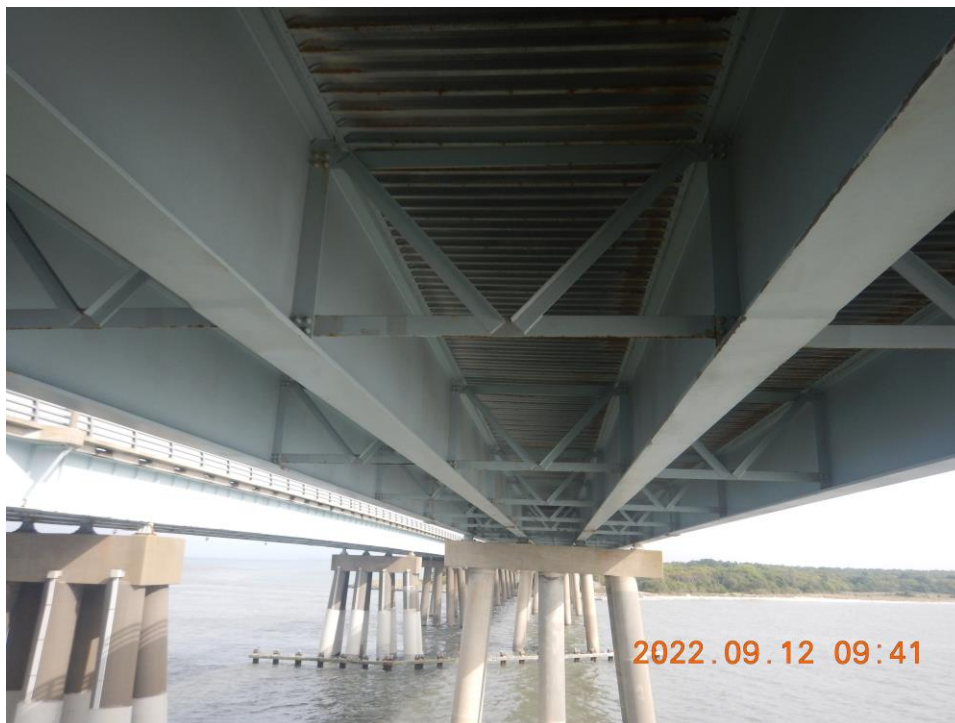
Photo 50: Steel Superstructure: Typical Good Condition of Steel Superstructure at FIB-NB (Span 1 Shown Looking North)

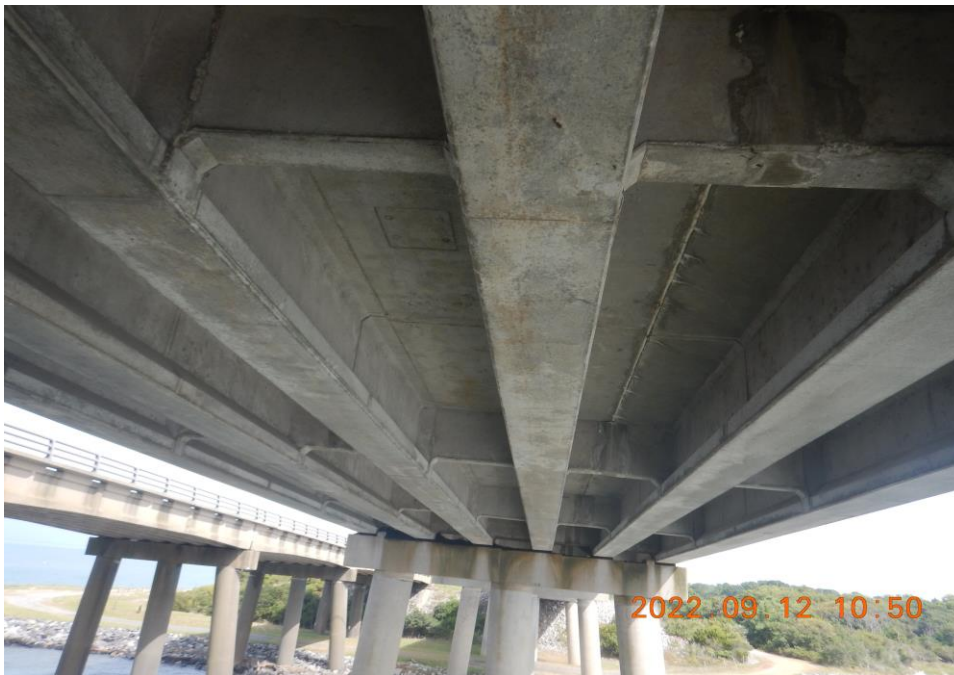
Photo 51: Superstructure – General Good Condition of Prestressed Concrete Girders in Trestle FNB (Looking North)

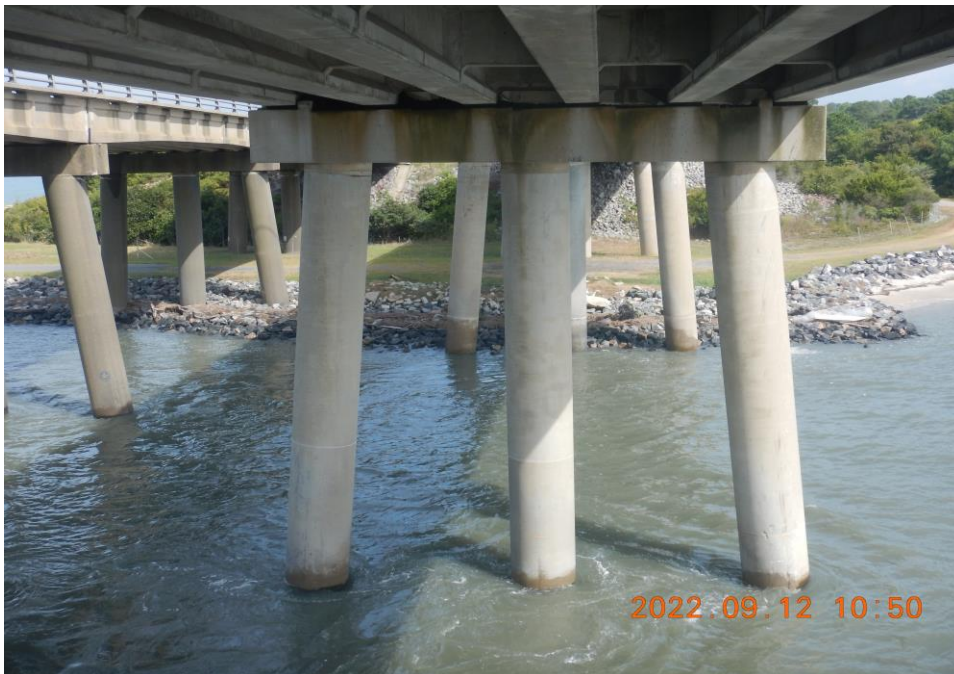
Photo 52: Substructure – Typical Good Condition of Bents in Trestle FNB (Looking North)

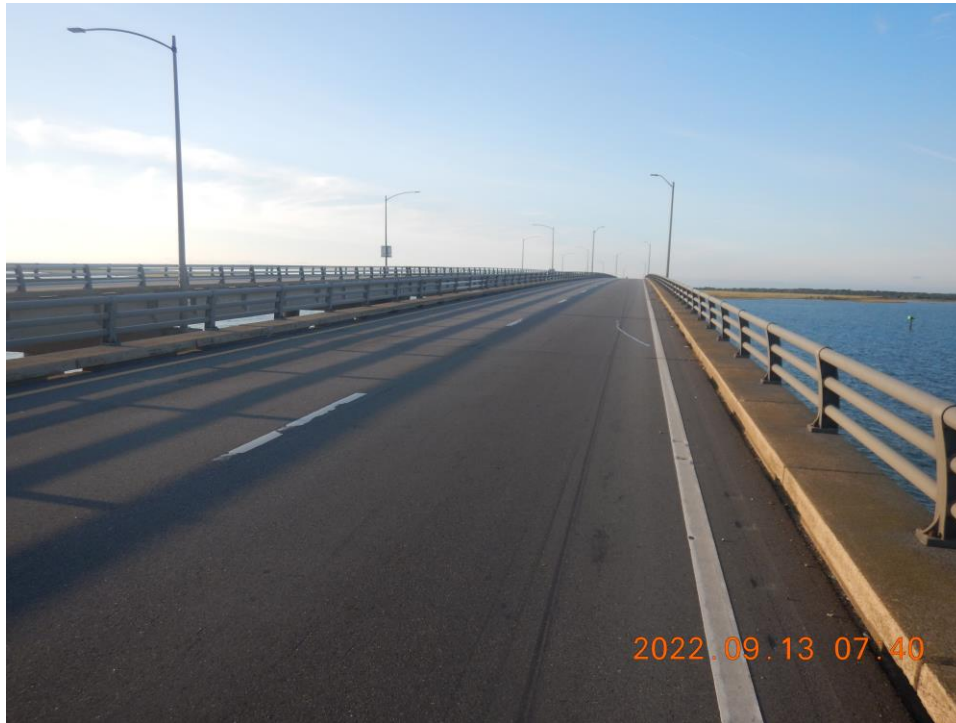
Photo 53: General Good Condition of Deck and Wearing Surface at Trestle FSB

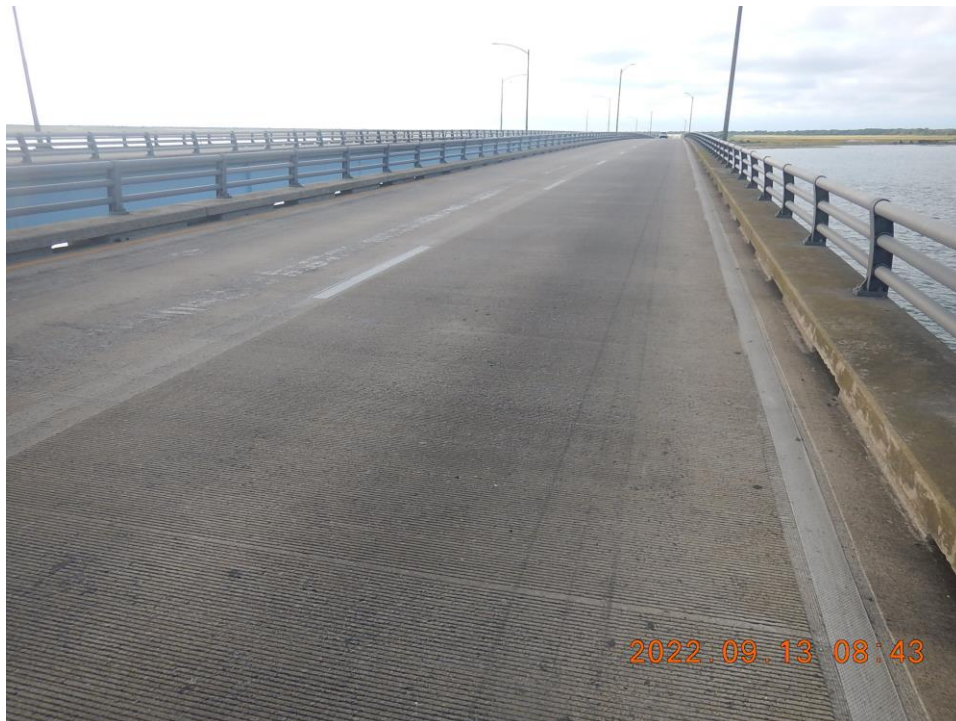
Photo 54: General Good Condition of Deck and Wearing Surface at Trestle FIB-SB

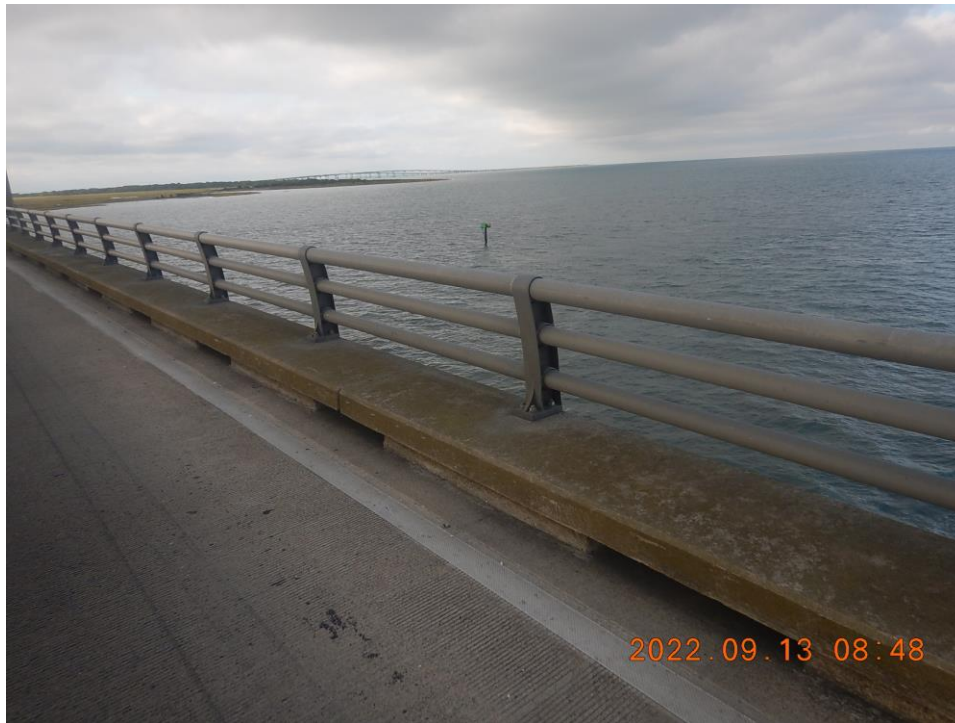
Photo 55 – Typical Good Condition of Railing at FIB-SB

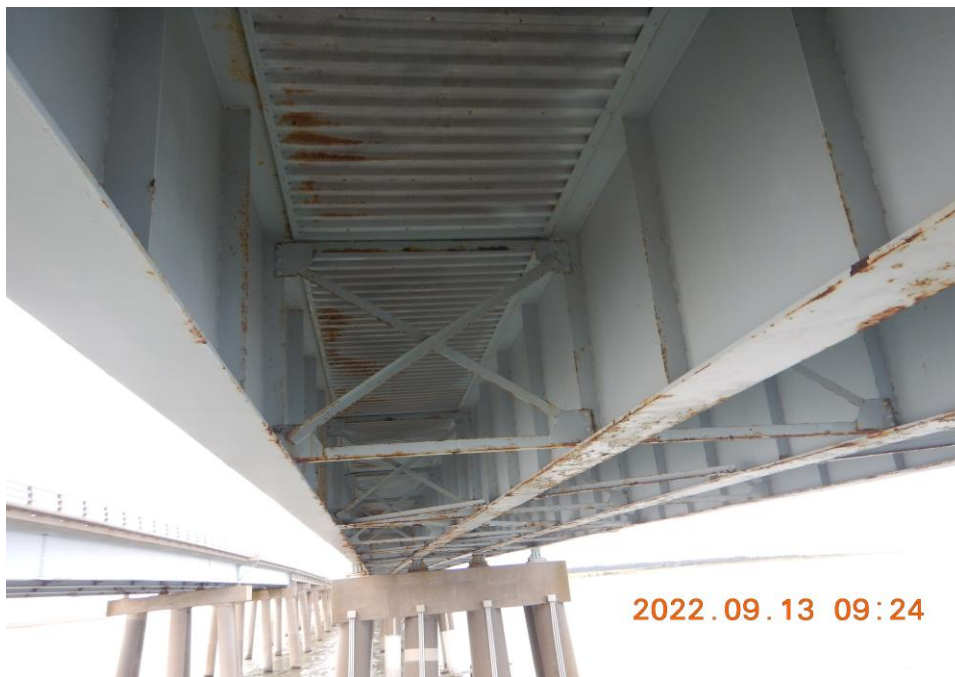
Photo 56: Superstructure – Typical Condition of Steel Superstructure in FIB-SB (Looking South)

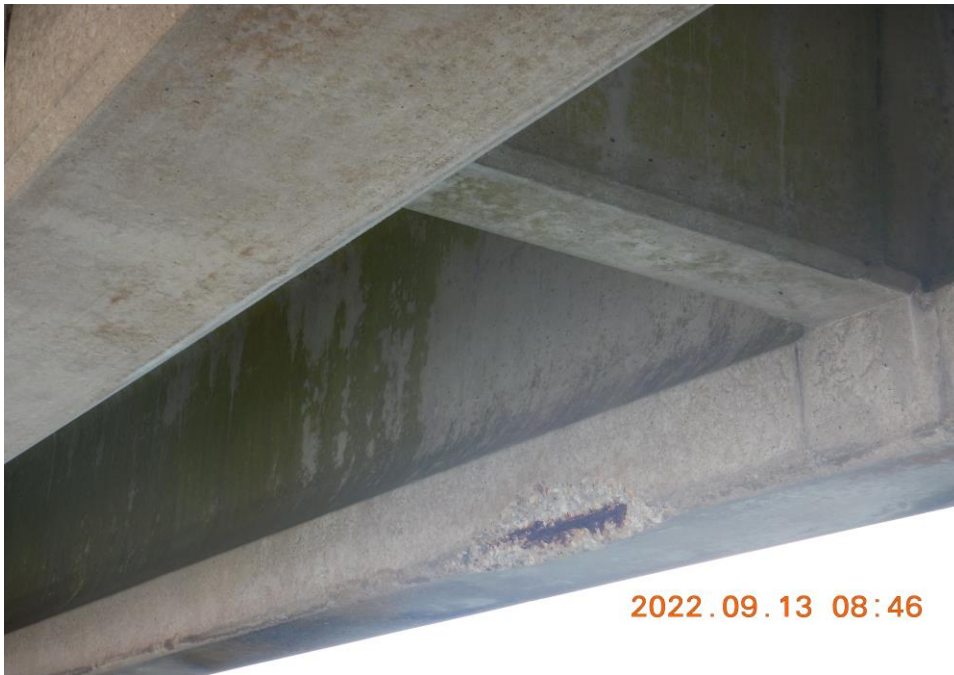
Photo 57: Prestressed Concrete Girders, FSB3 – Spall with Exposed Strand in Girder 1 (Looking North)

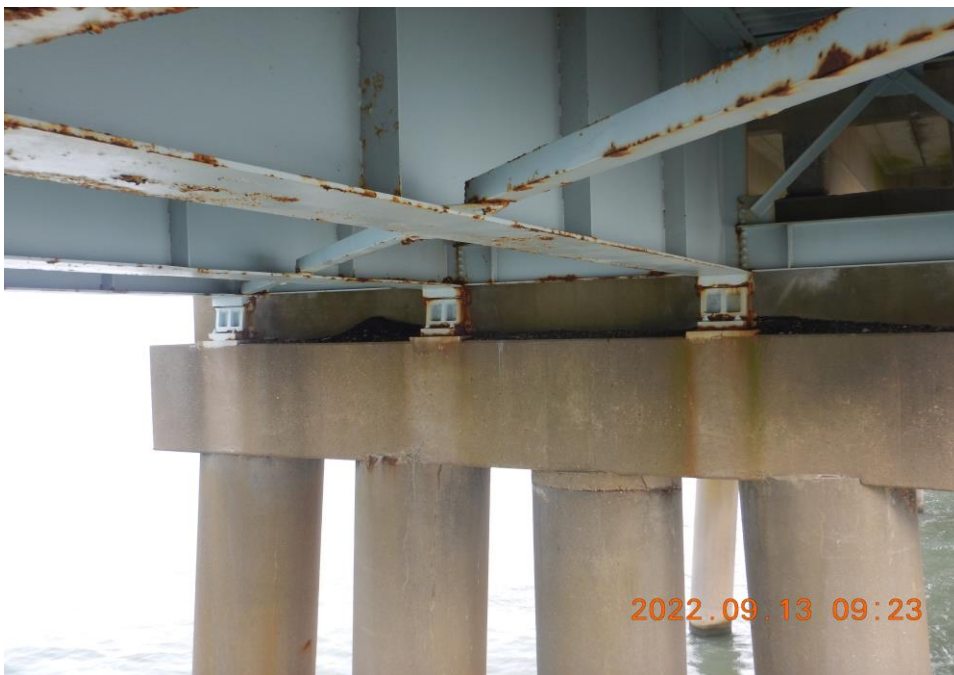
Photo 58: Bearings, FIB-SB – Minor Surface Corrosion of Bearings in Span 3 (Looking North)

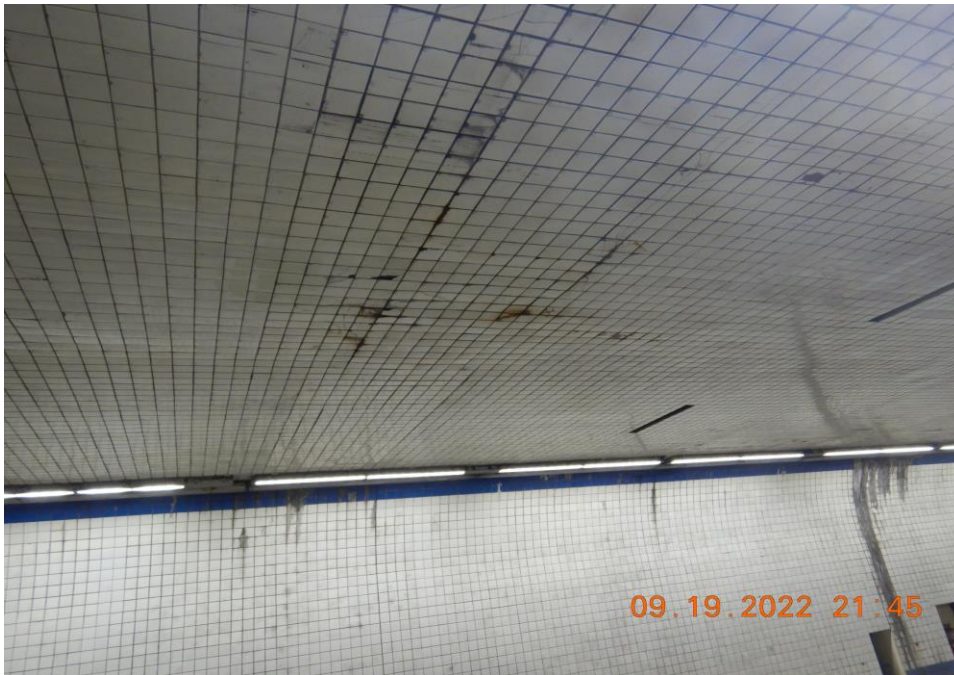
Photo 63: Tunnel Liner – Random Cracked Tiles in Tunnel Roadway Ceiling (Looking East)

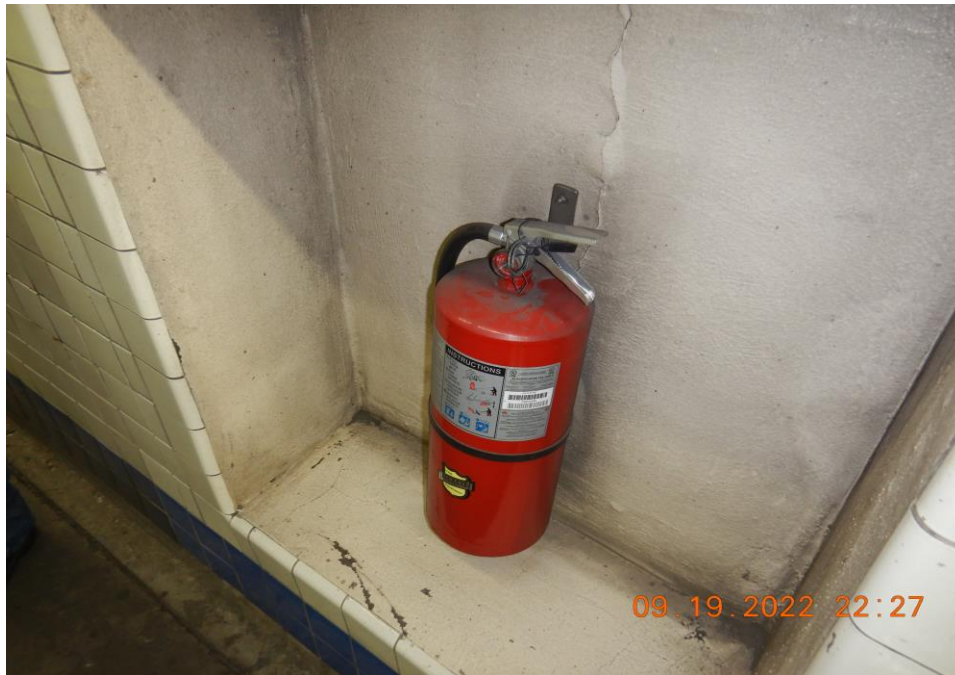
Photo 65: Fire Protection System – Typical Replaced Fire Extinguisher in Tunnel Roadway (Looking West)

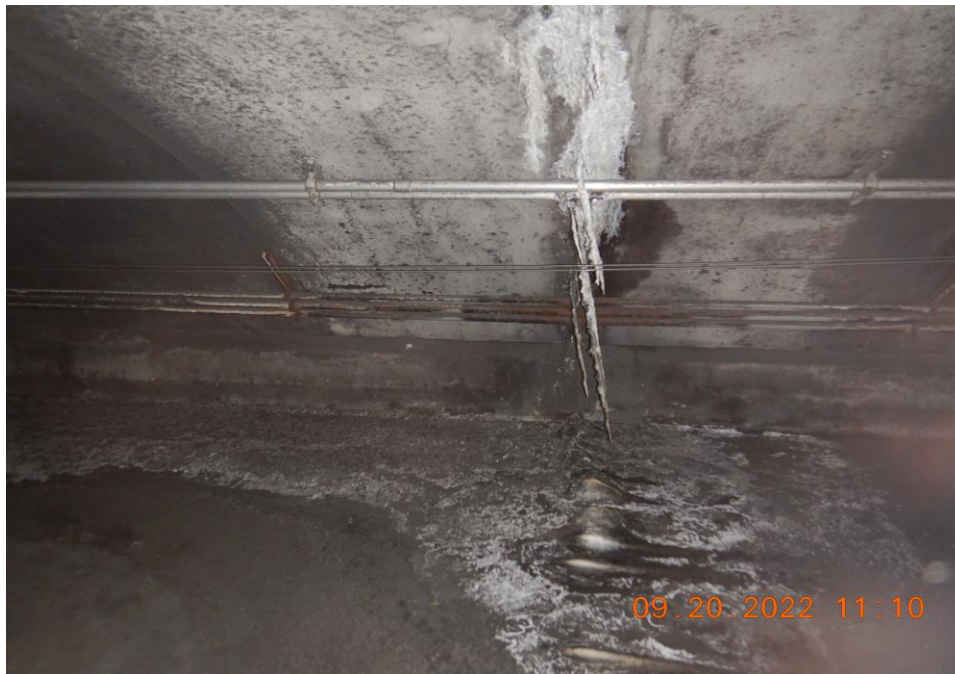
Photo 66: Exhaust Air Duct – Random Heavy Efflorescence in Tunnel Liner (Looking East)

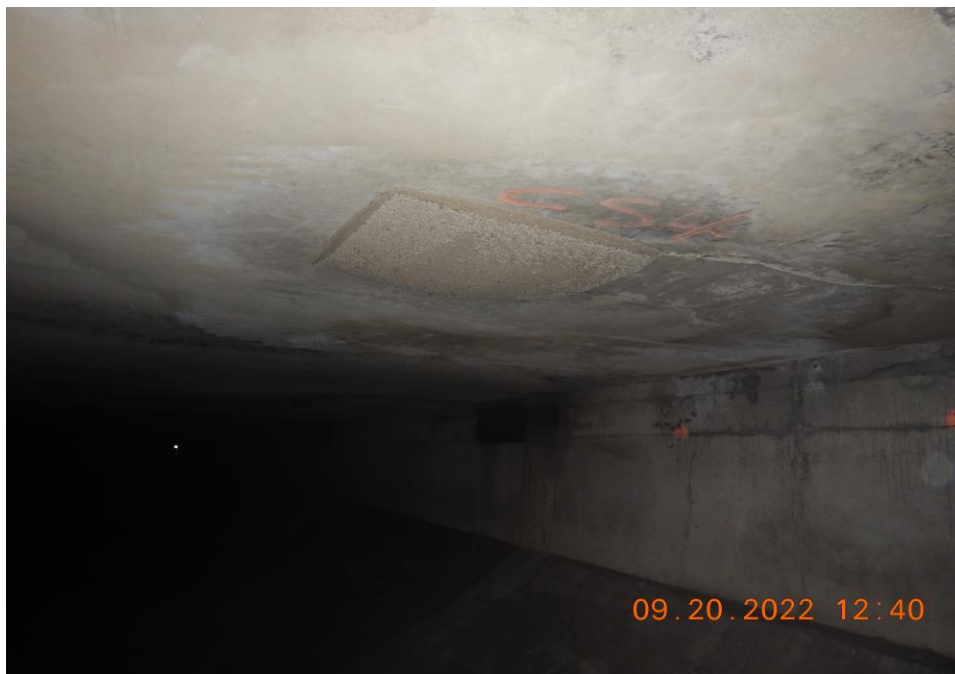
Photo 68: Fresh Air Duct – Typical Good Repair Patch in Roadway Slab Underside (Looking Northeast)

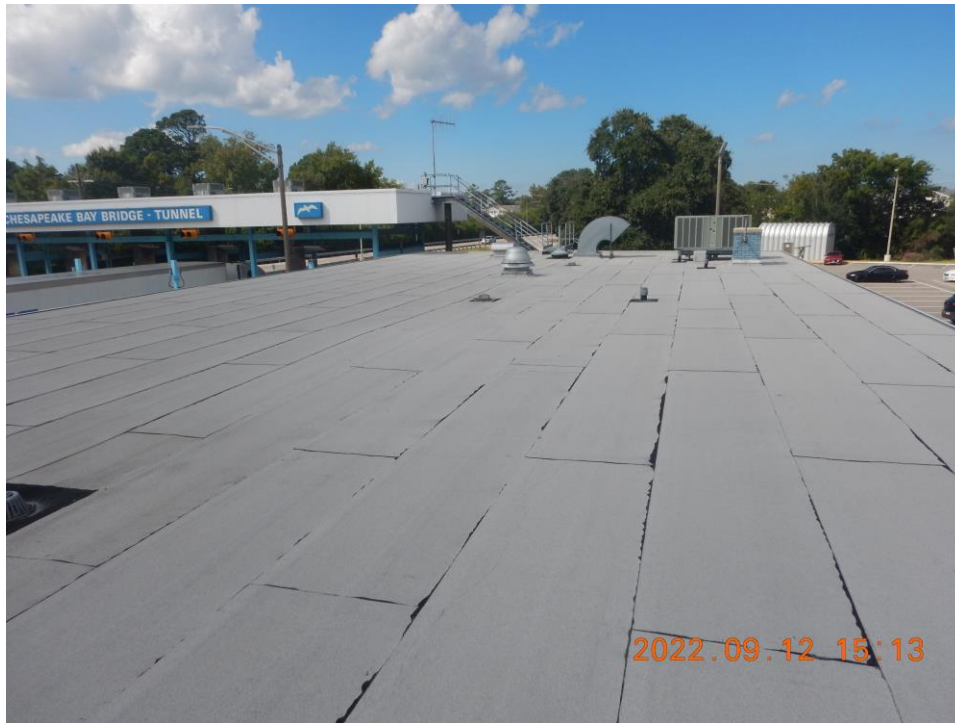
Photo 73: General Condition of South Toll Plaza Building Roof (Looking North)

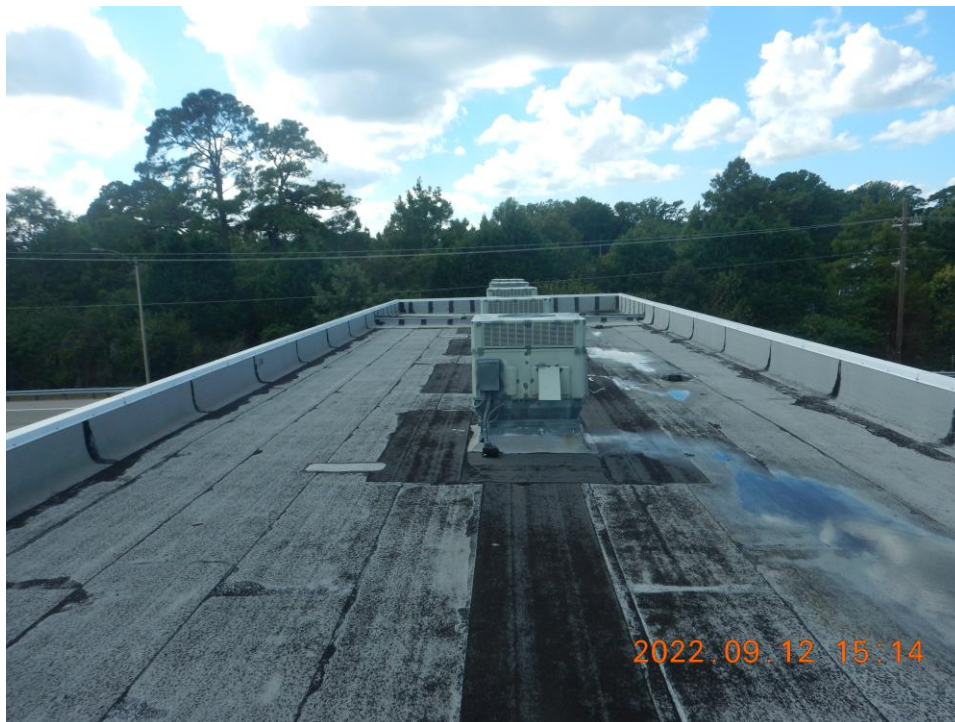
Photo 74: General Condition of South Toll Plaza Roof (Looking West)

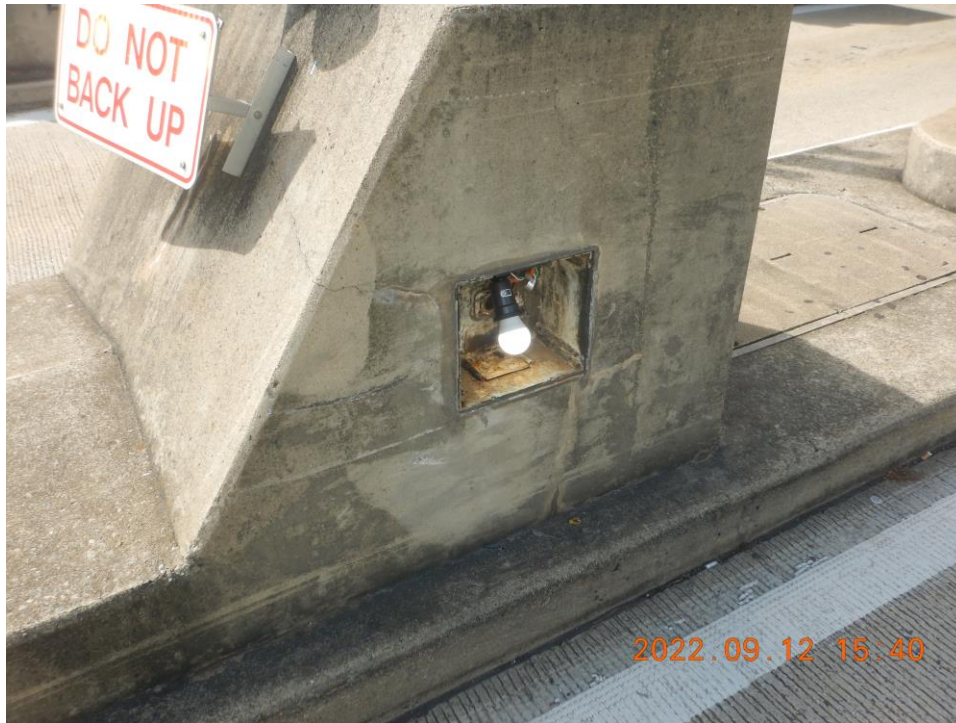
Photo 75: Missing Light Cover at South Toll Plaza, Lane 2 (Looking West)

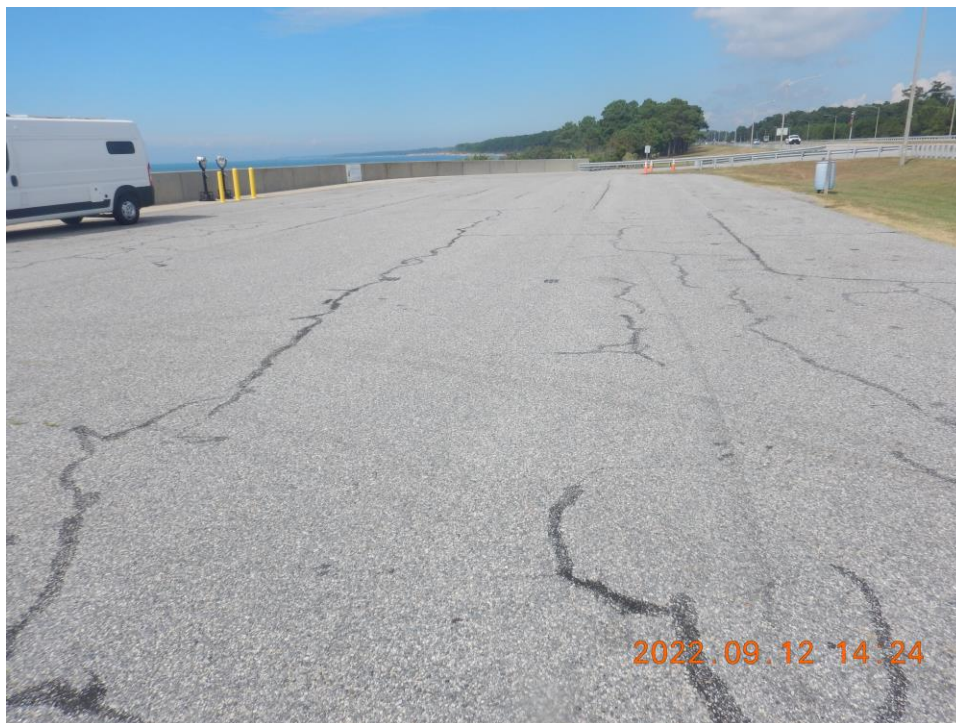
Photo 76: General Condition of Scenic Overlook (Looking North)

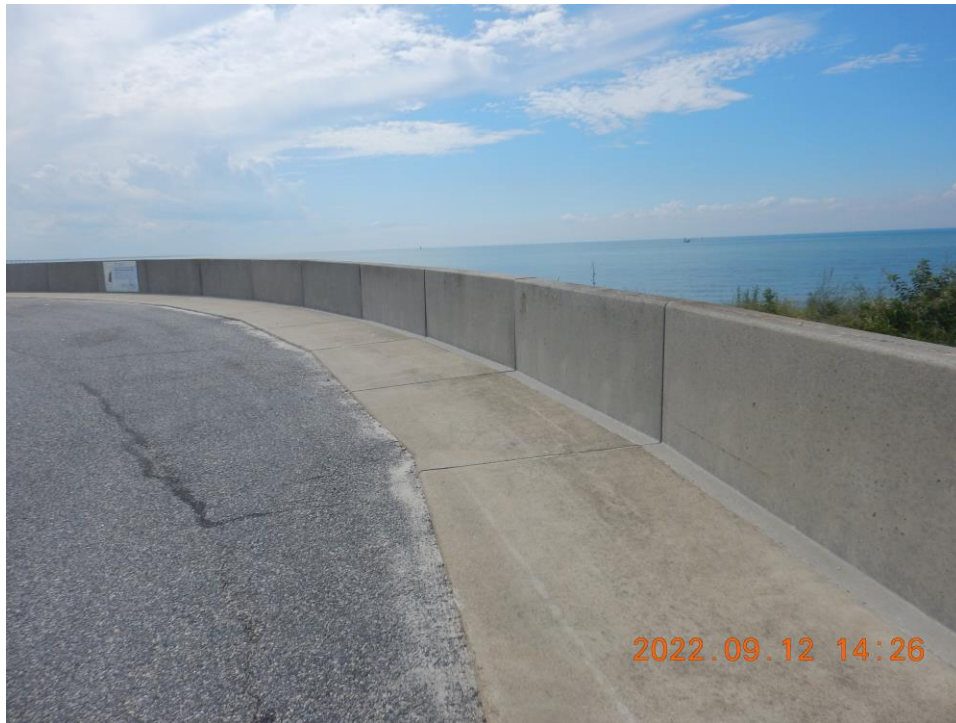
Photo 77: General Good Condition of Retaining Wall at Scenic Overlook (Looking Southwest)
