## FY2023 Annual Inspection and Underwater Inspection, Trestle CSB

### FY2023 Facility Annual Inspection Report FINAL

December 30, 2022

Chesapeake Bay Bridge and Tunnel District

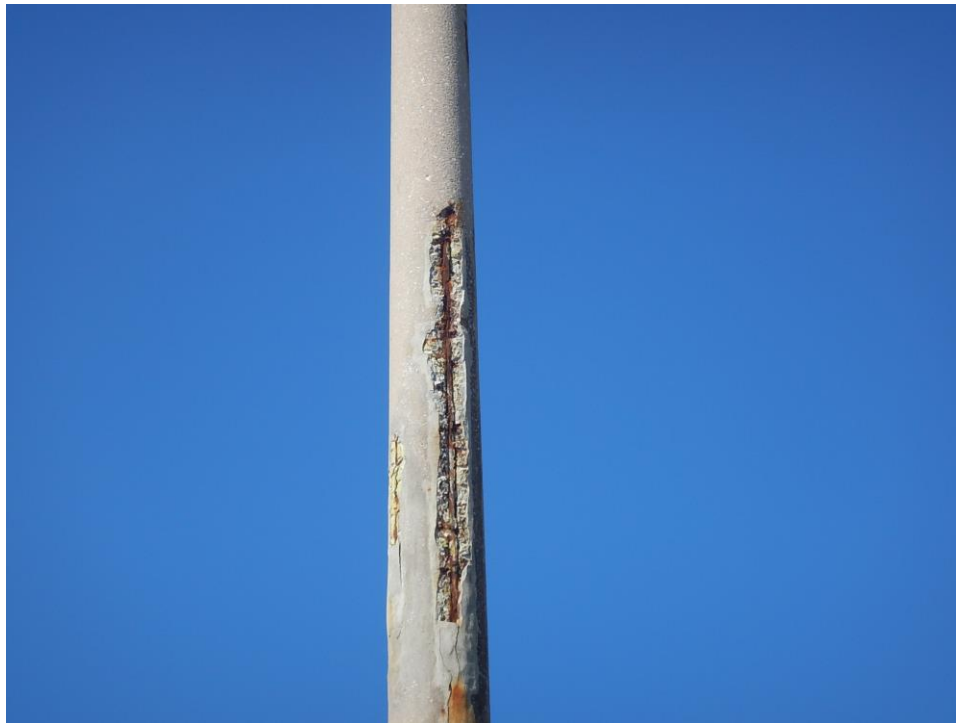
Photo 78: Island 4 Light Poles – Typical Spalling with Exposed and Corroded Strands (Looking West)
