FY2024 Annual Inspection and Underwater Inspection, Trestles ANB, A'NB & ASB

FY2024 Facility Annual Inspection Report FINAL

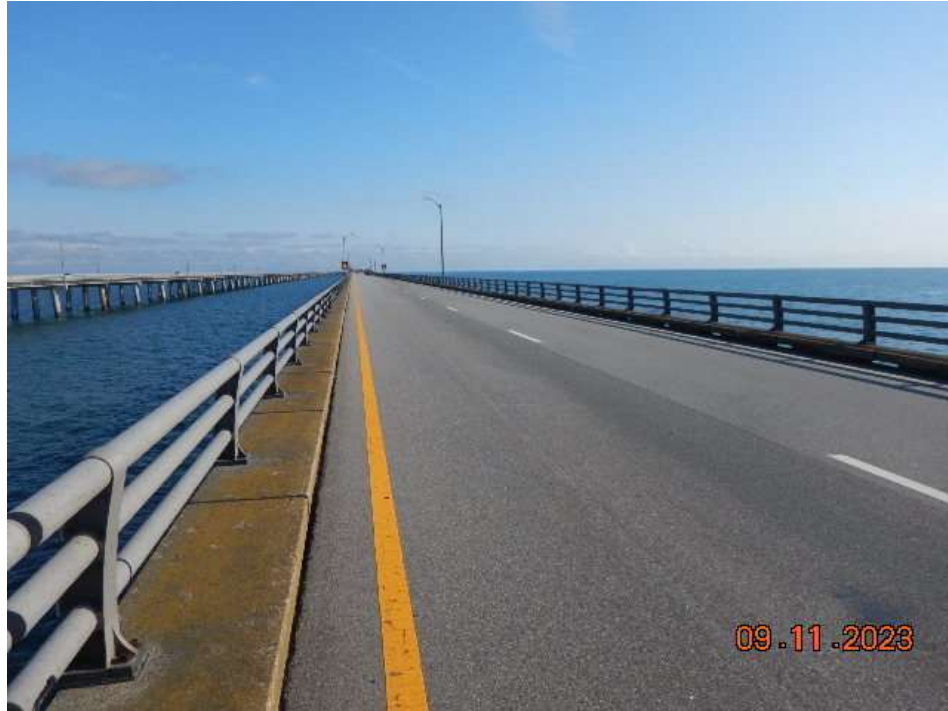
Photo 1: ANB141 Asphalt Wearing Surface – Typical Good Condition of Wearing Surface (Looking North)

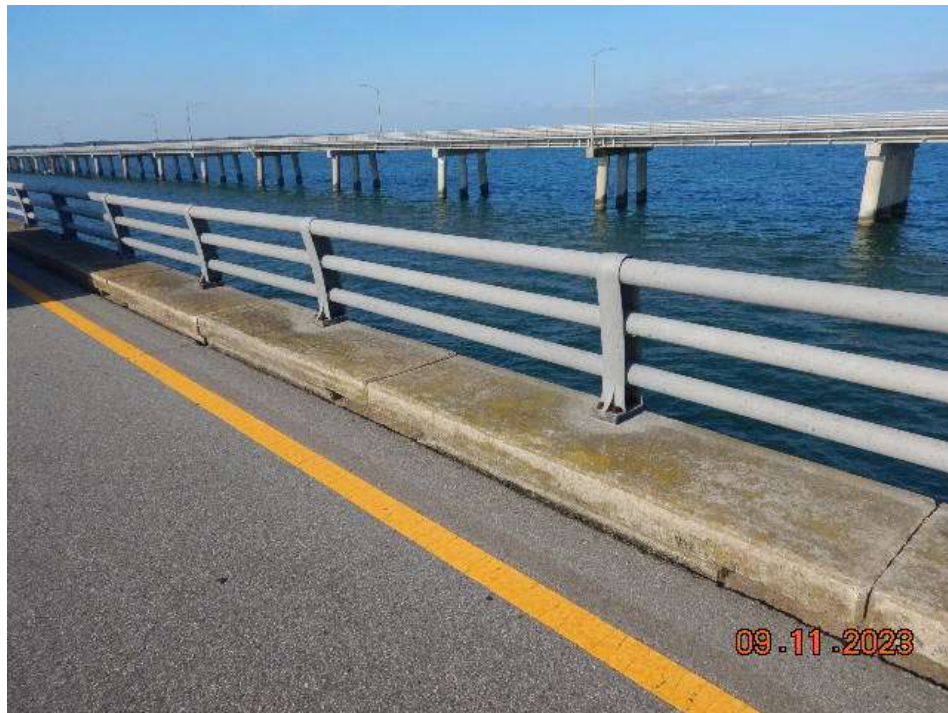
Photo 2: ANB141 Concrete Curb & Metal Bridge Railing – Typical Good Condition of Curb & Railing (Looking Southwest)

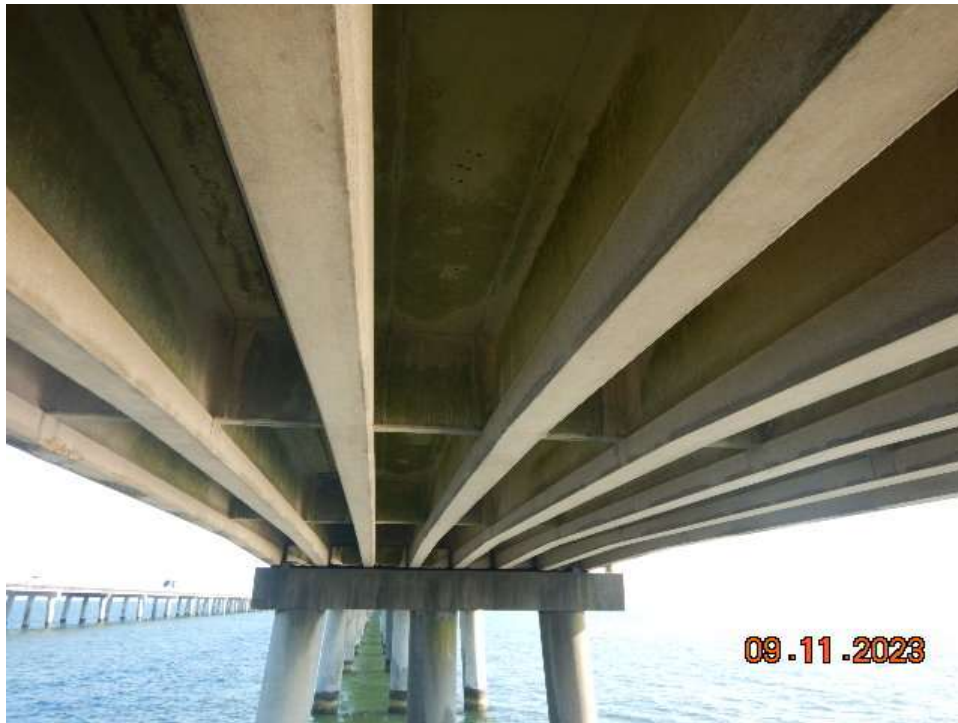
Photo 3: ANB140 - General Condition of Superstructure

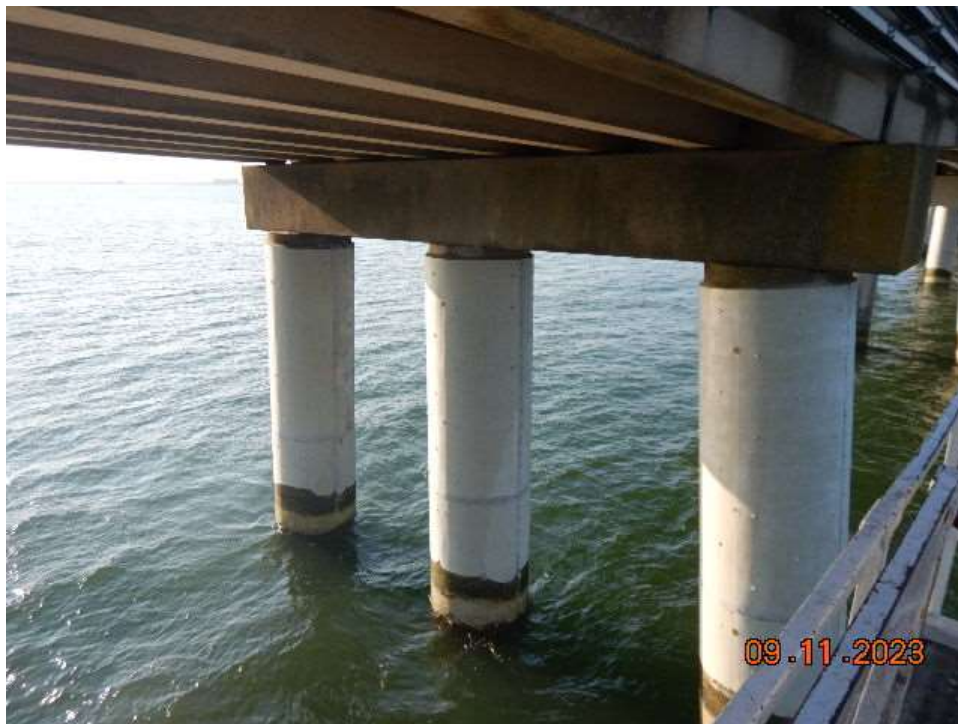
Photo 4: ANB Bent 133 – Typical Substructure with Fiberglass Jackets around Piles

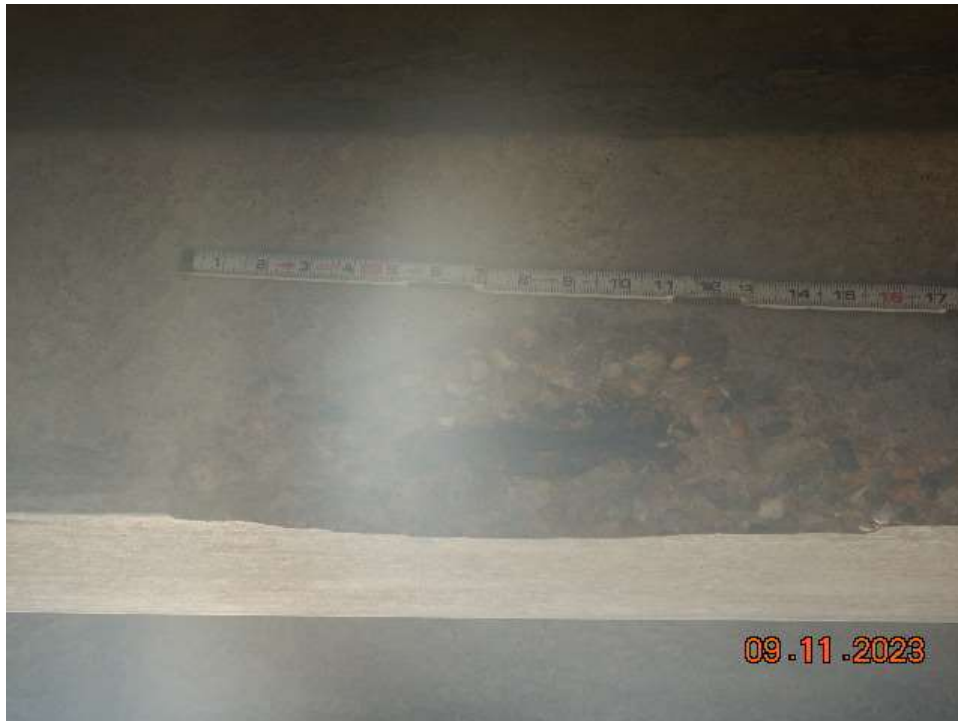
Photo 5: ANB133 Prestressed Concrete Girder – Spall with Exposed Strand in Girder 4 near Midspan

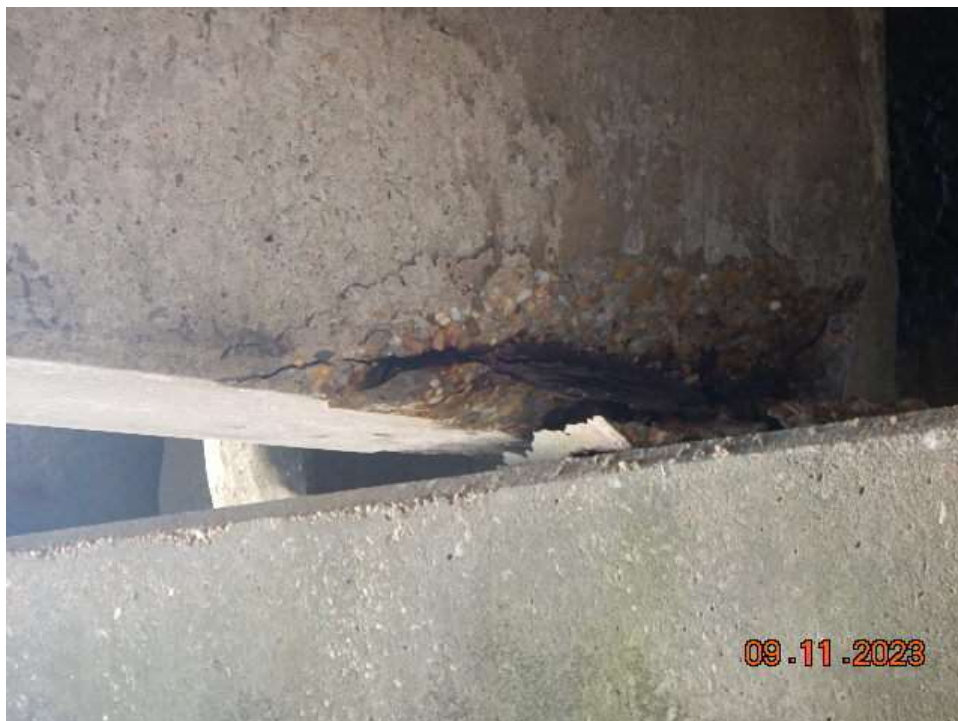
Photo 6: ANB133 – Prestressed Concrete Girder – 2' Long Spall with Exposed & Corroded Strand in Girder 3 at Bent 133

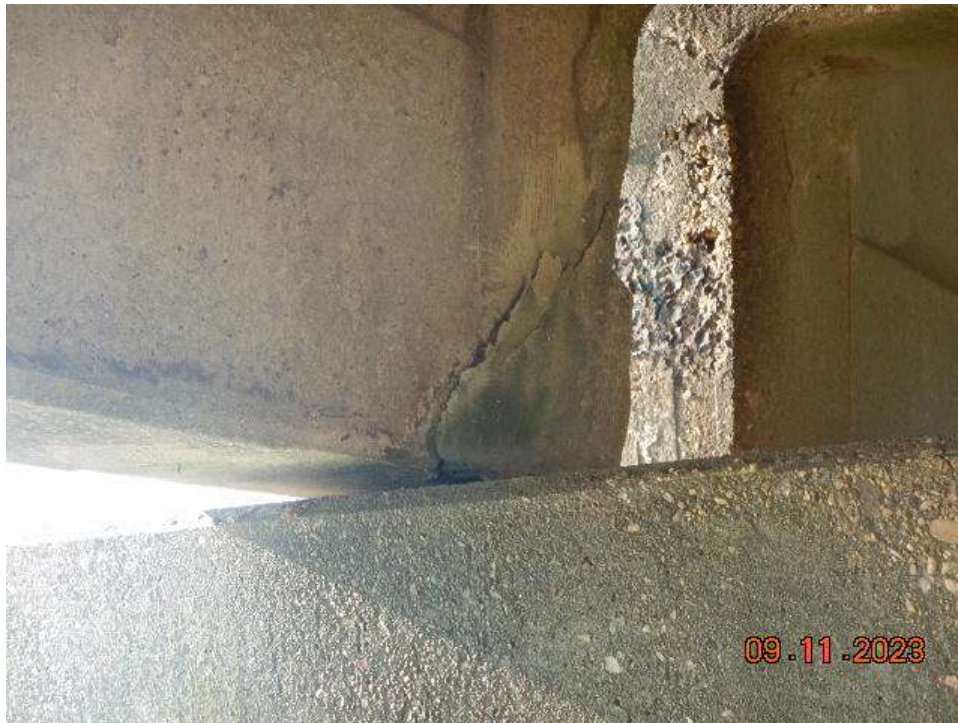
Photo 7: ANB137 Prestressed Concrete Girder – Delamination at End of Girder 1 at Bent 137

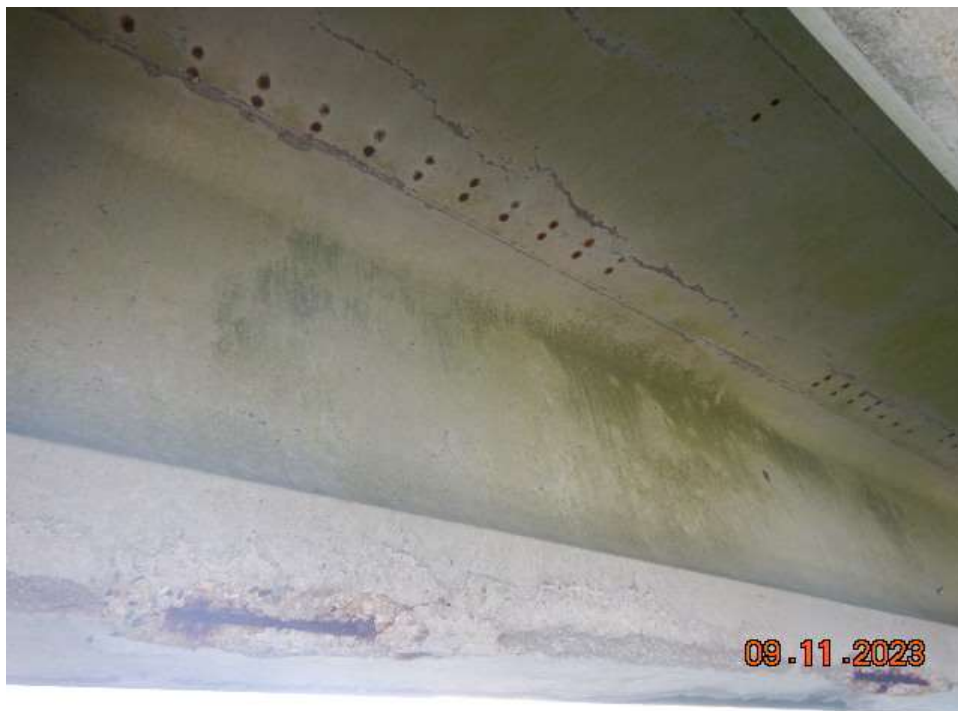
Photo 8: ANB157 Prestressed Concrete Girder – Two (2) Spalls with Exposed Strand in Girder 8

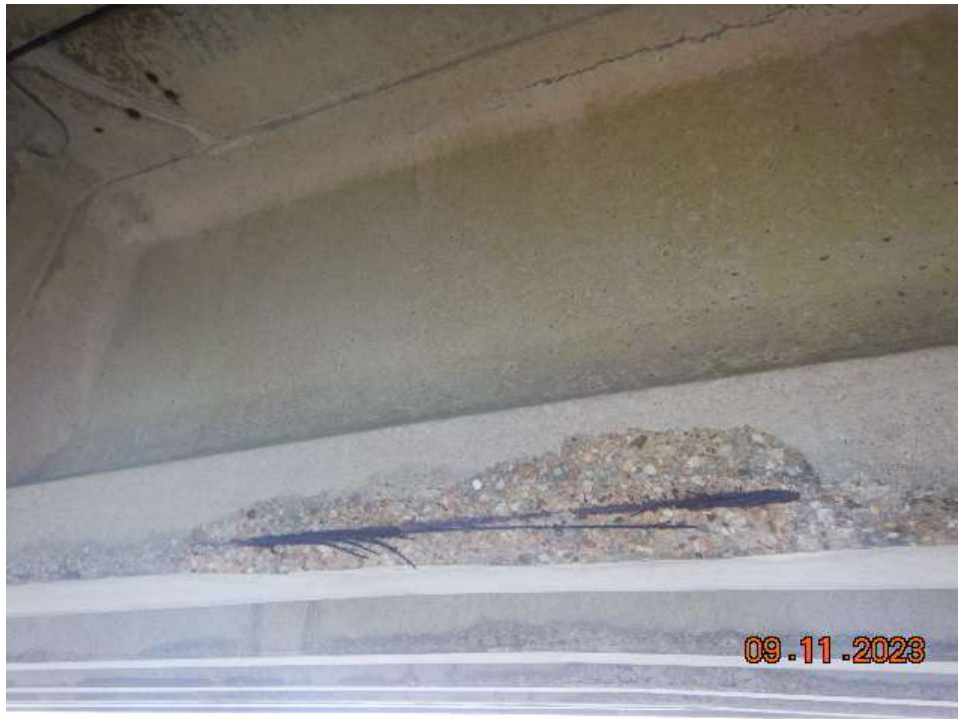
Photo 9: ANB159 – Prestressed Concrete Girder – 2' Long Spall with Exposed Strand in Girder 4

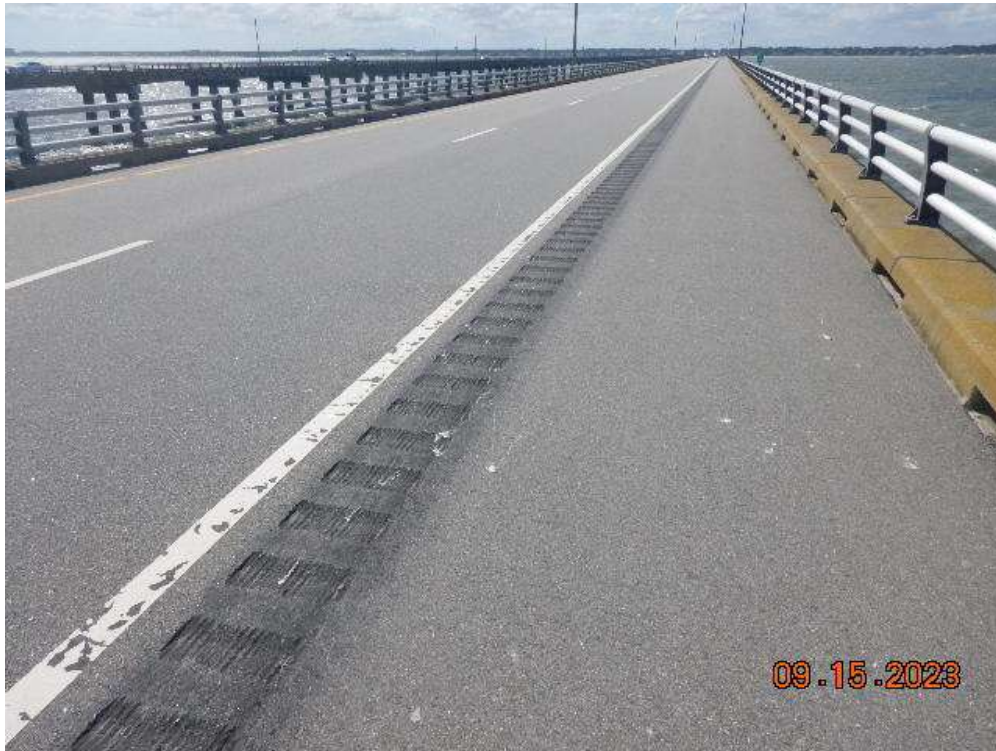
Photo 10: ASB119 Asphalt Wearing Surface – Typical Good Condition of Wearing Surface (Looking South)

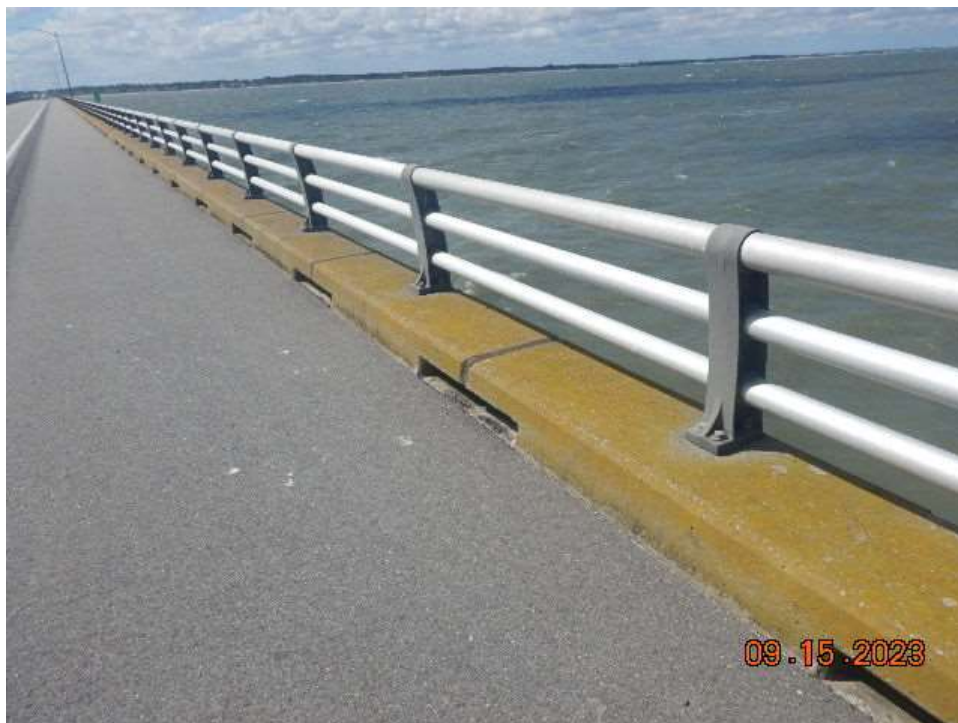
Photo 11: ASB118 Metal Bridge Railing – Typical Good Condition of Bridge Railing and Curb (Looking Southwest)

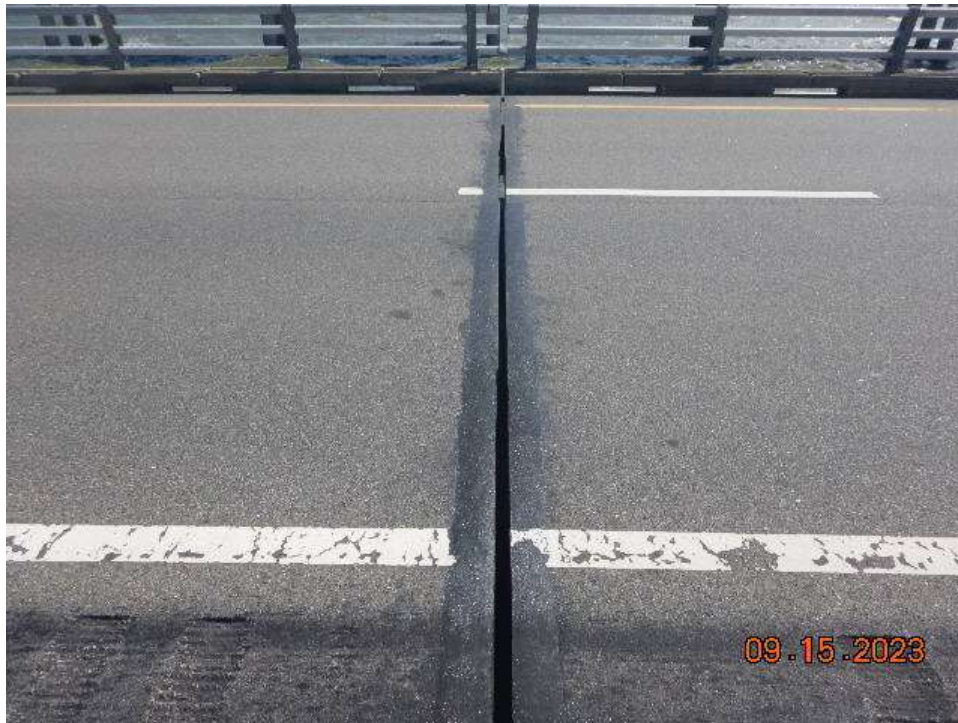
Photo 12: ASB119 Open Expansion Joint – Typical Good Condition of Joint (Looking East)

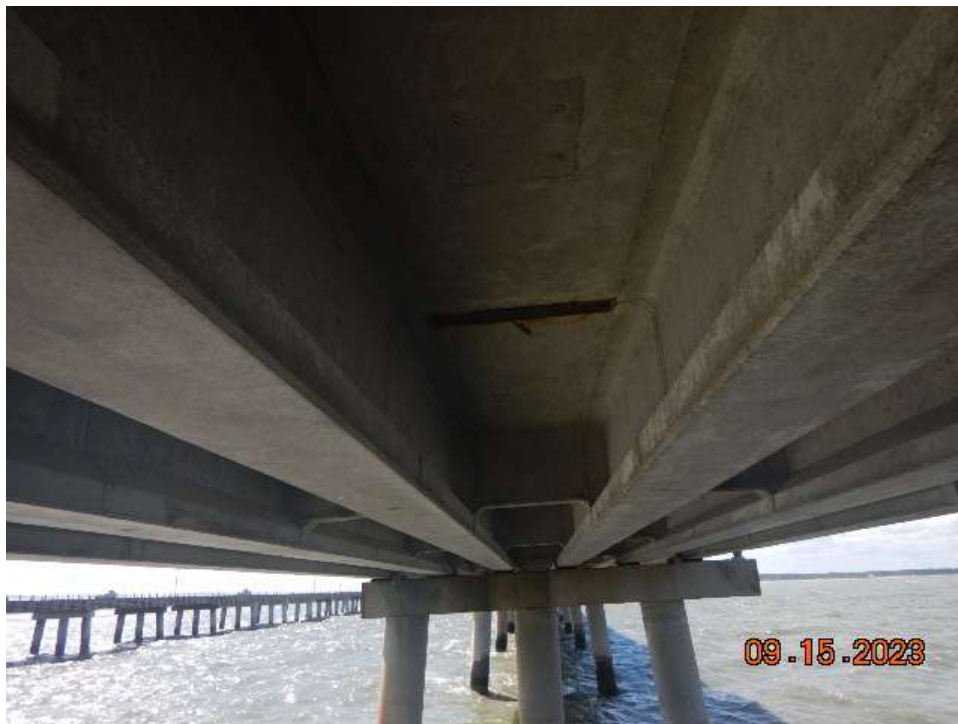
Photo 13: ASB119 – Typical Condition of Superstructure (Looking South)

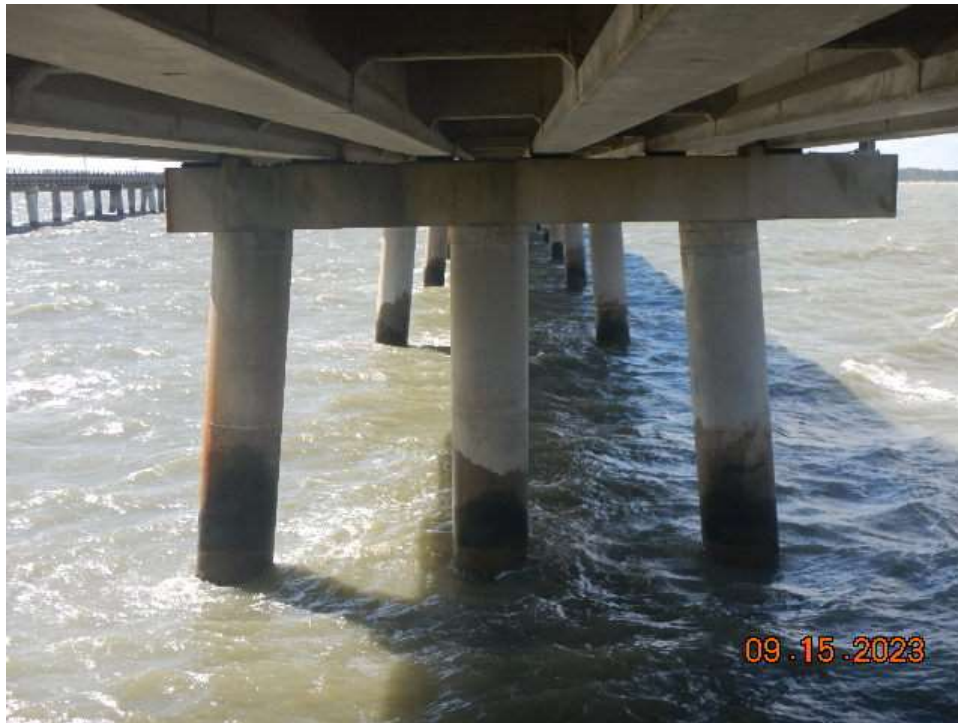
Photo 14: ASB119 – Typical Pile Bent Condition (Bent 119 Shown)

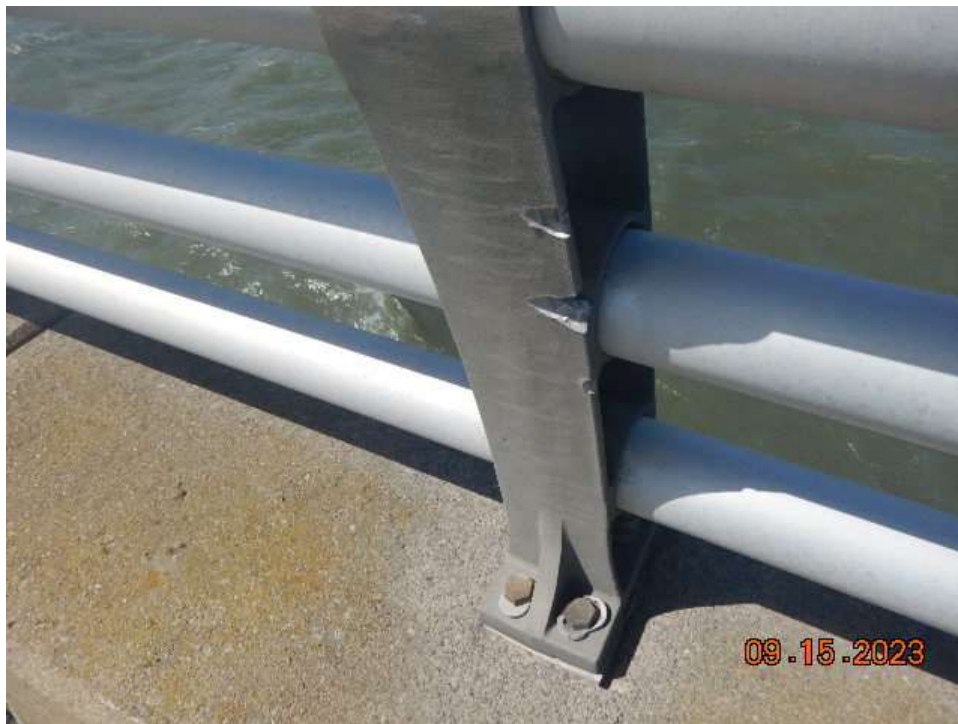
Photo 15: ASB111 Metal Bridge Railing – Minor Vehicle Impact Damage

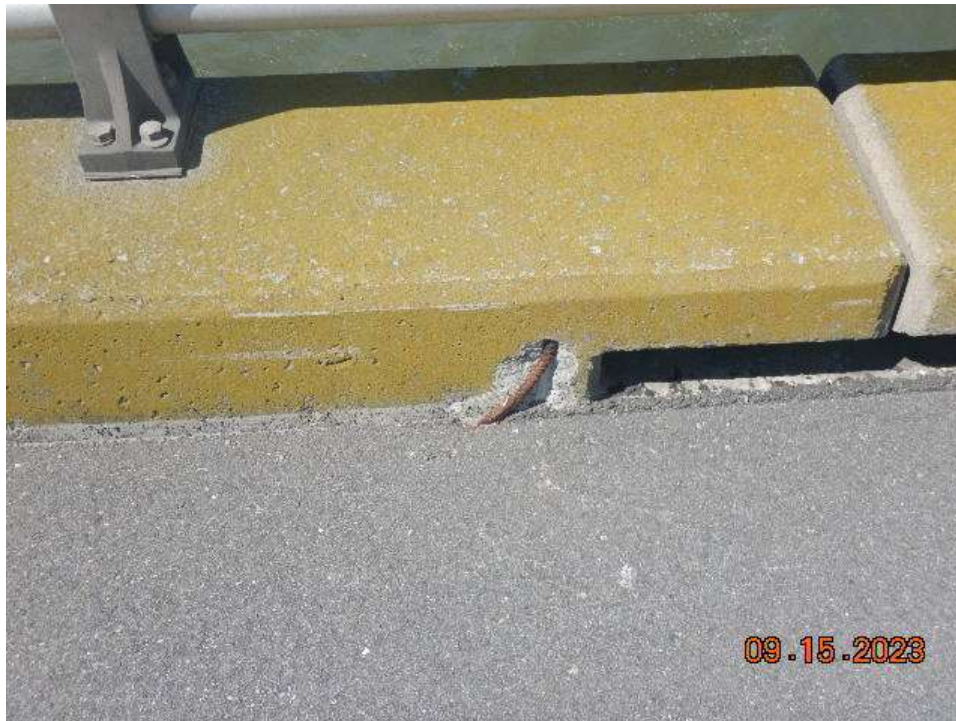
Photo 16: ASB102 Concrete Curb – Random Exposed Rebar in West Curb

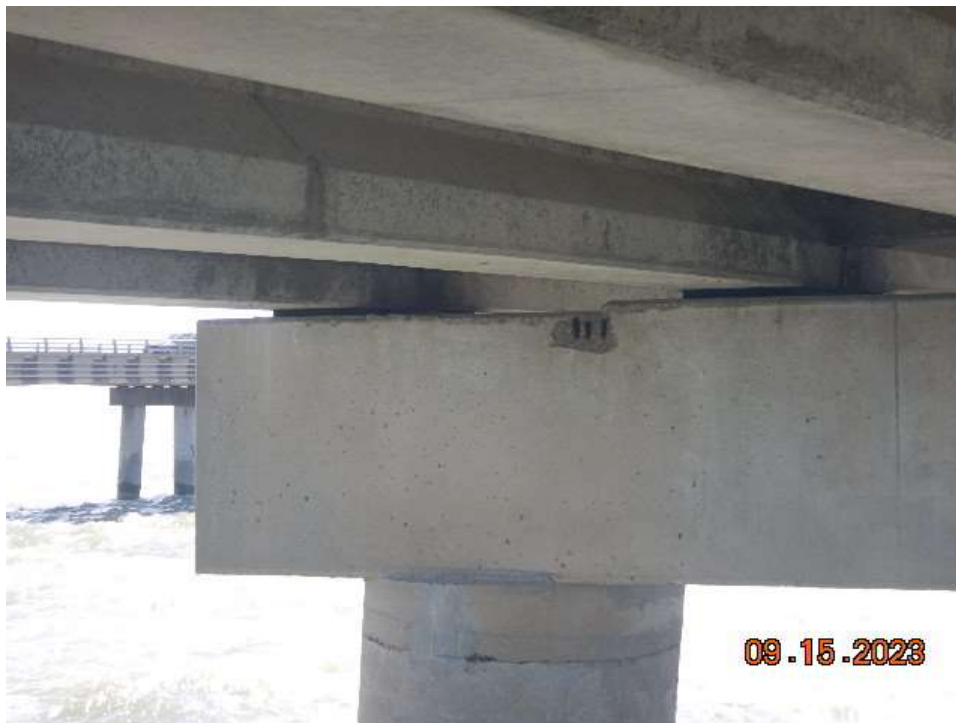
Photo 17: ASB98 Reinforced Concrete Pier Cap – Shallow Spall with Exposed Reinforcing

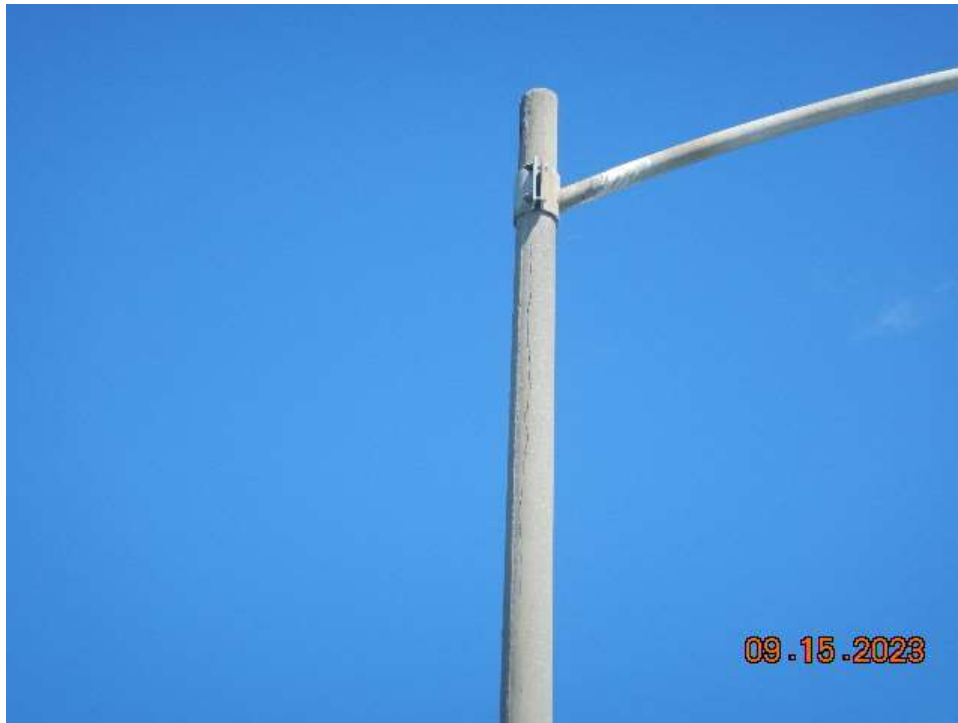
Photo 18: ASB115 – Vertical Crack in Light Pole at Bent 115

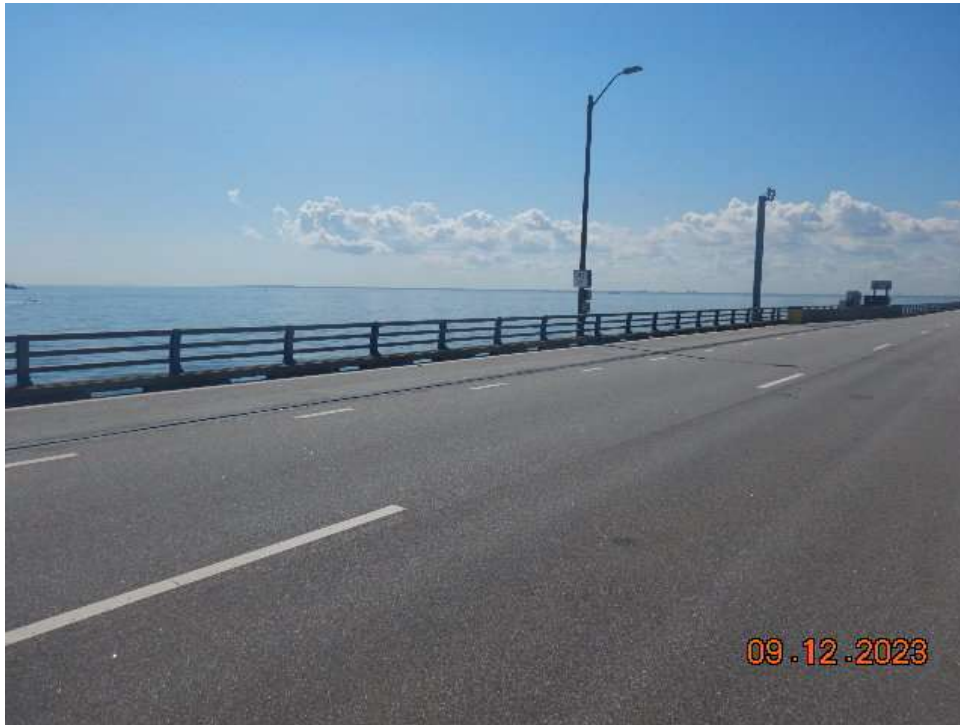
Photo 19: BNB132 - Wearing Surface and Metal Bridge Railing – Typical Good Condition (Looking Southeast)

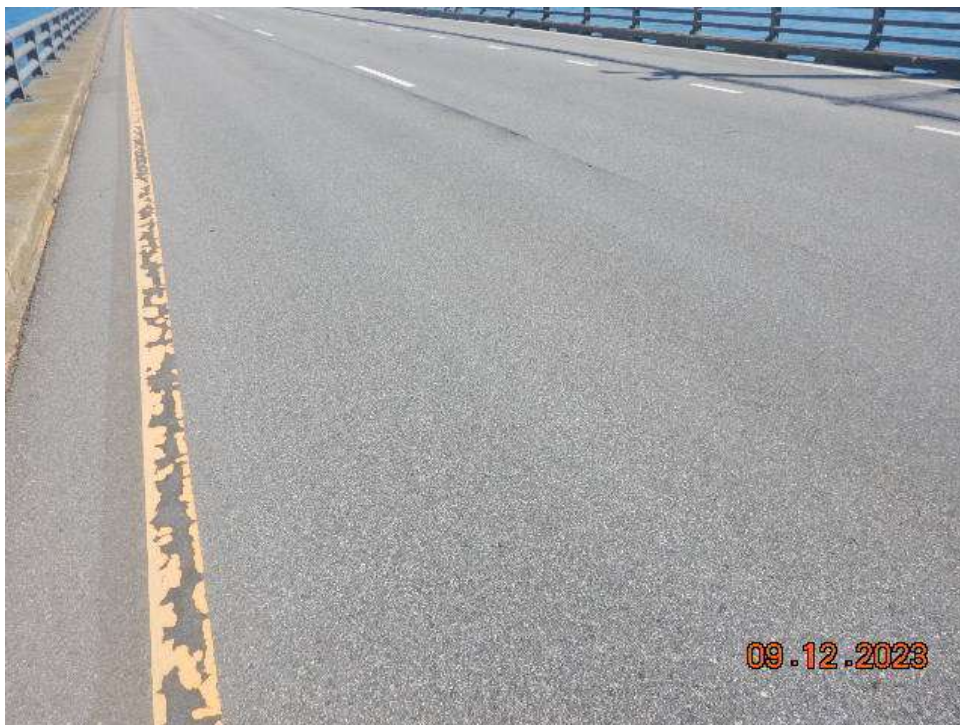
Photo 20: BNB129 Wearing Surface – Typical Condition of EPO (Looking North)

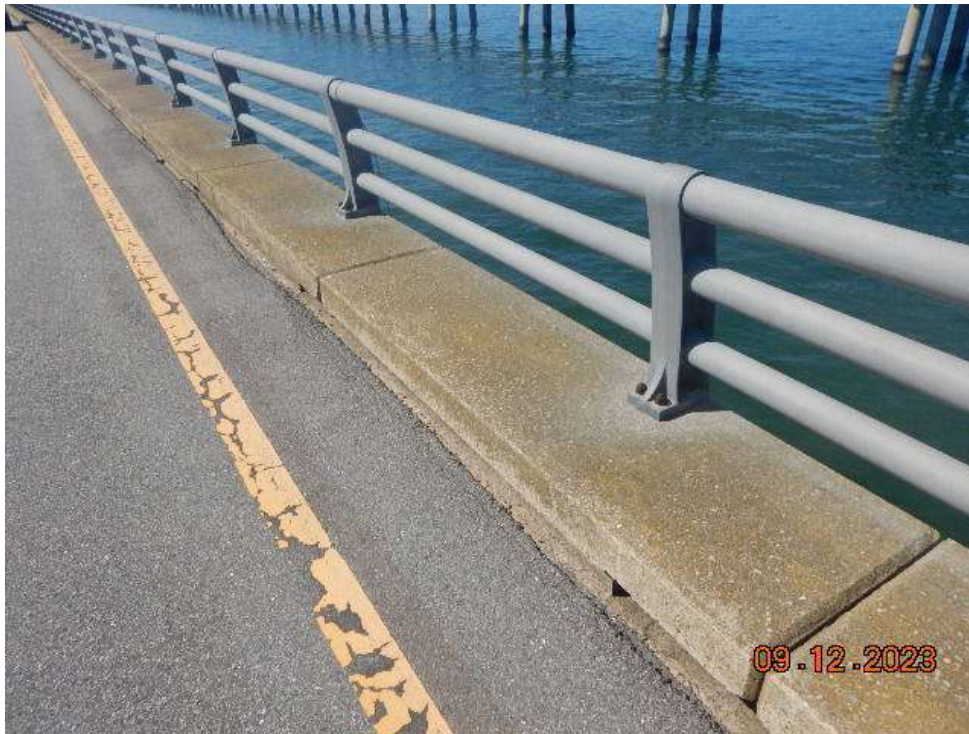
Photo 21: BNB133 Metal Bridge Railing – Typical Good Condition of Railing (Looking Southwest)

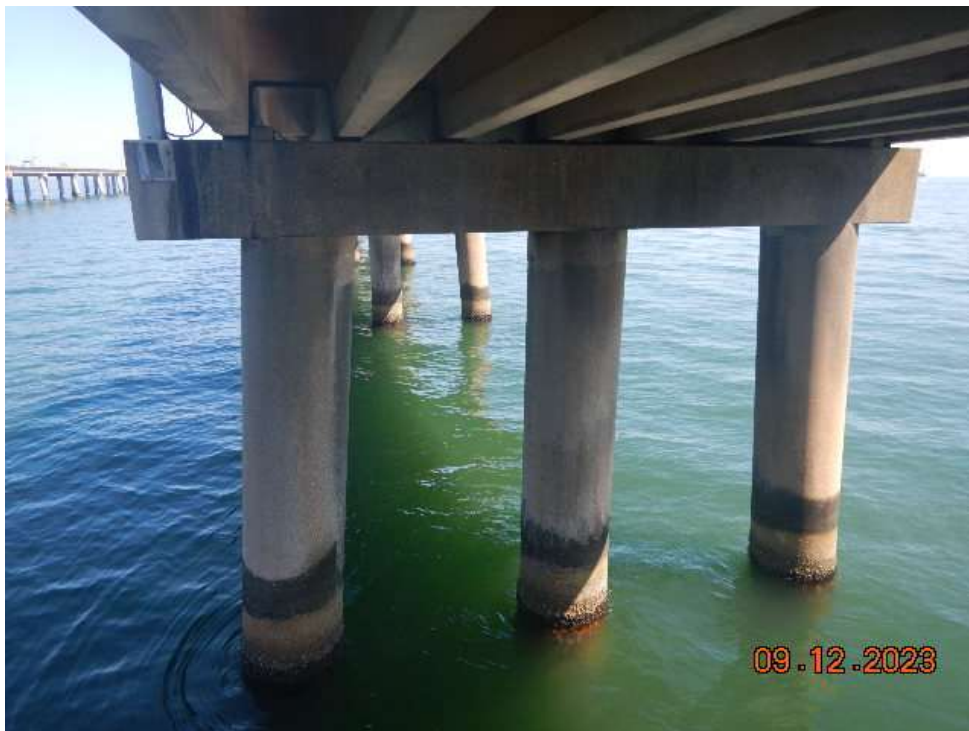
Photo 22: BNB129 – General Good Condition of Bent Cap and Piles (Looking North)

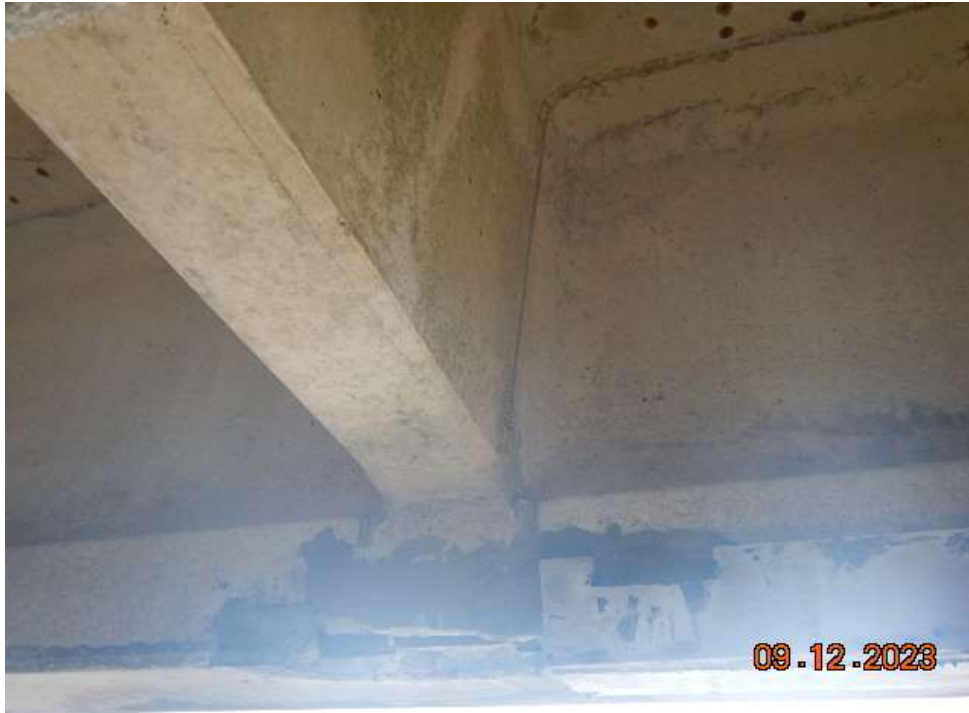
Photo 23: BNB124 Prestressed Concrete Girder – Failed Patch in Girder 2 with Formwork in Place

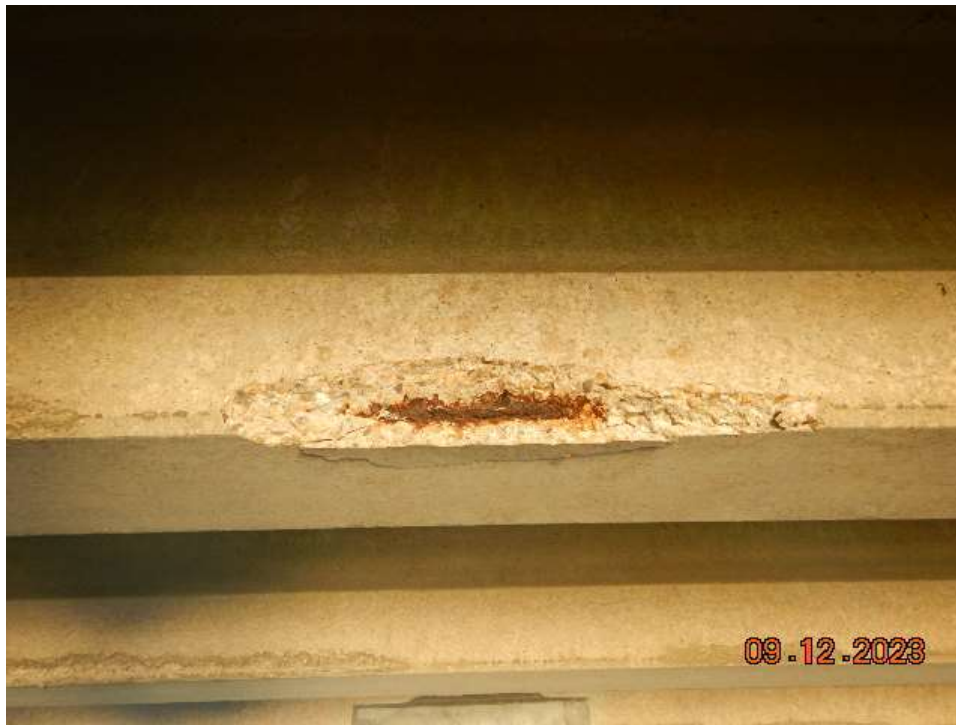
Photo 24: BNB108 Prestressed Concrete Girder – Spall with Exposed Strand in Girder 6

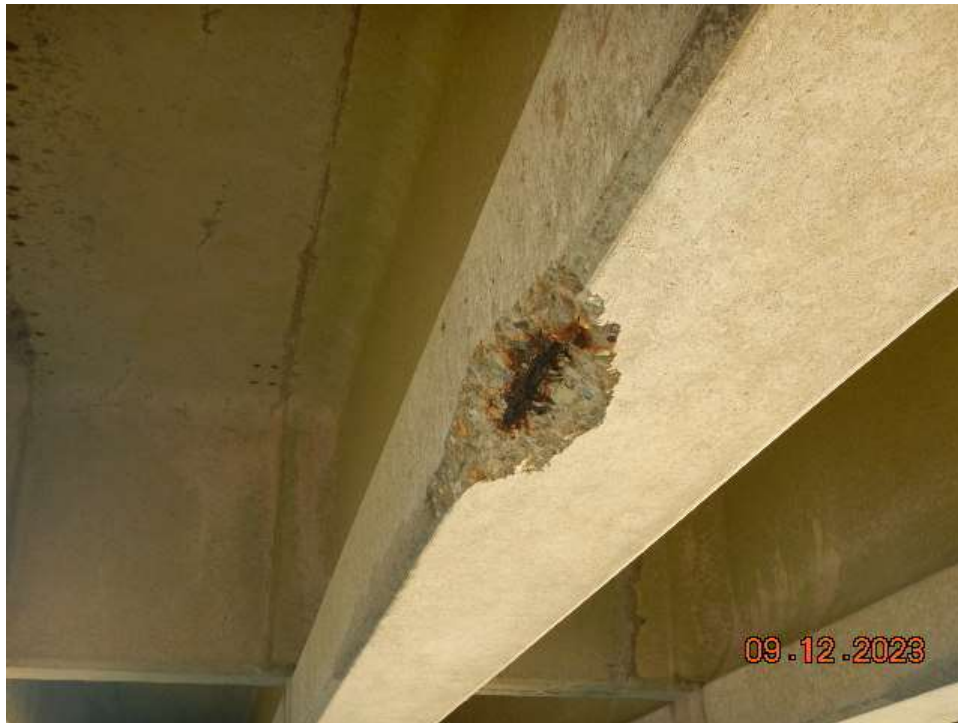
Photo 25: BNB110 Prestressed Concrete Girder – Girder 7 Spall with Exposed Strand

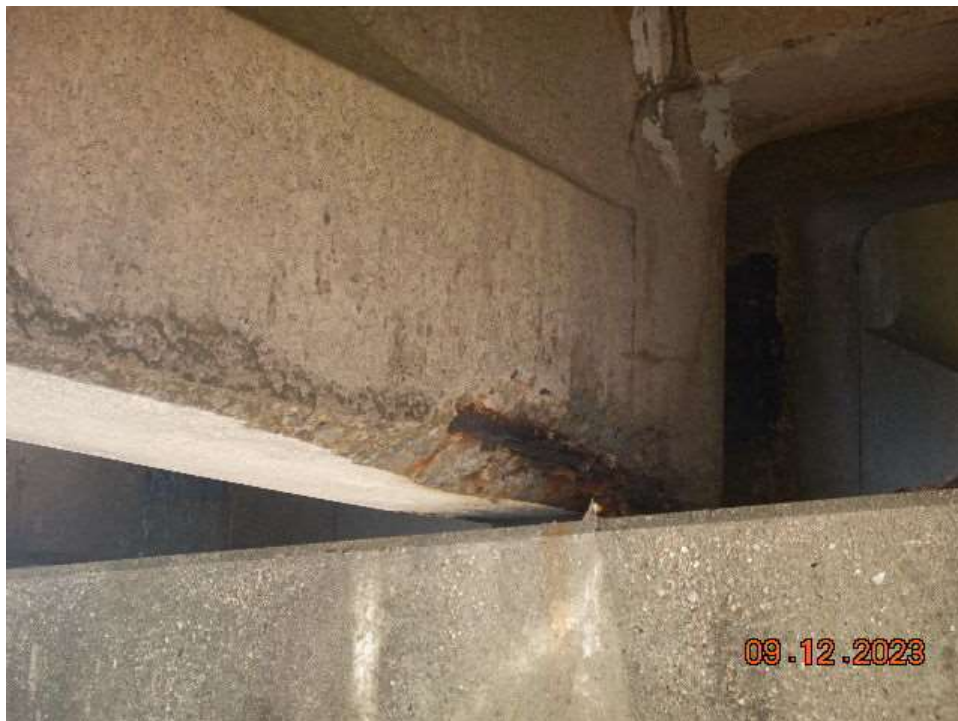
Photo 26: BNB109 Prestressed Concrete Girder – Girder 3 Spall with Exposed Strand at Bent 109

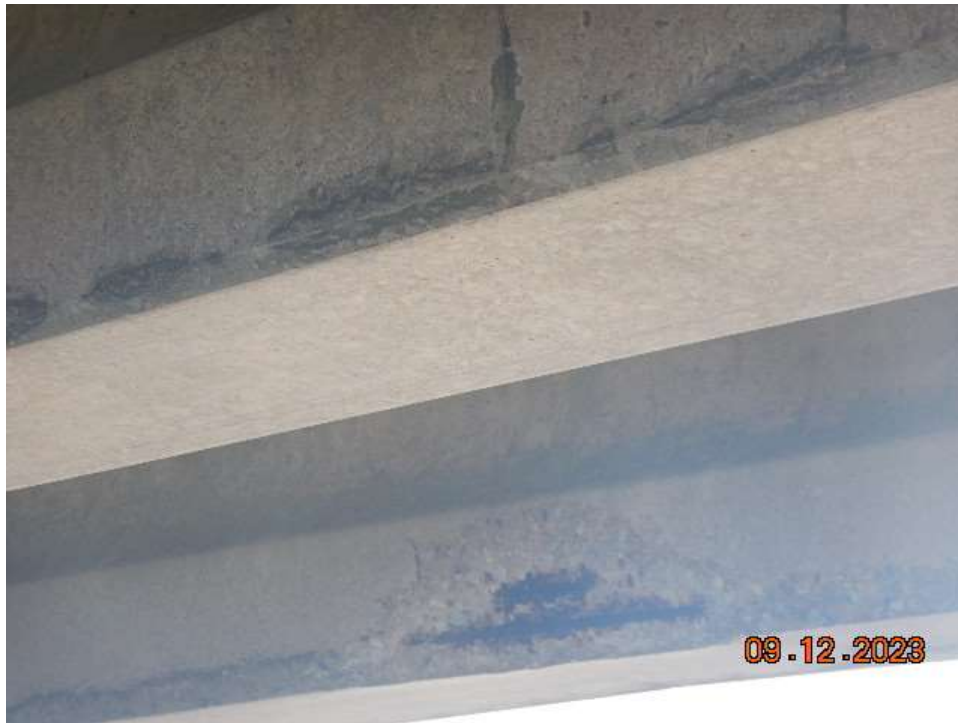
Photo 27: BNB121 Prestressed Concrete Girder – Girder 8 Spalling with Exposed Strands

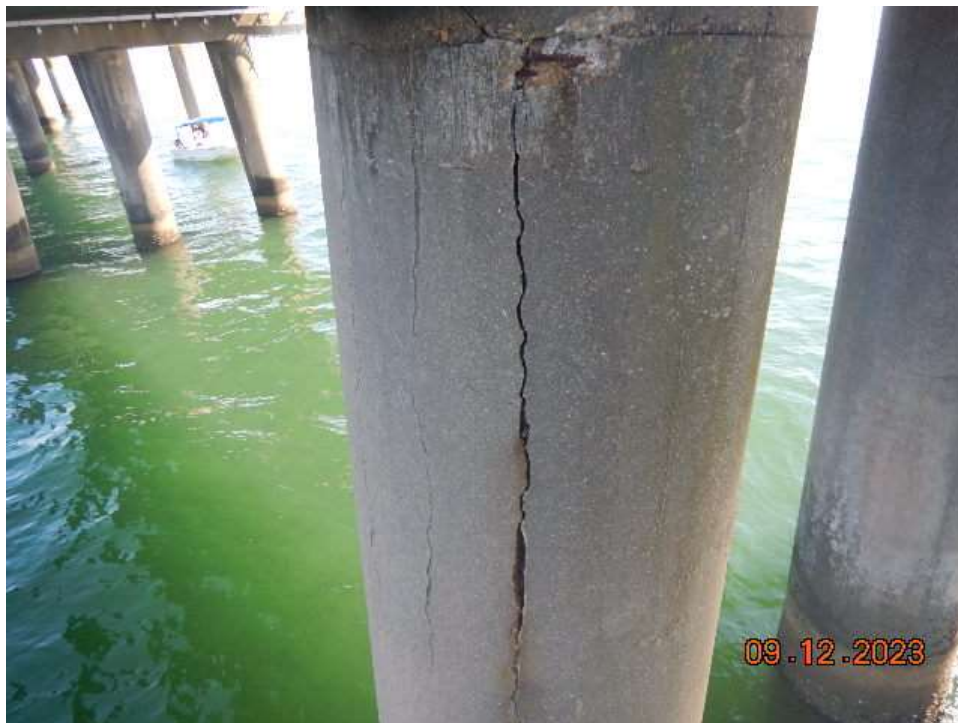
Photo 28: BNB123 Prestressed Concrete Pile – Bent 123, Pile A CS3 Crack in Southwest Face

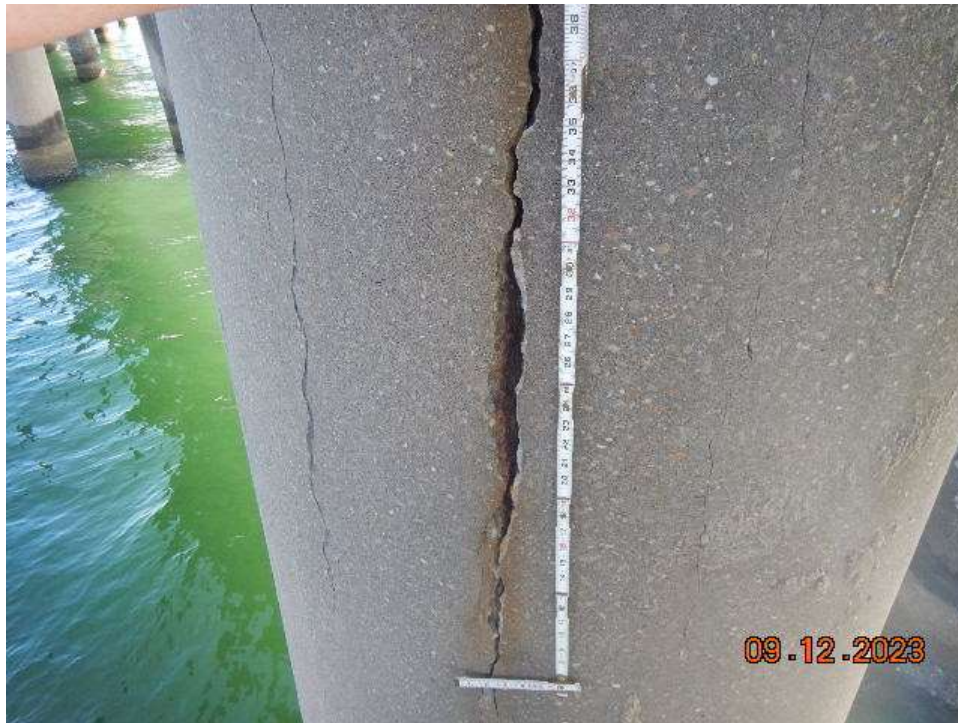
Photo 29: BNB123 Prestressed Concrete Pile – Bent 123, Pile A CS3 Crack in Southwest Face

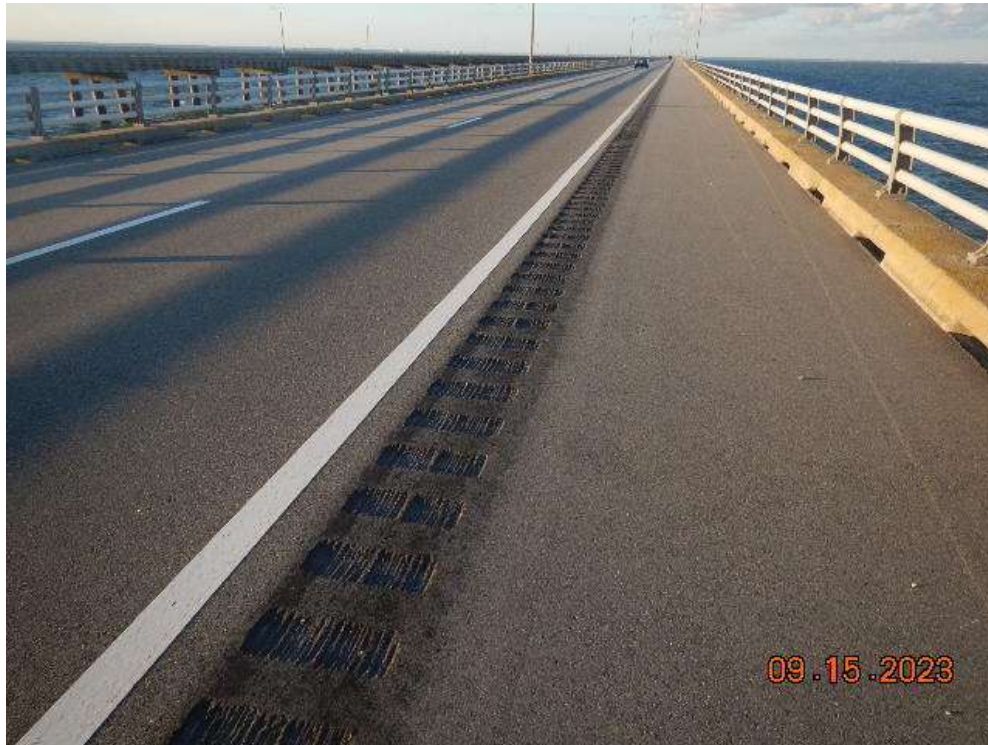
Photo 30: BSB140 Wearing Surface – Typical Good Condition of Wearing Surface (Looking Southeast)

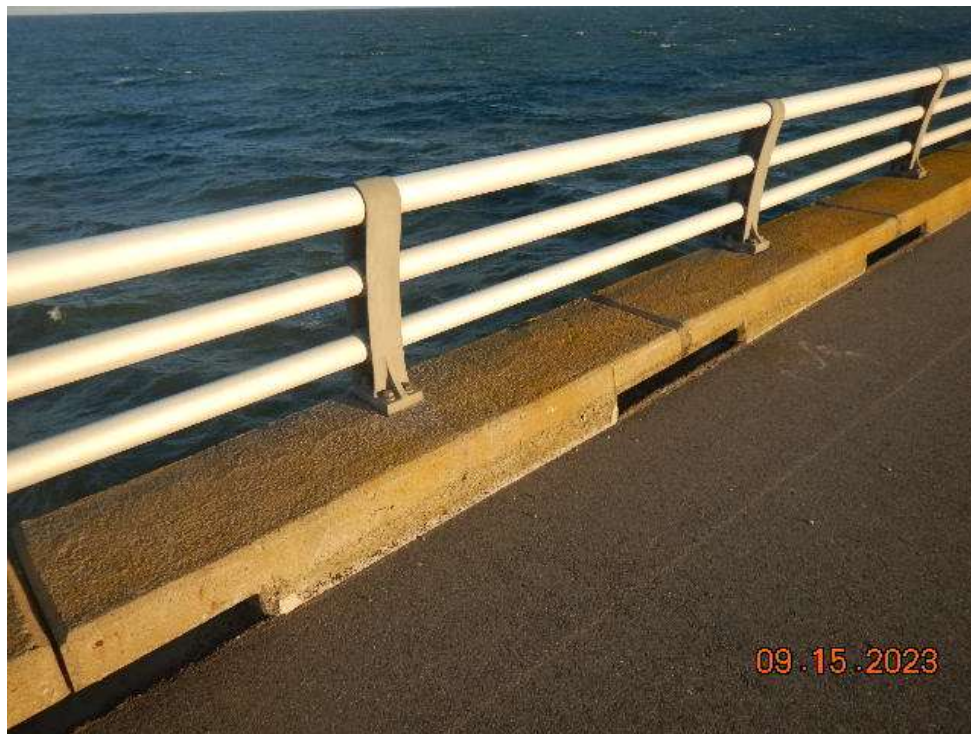
Photo 31: BSB140 Metal Bridge Railing – Typical Good Condition of Bridge Railing & Curb (Looking Northwest)

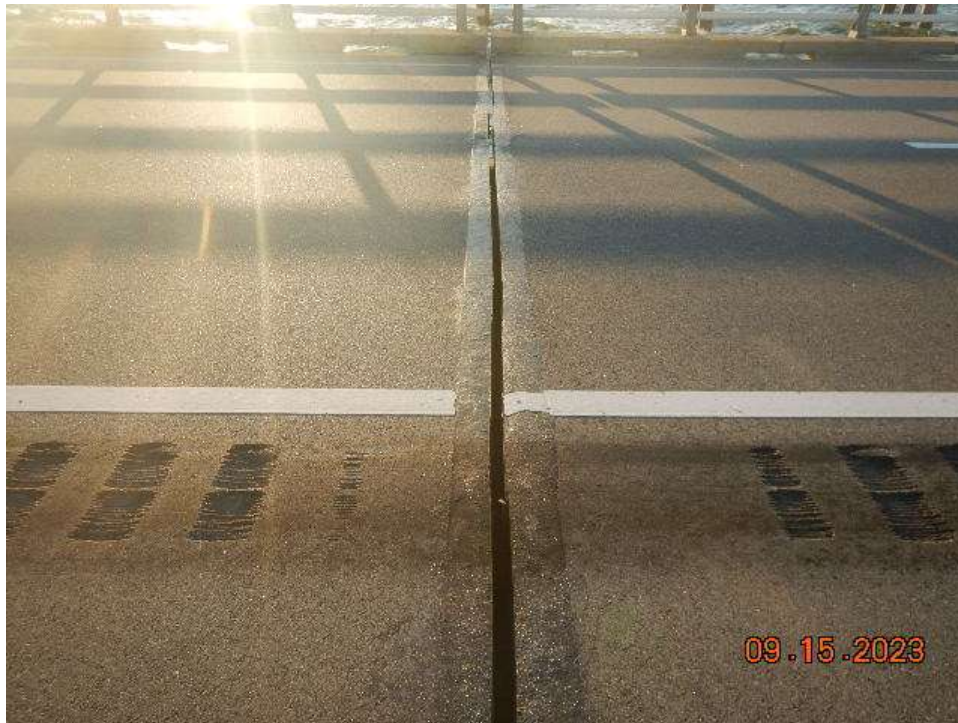
Photo 32: BSB138 Open Joint - Typical Condition of Open Joint
