FY2024 Annual Inspection and Underwater Inspection, Trestles ANB, A'NB & ASB

FY2024 Facility Annual Inspection Report FINAL

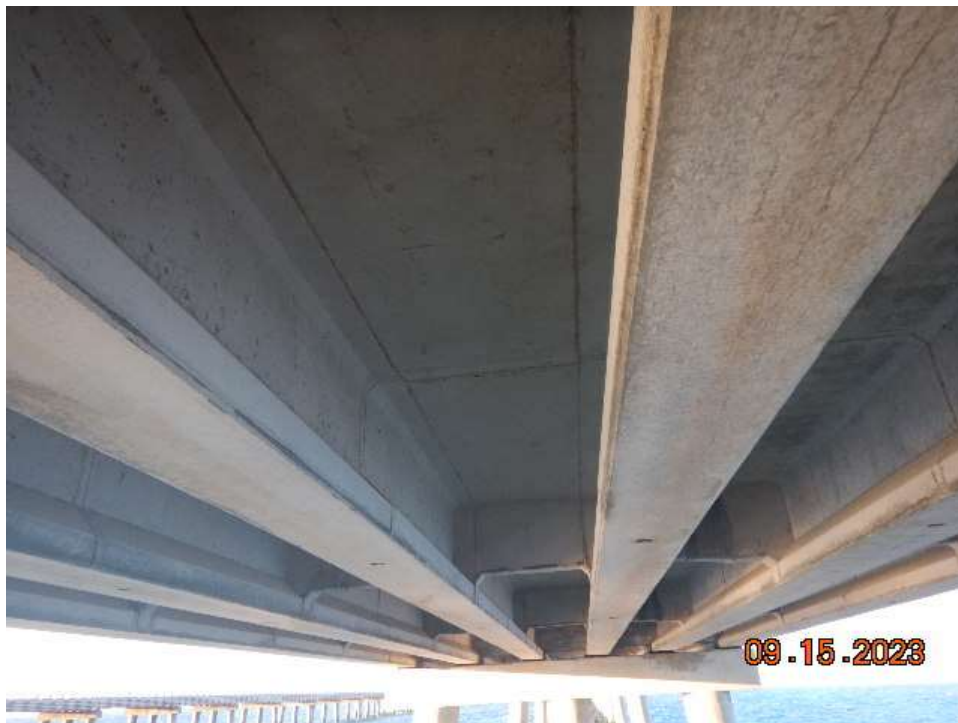
Photo 33: BSB141 - Typical Condition of Superstructure

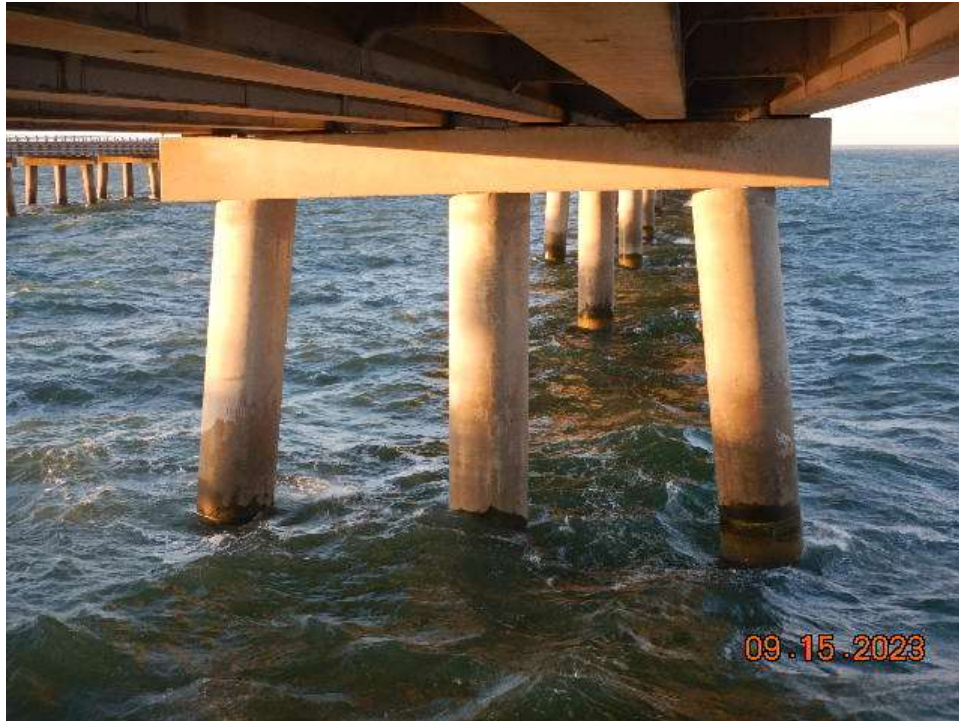
Photo 34: BSB142 - Typical Condition of Pile Bents

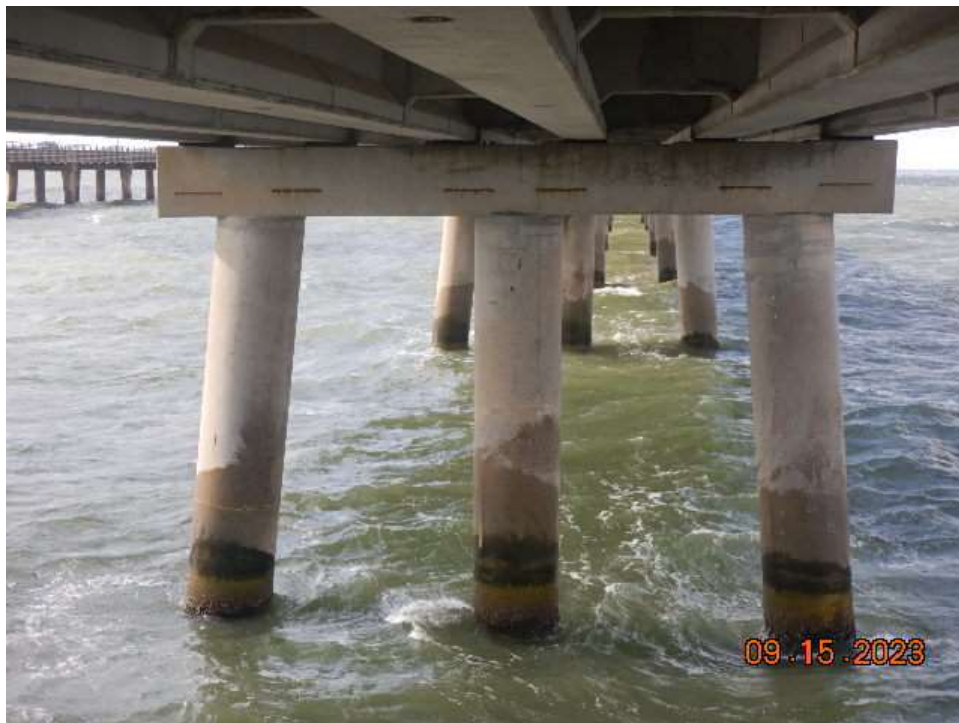
Photo 35: BSB113 Reinforced Concrete Pier Cap – Exposed Reinforcing due to Insufficient Cover

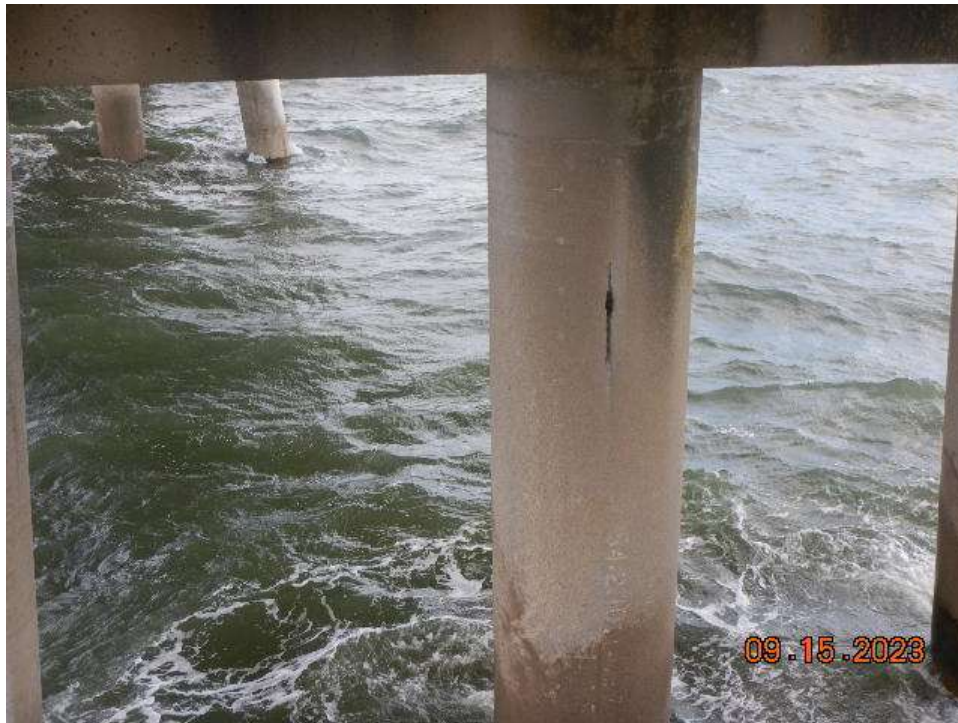
Photo 36: BSB111 Prestressed Concrete Pile – Spall in Pile B in South Face

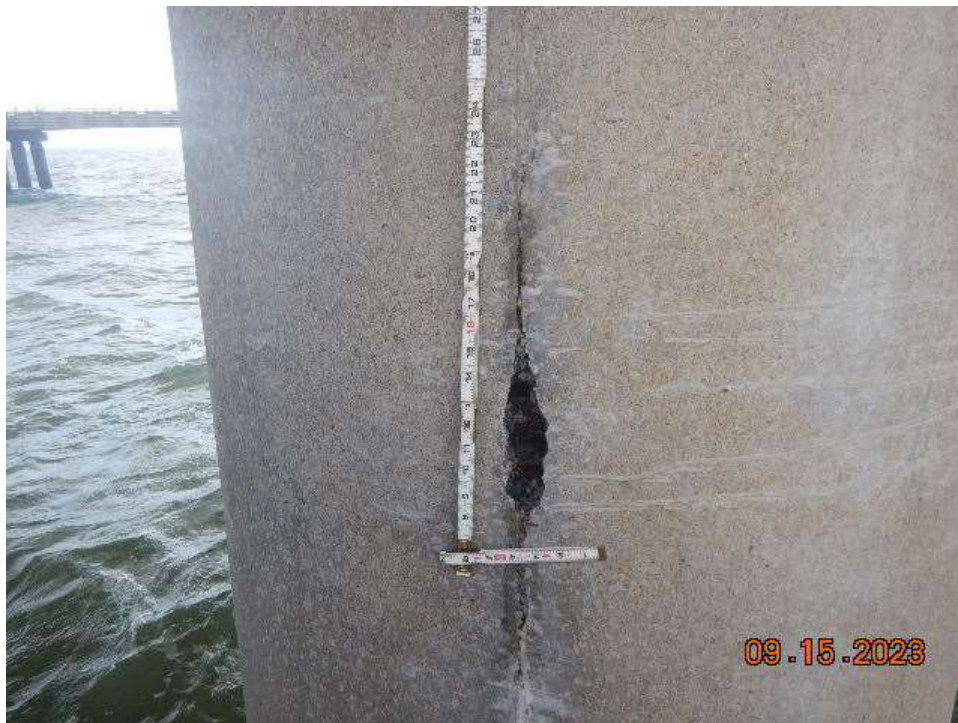
Photo 37: BSB108 Prestressed Concrete Pile – Spall in Pile A in West Face (Looking East)

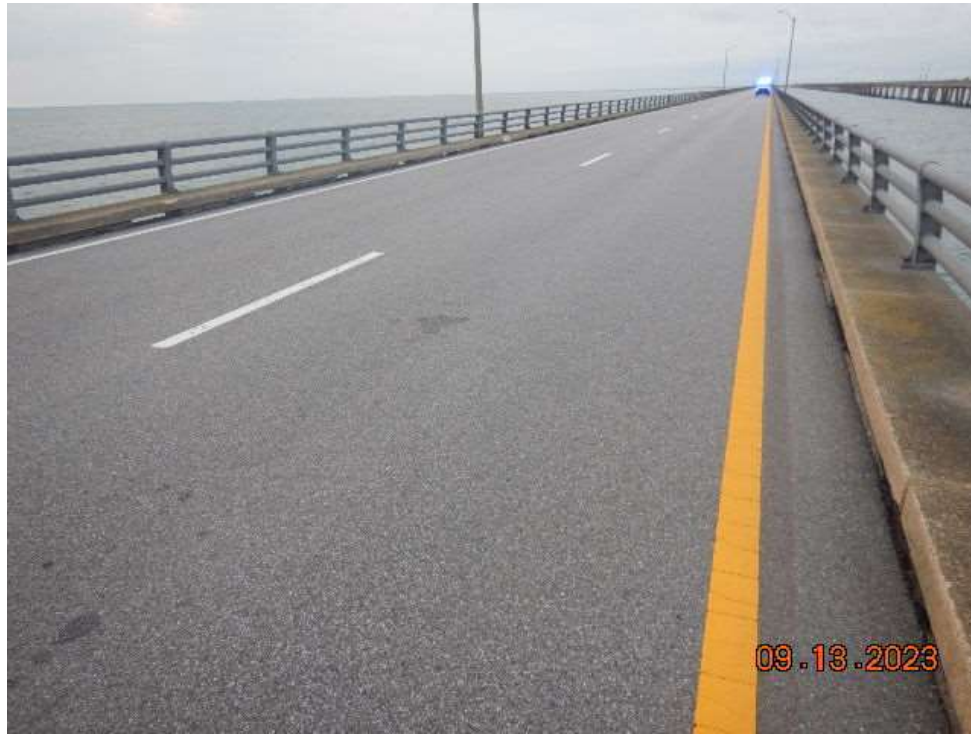
Photo 38: CNB140 - Wearing Surface – Typical Condition of Wearing Surface (Looking South)

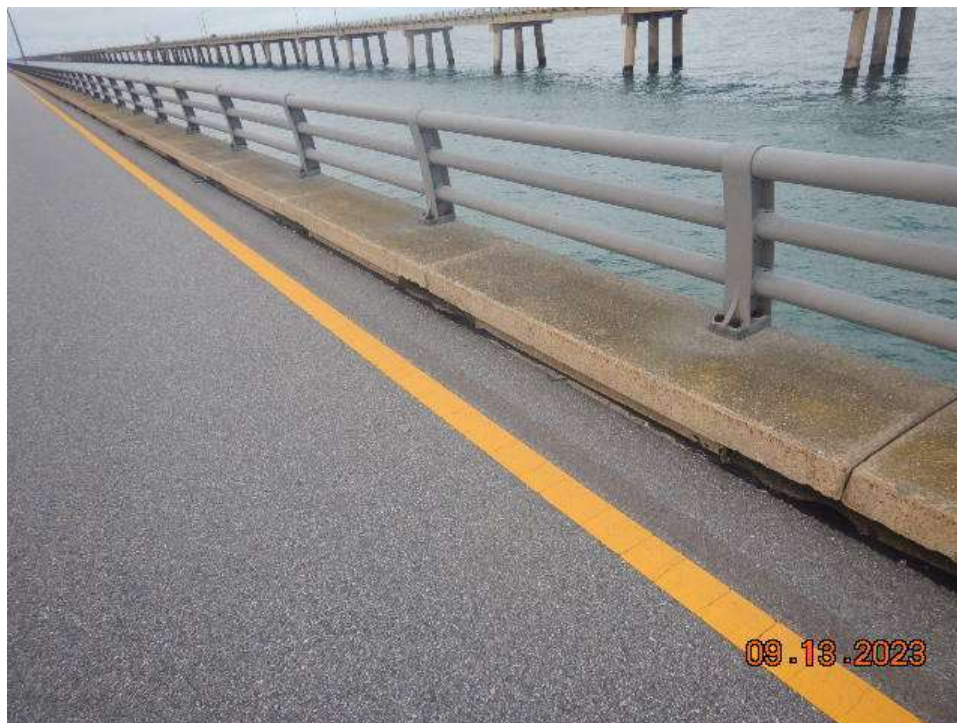
Photo 39: CNB140 – Metal Bridge Railing – Typical Condition of Metal Railing & Curb (Looking Southwest)

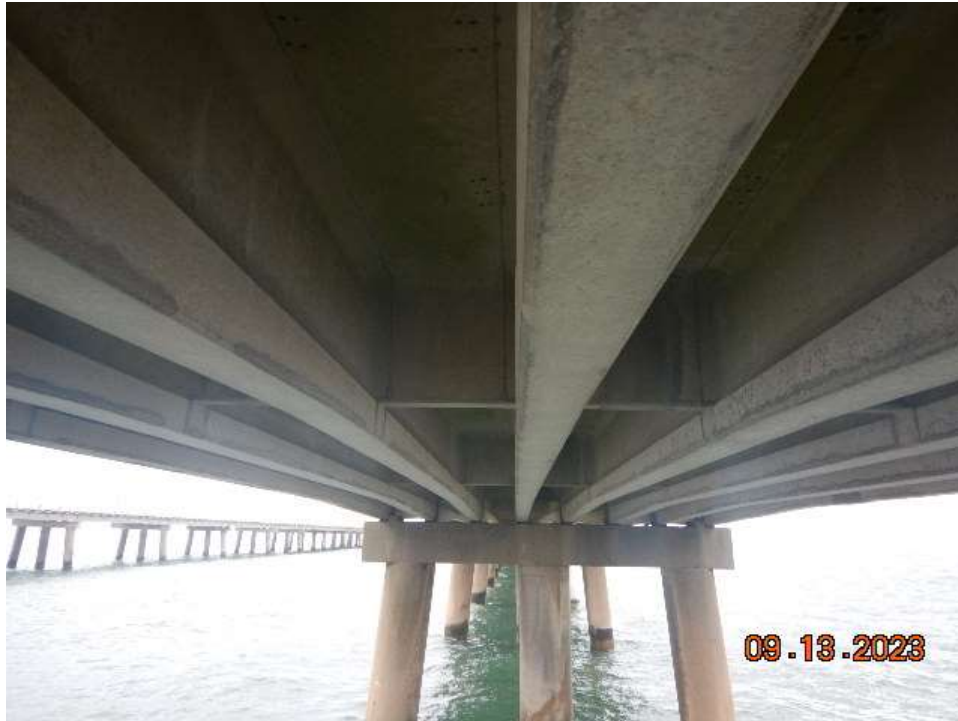
Photo 40: CNB141 – Typical Condition of Superstructure & Substructure

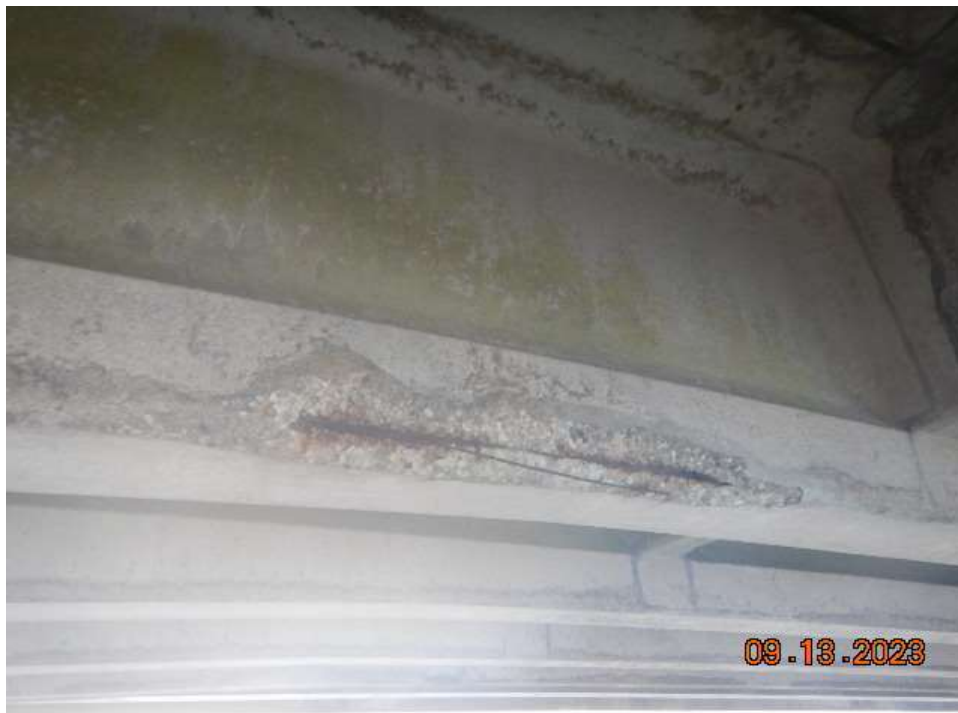
Photo 41: CNB136 Prestressed Concrete Girder – Girder 4 Spall with Exposed & Corroded Strand

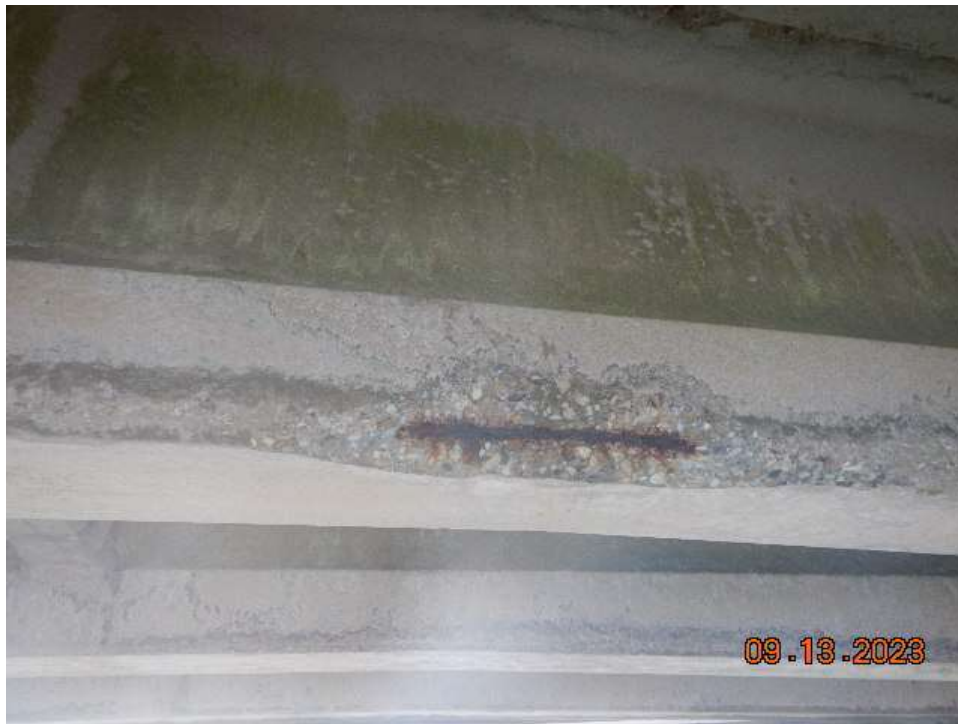
Photo 42: CNB137 Prestressed Concrete Girder – Girder 3 Spall with Exposed & Corroded Strand

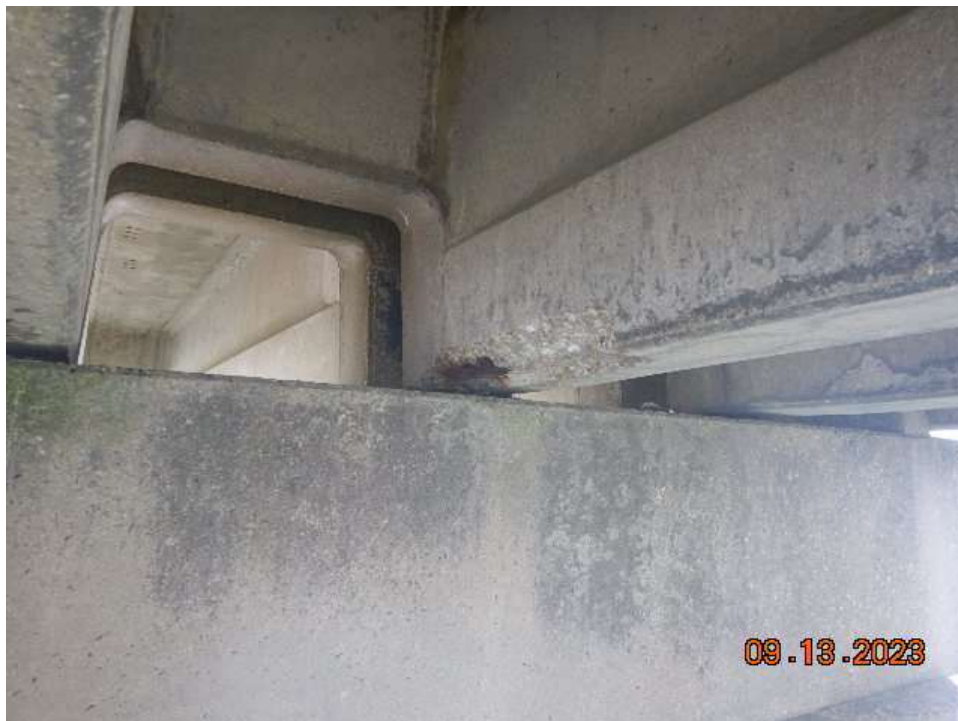
Photo 43: CNB196 Prestressed Concrete Girder – Girder 3 Spall with Exposed Strand at Bent 197

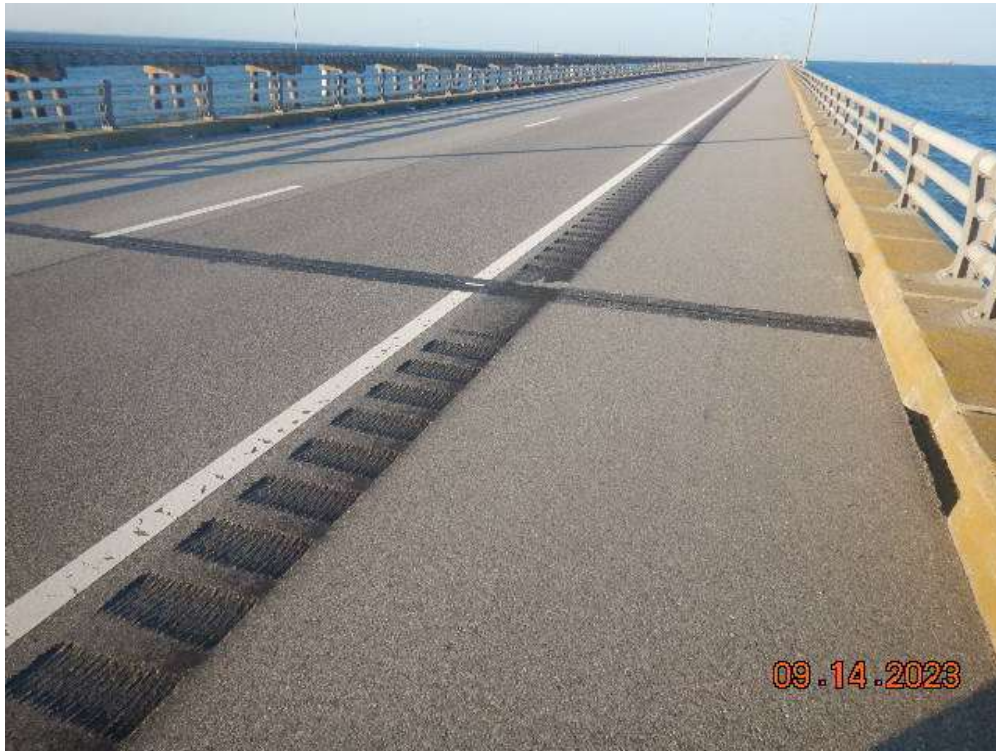
Photo 44: CSB153 Wearing Surface – Typical Good Condition of Deck and Bridge Railing (Looking South)

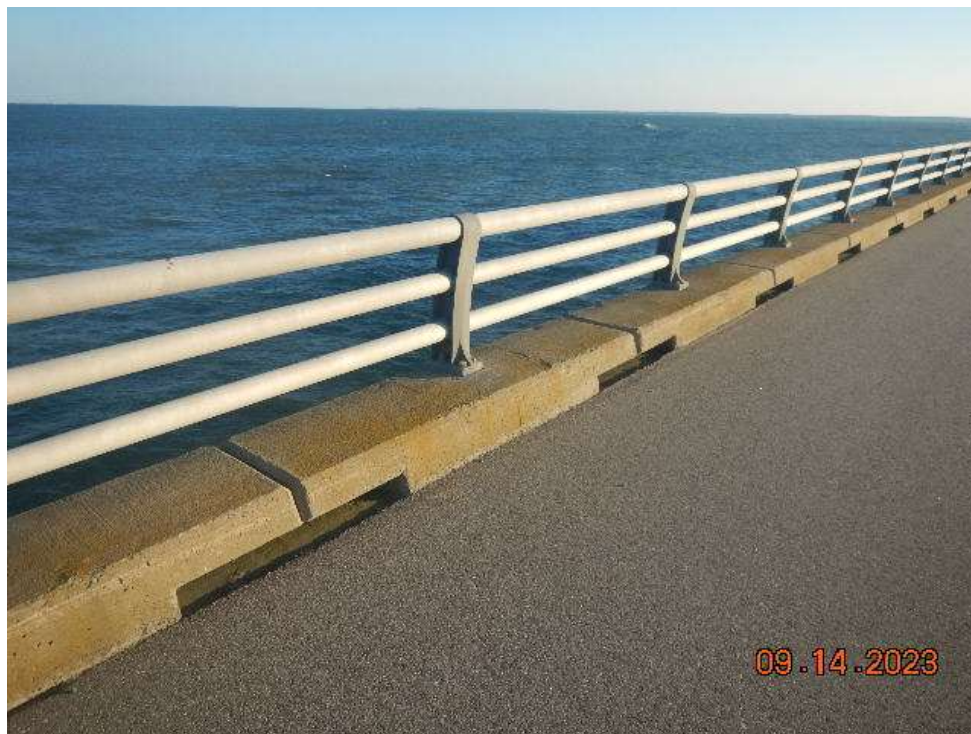
Photo 45: CSB153 Metal Bridge Railing– Typical Good Condition of Bridge Railing (Looking Northwest)

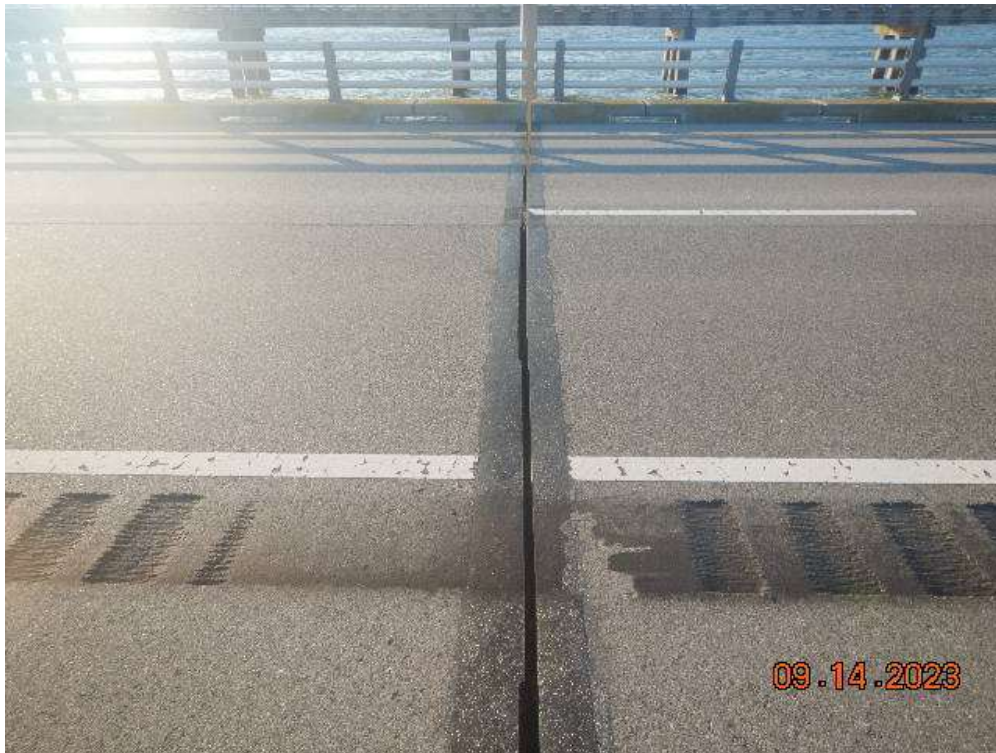
Photo 46: CSB153 Open Expansion Joint – Typical Good Condition of Open Expansion Joints (Looking East)

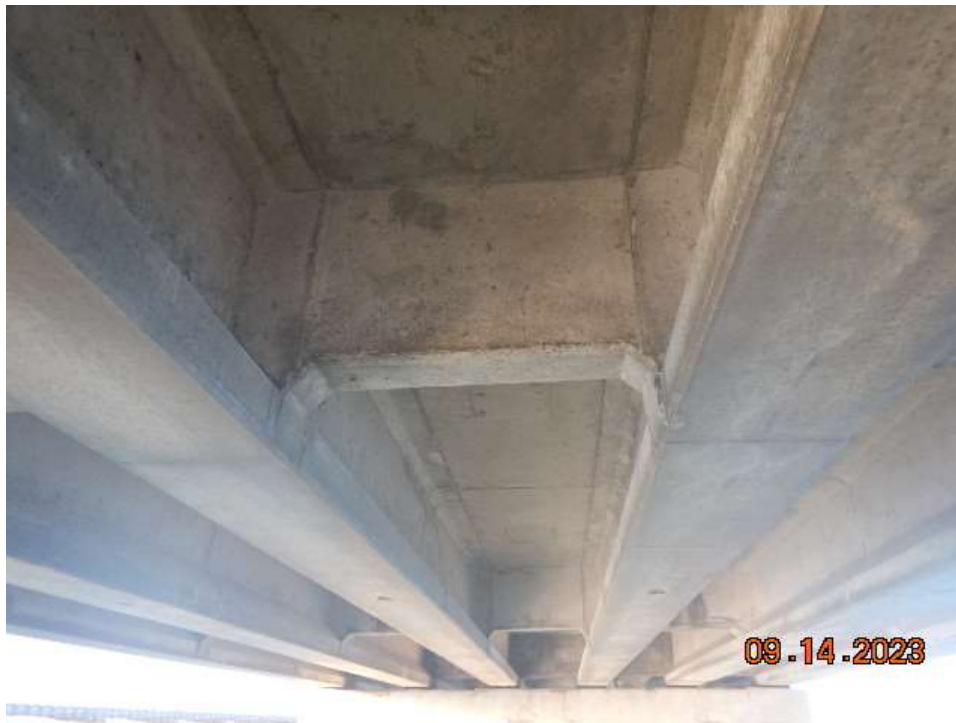
Photo 47: Typical Condition of Superstructure (CSB Span 154 Shown)

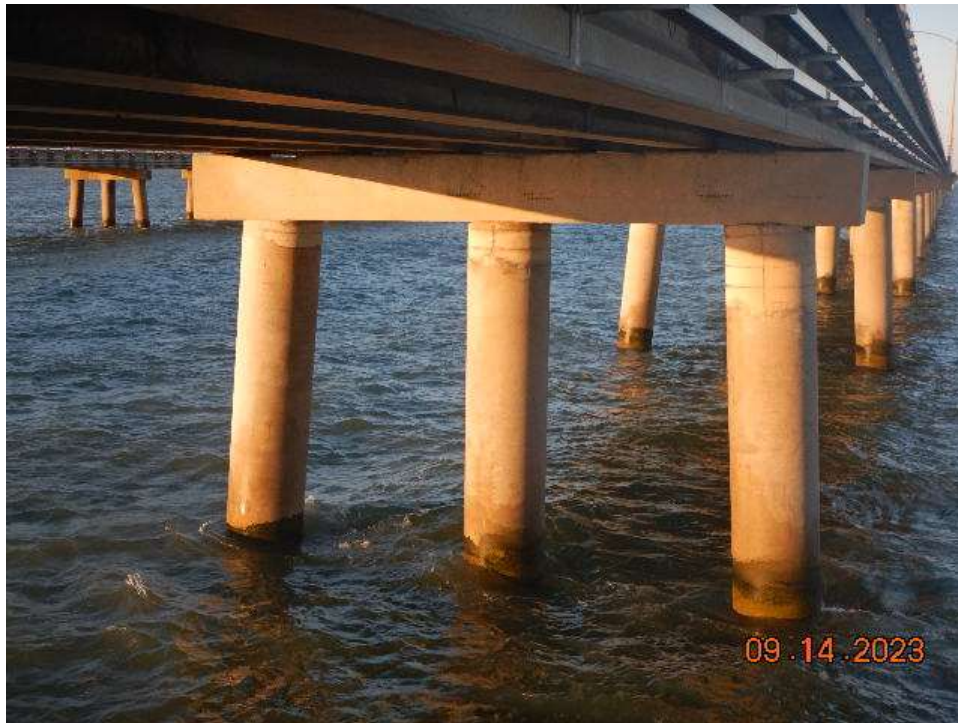
Photo 48: Typical Good Condition of the Pile Bents (Bent 154 Shown)

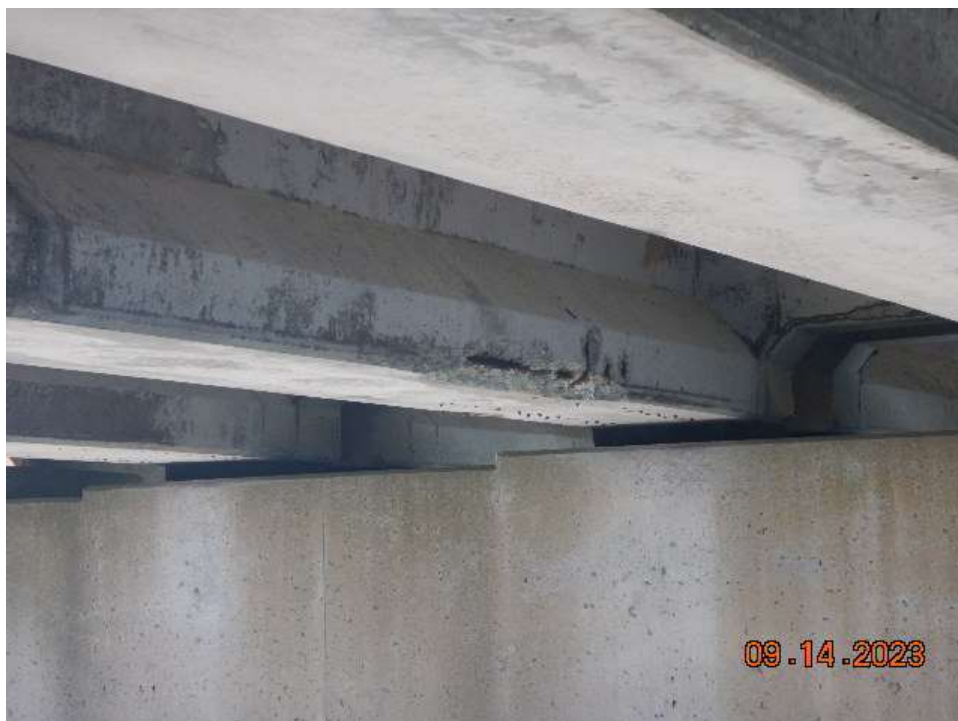
Photo 49: CSB100 – Prestressed Concrete Girder – Girder 4, Spall with Exposed Reinforcing

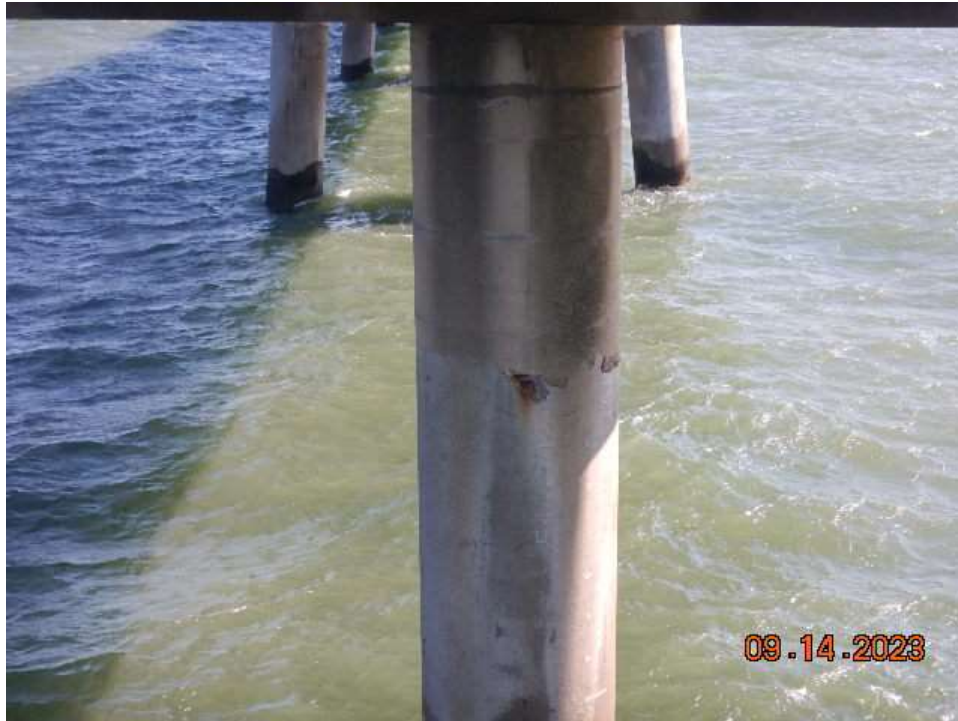
Photo 50: CSB127 Prestressed Concrete Piles – Bent 127, Pile B, Spall with Exposed Reinforcing

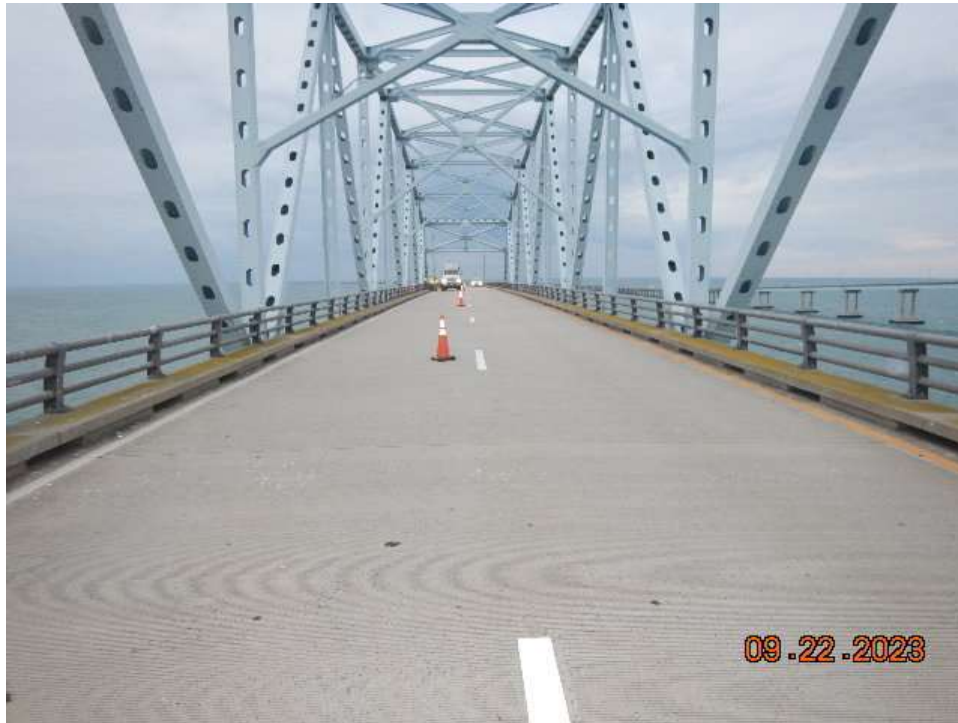
Photo 51: General Condition of Deck and Metal Bridge Railing

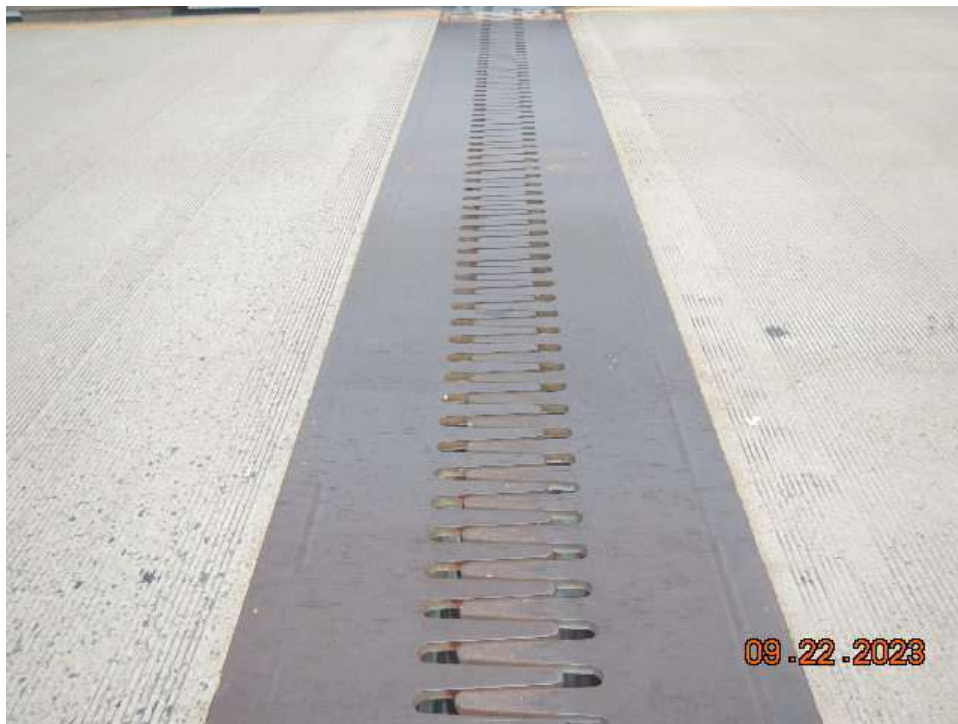
Photo 52: Typical Condition of Finger Joints

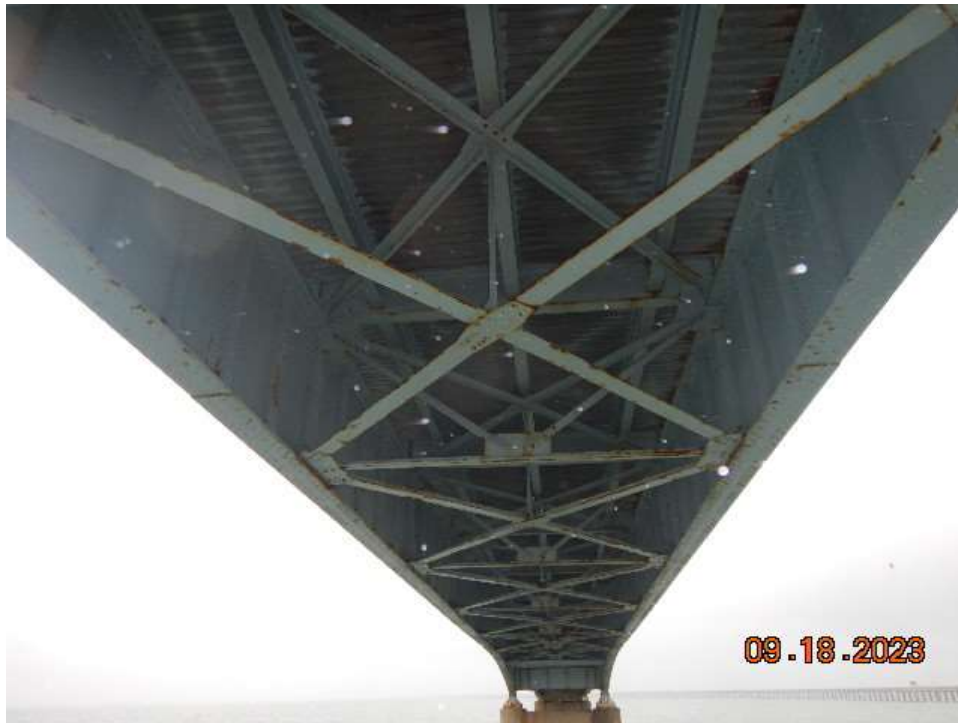
Photo 53: NCB-NB6 – General View of Steel Superstructure

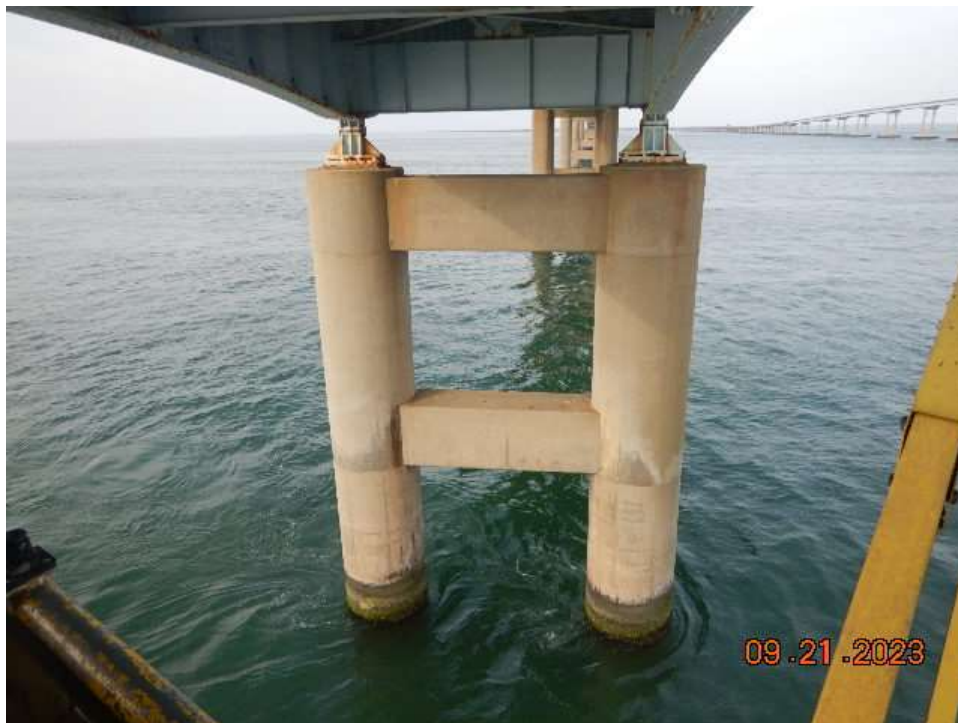
Photo 54: NCB-NB7 – General Condition of Concrete Bent

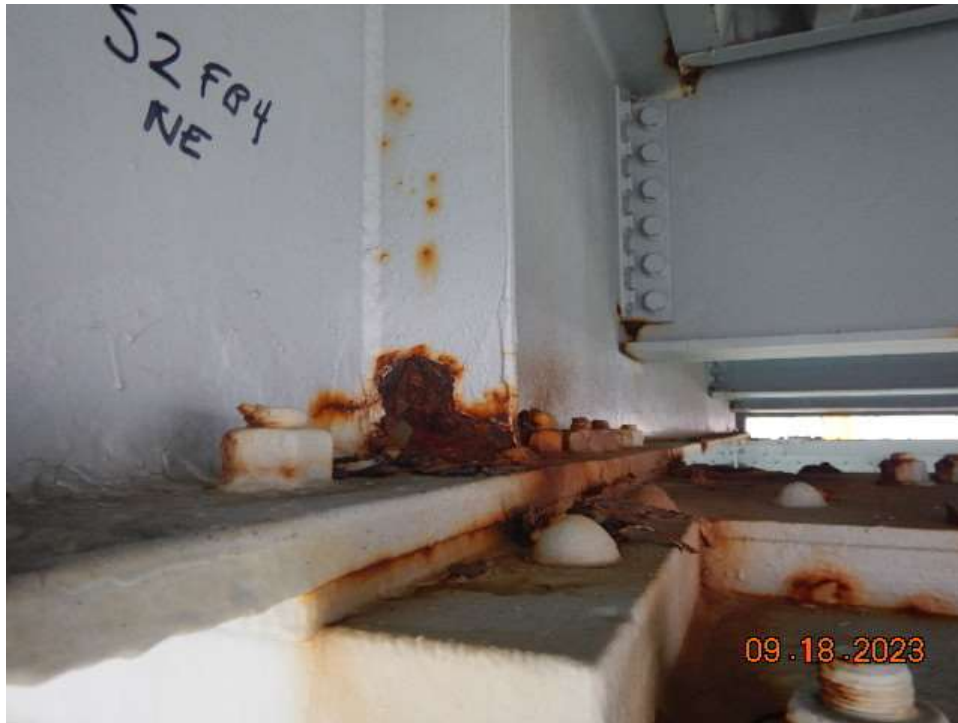
Photo 55: NCB-GB2 Floorbeam – Corrosion Hole in Floorbeam 4, Northeast Stiffener in Span 2

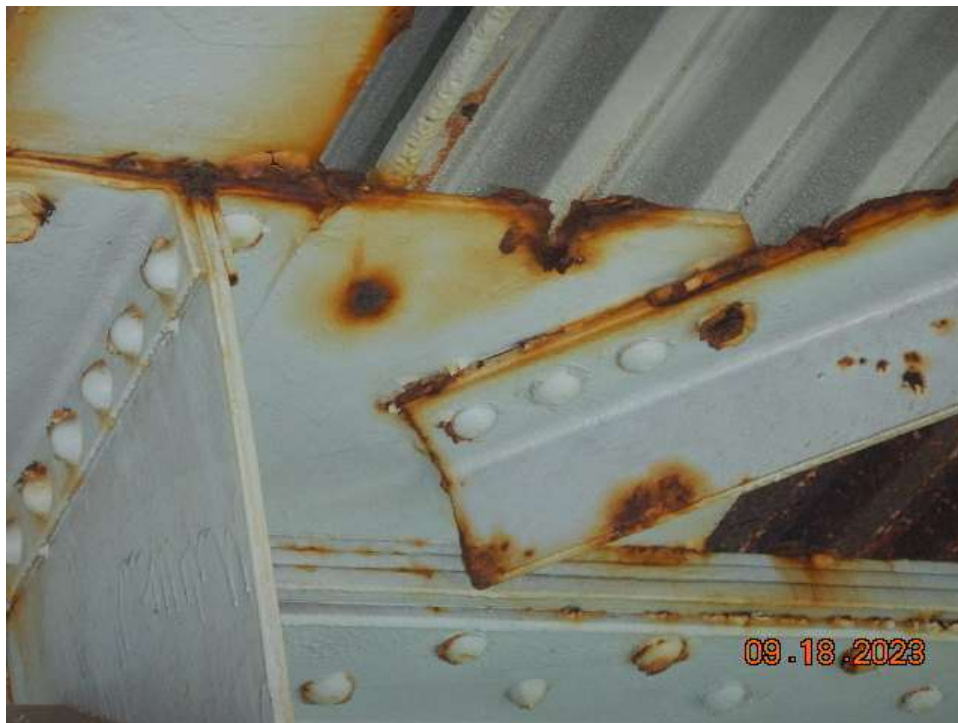
Photo 56: NCB-NB Corrosion with 100% Section Loss in Horizontal Connection Plate

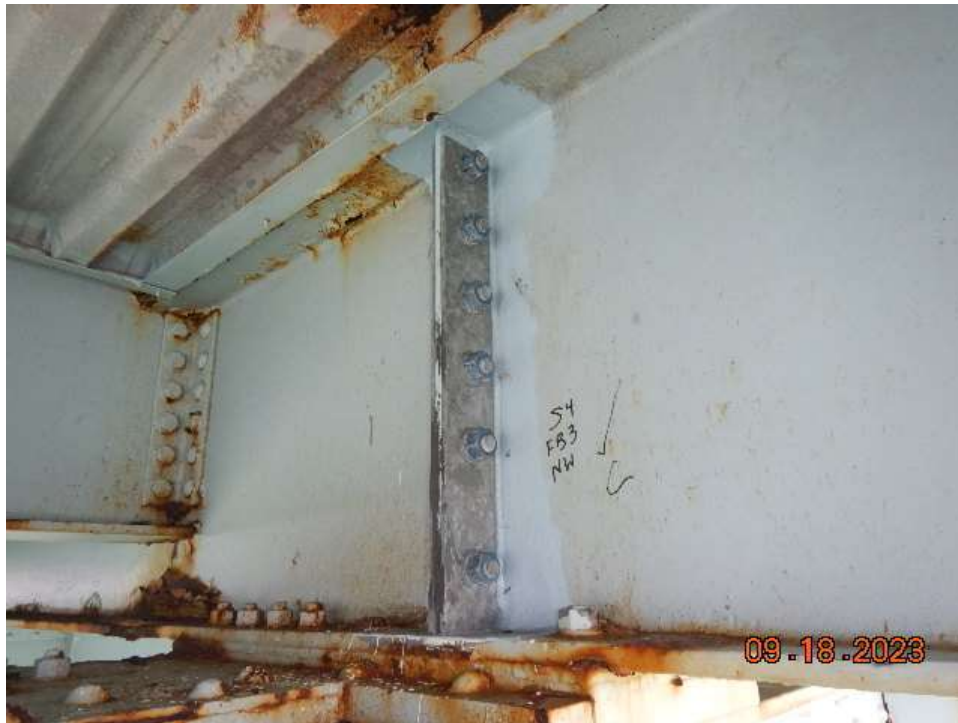
Photo 57: NCB-NB4 Floorbeams – Repaired Northwest Stiffener at Floorbeam 3

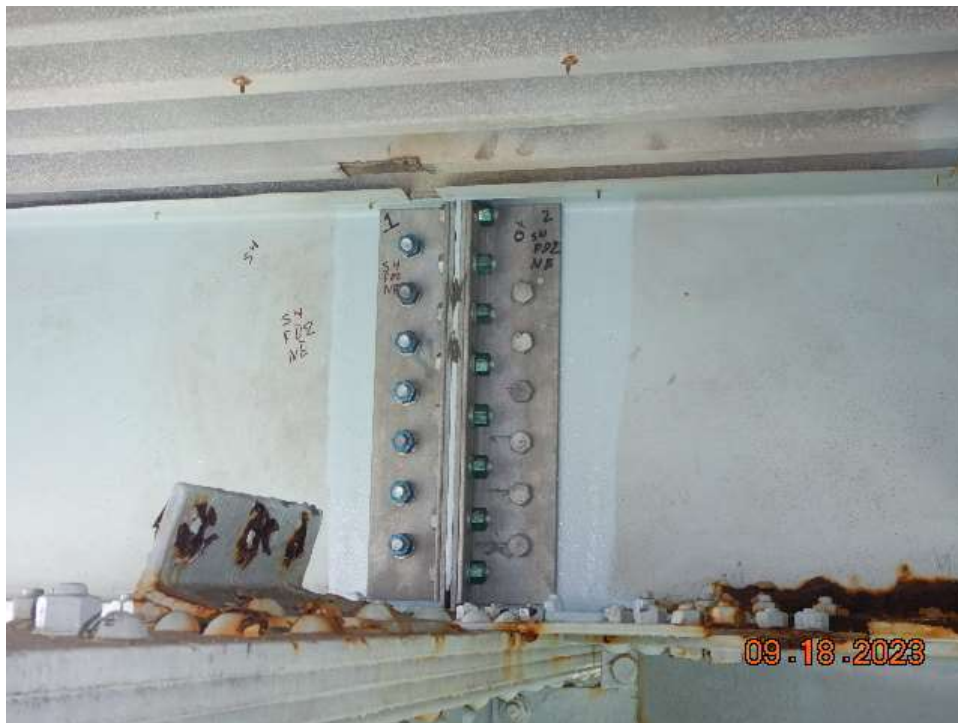
Photo 58: NCB-NB4 Floorbeams: Northeast Stiffener Repair at Floorbeam 2

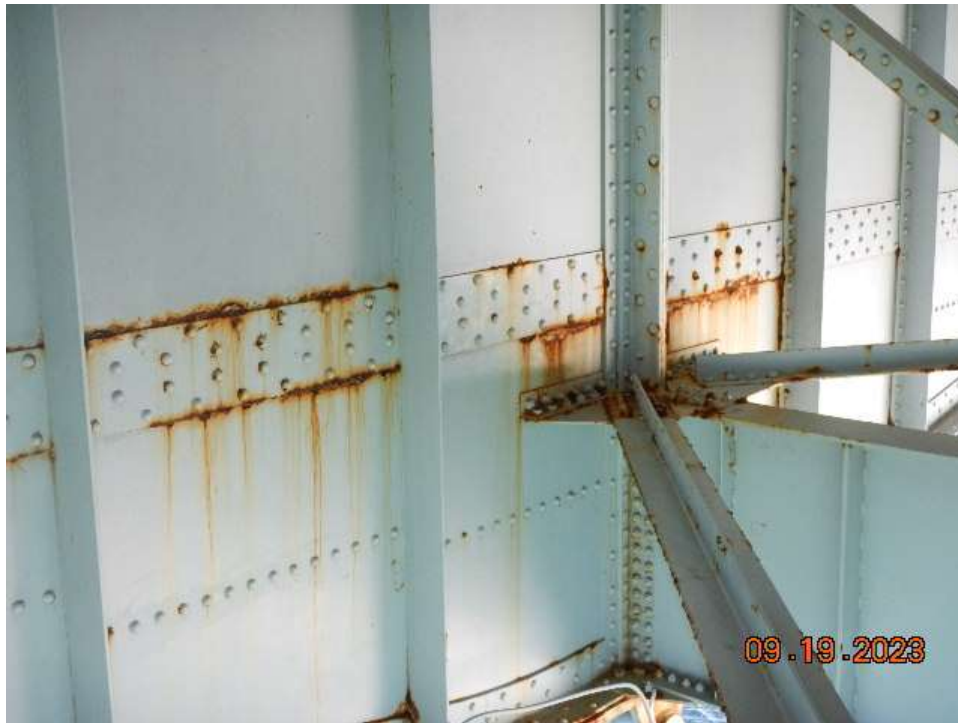
Photo 59: NCB-NB5 Steel Girder – Typical Corrosion at Haunch Splice, Girder 2 at Pier 6

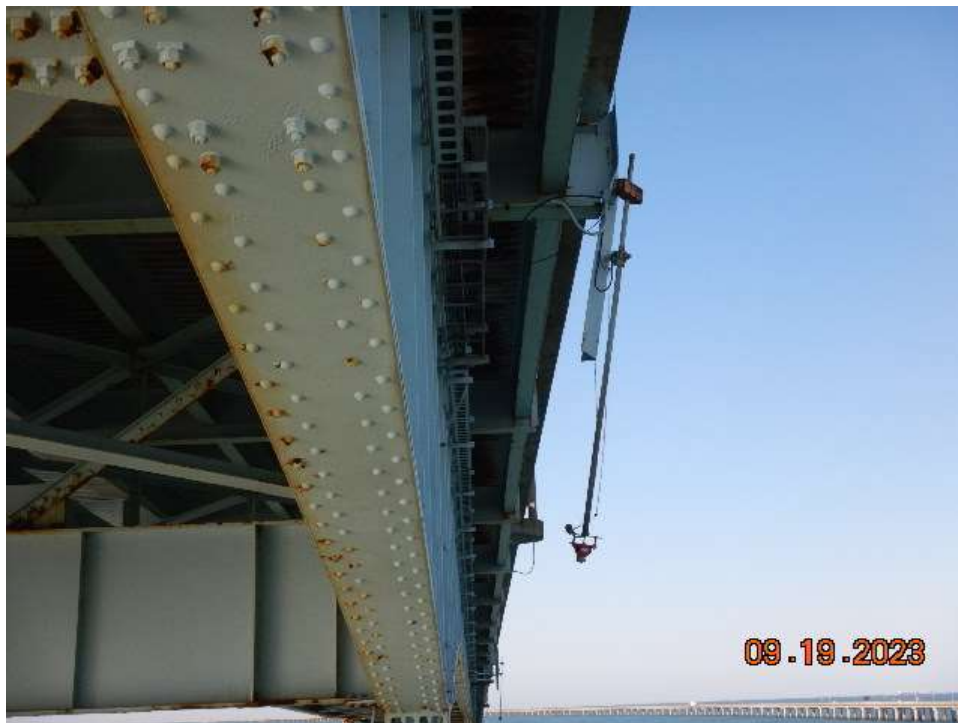
Photo 60: NCB-NB – Bent Connection for Channel Marker at Pier 6, West Side

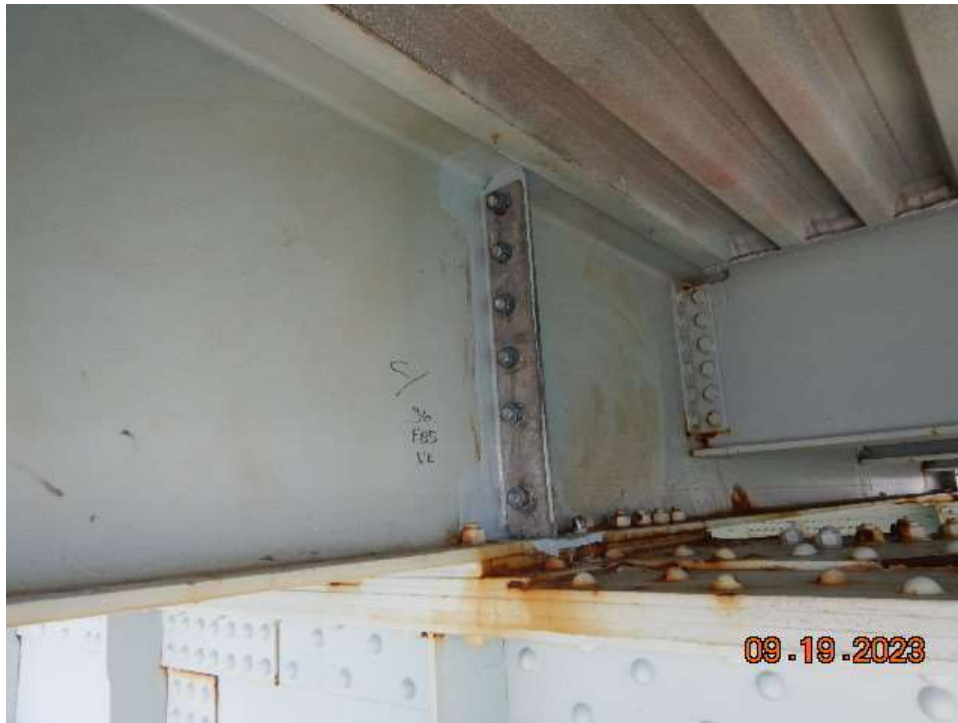
Photo 61: NCB-NB6 Steel Floorbeam – Repaired Northeast Stiffener at Floorbeam 5

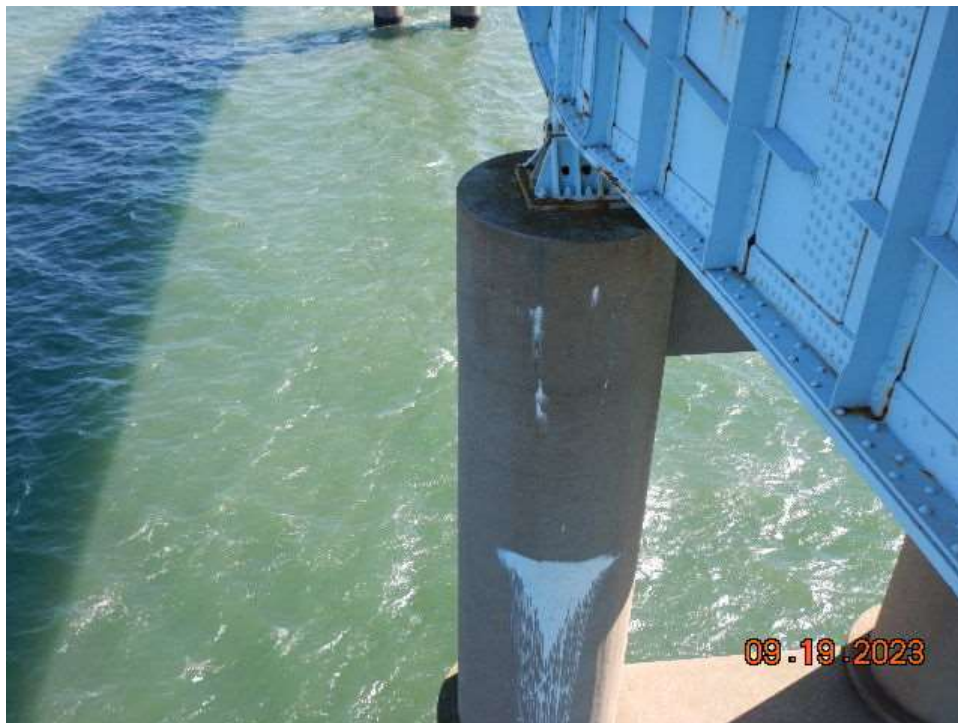
Photo 62: NCB-NB7 Reinforced Concrete Column – Cracking with Heavy Efflorescence on Column 1 at Bent 7

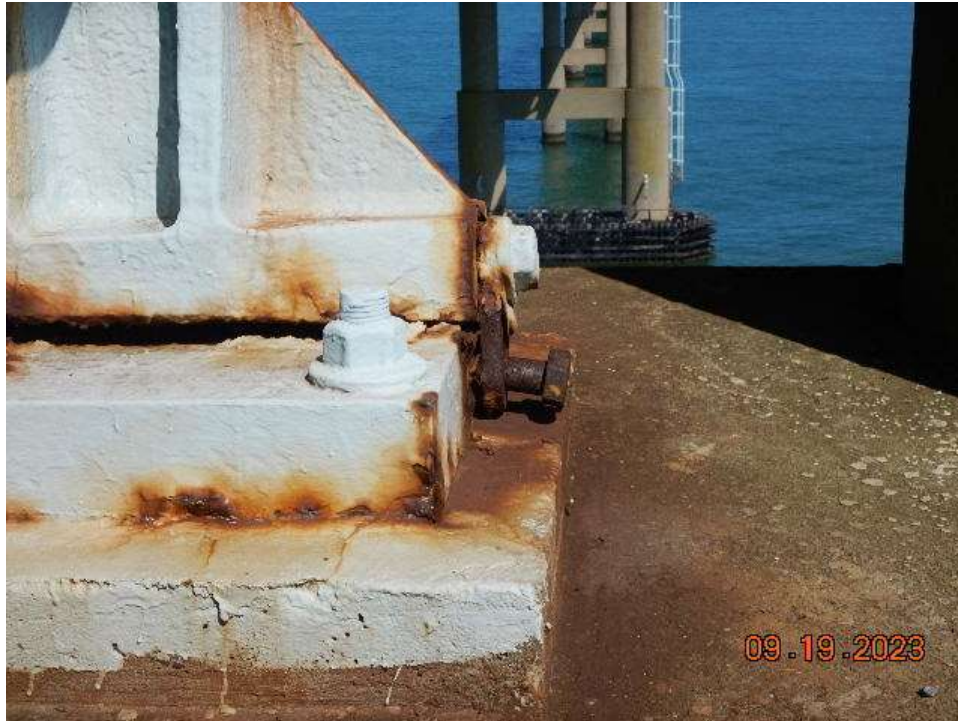
Photo 63: NCB-NB9 – Bearings – Loose Keeper Bolt at Bearing 1

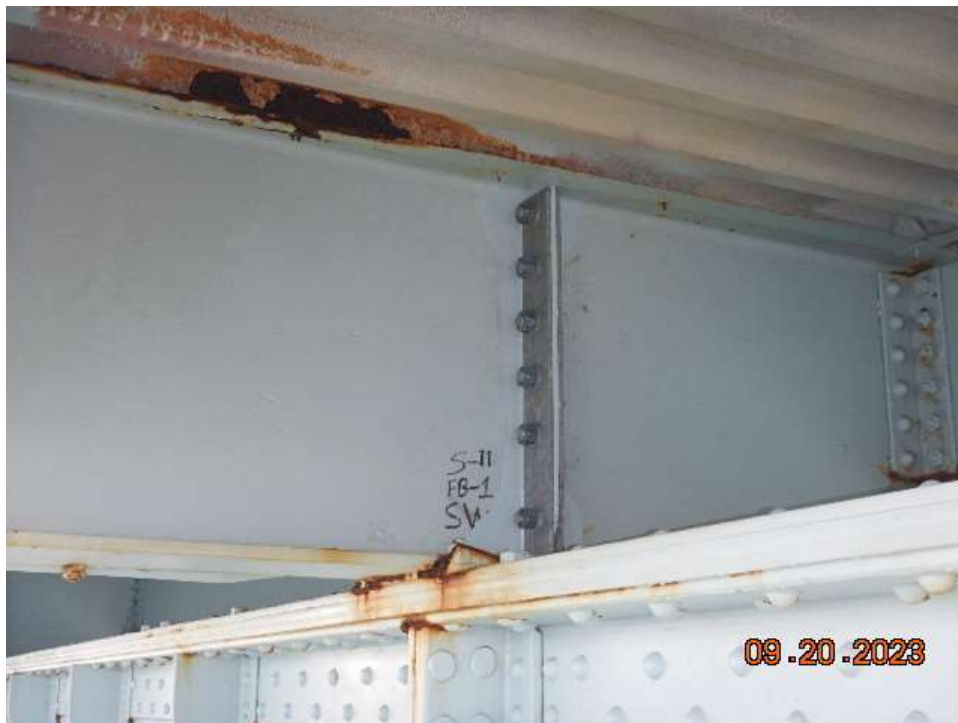
Photo 64: NCB-NB11 Steel Floorbeam – Repaired Southwest Stiffener at Floorbeam 1
