FY2024 Annual Inspection and Underwater Inspection, Trestles ANB, A'NB & ASB

FY2024 Facility Annual Inspection Report FINAL

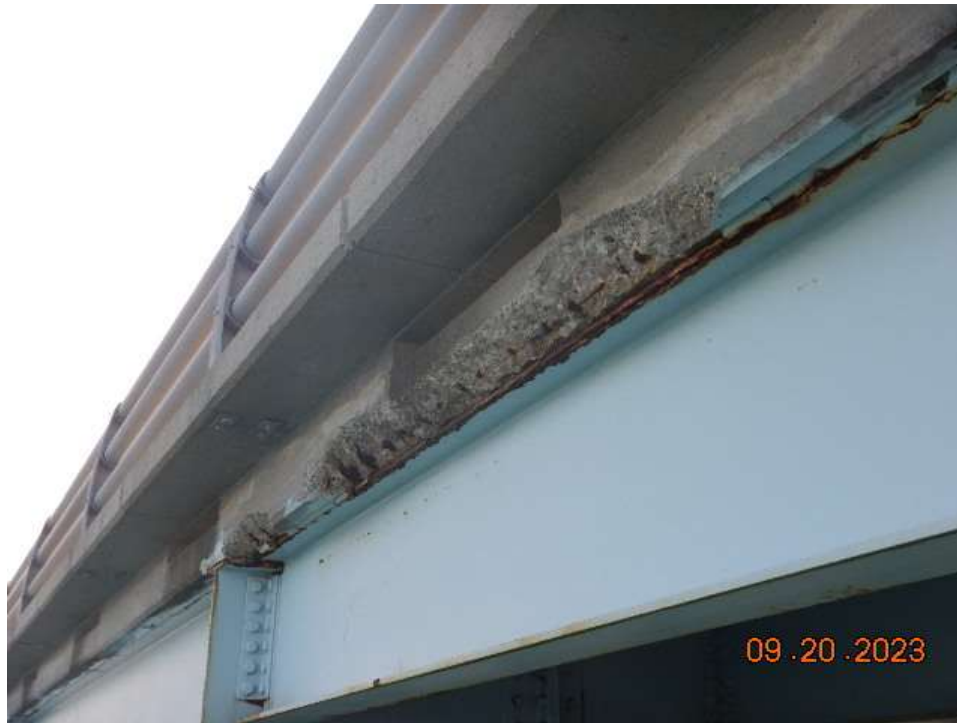
Photo 65: NCB-NB11 Reinforced Concrete Deck – Spall with Exposed Reinforcing in the West Fascia near Floorbeam 9

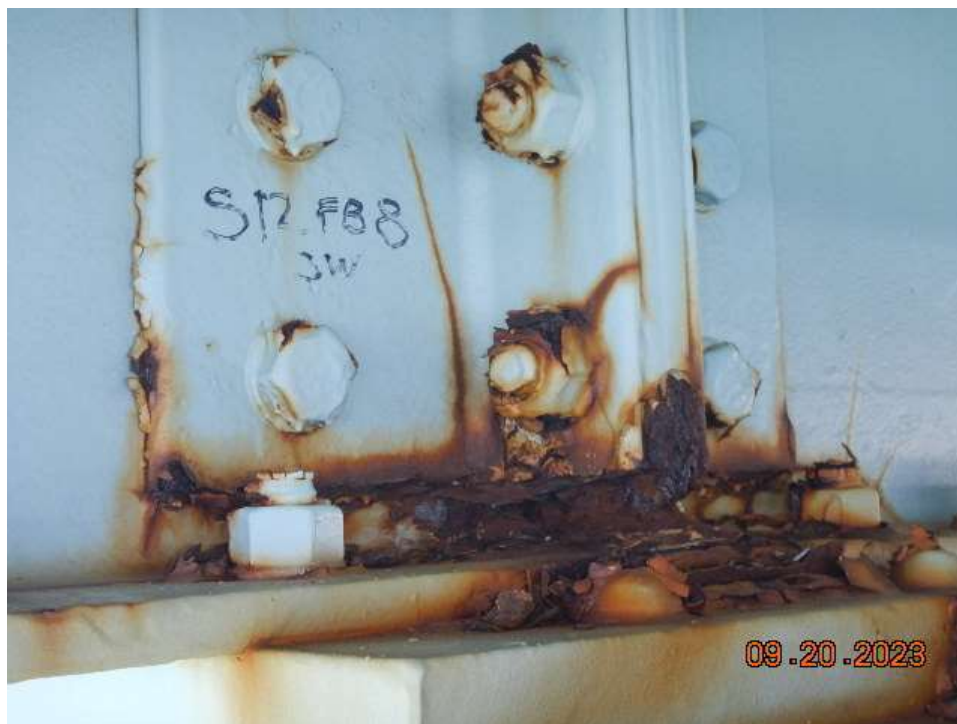
Photo 66: NCB-NB12 Steel Floorbeam – Crack in Connection Plate at the Southwest Stiffener at Floorbeam 8

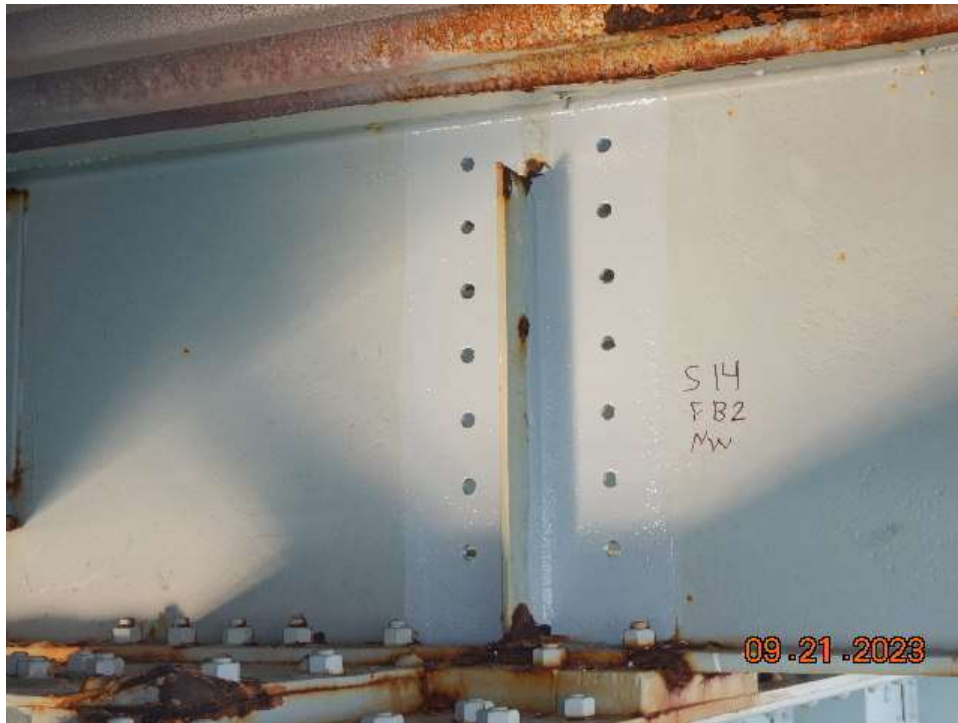
Photo 67: NCB-NB14 Steel Floorbeam – Northwest Stiffener Prepared for Repair at Floorbeam 2

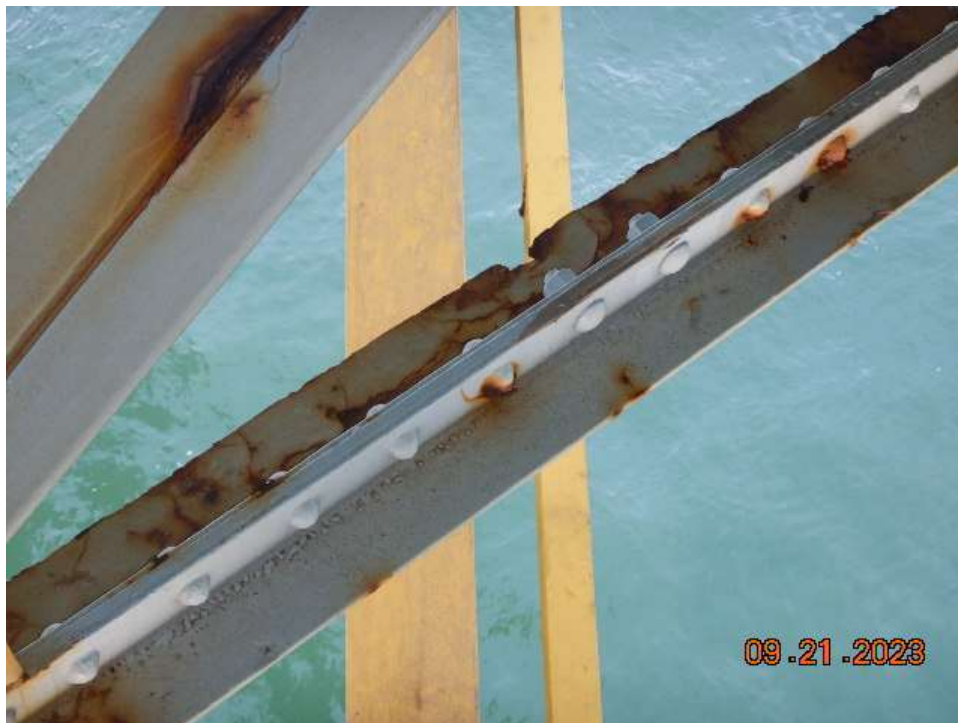
Photo 68: NCB-NB15 – Peeling Paint with up to 100% Section Loss in Cross Bracing at Floorbeam 6

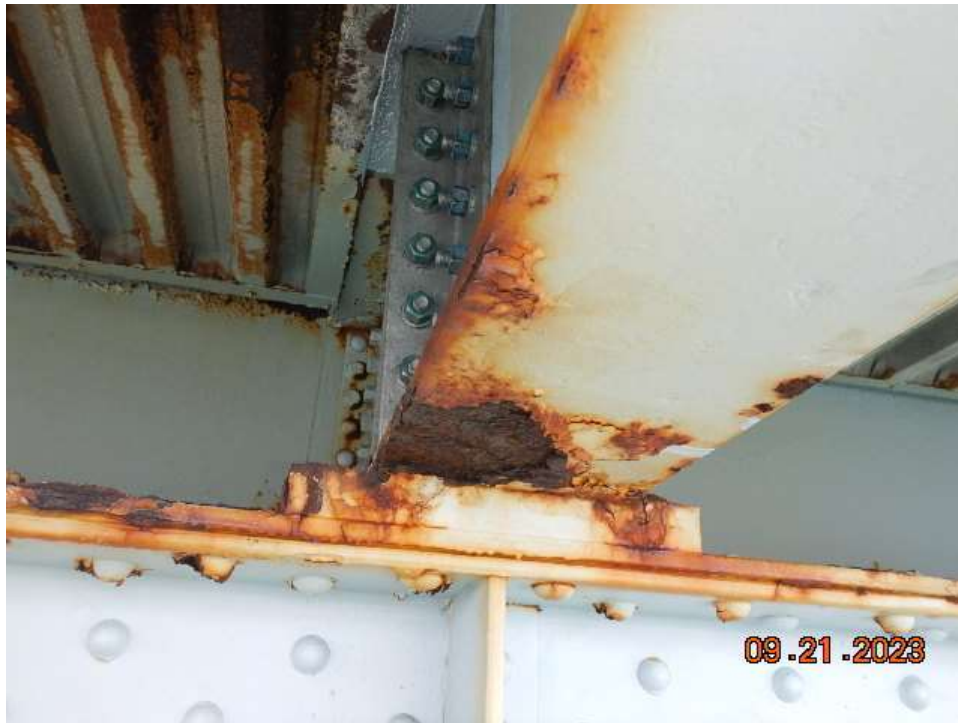
Photo 69: NCB-NB17 Steel Floorbeam – Corrosion with Section Loss on Bottom Flange of Floorbeam 8, West Cantilever

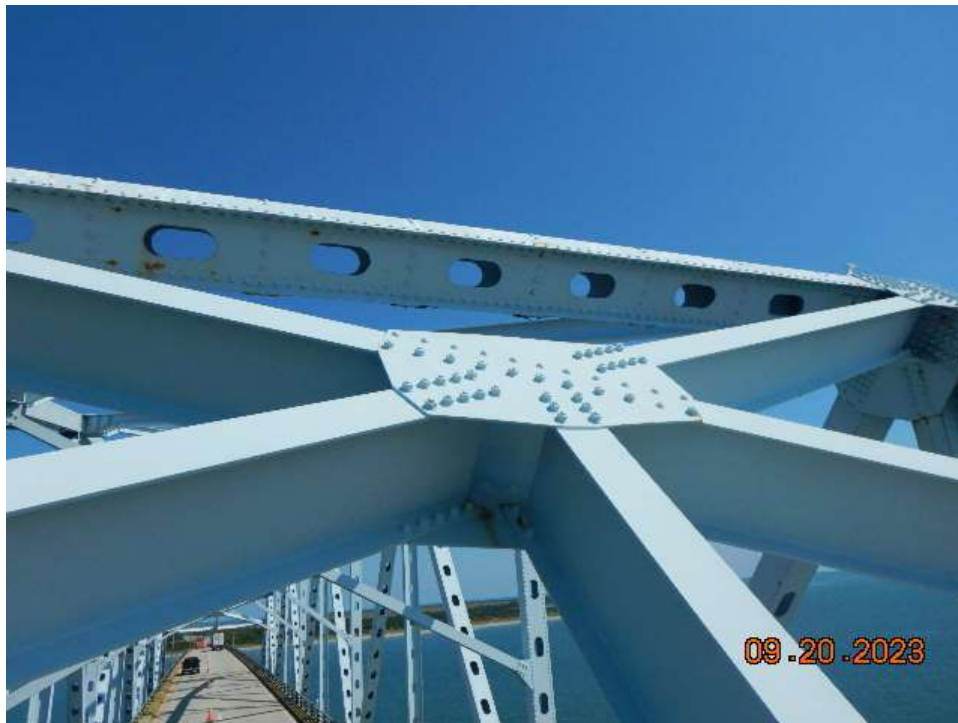
Photo 70: NCB-NB9 Steel Truss – Typical Condition of South Portal Bracing at Bent 9

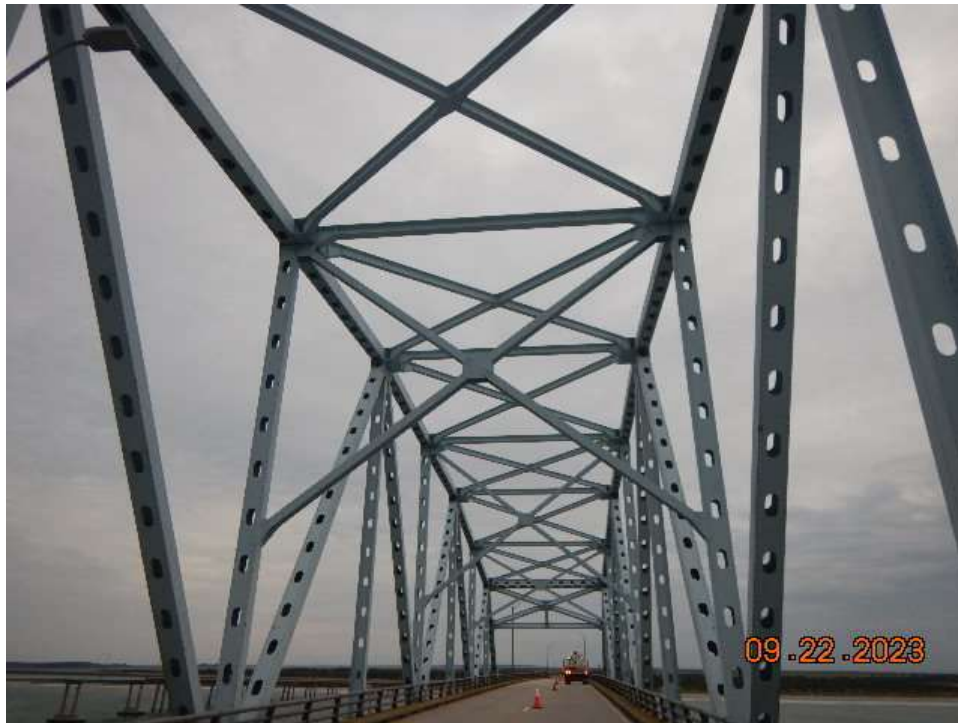
Photo 71: NCB-NB9 Steel Truss – Typical View and Condition of Upper Chord, Verticals and Diagonals

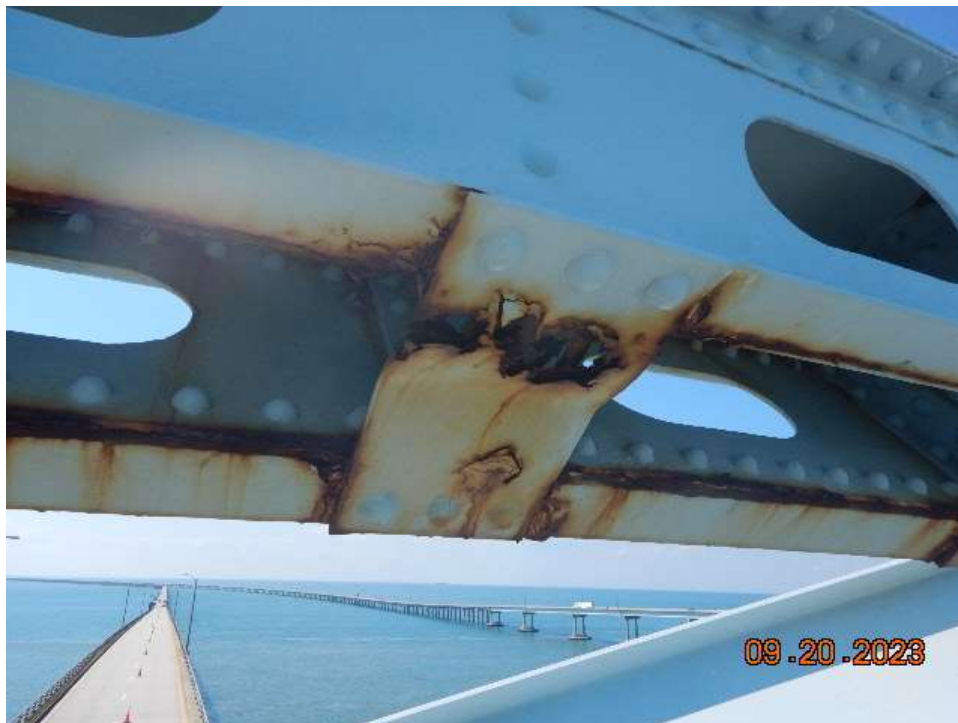
Photo 72: NCB-NB9 Steel Truss – Corrosion with 100% Section Loss of Batten Plates at South Portal Bracing

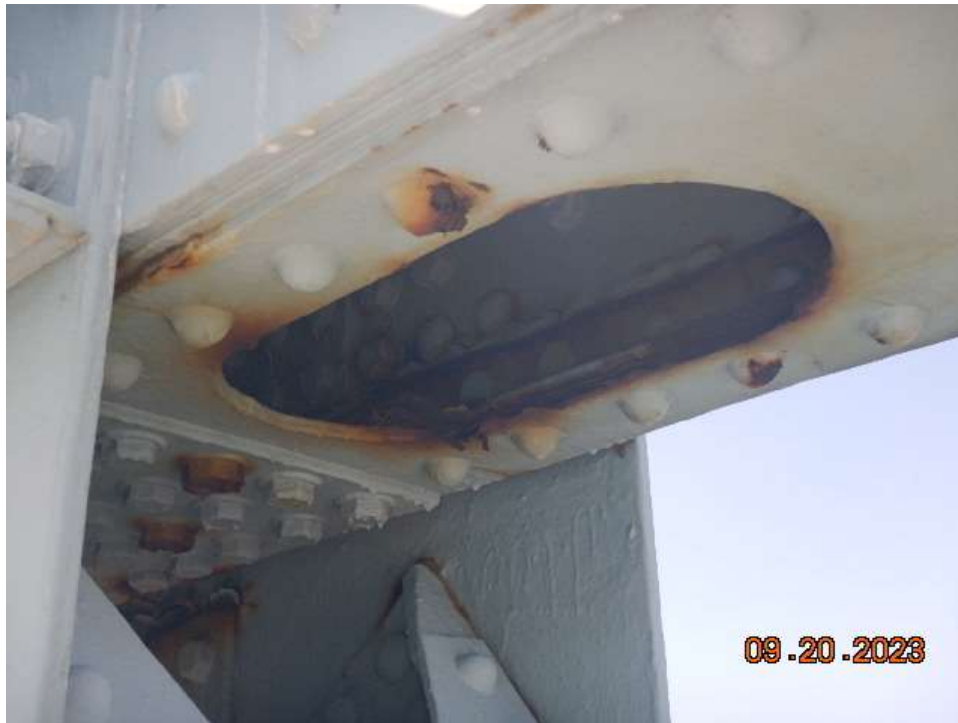
Photo 73: NCB-NB9 Steel Truss – Corrosion with Minor Section Loss at Handhole in the Upper Chord at U5, West Truss

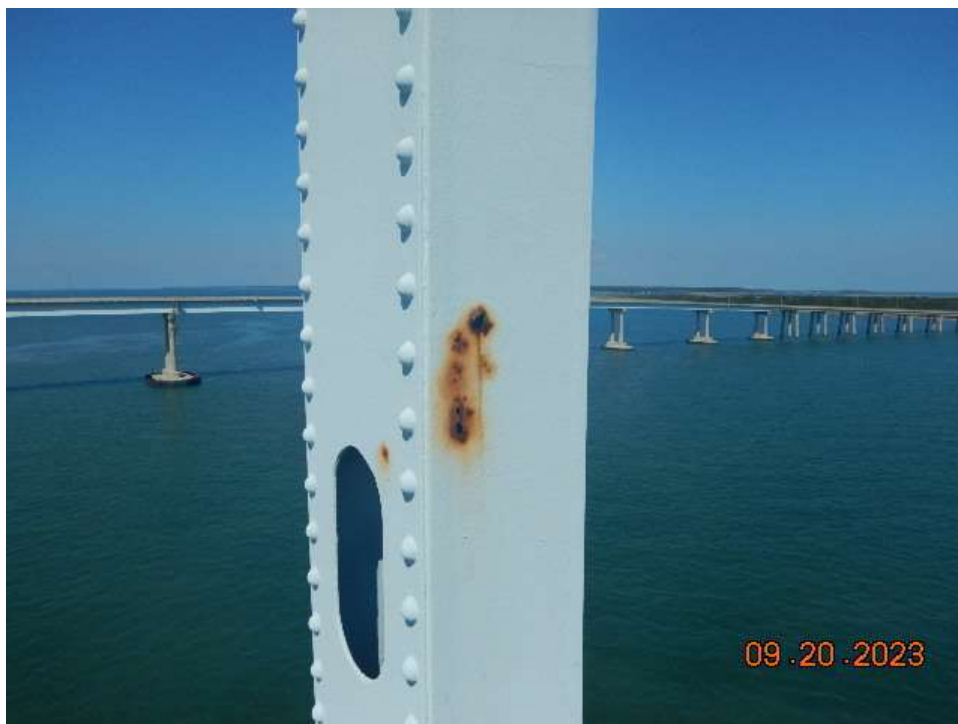
Photo 74: NCB-NB9 Steel Truss – Corrosion Holes in Vertical U4'L4', West Truss

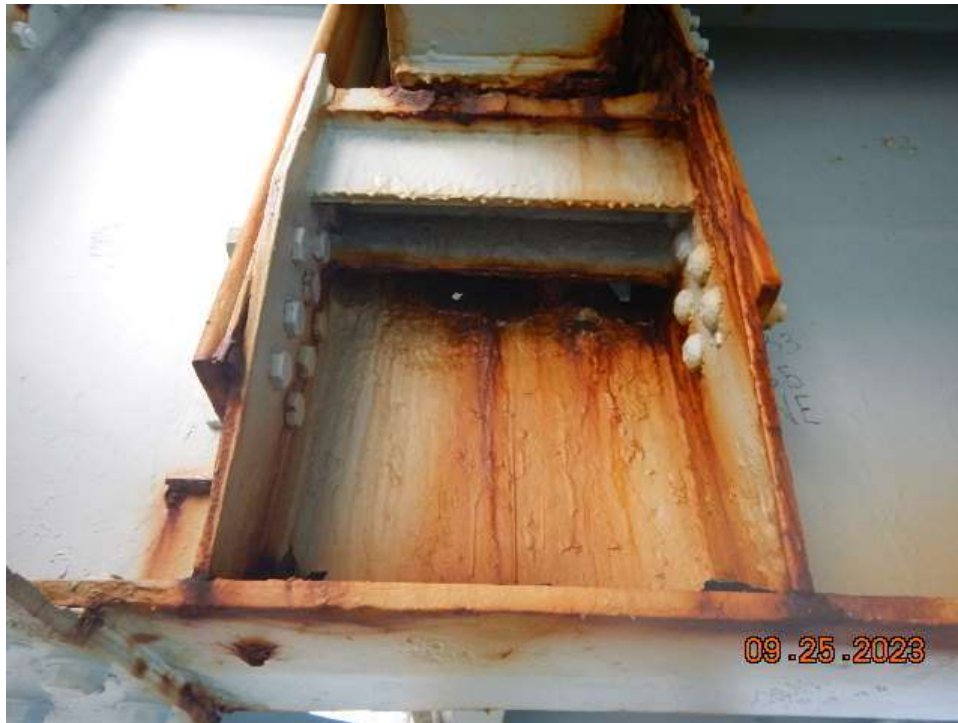
Photo 74: NCB-NB9 Steel Floorbeam – 100% Section Loss in Floorbeam 3 Web at the Northeast Corner below Stringer 5

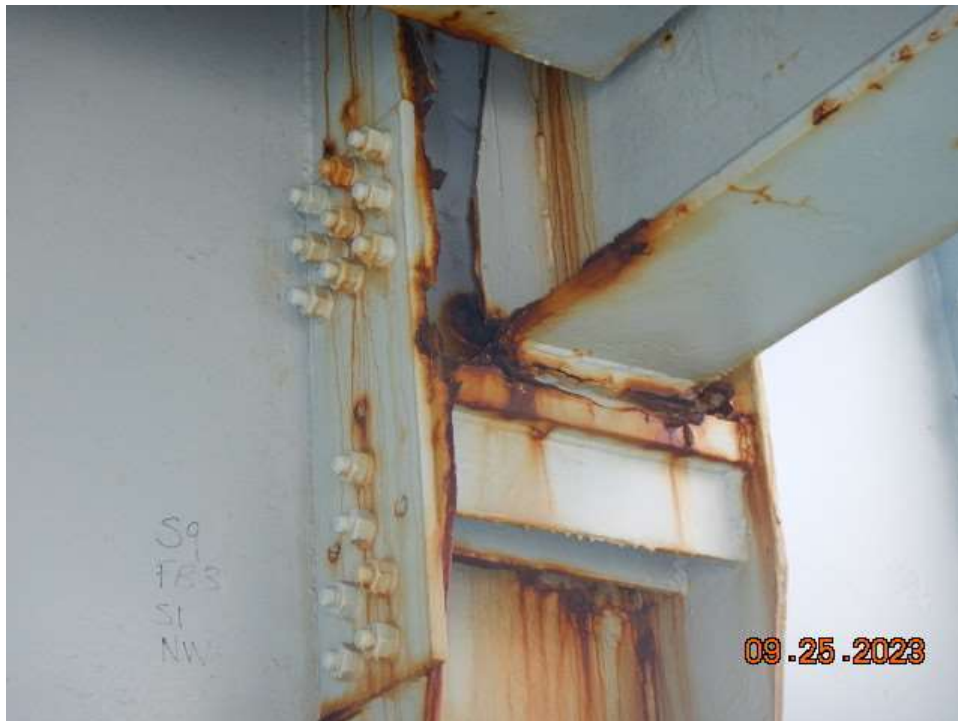
Photo 75: NCB-NB9 Steel Floorbeam – Severe Corrosion with 100% Section Loss in Floorbeam 3 Web under Stringer 1

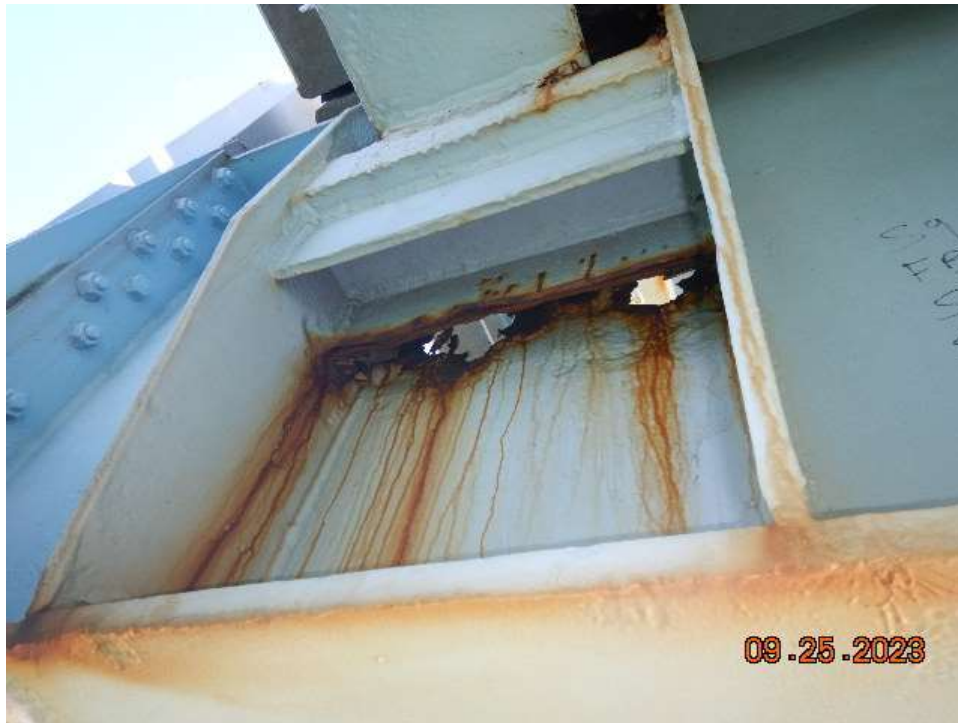
Photo 76: NCB-NB9 Steel Floorbeam – Severe Corrosion with 100% Section Loss in Floorbeam 3' Web

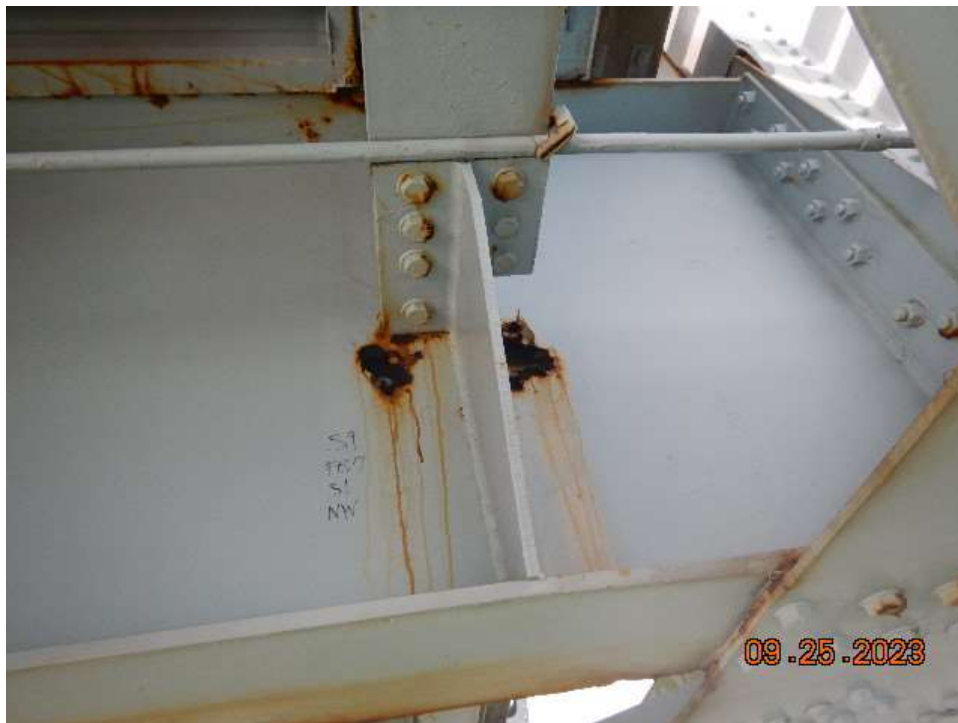
Photo 77: NCB-NB9 Steel Floorbeam – Severe Corrosion with 100% Section Loss in Floorbeam 3' Web at Stringer 1

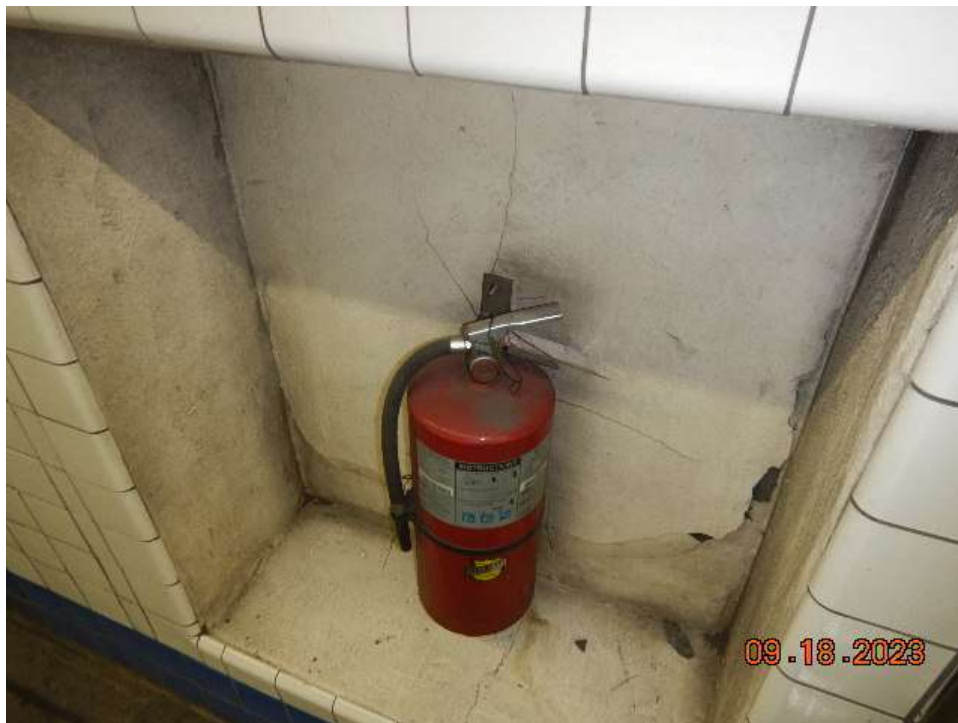
Photo 81: Typical Replaced Fire Extinguisher (100% of Fire Extinguishers replaced since 2021)

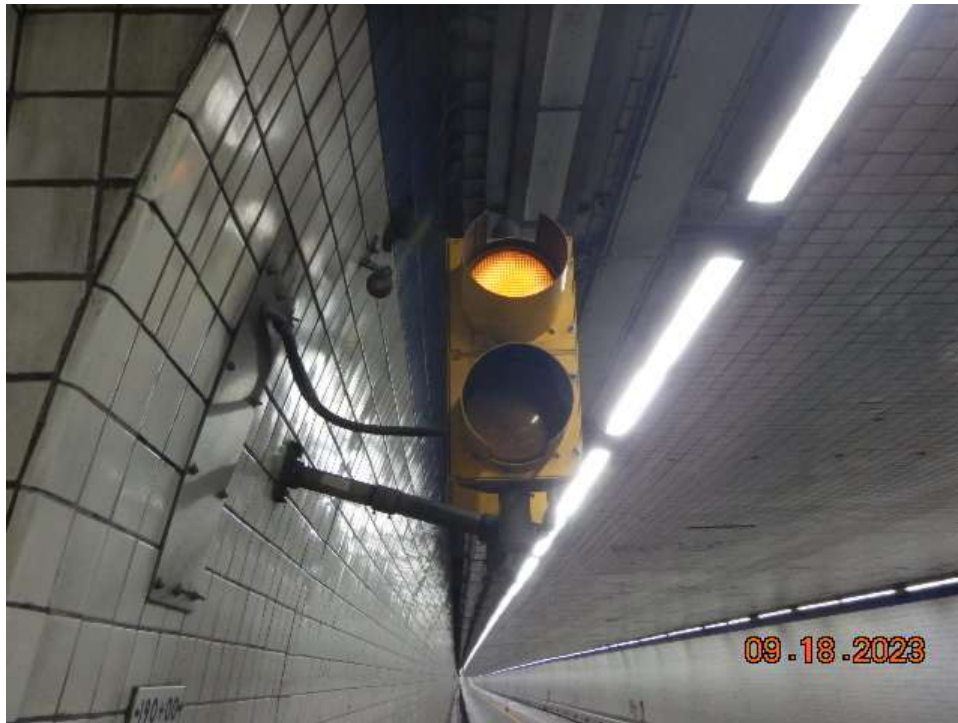
Photo 82: Sta. 190+00 – Non-functioning Signal Light (Bottom Light Never Illuminated)

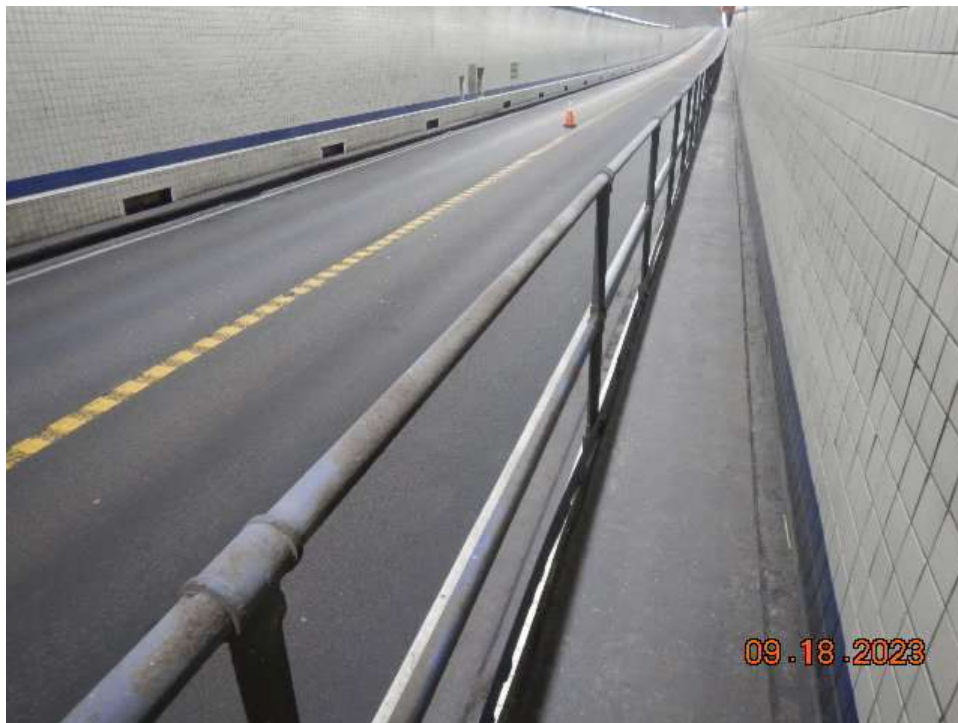
Photo 83: Typical Condition of Metal Handrail with Corrosion

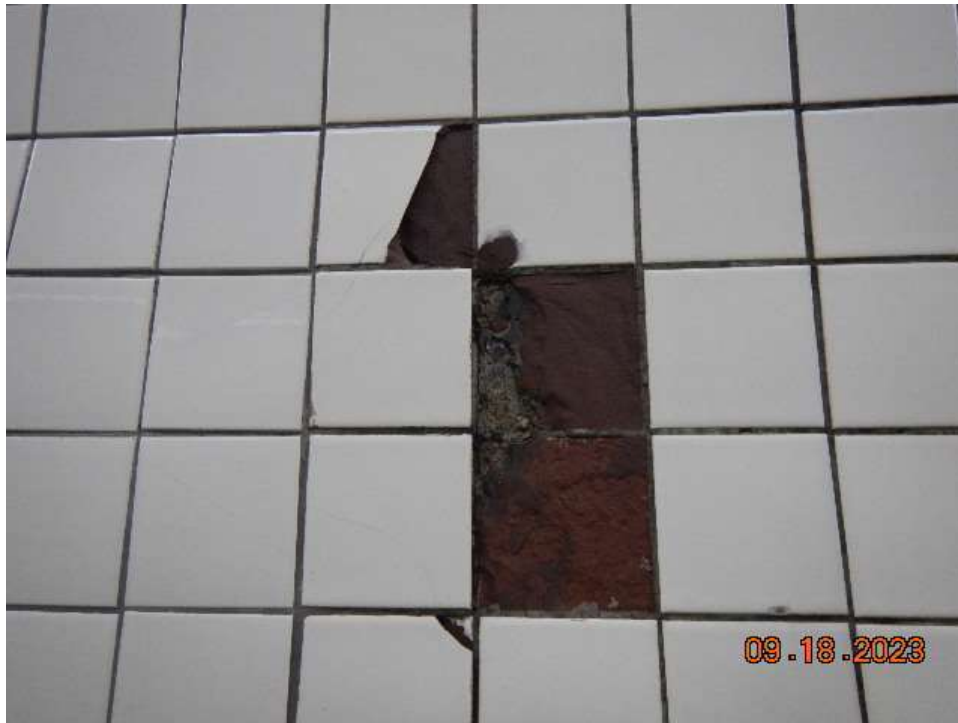
Photo 84: Sta. 194+05 – Broken and Missing Tiles on West Wall Adjacent to Safety Walkway

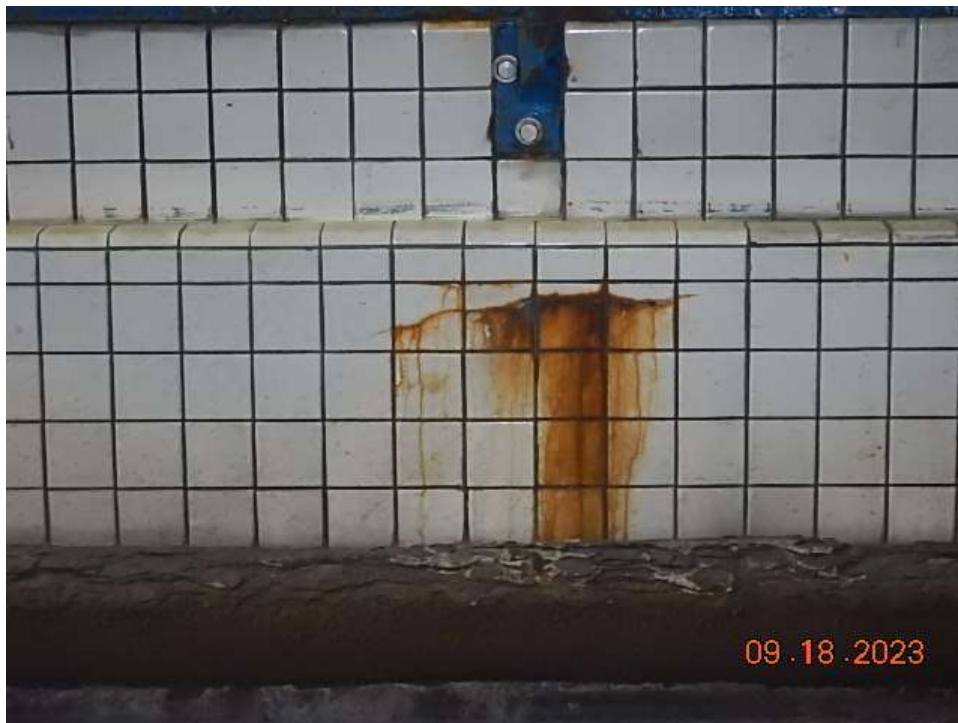
Photo 85: Sta. 210+95 – Four Cracked Tiles with Rust Staining Below Safety Walkway

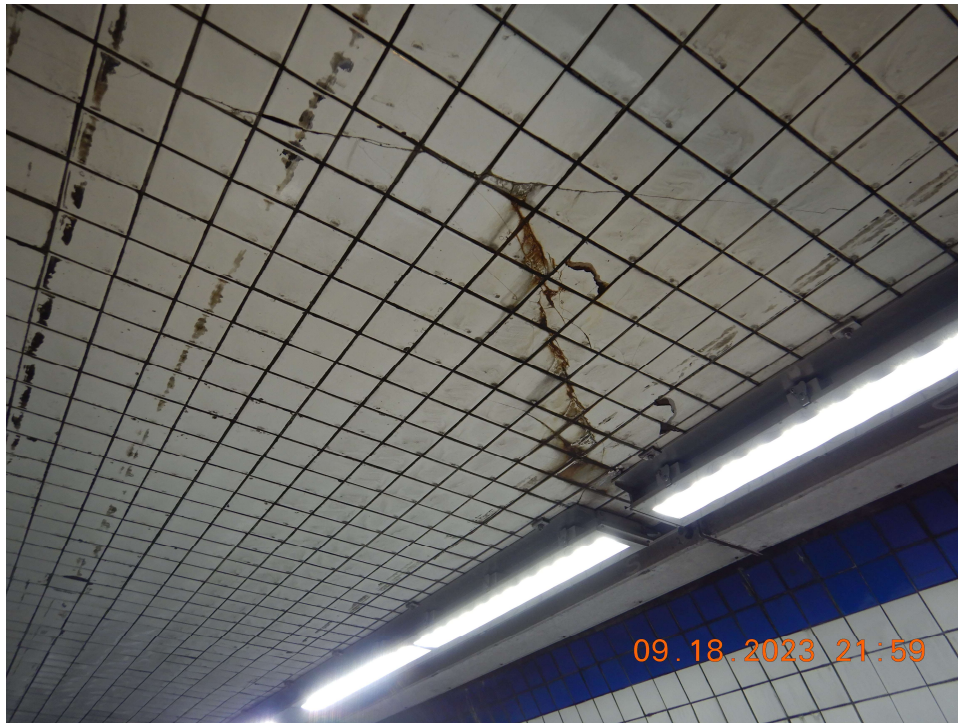
Photo 86: Sta. 195+65 – Cracked Ceiling Tiles with Rust Stains over NB Lane

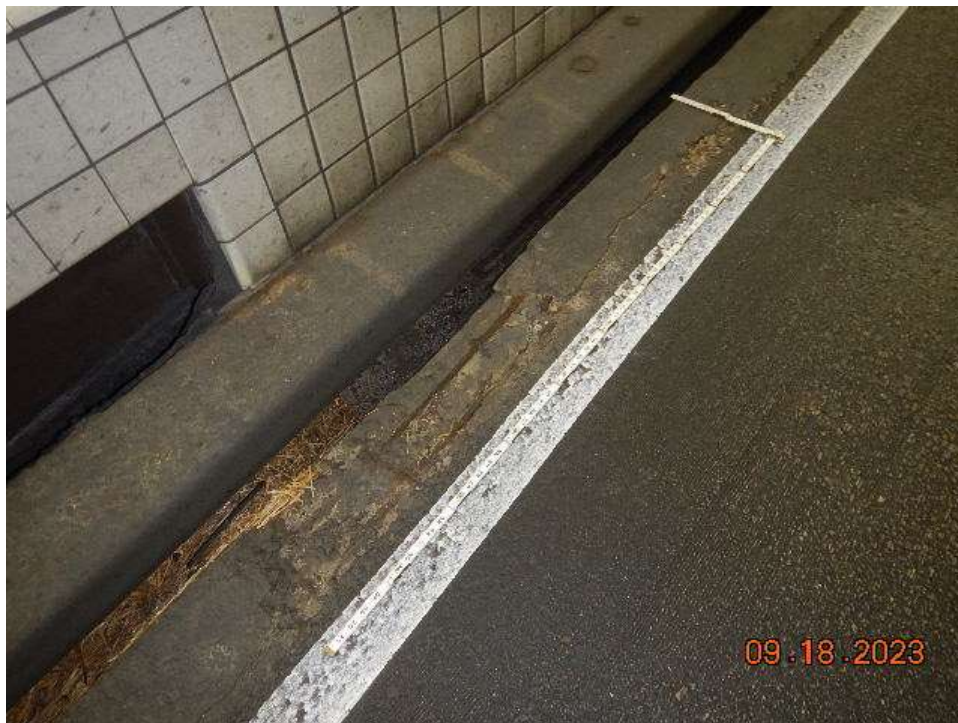
Photo 87: Typical Spalling of Invert Slab along Curblin (175 SF Total in Tunnel)

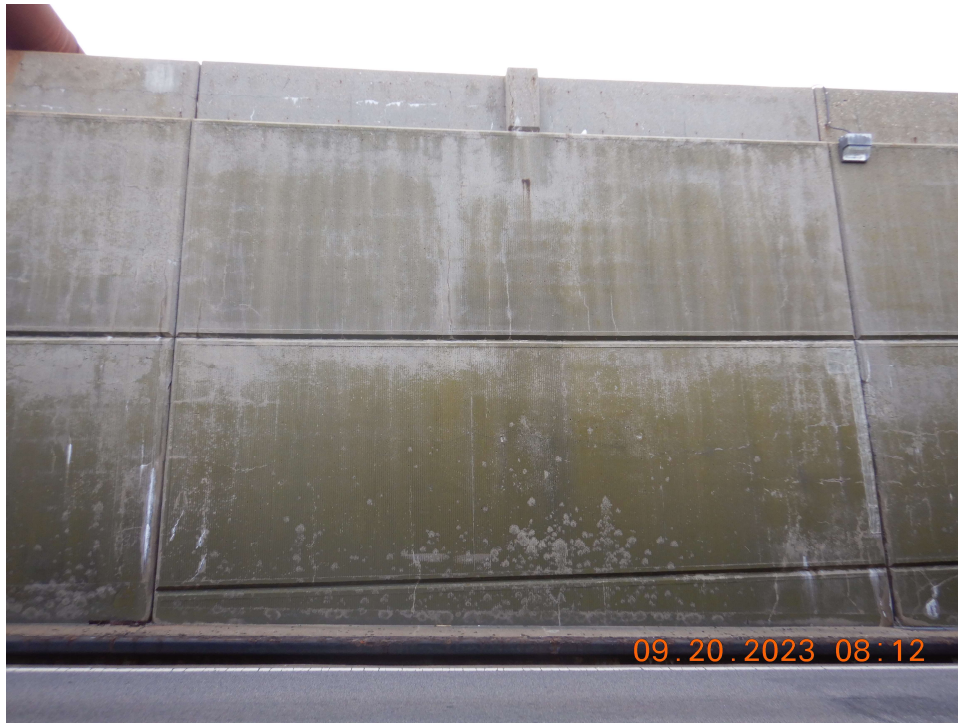
Photo 88: Typical Hairline Cracking with Efflorescence of Open Approach Retaining Walls (Island 2 Approach Shown)

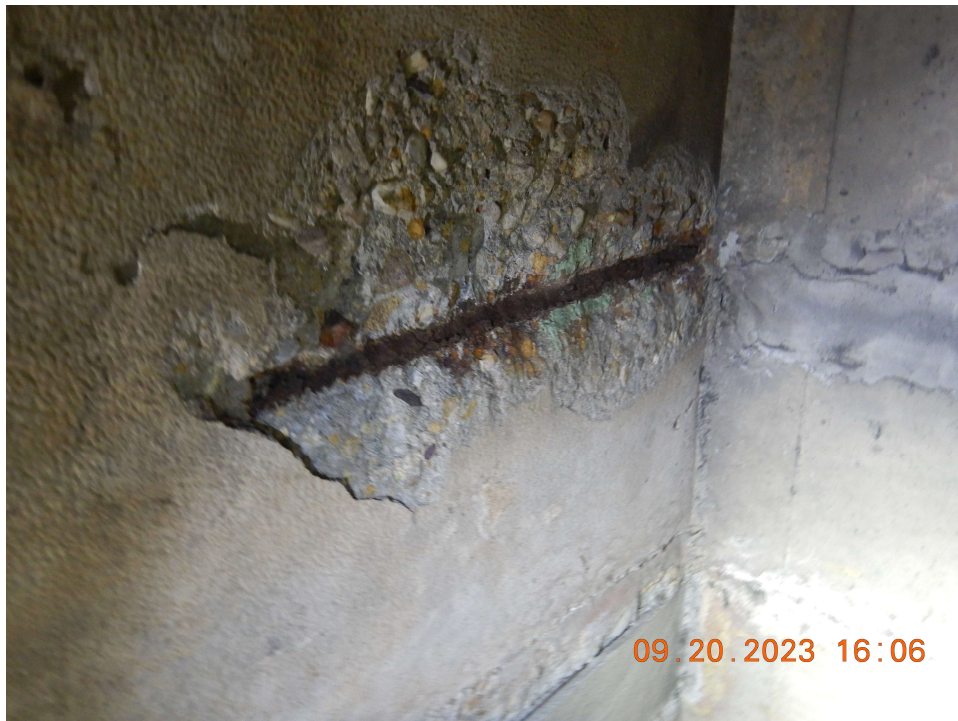
Photo 89: Supply Duct – Sta. 191+10 Spall with Exposed Reinforcement in Underside of Invert Slab

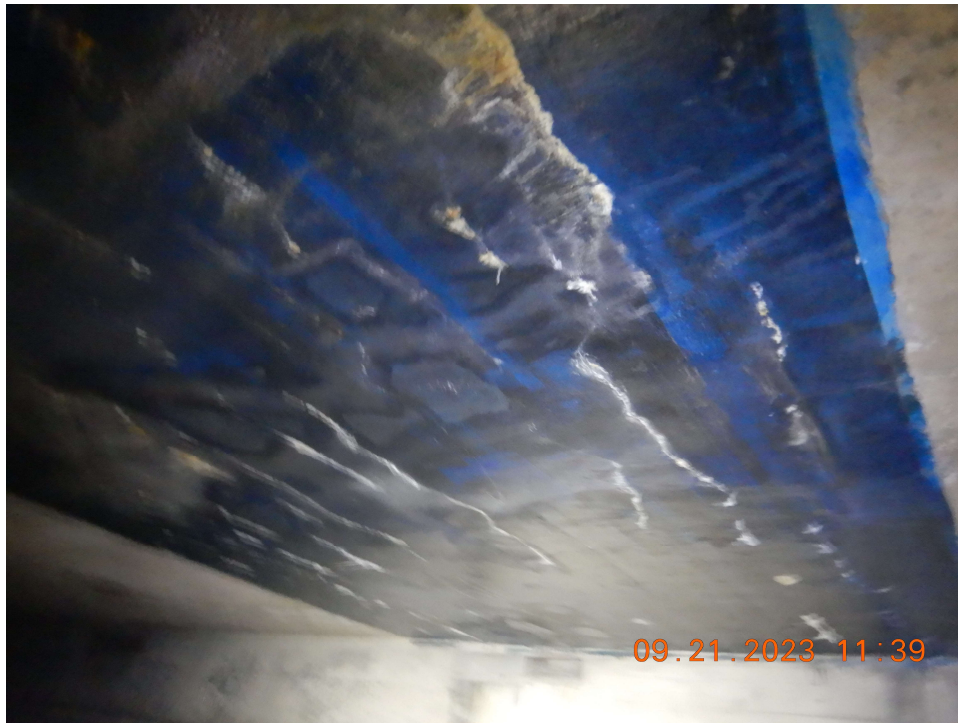
Photo 90: Supply Duct – Sta. 194+50 Patch in Underside of Slab with Carbon Fiber Wrap

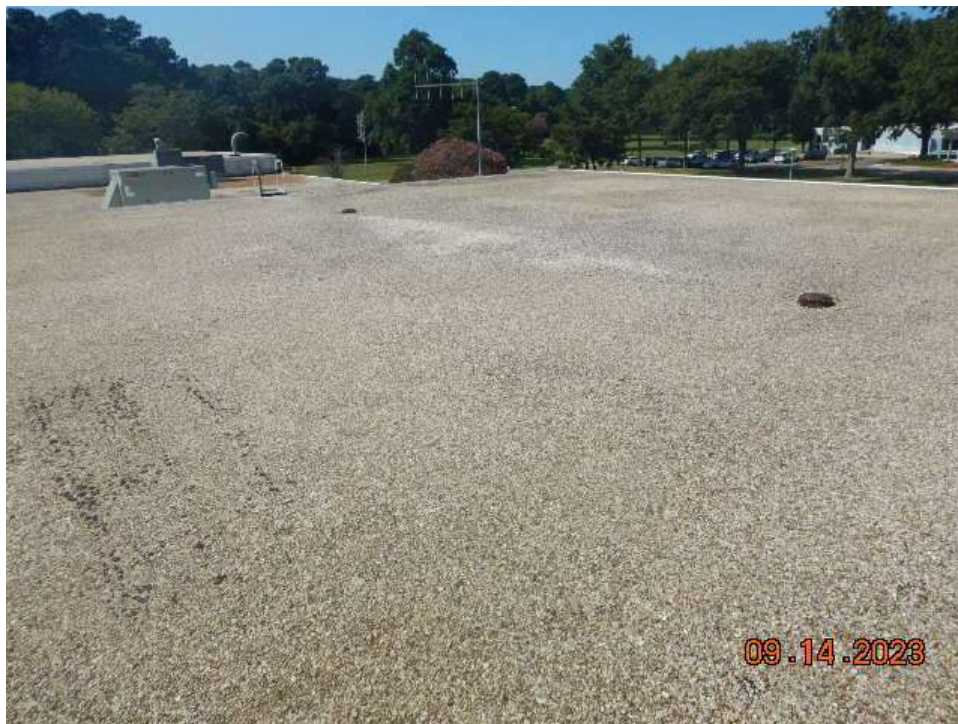
Photo 96: General Condition of Maintenance Building Roof (Looking Northwest)

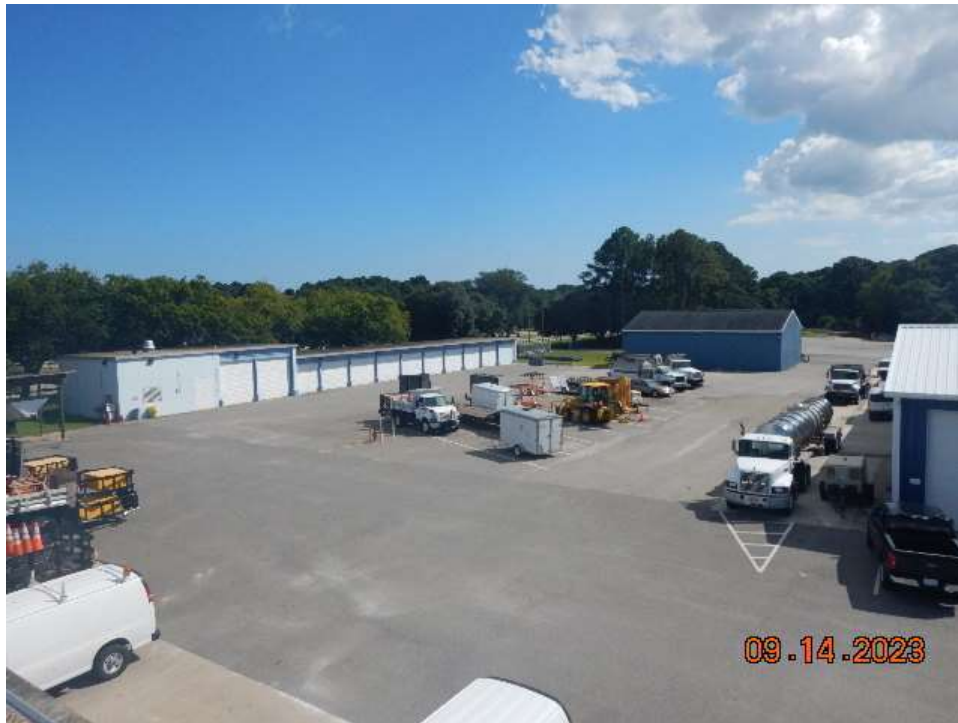
Photo 97: General View of Maintenance Yard (Looking South)

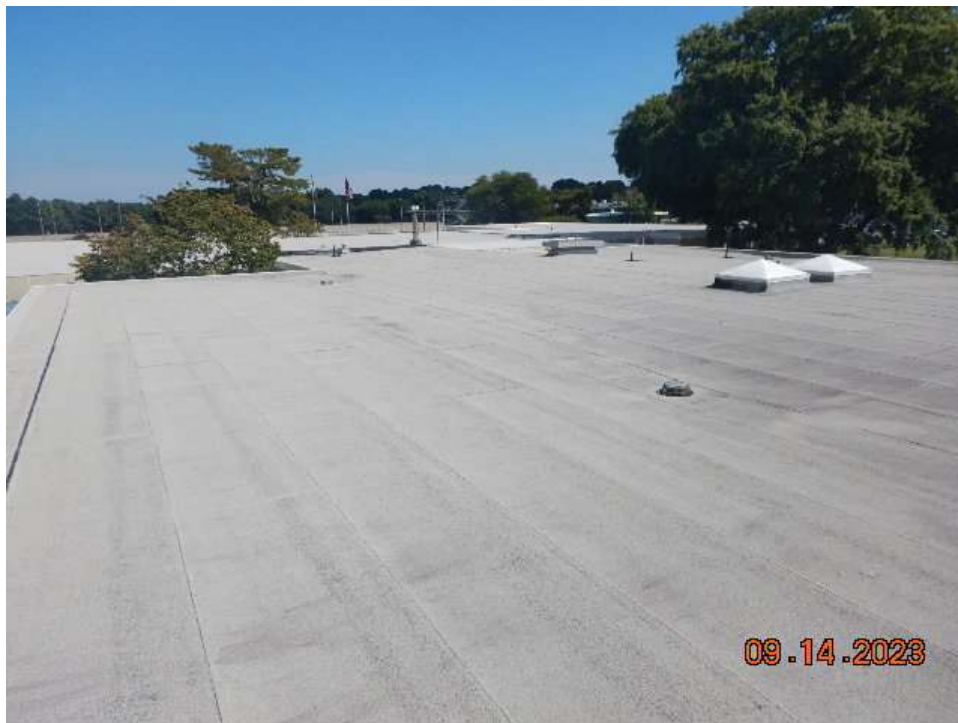
Photo 98: General Condition of CBBT Administration Building (Looking East)

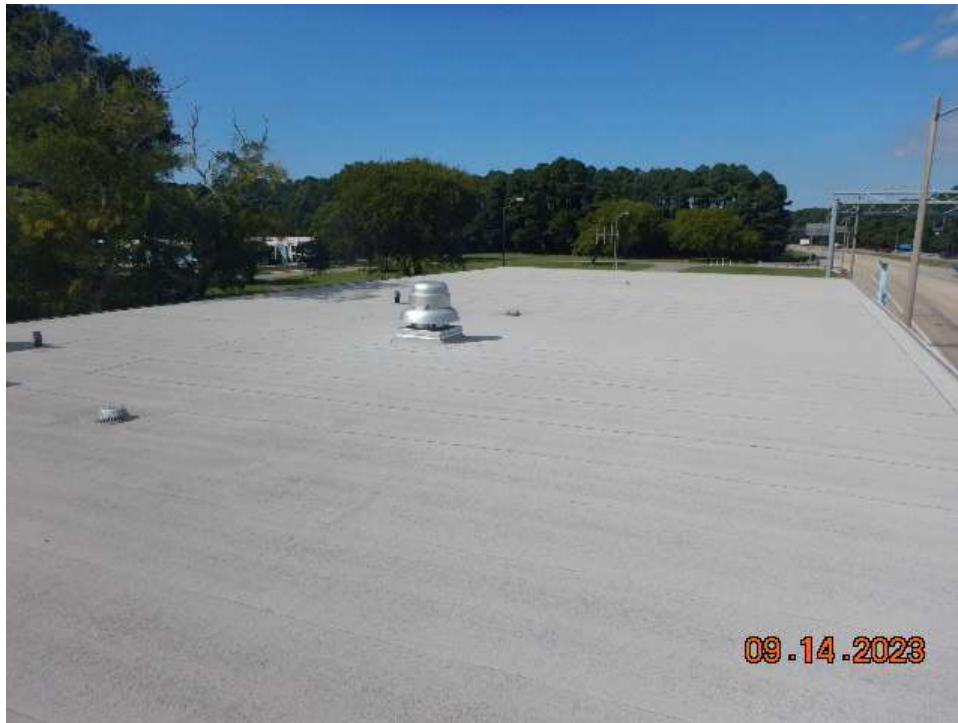
Photo 99: General Good Condition of North Toll Plaza Building Roof (Looking North)

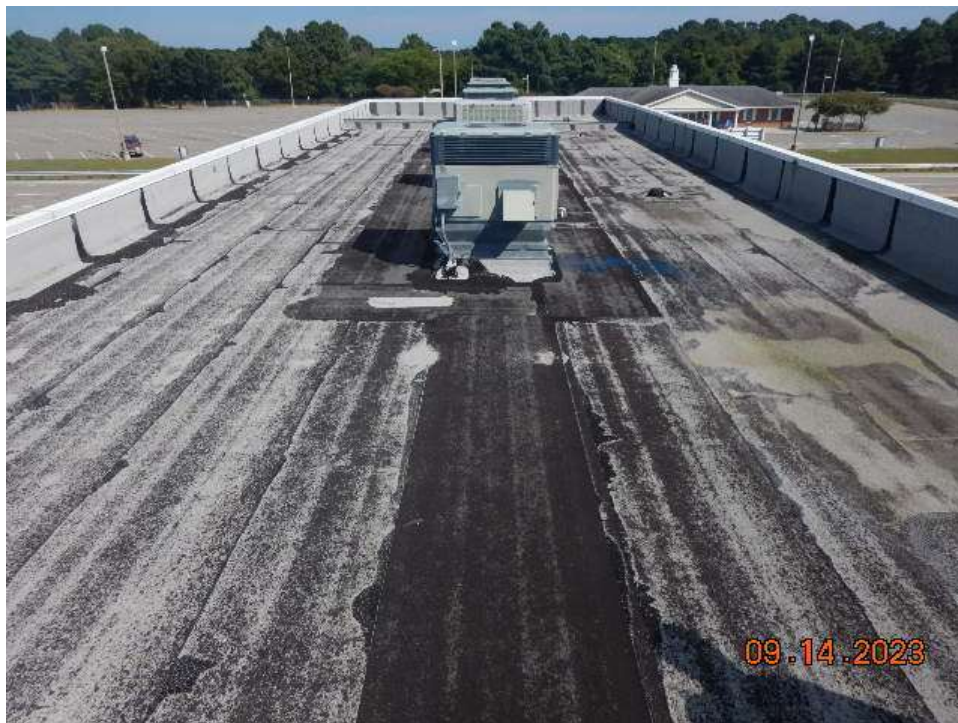
Photo 100: General Condition of North Toll Plaza Roof (Looking East)
