FY2022 Annual Inspection and Underwater Inspection, Trestles BSB, DNB, ESB & FSB, NCB-NB, and FIB-SB

FY2022 Facility Annual Inspection Report FINAL

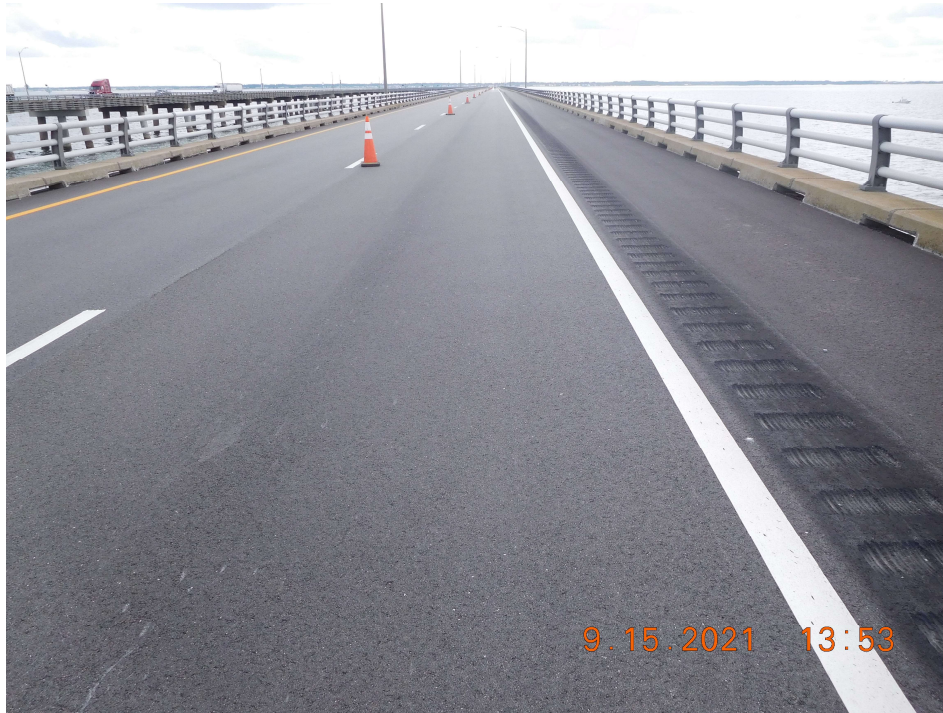
Photo 1: ANB36 Asphalt Wearing Surface – Typical Good Condition of Wearing Surface (Looking North)

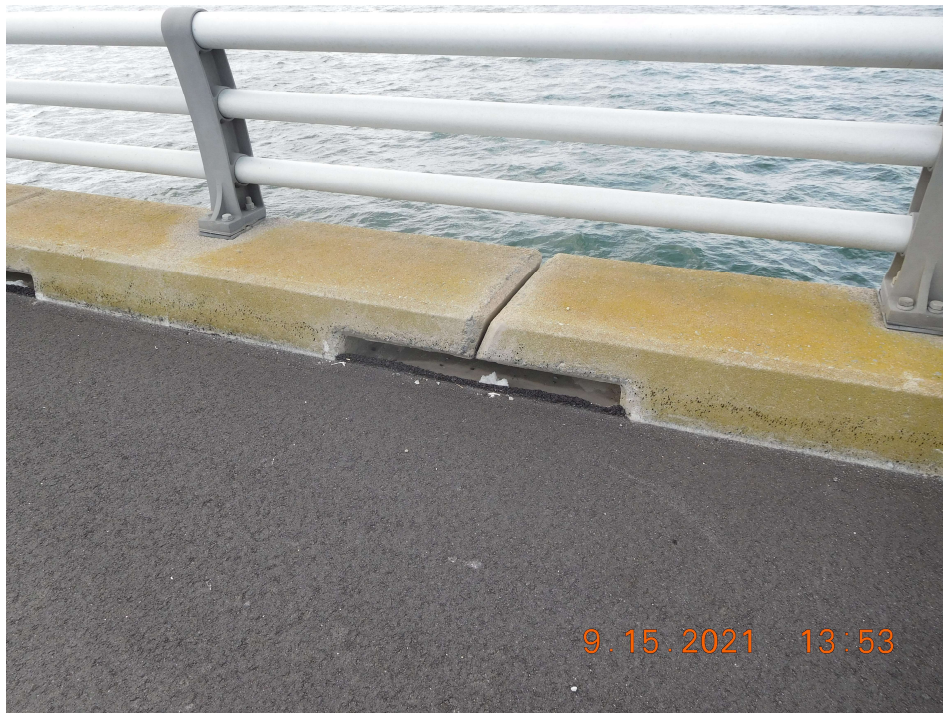
Photo 2: ANB37 Concrete Curb – Typical Good Condition of Concrete Curbs (Looking Southeast)

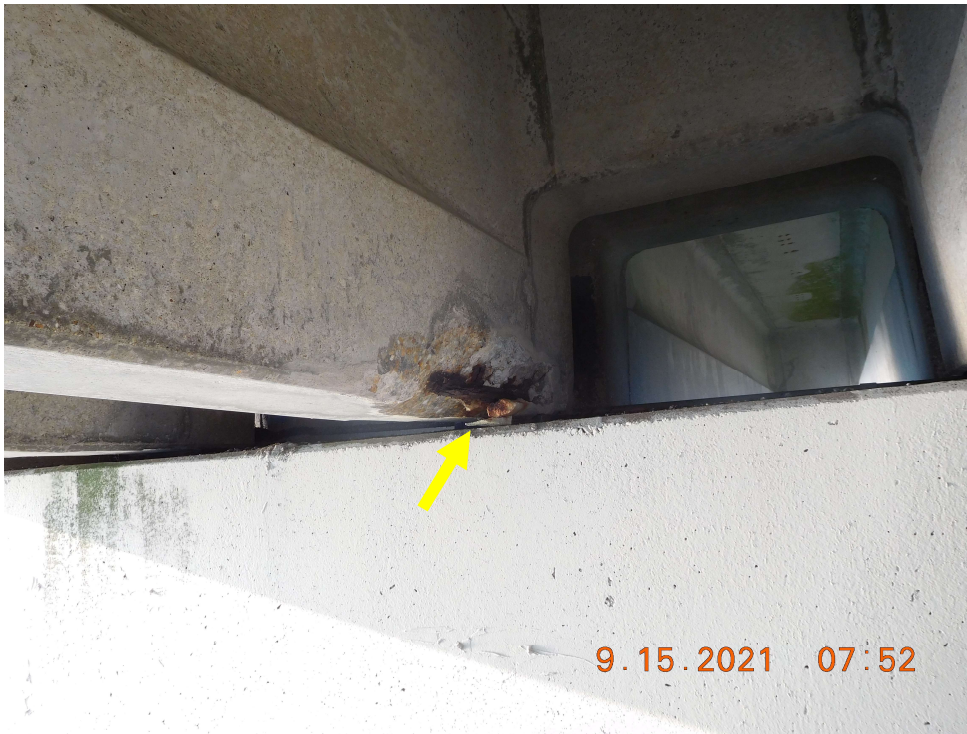
Photo 3: ANB37 Prestressed Concrete Girder – Spalling with Exposed Reinforcement in Bottom Flange of Girder 3 Beam End, Defect represents $<0.1\%$ of Total Quantity (Looking Southeast)

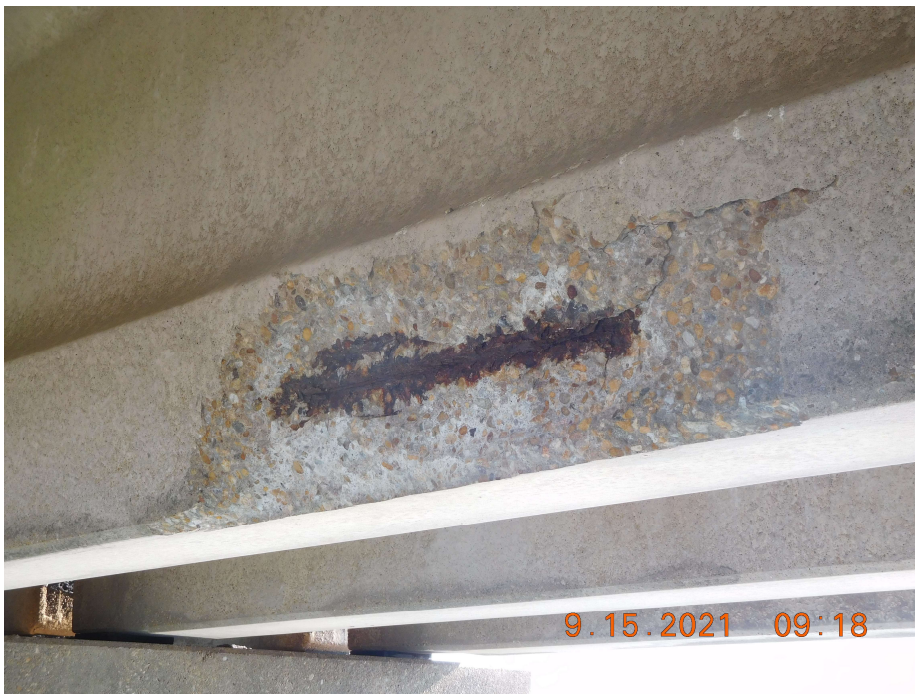
Photo 4: ANB37 Prestressed Concrete Girder – Spall with Two Exposed Strands in Bottom Flange of Girder 3, Defect Represents $<0.1\%$ of (Looking Northeast)

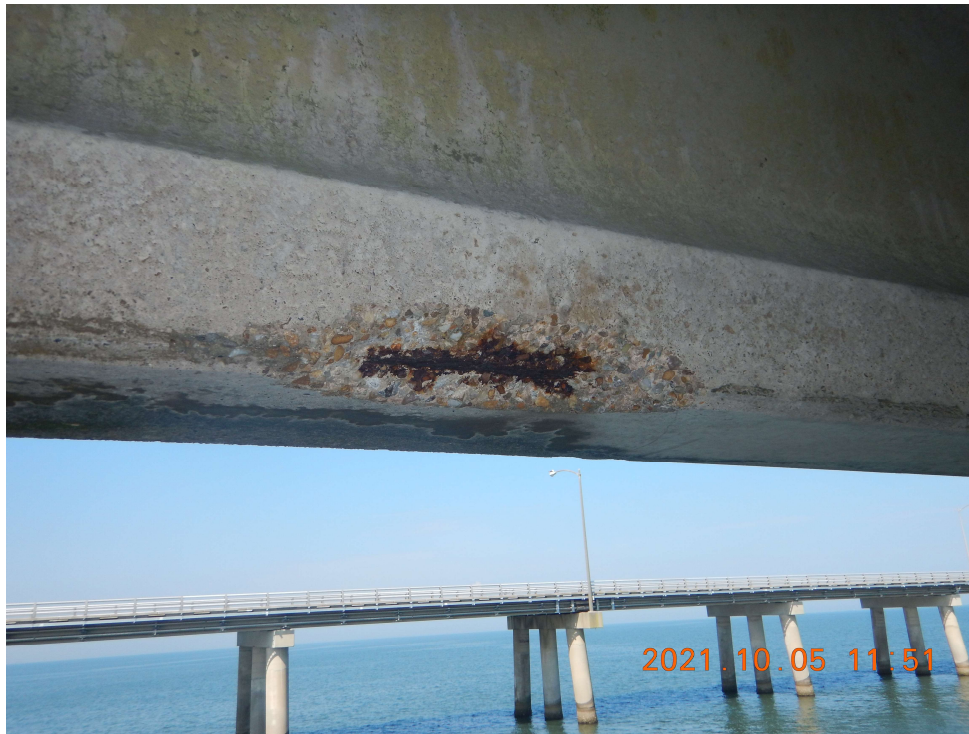
Photo 5: ANB77 Prestressed Concrete Girder – Spall with Exposed Strand in Bottom Flange of Girder 8, Defect Represents <0.1% of Total Quantity (Looking Northwest)

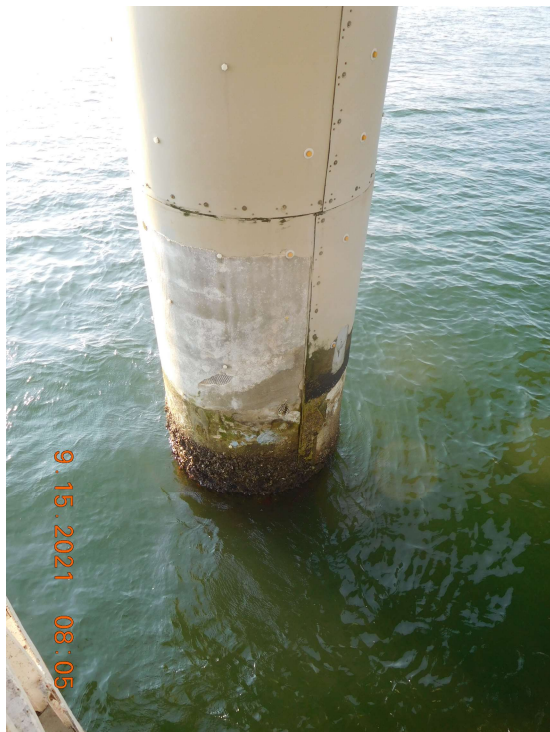
Photo 6: ANB37 Pile C – Missing Bottom Section of Protective Jacket (Looking Southeast)

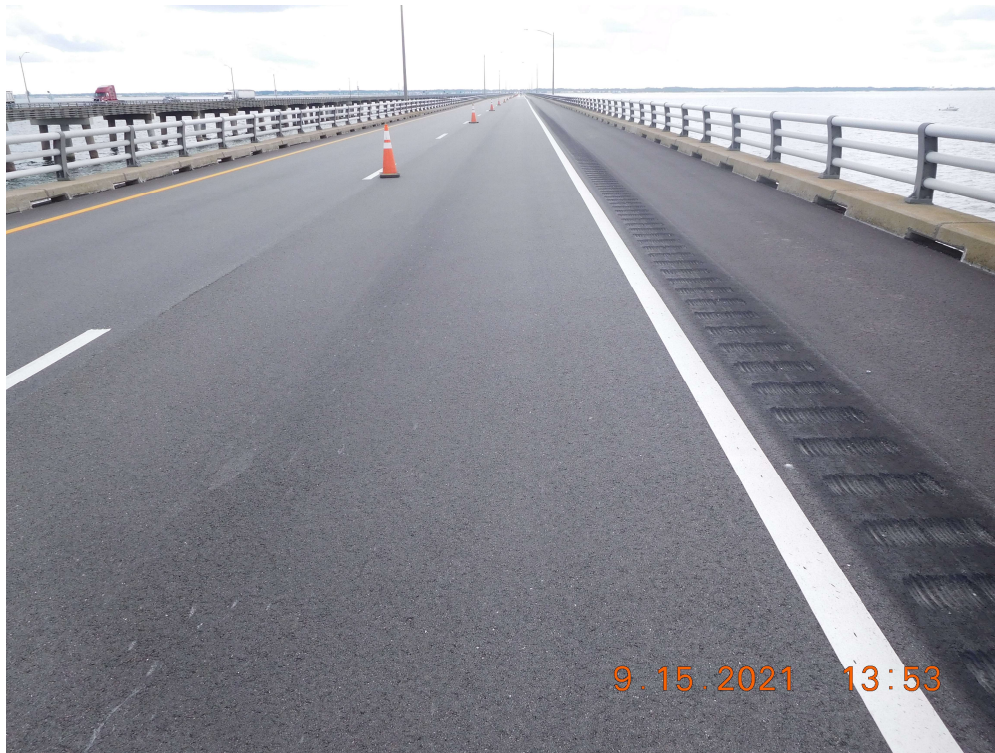
Photo 7: ASB182 Asphalt Wearing Surface – Typical Good Condition of Wearing Surface (Looking South)

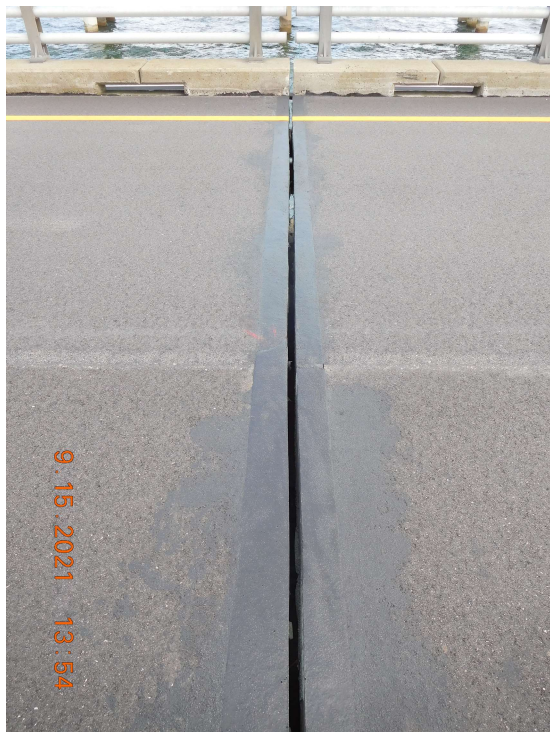
Photo 8: Open Expansion Joint – Typical Good Condition of Open Expansion Joint (Looking East)

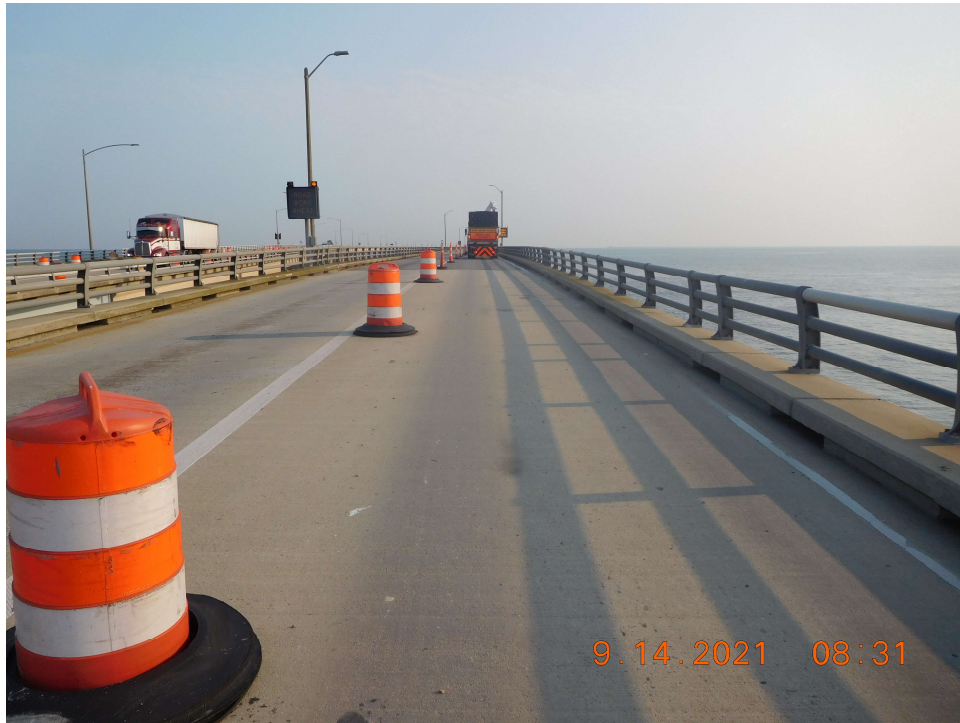
Photo 9: BNB4 Reinforced Concrete Top Flange and Metal Bridge Railing – Typical Good Condition (Looking North)

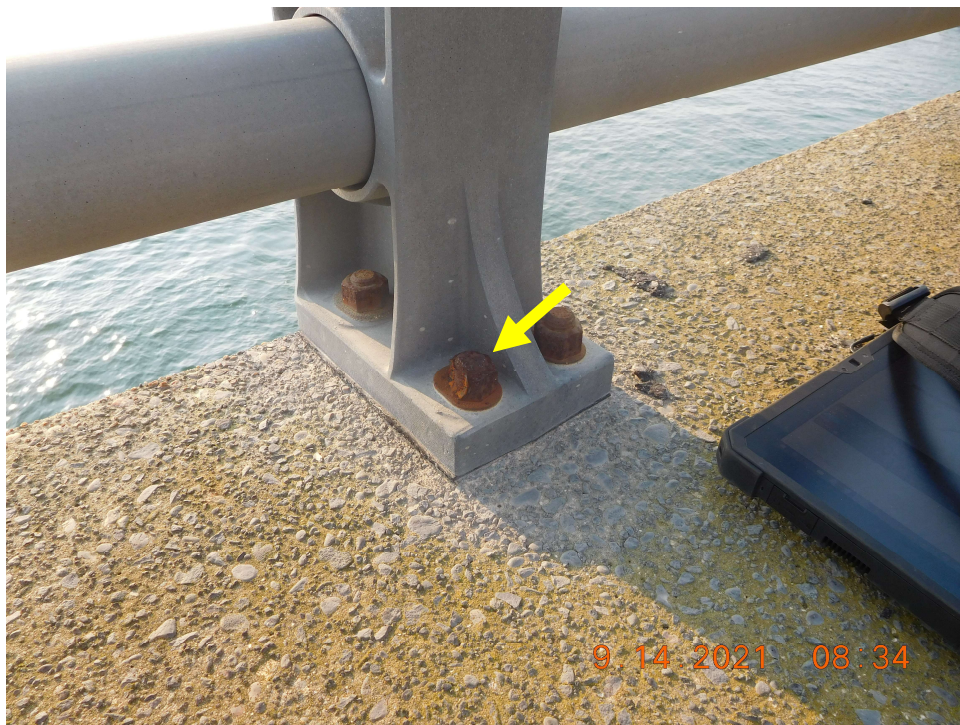
Photo 10: BNB4 Metal Bridge Railing – Corrosion with Section Loss of Rail Post Connections (Looking Southeast)

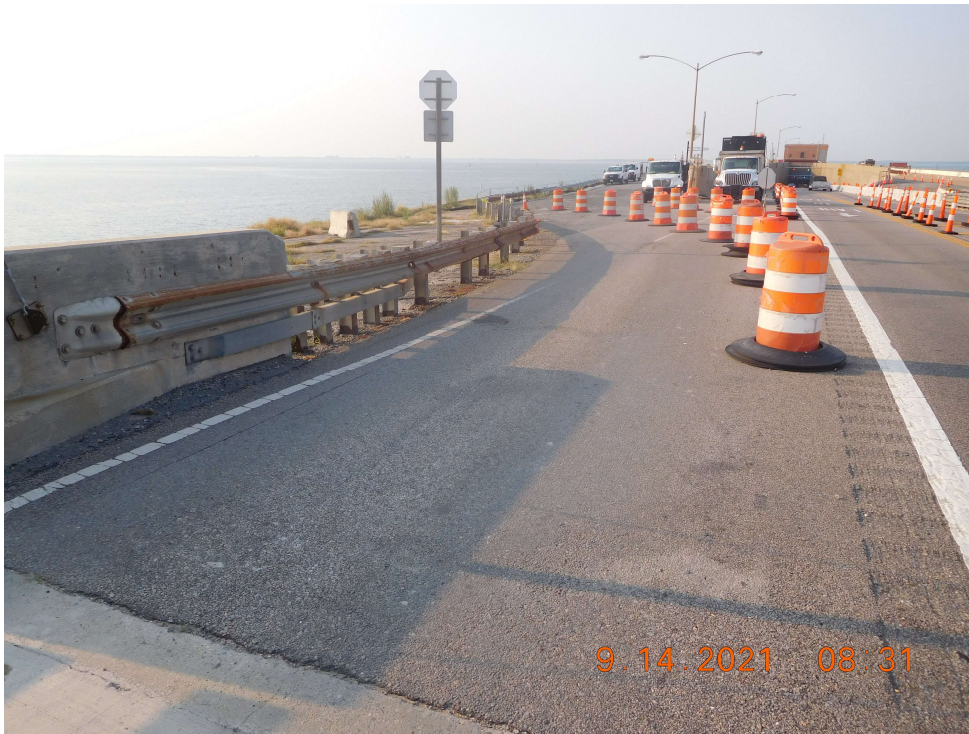
Photo 11: BNB Approach – Typical Condition of Approach Barrier Transition (Looking Southeast)

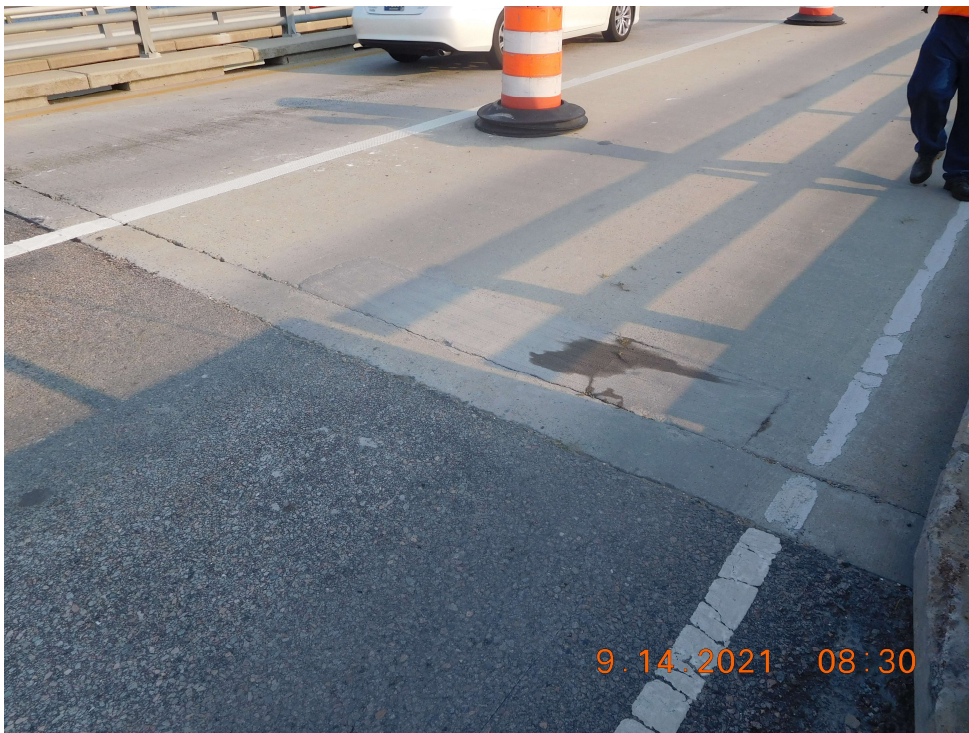
Photo 12: BNB1 Joint – General Good Condition of Expansion Joint (Looking Southeast)

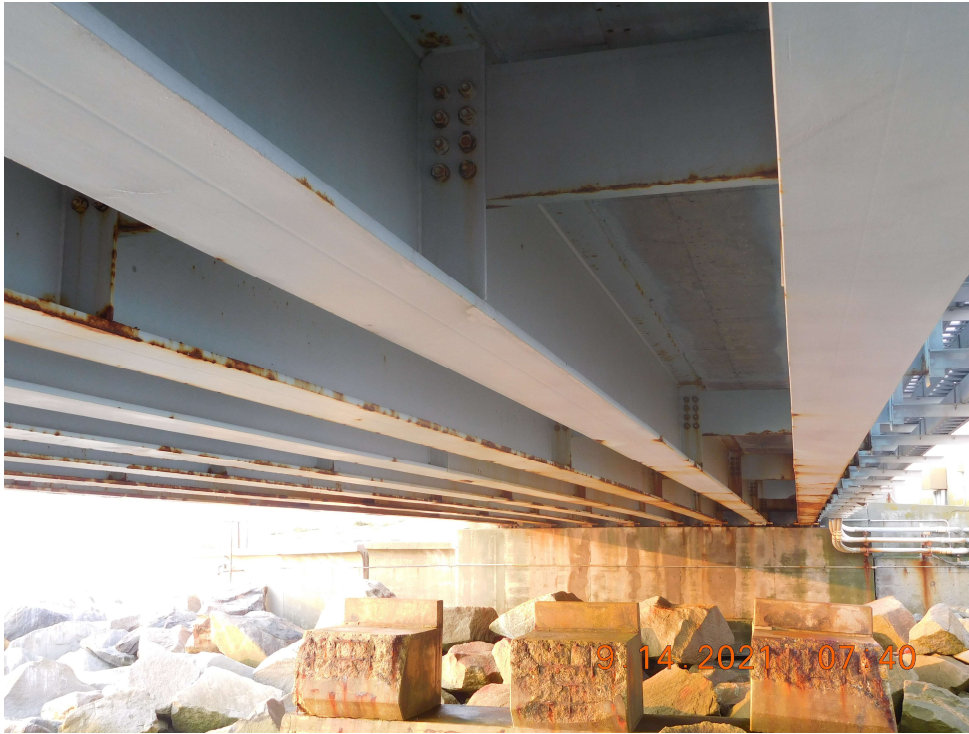
Photo 13: BNB1/3 Steel Superstructure – Typical Condition of Steel Superstructure with Minor Surface Corrosion (Looking South)

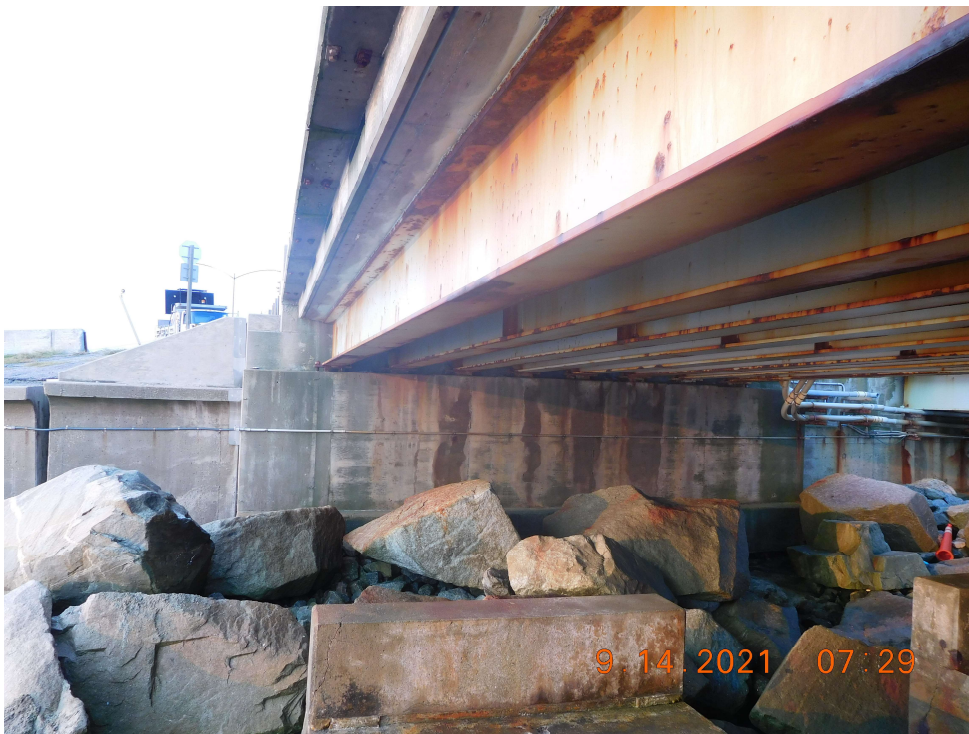
Photo 14: BNB1 Reinforced Concrete Abutment – Typical Good Condition of Abutment (Looking Southwest)

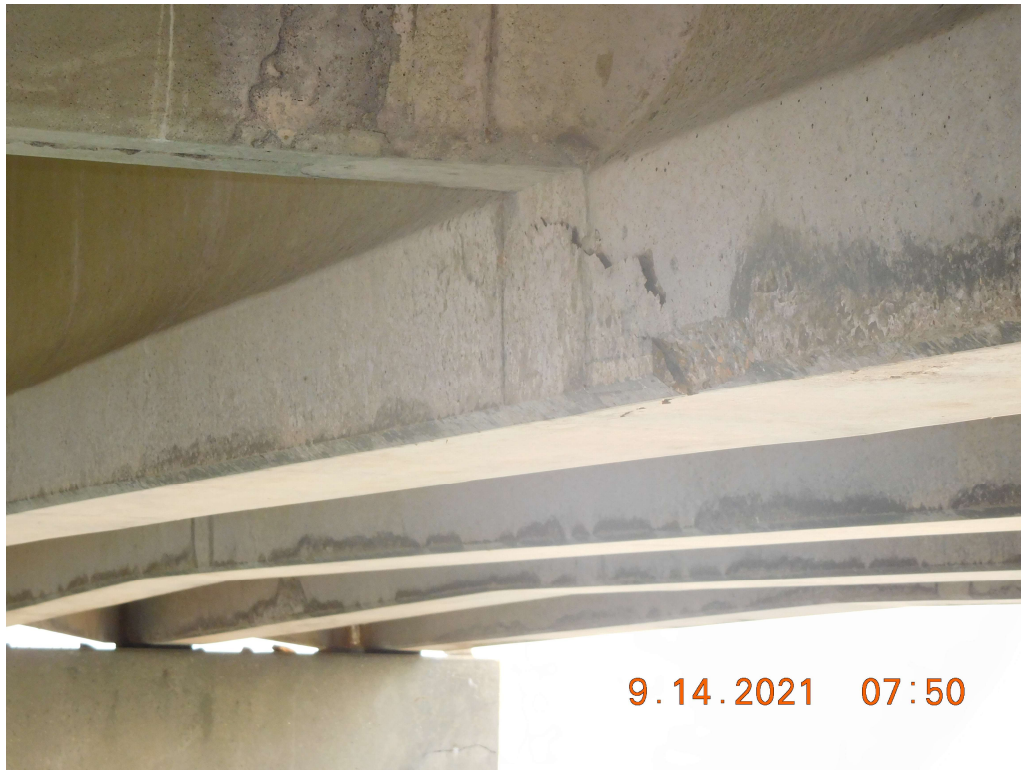
Photo 15: BNB3 Prestressed Girder – Delamination in Bottom Flange of Girder 4 (Looking East)

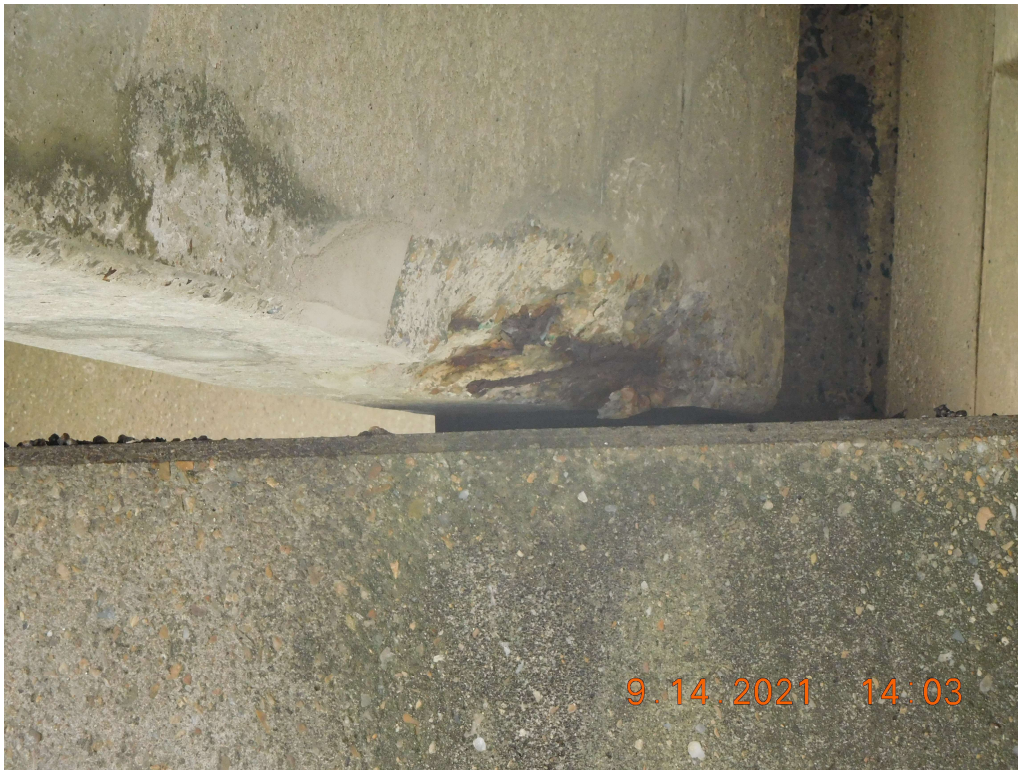
Photo 17: BNB29 Prestressed Concrete Girder – Spall with Exposed Prestressing Strand in Girder 2 in Zone 1 (Looking Southeast)

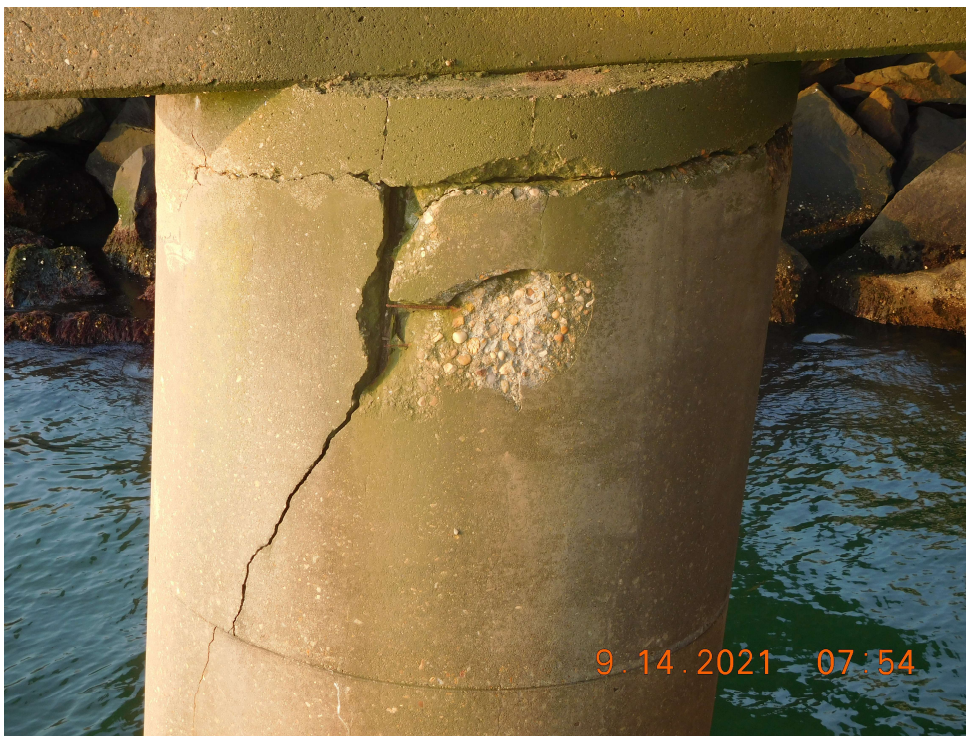
Photo 18: BNB3 Prestressed Concrete Pile – Moderate Cracking and Spalling in Pile C (Looking South)

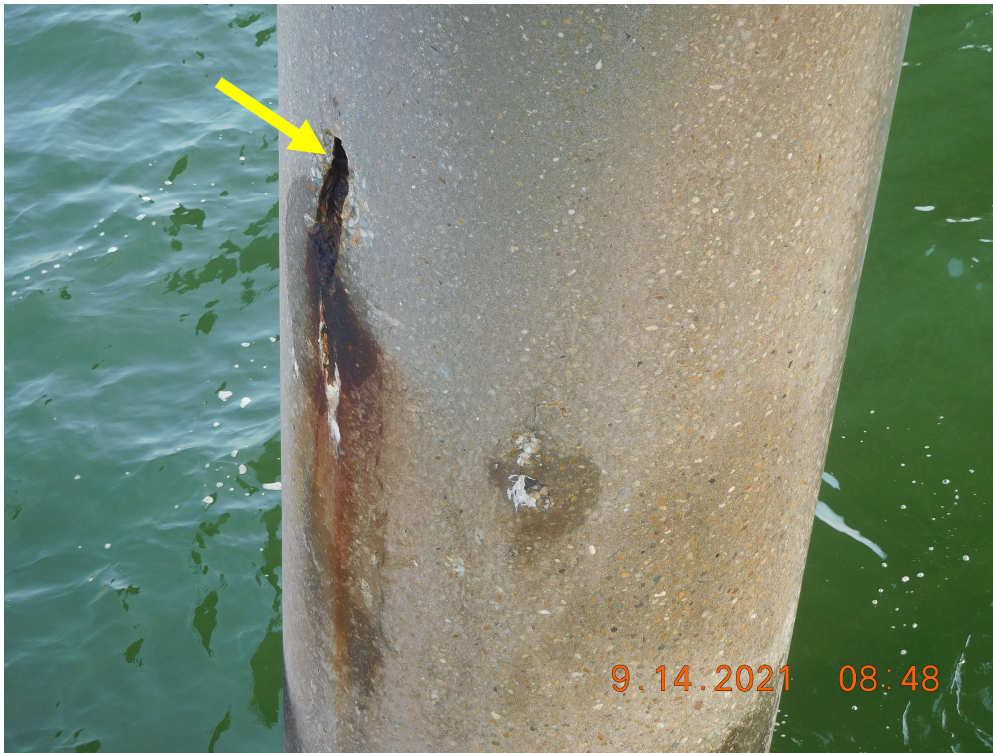
Photo 19: BNB7 Prestressed Concrete Pile – Spalling with Exposed Reinforcing on West Face of Pile A (Looking North)

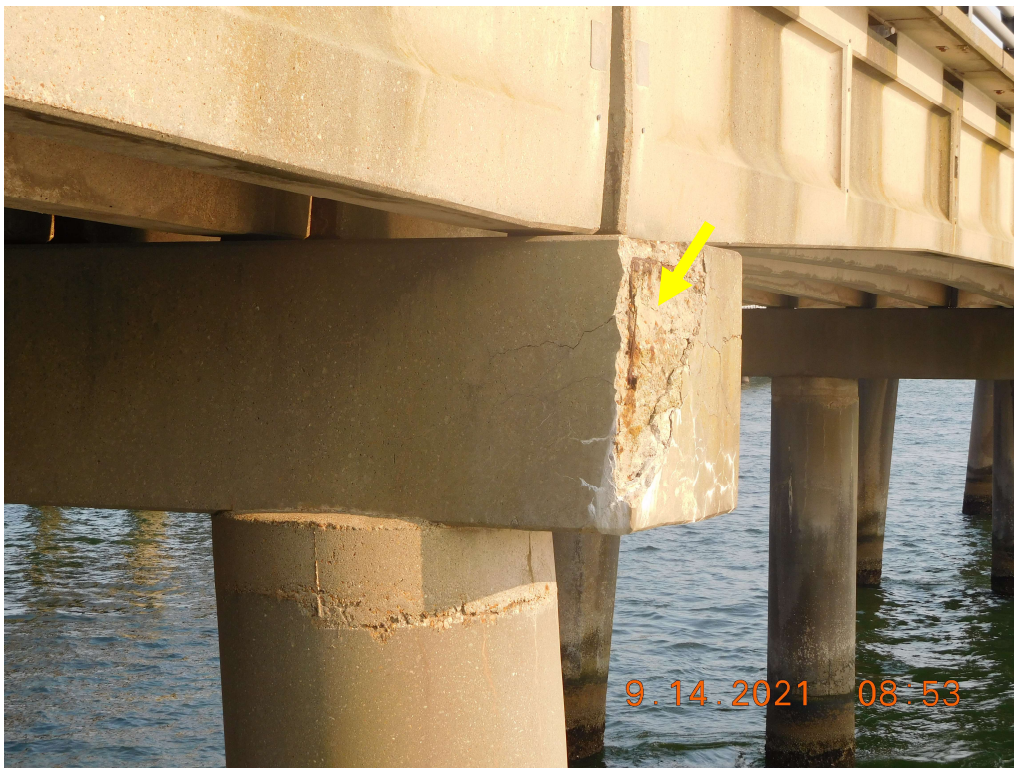
Photo 20: BNB7 Reinforced Concrete Pier Cap – Spalling with Exposed Reinforcement on East Face (Looking Northwest)

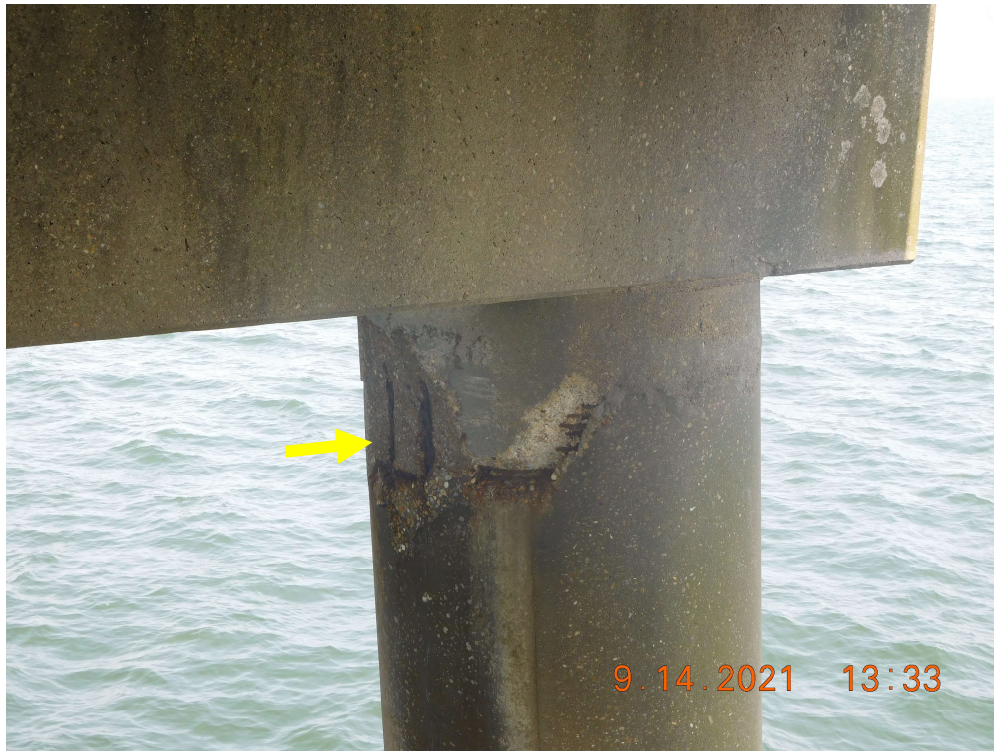
Photo 21: BNB25 Prestressed Concrete Pile – Spall with Exposed Reinforcement at Top of Pile C (Looking East)

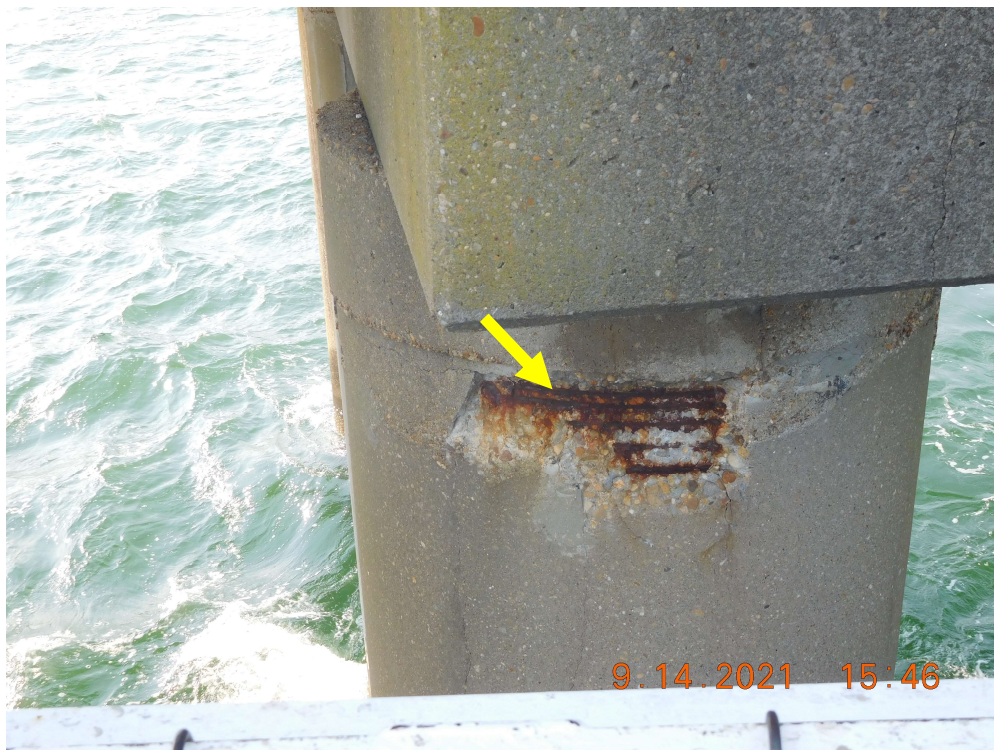
Photo 22: BNB40 Prestressed Concrete Pile – Spall with Exposed Reinforcement at Top of Pile C (Looking West)

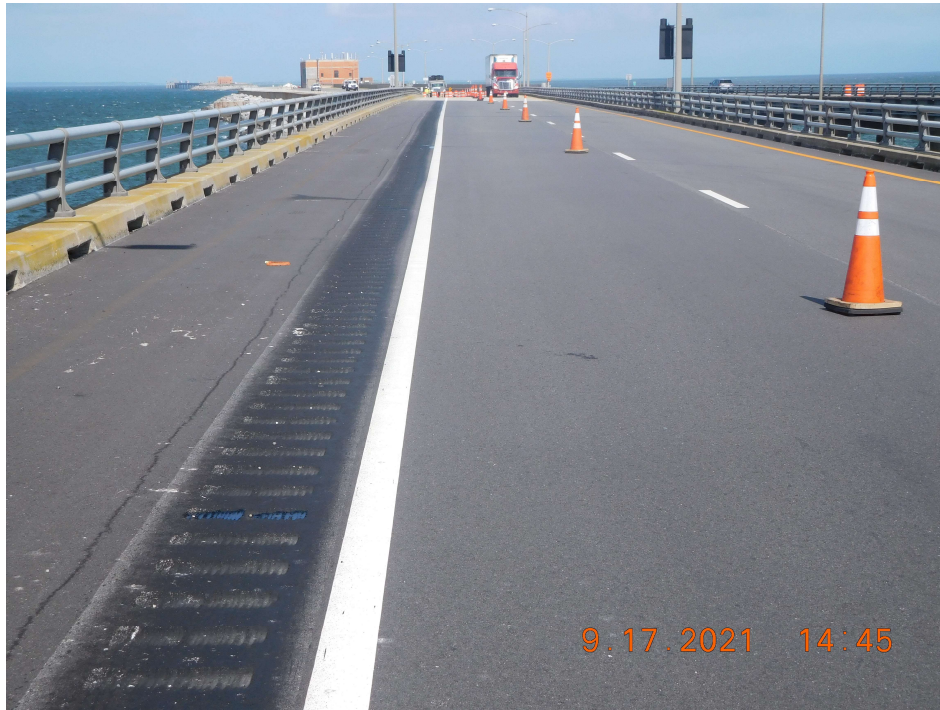
Photo 23: BSB186 Asphalt Wearing Surface – Typical Good Condition (Looking North)

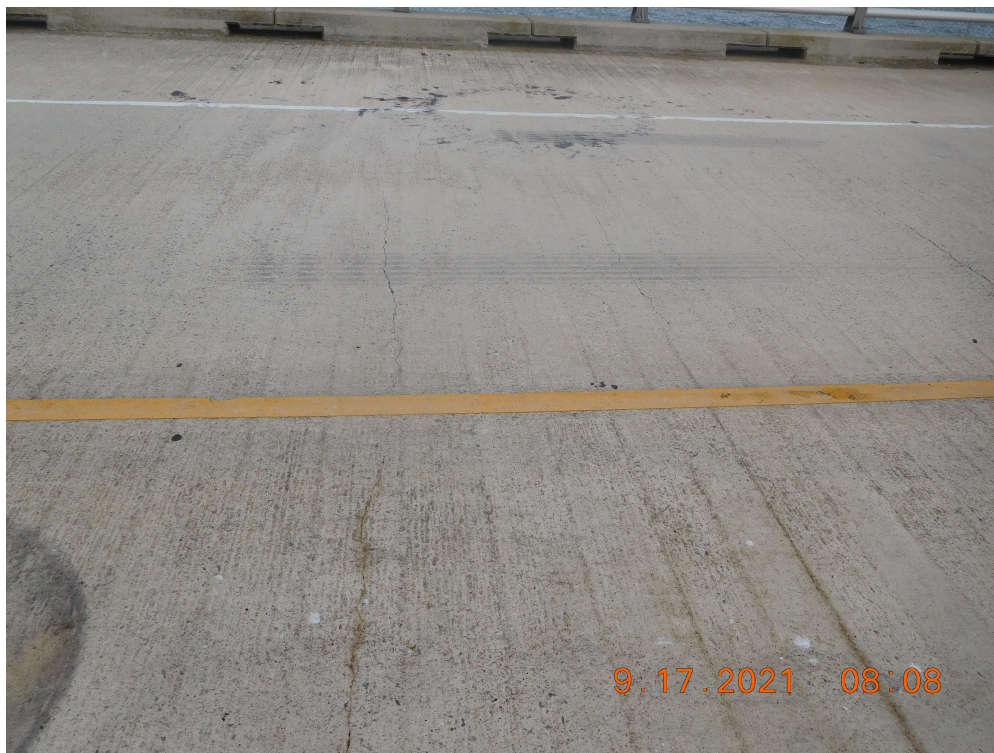
Photo 24: BSB16 Reinforced Concrete Top Flange – Typical Satisfactory Condition with Typical Transverse Cracking (Looking Southwest)

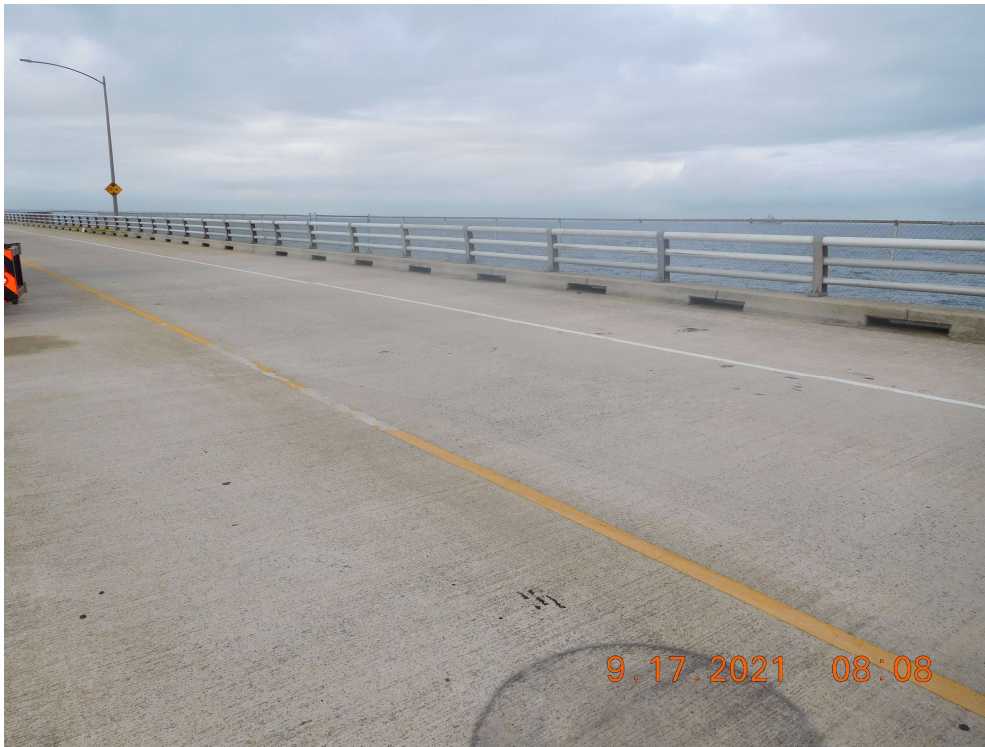
Photo 25: BSB16 Metal Bridge Railing – Typical Good Condition (Looking Southwest)

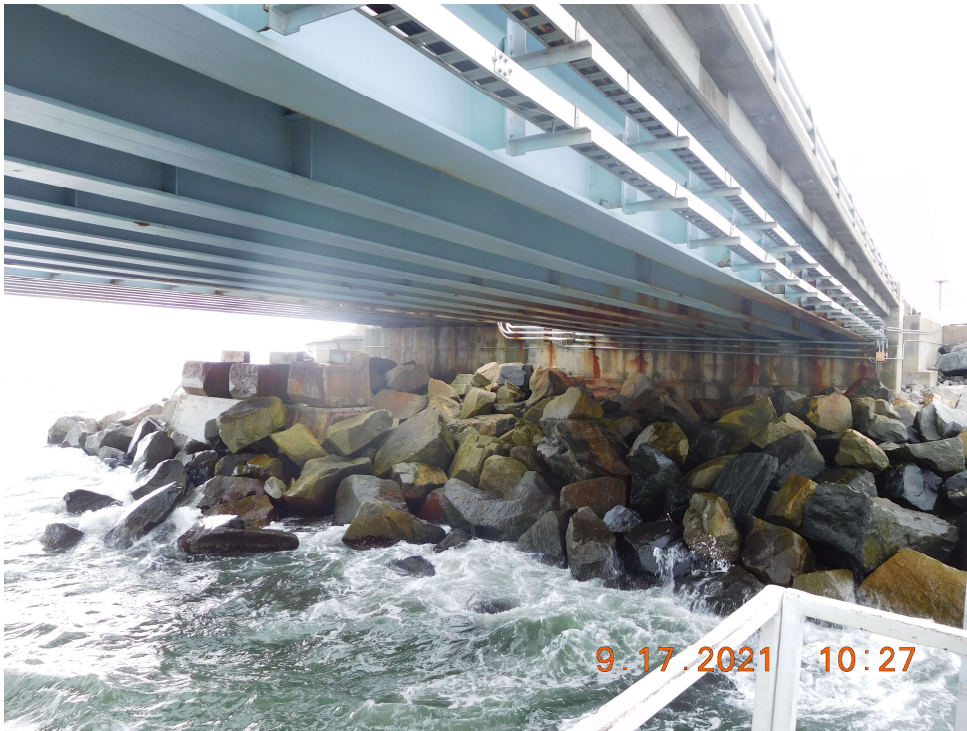
Photo 26: BSB1 Superstructure – Typical Good Condition with Isolated Areas of Surface Corrosion (Looking Southeast)

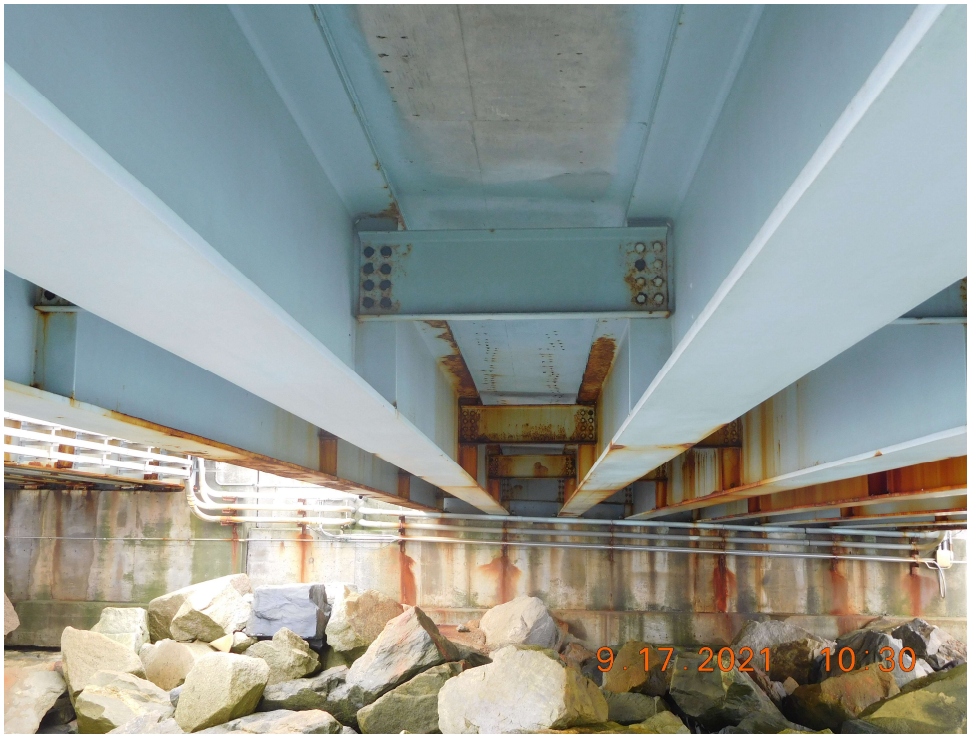
Photo 27: BSB1 Abutment – Typical Condition with Isolated Areas of Rust Stains (Looking South)

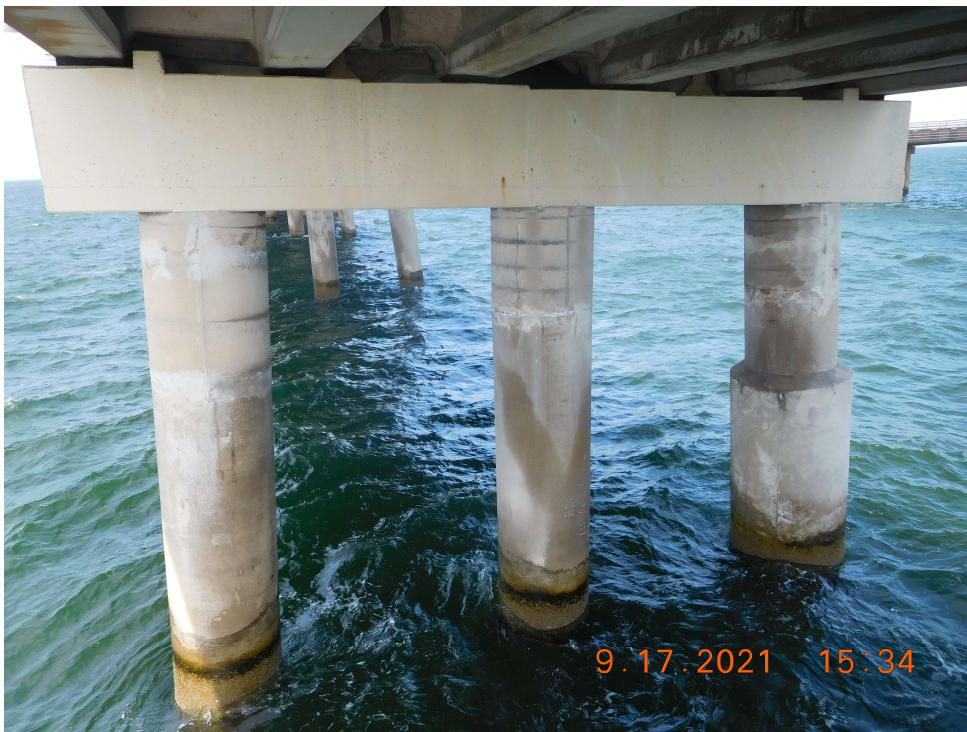
Photo 28: BSB186 Prestressed Concrete Pile – Hairline Cracking with Minor Efflorescence in Pile C (Looking Northeast)

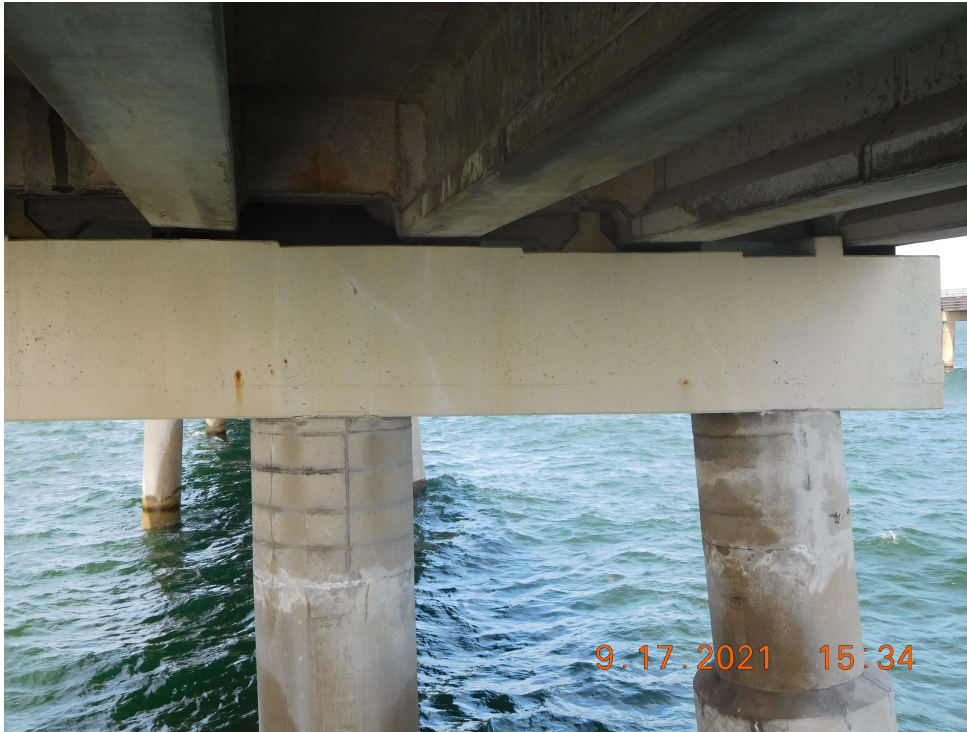
Photo 29: BSB186 Reinforced Concrete Pier Cap – Typical Minor Cracking with Efflorescence (Looking North)

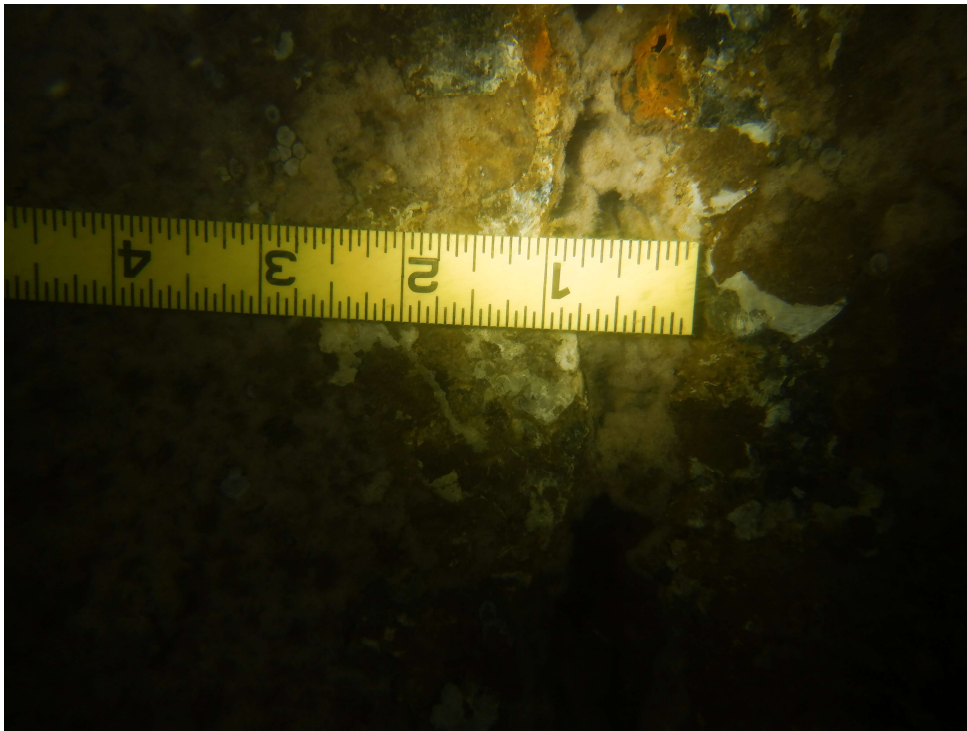
Photo 30: BSB101 Pile C – Minor Cracking in South Face (Looking North)

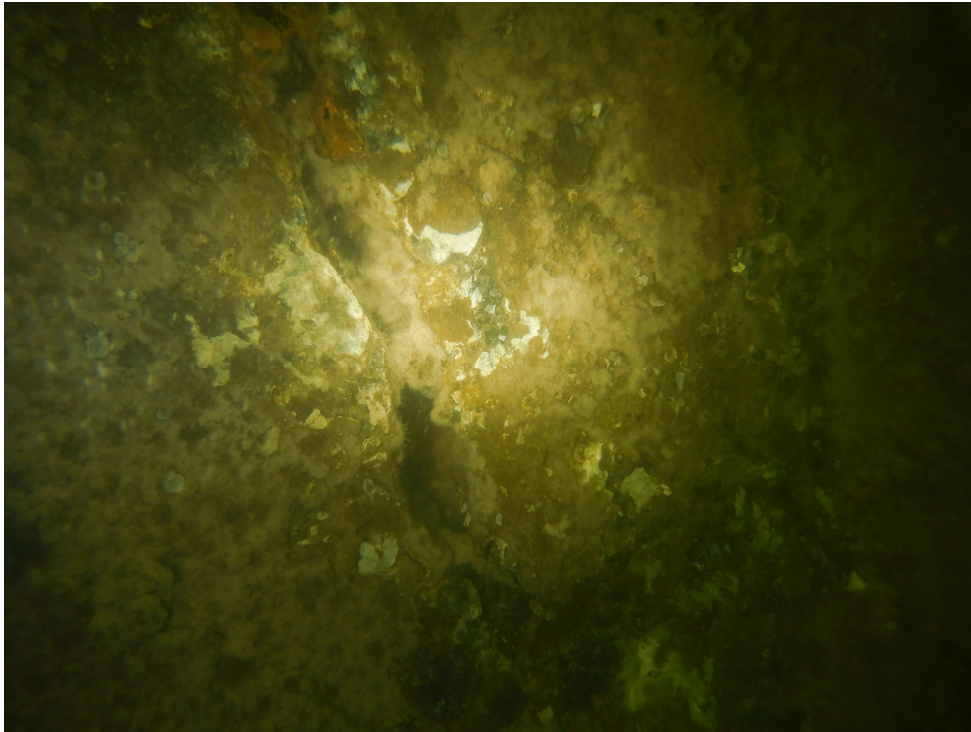
Photo 31: BSB101 Pile C – Minor Cracking in South Face (Looking North)

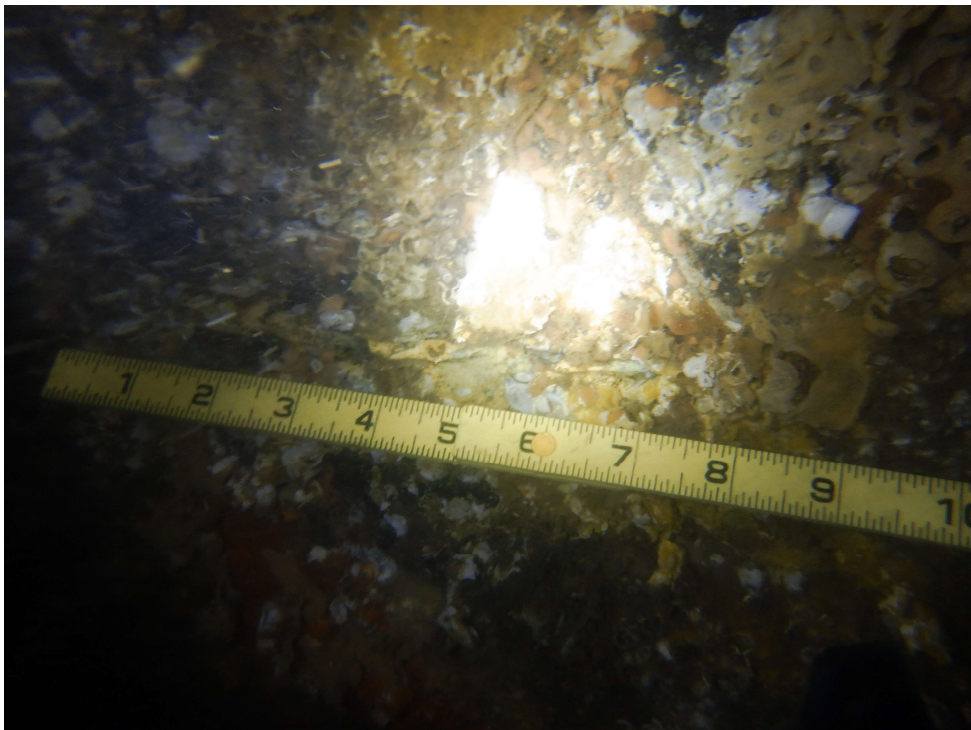
Photo 32: BSB125 Pile A – Spall in North Face, 25' below Water Line, Defect is Worst Case Defect (Looking Southwest)

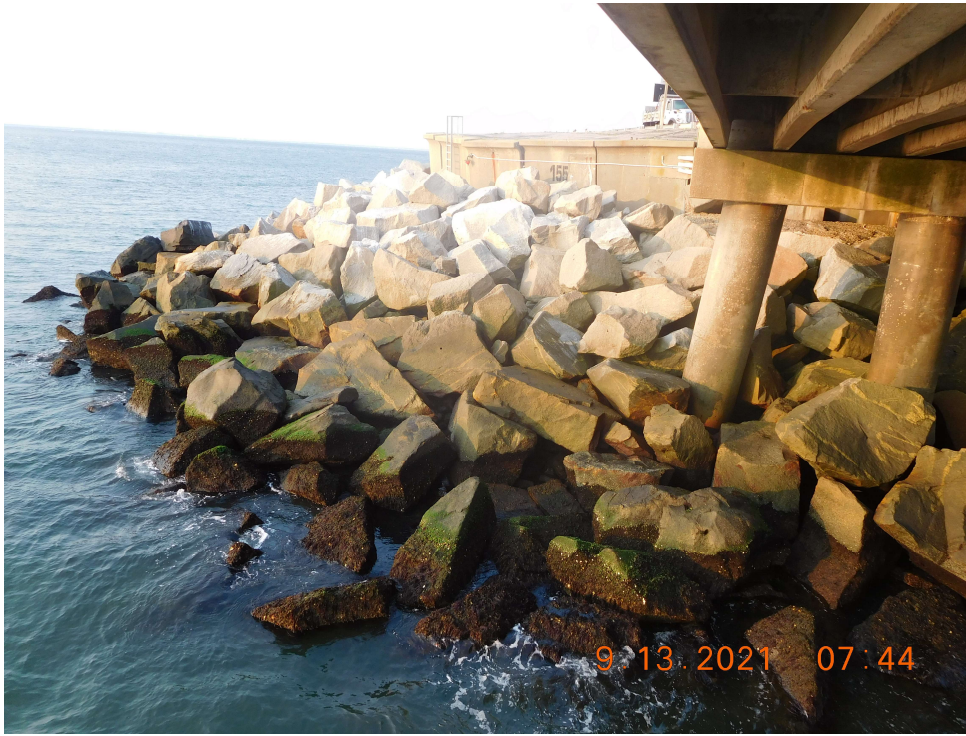
Photo 33: CNB1 Abutment – Typical Condition of Abutment and Riprap Protection (Looking Southeast)
