FY2022 Annual Inspection and Underwater Inspection, Trestles BSB, DNB, ESB & FSB, NCB-NB, and FIB-SB

FY2022 Facility Annual Inspection Report FINAL

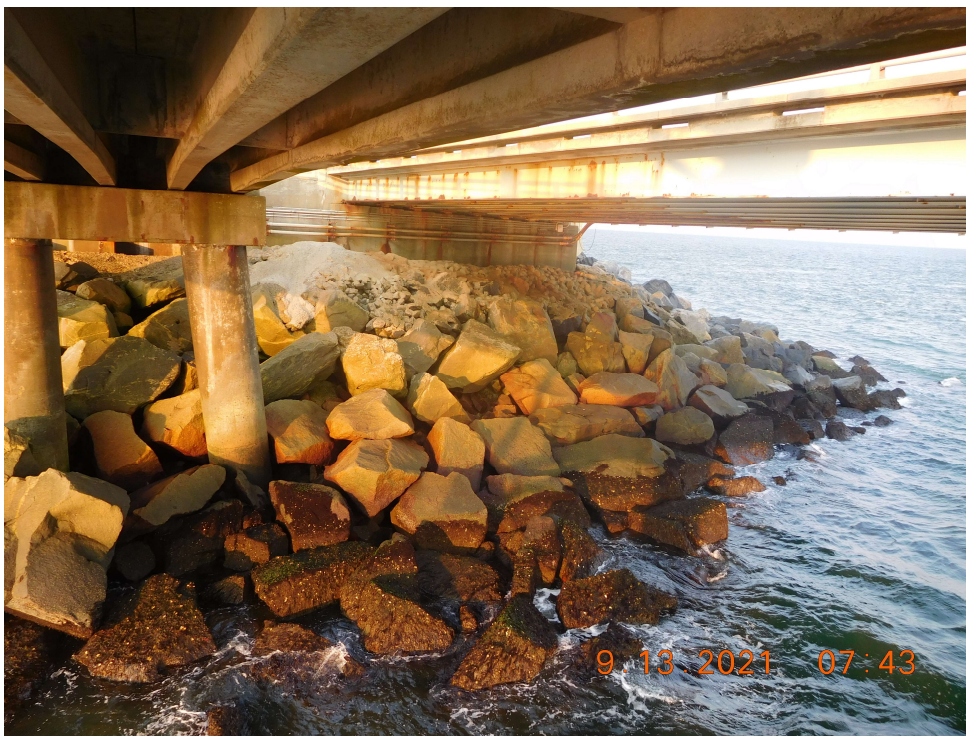
Photo 34: CNB1 Abutment – Typical Condition of Abutment and Riprap Protection (Looking Southwest)

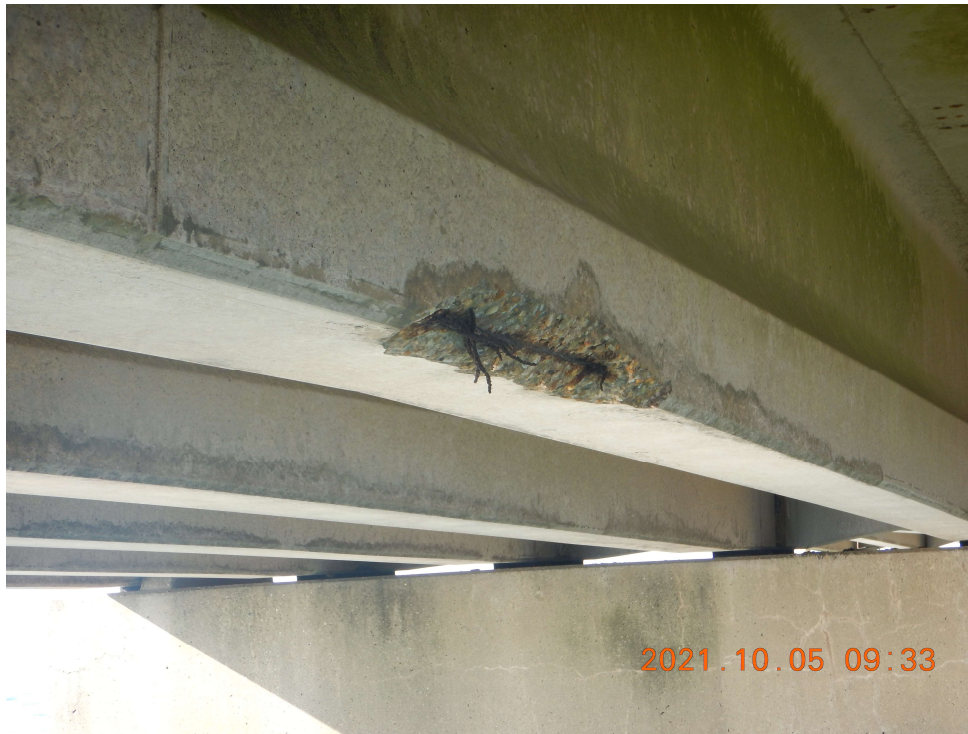
Photo 35: CNB40 Prestressed Girder – Spalling with Exposed and Broken Strands at Girder 5 (Worst Case Observed) (Looking Southeast)

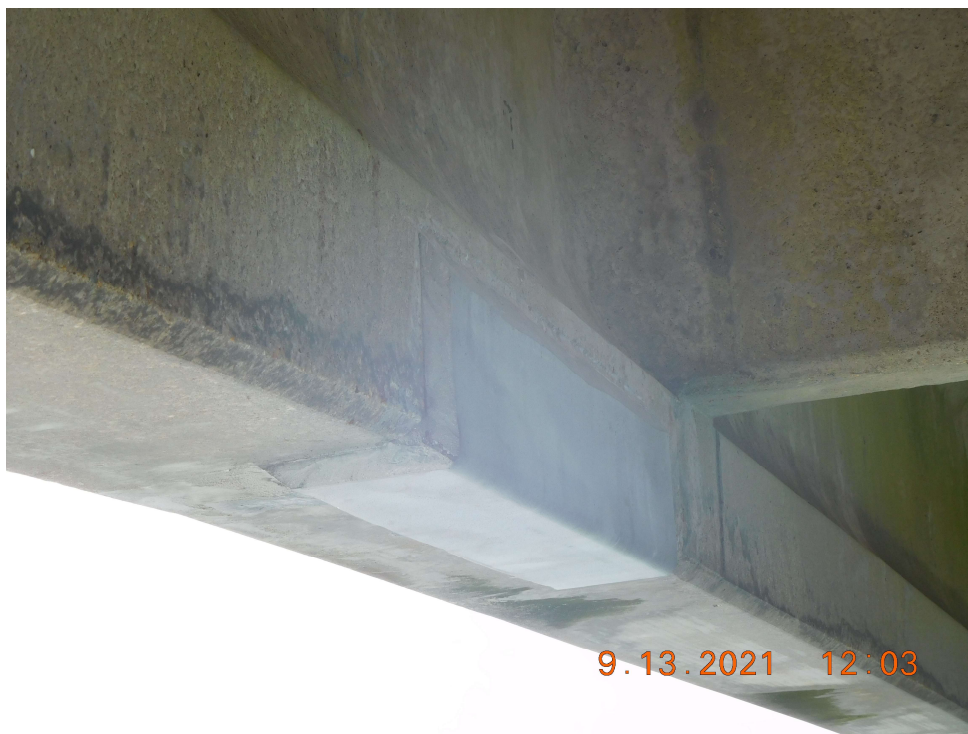
Photo 36: CNB13 Prestressed Girder 1 – Typical Sound Patch, Defect Represents 2.5% of Total Quantity (Looking Southeast)

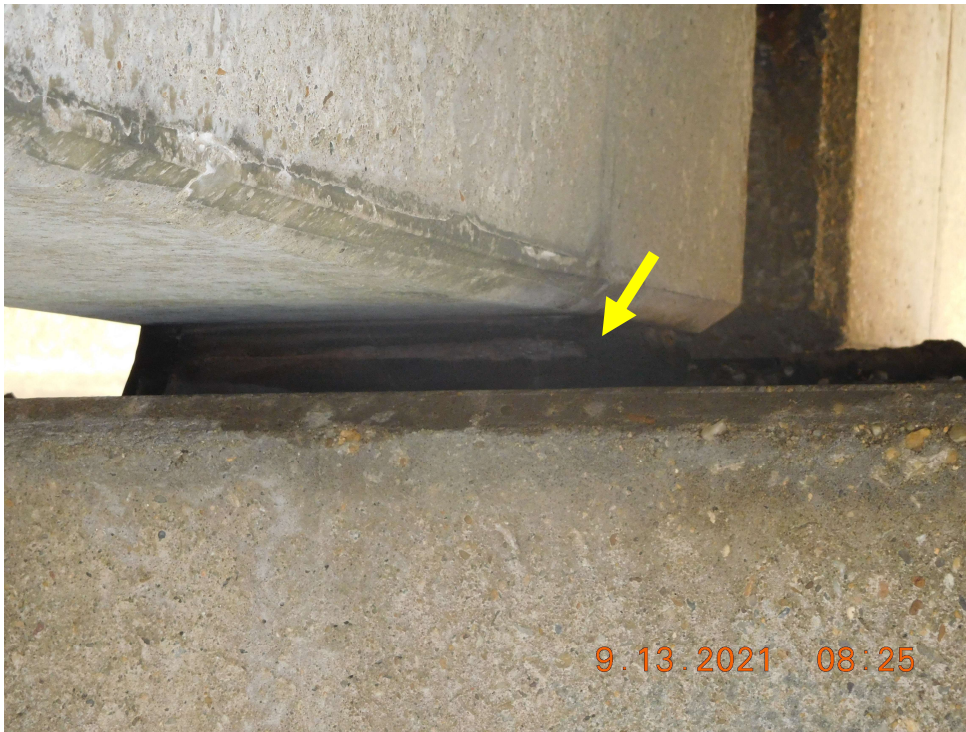
Photo 37: CNB3 Elastomeric Bearing – Deformed Elastomeric Bearing at Bent 4 for Beam 6 (Looking Northwest)

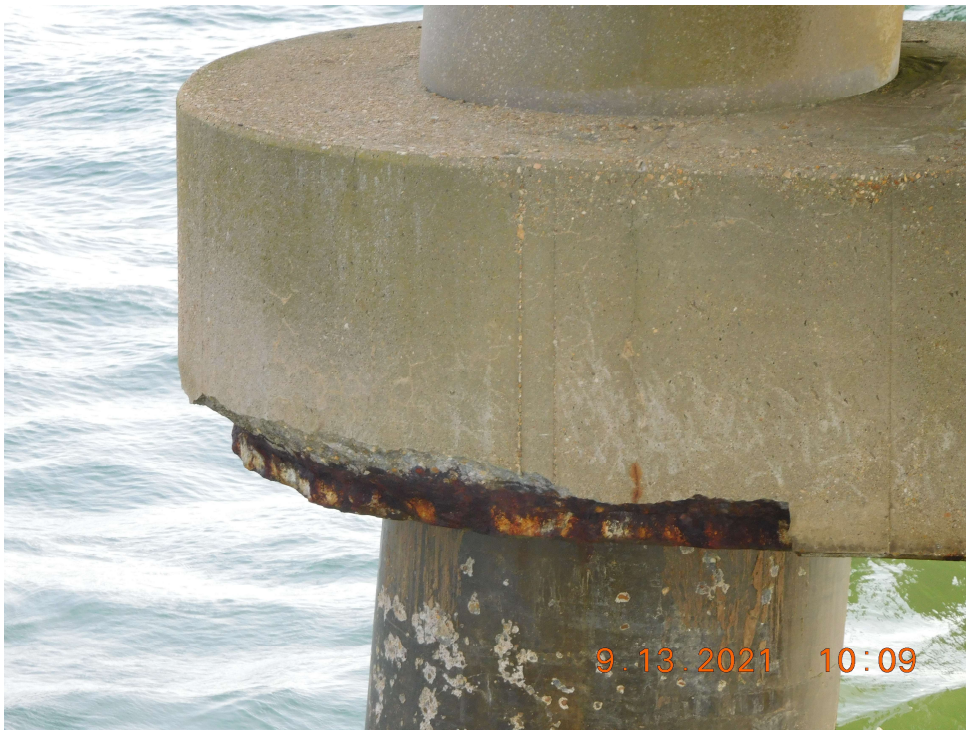
Photo 38: CNB8 Reinforced Concrete Pier Cap – Spalling with Exposed Reinforcement at Base of Cap over Pile A (Looking North)

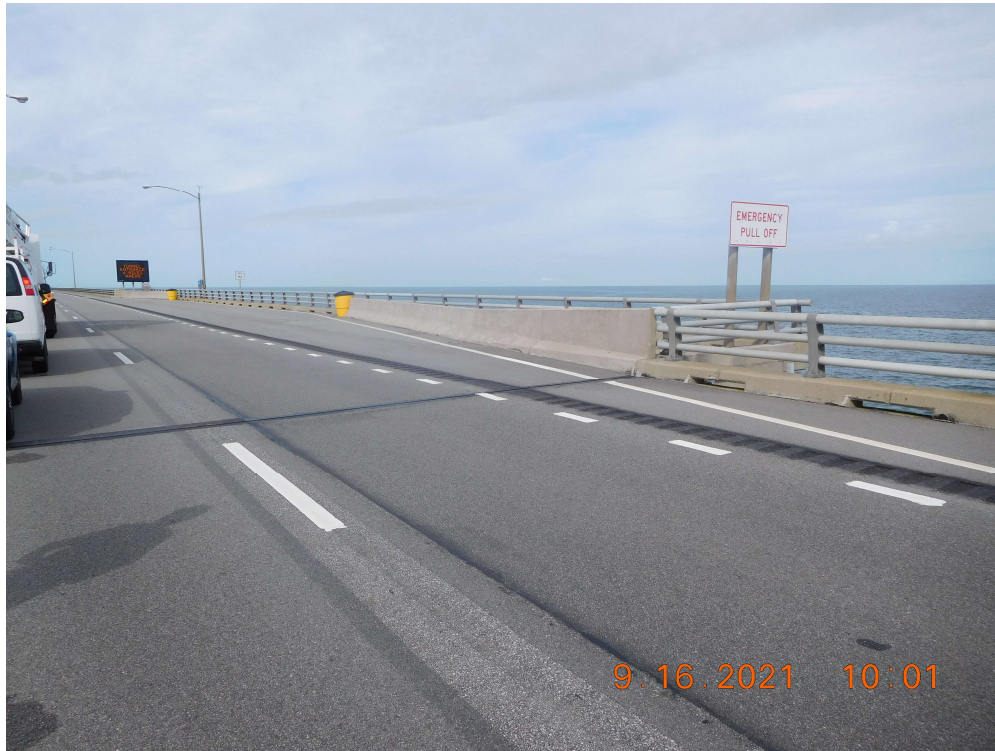
Photo 39: CSB232 – Typical Good Condition of Deck and Bridge Railing at EPO (Looking Southwest)

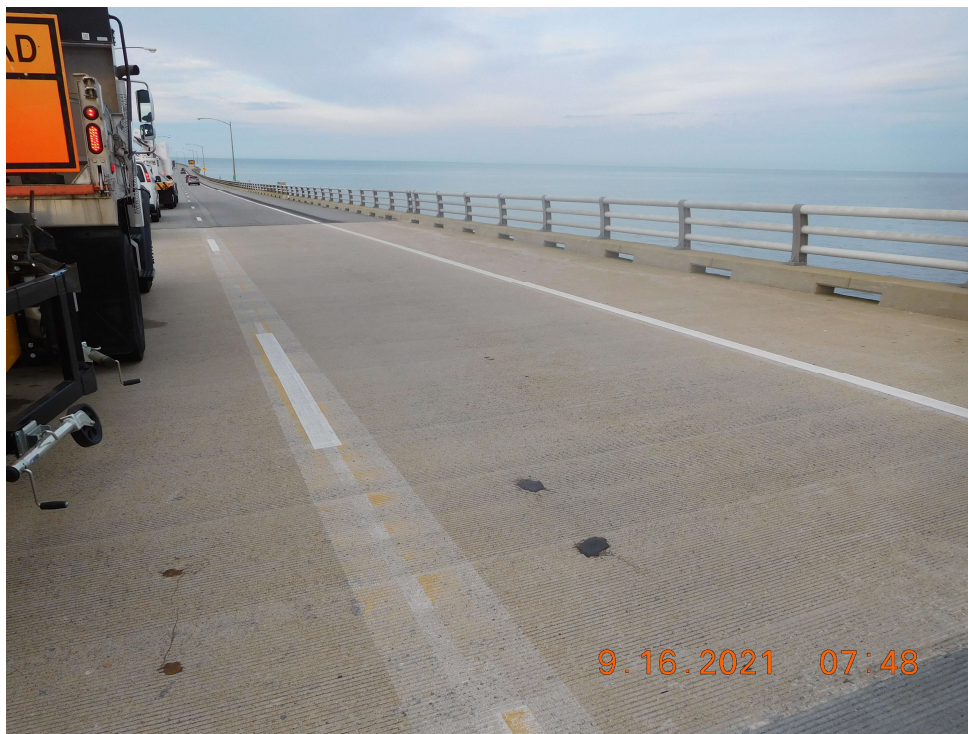
Photo 40: CSB246 – Typical Good Condition of Top of Deck and Bridge Railing (Looking Southwest)

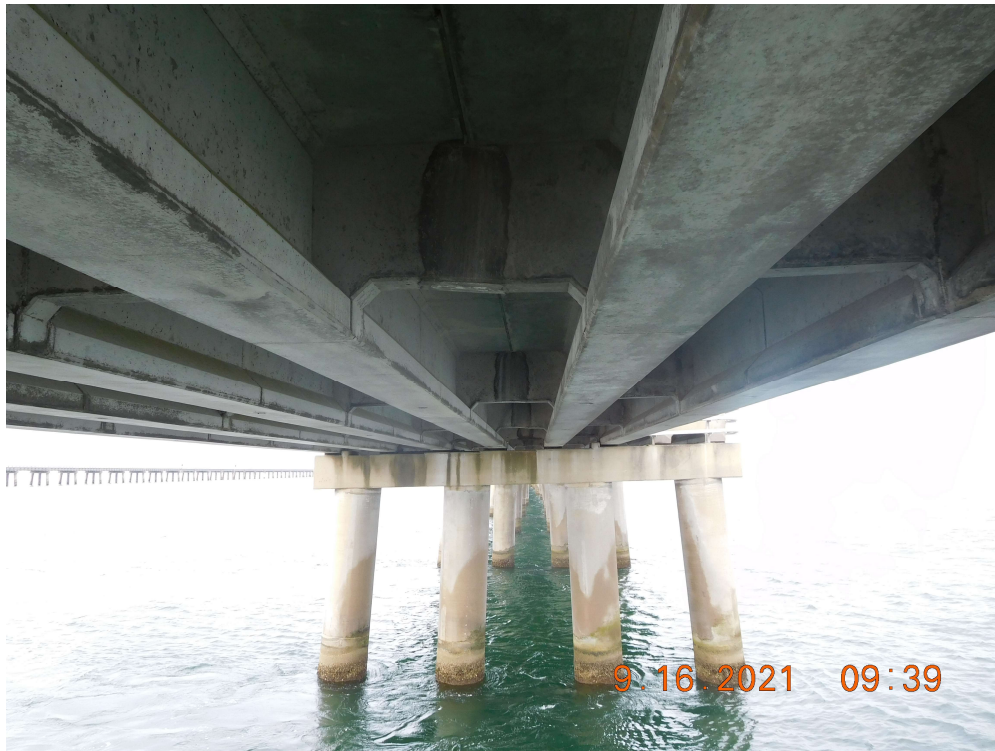
Photo 40: CSB234 – General Good Condition of Superstructure and Substructure (Looking North)

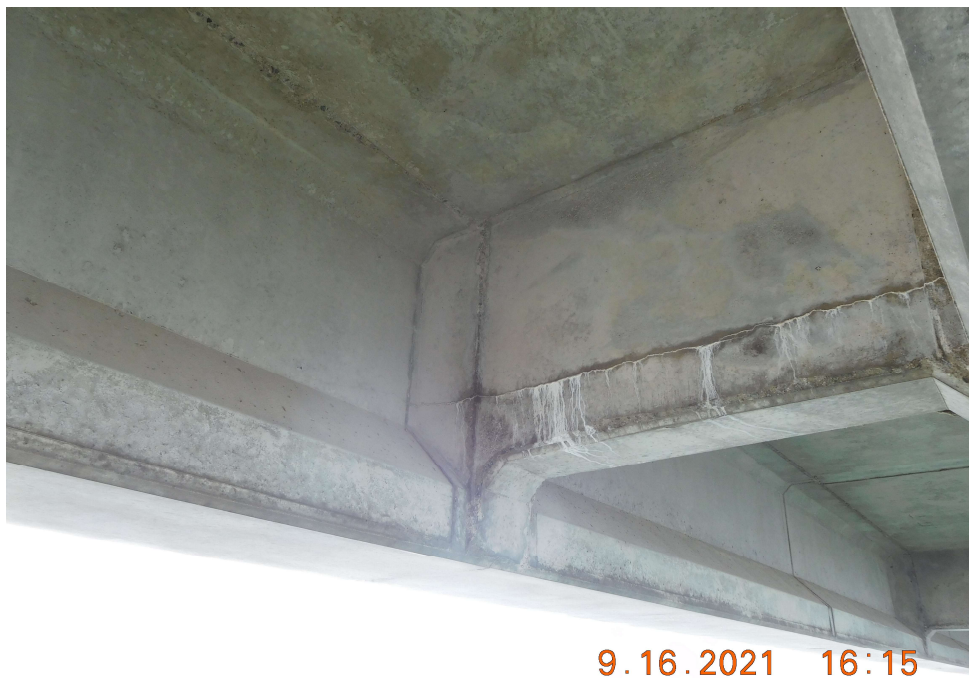
Photo 41: CSB 201 Prestressed Girder 6– Hairline Cracking with Light Efflorescence (Looking North)

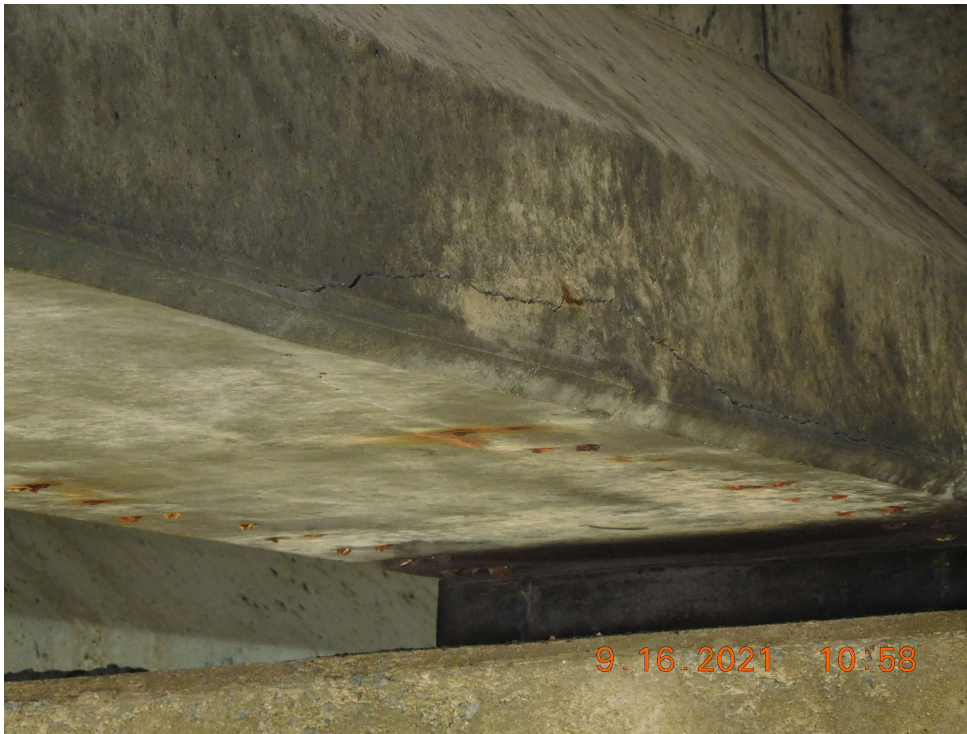
Photo 42: CSB227 Prestressed Concrete Girder – Delaminated Concrete at Bottom Flange of Girder 3

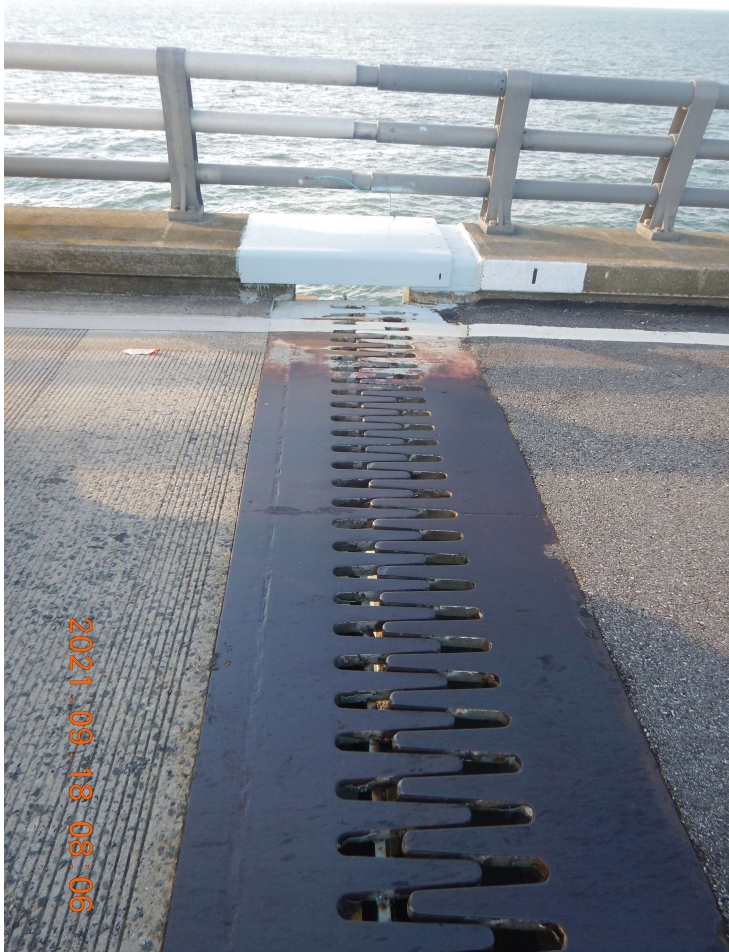
Photo 43: NCB-NB1- Typical Condition of Finger Joint

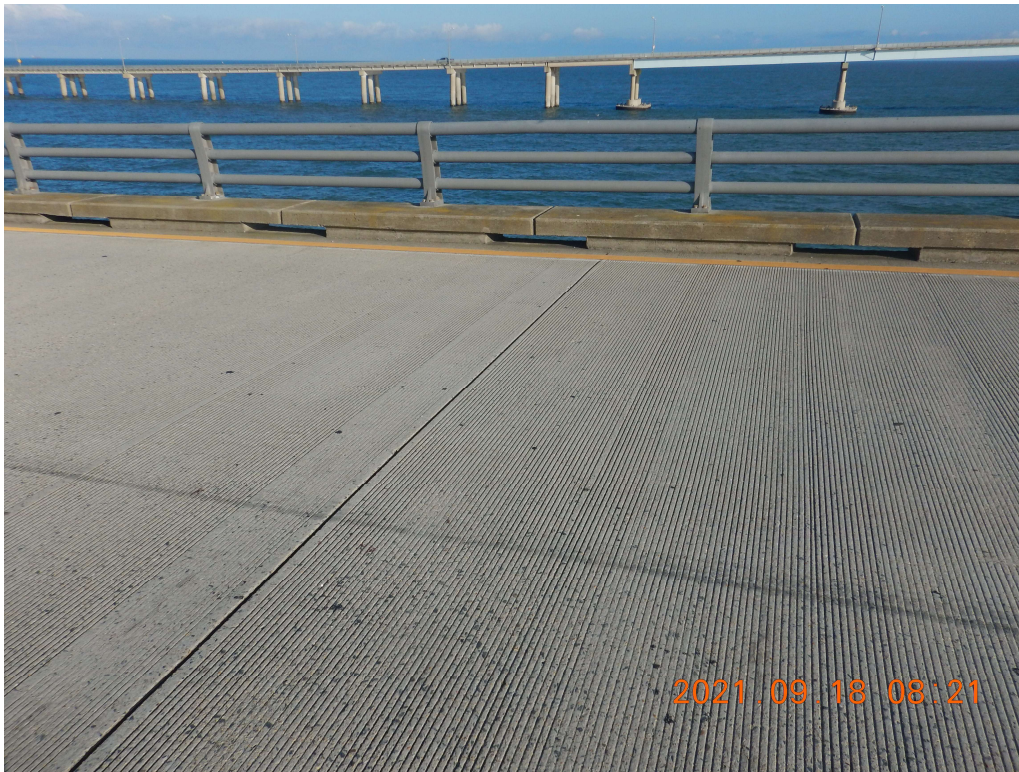
Photo 44: NCB-NB Deck and Railing- Typical Condition of Deck and Railing over Pier 2

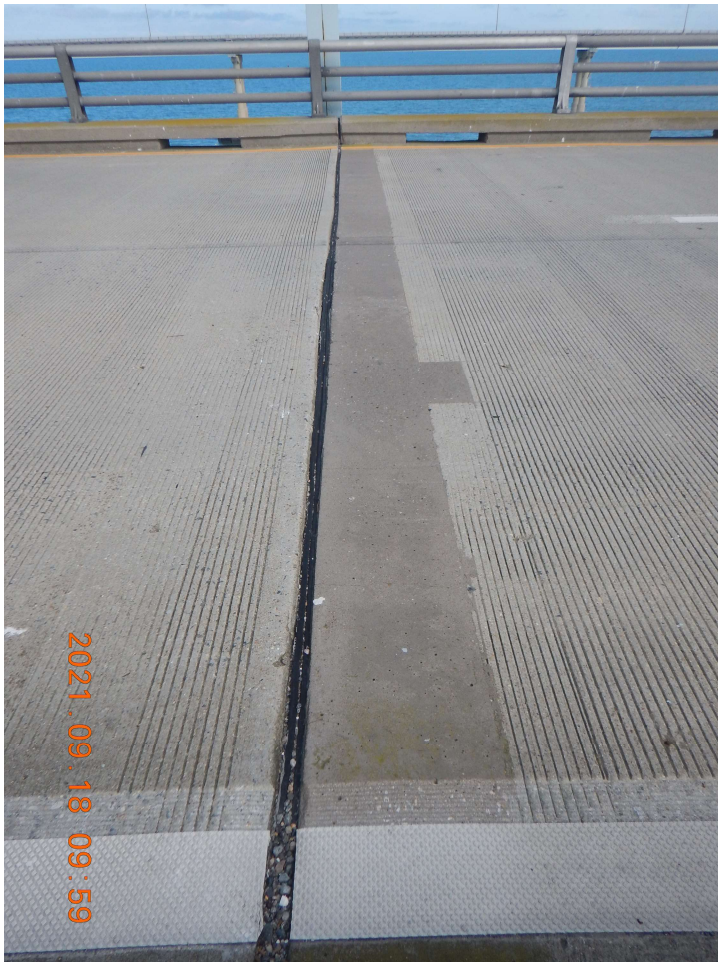
Photo 45: NCB-NB9- Deck patch adjacent to joint in satisfactory condition

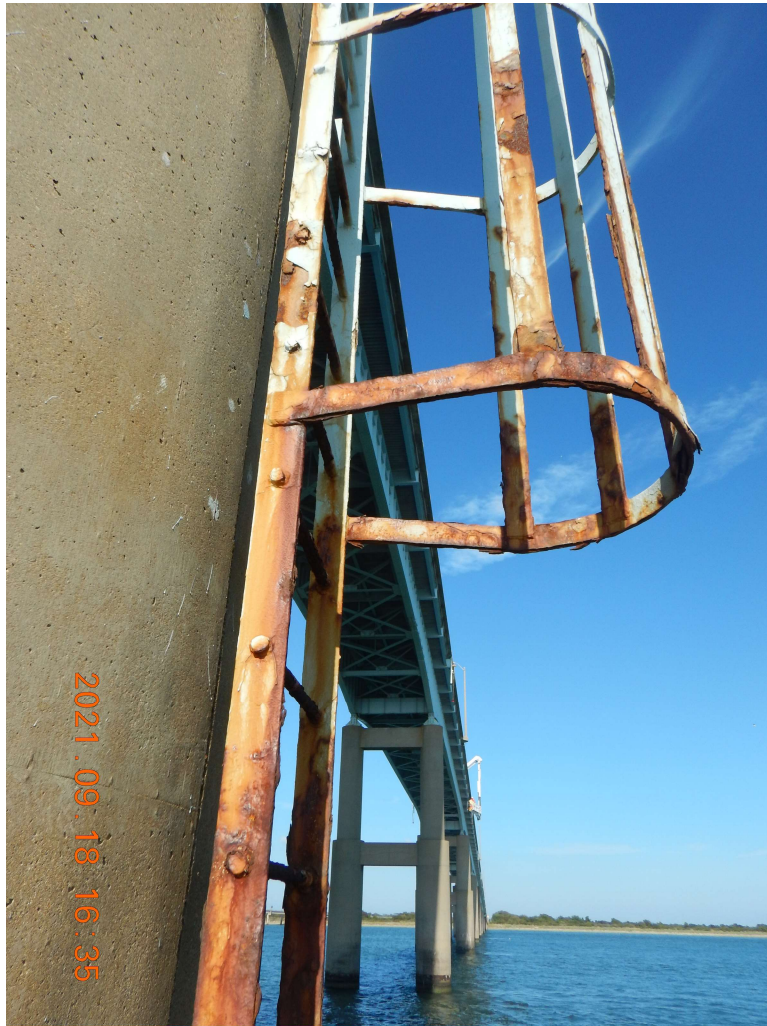
Photo 46: NCB-NB10- Peeling Paint with Minor to Moderate Corrosion of Access Ladder at Pier 10

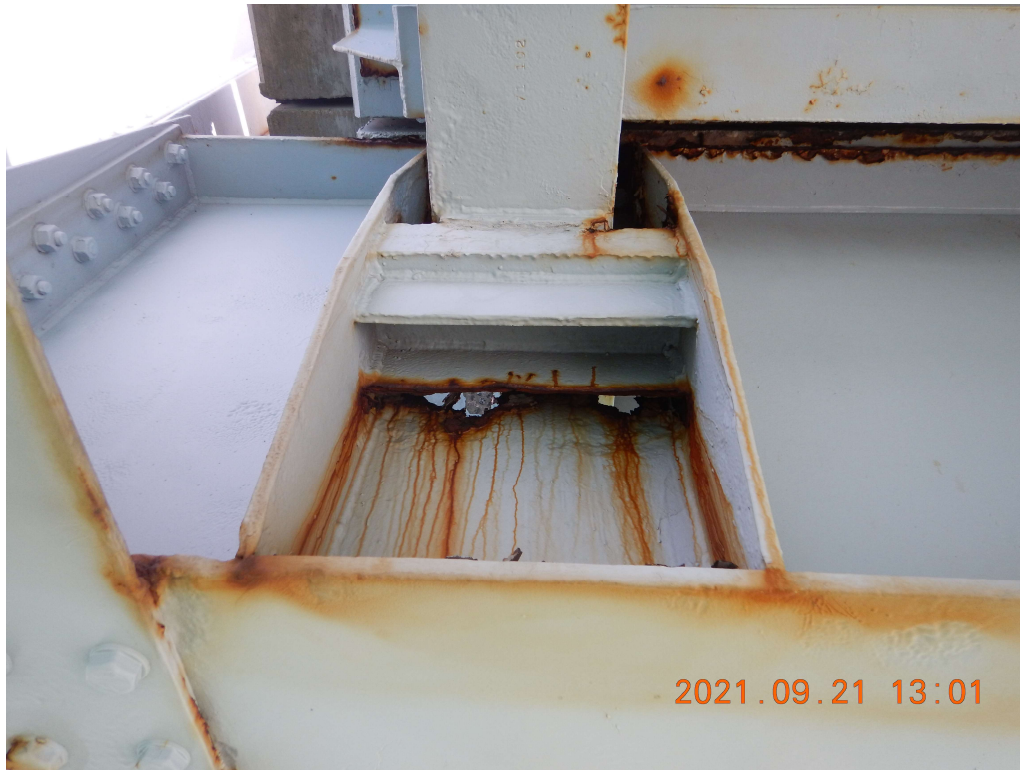
Photo 47: NCB-NB FB3'- Corrosion Holes in Web of Floorbeam at Stringer 1

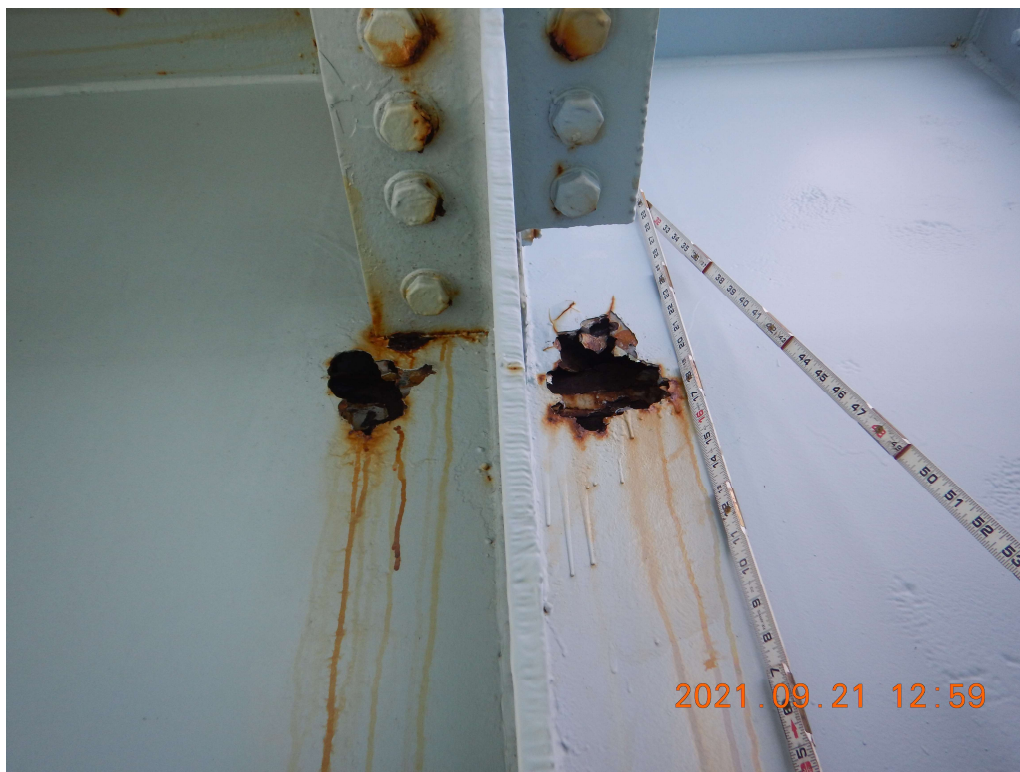
Photo 48: NCB-NB FB3' – Corrosion Holes in Transverse Stiffeners at Stringer 1

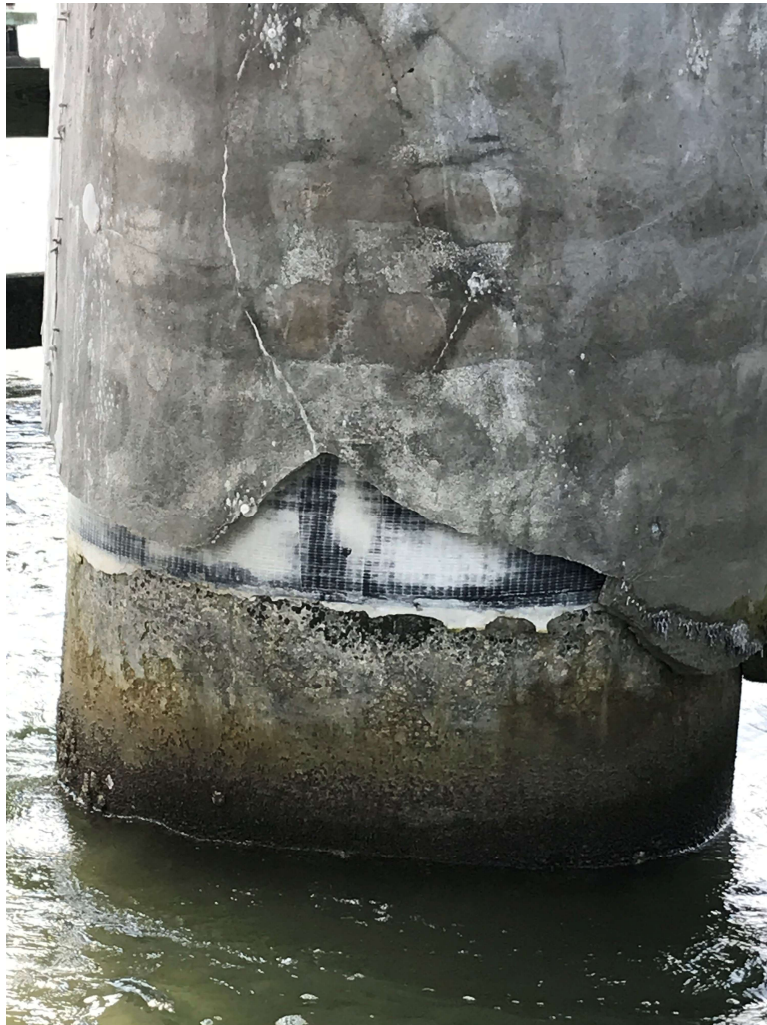
Photo 49: FIB-SB Bent 3, Pile C– Missing Fiberglass Jacket and Grout Annulus with Exposed Fiber Mesh

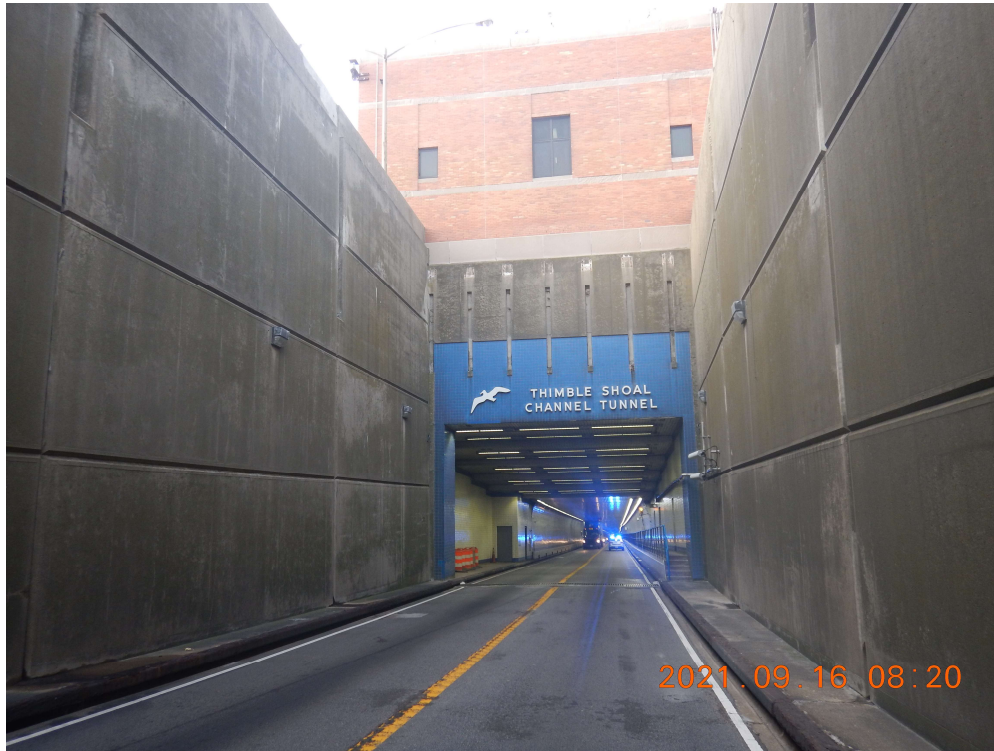
Photo 50: TSCT North Portal –Typical Good Condition with Isolated Areas of Minor Degradation (Looking Southeast)

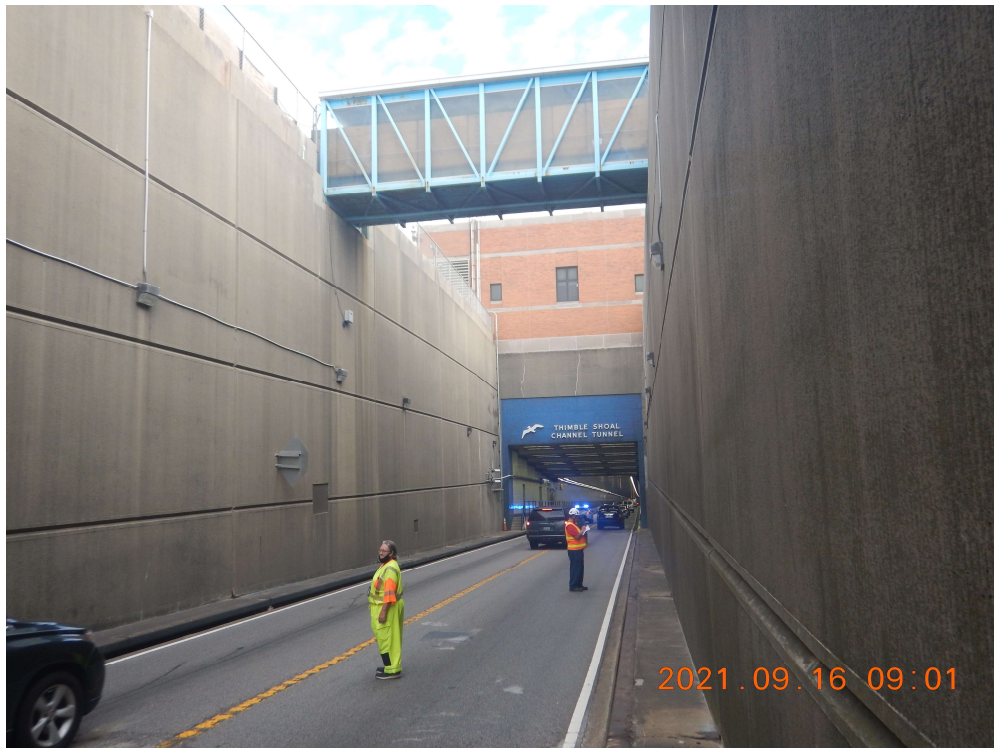
Photo 51: TSCT South Portal –Typical Good Condition with Isolated Areas of Minor Degradation (Looking Northwest)

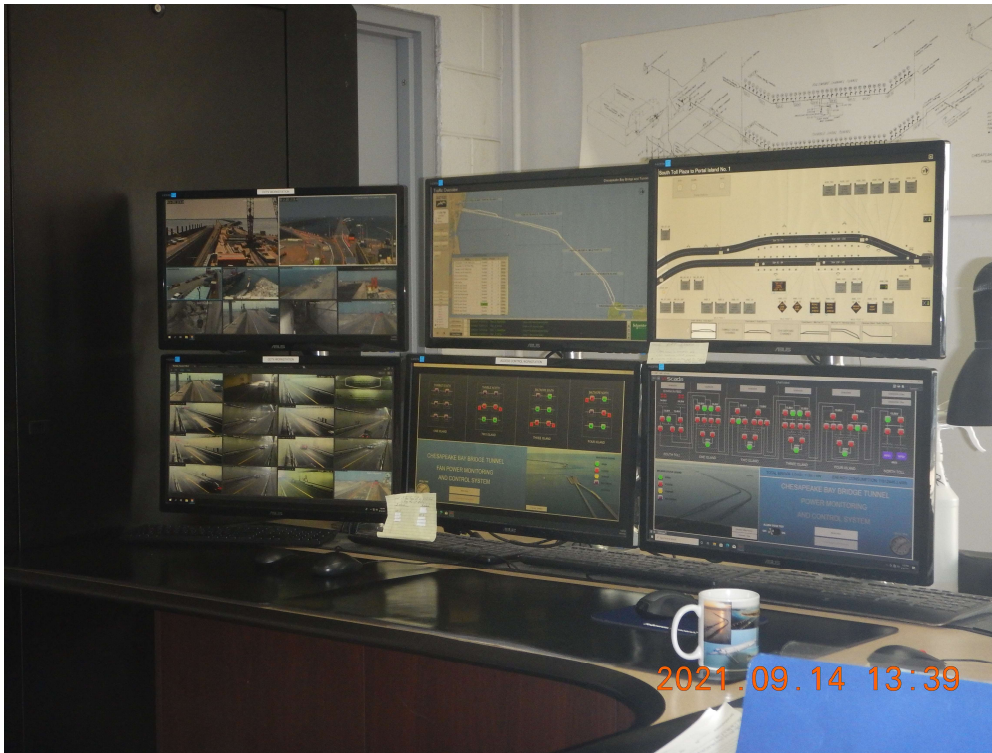
Photo 52: TSCT Island 1 Control Room –Typical Condition of Camera Control Room

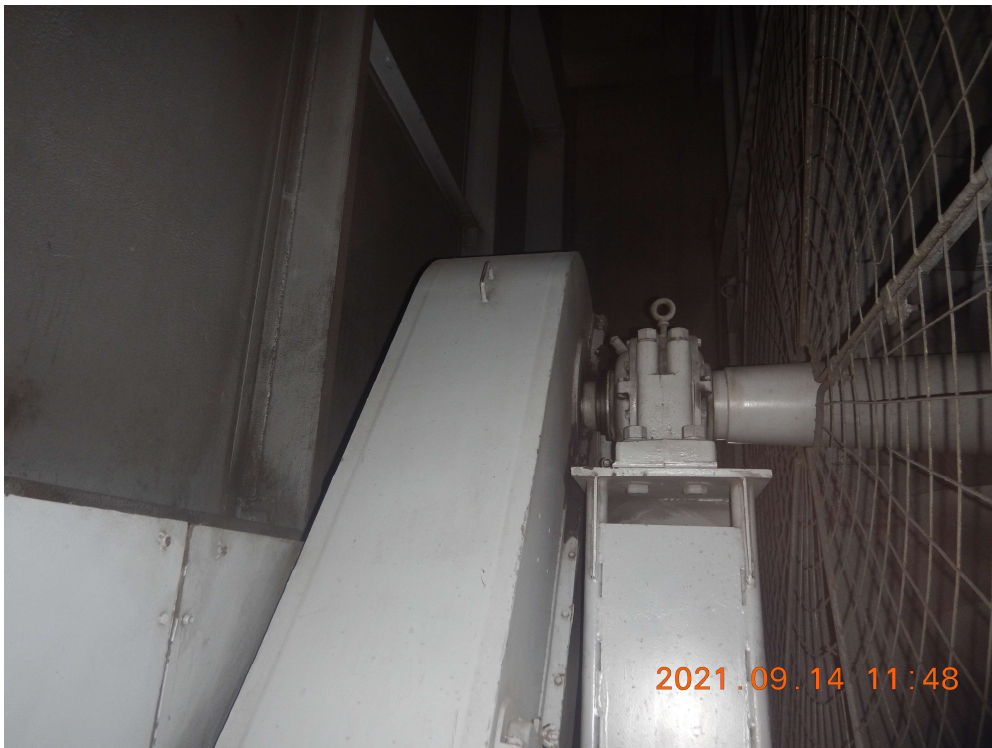
Photo 53: TSCT Island 1 Fans –Typical Good Condition

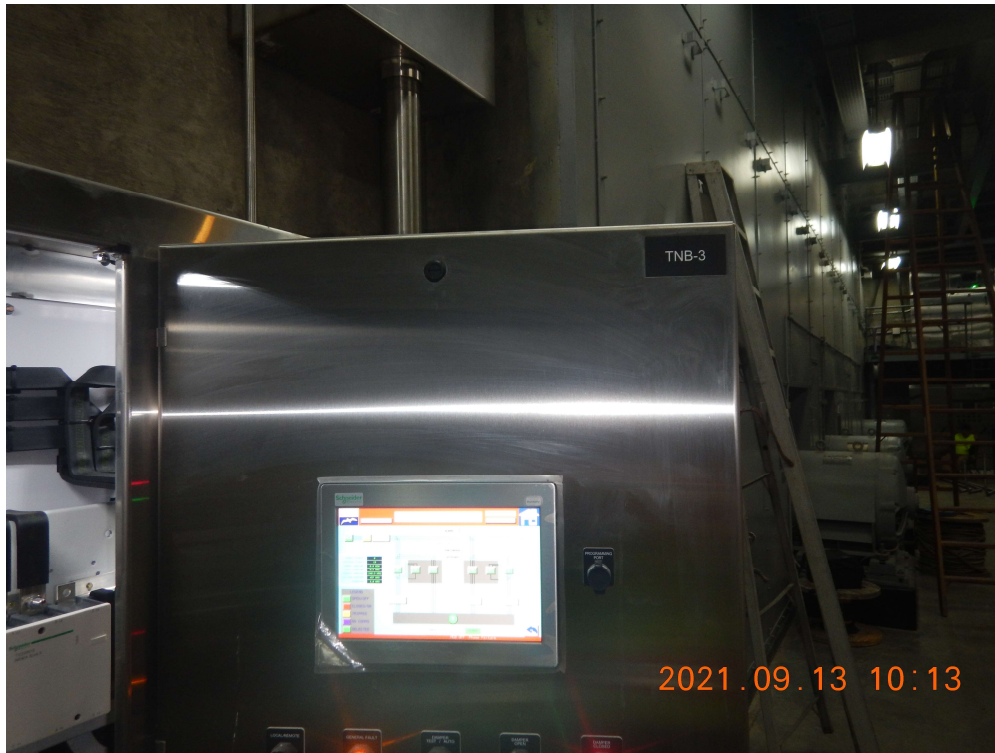
Photo 54: TSCT Island 2 Fans –HMI for New Ventilation Fan MCCs

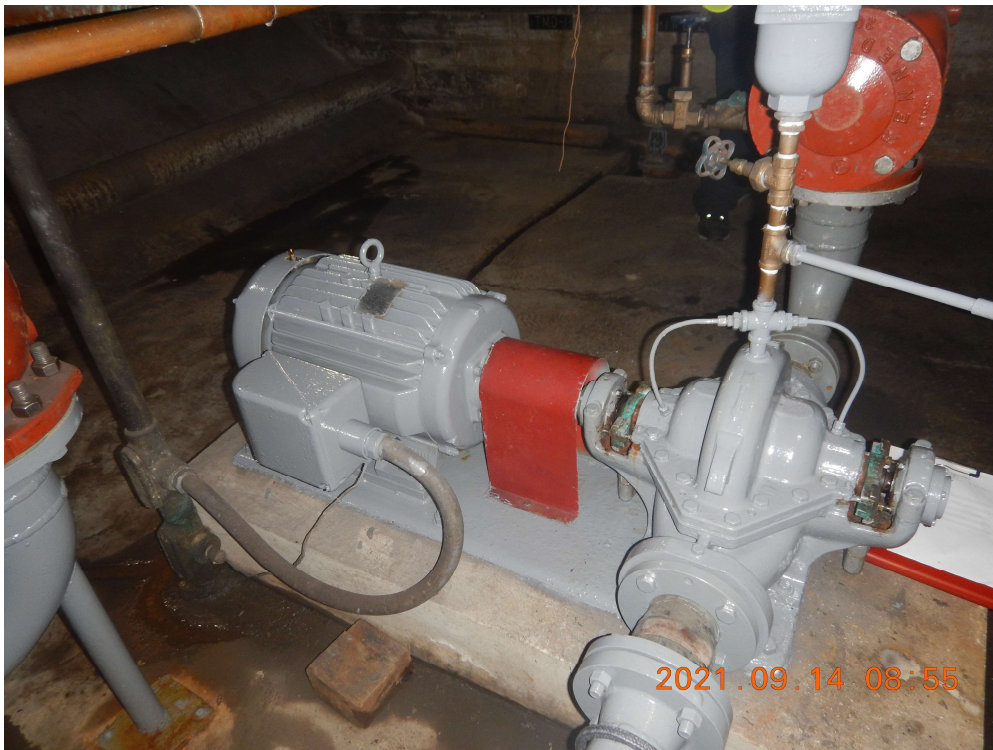
Photo 57: TSCT Pumps –Typical Good Condition of Mid-channel Pump #2

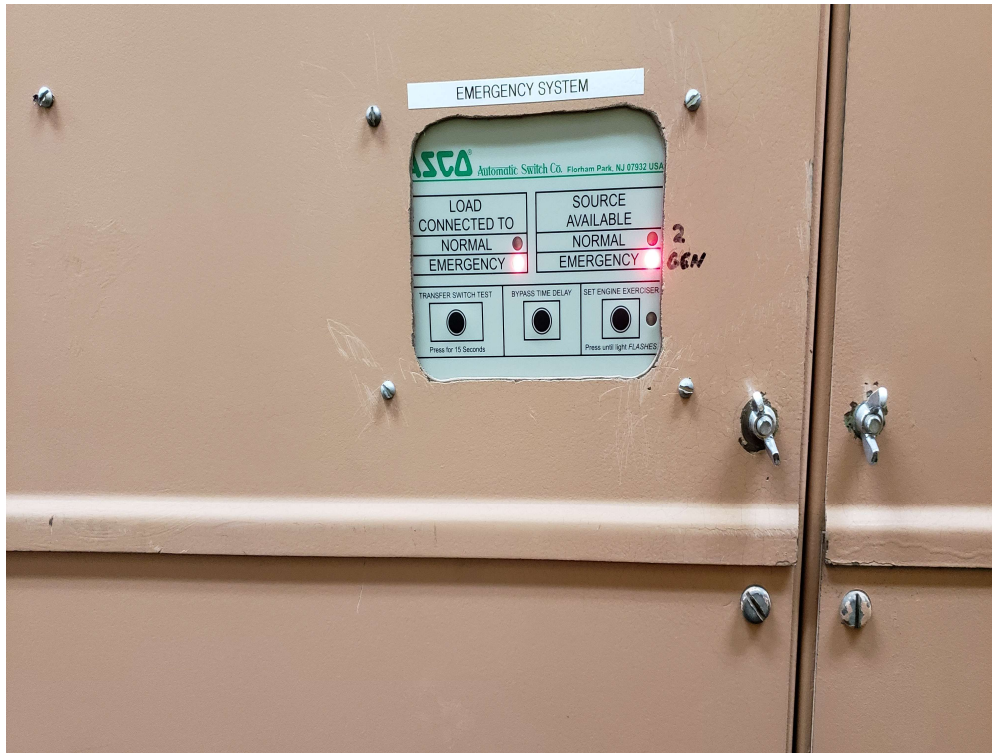
Photo 58: TSCT Island 1 –ATS Status Indicators during Emergency Testing Phase

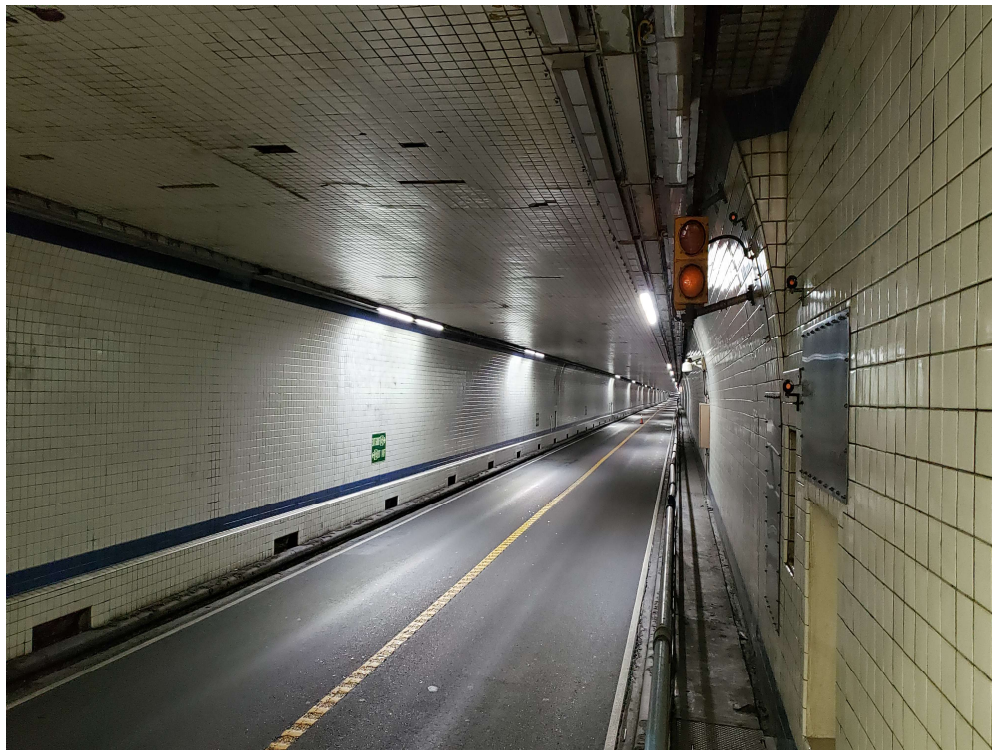
Photo 59: TSCT Lighting –Typical Condition of Emergency Lighting at Island 2 Portal (Looking South)

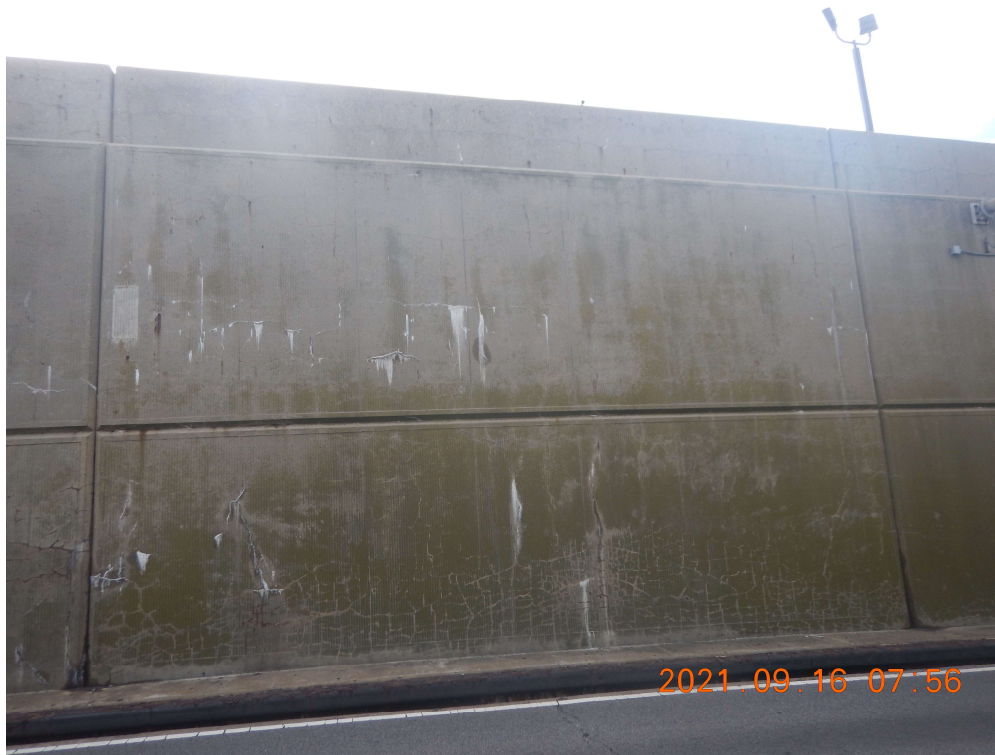
Photo 60: TSCT Island 2 Open Approach –Typical Satisfactory Condition with Minor Cracking with Efflorescence (Looking East)

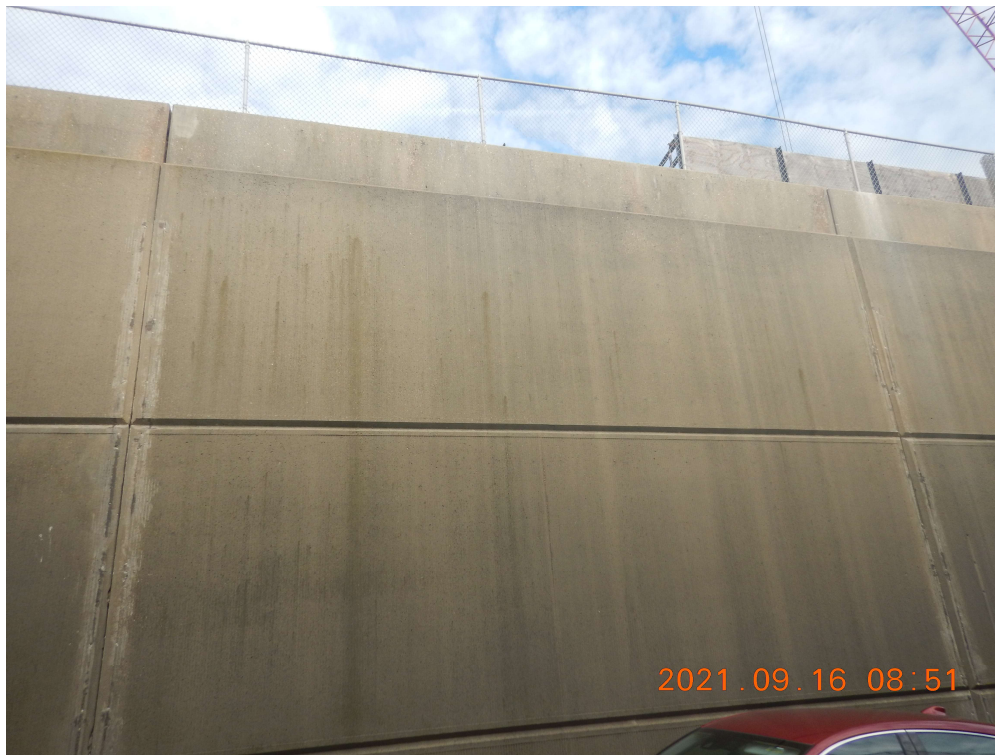
Photo 61: TSCT Island 1 Open Approach –Typical Satisfactory Condition with Minor Cracking, some Efflorescence and Rust Stains (Looking West)

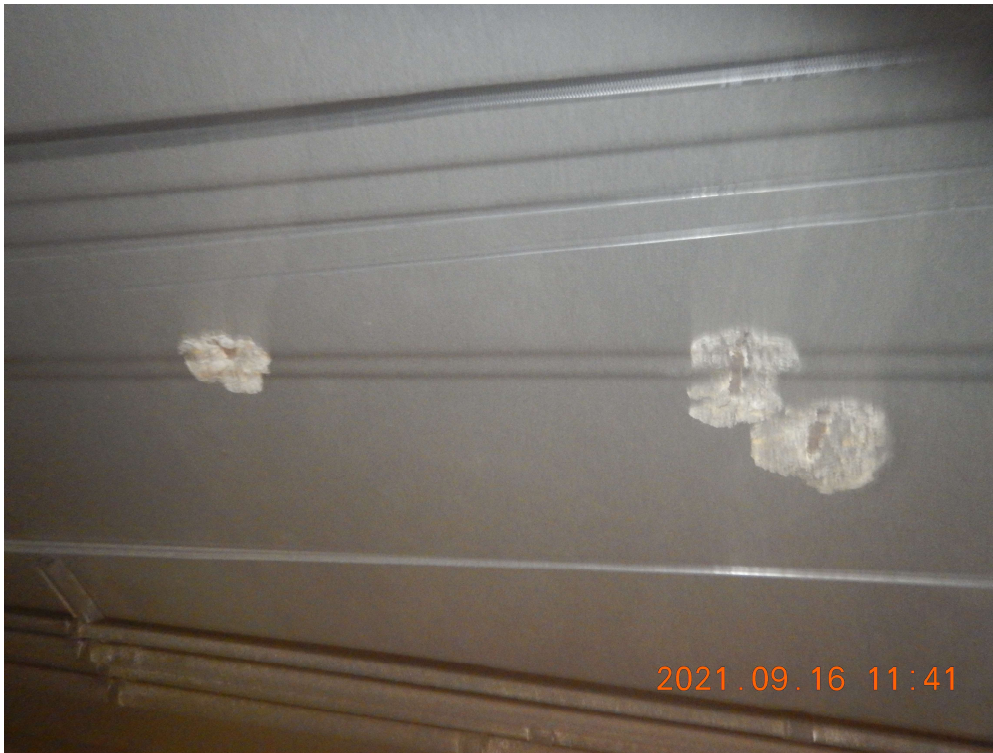
Photo 62: TSCT Tunnel Liner –STA 191+00 Minor Spalling with Exposed reinforcement (Looking East)

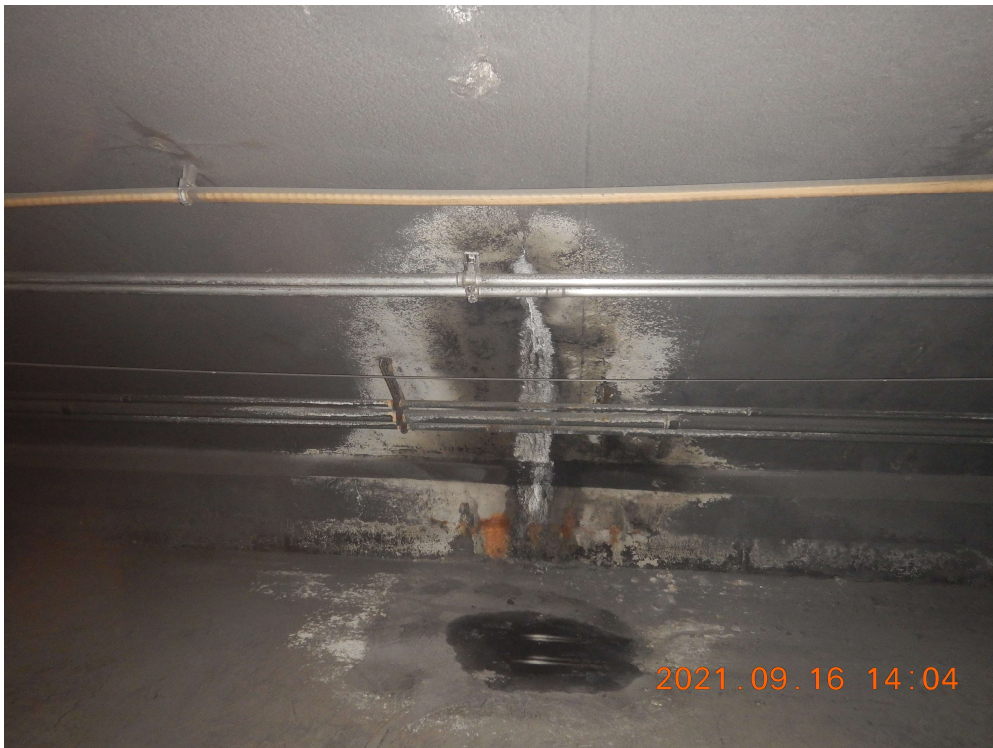
Photo 63: TSCT Tunnel Liner –STA 231+20 in Exhaust Duct Hairline Cracking with Heavy Efflorescence (Looking East)

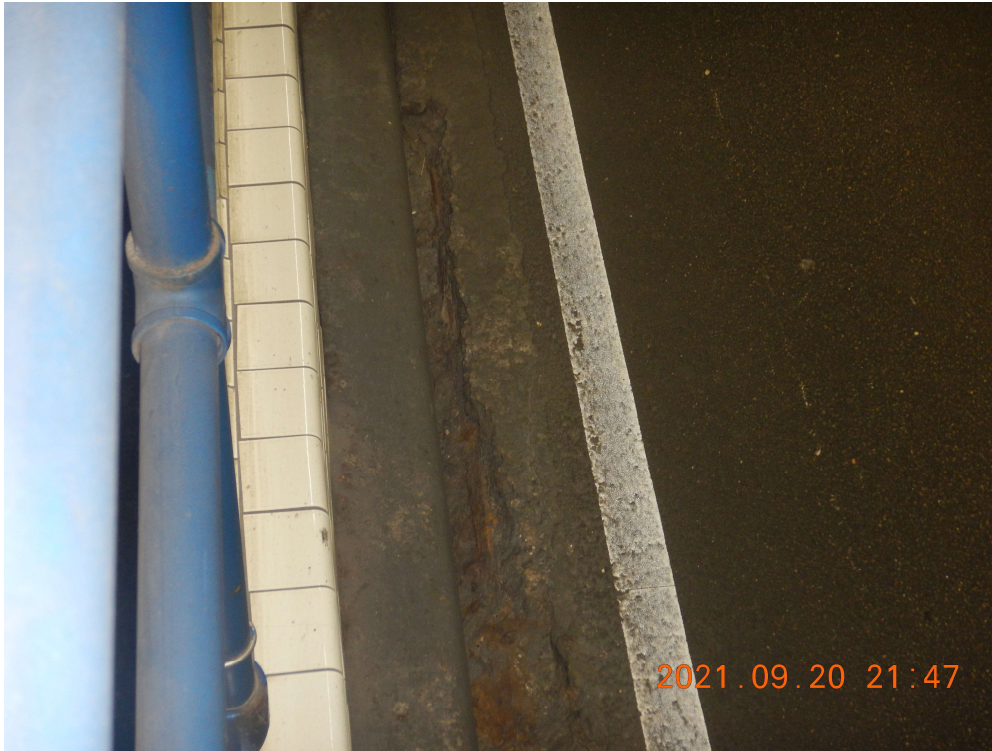
Photo 64: TSCT Roadway – STA193+50 Random Edge Spalling with Exposed Reinforcement along Roadway Curb, Worst Case Scenario (Looking North)
