FY2022 Annual Inspection and Underwater Inspection, Trestles BSB, DNB, ESB & FSB, NCB-NB, and FIB-SB

FY2022 Facility Annual Inspection Report FINAL

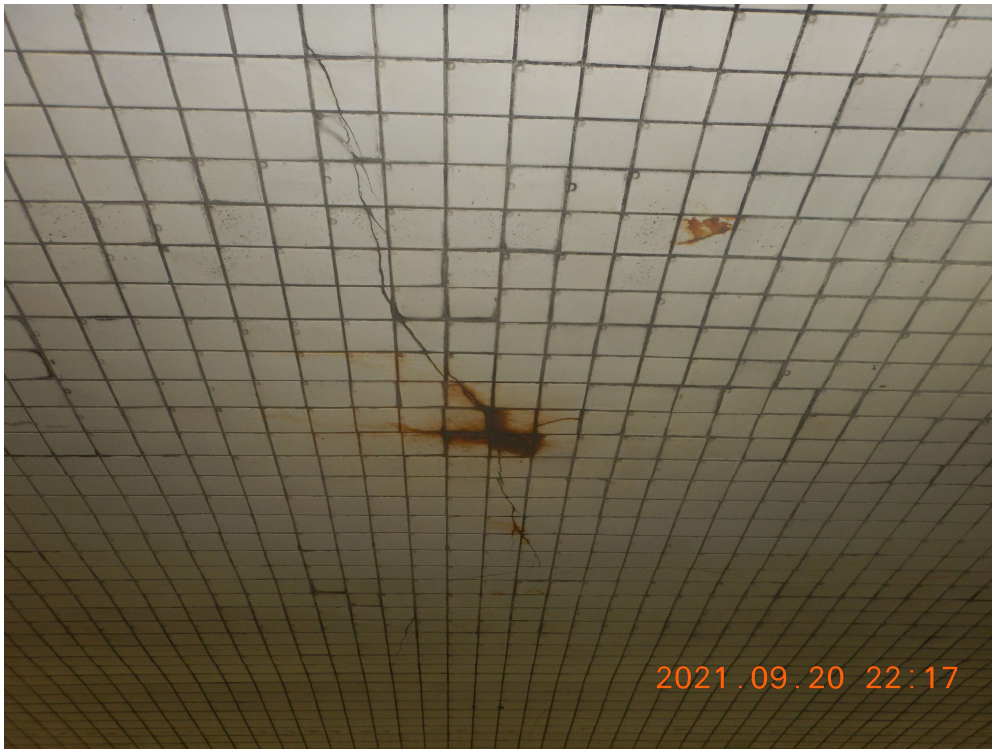
Photo 65: TSCT Roadway –STA 235+20 Cracked Ceiling Tiles with Minor to Moderate Rust Staining, Worst Case Scenario (Looking East)

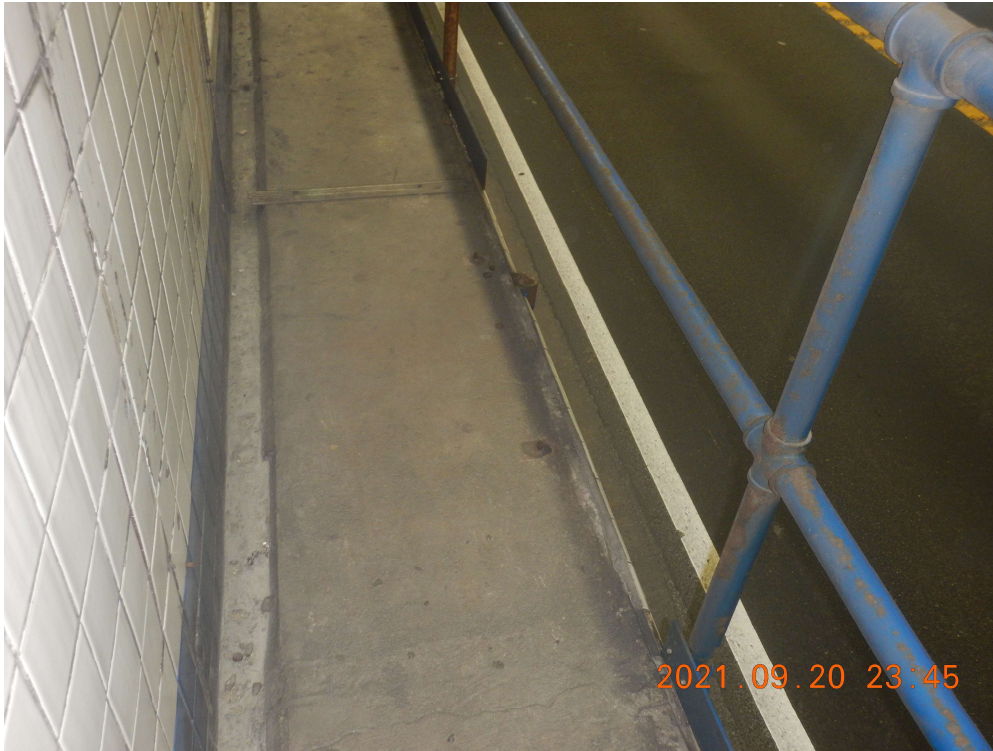
Photo 66: TSCT Steel Railing – STA203+50 Missing toe board and post, Worst Case Location (Looking Northeast)

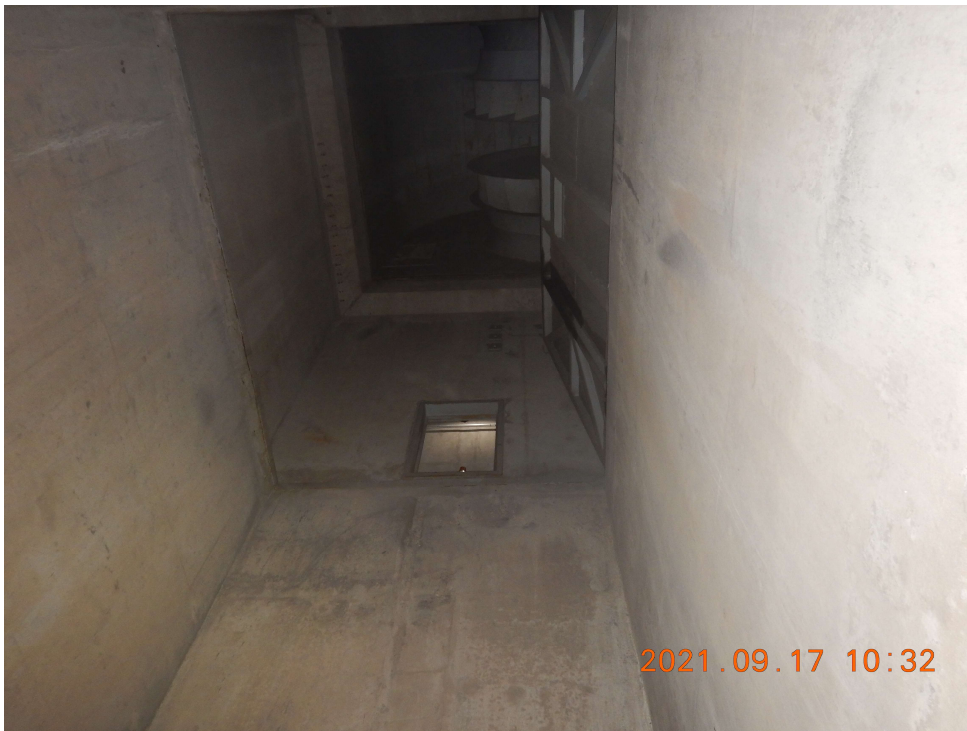
Photo 67: TSCT Supply Duct, Island 1 – Typical Good Condition of Fan Supply Duct Shaft; Note Open Access Door for Ventilation

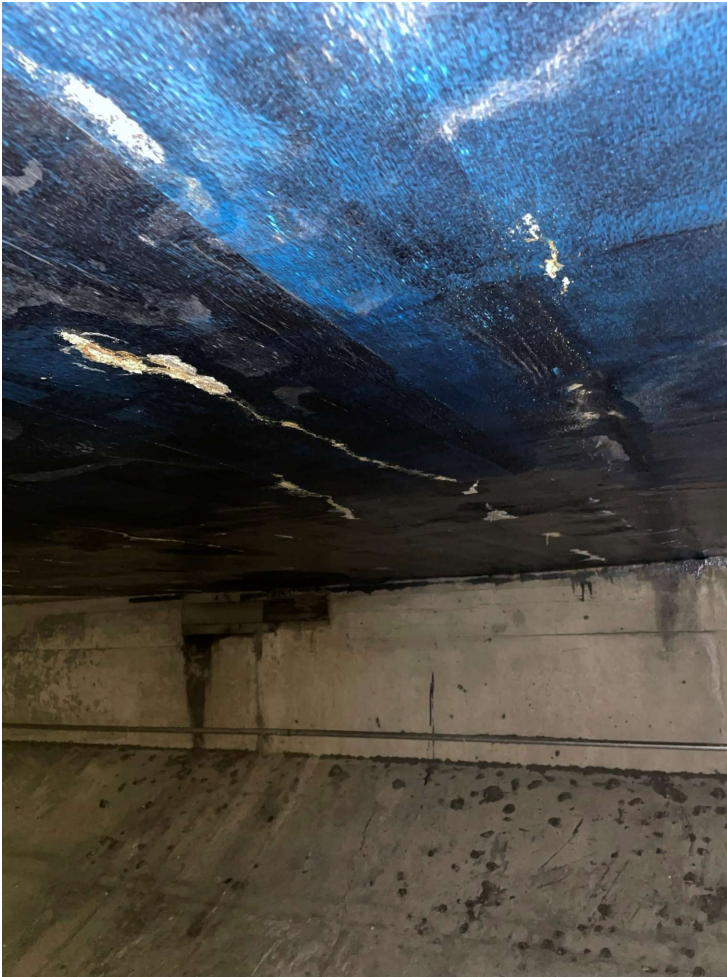
Photo 69: TSCT Invert Slab – STA197+40 Repaired Spall with Fiber Wrap on Underside of Invert Slab

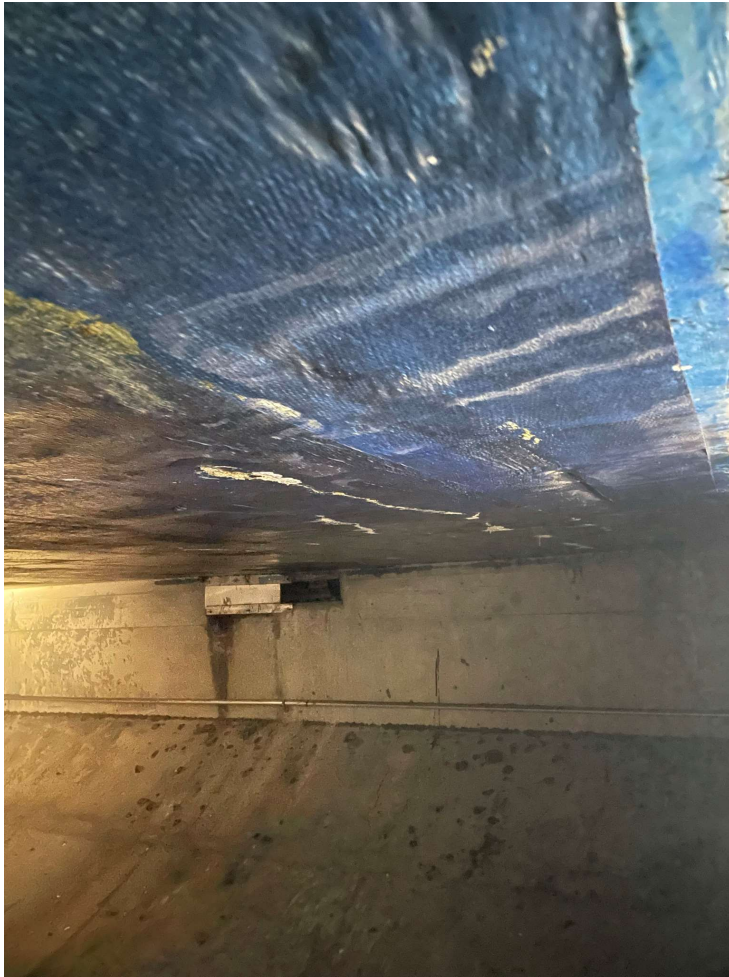
Photo 70: TSCT Invert Slab – STA197+40 Repaired Spall with Fiber Wrap on Underside of Invert Slab
