FY2019 Annual Inspection and Underwater Inspection, Trestle A'NB, ANB, & ASB

Chesapeake Bay Bridge and Tunnel District

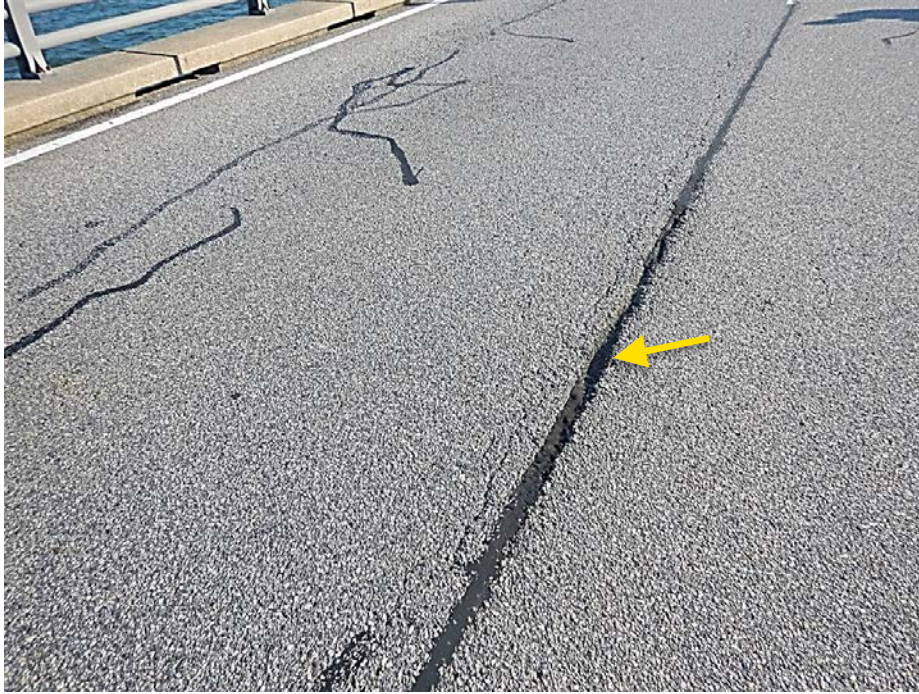
Photo 8.1-1: ANB129 Asphalt Wearing Surface – Surface Spall along Center Line (Looking Southeast)

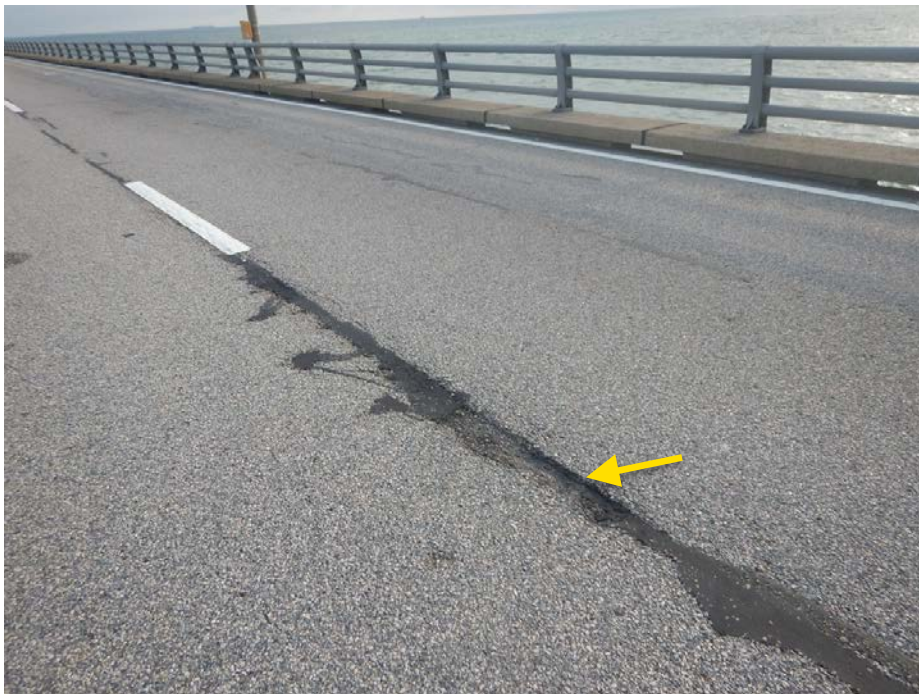
Photo 8.1-2: ANB143 Asphalt Wearing Surface – Surface Spall along Center Line (Looking Northeast)

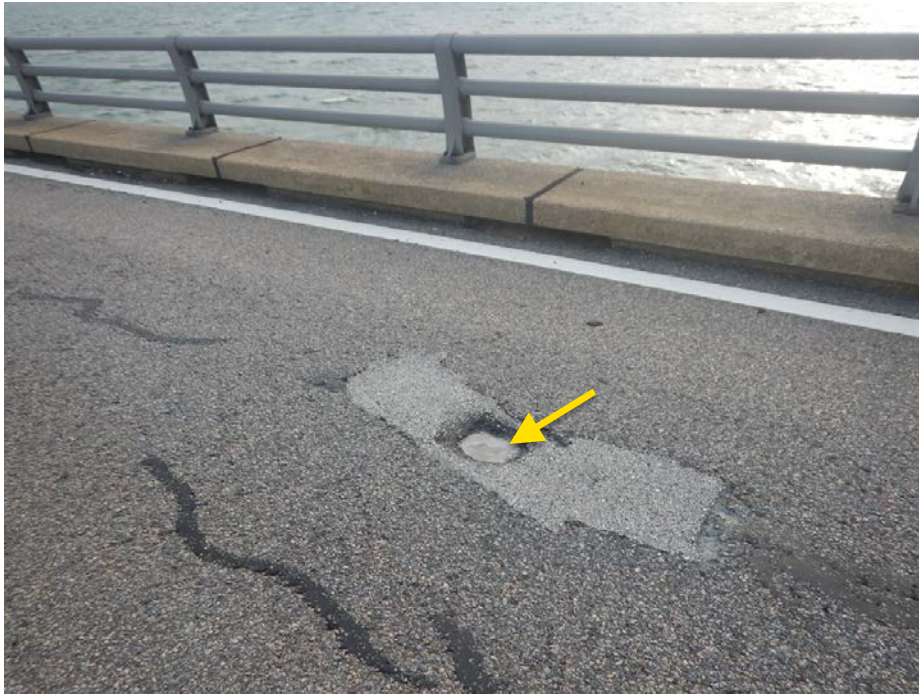
Photo 8.1-3: ANB144 Asphalt Wearing Surface – Full Depth Surface Spall in Right Lane (Looking Northeast)

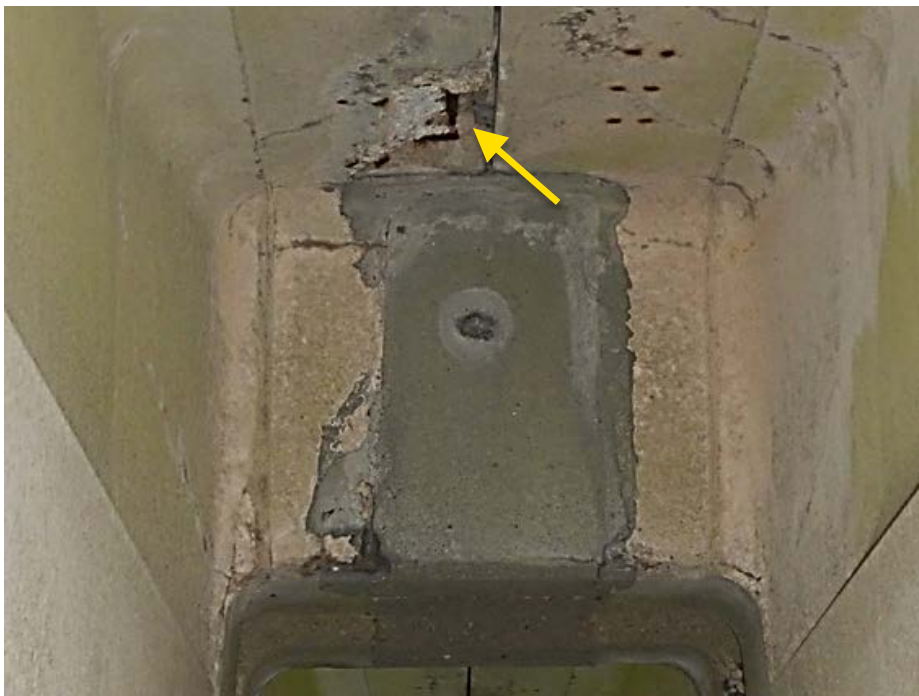
Photo 8.1-4: ANB142 Reinforced Concrete Top Flange (Underside) - Spall with Exposed Reinforcing in Bay 3 Zone 3 (Looking North)

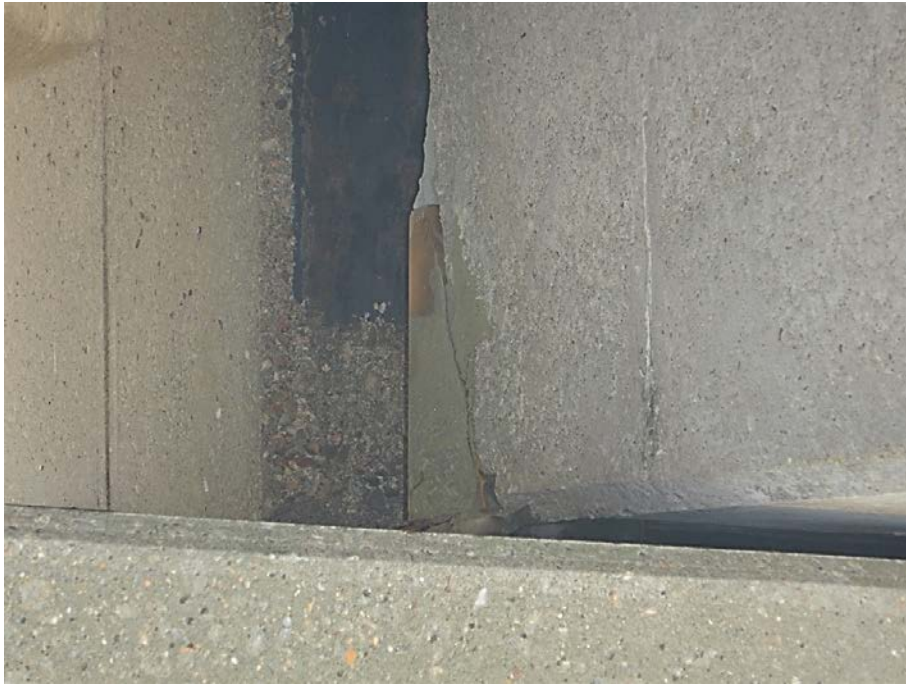
Photo 8.1-5: ANB132 Girder 6 – Failed Repair at Bearing (Looking Southwest)

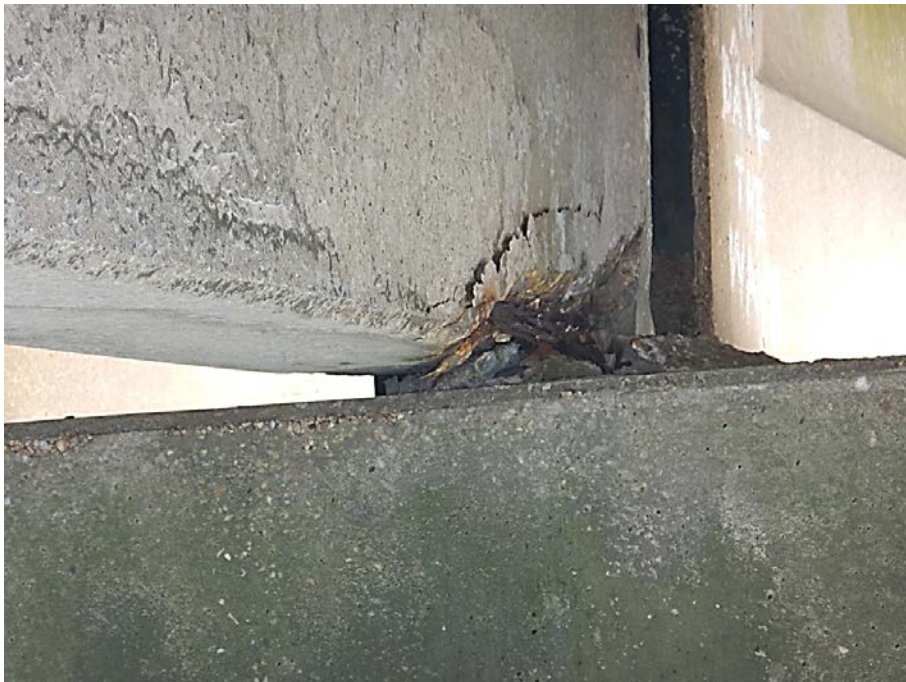
Photo 8.1-6: ANB133 Girder 3 - Spall at Bearing with 1 Exposed Reinforcement Bar (Looking Southeast)

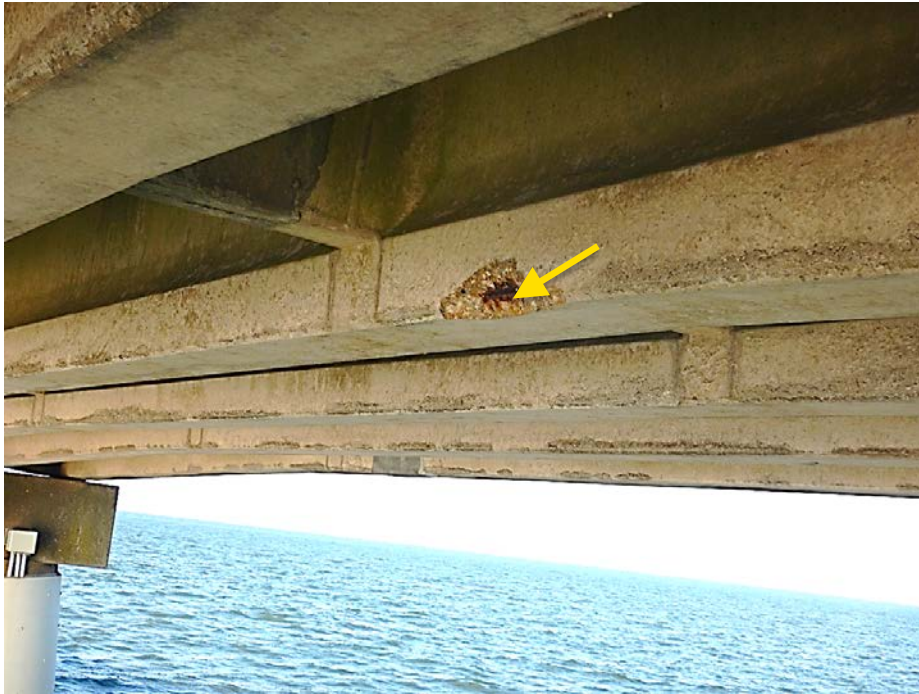
Photo 8.1-7: ANB133 Girder 4 - Spall with 1 Exposed Prestressing Strand (Looking Northeast)

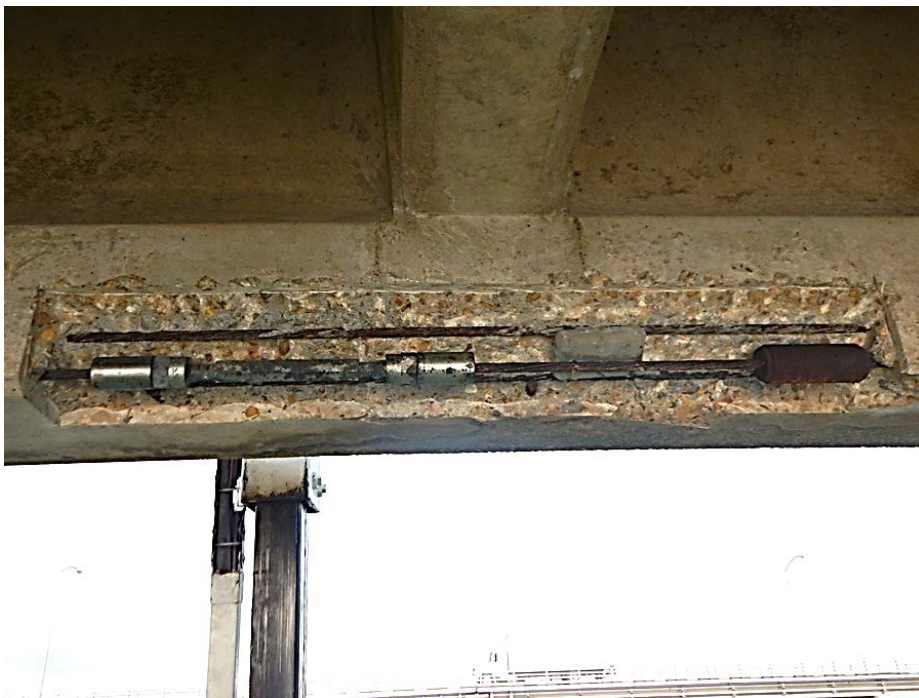
Photo 8.1-8: ANB149 Girder 8 - Girder Spall and Prestressing Strand Repair Preparation exhibiting Corrosion along Replacement Strand and Coupler (Looking West) ~ The District Corrected and Completed the Repair per Email dated 11/20/2018

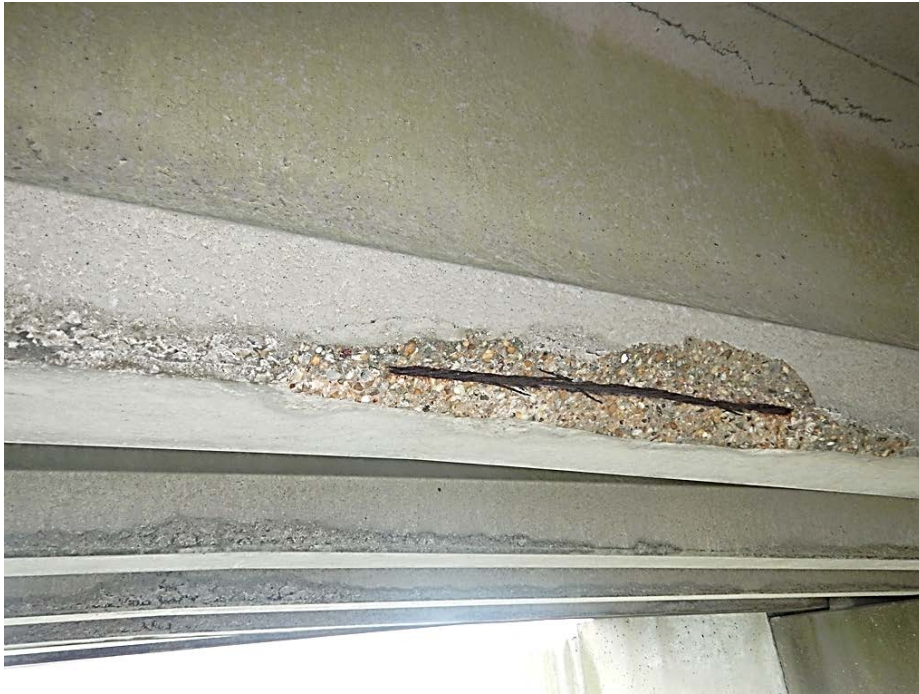
Photo 8.1-9: ANB159 Girder 6 - Spall with 1 Exposed Prestressing Strand (Looking Southeast)

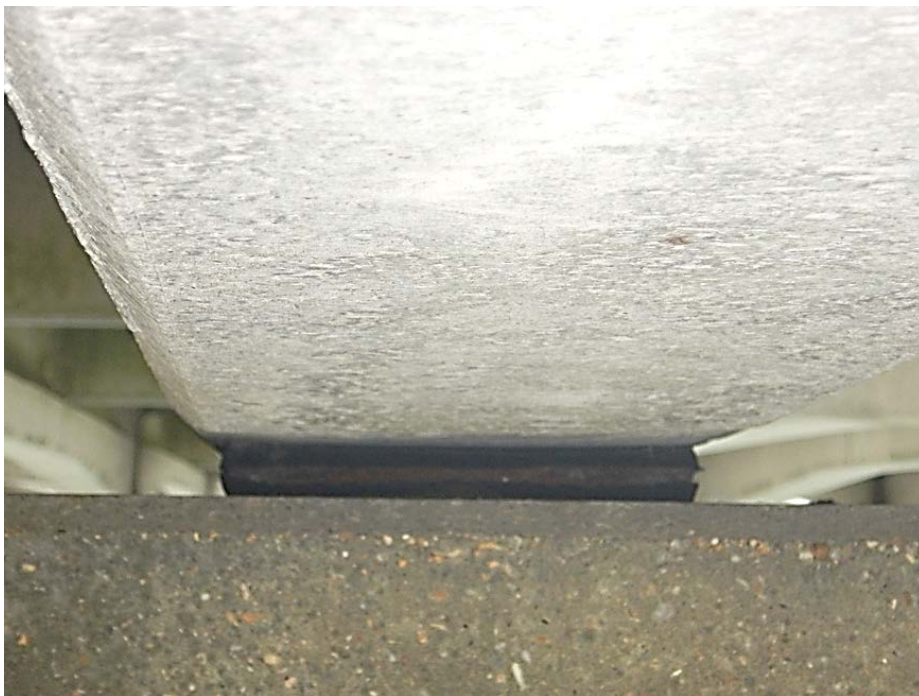
Photo 8.1-10: ANB146 Elastomeric Bearing at Girder 4 - Split with Exposed and Corroded Steel Plates (Looking South)

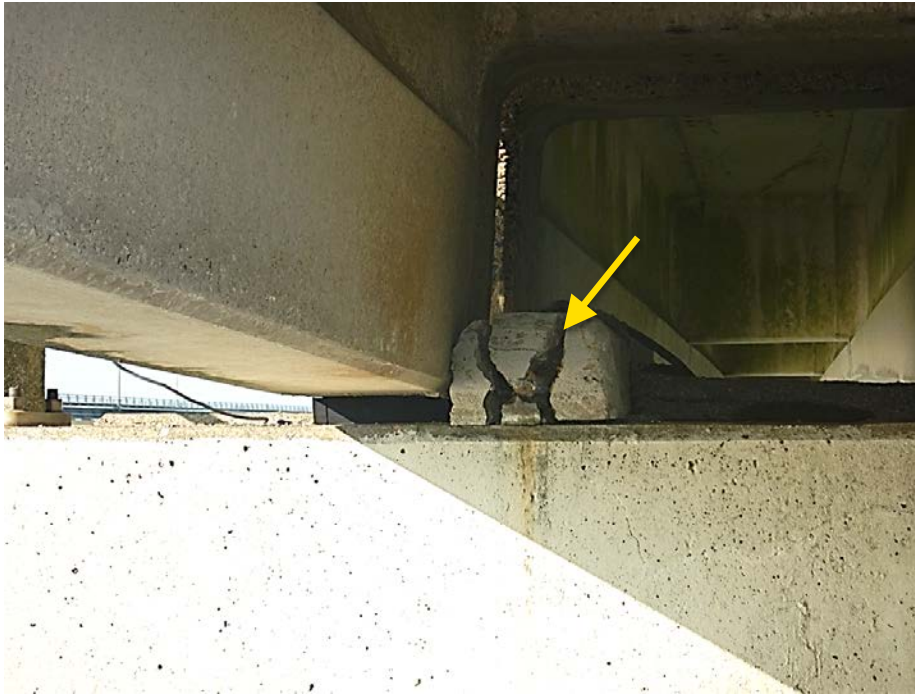
Photo 8.1-11: ASB Bent 135 – Spalled Shear Tab (Looking Northwest)

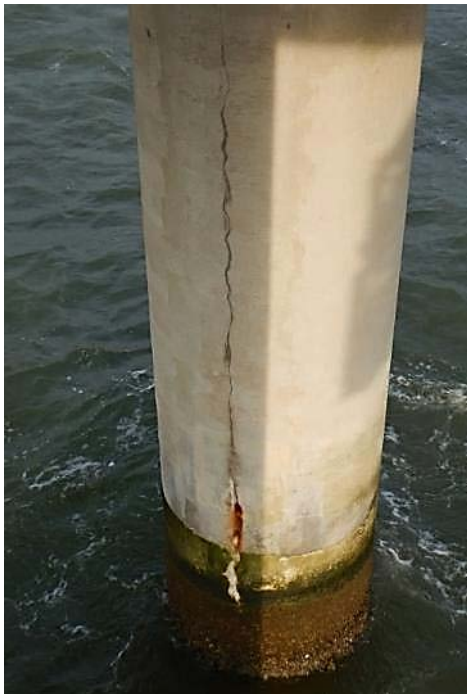
Photo 8.1-12: ANB75 Pile A - Wide Crack in Pile through Protective Coating with Rust Staining (Looking West)

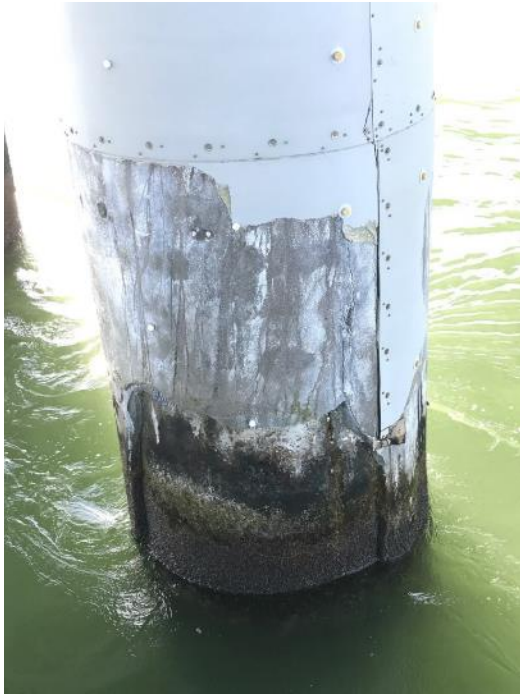
Photo 8.1-13: ANB89 Pile A - Damaged Life Jacket missing Grout and Zinc Mesh on Northwest Quadrant

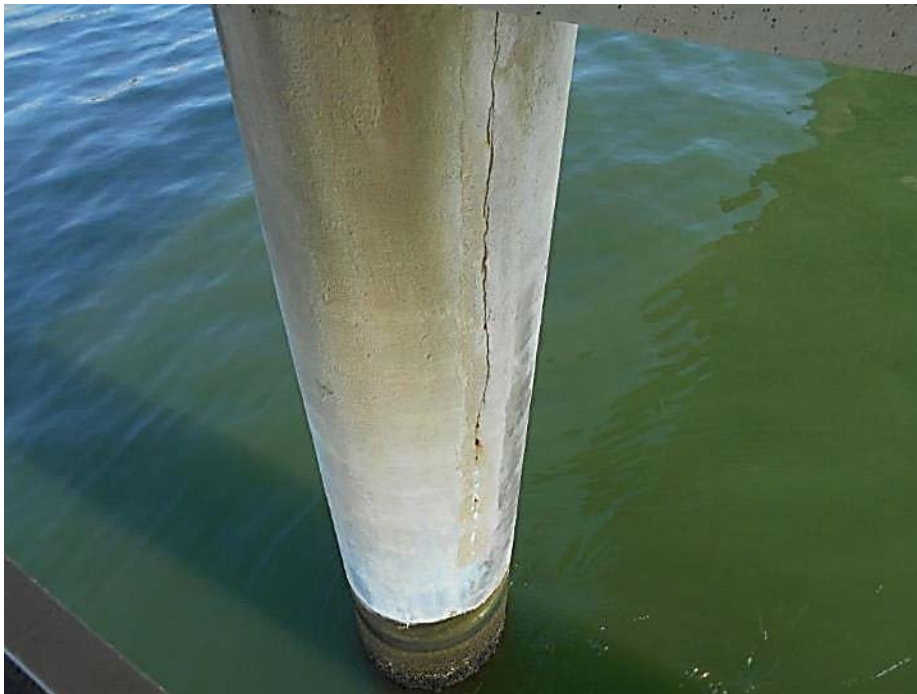
Photo 8.1-14: ANB96 Pile A - Crack through Protective Coating with Rust Staining (Looking Northeast)

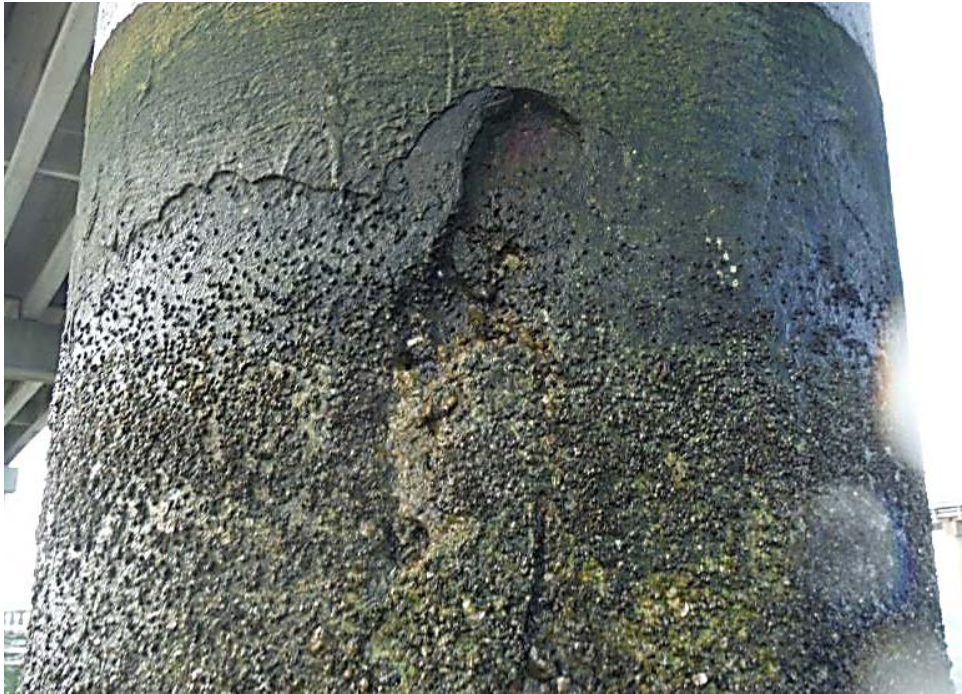
Photo 8.1-15: ANB112 Pile B - Protective Coating Failures with Cracking, Spalling, and Rust Staining (Looking South)

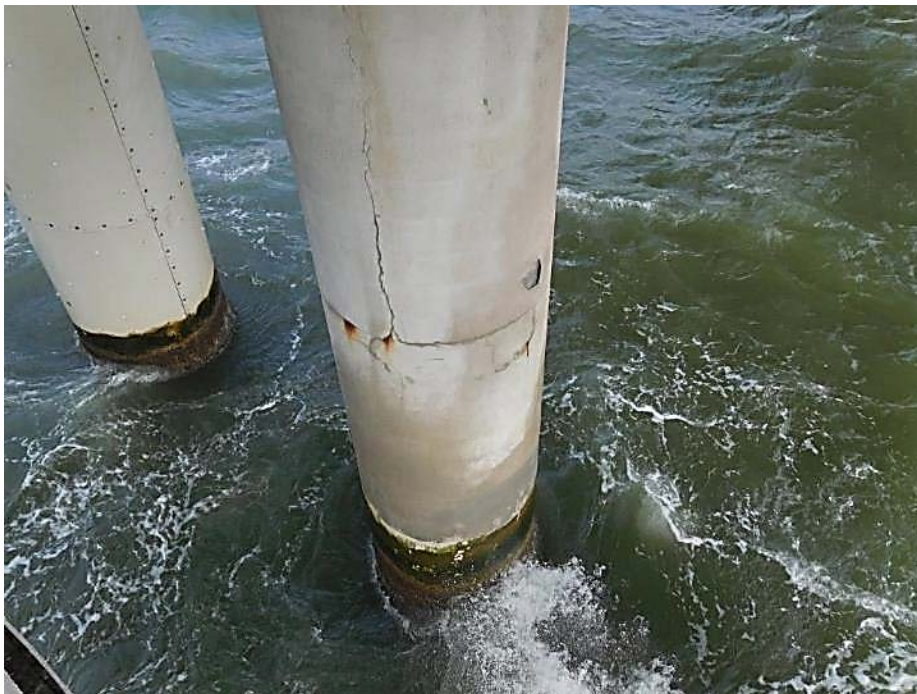
Photo 8.1-16: ANB122 Pile B - Protective Coating Failures with Cracking and Rust Staining (Looking Northwest)

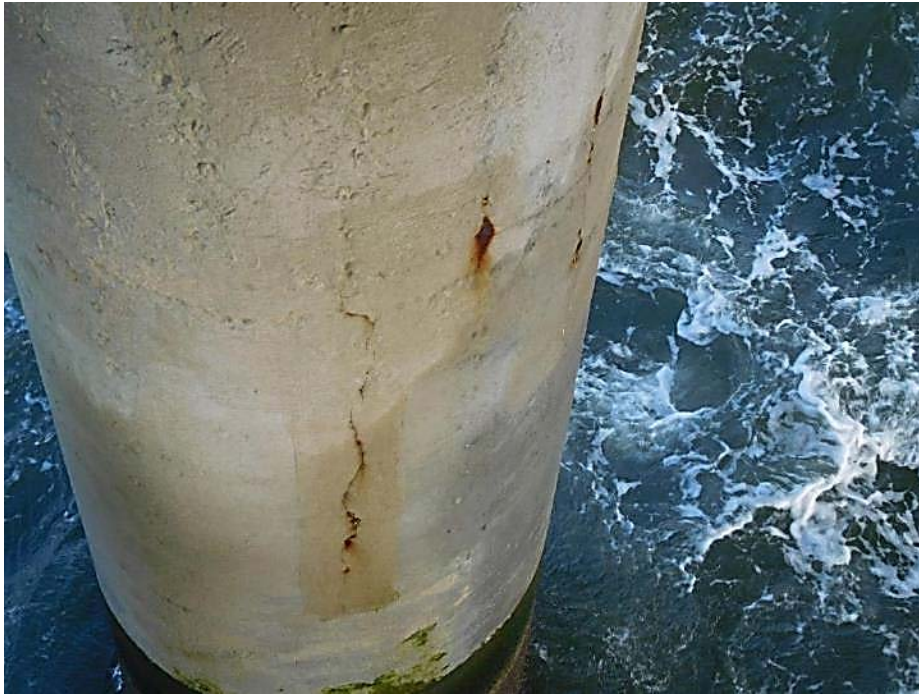
Photo 8.1-17: ANB117 Pile A - Cracks through Protective Coating with Rust Staining (Looking Northwest)

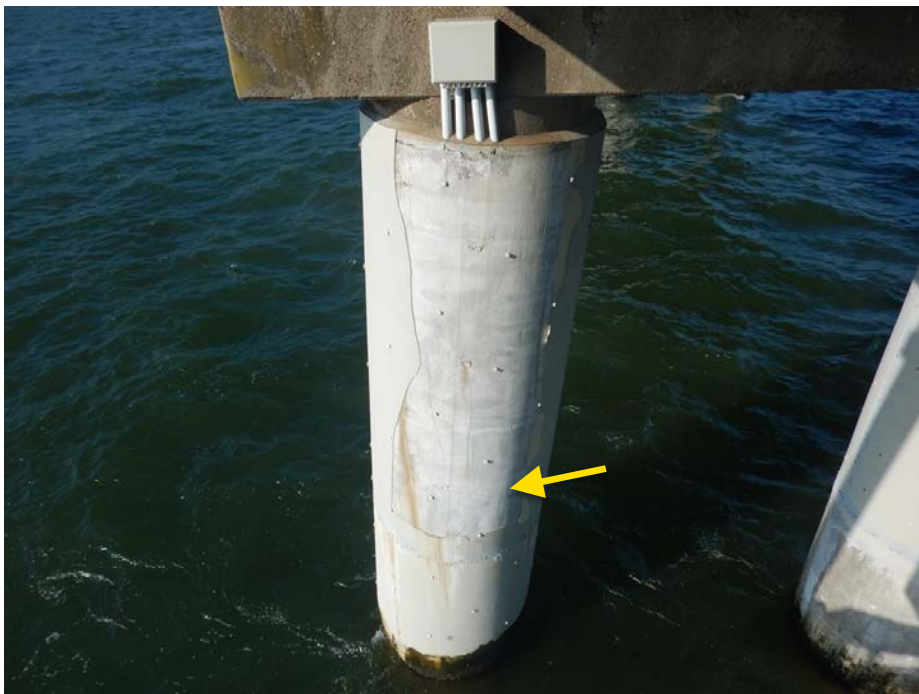
Photo 8.1-18: BNB133 Pile A - Life Jacket with Damaged Fiberglass Jacket and Slightly Exposed Zinc Mesh (Looking North)

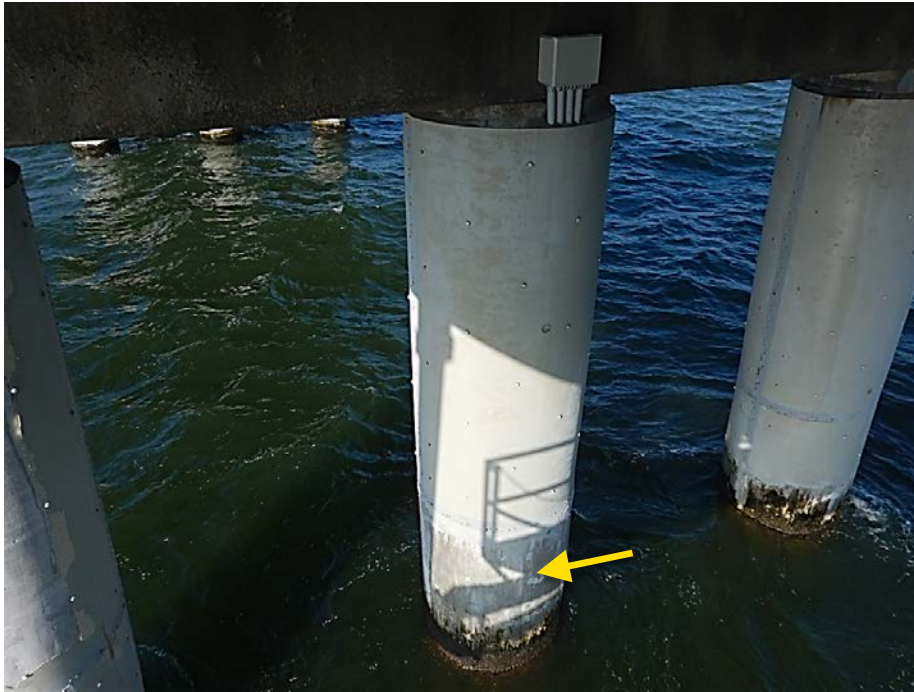
Photo 8.1-19: BNB133 Pile A - Life Jacket with Damaged Fiberglass Jacket and Slightly Exposed Zinc Mesh (Looking Northeast)

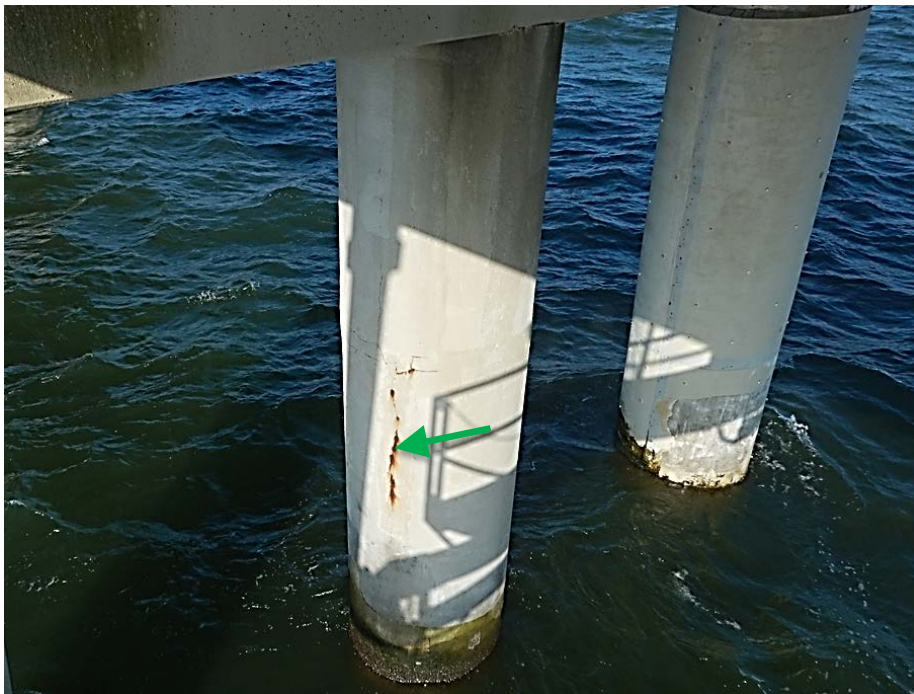
Photo 8.1-20: BNB135 Pile B - Cracks through Protective Coating with Rust Staining (Looking Northeast)

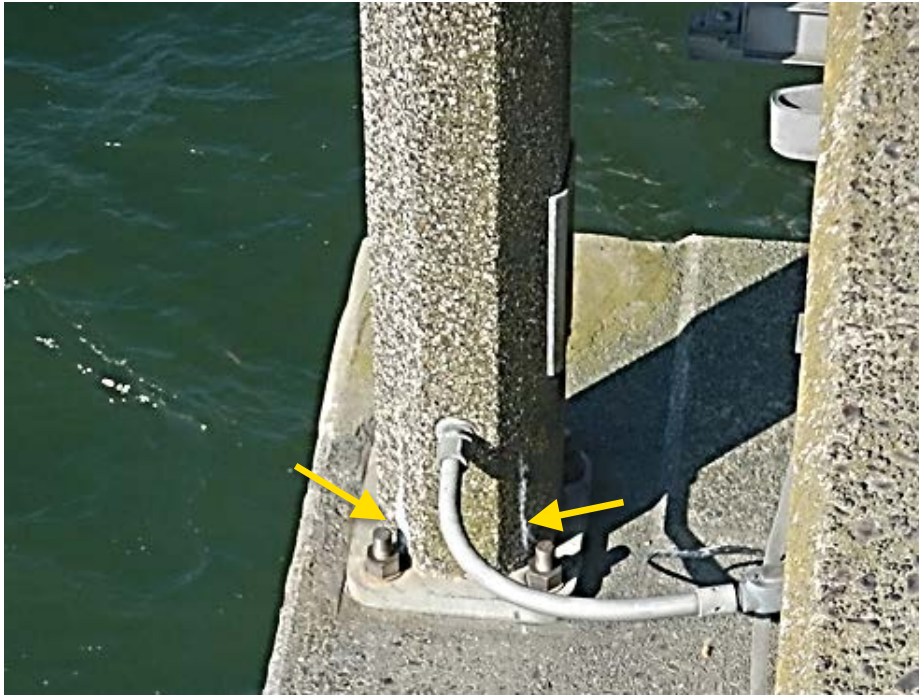
Photo 8.1-21: ANB129 Light Pole – Cracking at Baseplate (Looking Northwest)

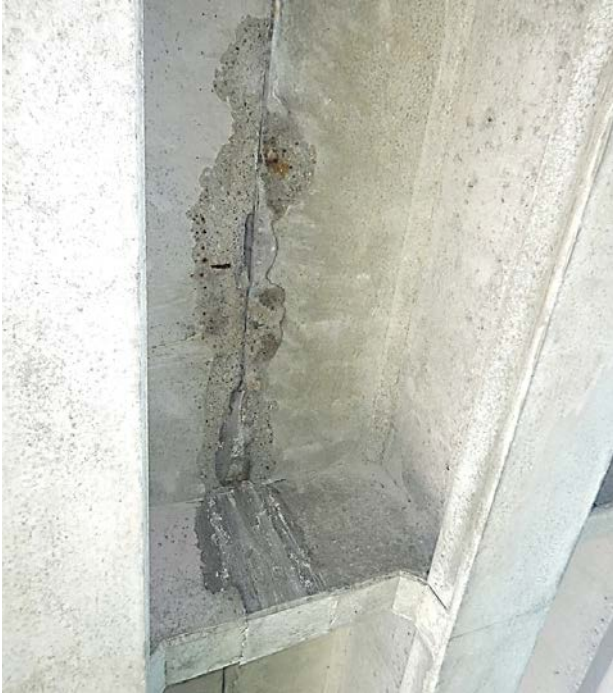
Photo 8.2-1: ASB109 Bay 2 Zone 3 Reinforced Concrete Top Flange (Underside) – Spall with Exposed Reinforcement (Looking Southwest)

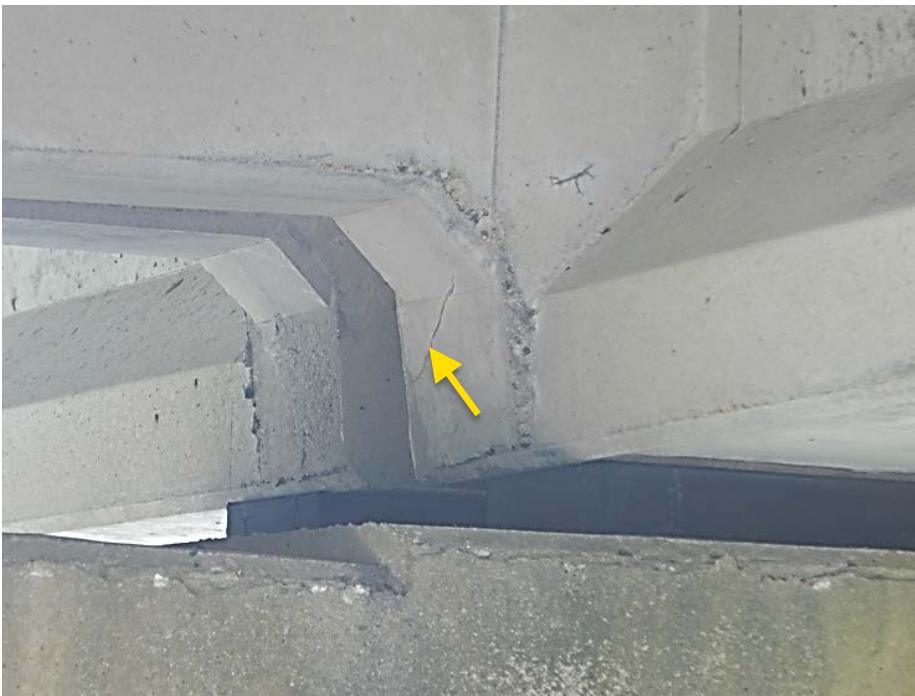
Photo 8.2-2: ASB95 Girder 5 – End Cracking at Bearing (Looking Southwest)

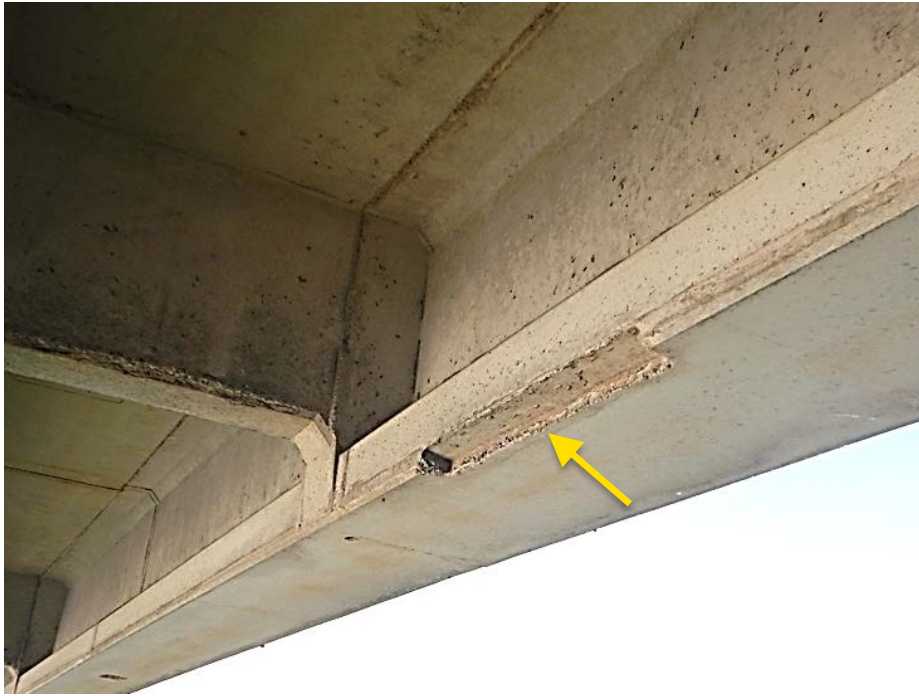
Photo 8.2-3: ASB117 Girder 1 – Portion of Bottom Corner Missing (appears to have been constructed this way) (Looking Southeast)

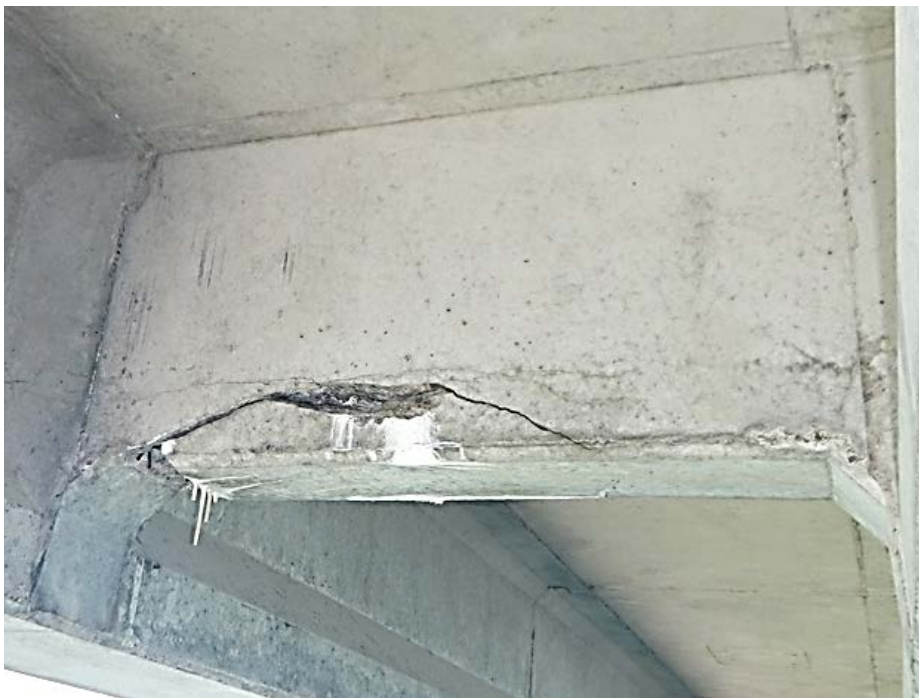
Photo 8.2-4: ASB93 Bay 5 Zone 1/2 Intermediate Diaphragm – Spalling, Cracking, and Efflorescence Surrounding the Lower Post Tension Duct (Looking Southeast)

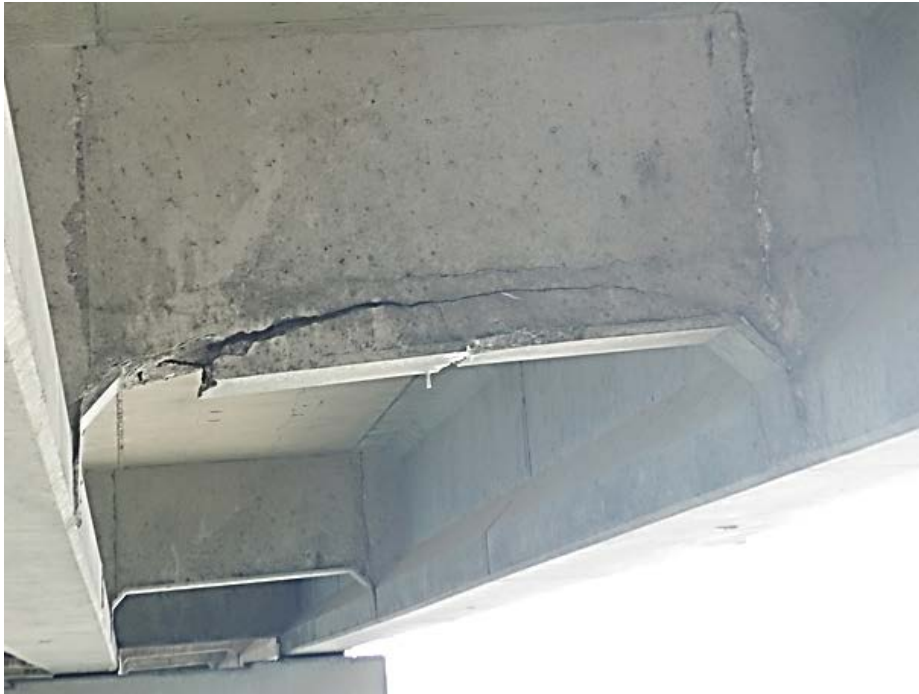
Photo 8.2-5: ASB82 Bay 1 Zone 2/3 Intermediate Diaphragm – Spalling, Cracking, and Efflorescence Surrounding the Lower Post Tension Duct (Looking Southeast)

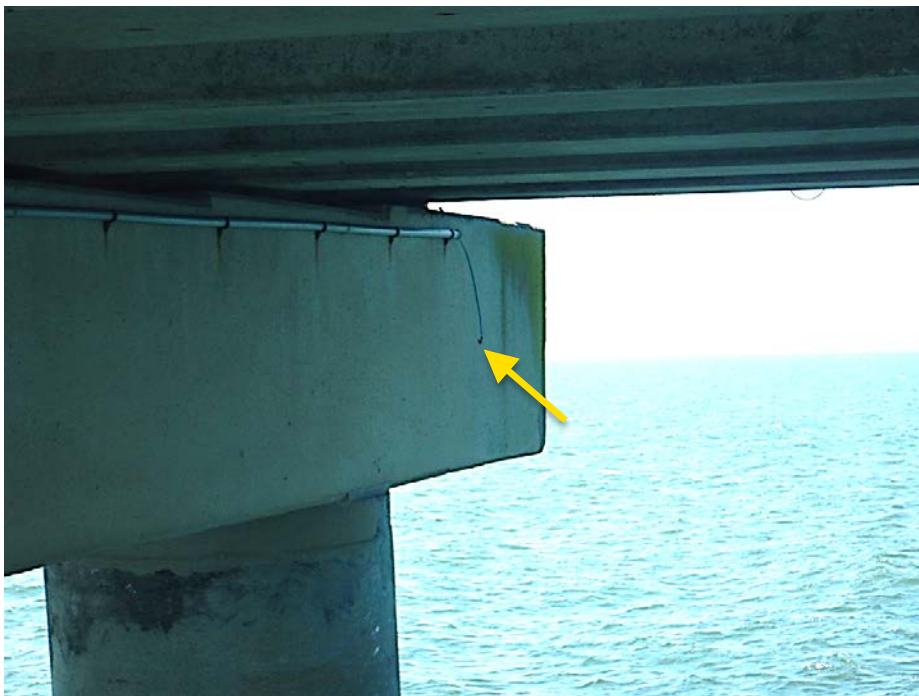
Photo 8.2-6: ASB Bent 96 - Disconnected Cable (Looking Southwest)

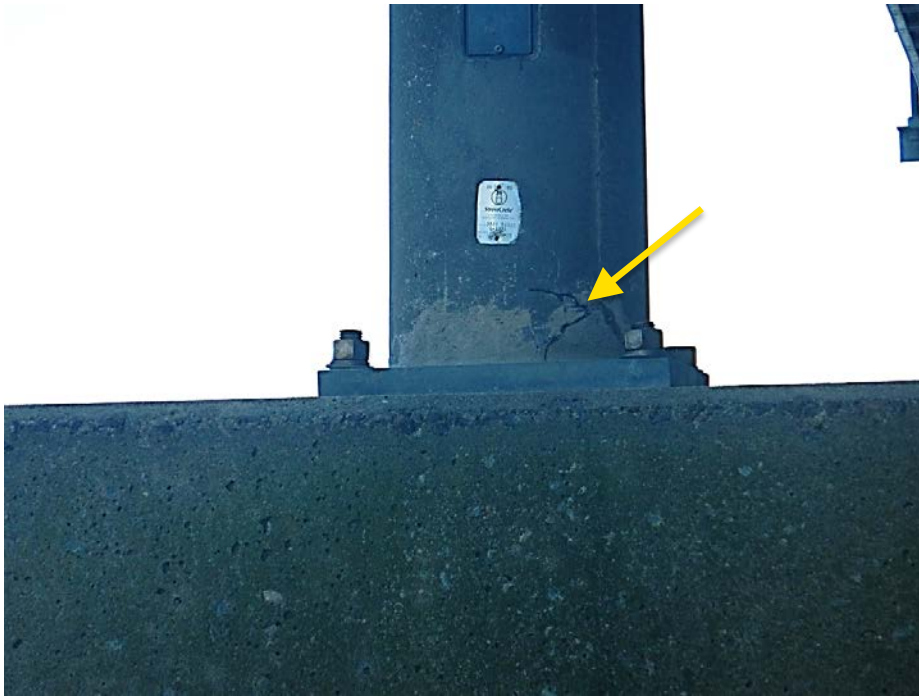
Photo 8.2-7: ASB87 Light Pole – Vertical Cracking Near Baseplate (Looking Southwest)

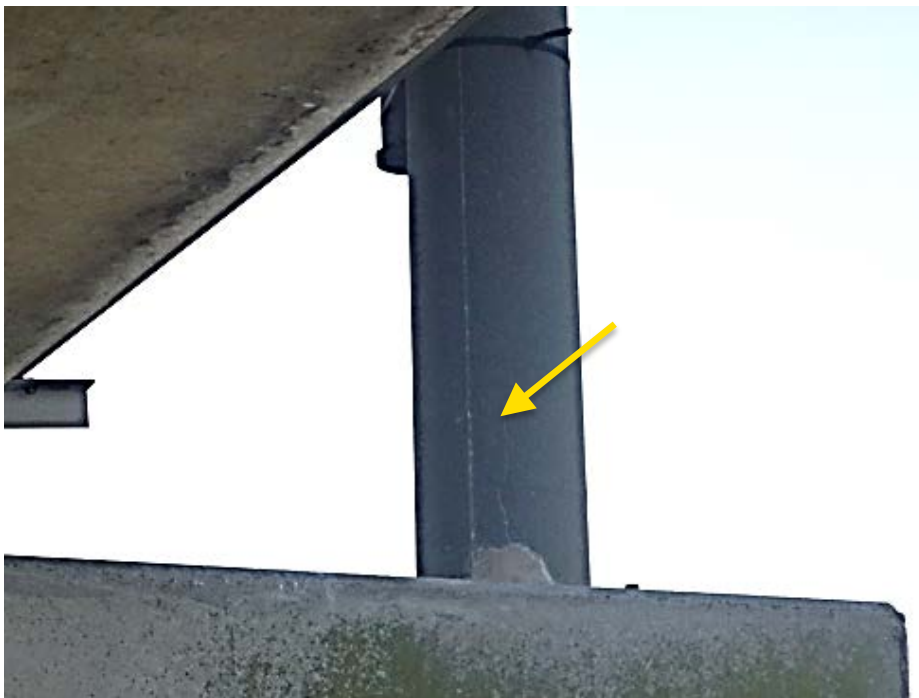
Photo 8.2-8: ASB15 Light Pole – Vertical Cracking Near Baseplate above Repair Area (Looking Southwest)

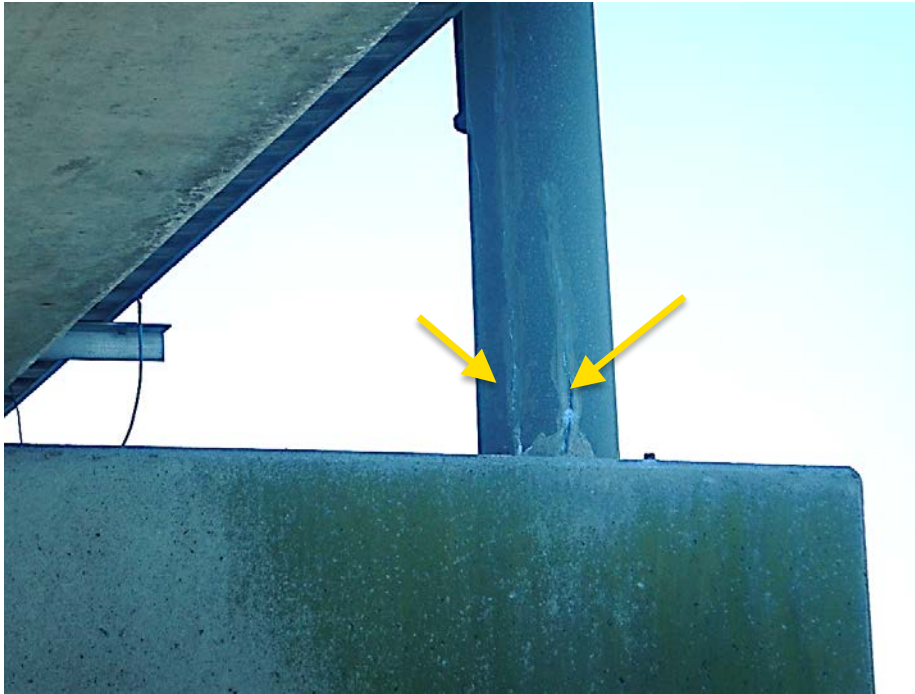
Photo 8.2-9: ASB119 Light Pole – Vertical Cracking Near Baseplate (Looking Southwest)

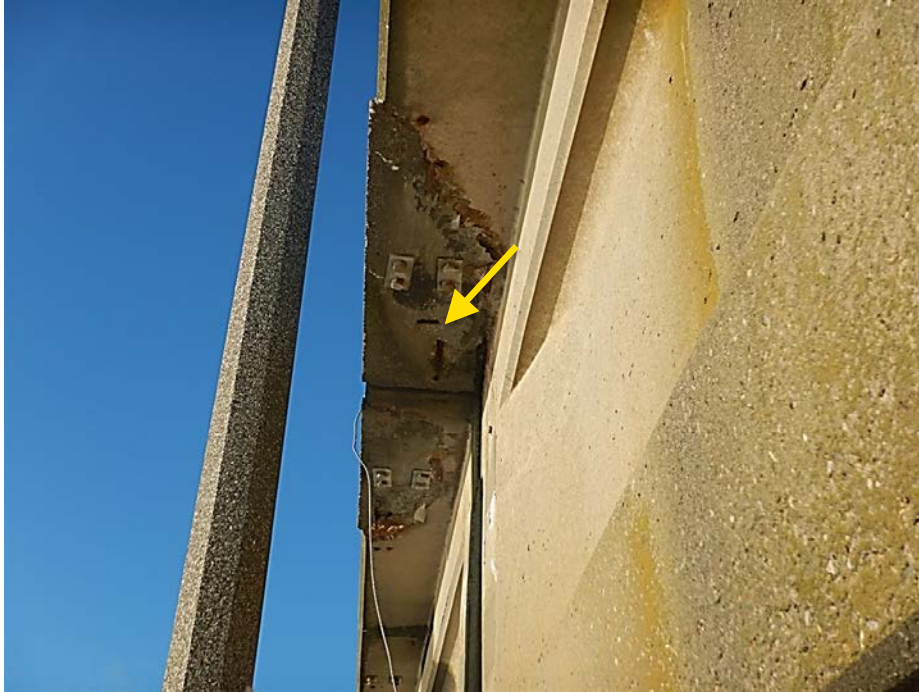
Photo 8.3-1: BNB119 Metal Bridge Railing – Failed Curb Repair with Exposed Reinforcement (Looking South)

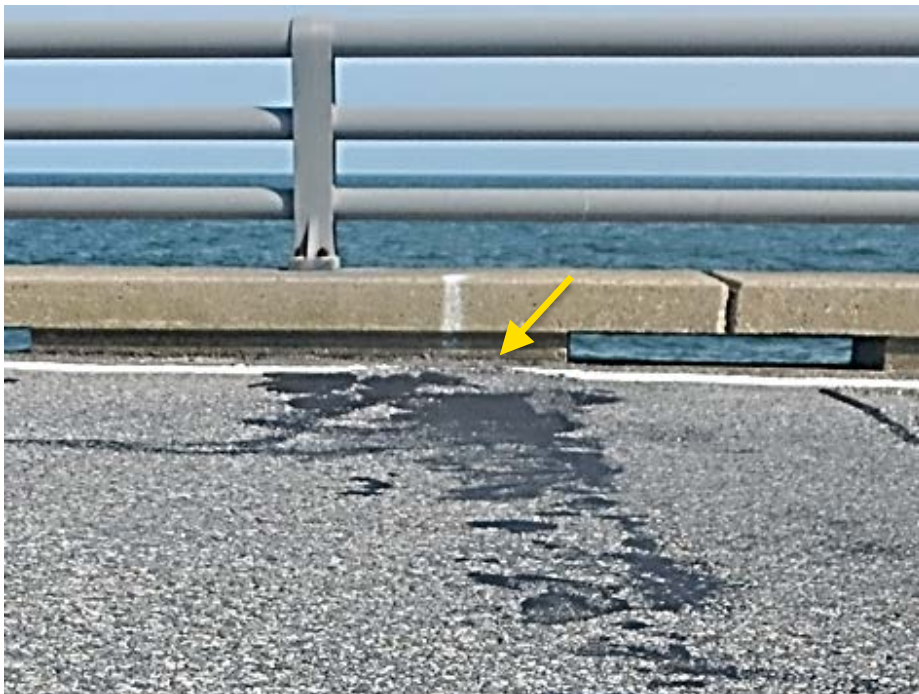
Photo 8.3-2: BNB109 Asphalt Wearing Surface – Elevated Pavement at Previous Repair in Right Lane (Looking East)

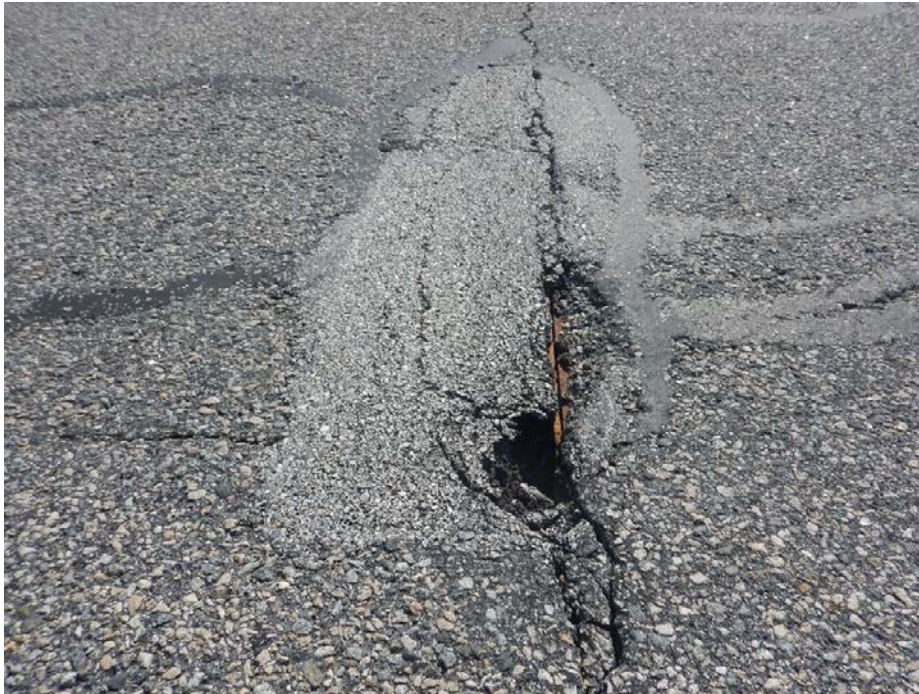
Photo 8.3-3: BNB130 Asphalt Wearing Surface – Deck Spall at Patch (Looking East)

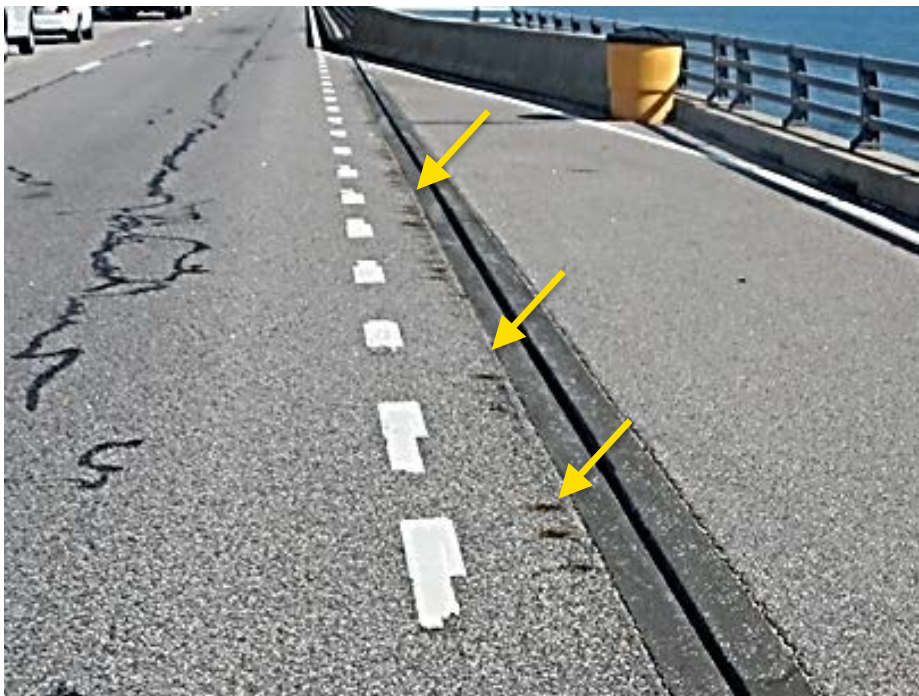
Photo 8.3-4: BNB132 Asphalt Wearing Surface – Rust Staining along Joint with EPO (Looking North)

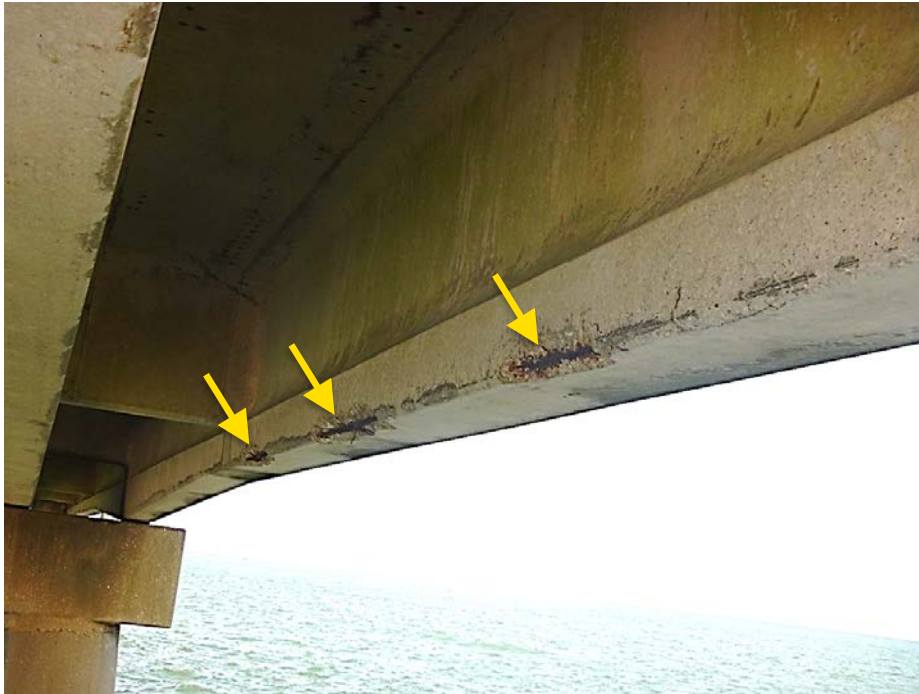
Photo 8.3-5: BNB106 Girder 1 - Spall with 1 Exposed Prestressing Strand, 3 Locations (Looking Northeast)

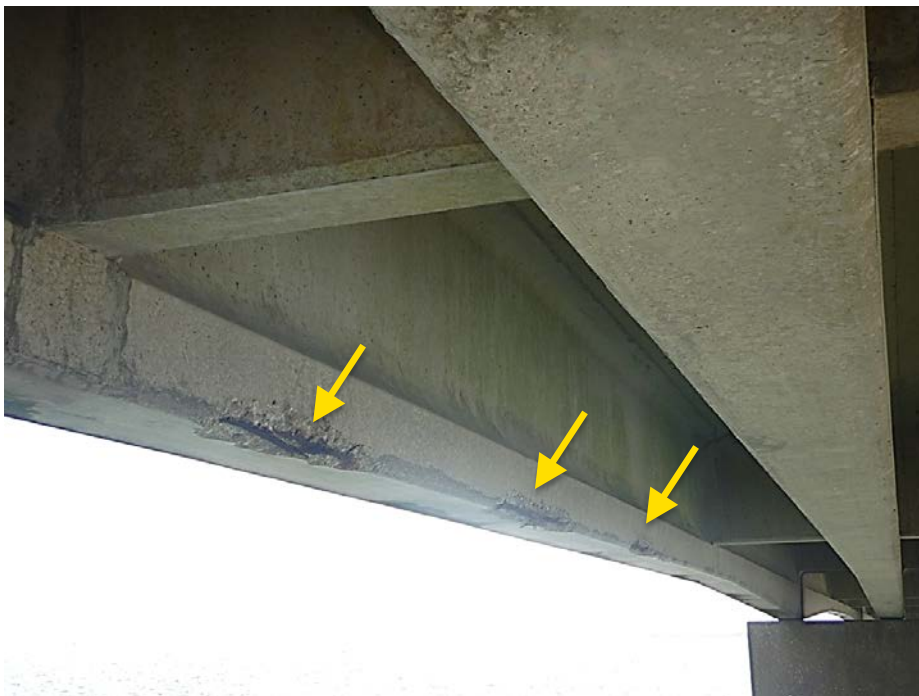
Photo 8.3-6: BNB107 Girder 8 - Spall with 1 Exposed Prestressing Strand, 3 Locations (Looking Southeast)
