FY2019 Annual Inspection and Underwater Inspection, Trestle A'NB, ANB, & ASB

Chesapeake Bay Bridge and Tunnel District

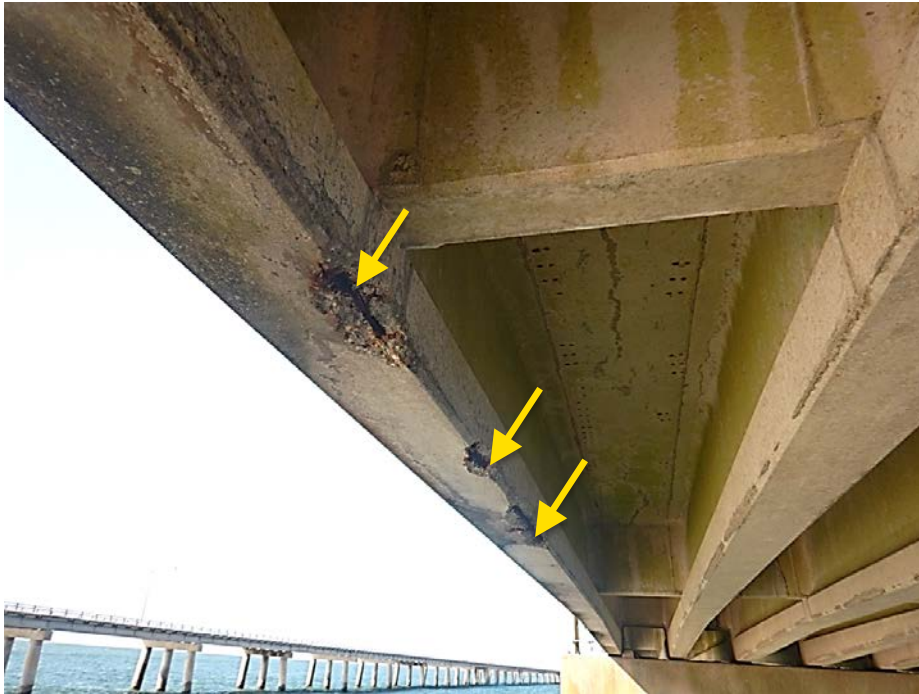
Photo 8.3-7: BNB116 Girder 8 - Spall with 1 Exposed Prestressing Strand, 3 Locations (Looking Northwest)

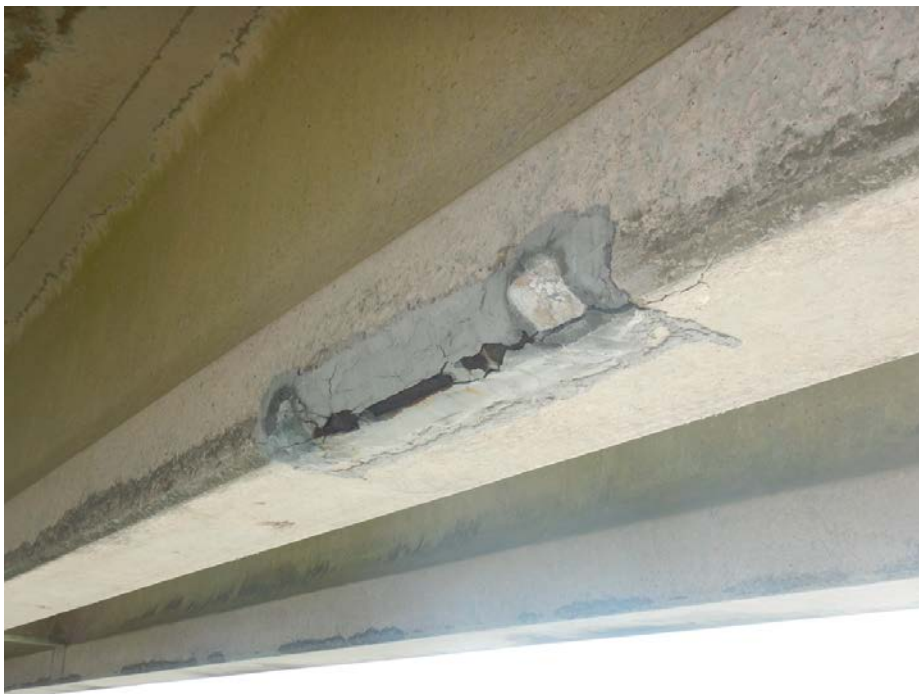
Photo 8.3-8: ANB127 Girder 2 - Failed Repair with 1 Exposed Prestressing Strand (Looking Northeast)

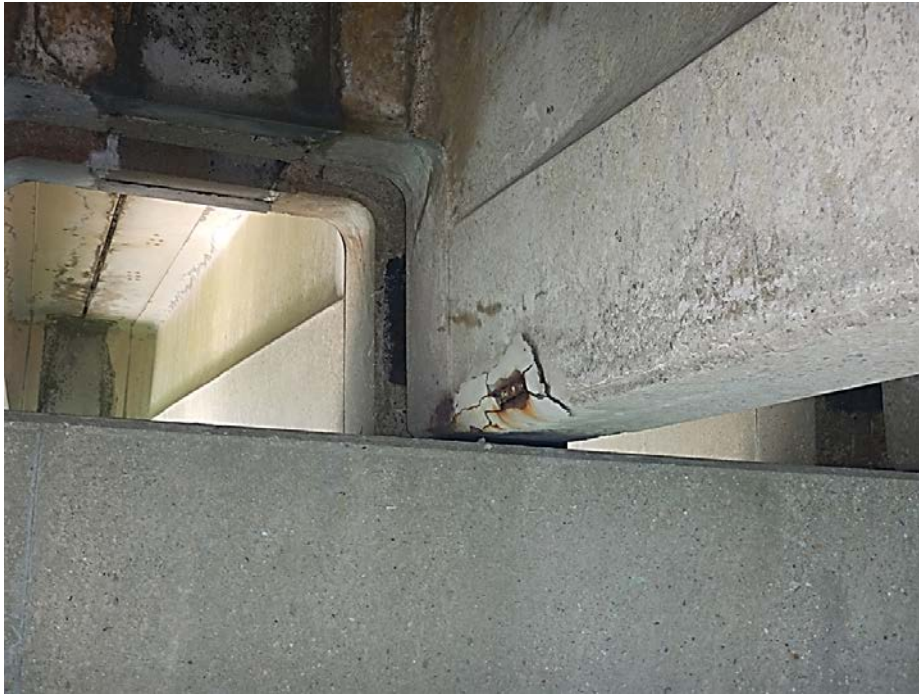
Photo 8.3-9: ANB145 Girder 5 - Failed Repair at Bearing with 1 Exposed Reinforcement Bar (Looking Southwest)

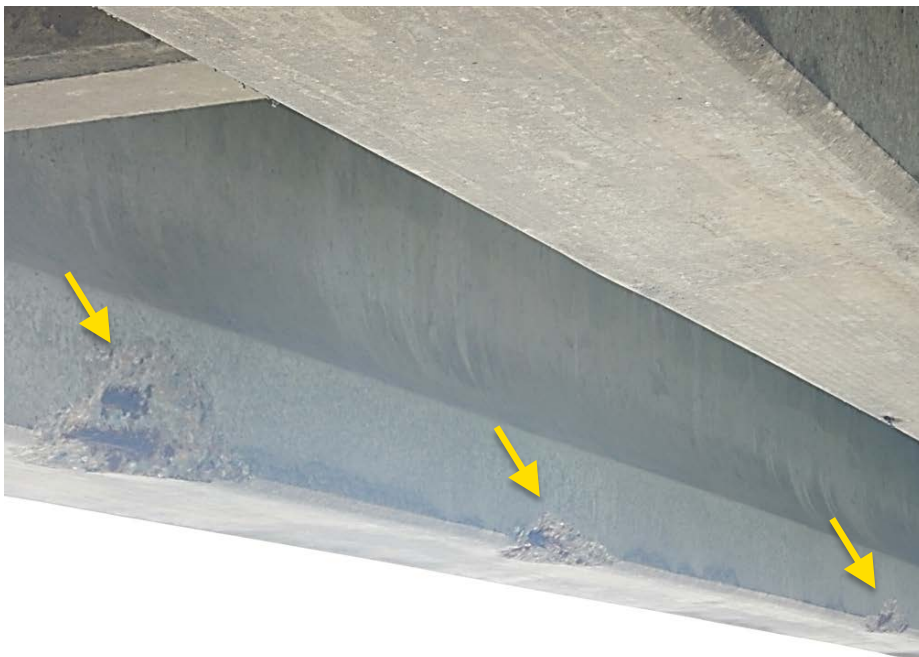
Photo 8.3-10: BNB151 Girder 1 - Spall with 2 Exposed Prestressing Strands, 2 Locations with 1 Exposed Strand (Looking Southeast)

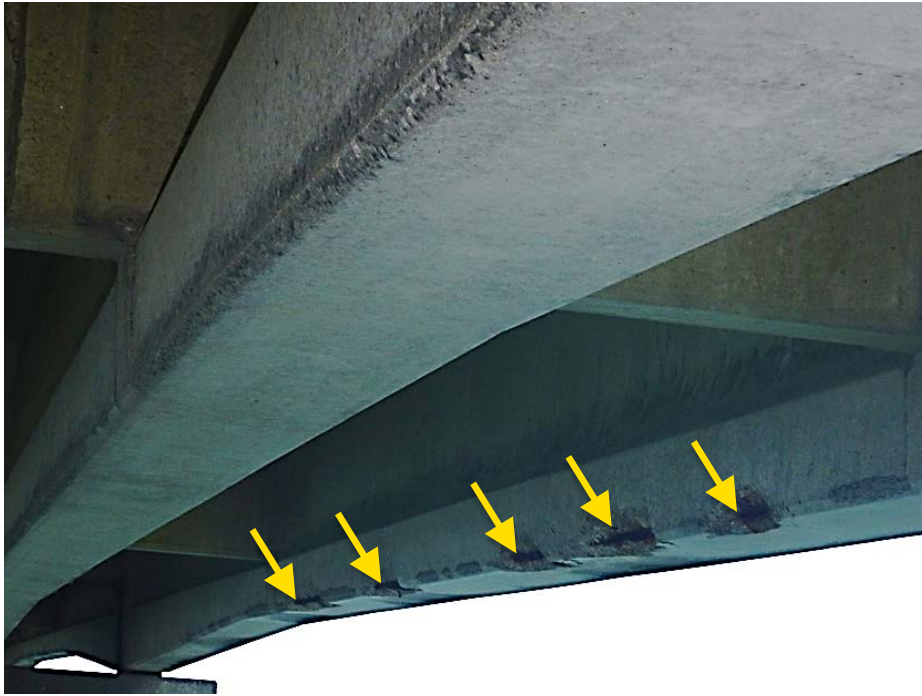
Photo 8.3-11: BNB157 Girder 1 - Spall with 1 Exposed Prestressing Strand, 5 Locations (Looking Northeast)

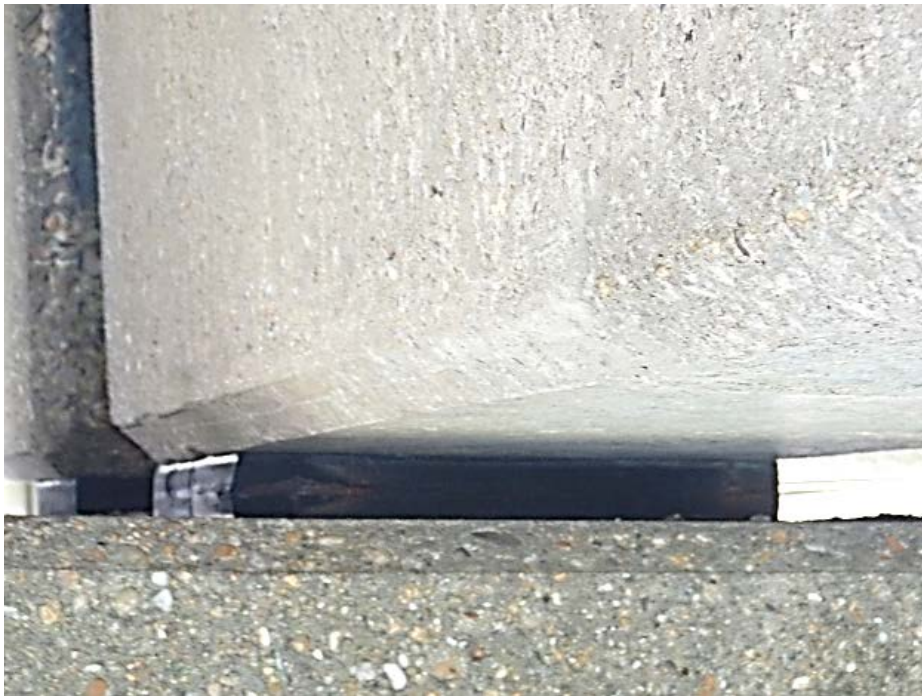
Photo 8.3-12: BNB109 Elastomeric Bearing at Girder 2 - Split with Exposed and Corroded Steel Plates (Looking South)

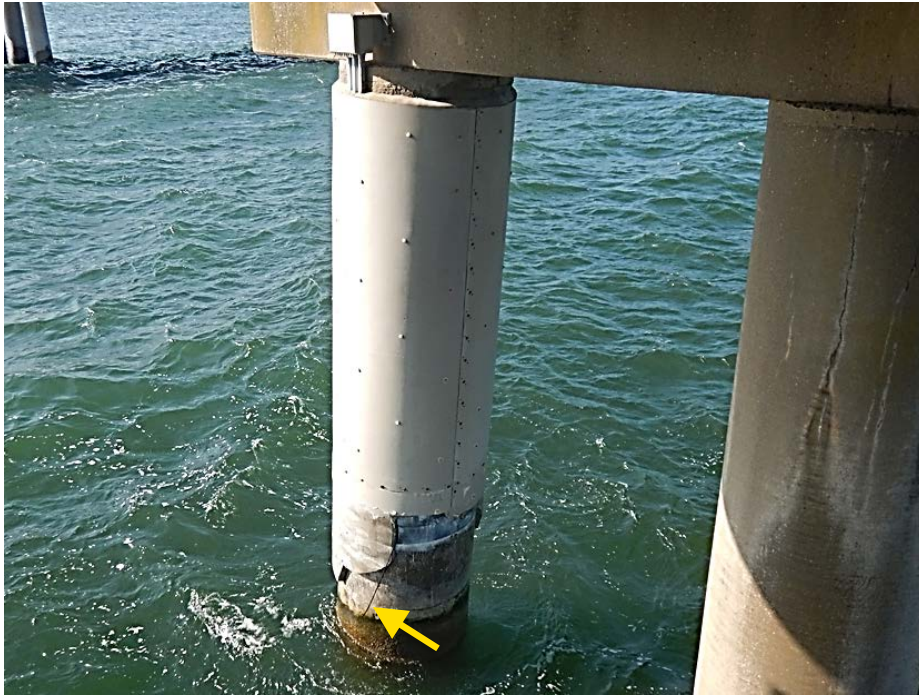
Photo 8.3-13: BNB116 Pile A - Damaged Life Jacket missing Grout and Zinc Mesh on Southeast Quadrant with Exposed Cable (Looking Northwest)

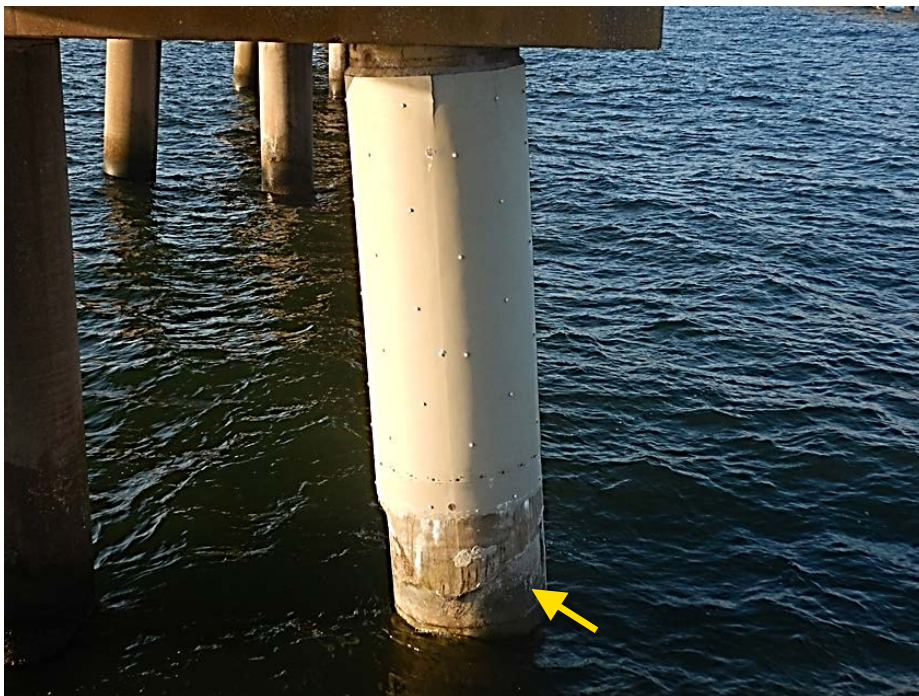
Photo 8.3-14: BNB117 Pile A - Damaged Life Jacket missing Grout and Zinc Mesh (Looking South)

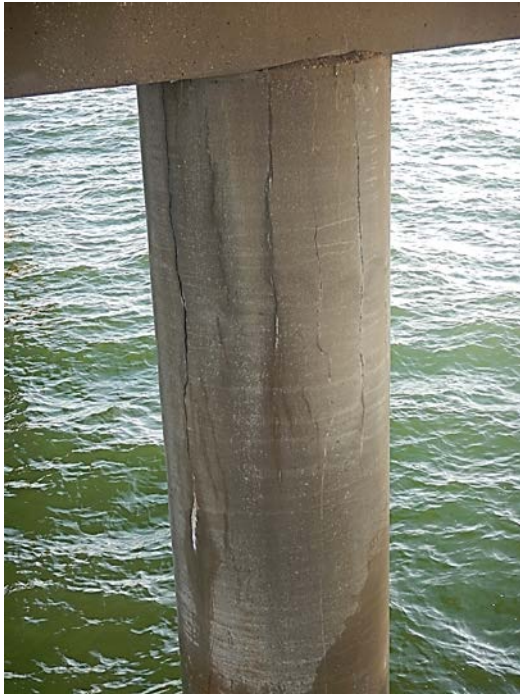
Photo 8.3-15: BNB121 Pile B – Wide Cracks with Efflorescence (Looking Northeast)

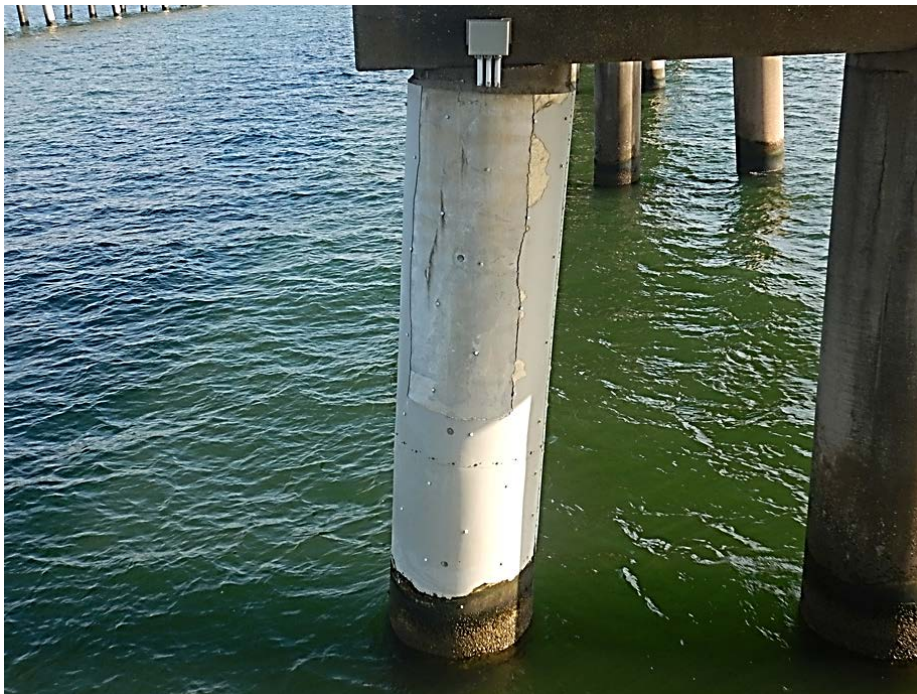
Photo 8.3-16: BNB127 Pile A – Life Jacket with Damaged Fiberglass Jacket, Cracking in Grout at Nylon Spacers, and Slightly Exposed Zinc Mesh (Looking North)

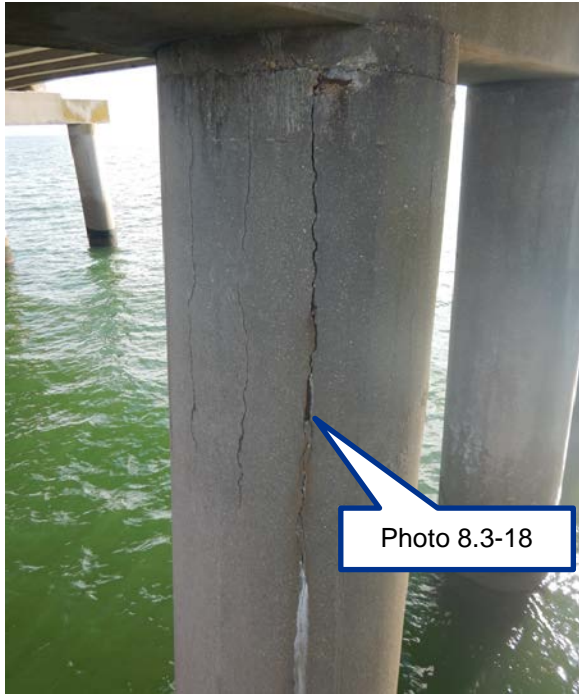
Photo 8.3-17: BNB129 Pile A – Wide Crack along Exposed Prestressing Strand with Efflorescence and Rust Staining (Looking Northeast)

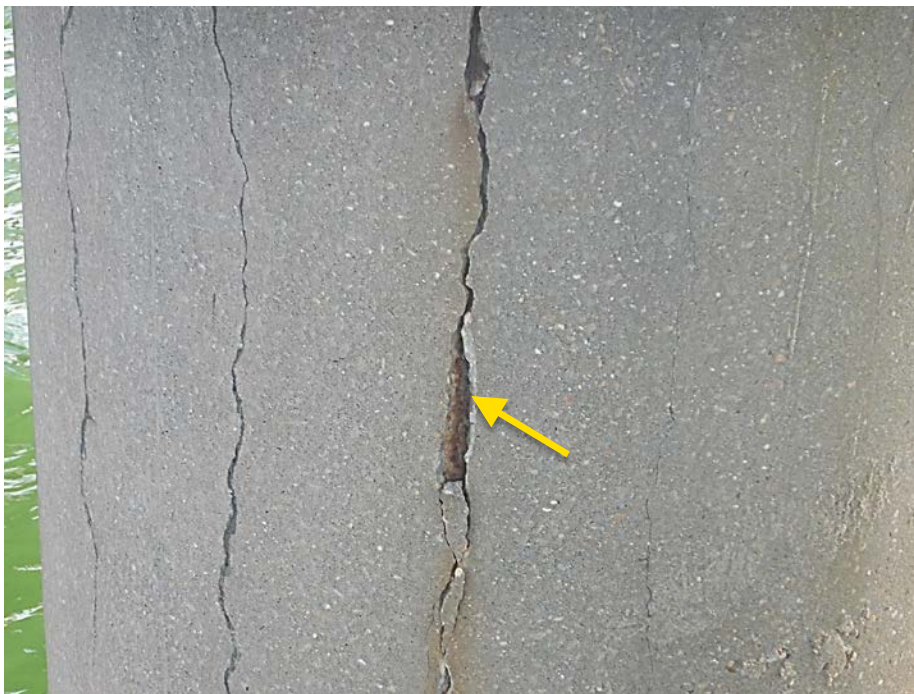
Photo 8.3-18: BNB129 Pile A – Wide Crack along Exposed Prestressing Strand with Efflorescence and Rust Staining (Looking Northeast) - Closeup

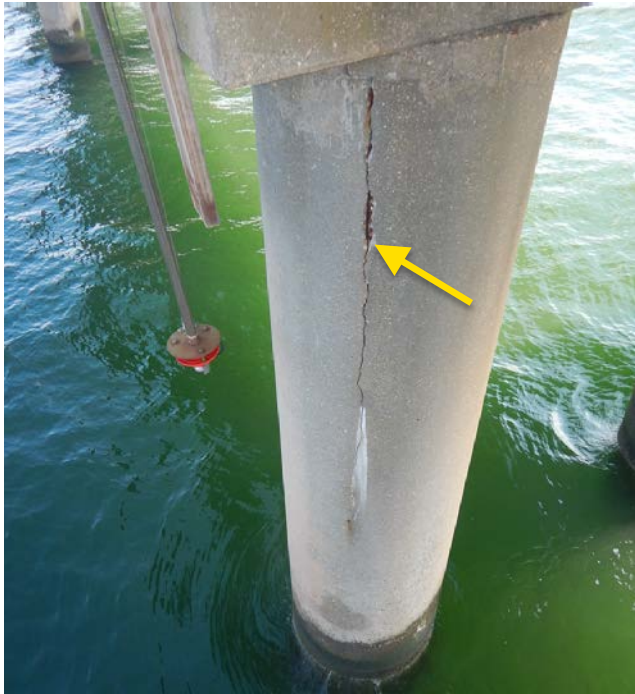
Photo 8.3-19: BNB131 Pile A – Wide Crack along Exposed Prestressing Strand with Efflorescence and Rust Staining (Looking Northeast)

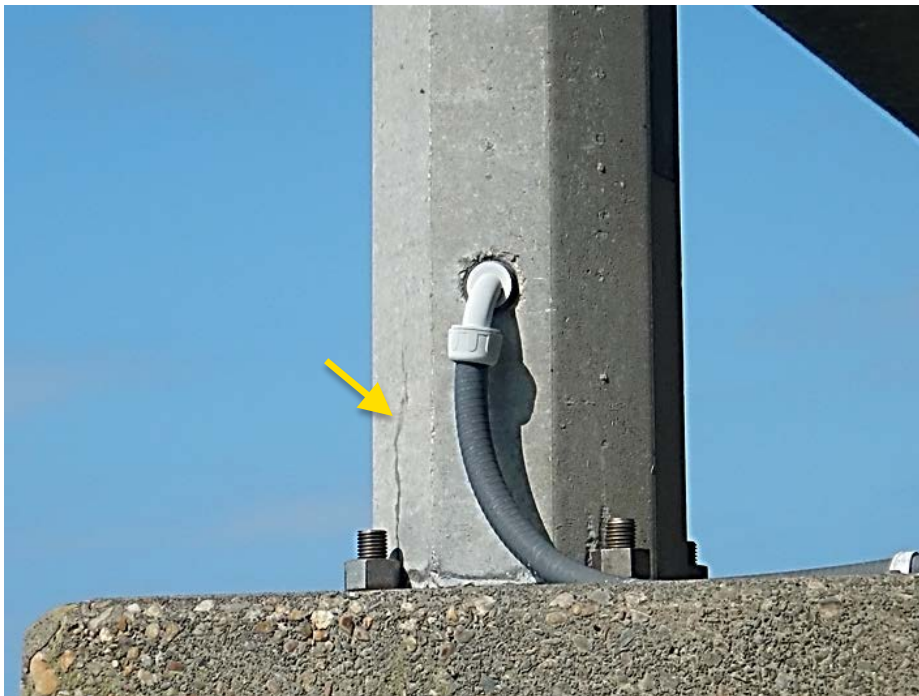
Photo 8.3-20: BNB111 Light Pole – Cracking at Baseplate (Looking Northwest)

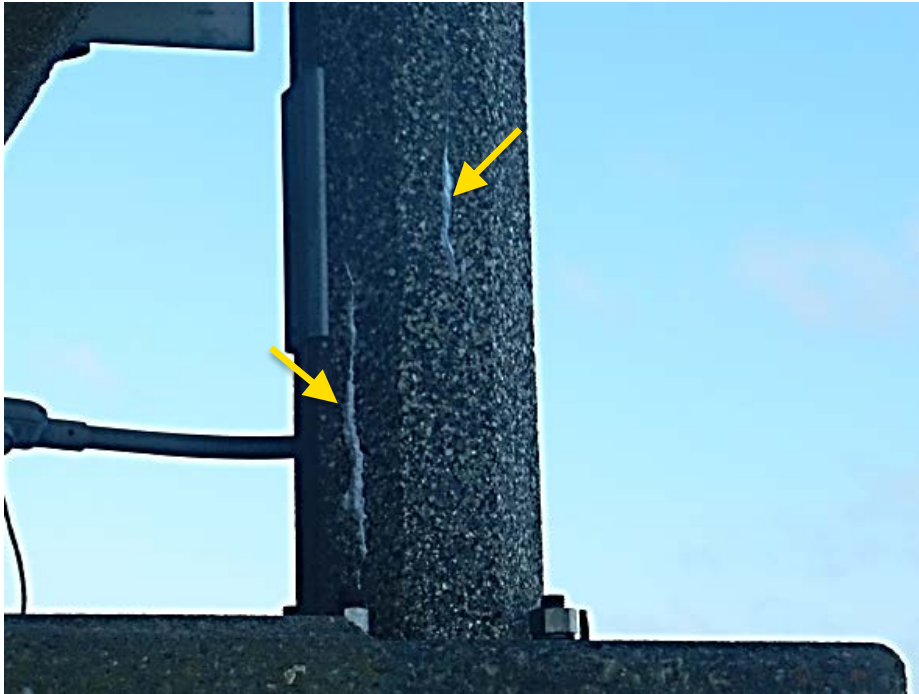
Photo 8.3-21: BNB129 Light Pole – Cracking at Baseplate with Efflorescence (Looking Southwest)

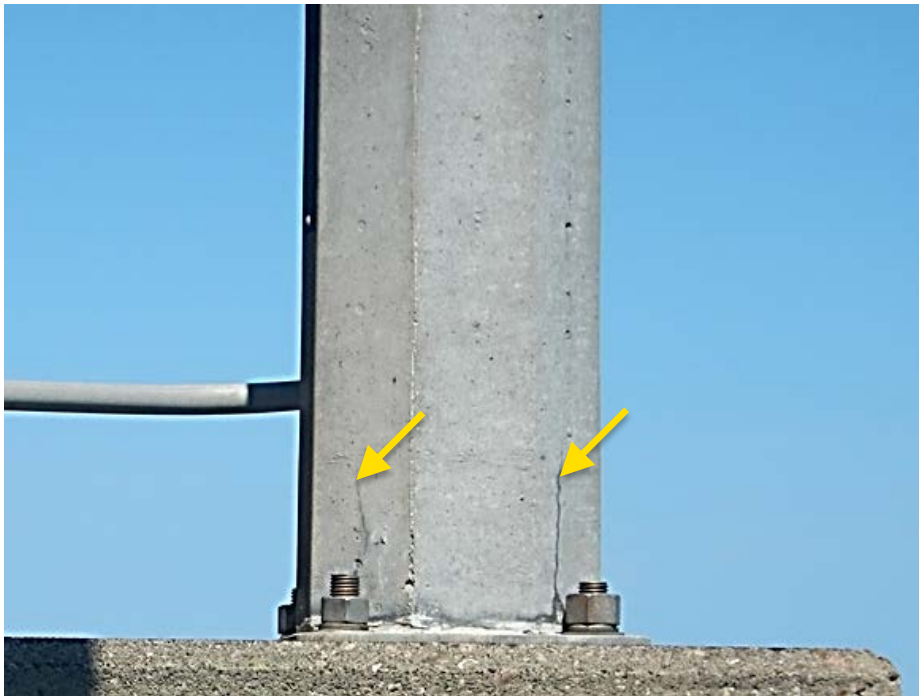
Photo 8.3-22: BNB144 Light Pole – Cracking at Baseplate (Looking North)

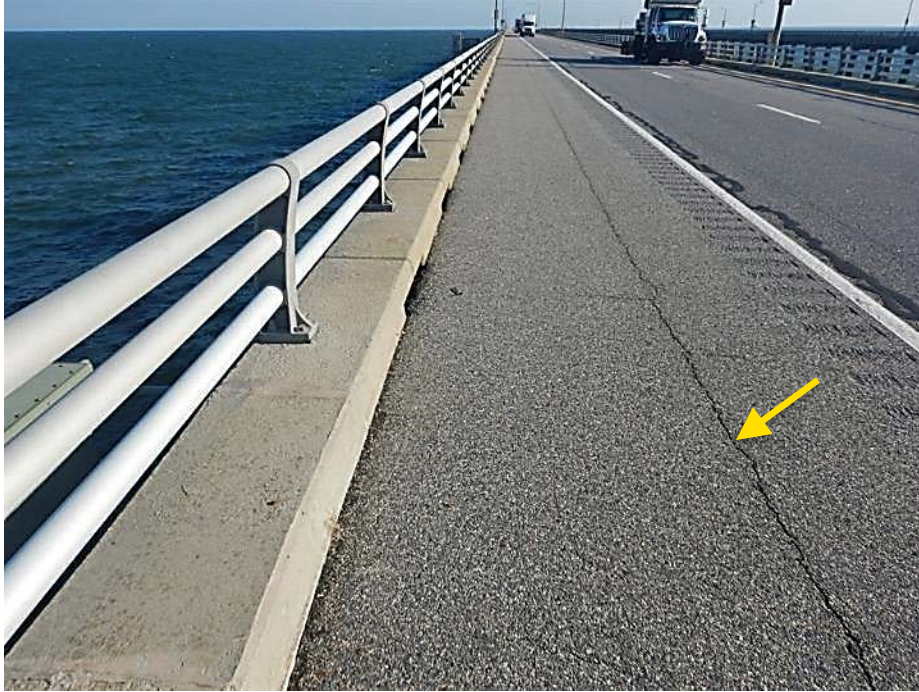
Photo 8.4-1: BSB104 Asphalt Wearing Surface – Crack along Pavement extends to BSB105 (Looking North)

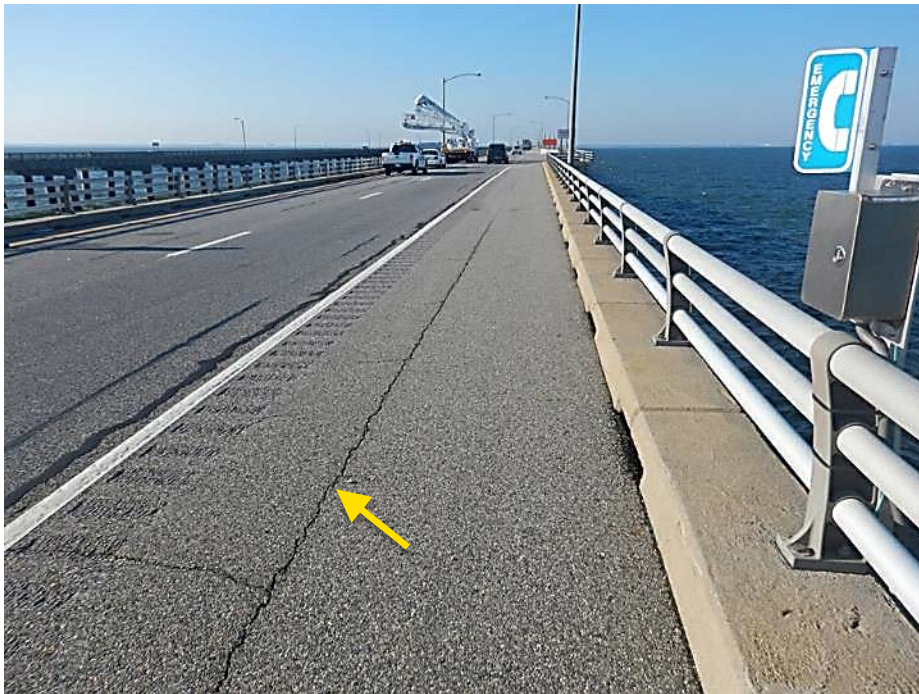
Photo 8.4-2: BSB103 Asphalt Wearing Surface – Crack along Pavement extends to BSB102 (Looking South)

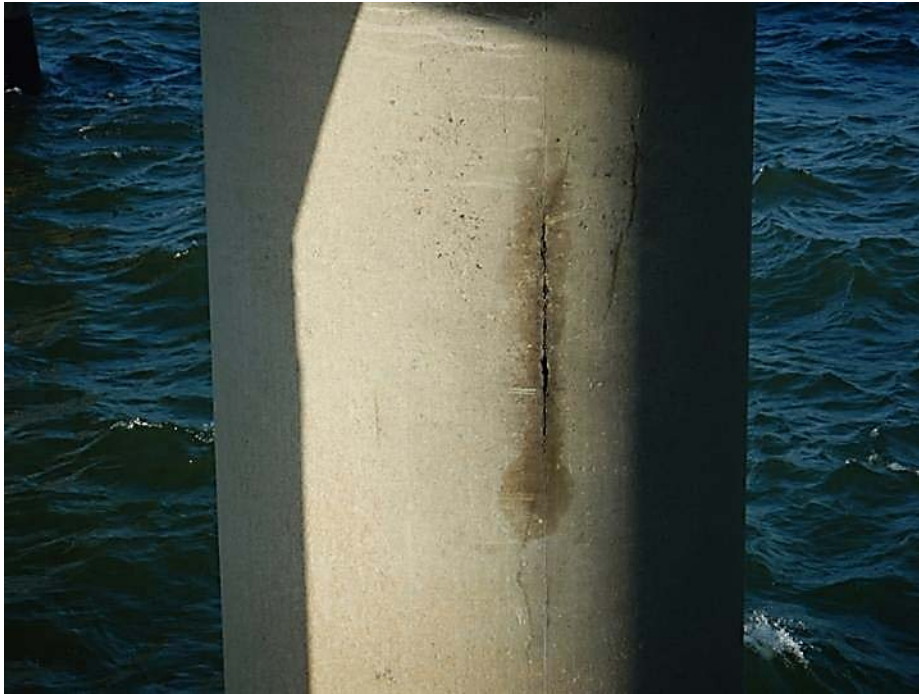
Photo 8.4-3: BSB 103 Pile B - Wide Crack/Minor Spalling along Seam (Looking Southwest)

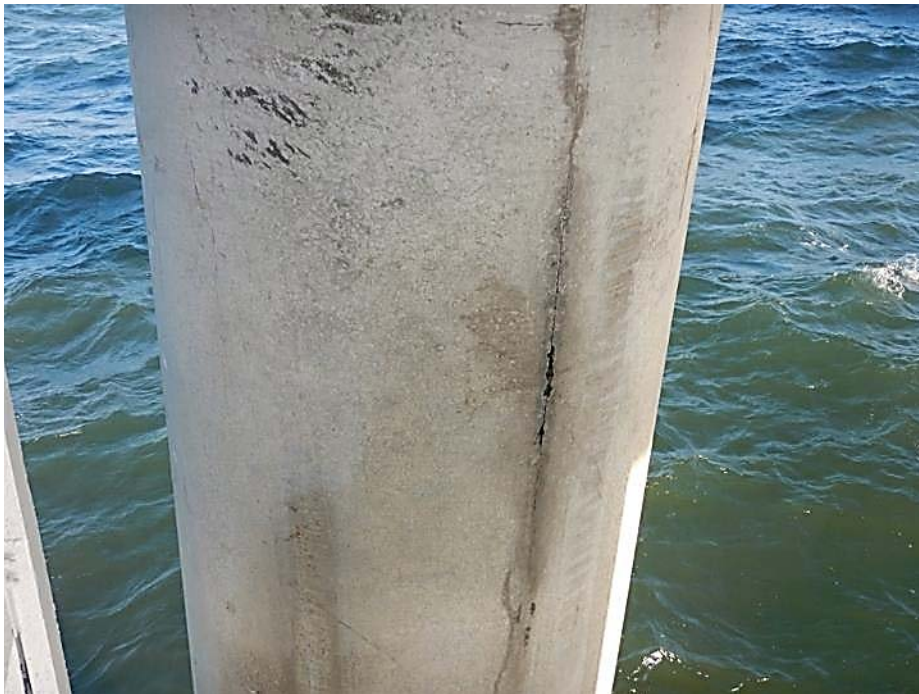
Photo 8.4-4: BSB 104 Pile A - Wide Crack/Minor Spalling along Seam (Looking Northwest)

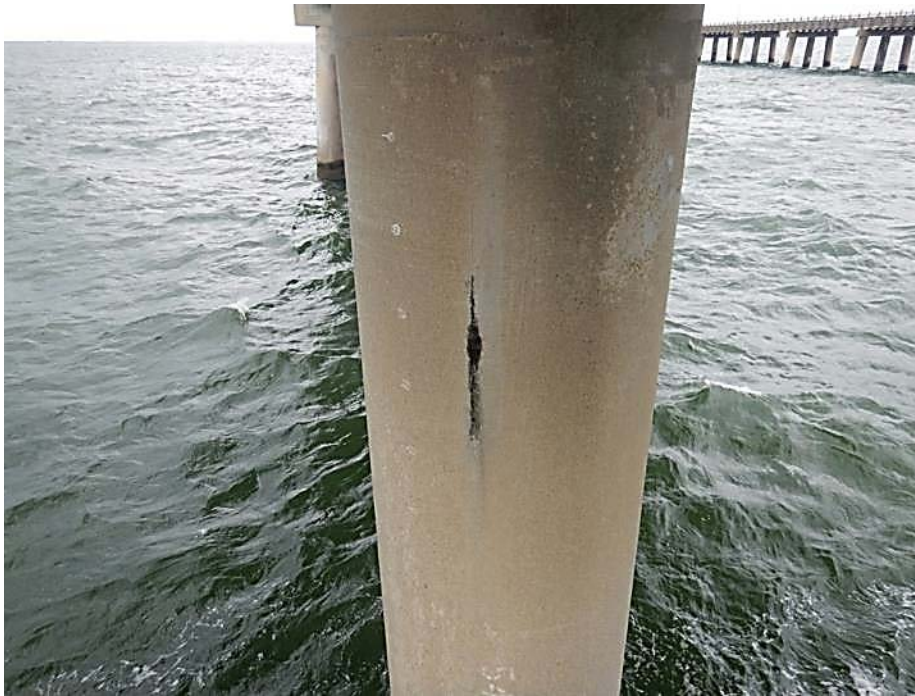
Photo 8.4-5: BSB 111 Pile B - Wide Crack/Minor Spalling along Seam (Looking North)

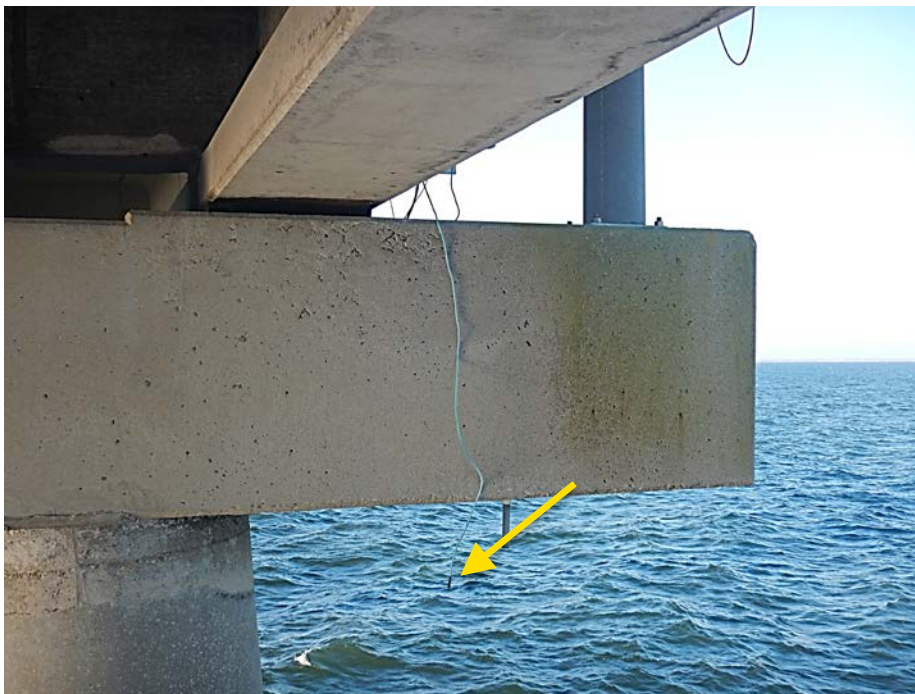
Photo 8.4-6: BSB Bent 107 - Disconnected Cable (Looking Southwest)

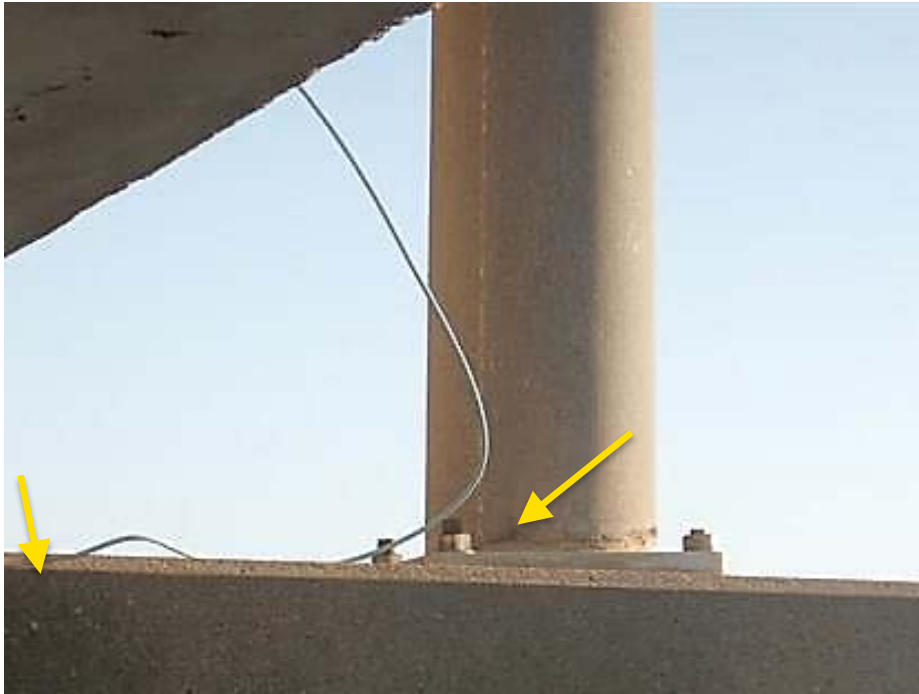
Photo 8.4-7: BSB105 Light Pole – Vertical Cracking Near Baseplate and Disconnected Cable (Looking Northeast)

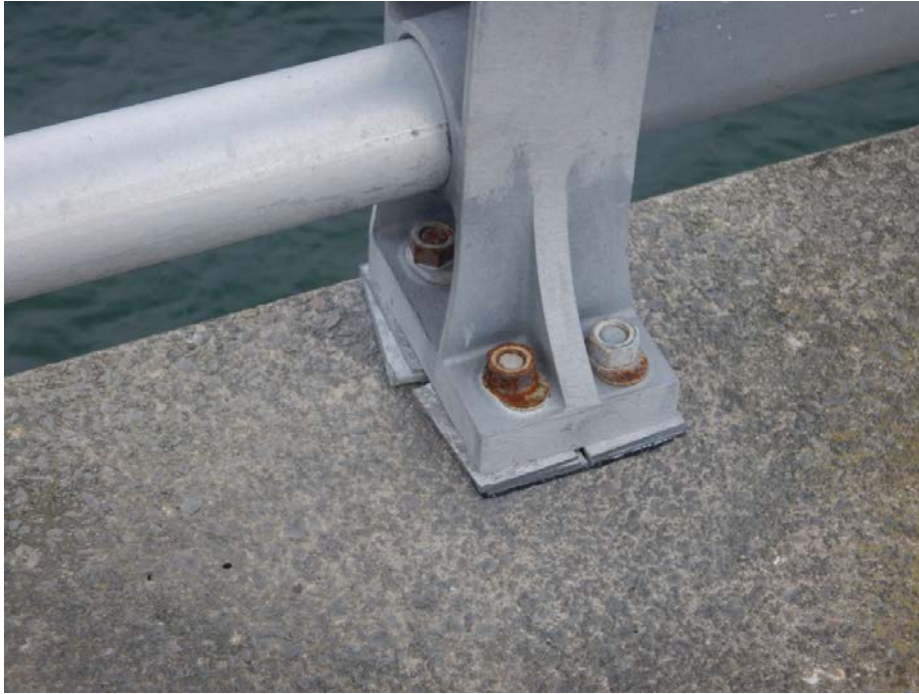
Photo 8.5-1: CNB171 Metal Bridge Railing 1st Post from the South – Rust and Tightly Fastened Connection Results in Bolts that do not Extend Above Nuts (Looking Northwest)

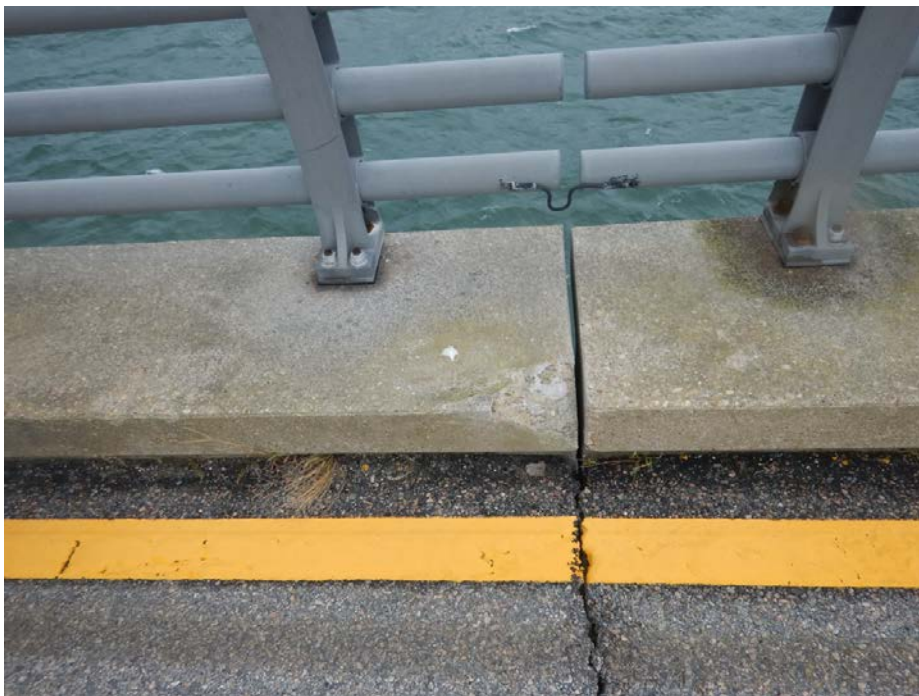
Photo 8.5-2: CNB178 Metal Bridge Railing - Failed Curb Repair

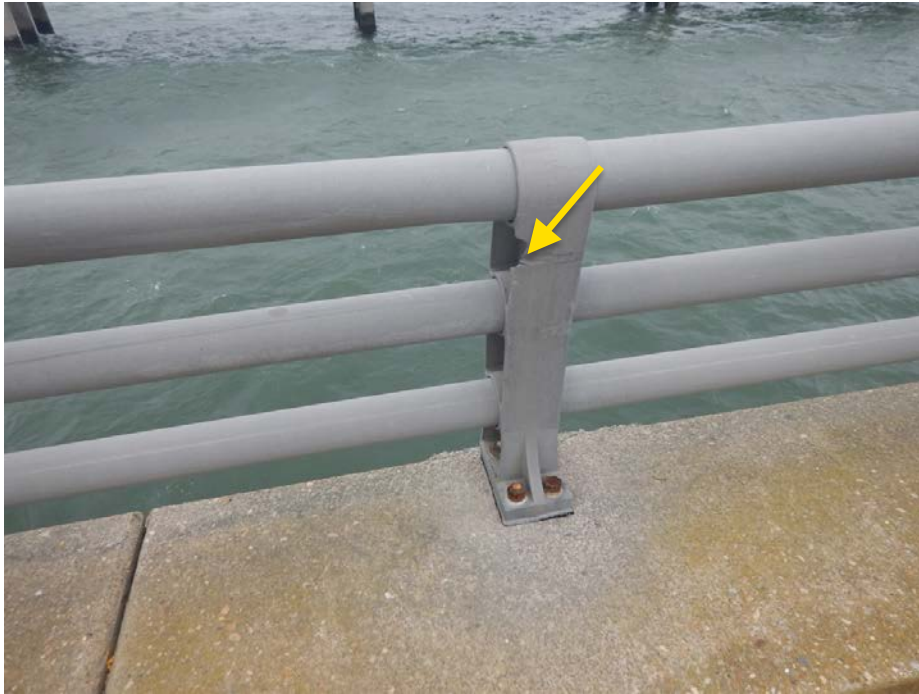
Photo 8.5-3: CNB181 Metal Bridge Railing 2nd Post from the North - Impact Damage to Post above Middle Rail (Looking Northwest)

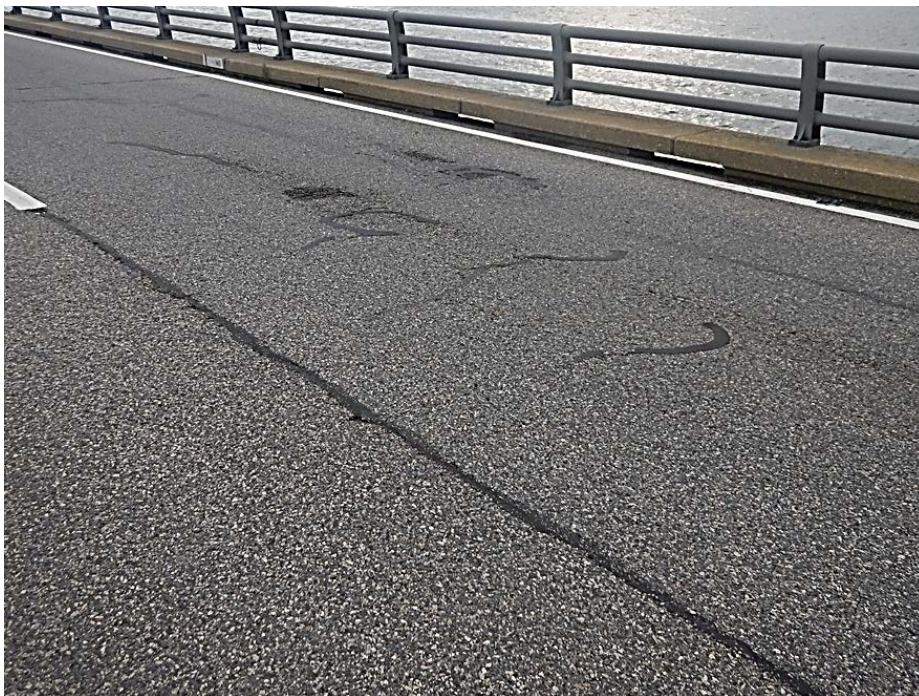
Photo 8.5-4: CNB144 Asphalt Wearing Surface – Scaling and Surface Spalling (Looking Northeast)

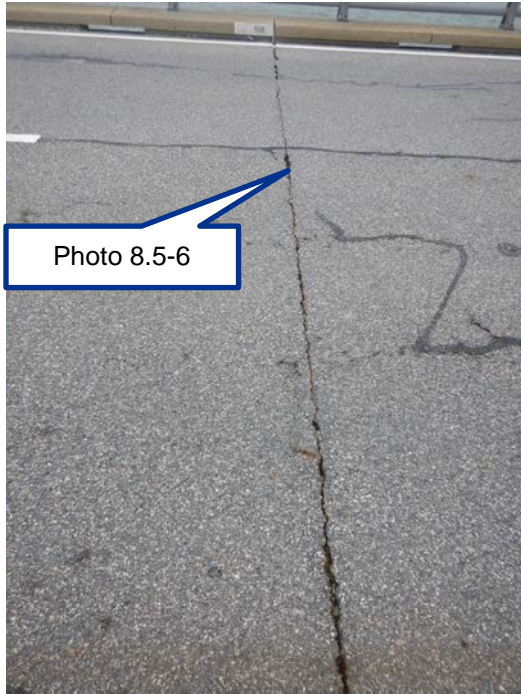
Photo 8.5-5: CNB150 Open Expansion Joint that has been Paved over Exhibiting Reflective Cracking (Looking East)

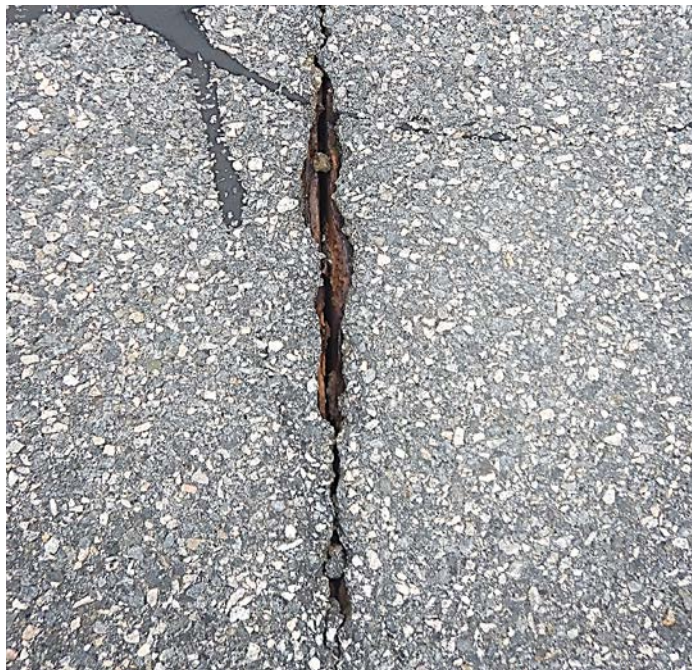
Photo 8.5-6: CNB150 Open Expansion Joint – Steel Joint Header, Worse Condition observed during FY2019 Inspection – Closeup

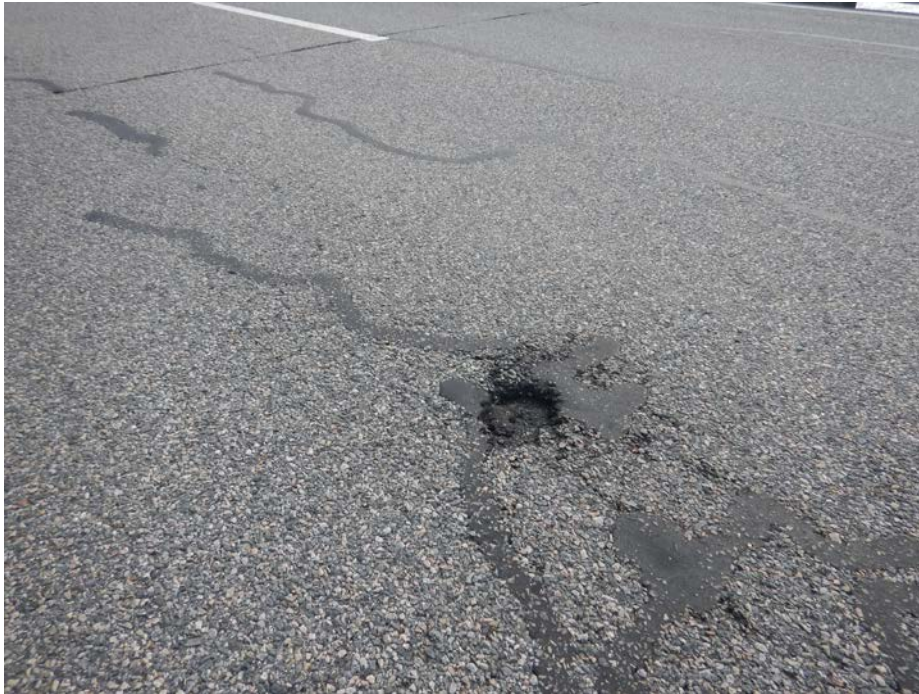
Photo 8.5-7: CNB156 Asphalt Wearing Surface – Surface Spalling (Looking Northeast)

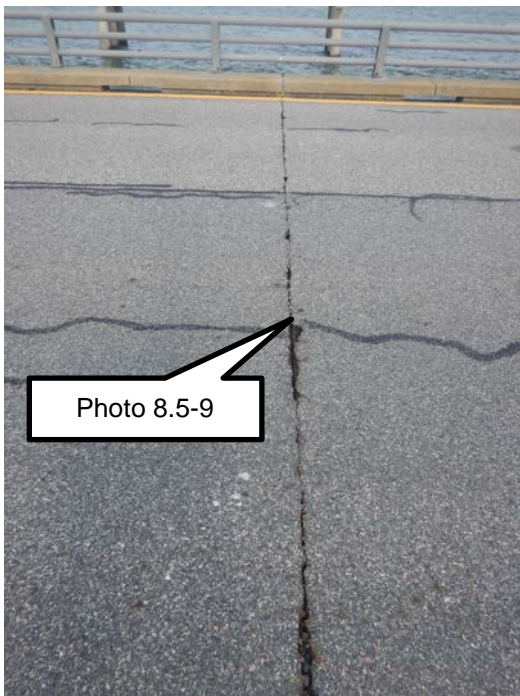
Photo 8.5-8: CNB159 Open Expansion Joint that has been Paved over Exhibiting Reflective Cracking (Looking West)

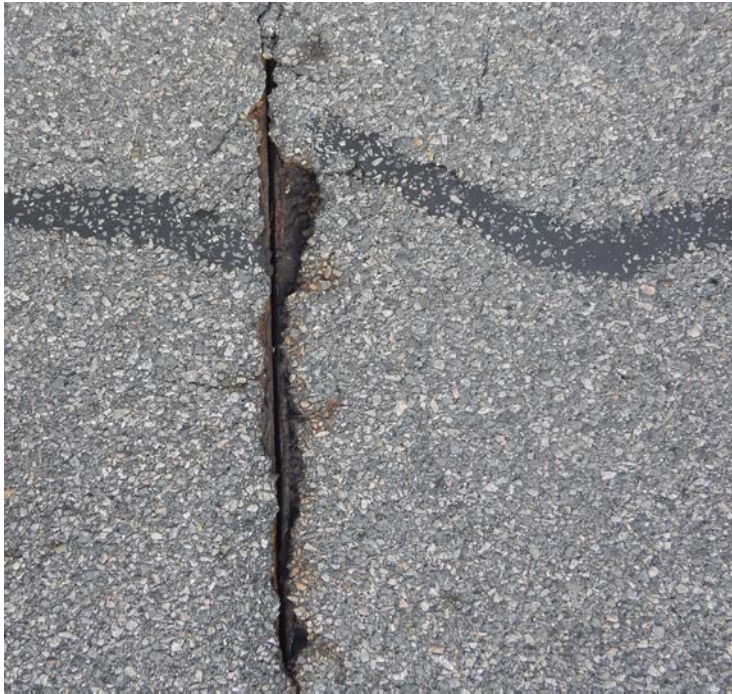
Photo 8.5-9: CNB159 Open Expansion Joint – Steel Joint Header - Closeup

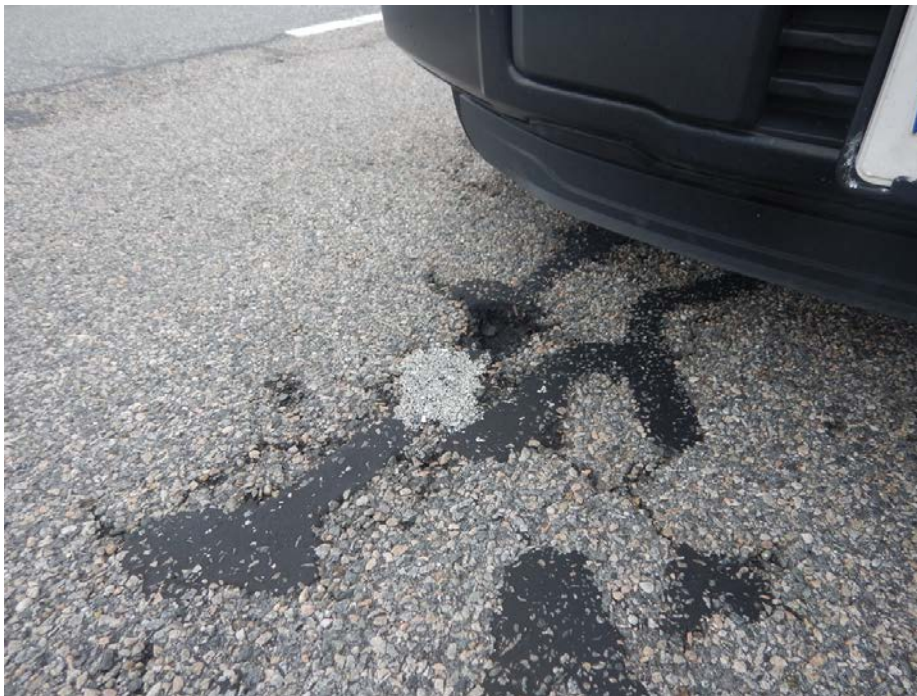
Photo 8.5-10: CNB184 Asphalt Wearing Surface – Surface Spalling and Cracking (Looking Southeast)

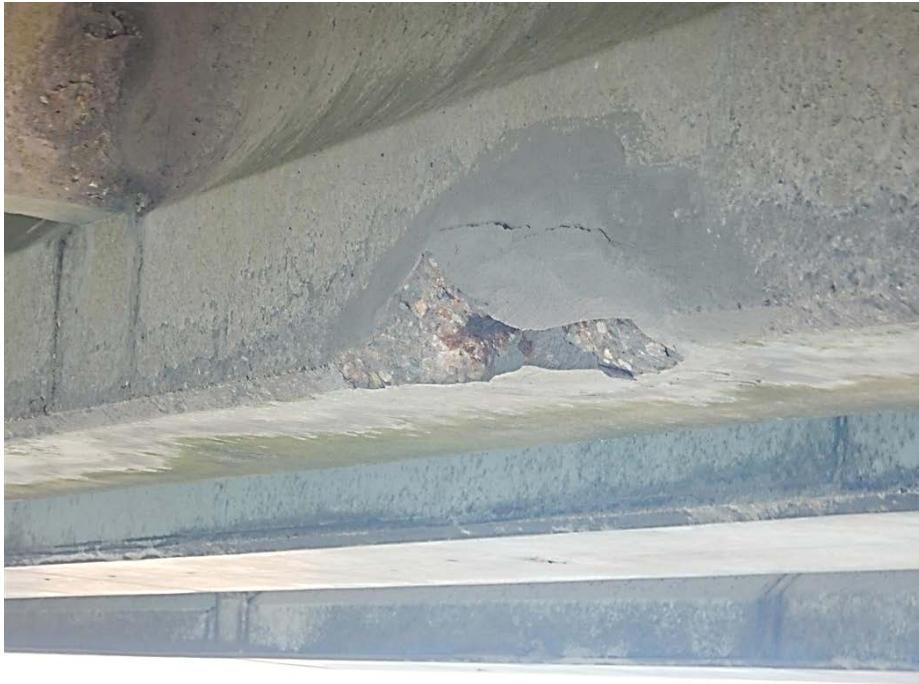
Photo 8.5-11: CNB136 Girder 3 - Repair with Exposed Prestressing Strand (Looking Northeast)

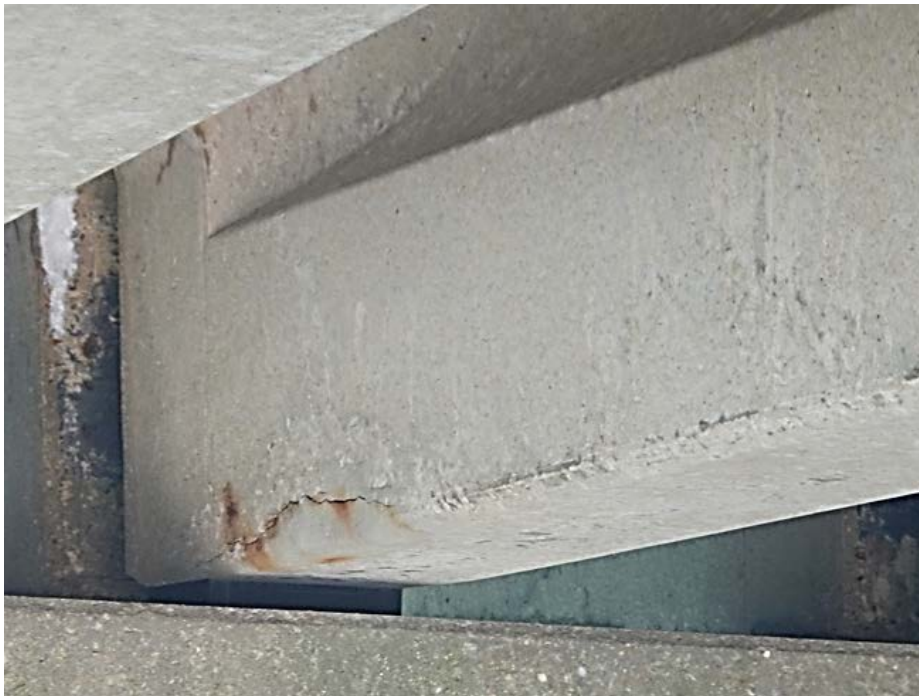
Photo 8.5-12: CNB138 Girder 8 - Failed Repair with Rust Staining Near Bearing (Looking Northeast)

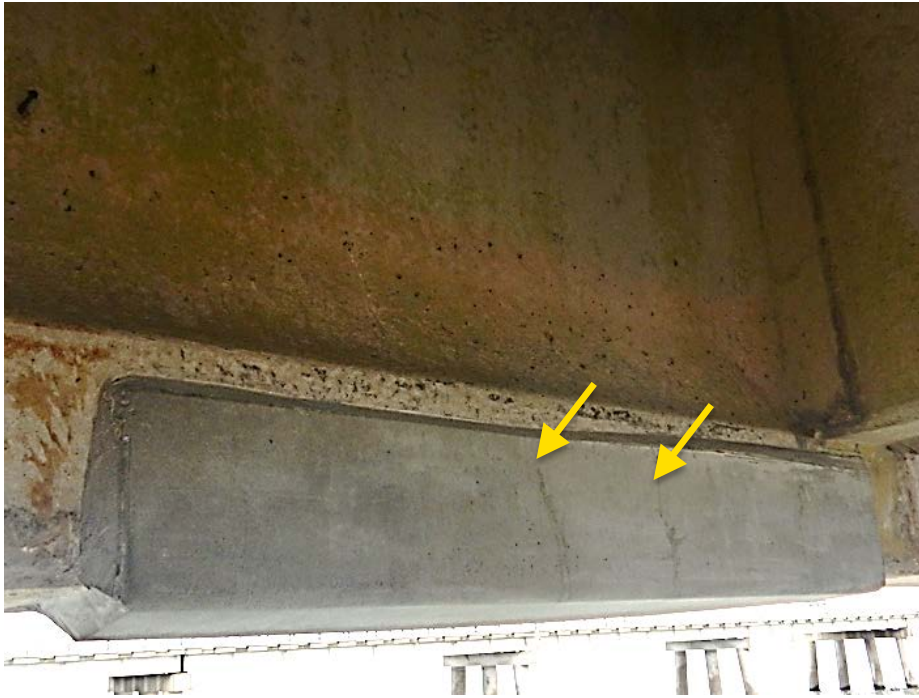
Photo 8.5-13: CNB147 Girder 8 - Repair with Minor Transverse Cracking (Looking Northwest)

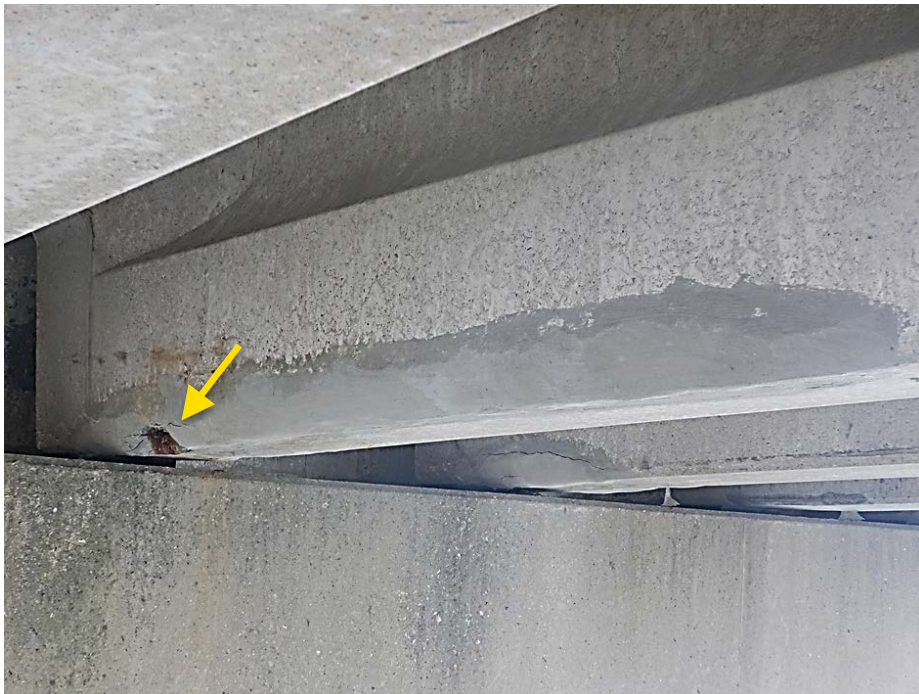
Photo 8.5-14: CNB138 Girder 8 - Failed Repair with Rust Staining Near Bearing (Looking Northeast)
