FY2019 Annual Inspection and Underwater Inspection, Trestle A'NB, ANB, & ASB

Chesapeake Bay Bridge and Tunnel District

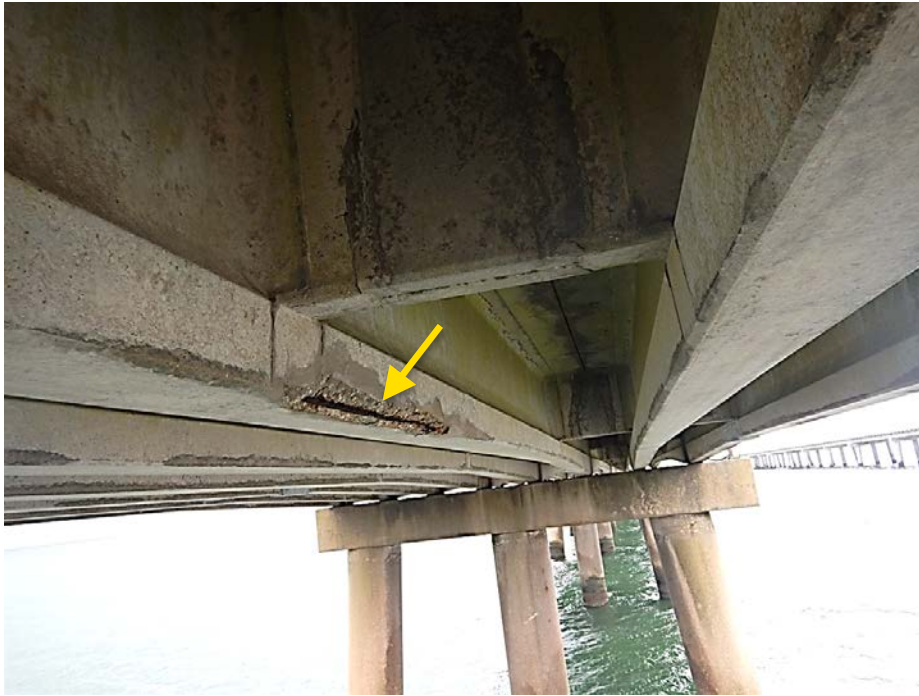
Photo 8.5-15: CNB174 Girder 6 - Failed Repair with Exposed Reinforcement Near Bearing (Looking Southeast)

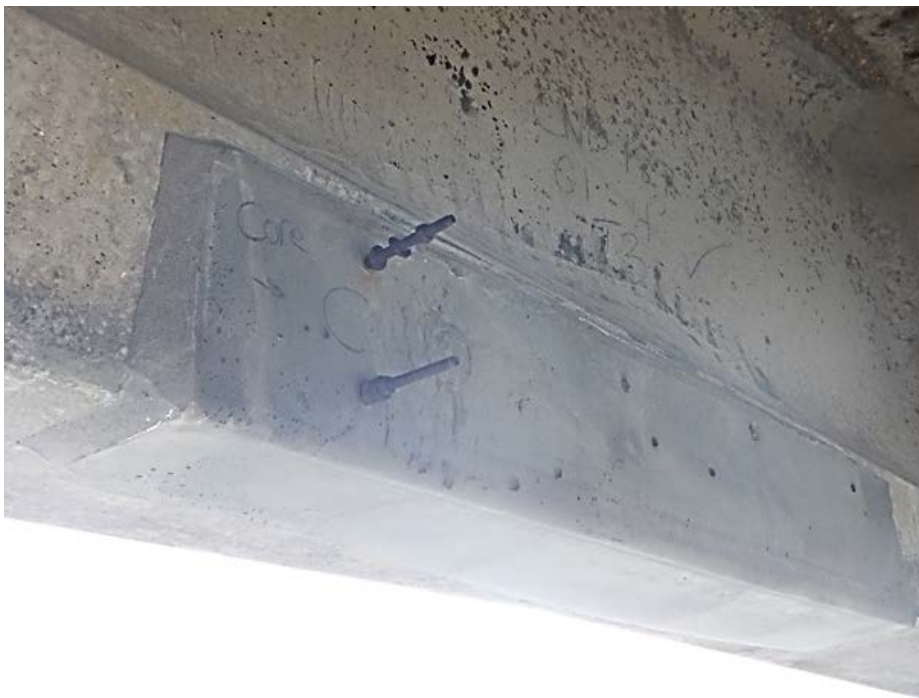
Photo 8.5-16: CNB187 Girder 1 - Galvanized Hardware used for Core Extraction should be removed (Looking Southeast)

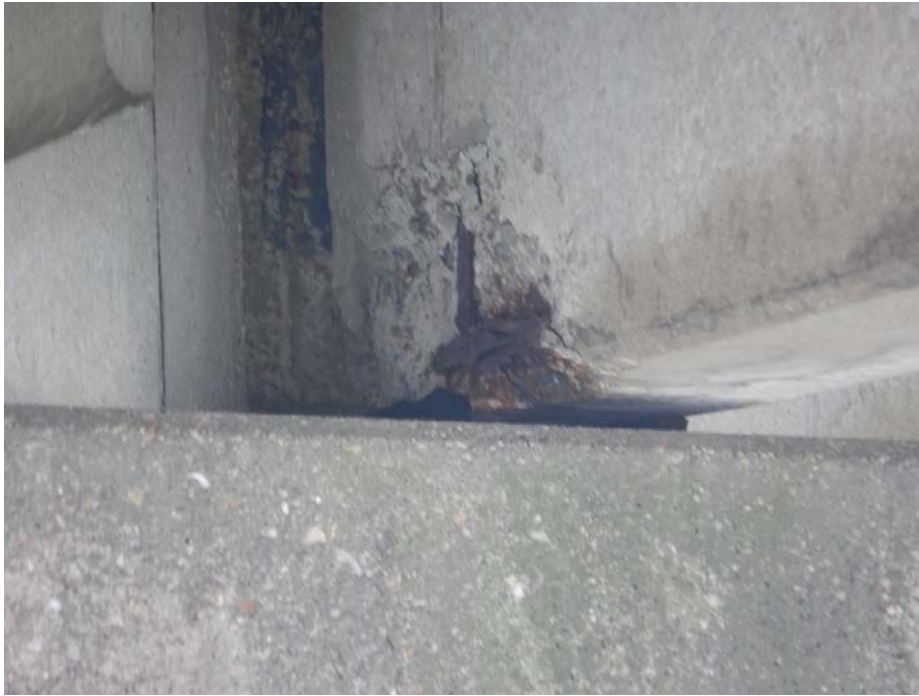
Photo 8.5-17: CNB187 Girder 8 - Failed Repair with Exposed Reinforcement Near Bearing (Looking Northeast)

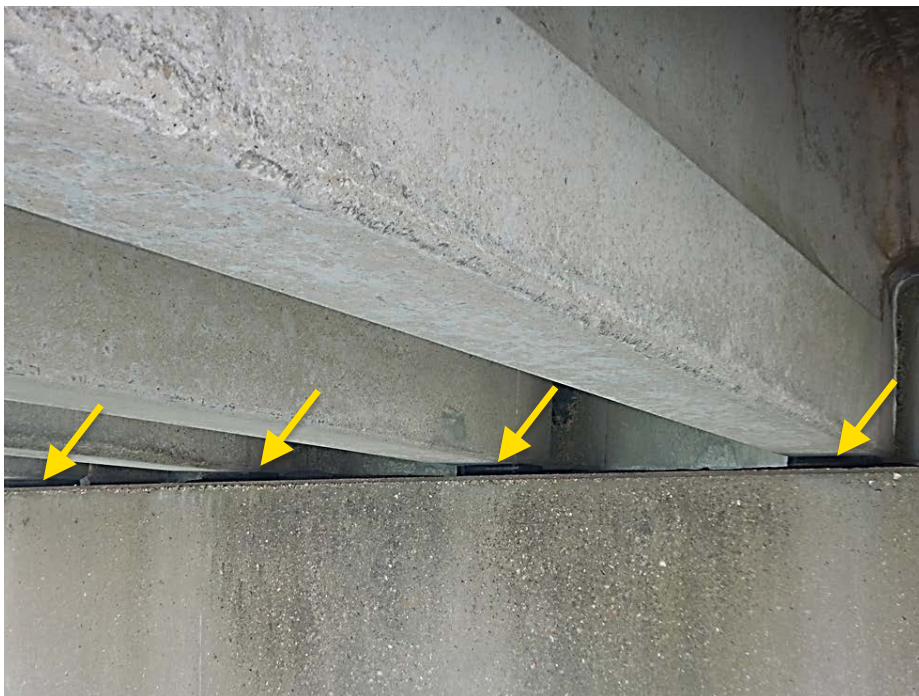
Photo 8.5-18: CNB138 Elastomeric Bearings at Girders 4, 5, 6, & 7 - Split with Exposed and Corroded Steel Plates (Looking Northwest)

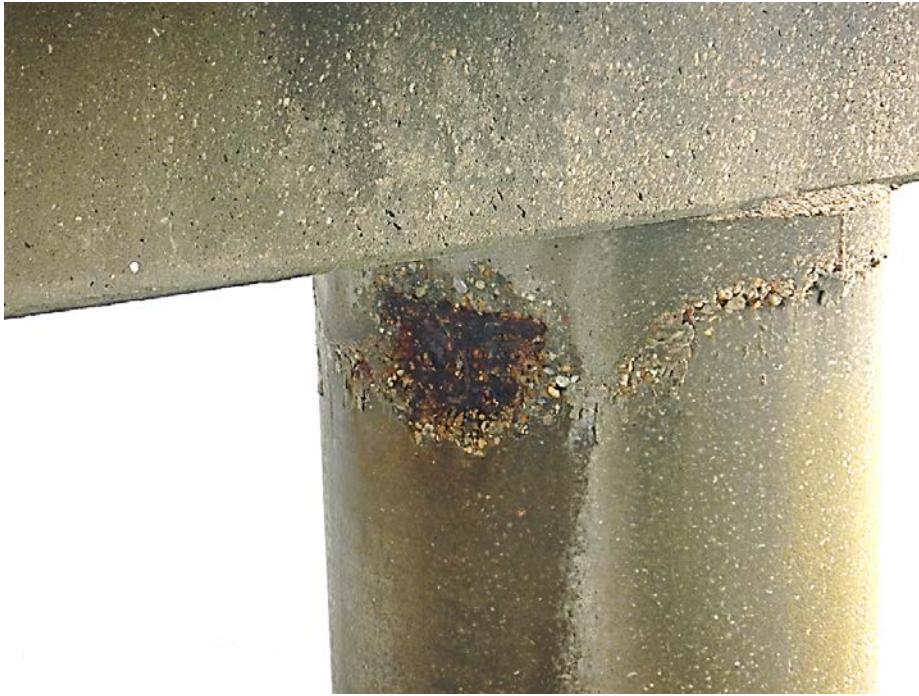
Photo 8.5-19: CNB175 Pile A - Spall with Exposed Reinforcement (Looking Southwest)

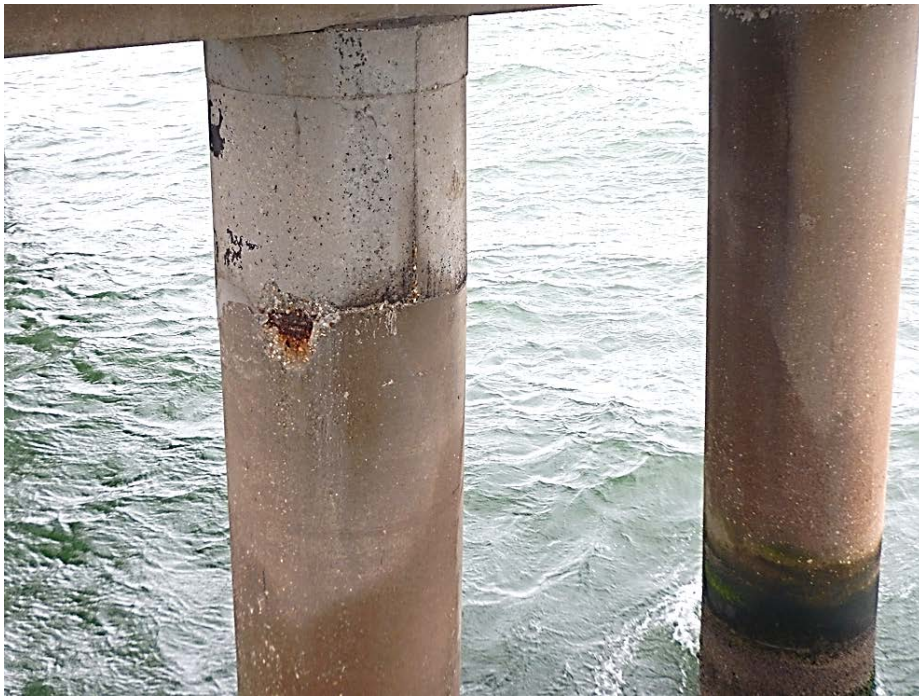
Photo 8.5-20: CNB182 Pile B - Spall with Exposed Reinforcement (Looking Northeast)

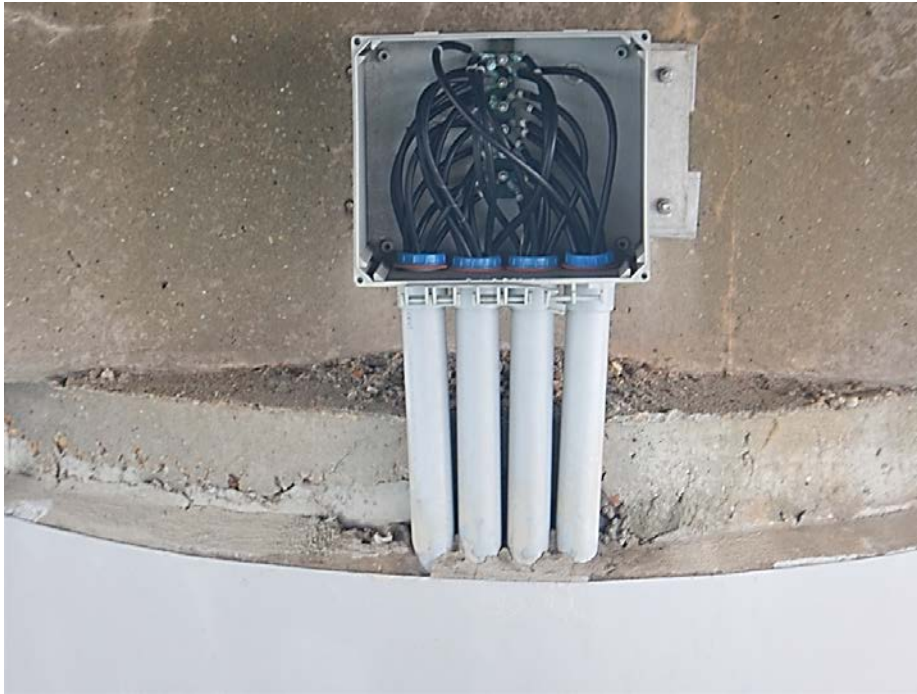
Photo 8.5-21: CNB183 Pile B – Life Jacket Rectifier with No Cover (Looking North)

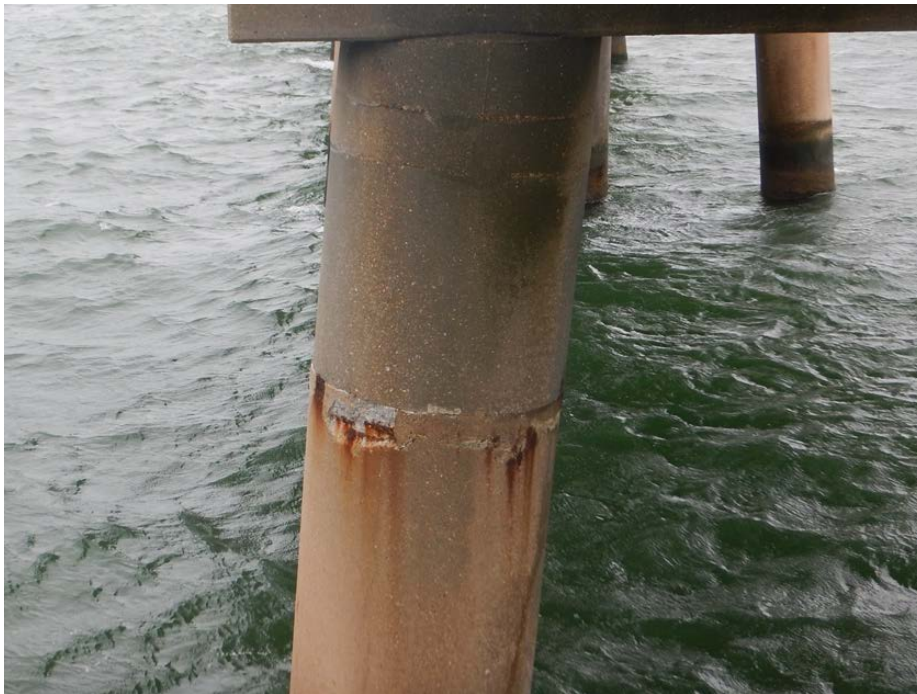
Photo 8.5-22: CNB184 Pile A - Spall with Exposed Reinforcement (Looking Northeast)

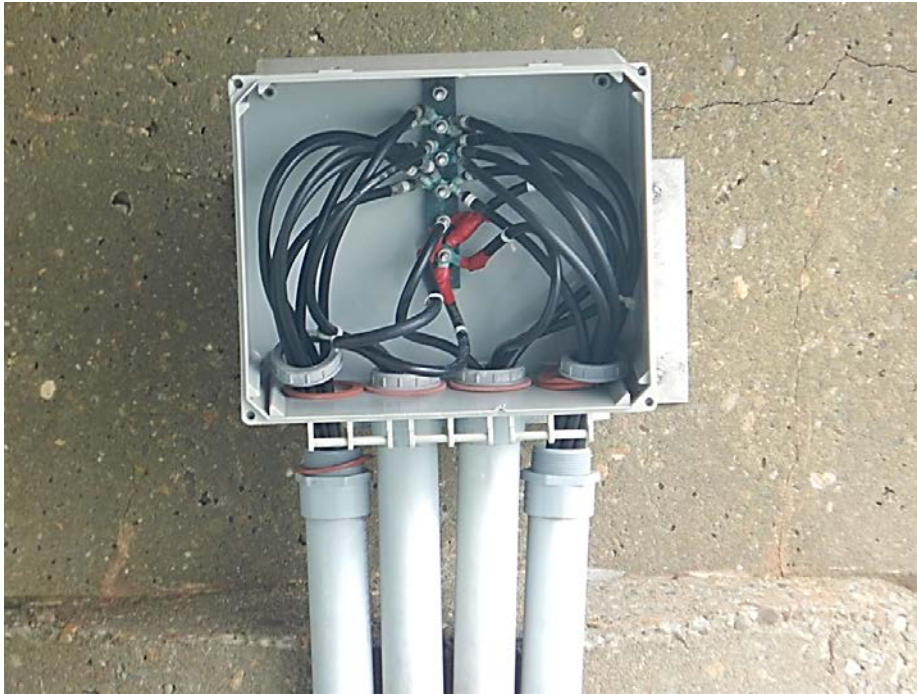
Photo 8.5-23: CNB191 Pile C – Life Jacket Rectifier with No Cover (Looking North)

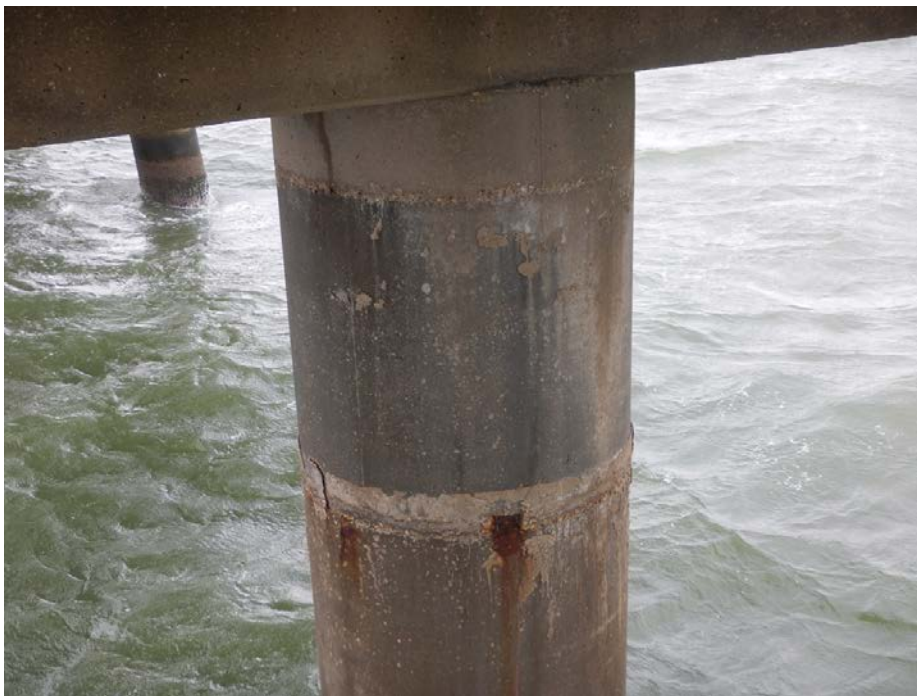
Photo 8.5-24: CNB193 Pile B - Spall with Exposed Reinforcement (Looking Northeast)

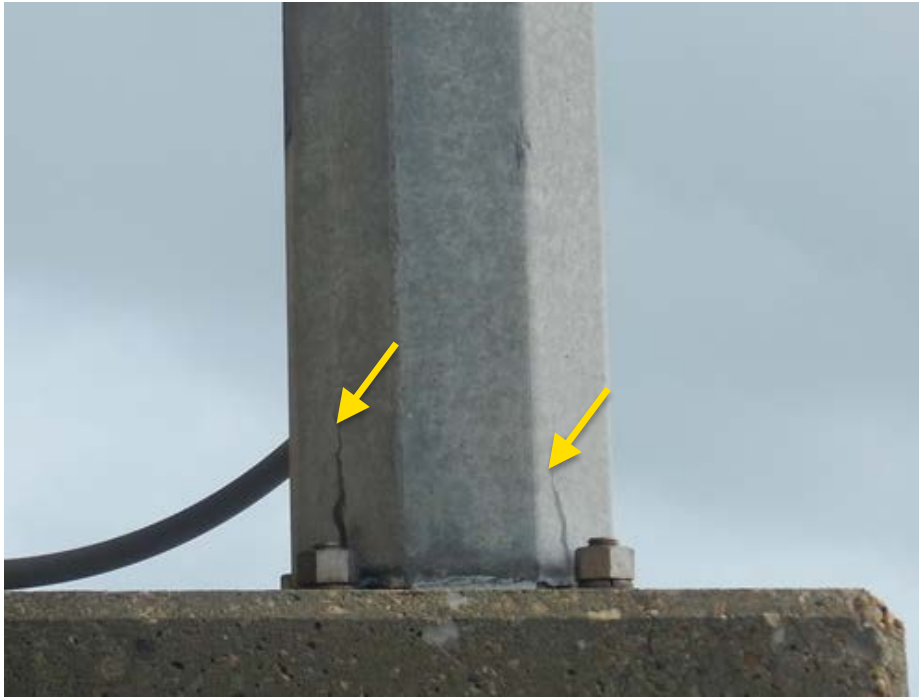
Photo 8.5-25: CNB159 Light Pole – Cracking at Baseplate (Looking North)

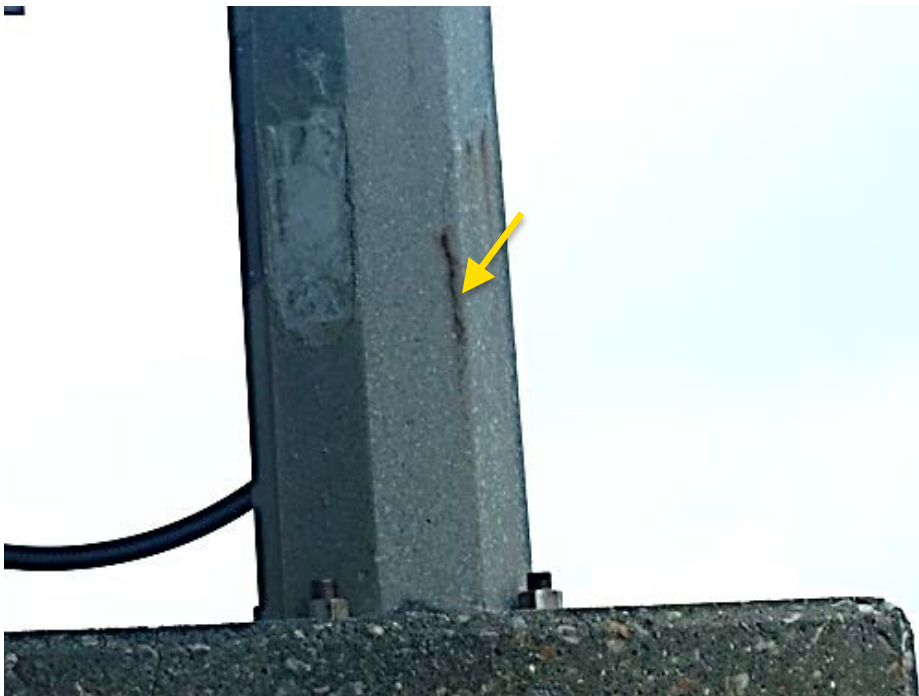
Photo 8.5-26: CNB162 Light Pole – Cracking near Baseplate with Rust Staining (Looking Southwest)

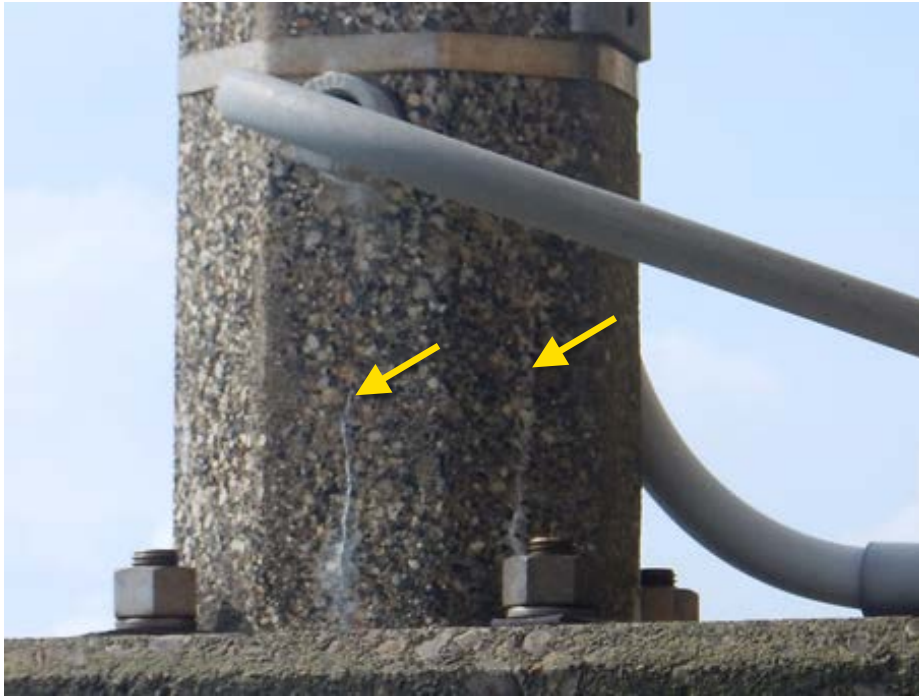
Photo 8.5-27: CNB165 Light Pole – Cracking at Baseplate with Efflorescence (Looking Southeast)

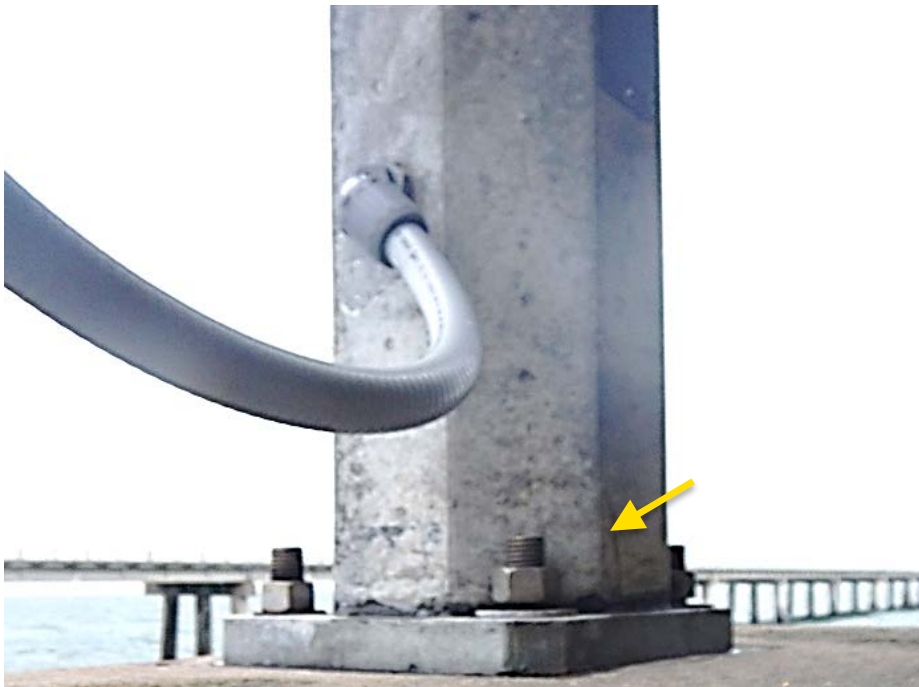
Photo 8.5-28: CNB186 Light Pole – Cracking at Baseplate (Looking Northwest)

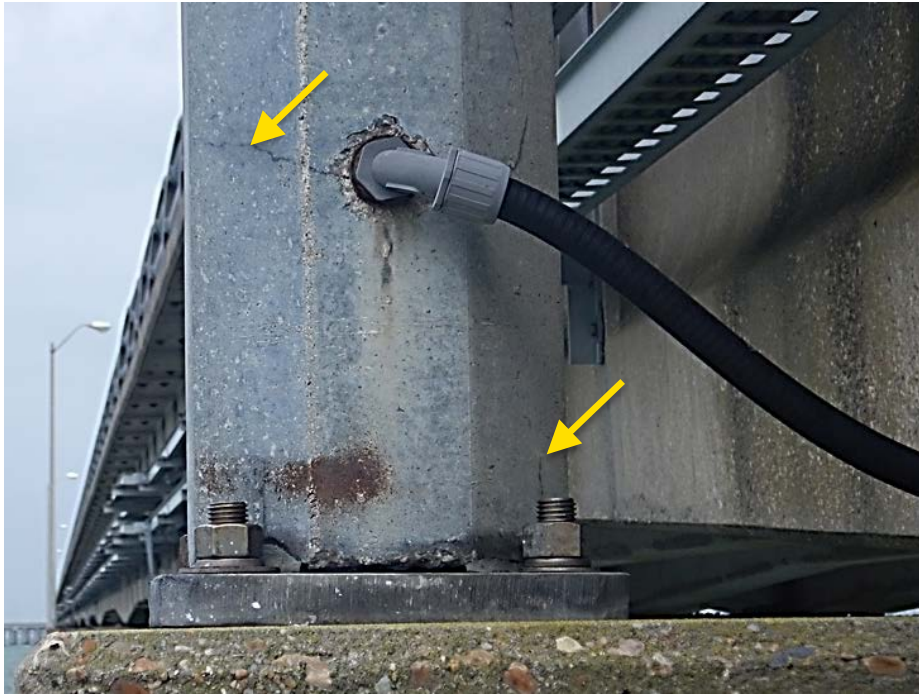
Photo 8.5-29: CNB192 Light Pole – Cracking at Baseplate (Looking Northeast)

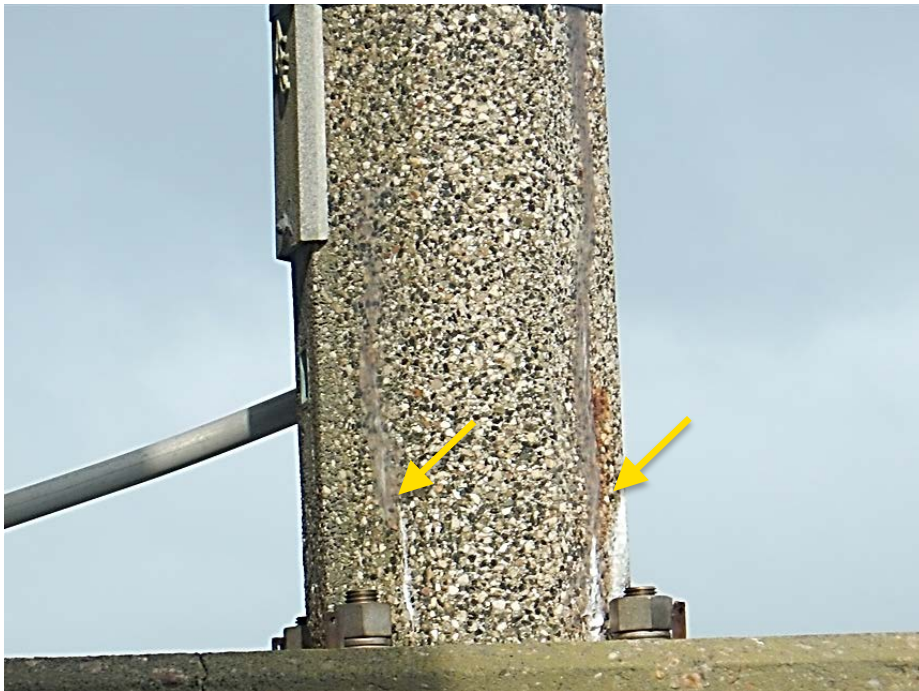
Photo 8.5-30: CNB195 Light Pole – Cracking at Baseplate with Efflorescence and Rust Staining (Looking North)

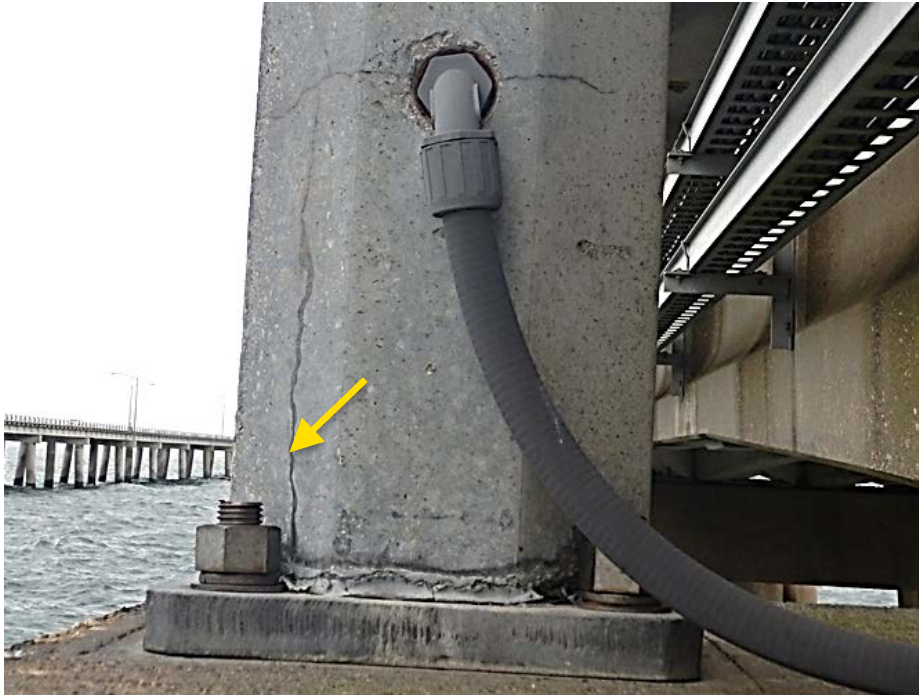
Photo 8.5-31: CNB198 Light Pole – Cracking at Baseplate (Looking North)

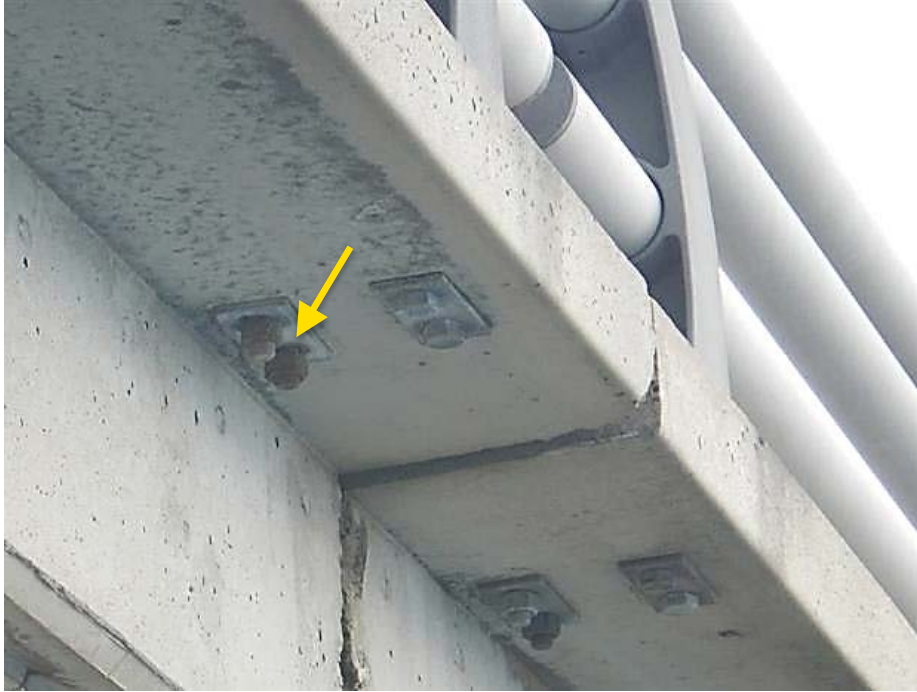
Photo 8.6-1: CSB115 Metal Bridge Railing – Loose Anchor Bolt Connection near Bent CSB115 (Looking Northwest)

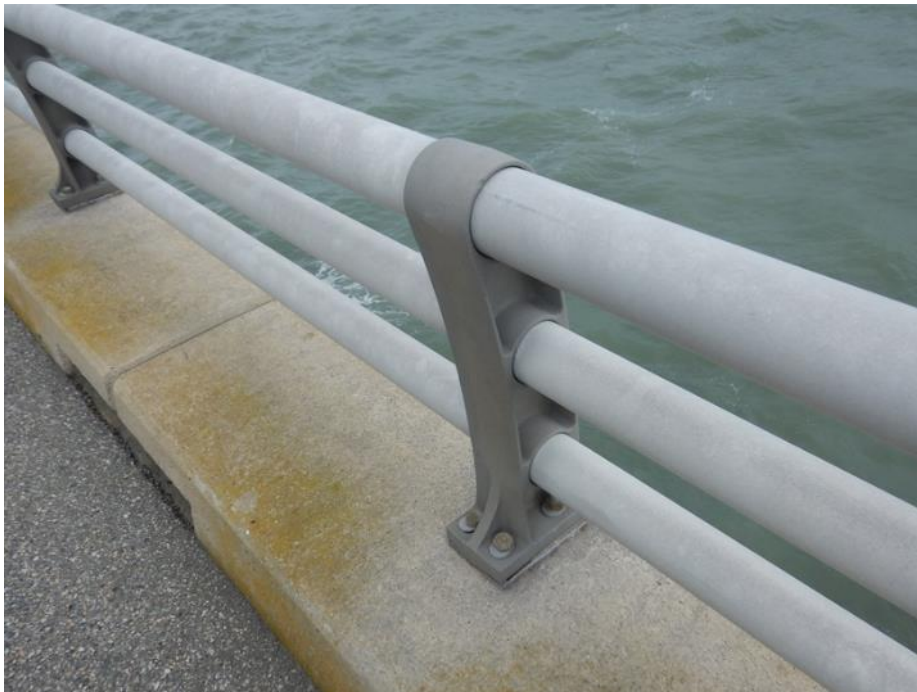
Photo 8.6-2: CSB136 Metal Bridge Railing – Top Connection is Loose, 4th Post from North (Looking Southwest)

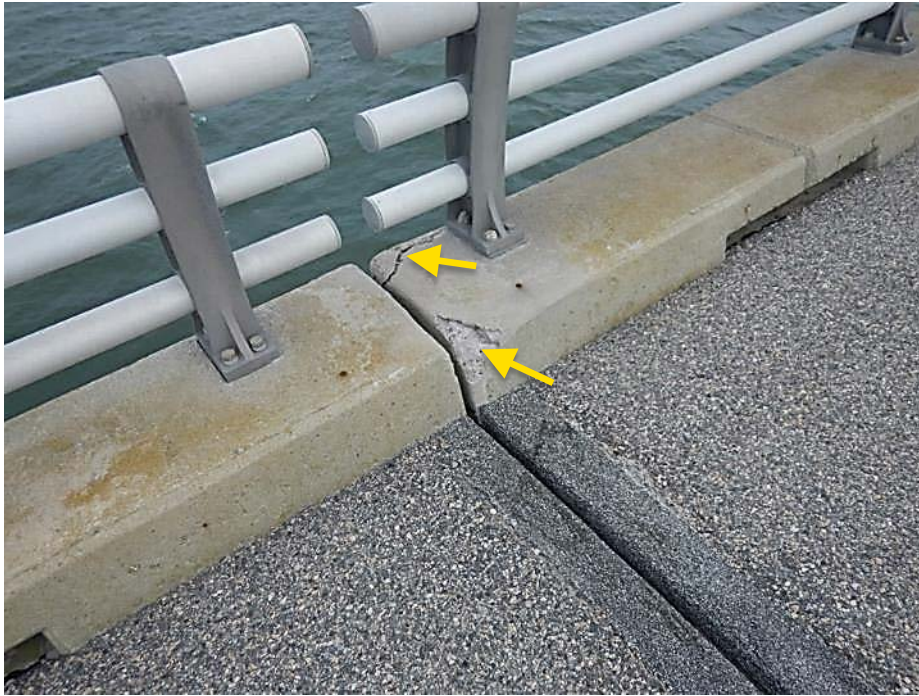
Photo 8.6-3: CSB152 Metal Bridge Railing – Failed Curb Repair (Looking Northwest)

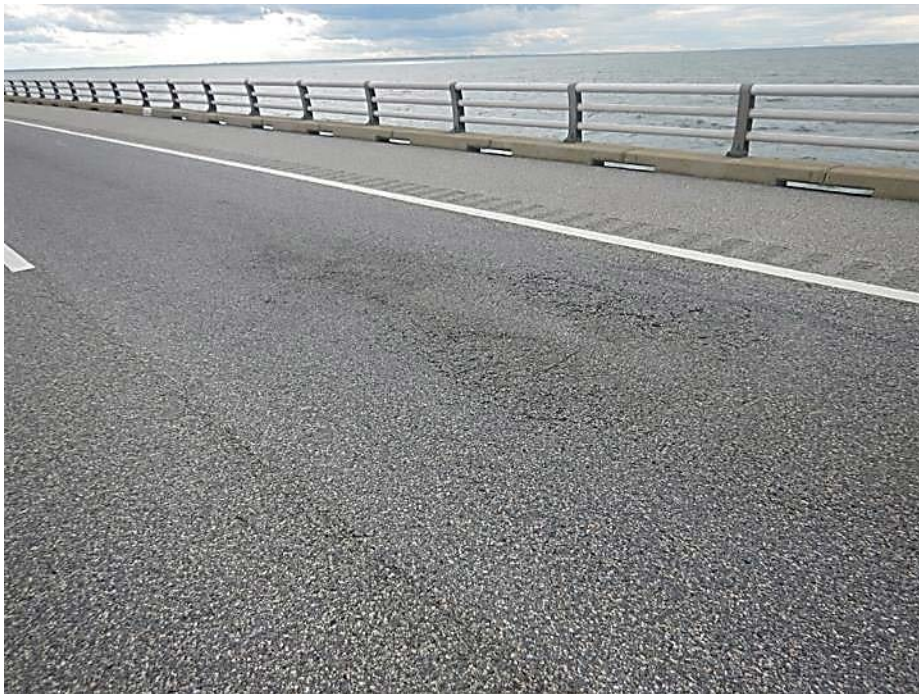
Photo 8.6-4: CSB110 Asphalt Wearing Surface – Typical Abrasion and Scaling (Looking Southwest)

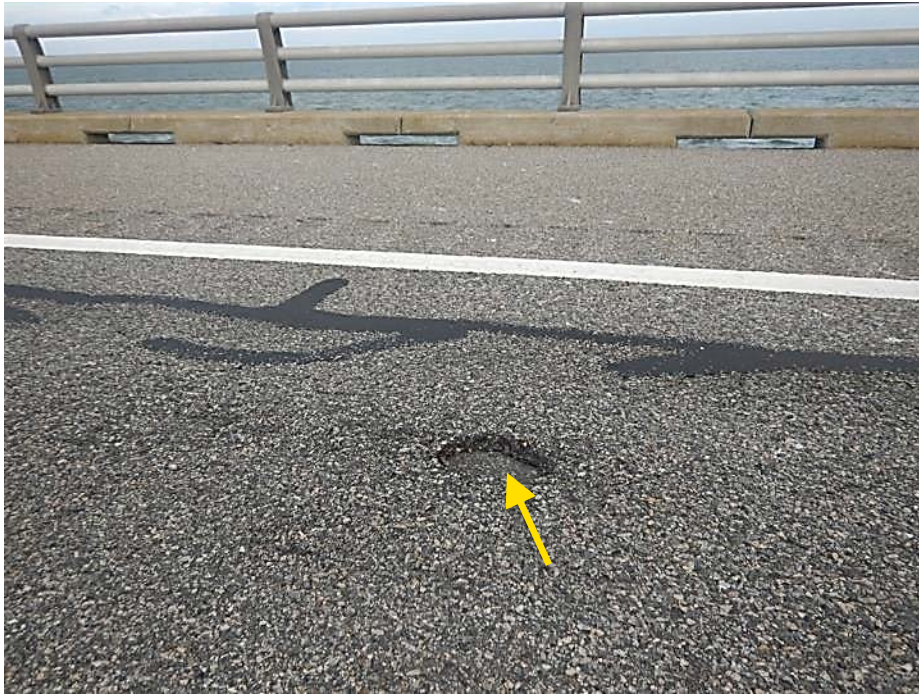
Photo 8.6-5: CSB120 Asphalt Wearing Surface – Surface Spall in Right Lane (Looking West)

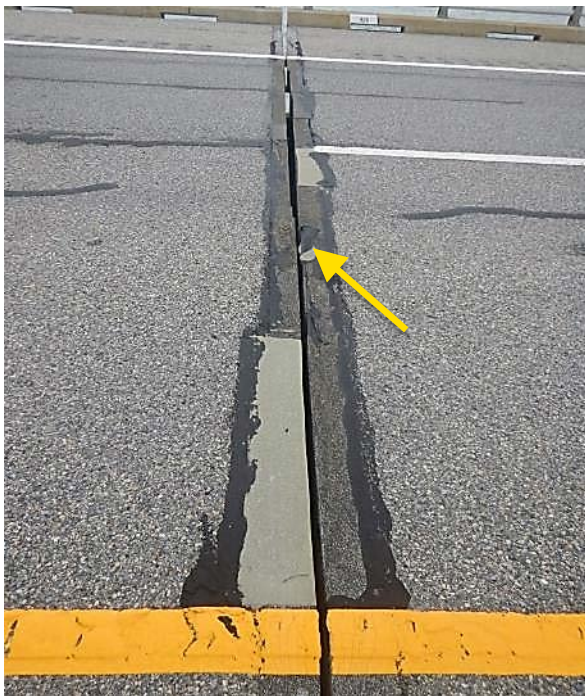
Photo 8.6-6: CSB125 Open Joint – Area of Degradation in Header (Looking West)

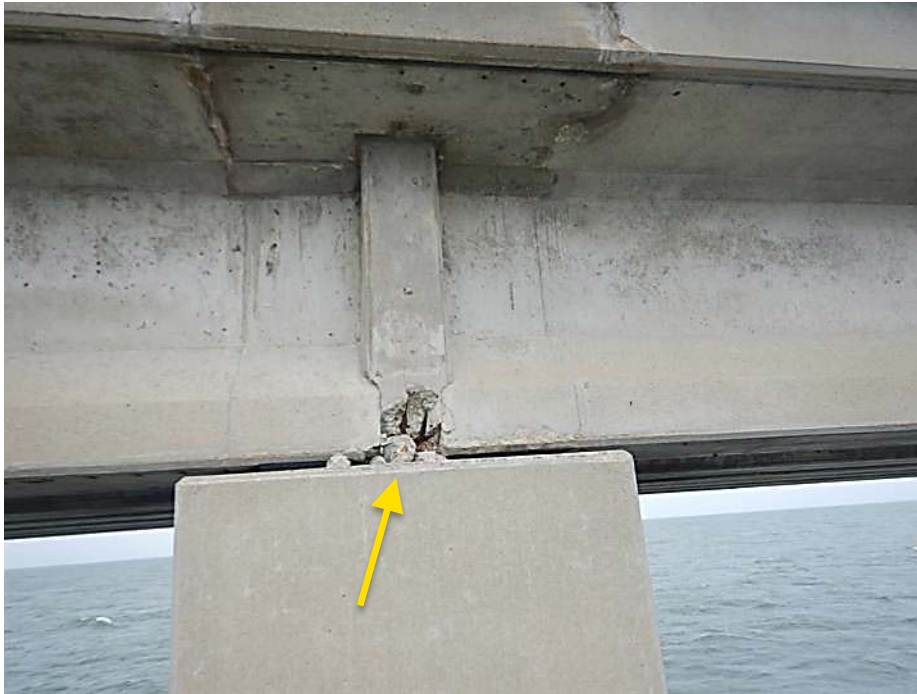
Photo 8.6-7: CSB153 Girder 6 – Spalling at Closure Diaphragm with Exposed Reinforcement and Prestressing Strand (Looking West)

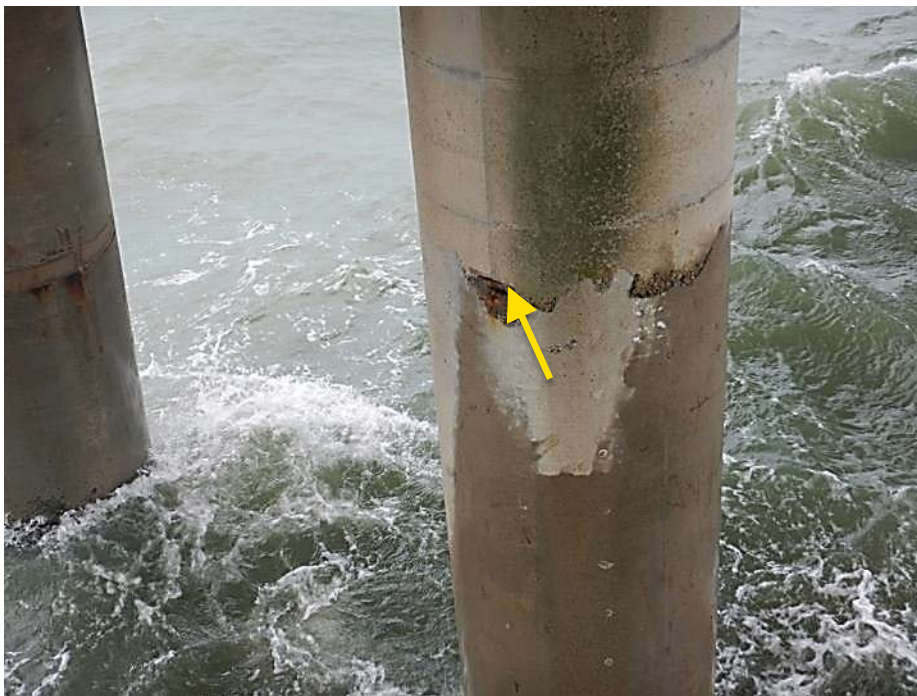
Photo 8.6-8: CSB128 Pile B - Spall with Exposed Reinforcement Spirals (Looking North)

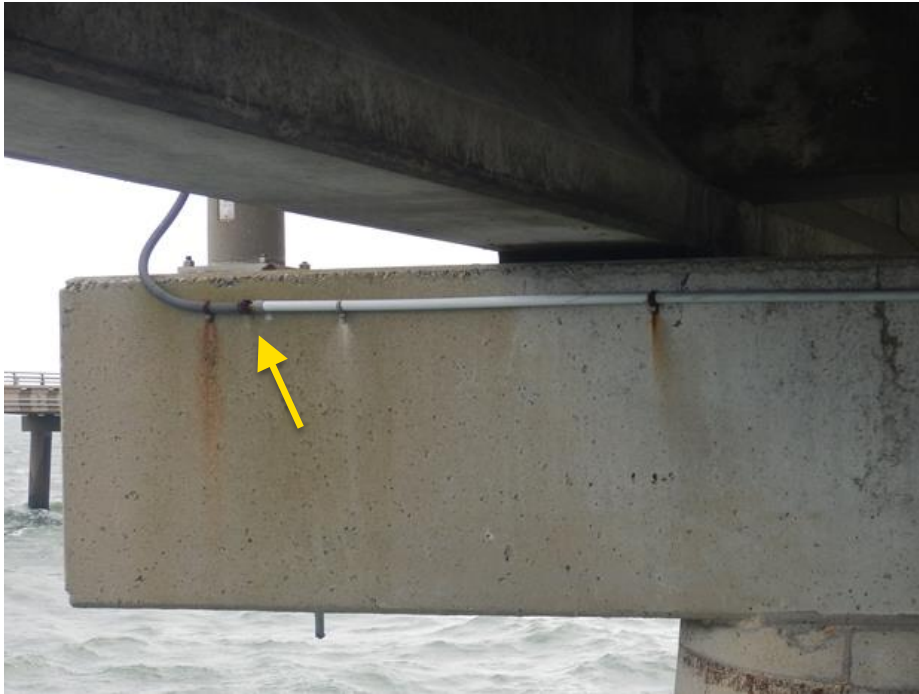
Photo 8.6-9: CSB Bent 121 - Conduit Separated (Looking South)

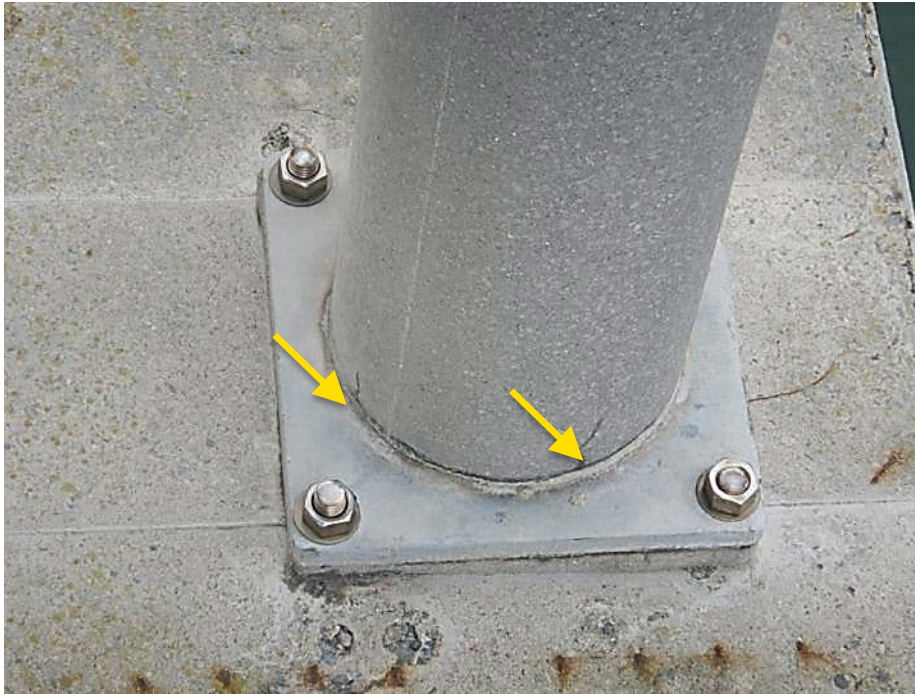
Photo 8.6-11: CSB115 Light Pole – Vertical Cracking Near Baseplate (Looking Southwest)

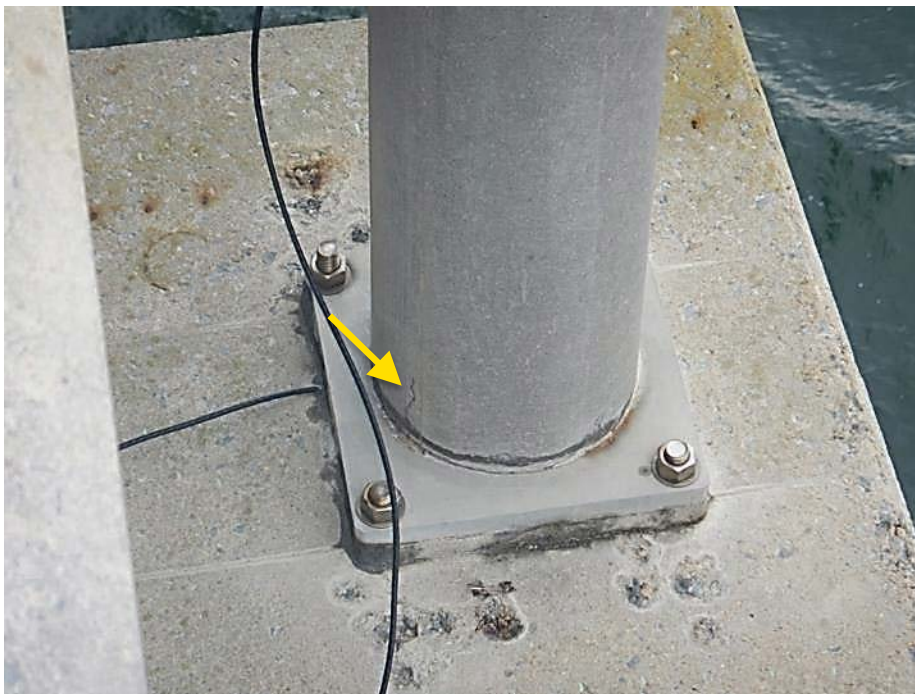
Photo 8.6-12: CSB117 Light Pole – Vertical Cracking Near Baseplate (Looking North)

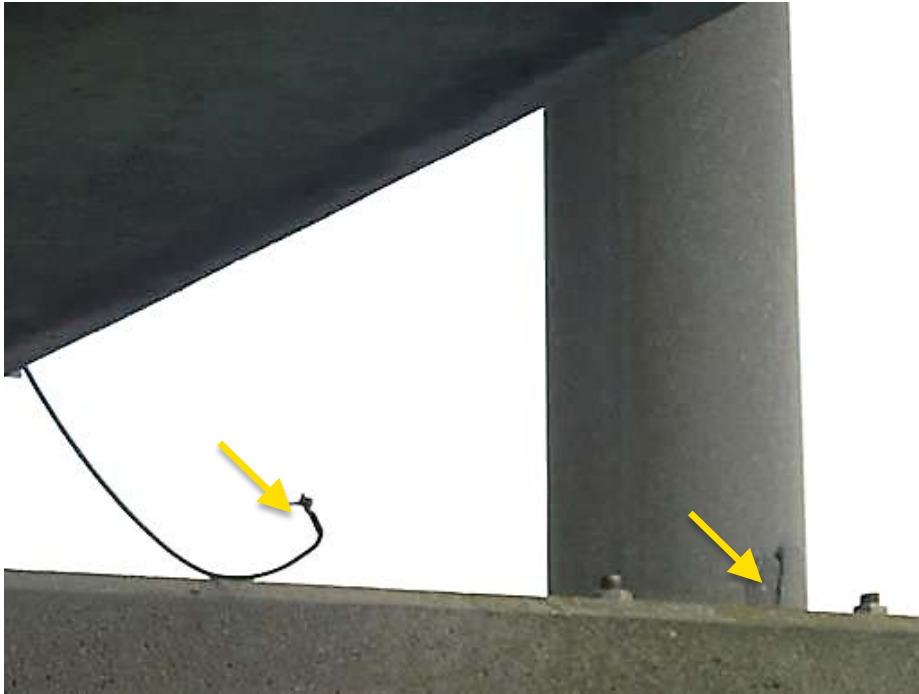
Photo 8.6-13: CSB123 Light Pole – Delamination Near Baseplate and Disconnected Cable (Looking Southwest)

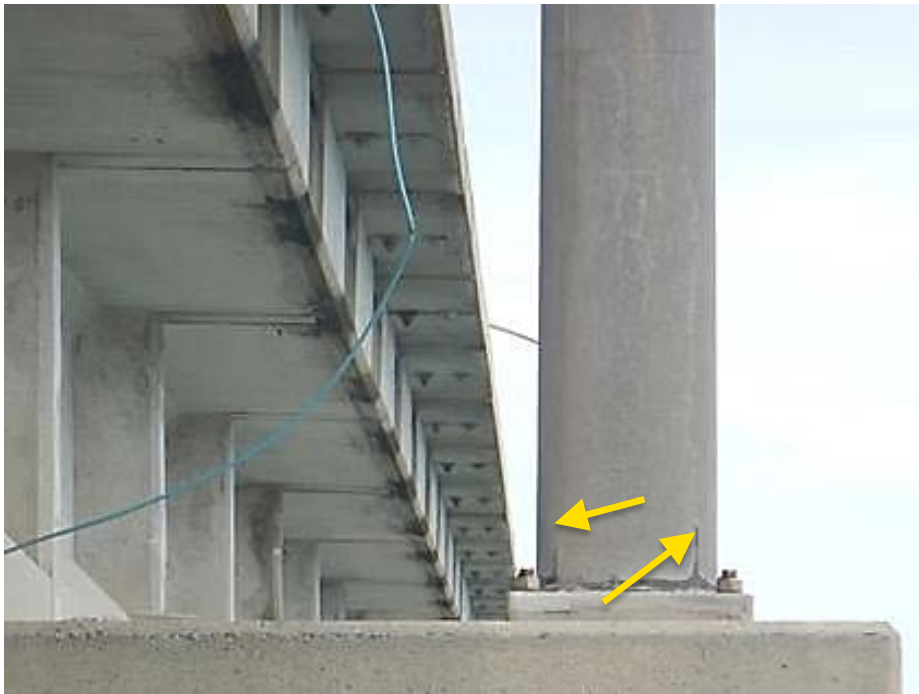
Photo 8.6-14: CSB129 Light Pole – Vertical Cracking Near Baseplate (Looking North)

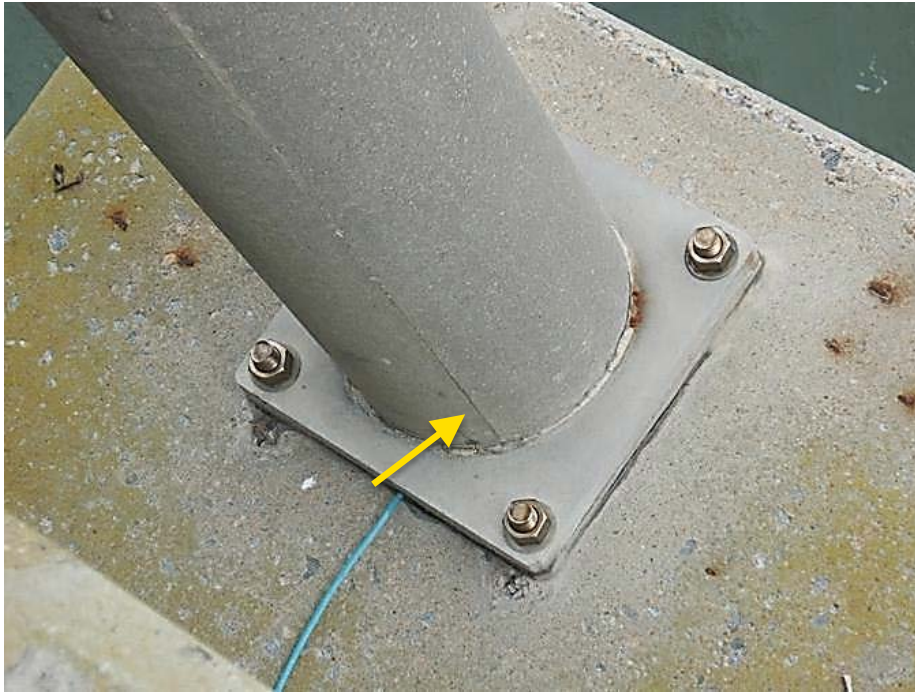
Photo 8.6-15: CSB133 Light Pole – Vertical Cracking Near Baseplate (Looking Northeast)

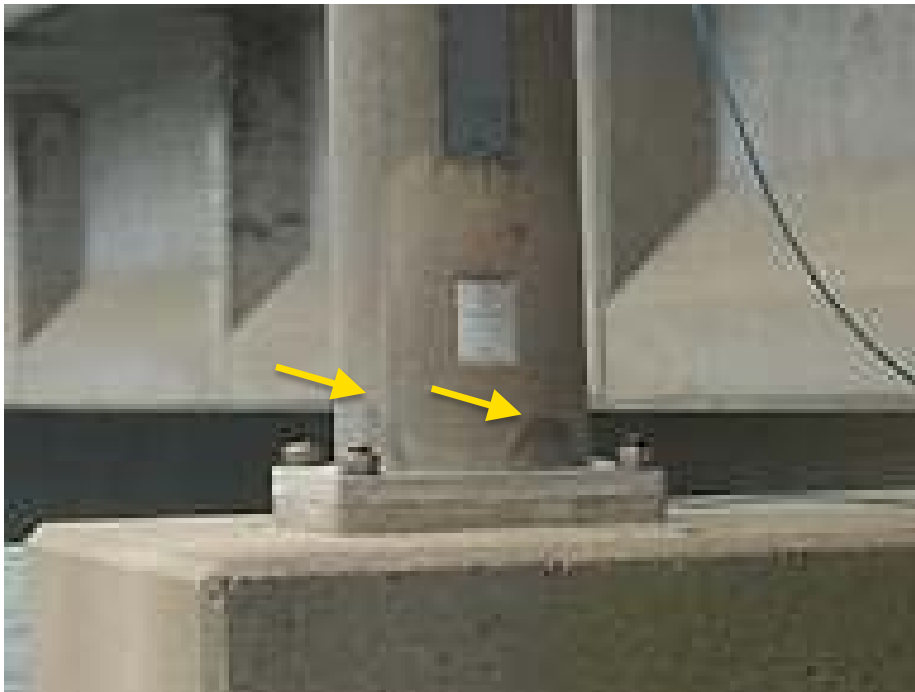
Photo 8.6-16: CSB139 Light Pole – Delamination Near Baseplate (Looking Southwest)

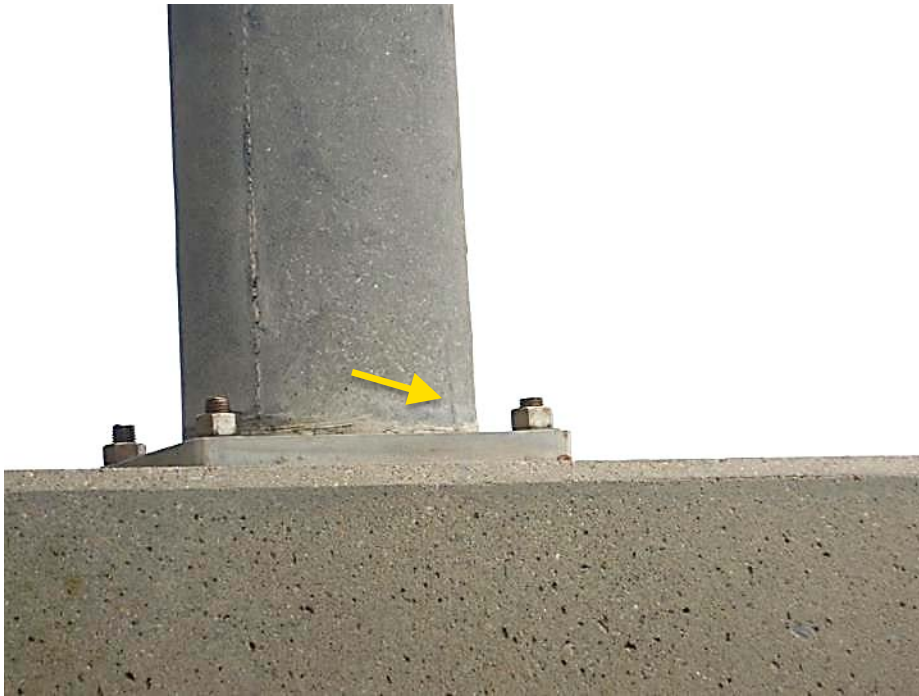
Photo 8.6-17: CSB141 Light Pole – Vertical Cracking Near Baseplate (Looking Northeast)

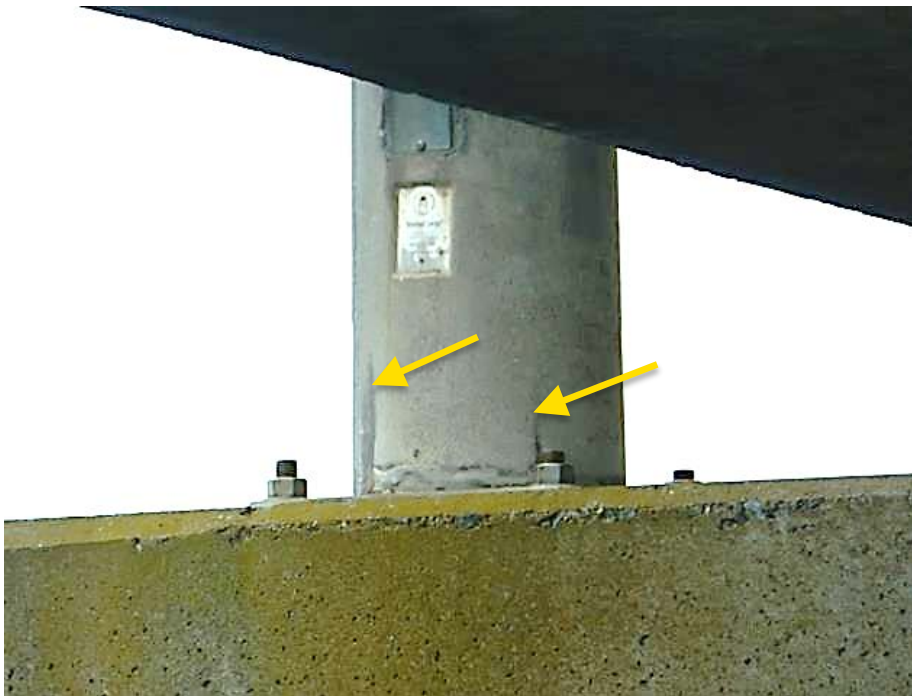
Photo 8.6-18: CSB147 Light Pole – Vertical Cracking Near Baseplate (Looking Northwest)

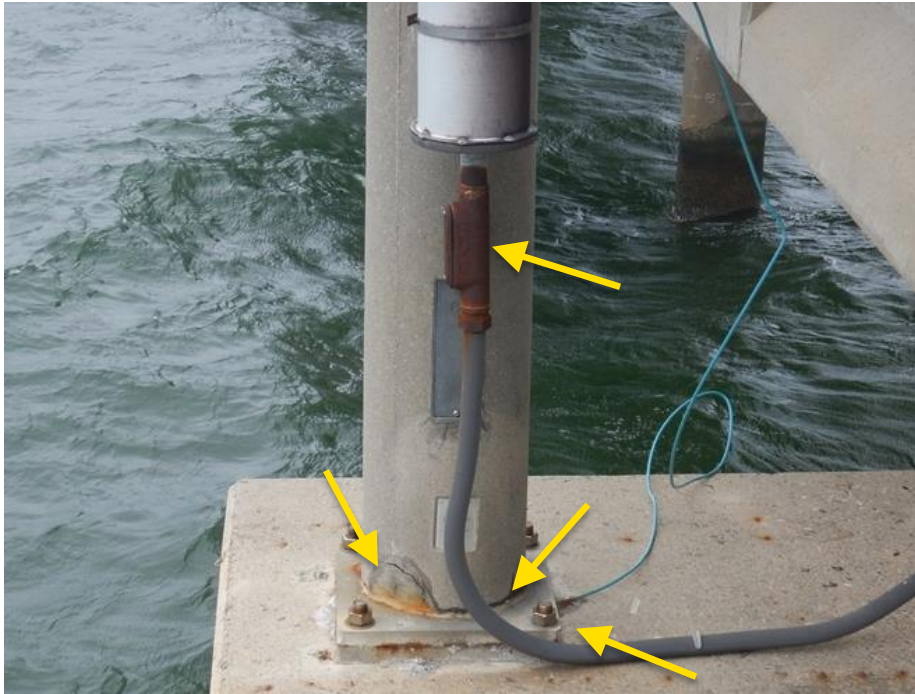
Photo 8.6-19: CSB149 Light Pole – Vertical Cracking and Failed Repair Near Baseplate, Corroded Conduit and Disconnected Cable (Looking South)
