FY2019 Annual Inspection and Underwater Inspection, Trestle A'NB, ANB, & ASB

Chesapeake Bay Bridge and Tunnel District

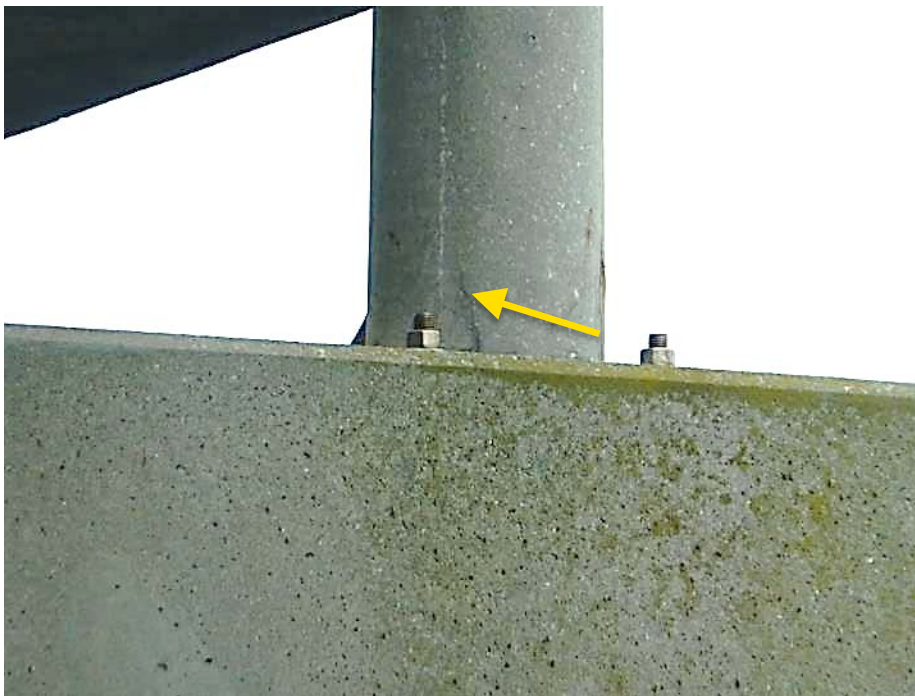
Photo 8.6-20: CSB151 Light Pole – Vertical Cracking Near Baseplate (Looking Southwest)

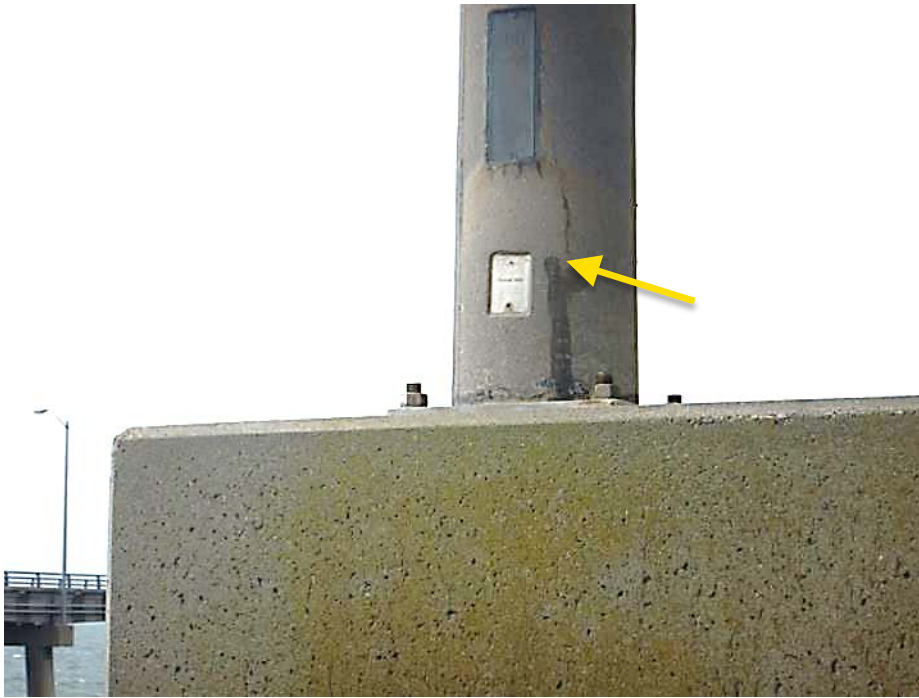
Photo 8.6-21: CSB153 Light Pole – Vertical Cracking Near Baseplate (Looking Southeast)

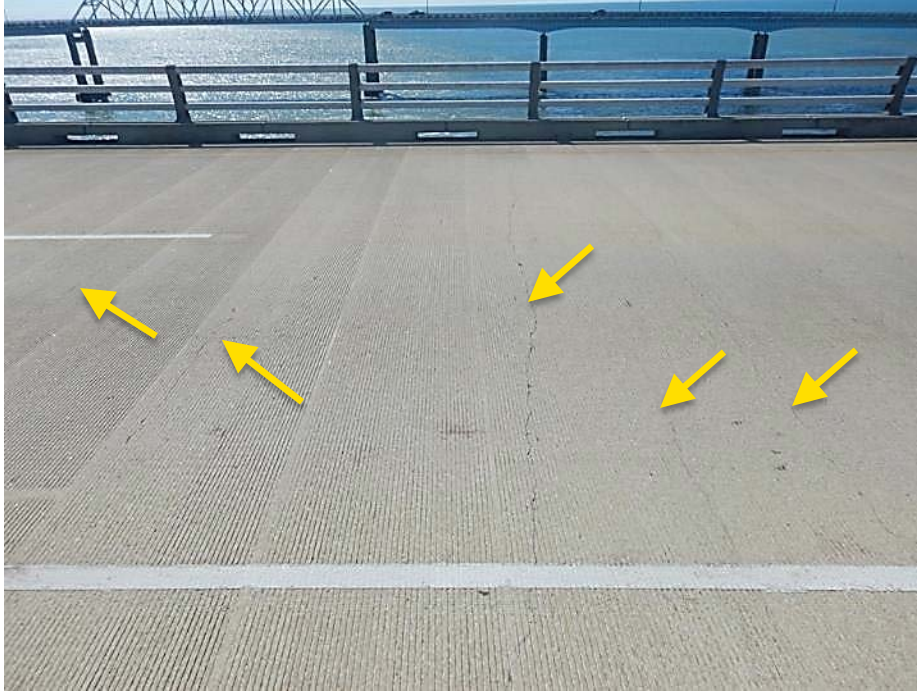
Photo 8.8-1: NCB-SB Span 8 Concrete Deck – Typical Frequent Transverse Cracking (Looking East)

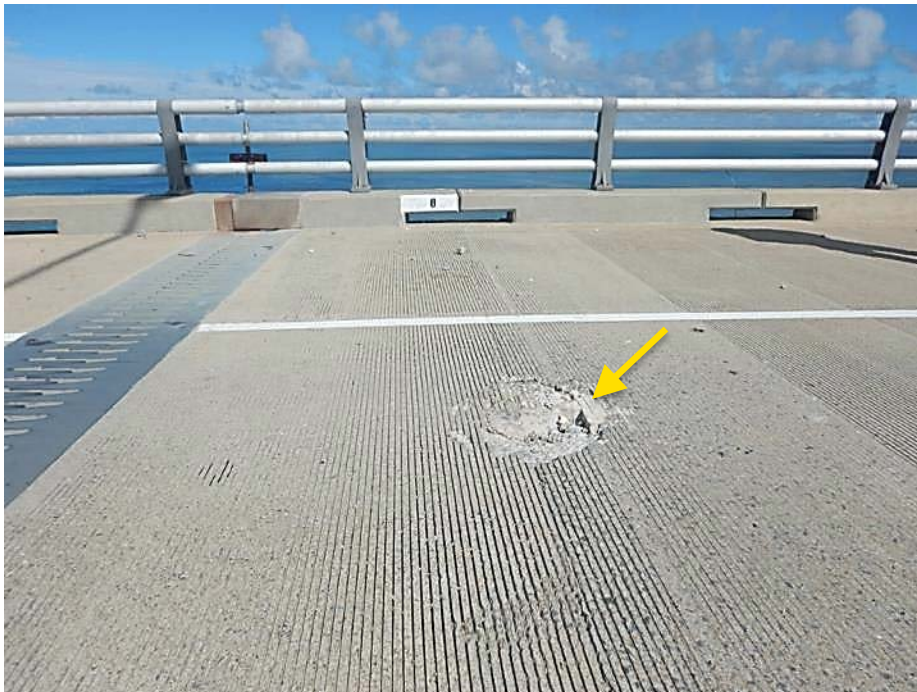
Photo 8.8-2: NCB-SB Span 8 Concrete Deck – Spall (Previously Patched), No Exposed Reinforcement (Looking West)

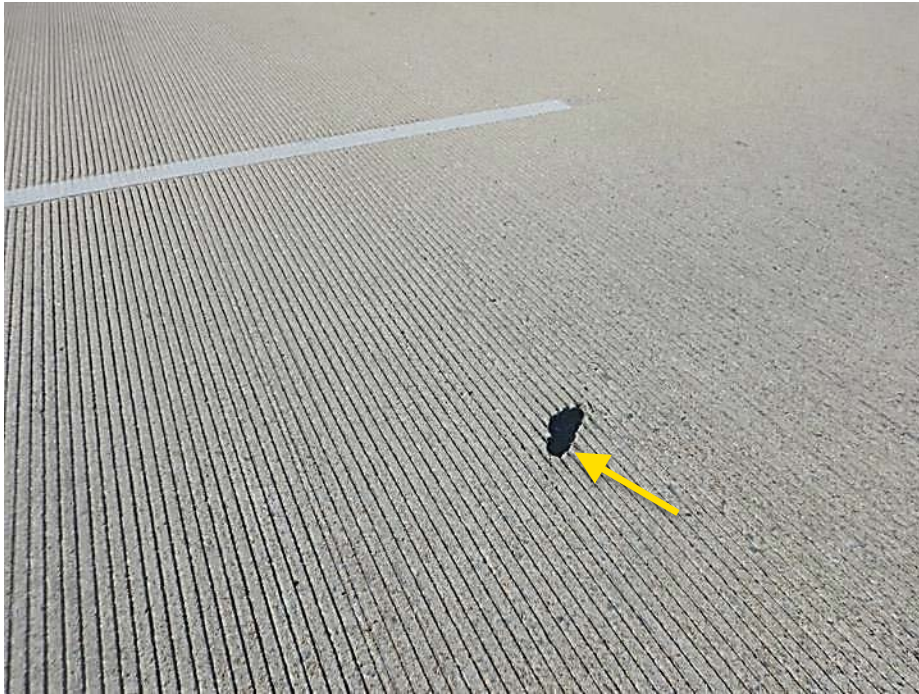
Photo 8.8-3: NCB-SB Span 10 Concrete Deck – Surface Spall, No Exposed Reinforcement (Looking Southeast)

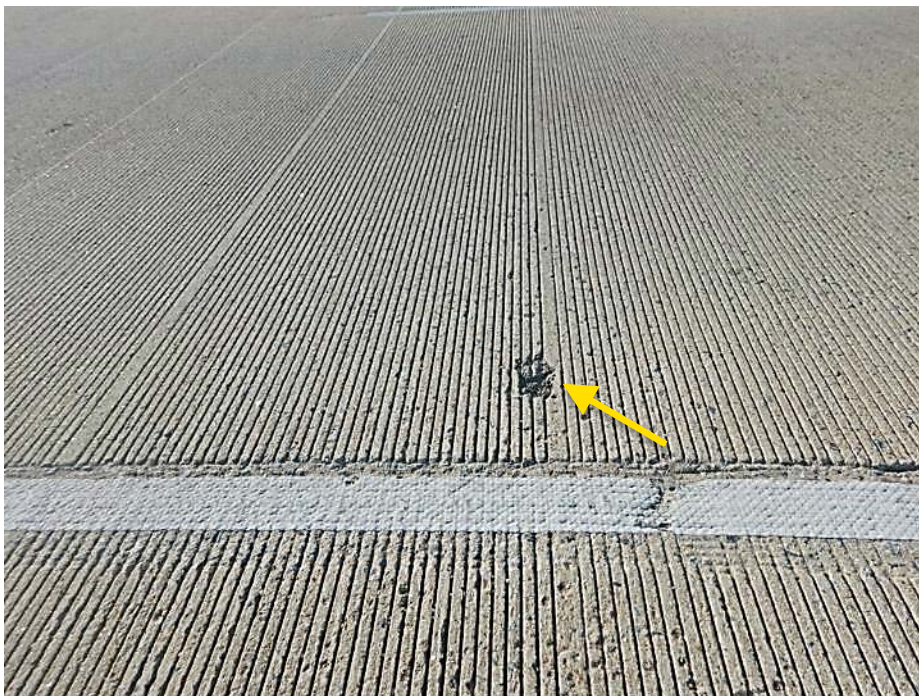
Photo 8.8-4: NCB-SB Span 12 Concrete Deck – Surface Spall, No Exposed Reinforcement (Looking East)

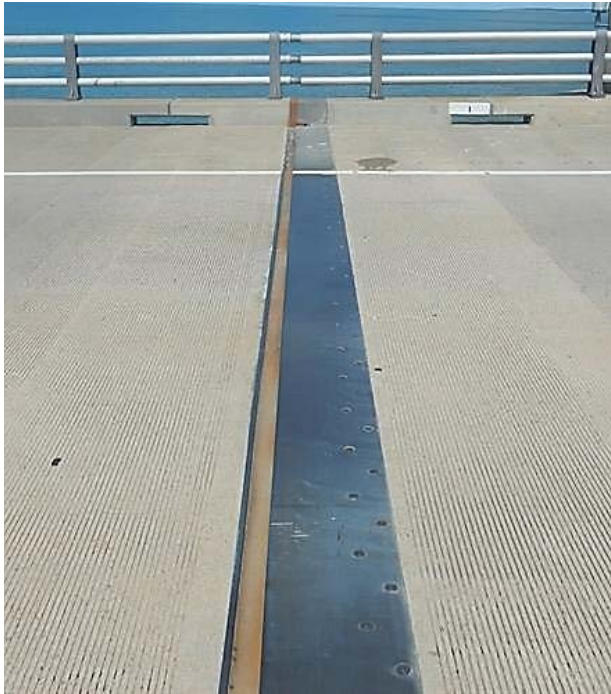
Photo 8.8-5: NCB-NB Pier 1 Assembly Joint without Seal – Sliding Plate Expansion Joint Typical Condition with Minor and Isolated Locations of Freckled Rust (Looking West)

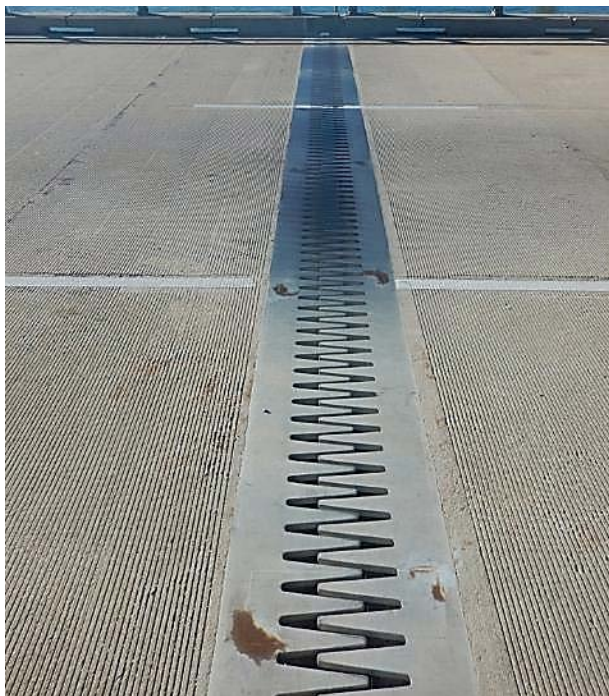
Photo 8.8-6: NCB-SB Pier 11 Assembly Joint without Seal – Tooth Expansion Joint Typical Condition with Minor and Isolated Locations of Freckled Rust (Looking East)

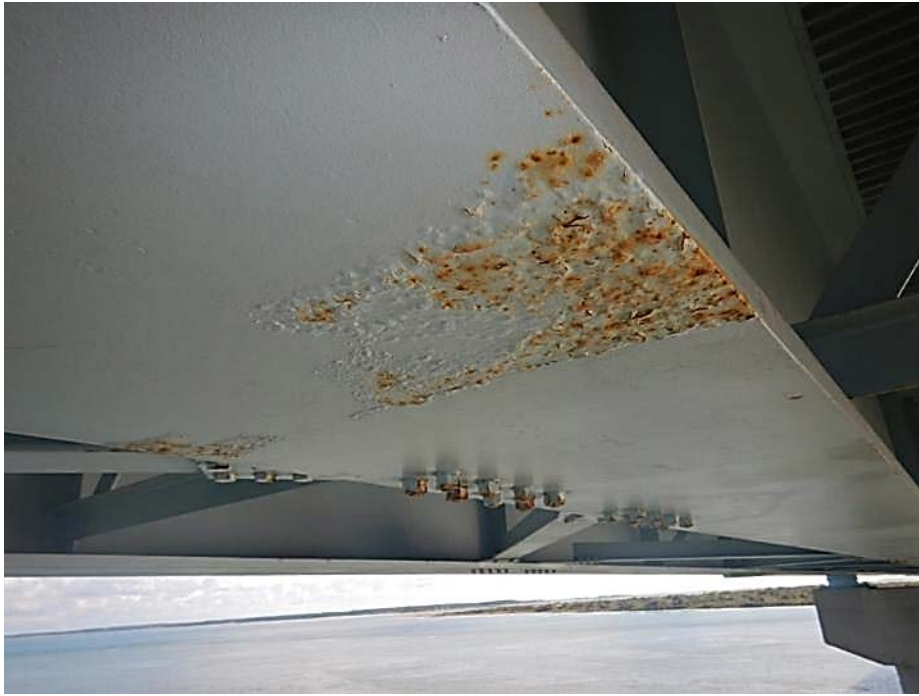
Photo 8.8-7: NCB-SB Span 9 Girder 2 – Top Protective Coating Bubbling with Freckled Rust (Looking Northwest)

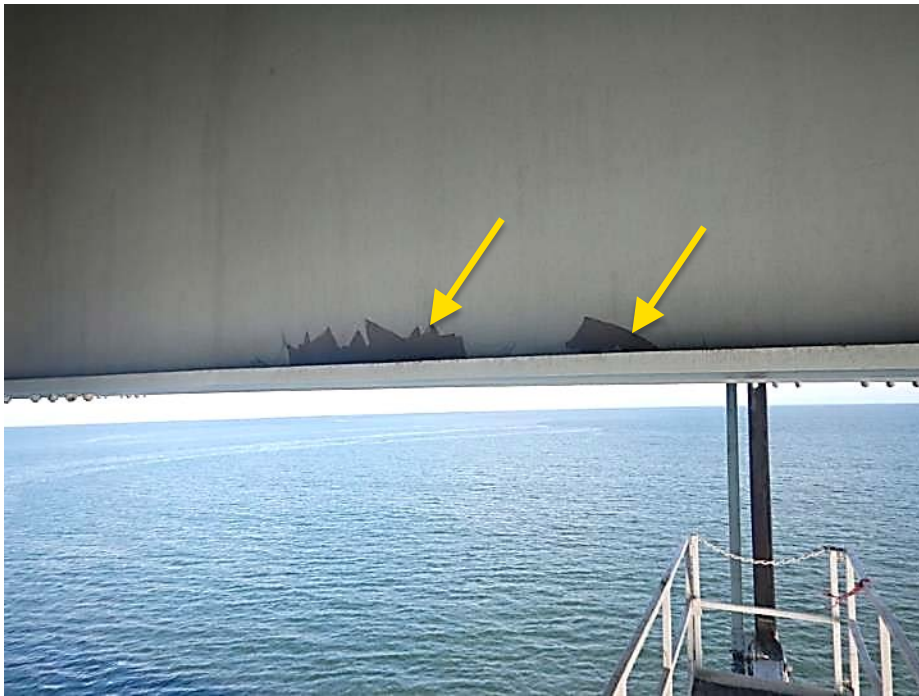
Photo 8.8-8: NCB-SB Span 12 Girder 2 – Top Protective Coating Peeled Off Exposing Zinc Primer (Looking West)

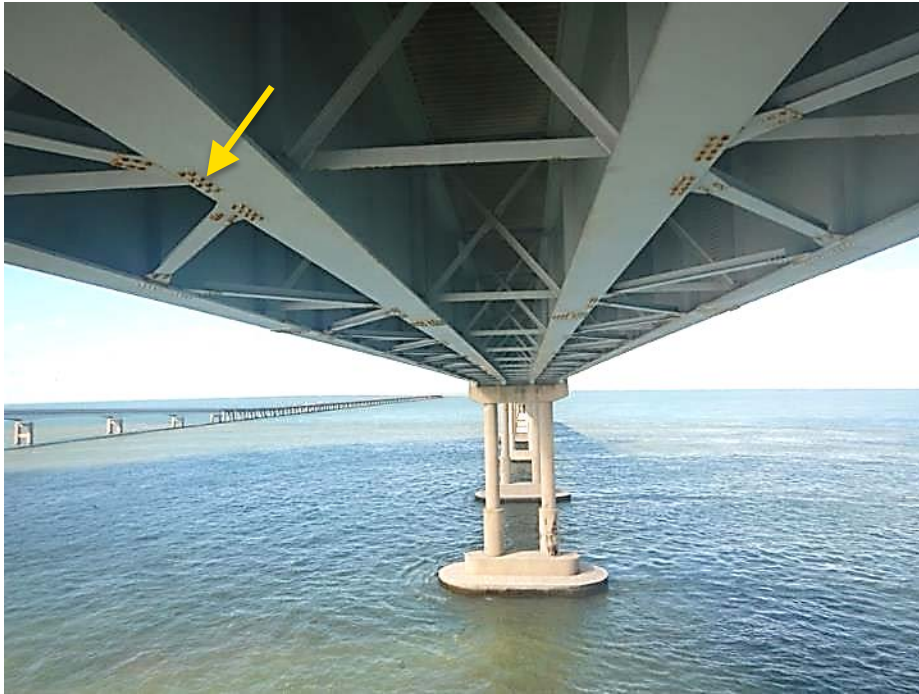
Photo 8.8-9: NCB-SB Span 8 Bracing – Typical Freckled Rust at Connections (Looking South)

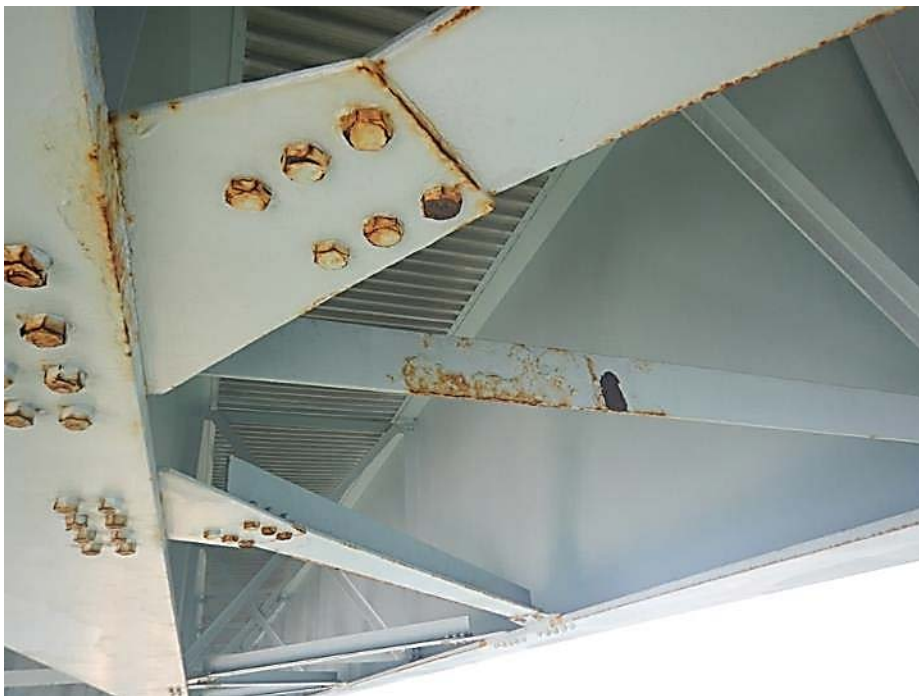
Photo 8.8-10: NCB-SB Span 8, Bay 1, Cross Frame 7 Bracing – Typical Freckled Rust at Connections and Paint Failure on Bracing (Looking Southwest)

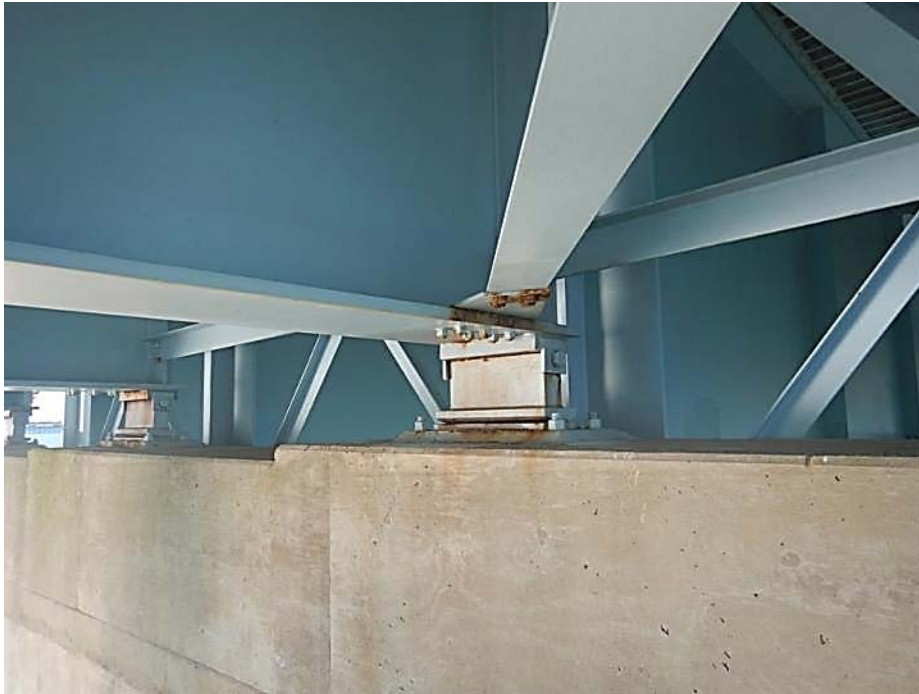
Photo 8.8-11: NCB-NB Pier 11 G2 Movable Bearing - Typical Condition of Isolated areas of Surface Rust (Looking Southeast)

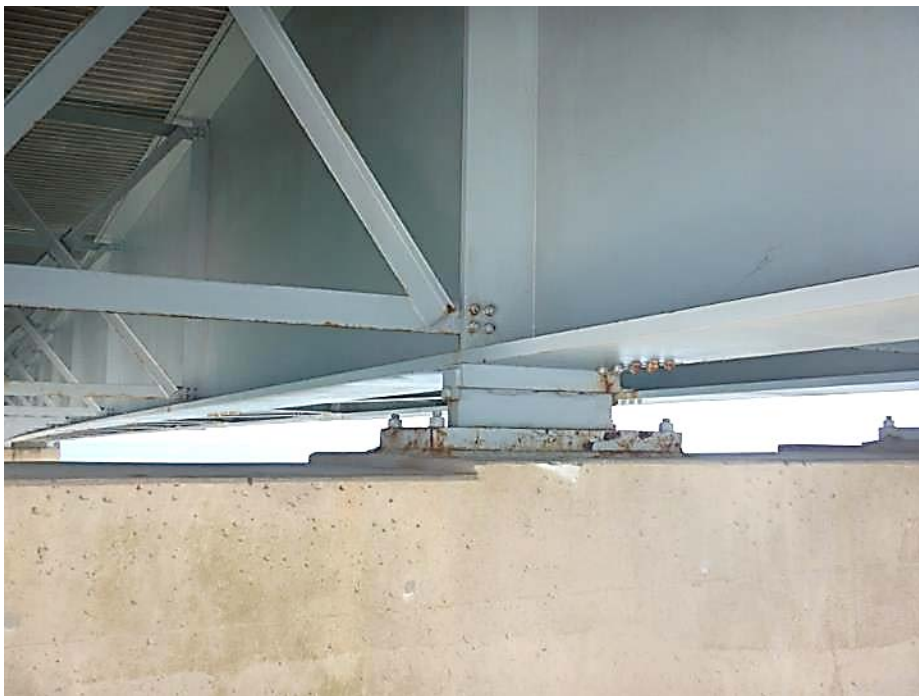
Photo 8.8-12: NCB-NB Pier 9 G2 Fixed Bearing - Typical Condition of Isolated areas of Surface Rust (Looking Southwest)

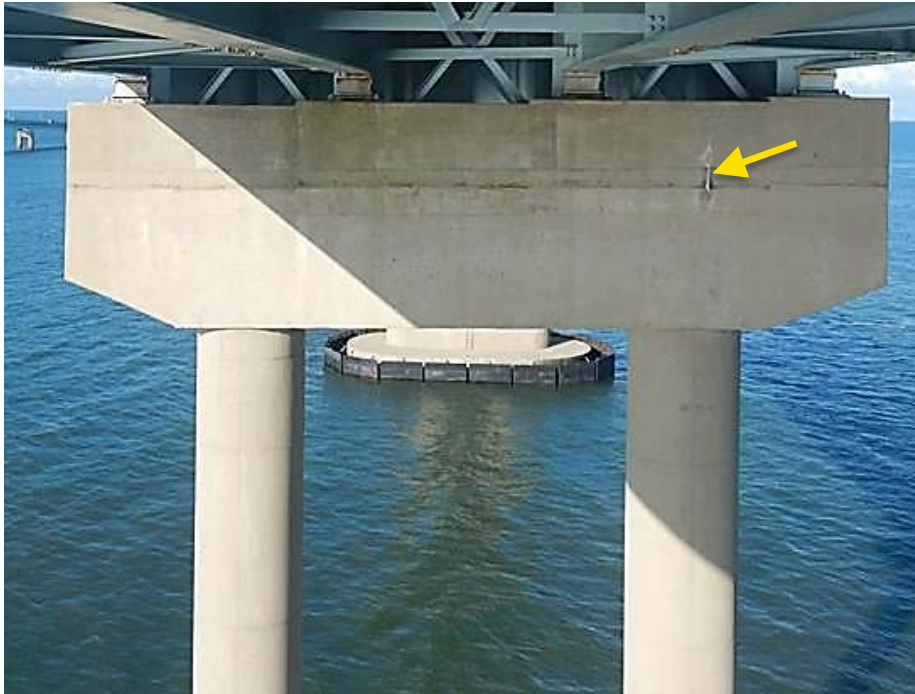
Photo 8.8-13: NCB-SB Pier 11 Reinforced Concrete Pier Cap and Columns - Minor Cracking with Efflorescence (Looking South)

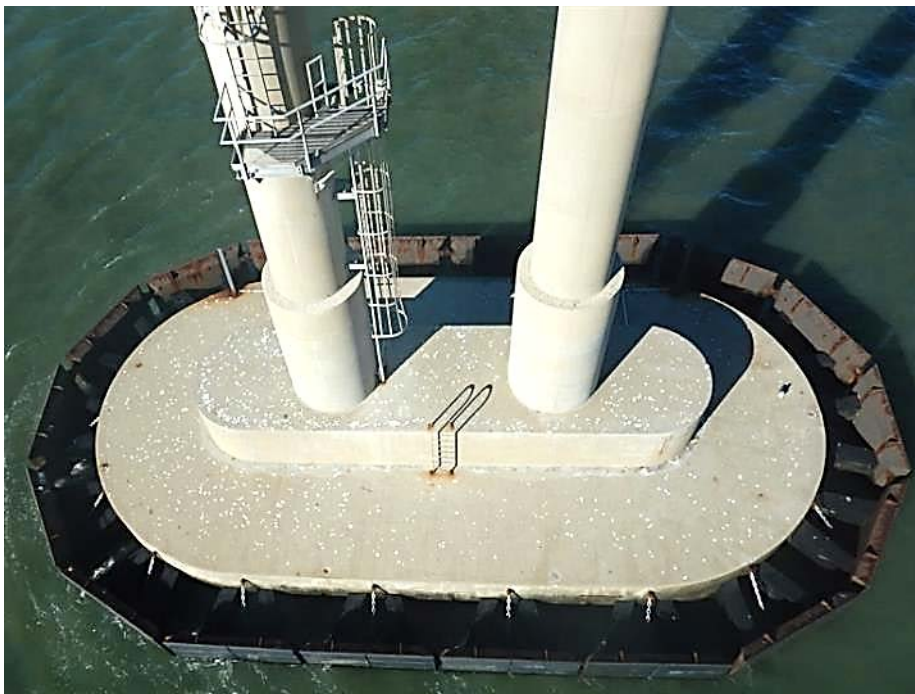
Photo 8.8-14: NCB-SB Pier 10 Reinforced Concrete Pile Cap/Footing and Columns - Minor Cracking with Efflorescence/Rust Staining (Looking South)

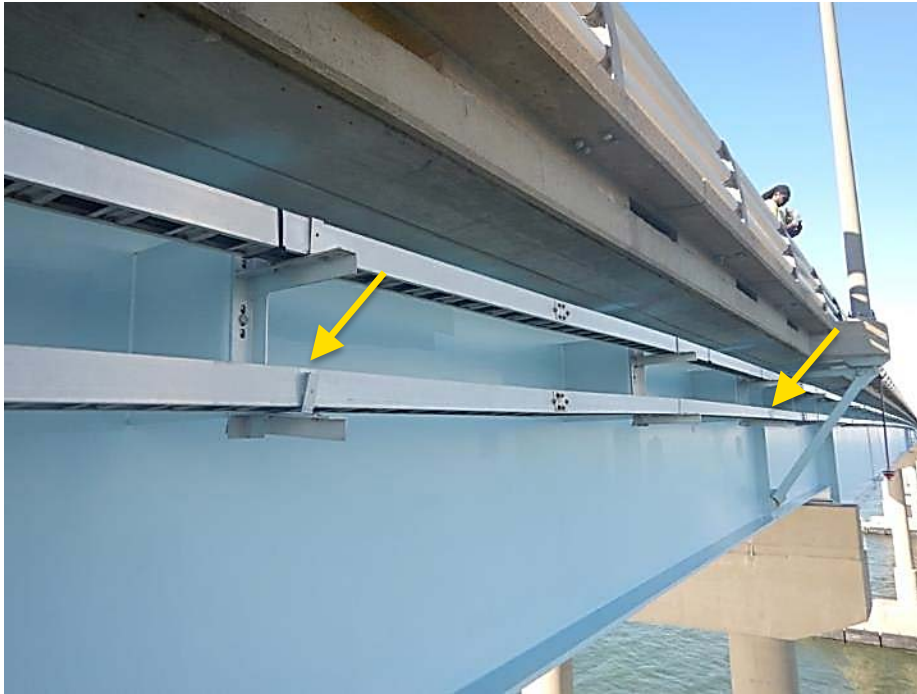
Photo 8.8-15: NCB-SB Span 11 Cable Tray – Lower Cable Tray Detached at 2 Clips Adjacent to Light Pole (Looking Southeast)

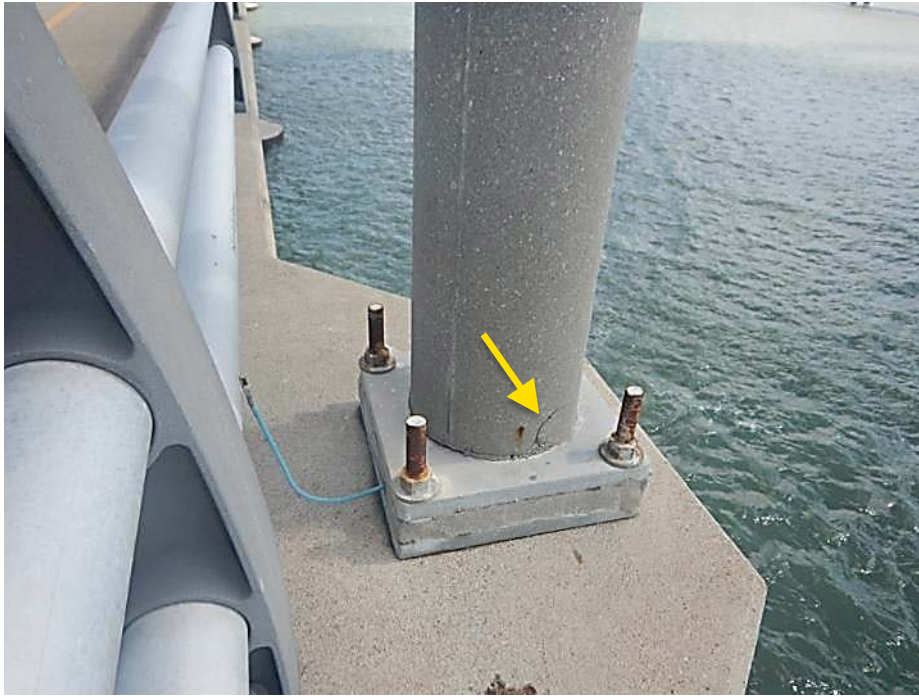
Photo 8.8-17: NCB-SB Span 2 Southeast Light Pole – Cracking at Baseplate (Looking Northeast)

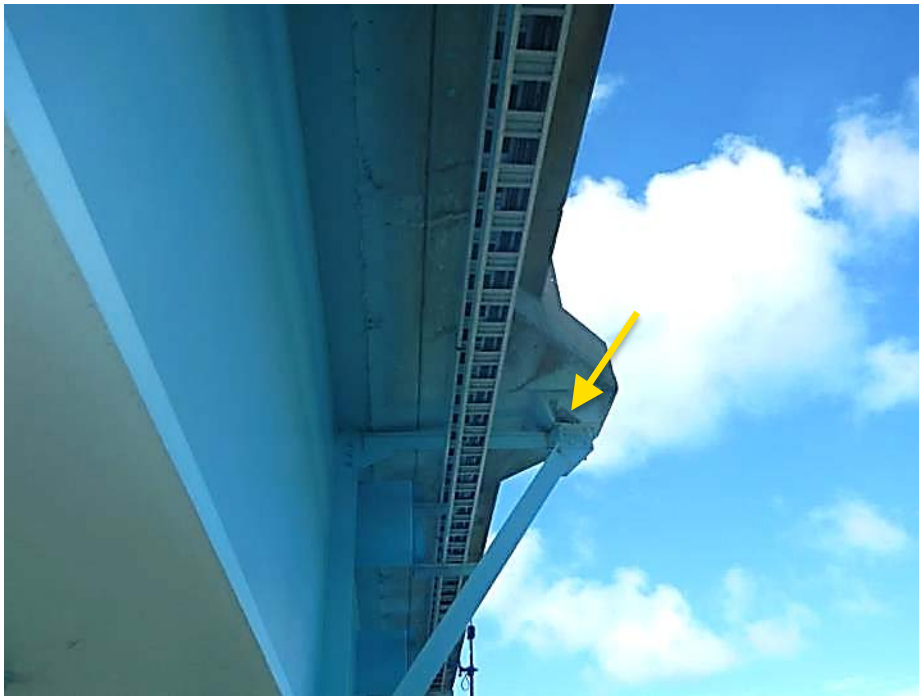
Photo 8.8-18: NCB-SB Span 5 Light Pole – Concrete Support Pedestal Spalled with Exposed Reinforcement (Looking Southwest)

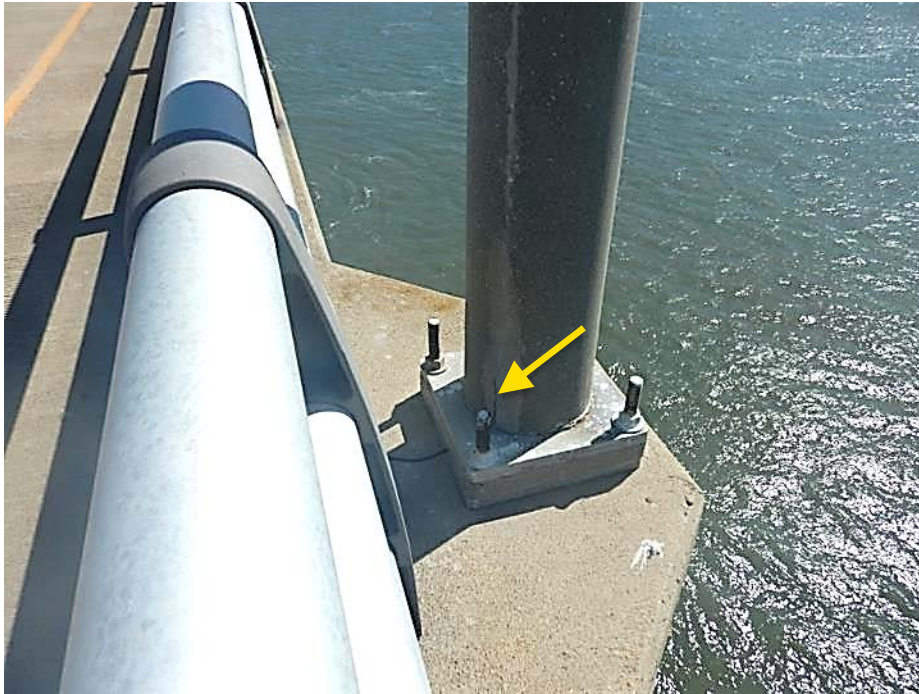
Photo 8.8-19: NCB-SB Span 6 Southeast Light Pole – Cracking at Baseplate (Looking Northeast)

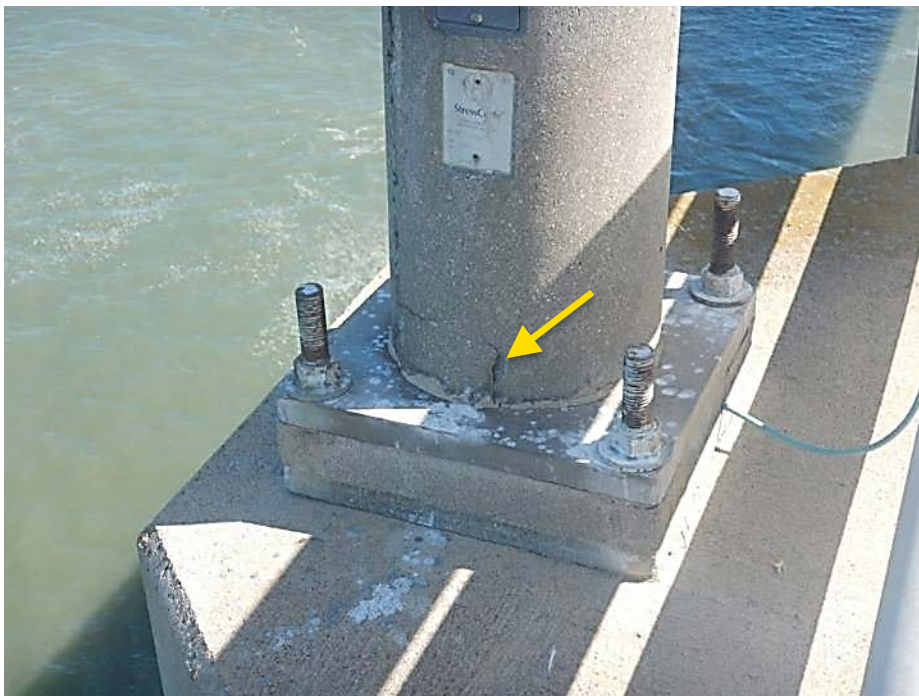
Photo 8.8-20: NCB-SB Span 6 Northwest Light Pole – Cracking and Delamination at Baseplate (Looking Northwest)

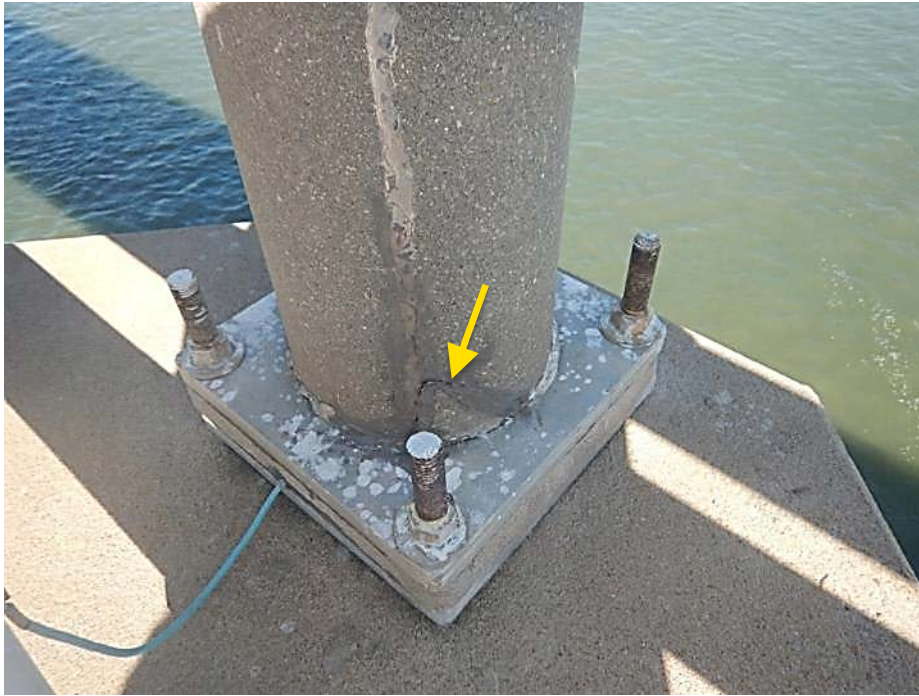
Photo 8.8-21: NCB-SB Span 9 Light Pole – Cracking at Baseplate was Previously Filled and Crack Has Reappeared (Looking Southwest)

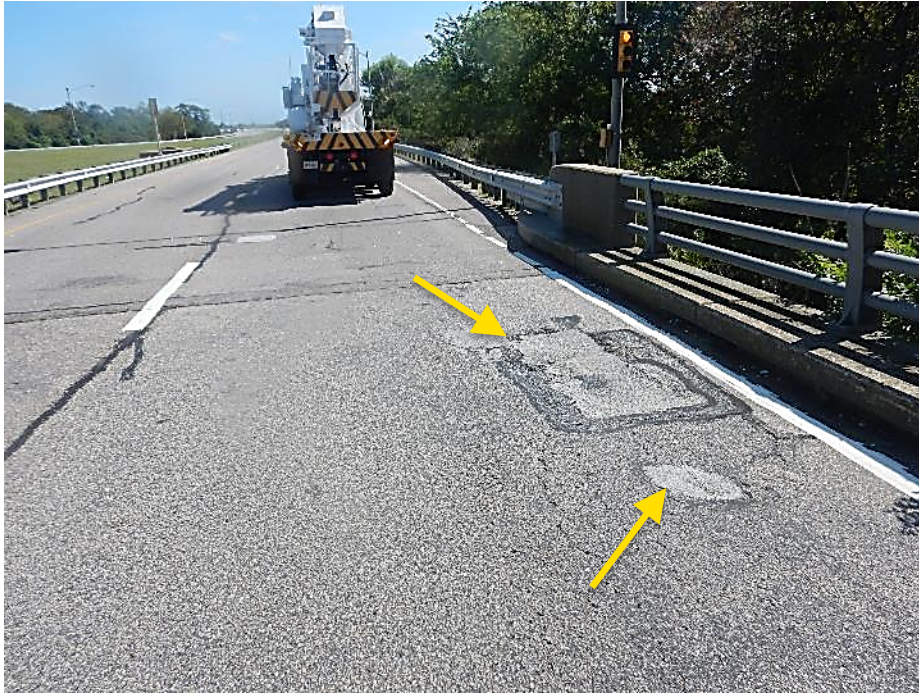
Photo 8.9-1: DNB18 Asphalt Wearing Surface – Repair Areas and Minor Cracking (Looking Northeast)

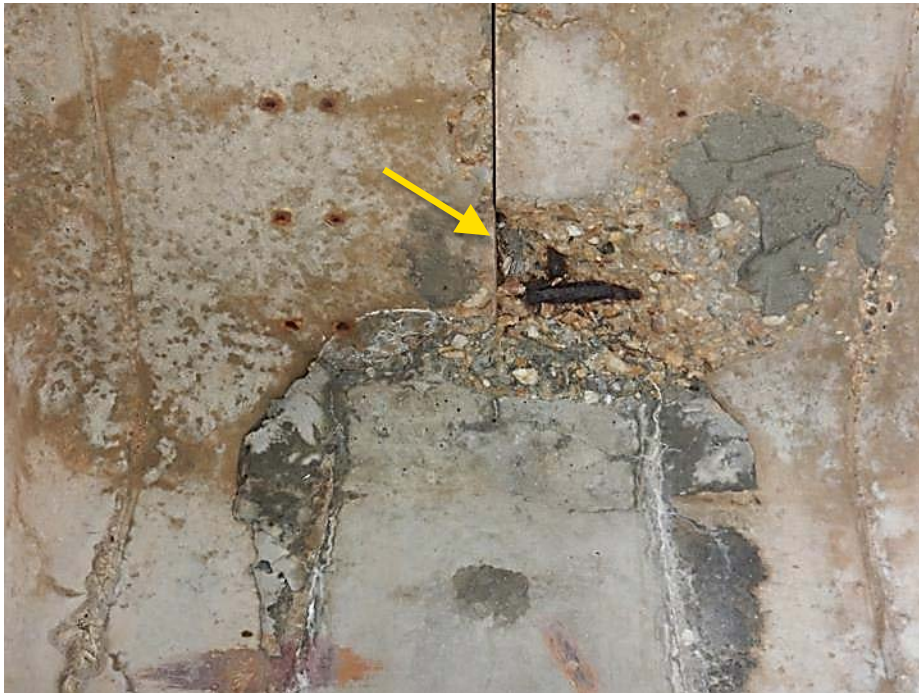
Photo 8.9-2: DNB1 Reinforced Concrete Top Flange (Underside) - Spall with Exposed Reinforcing in Zone 1 between Girder 4 and Girder 5 (Looking South)

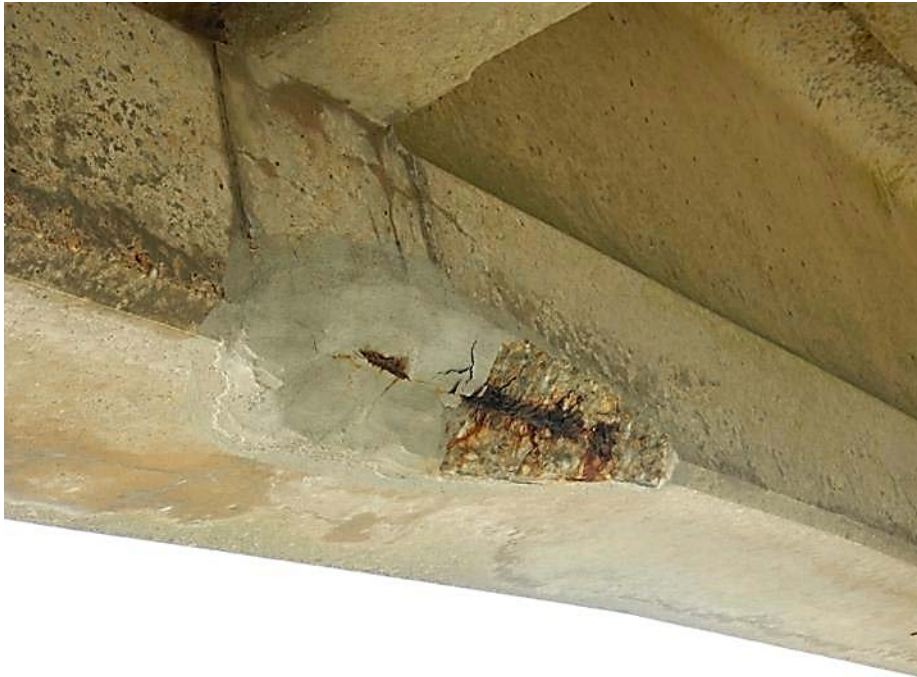
Photo 8.9-3: DNB1 Girder 1 - Failed Repair in Zone 1 with 1 Exposed Prestressing Strands (Looking Southeast)

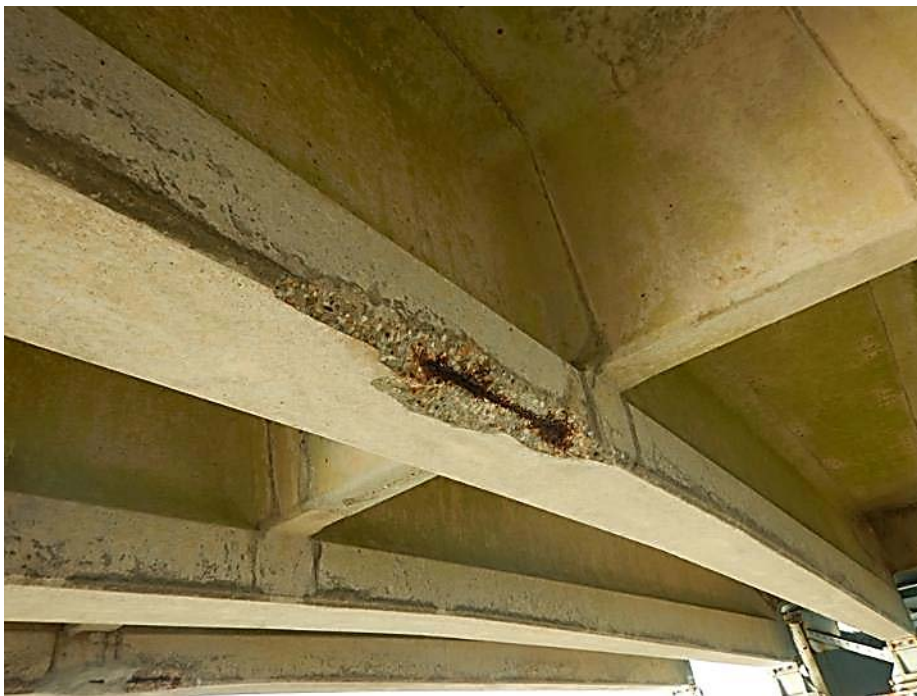
Photo 8.9-4: DNB1 Girder 3 - Spall with 1 Exposed Prestressing Strand (Looking Southeast)

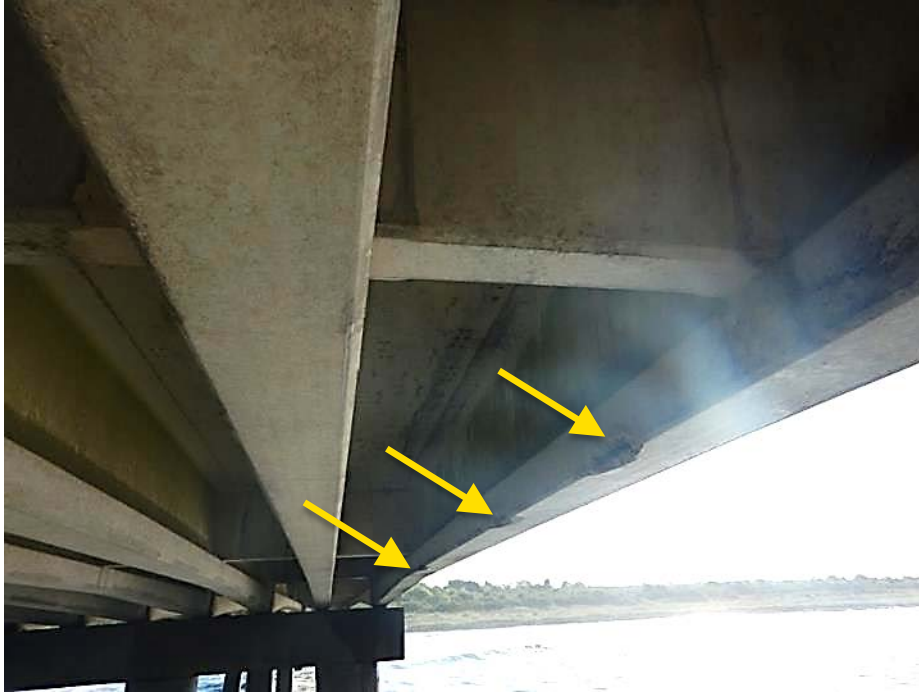
Photo 8.9-5: DNB2 Girder 1 – 3 Spall Locations with 1 Exposed Prestressing Strand (Looking Northeast)

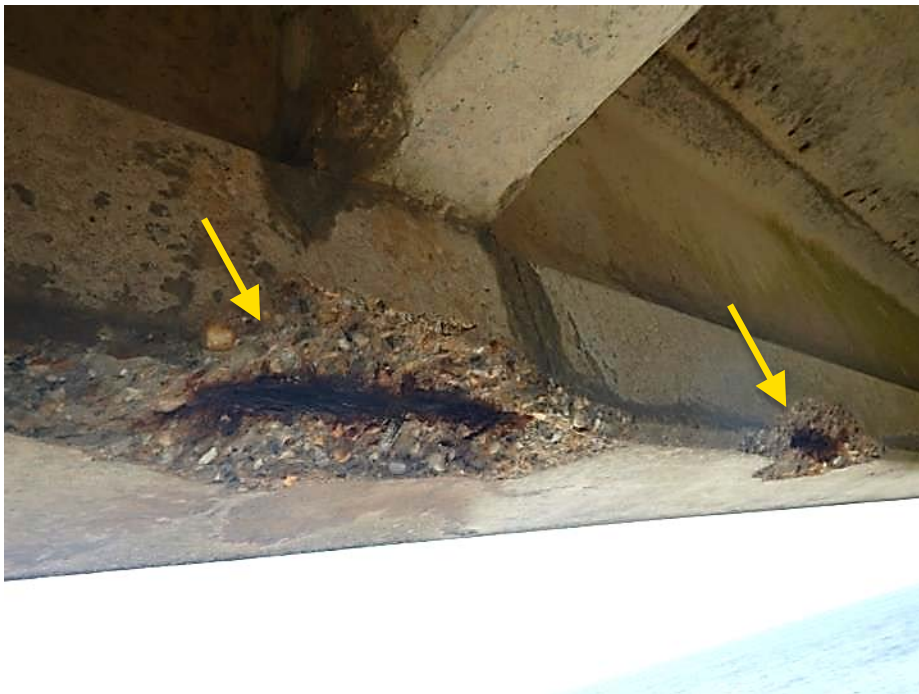
Photo 8.9-6: DNB3 Girder 3 – 2 Spall Locations with 1 Exposed Prestressing Strand (Looking Southeast)

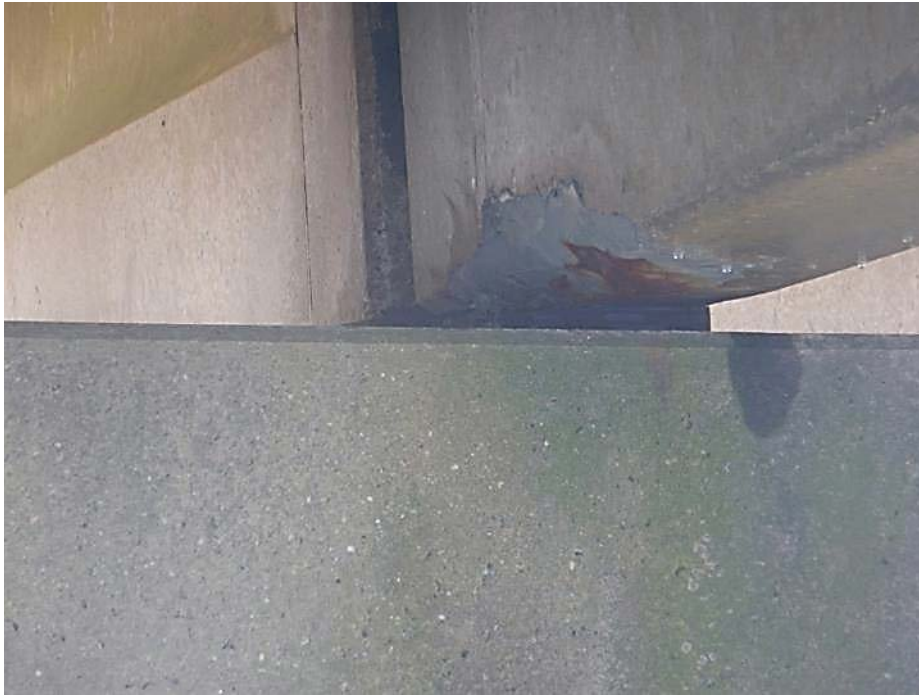
Photo 8.9-7: DNB5 Girder 5 – Failed Repair at Bearing (Looking Northeast)

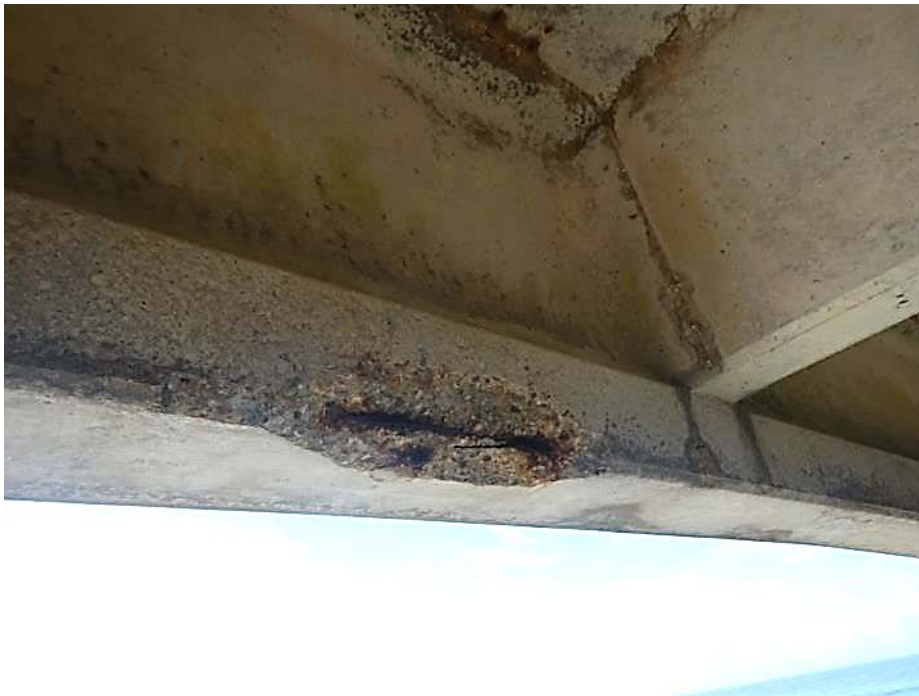
Photo 8.9-8: DNB7 Girder 1 – Spall with 1 Exposed Prestressing Strand (Looking Southeast)

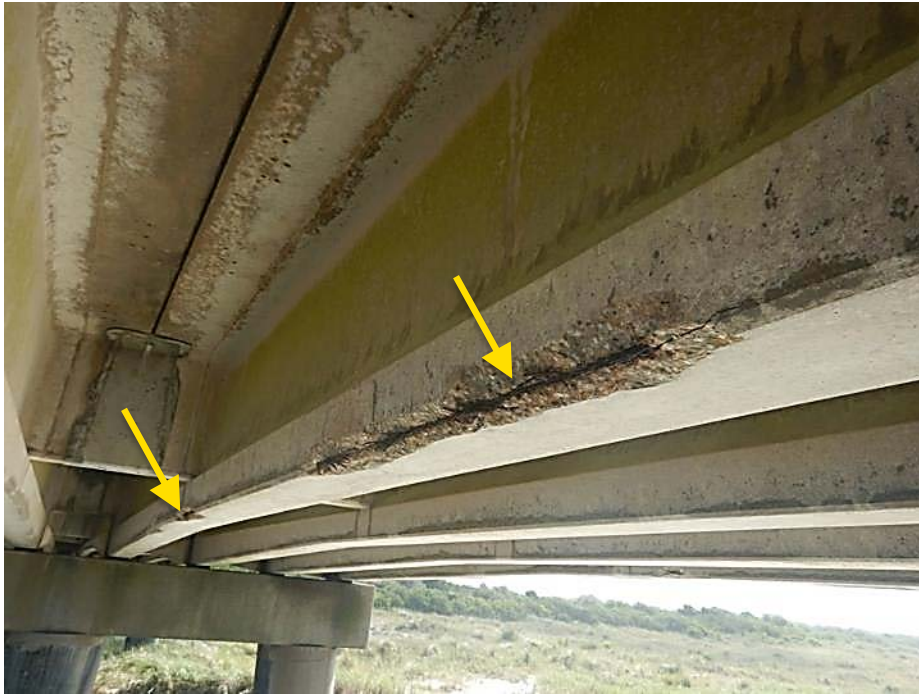
Photo 8.9-9: DNB7 Girder 4 – 2 Spall Locations with 1 Exposed Prestressing Strand (Looking Northeast)

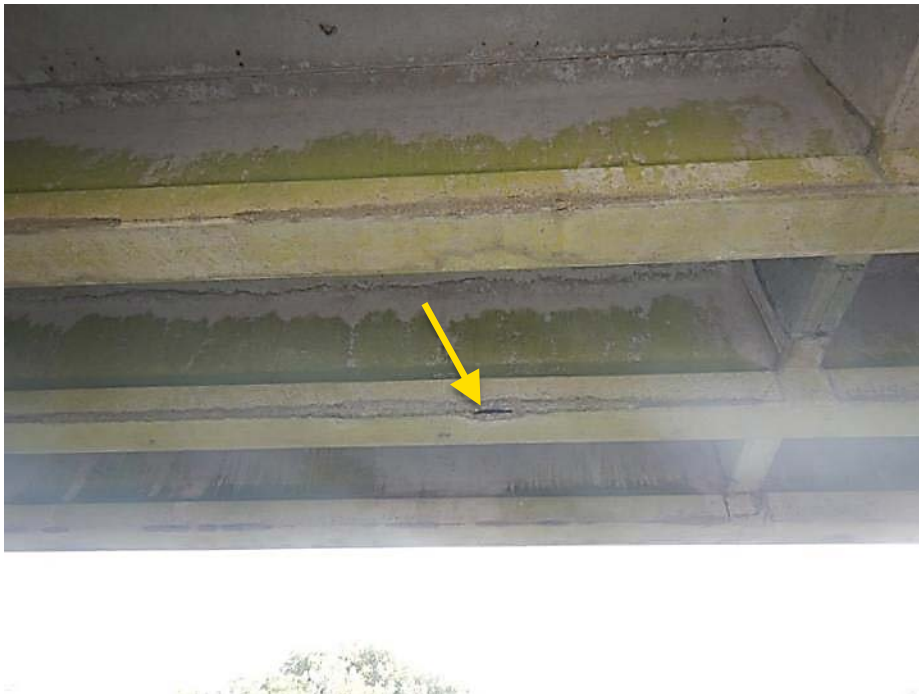
Photo 8.9-10: DNB11 – Girder 2 – Spall with 1 Exposed Prestressing Strand (Looking East)

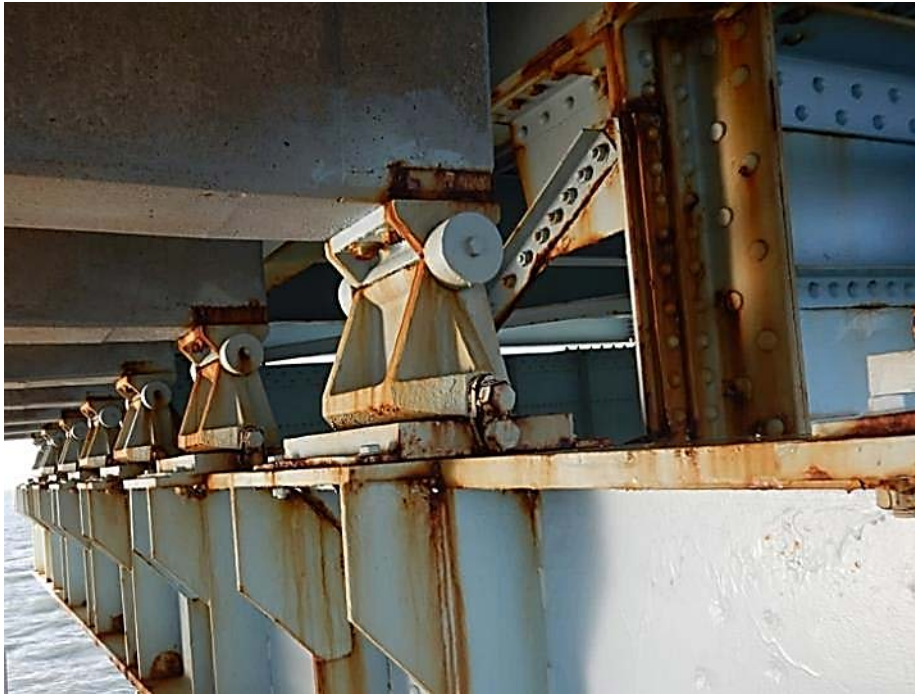
Photo 8.9-11: DNB1 – Rocker Bearings with Minor Paint Failure, Rust Staining, and Relatively No Section Loss (Looking Southeast)

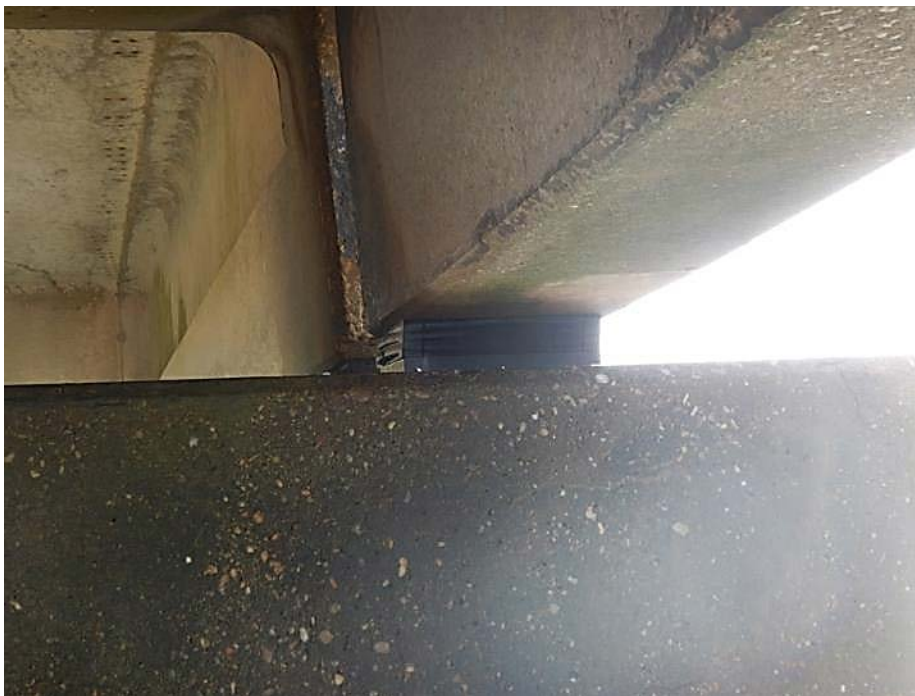
Photo 8.9-12: DNB1 Girder 1 – Elastomeric Bearing Bulging Greater than 15% of Thickness (Looking North)

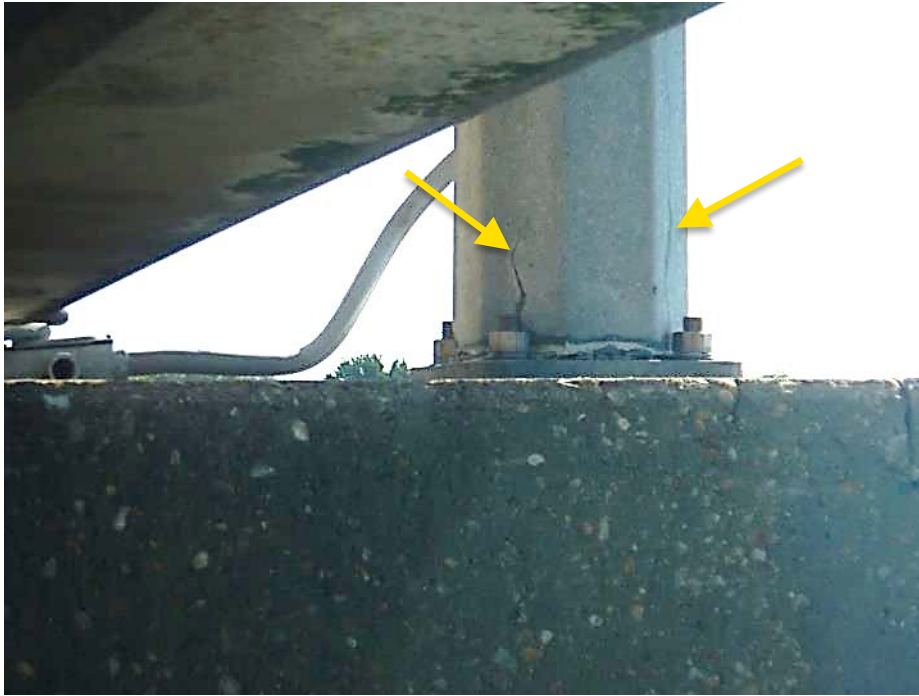
Photo 8.9-13: DNB5 Light Pole – Cracking at Baseplate (Looking Northeast)
