FY2019 Annual Inspection and Underwater Inspection, Trestle A'NB, ANB, & ASB

Chesapeake Bay Bridge and Tunnel District

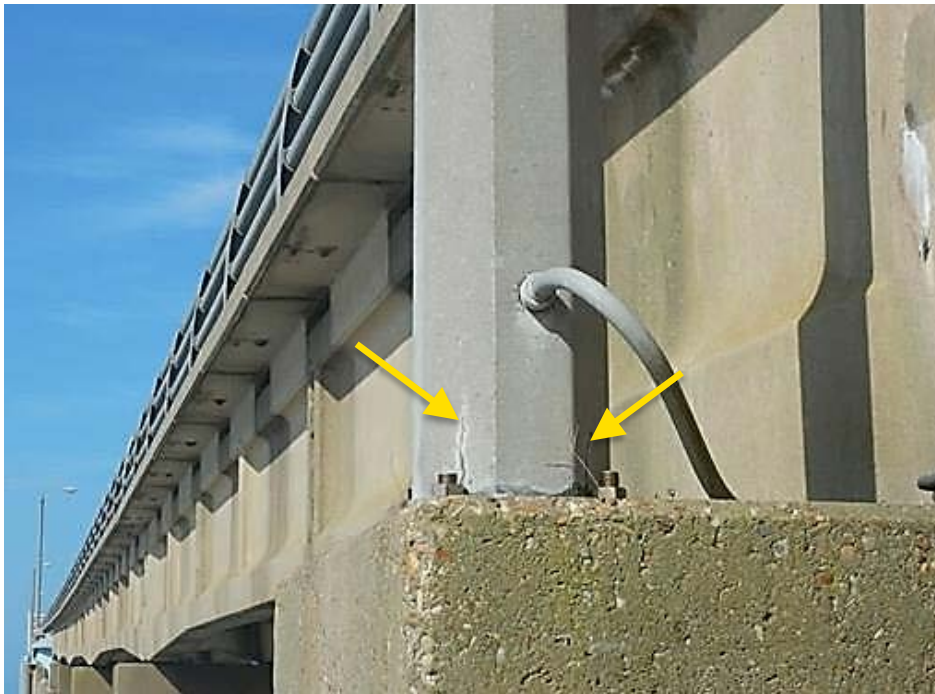
Photo 8.9-14: DNB5 Light Pole – Cracking at Baseplate (Looking Southwest)

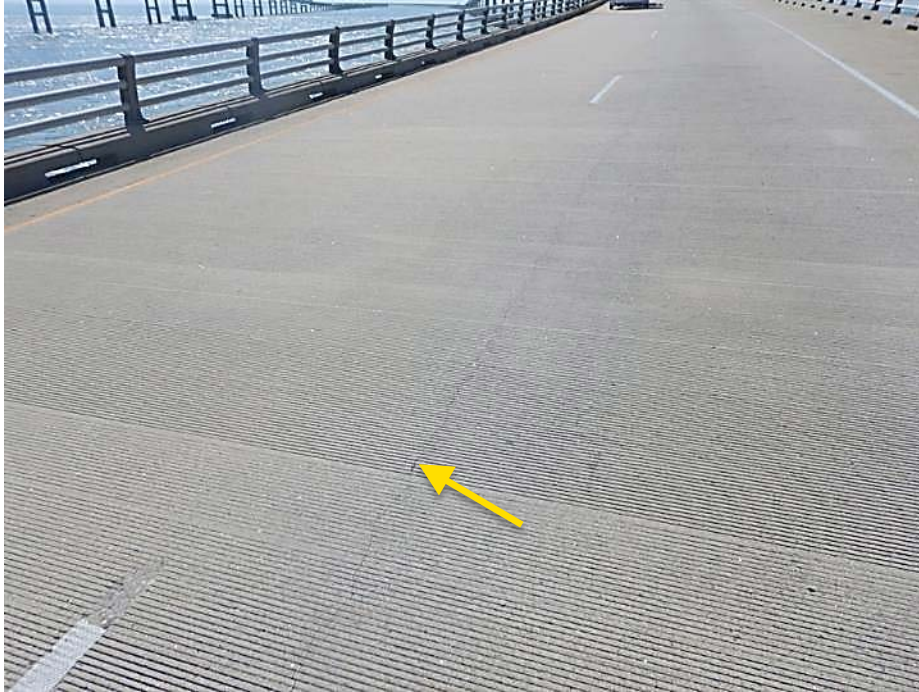
Photo 8.10-1: DSB9 Concrete Deck – Narrow Width Longitudinal Crack, Full Span Length (Looking Southeast)

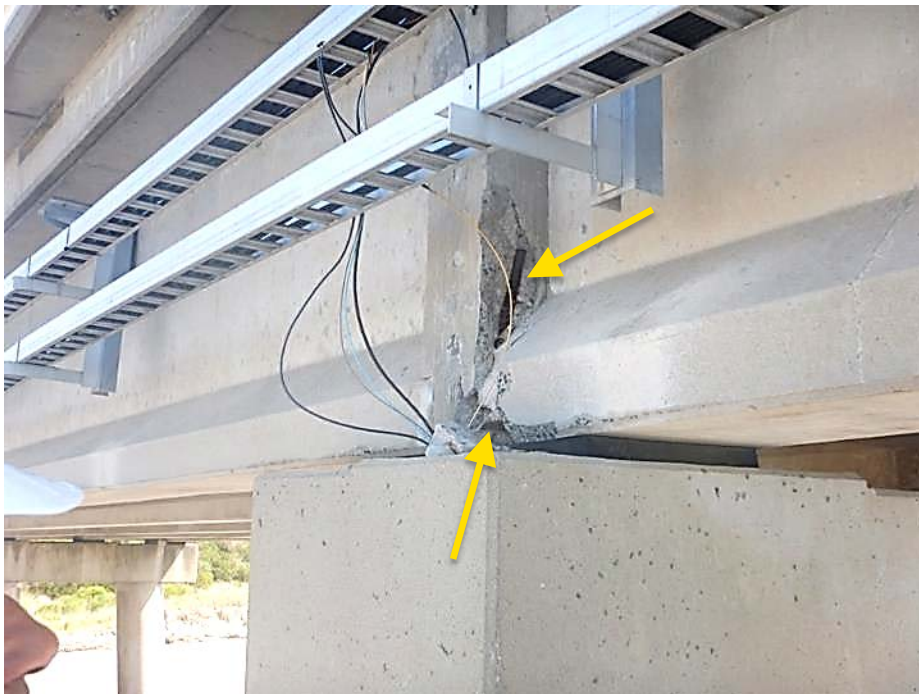
Photo 8.10-2: DSB11 Girder 1 – Spalling at Closure Diaphragm with Exposed Reinforcement and Prestressing Strand (Looking Northeast)

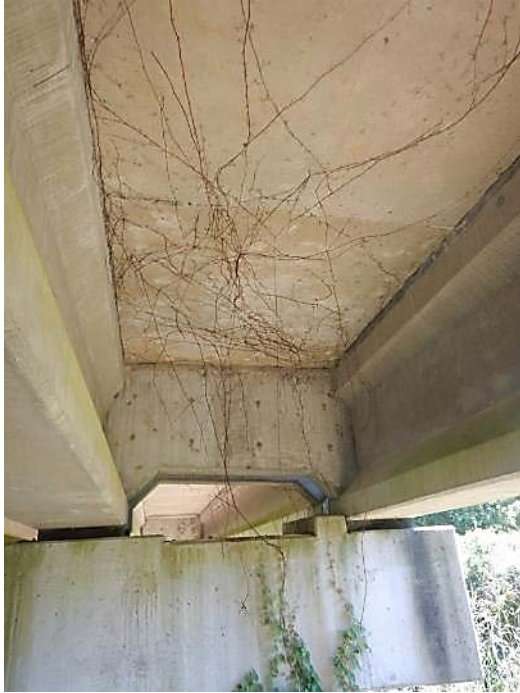
Photo 8.10-3: DSB18 Bay 4 – Vegetation on Pile Cap, Diaphragm, Girders, and Deck Underside (Looking North)

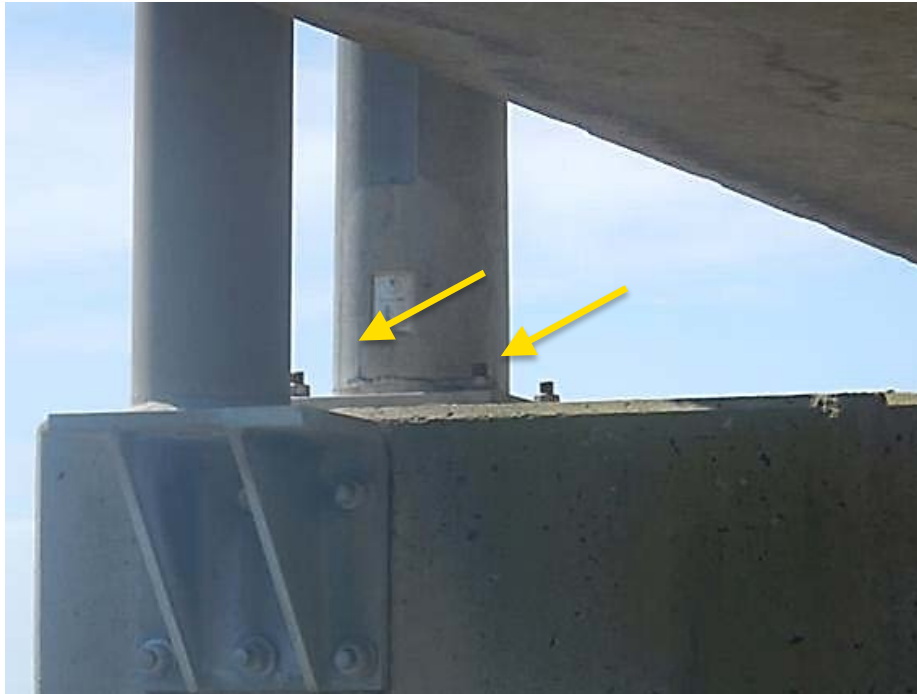
Photo 8.10-5: DSB11 Light Pole – Vertical Cracking Near Baseplate (Looking Southeast)

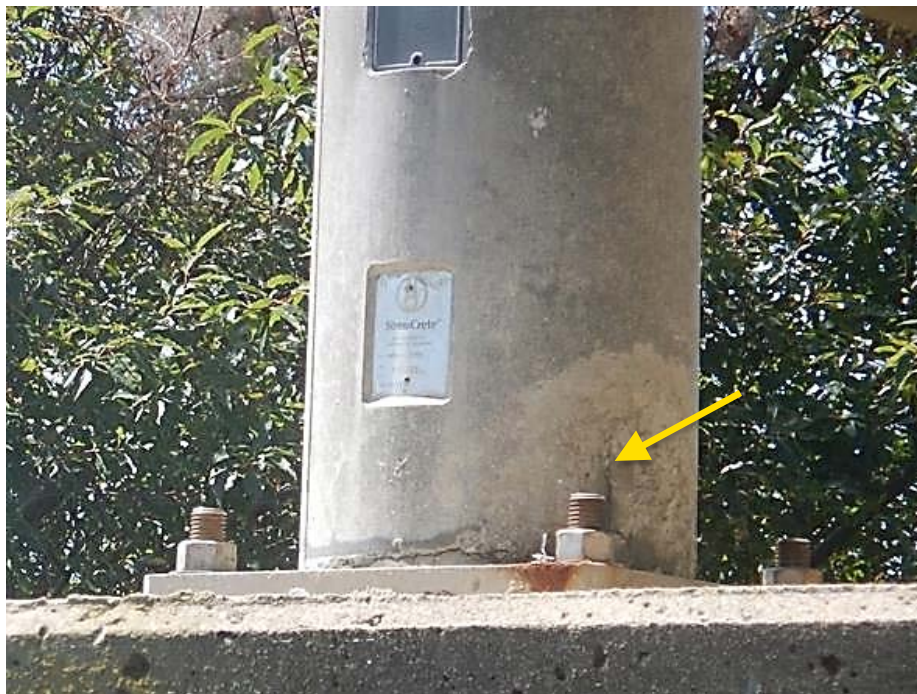
Photo 8.10-6: DSB15 Light Pole – Delamination and Vertical Cracking Near Baseplate (Looking Northwest)

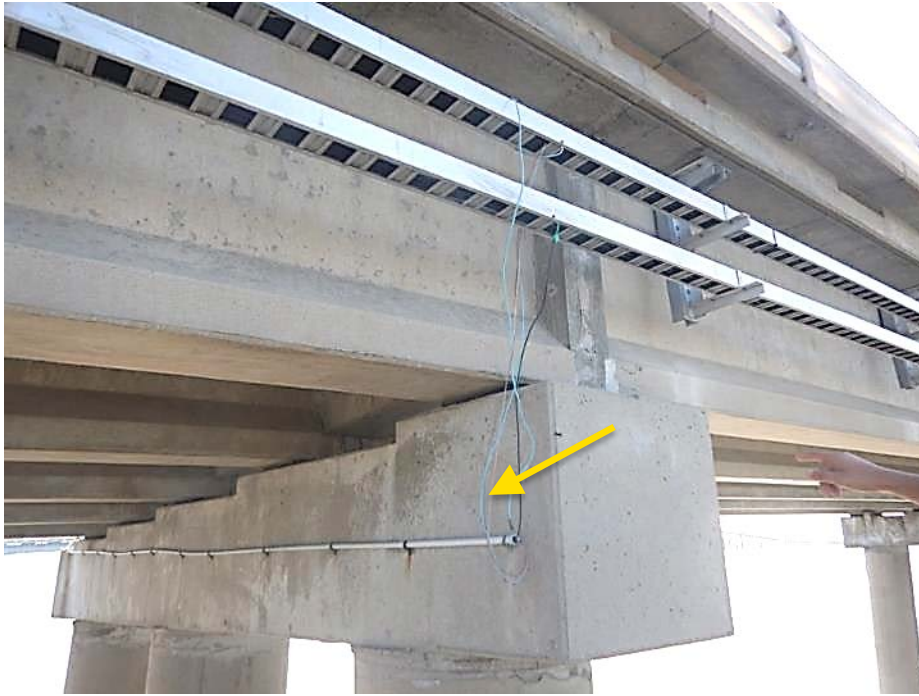
Photo 8.10-7: DSB7 Cable Tray – Blue Cable Disconnected (Looking Southeast)

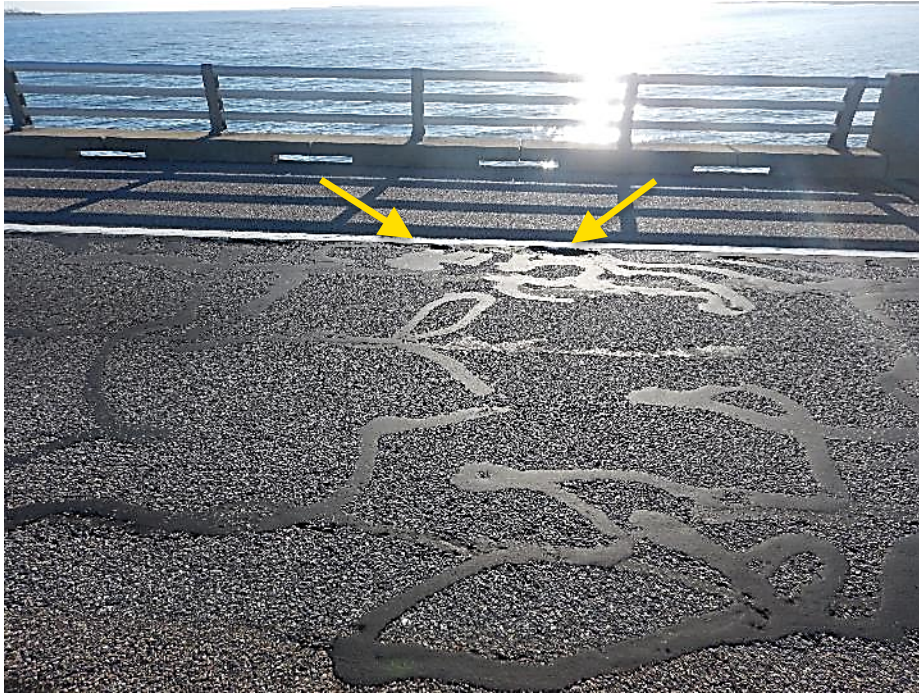
Photo 8.11-1: ENB1 Asphalt Wearing Surface - Good Seal Repair of Cracks and Surface Spalls at Striping Patch (Looking East)

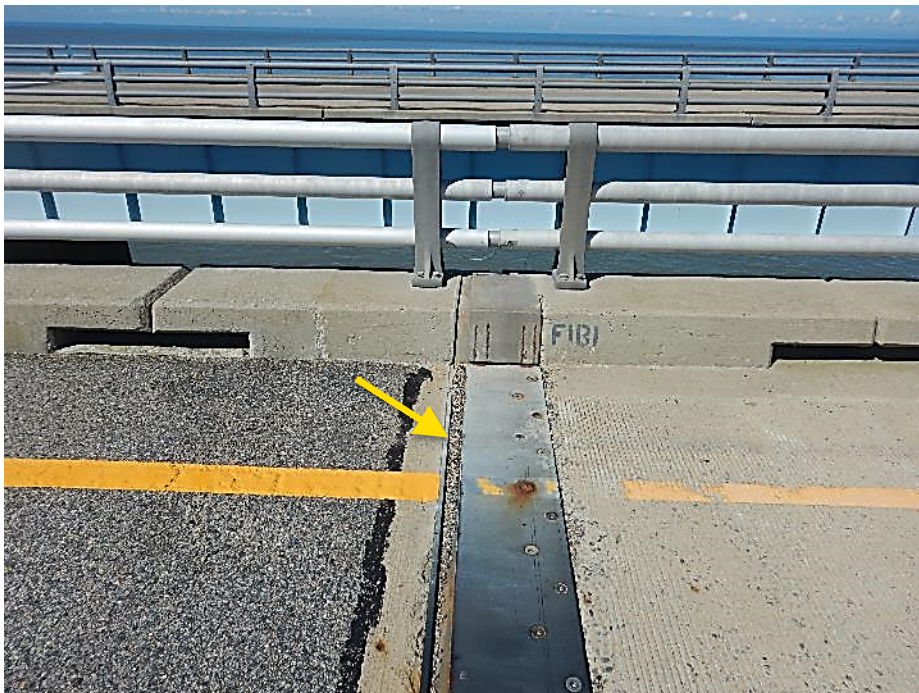
Photo 8.11-2: FIB1 Assembly Joint without Seal - Sliding Plate Expansion Joint Loose Debris Present in Joint (Looking West)

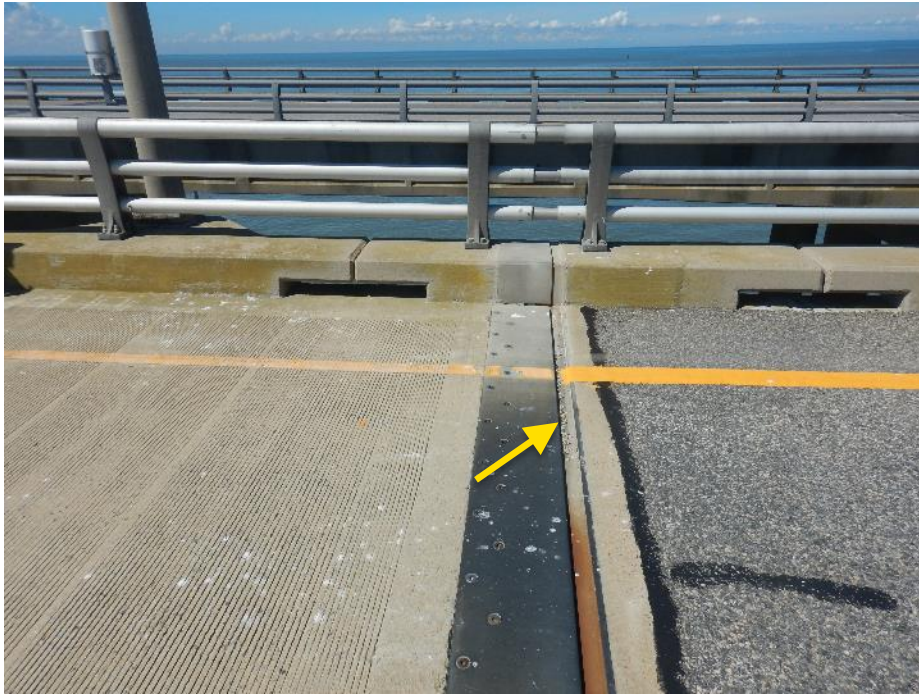
Photo 8.11-3: FIB4 Assembly Joint without Seal - Sliding Plate Expansion Joint Loose Debris Present in Joint (Looking West)

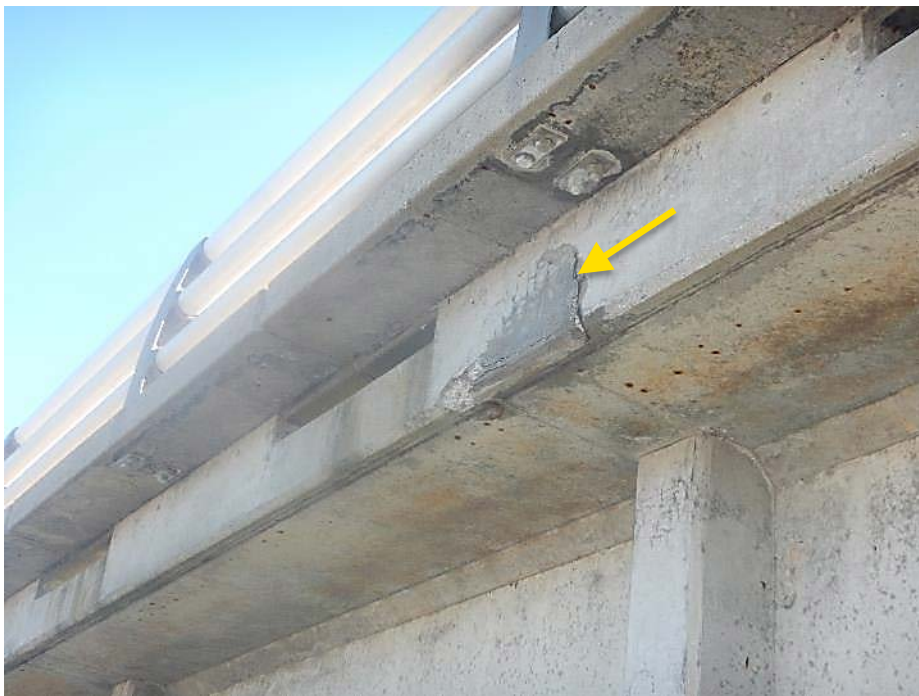
Photo 8.11-4: ENB6 Reinforced Concrete Deck – Delamination (Looking Northeast)

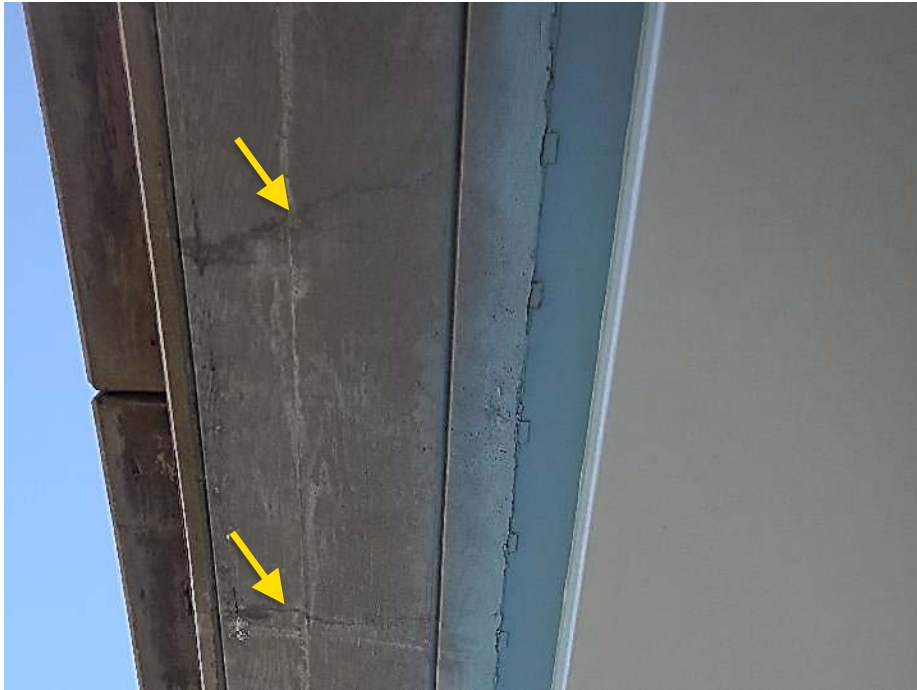
Photo 8.11-5: FIB-NB1 Reinforced Concrete Deck – Typical Minor Cracking along Edge Spaced at About 3-feet (Looking North)

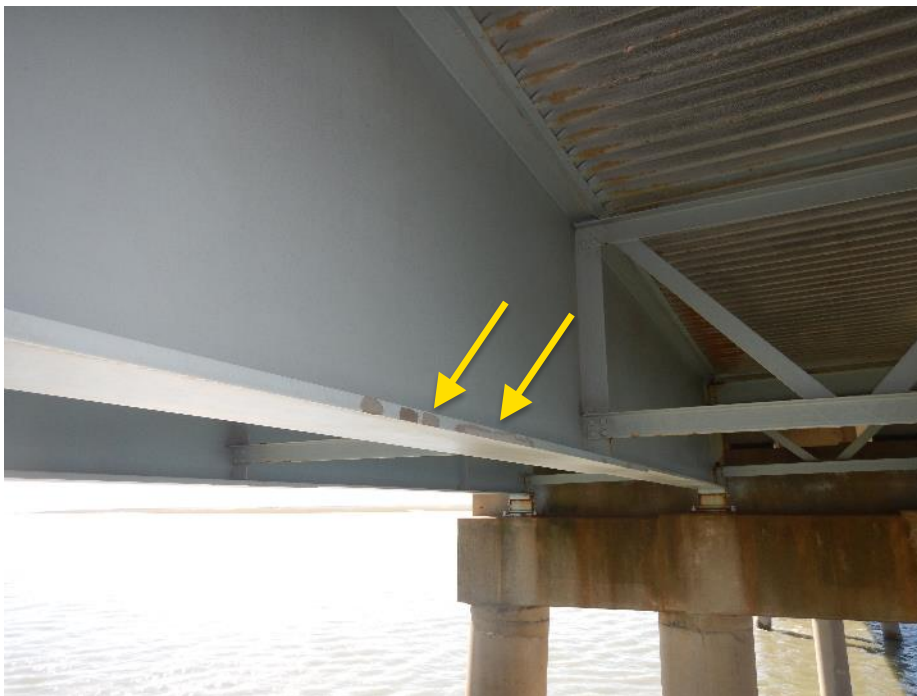
Photo 8.11-6: NCB-SB Span 1 Girder 2 – Top Protective Coating Peeled Off Exposing Zinc Primer (Looking Southeast)

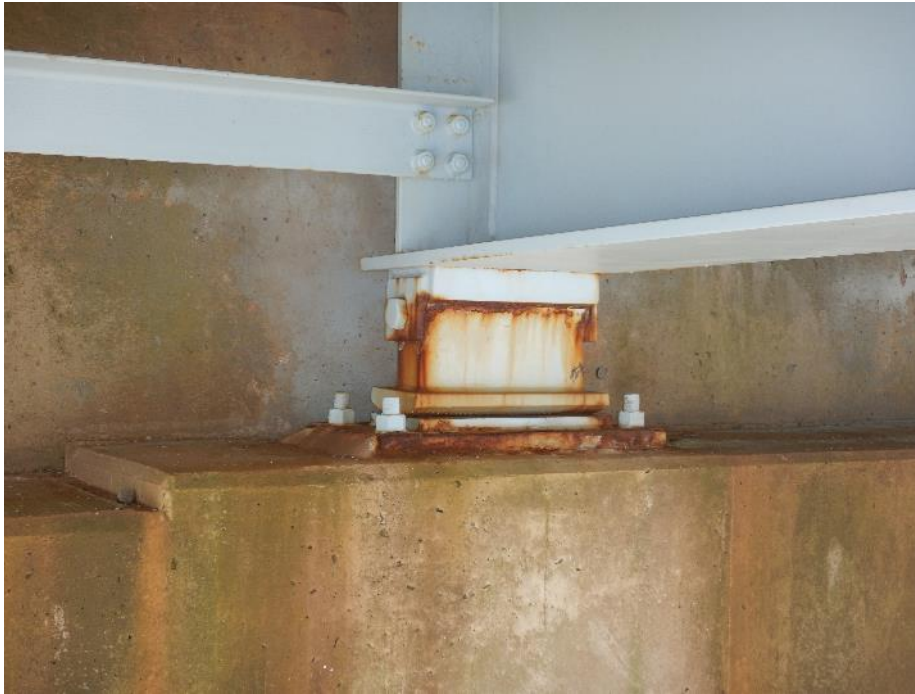
Photo 8.11-7: FIB-NB Pier 1 G3 Movable Bearing - Typical Condition of Isolated areas of Surface Rust (Looking Southwest)

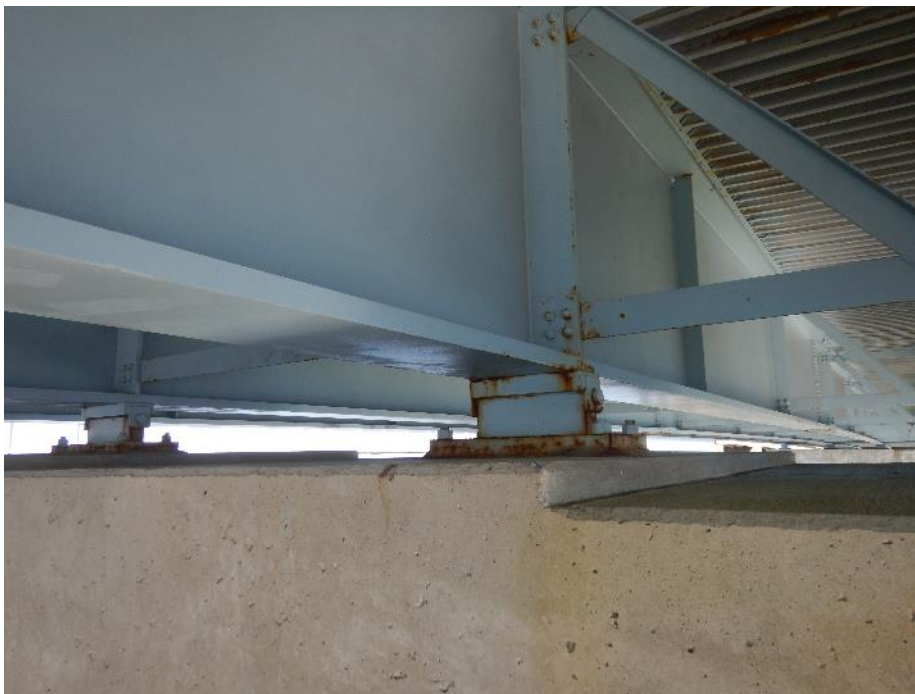
Photo 8.11-8: FIB-NB Pier 2 G2 Fixed Bearing - Typical Condition of Isolated areas of Surface Rust (Looking Northwest)

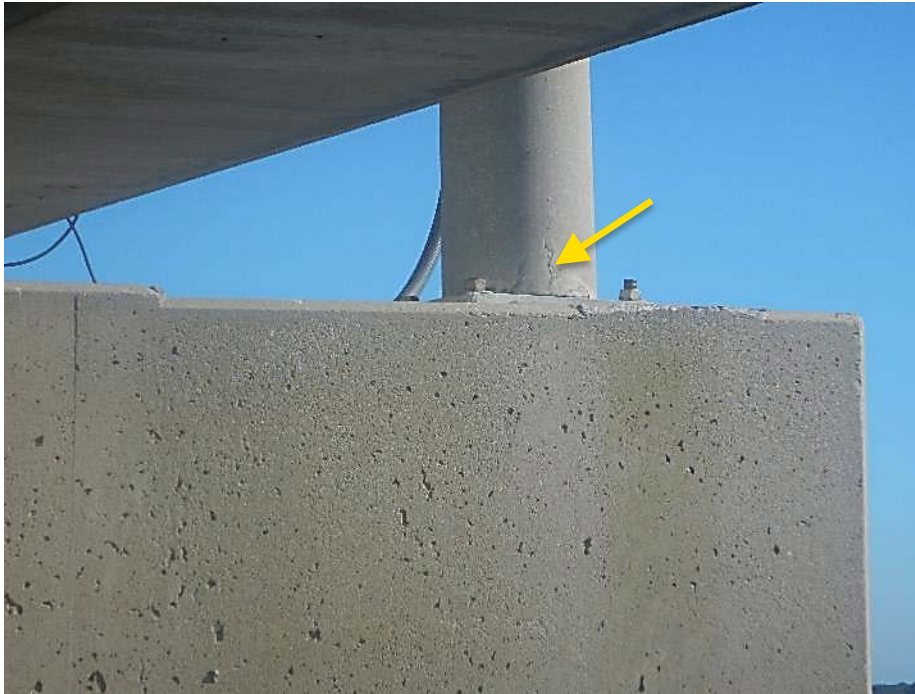
Photo 8.11-9: ENB8 Light Pole – Cracking at Baseplate (Looking Northeast)

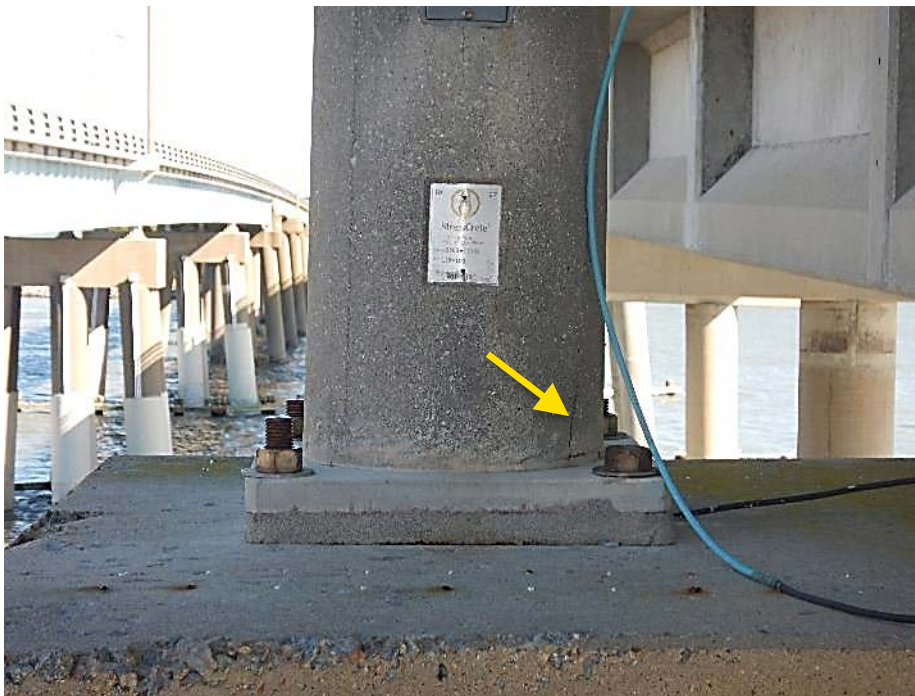
Photo 8.11-10: ENB10 Light Pole – Cracking at Baseplate (Looking North)

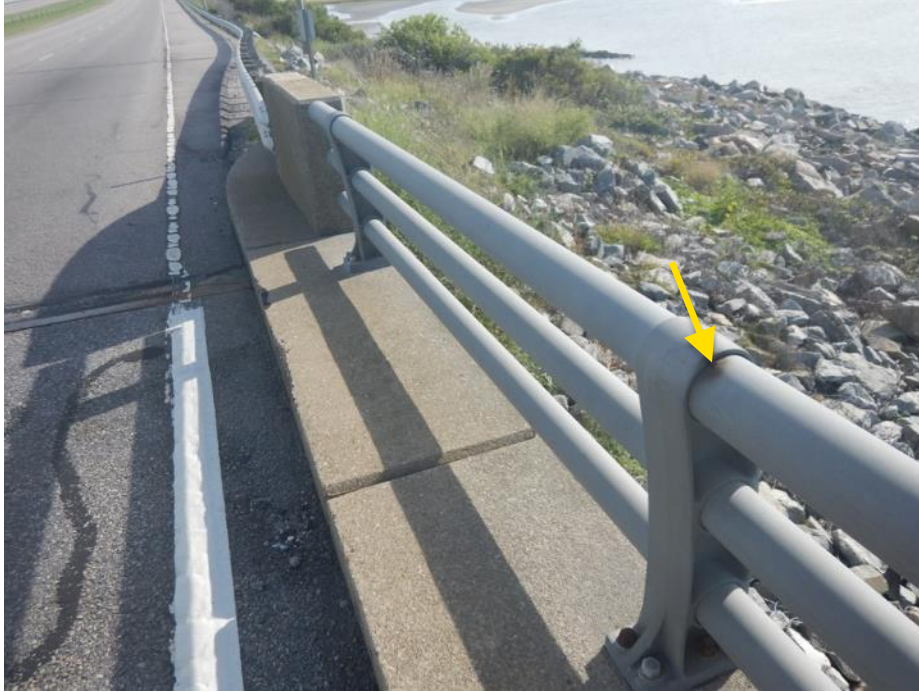
Photo 8.12-1: ESB1 Metal Bridge Railing - Corrosion on Top Rail at Post (Looking Southwest)

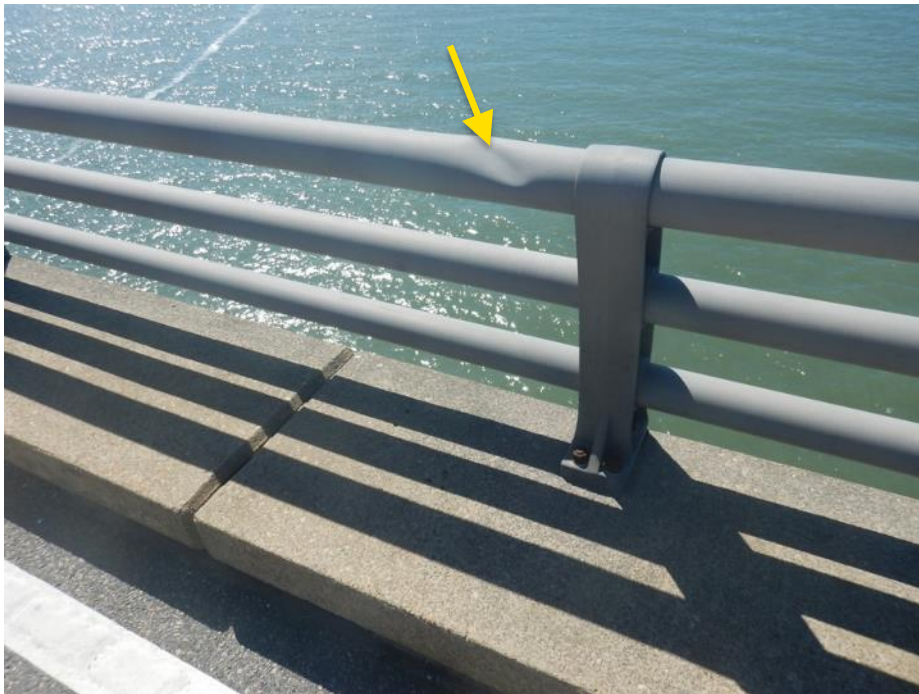
Photo 8.12-2: ESB13 Metal Bridge Railing 4th Span from the North - Impact Damage to Top Rail (Looking Southwest)

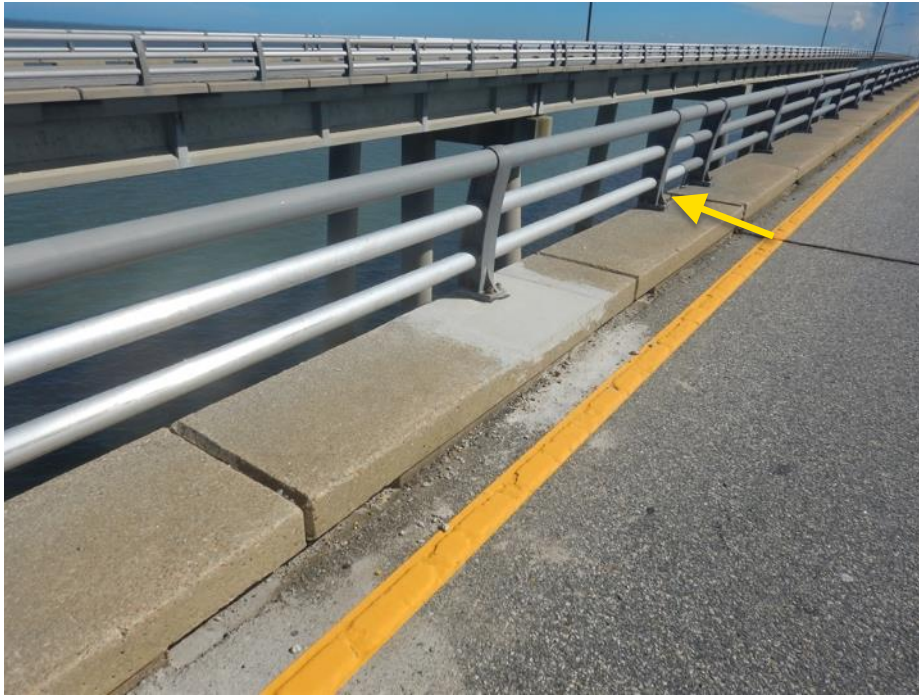
Photo 8.12-3: FSB6 Metal Bridge Railing - Disconnected Grounding Cable at Location of Recent Repair (Looking Southeast)

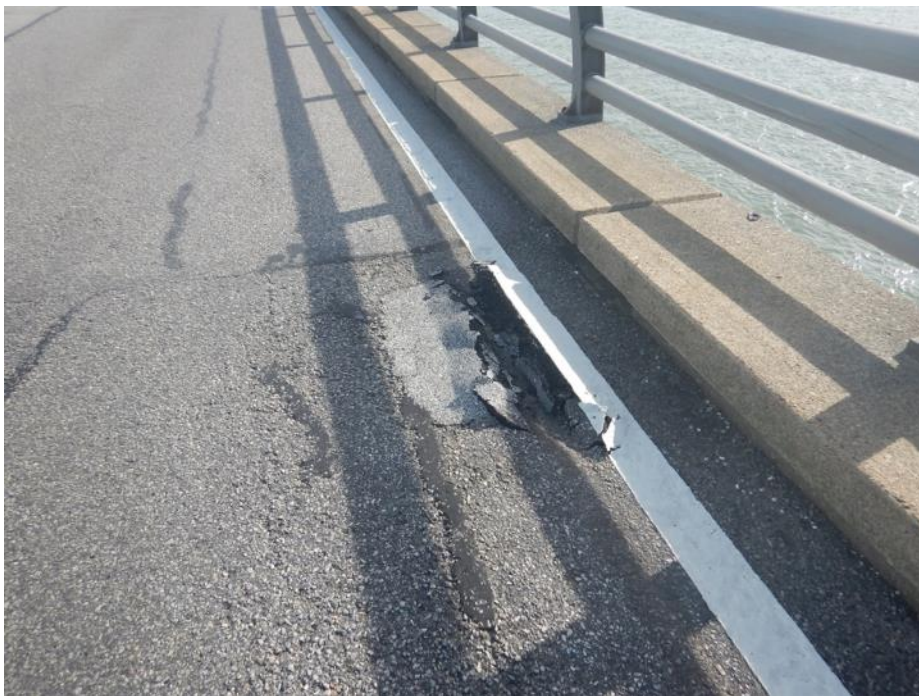
Photo 8.12-4: ESB5 Asphalt Wearing Surface - Deck Spall at Patch (Looking Southwest)

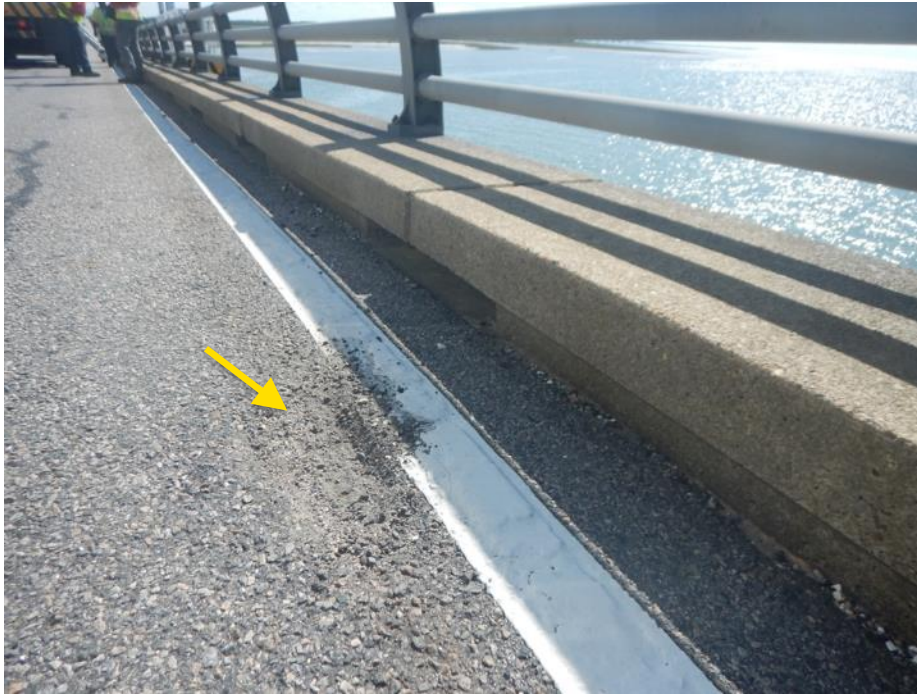
Photo 8.12-5: ESB8 Asphalt Wearing Surface - Deck Spall (Looking Southwest)

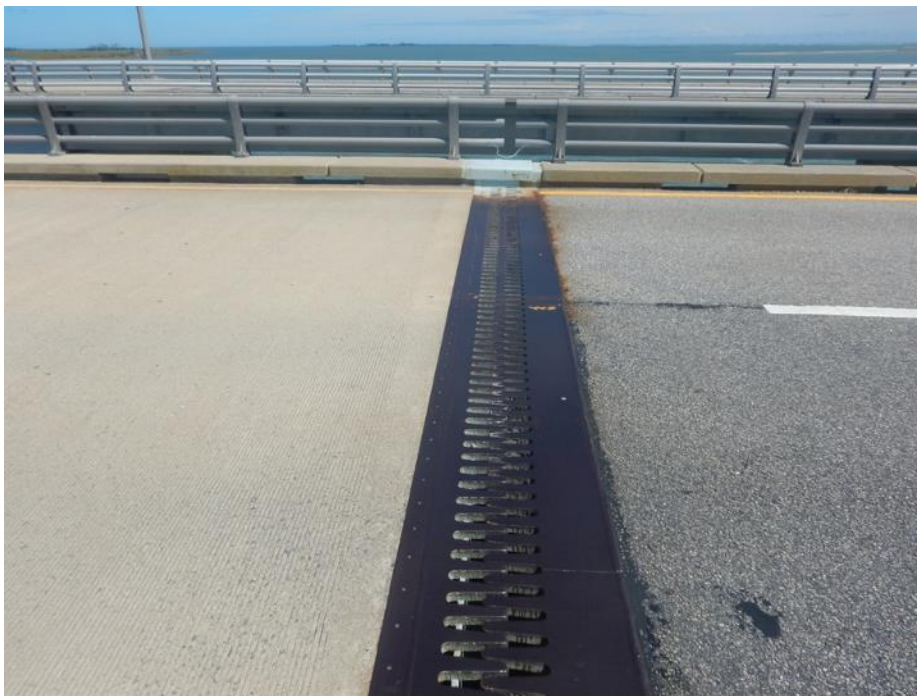
Photo 8.12-6: FIB-SB Pier 1 Assembly Joint without Seal - Tooth Expansion Joint Typical Condition with Minor and Isolated Locations of Freckled Rust (Looking East)

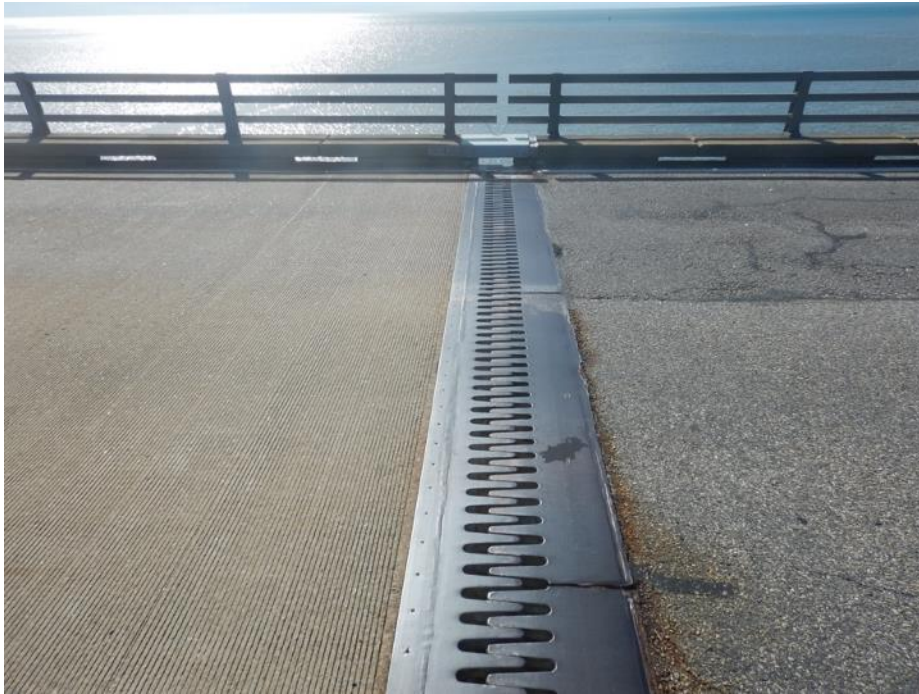
Photo 8.12-7: FIB-SB Pier 4 Assembly Joint without Seal - Tooth Expansion Joint Typical Condition with Minor and Isolated Locations of Freckled Rust (Looking West)

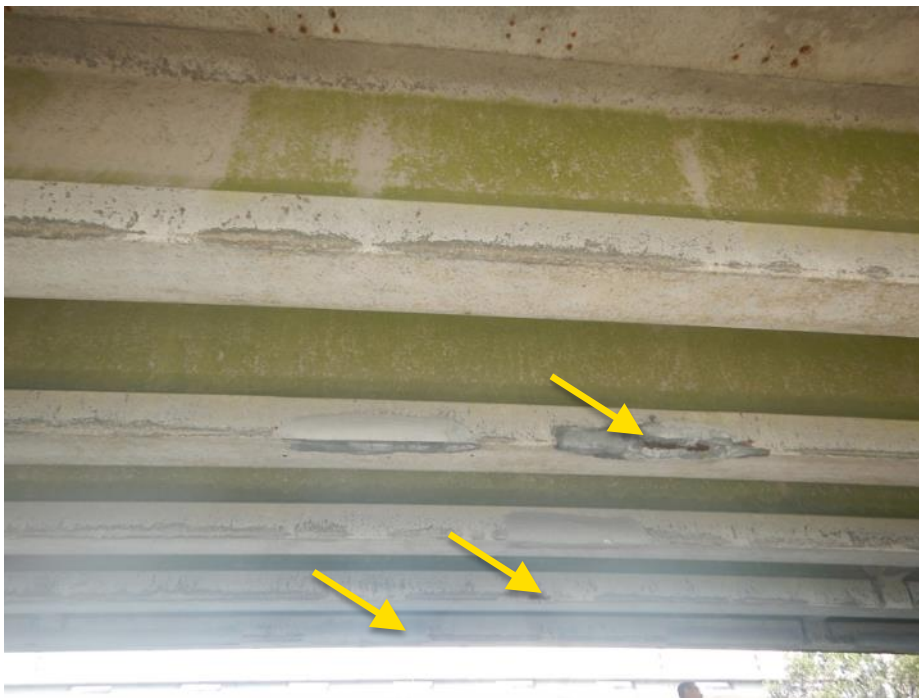
Photo 8.12-8: ESB1 Girders 5 thru 8 – Exposed Strand in Girder 5, and Cracking and Rust Staining in Repairs of Girders 7 and 8 (Looking East)

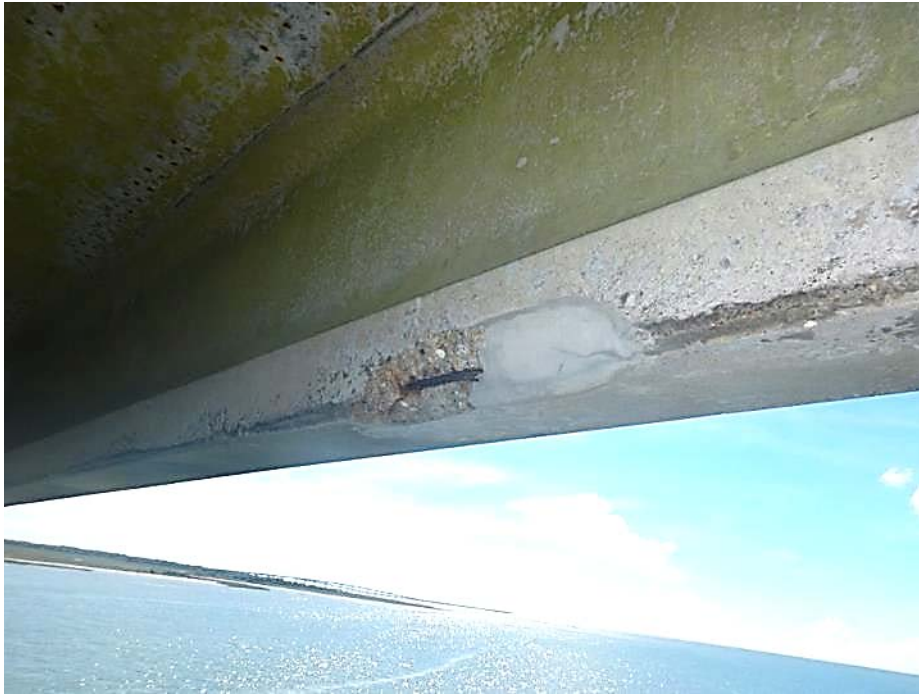
Photo 8.12-9: ESB10 Girder 1 - Failed Repair in Zone 2 with 1 Exposed Prestressing Strands (Looking Southwest)

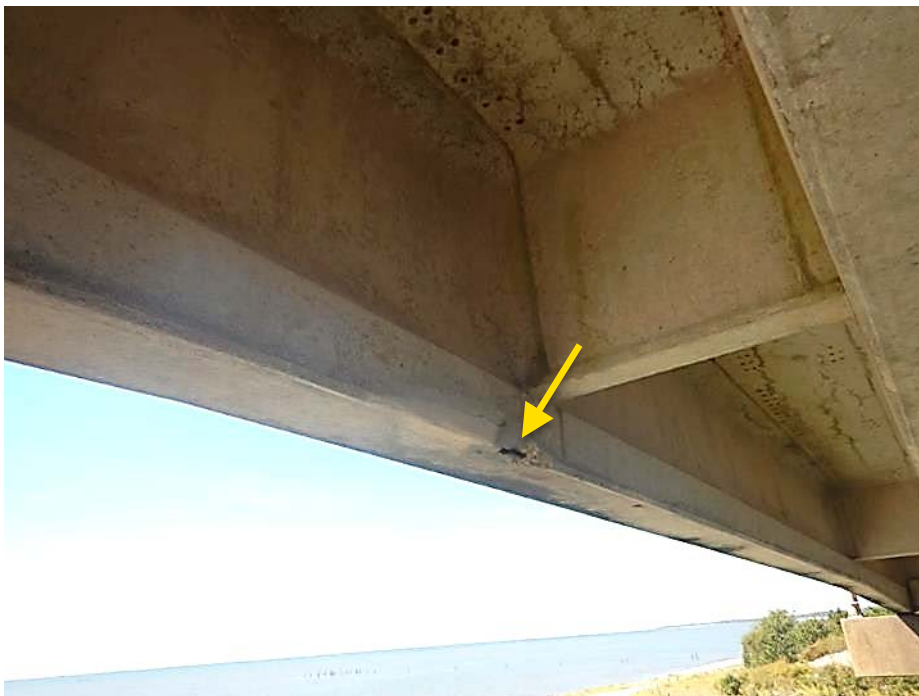
Photo 8.12-10: FSB4 Girder 1 - Failed Repair in Zone 1 with 1 Exposed Prestressing Strands (Looking Northwest)

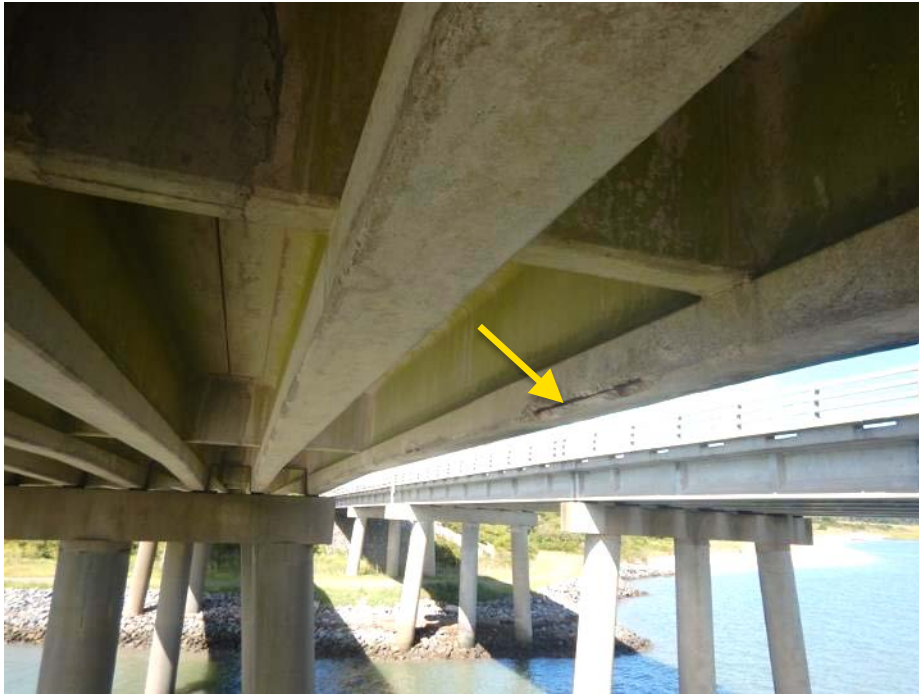
Photo 8.12-11: FSB4 Girder 8 - Failed Repair in Zone 2 with 1 Exposed Prestressing Strands (Looking Northeast)

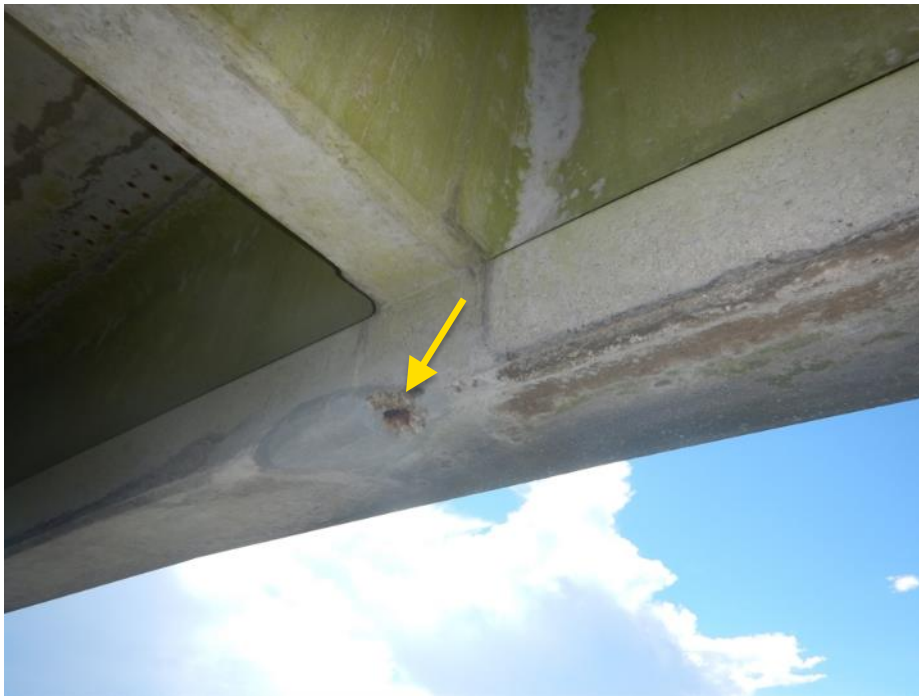
Photo 8.12-12: FSB6 Girder 1 - Failed Repair in Zone 1 with 1 Exposed Prestressing Strands (Looking Southeast)

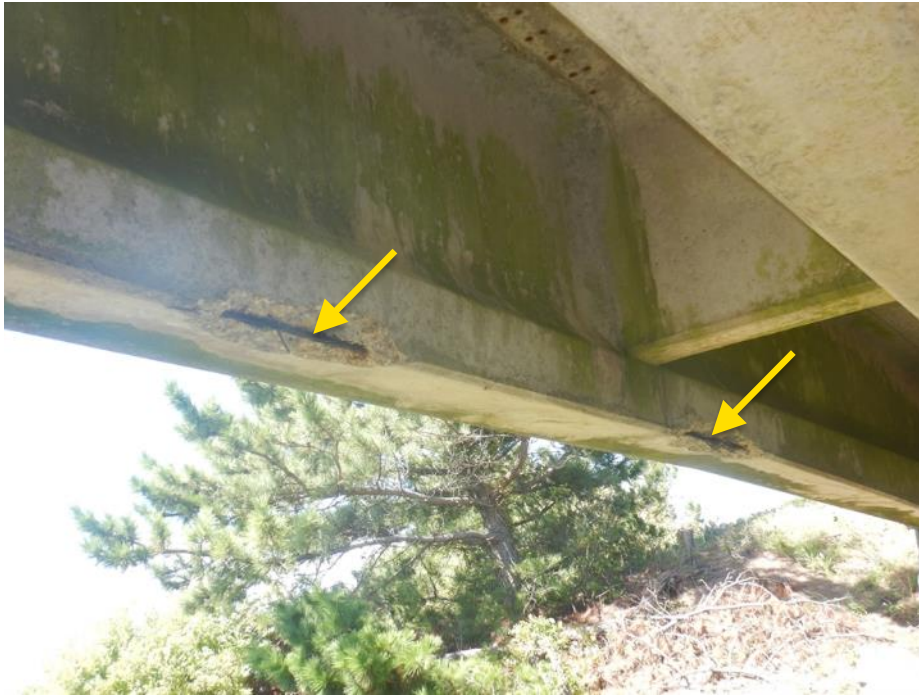
Photo 8.12-13: FSB8 Girder 1 - Two Spalls with 1 Exposed Prestressing Strand (Looking Northwest)

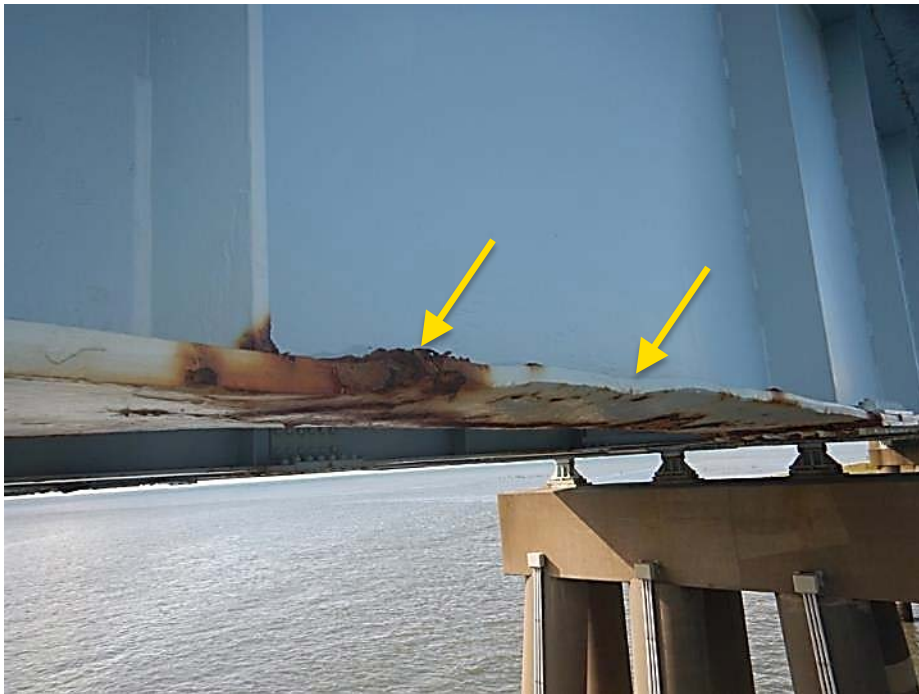
Photo 8.12-14: FIB-SB Span 2 Girder 4 – Bottom Flange Distorted for 3' on East Edge (No Mitigation Required) with Typical Freckled Rust and Paint Failure (Looking Northwest)

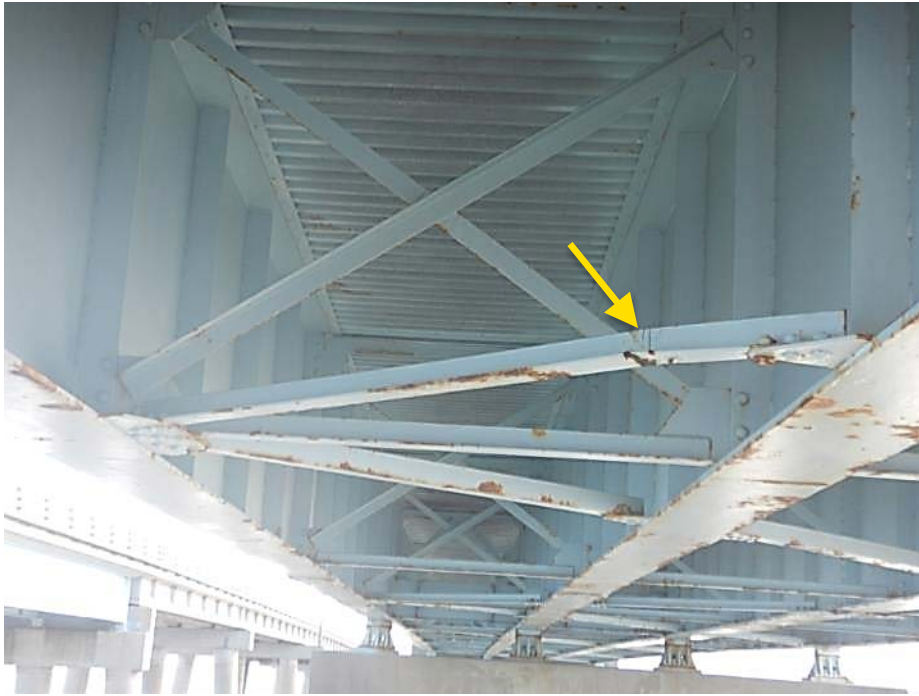
Photo 8.12-15: FIB-SB Span 2, Bay 3, Cross Frame 4 Lower Lateral Bracing - Buckled Lower Lateral Bracing Member with Typical Freckled Rust and Paint Failure (Looking South)

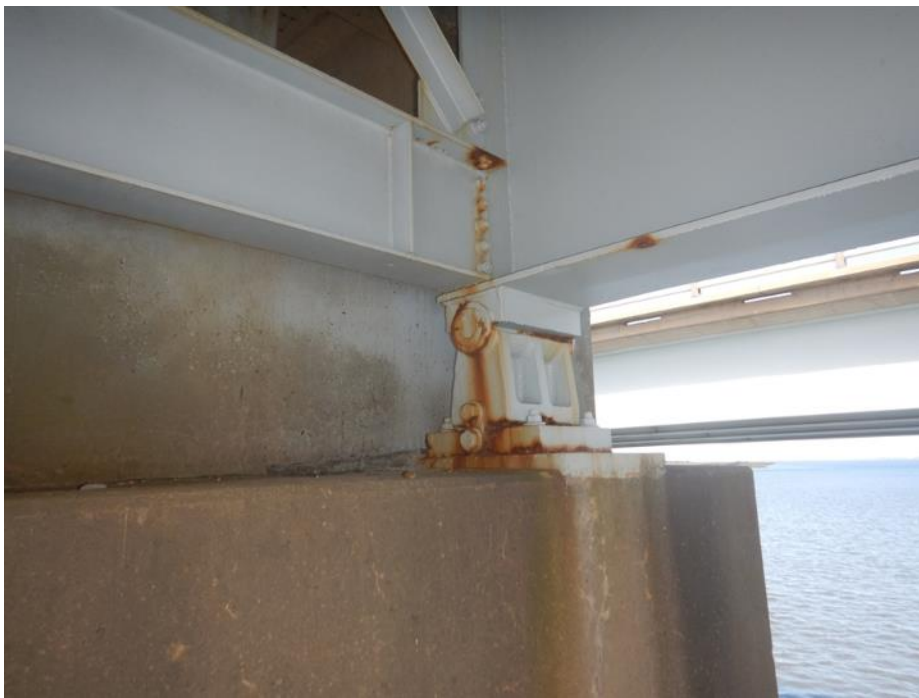
Photo 8.12-16: FIB-SB Pier 4 G4 Movable Bearing - Typical Condition of Isolated areas of Surface Rust (Looking Southwest)

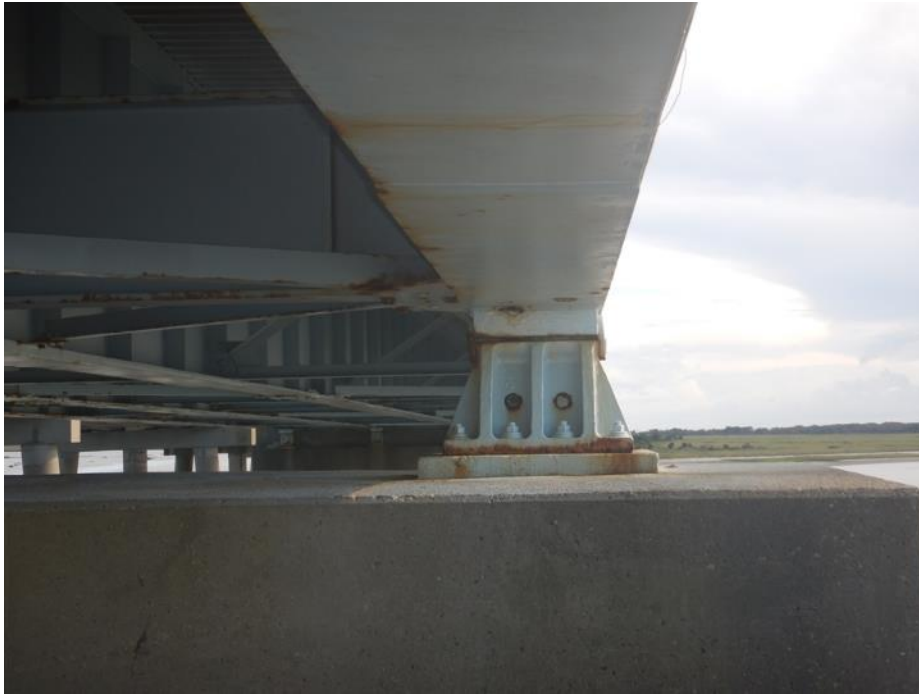
Photo 8.12-17: FIB-SB Pier 2 G1 Fixed Bearing - Typical Condition of Isolated areas of Surface Rust (Looking South)

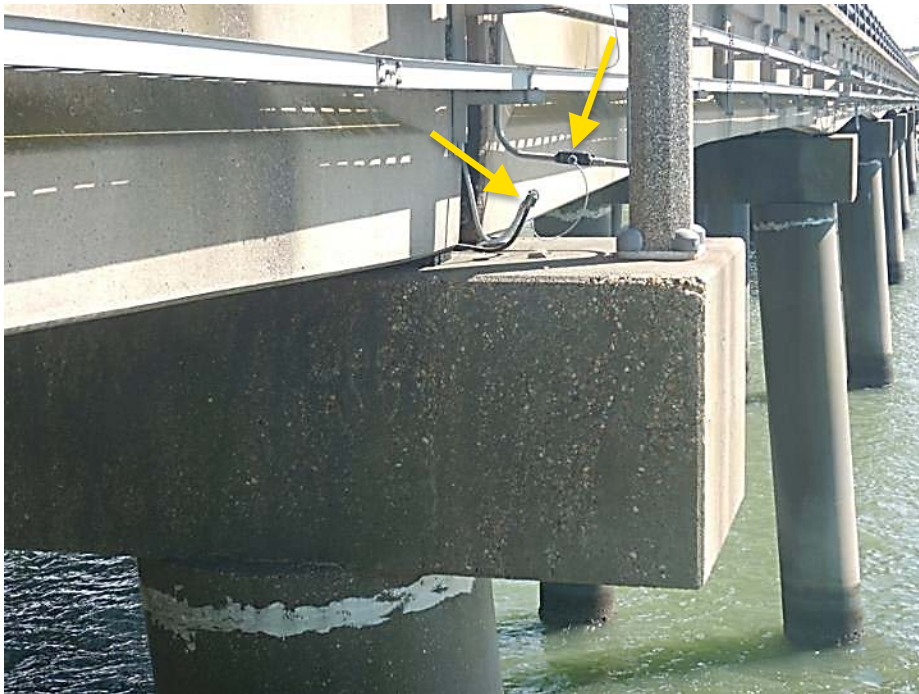
Photo 8.12-18: ESB8 Light Pole - Disconnected Cable (Looking Southeast)
