FY2019 Annual Inspection and Underwater Inspection, Trestle A'NB, ANB, & ASB

Chesapeake Bay Bridge and Tunnel District

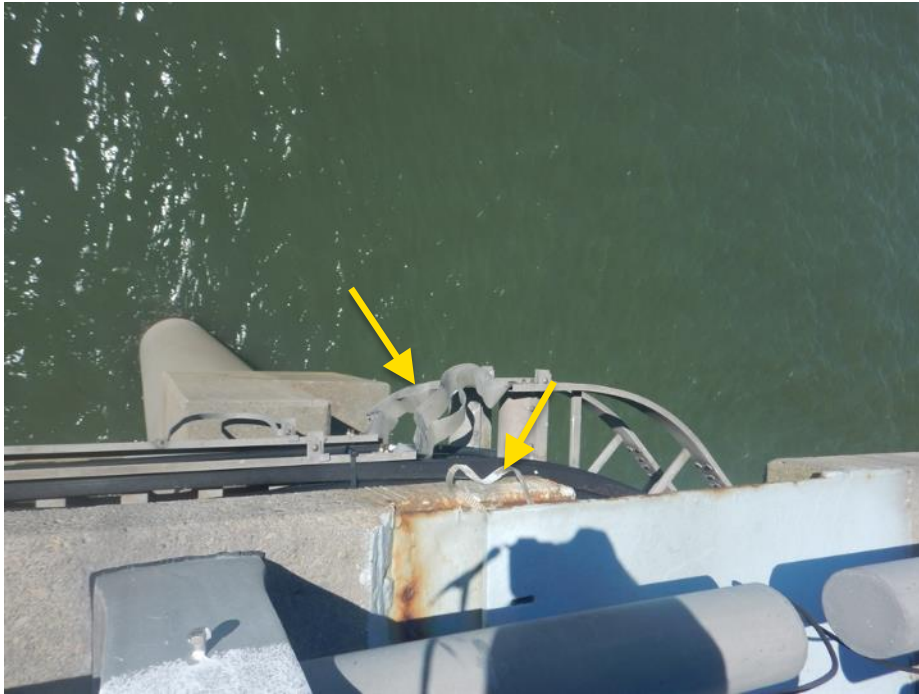
Photo 8.12-21: FIB-SB Pier 1 Cable Tray - 2 Broken Cable Tray Expansion Straps (Looking West)

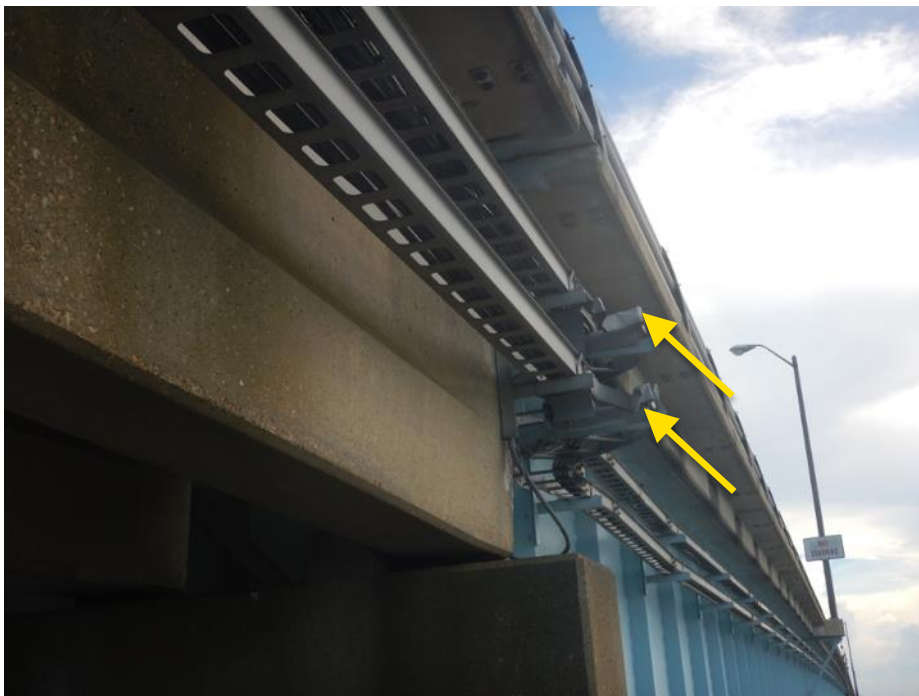
Photo 8.12-22: FIB-SB Pier 4 Cable Tray - 2 Broken Cable Tray Expansion Straps (Looking Southeast)

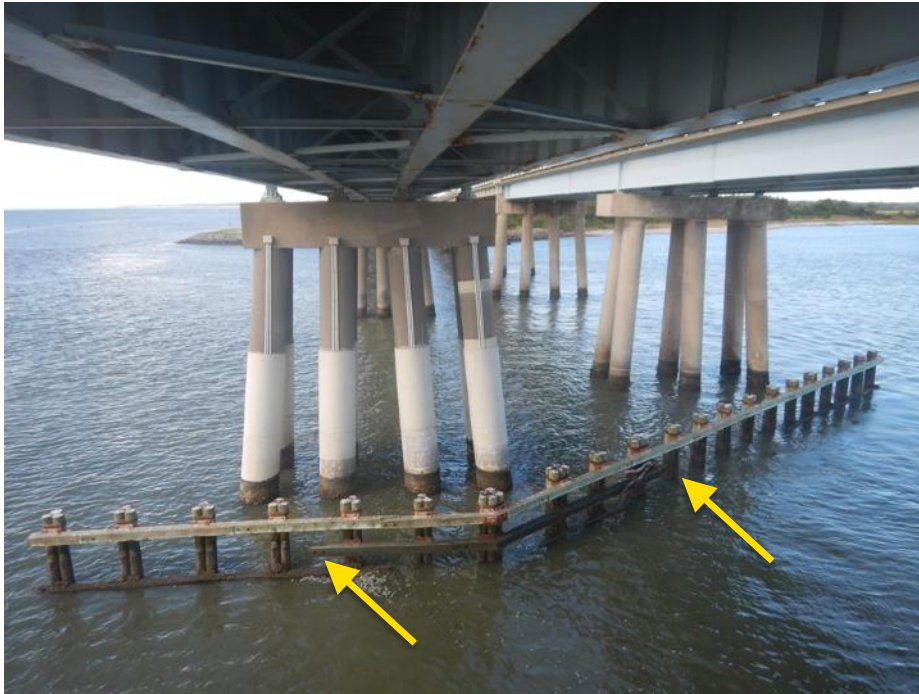
Photo 8.12-23: FIB-SB & FIB-NB Span 2 North Fender System – Missing Timber Wales and Other Damage from Vessel Impact in May 2018, Under Repair at Time of Inspection (Looking North)

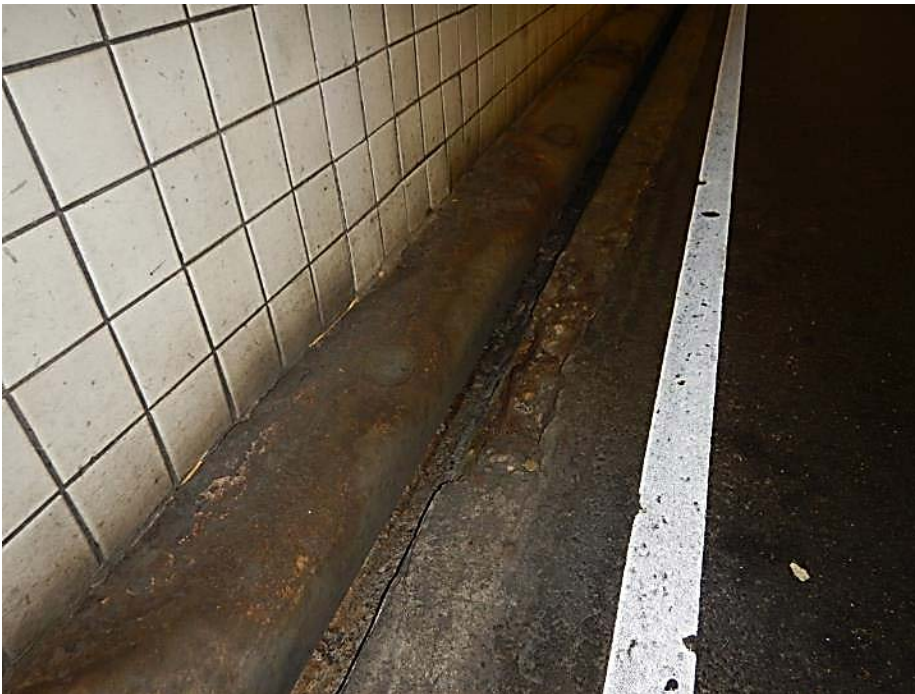
Photo 8.14-2: Invert Slab at STA 473+20 - Spall at Roadway Edge with Exposed Reinforcement

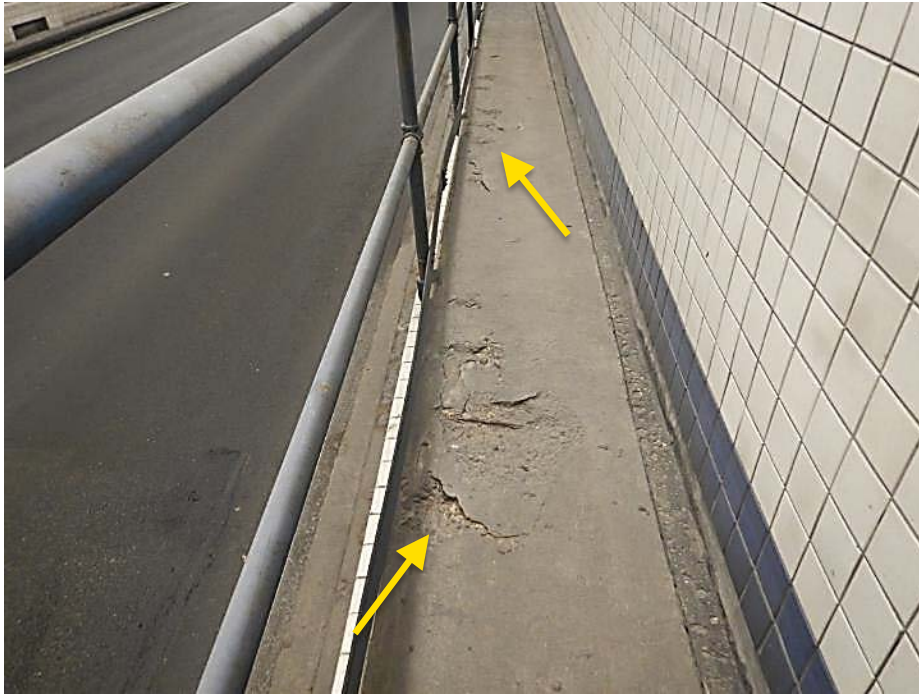
Photo 8.14-3: Sidewalk at STA 511+30 - Spalling with Exposed Reinforcement

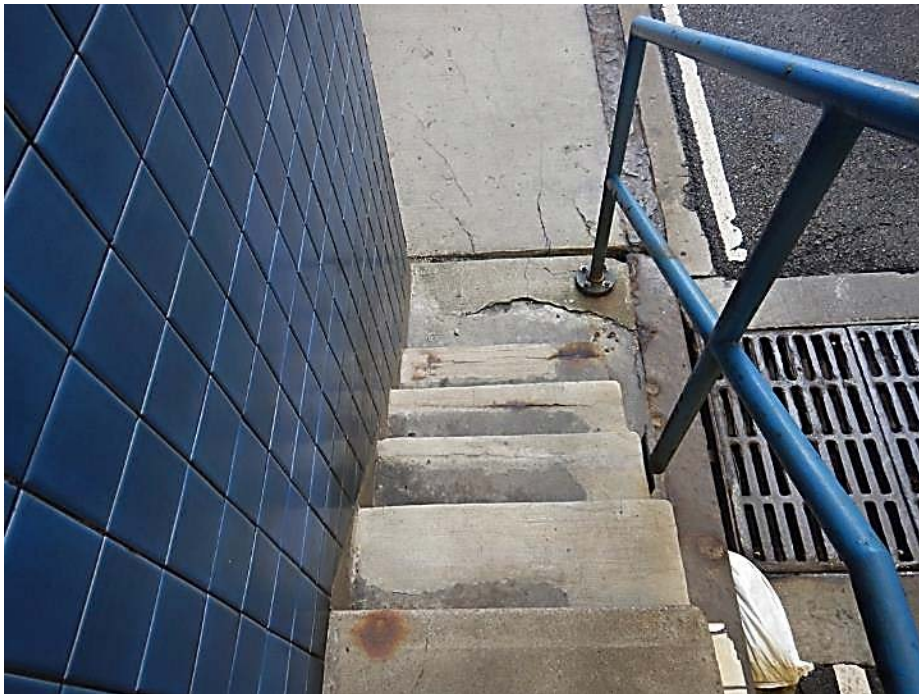
Photo 8.14-4: Sidewalk at STA 523+36 - Cracking with Rust Staining

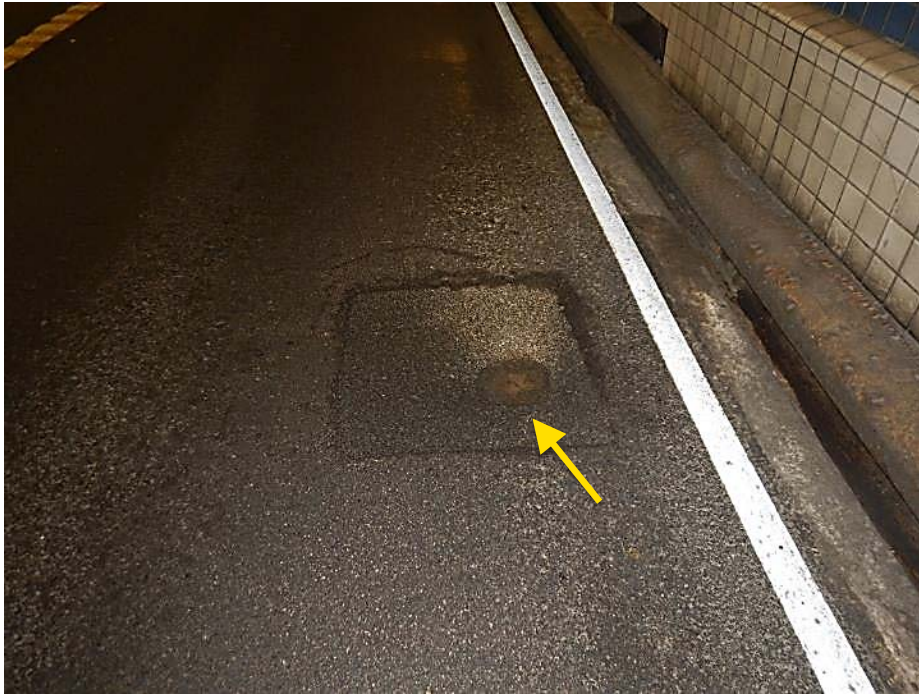
Photo 8.14-5: Asphalt Wearing Surface at STA 513+90 – Repair Patch with Depression (Looking North)

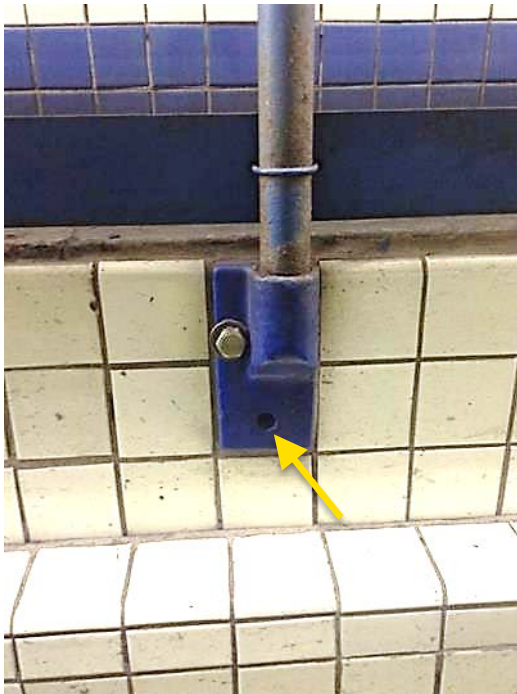
Photo 8.14-6: Steel Pedestrian Railing at STA 486+18 - Anchor Bolt Missing

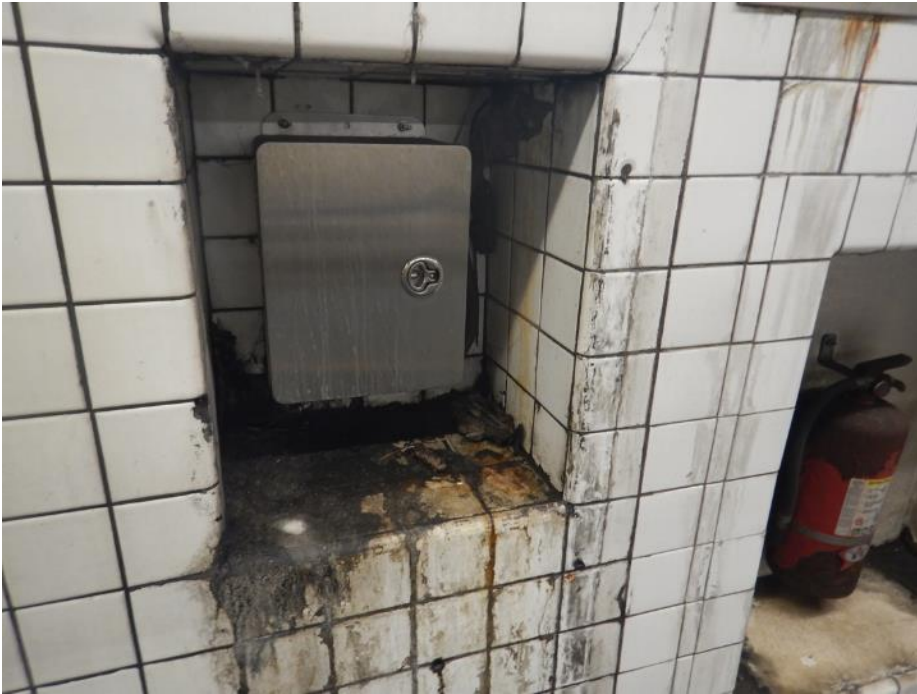
Photo 8.14-7: Fire Extinguisher and Phone Box Niche at STA 493+42 - Fire Extinguisher with Paint Loss and No Inspection Tag, and Clogged, and Heavy Efflorescence with Rust Staining at Phone Box Niche (Phone Box not Damaged)

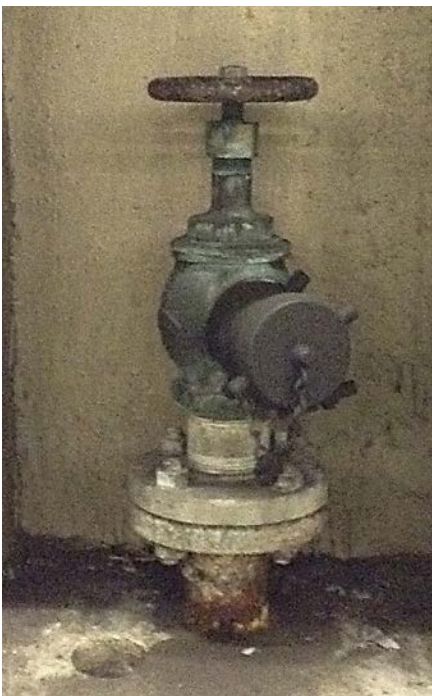
Photo 8.14-8: Hose Valve #4 at STA 474+50 - Corrosion at Concrete Interface

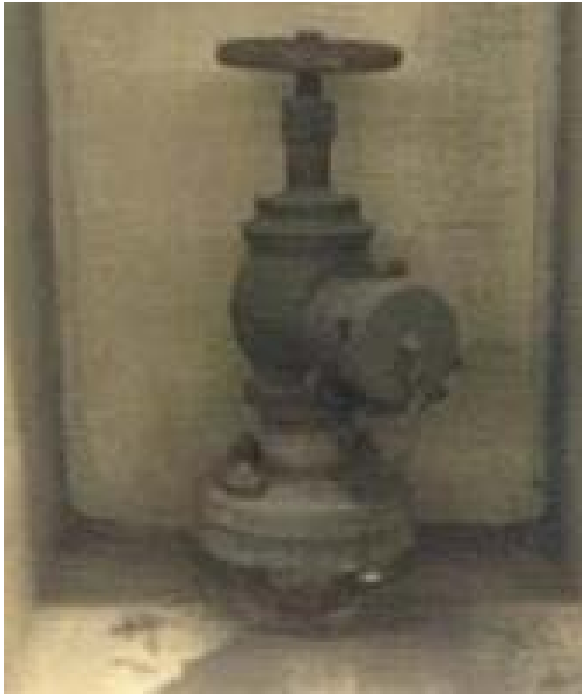
Photo 8.14-9: Hose Valve #22 at STA 500+79 - Corrosion at Concrete Interface

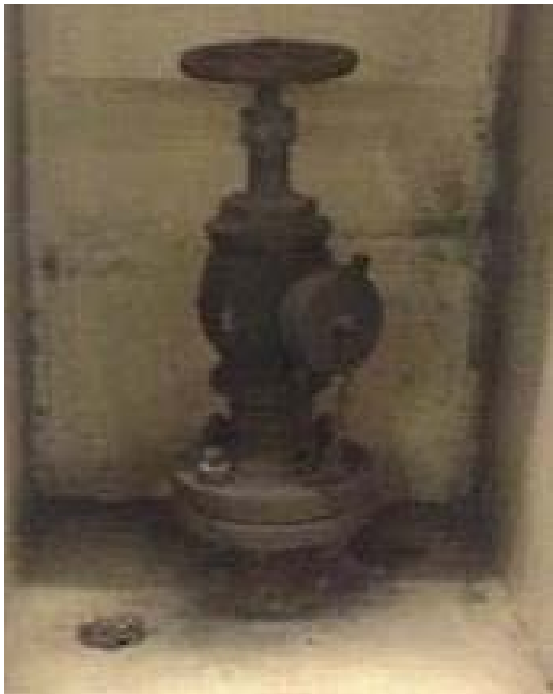
Photo 8.14-10: Hose Valve #27 at STA 508+10 - Corrosion at Concrete Interface

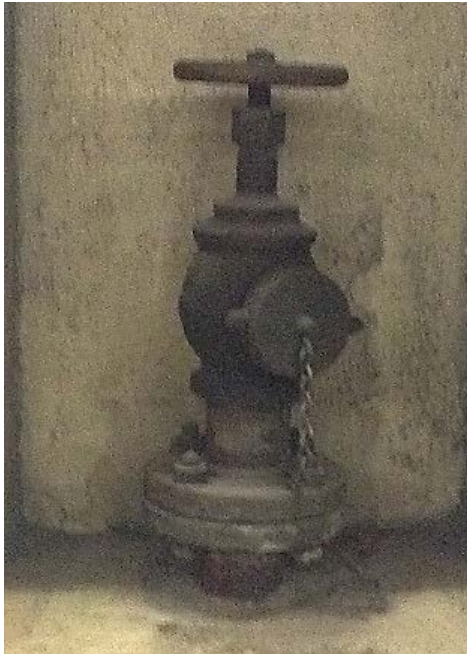
Photo 8.14-11: Hose Valve #30 at STA 512+23 - Corrosion at Concrete Interface

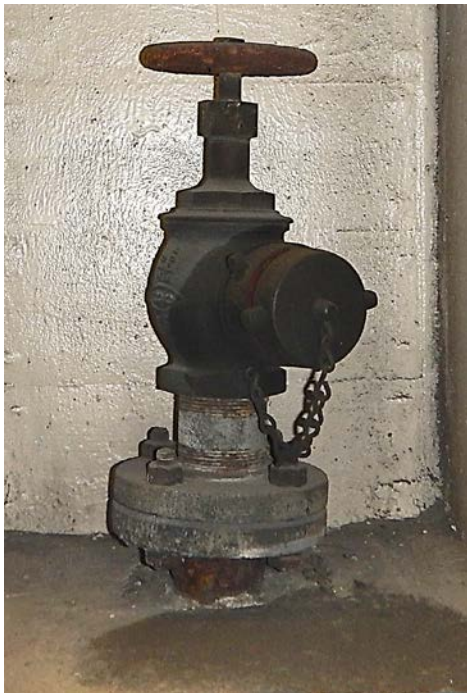
Photo 8.14-12: Hose Valve #31 at STA 513+69 - Corrosion at Concrete Interface

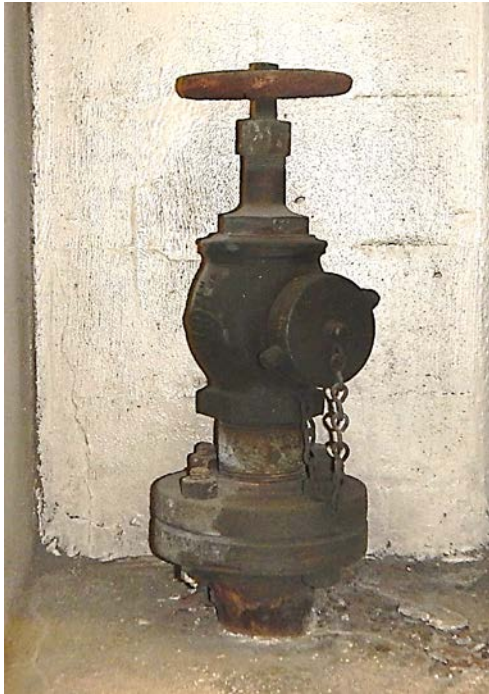
Photo 8.14-13: Hose Valve #32 at STA 515+15 - Corrosion at Concrete Interface

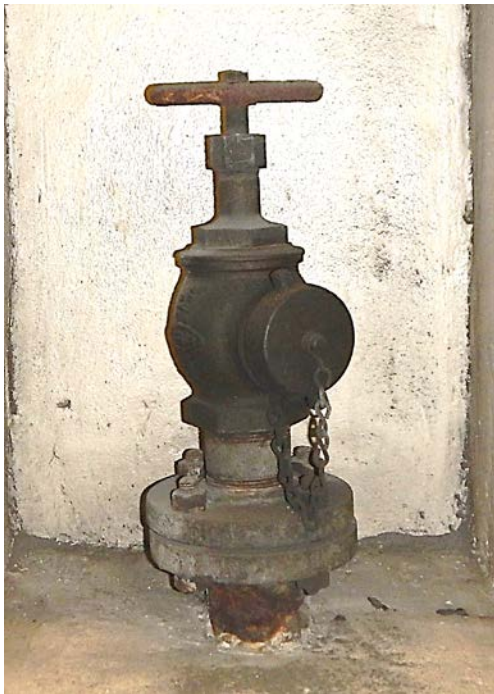
Photo 8.14-14: Hose Valve #35 at STA 519+53 - Corrosion at Concrete Interface

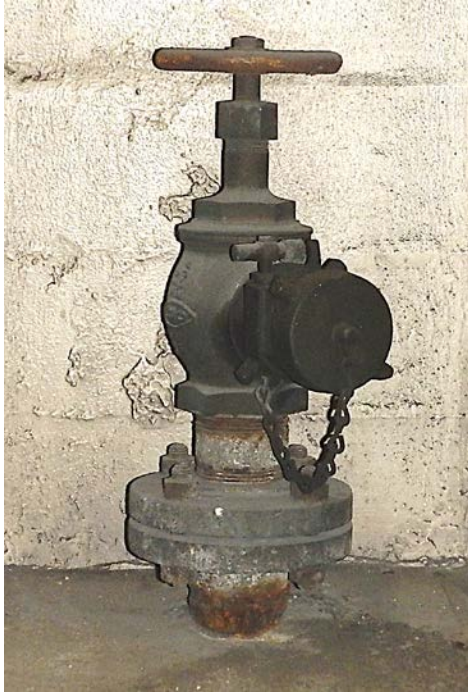
Photo 8.14-15: Hose Valve #36 at STA 521+10 - Corrosion at Concrete Interface

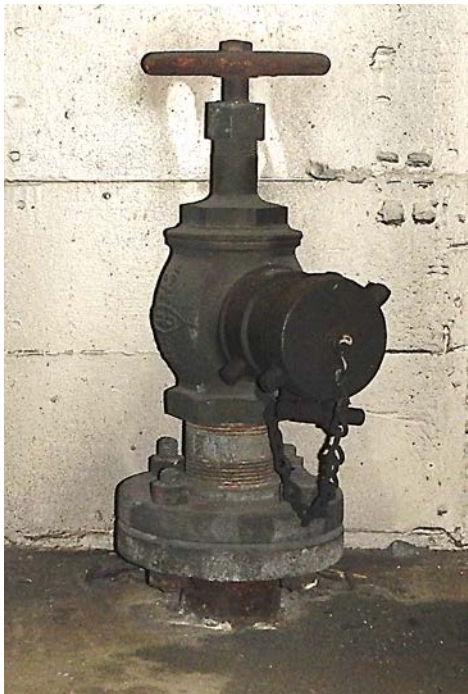
Photo 8.14-16: Hose Valve #37 at STA 522+40 - Corrosion at Concrete Interface

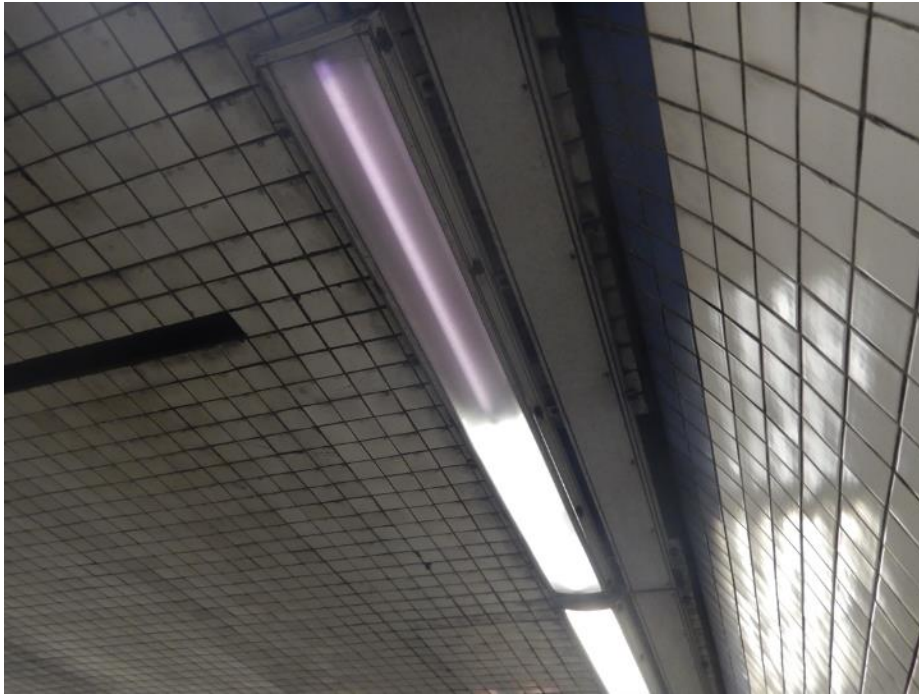
Photo 8.14-17: Light on Sidewalk Side at STA 488+75 - Light Bulb is not Lighting Completely

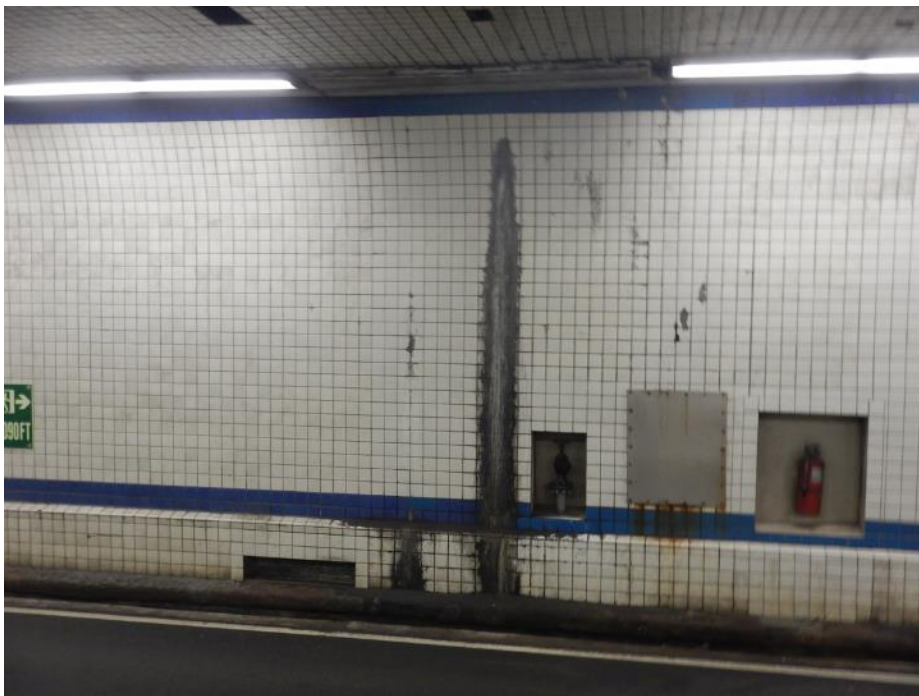
Photo 8.14-18: Wall and Light Fixture at STA 502+25 – Wall with Heavy Efflorescence and Rust Staining at Panel, Light Fixture Exhibits Corrosion with No Notable Section Loss, and Light Bulb is not Lighting

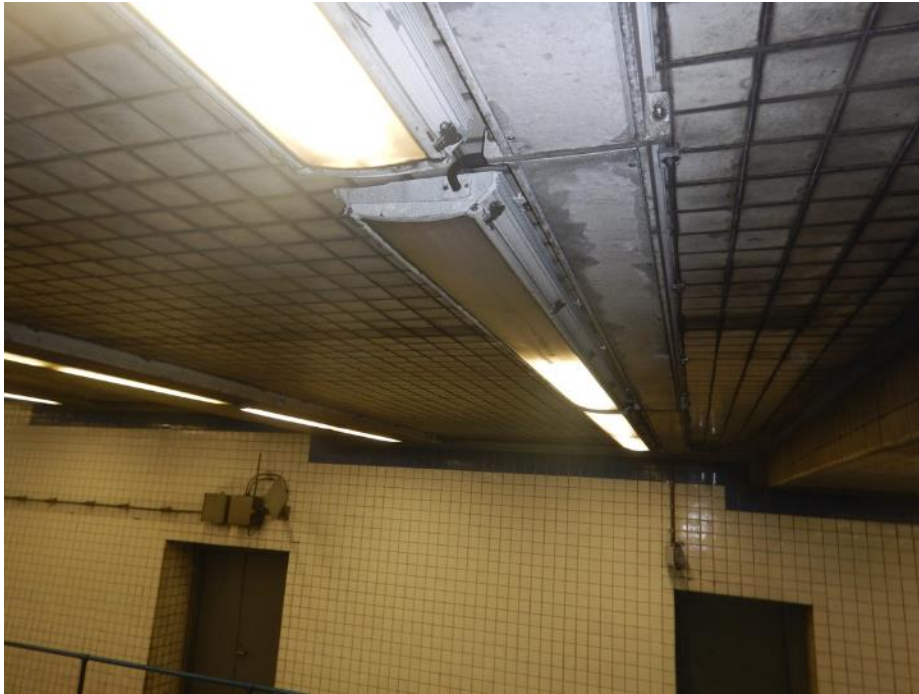
Photo 8.14-19: Light on Sidewalk Side at STA 469+85 - Light Bulb is not Lighting

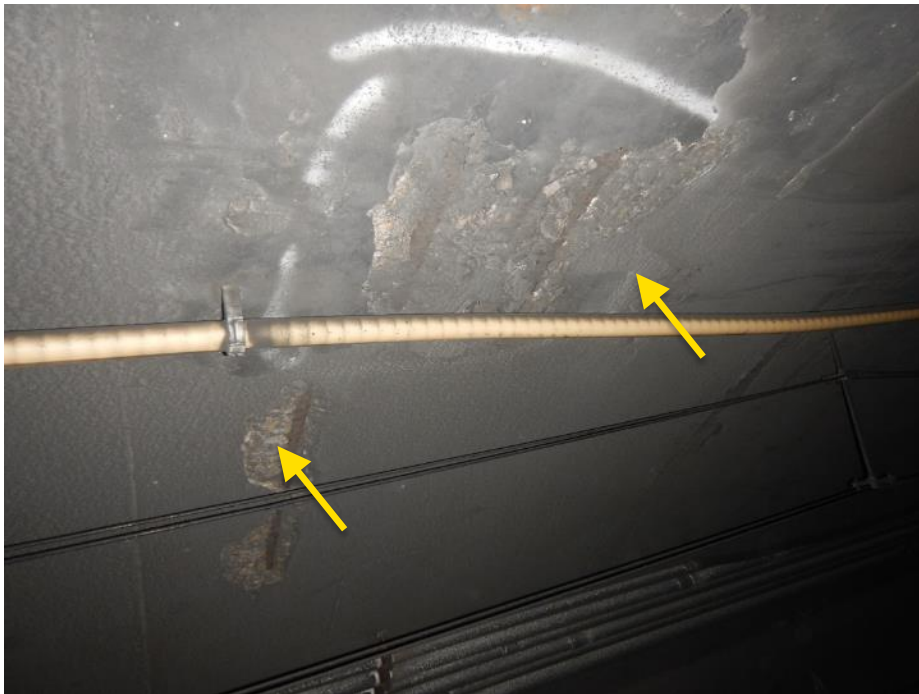
Photo 8.14-20: Exhaust Duct Liner at STA 470+98 - Spalling with Exposed Transverse Reinforcement (Little to No Section Loss of Steel Reinforcement, Looking East)

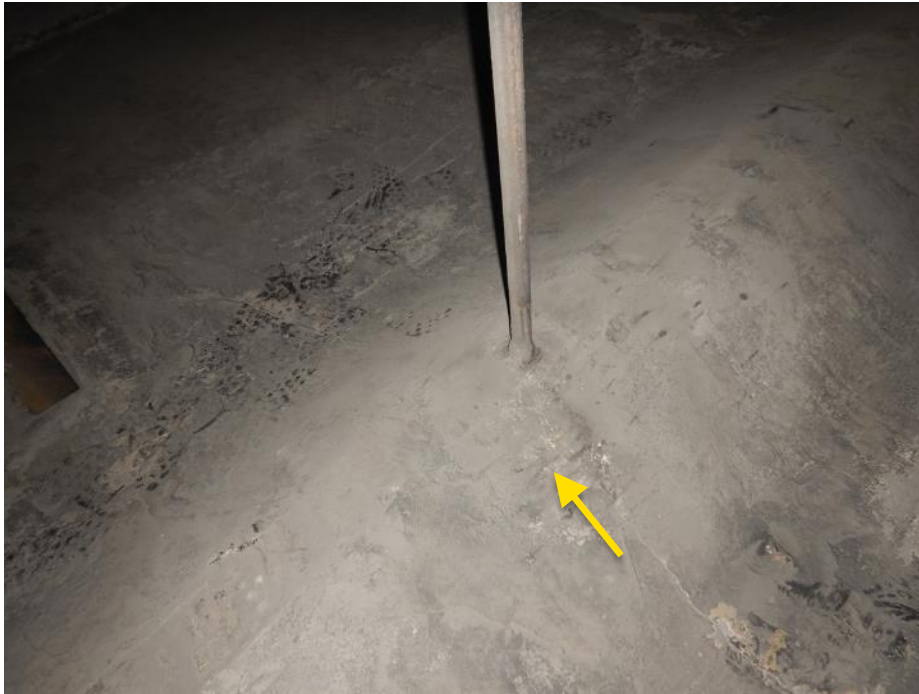
Photo 8.14-21: Ceiling Slab at STA 474+98 - Delamination in Haunch Beam Adjacent to Hanger Anchorage (Looking Northwest)

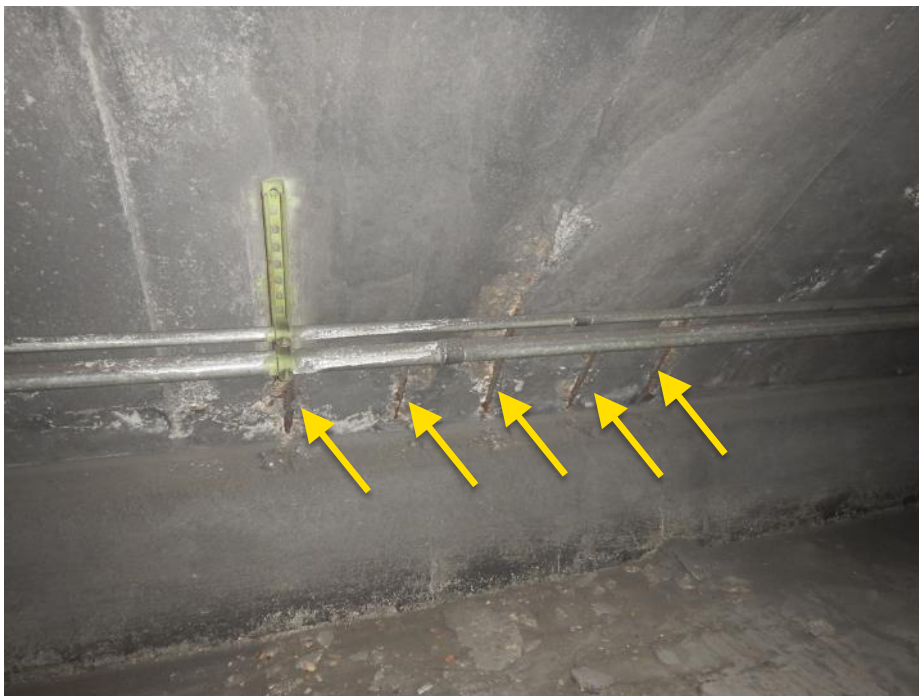
Photo 8.14-22: Exhaust Duct Liner at STA 482+70 - Spalling with Exposed Transverse Reinforcement (Little to No Section Loss of Steel Reinforcement, Looking East)

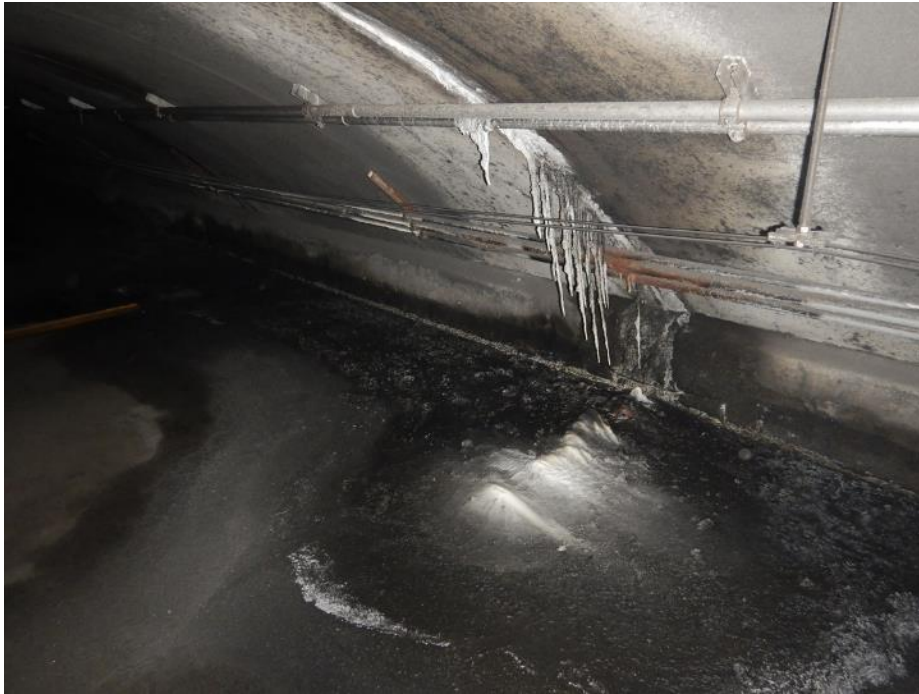
Photo 8.14-23: Exhaust Duct at STA 502+50 - Crack in Tunnel Liner with Active Heavy Efflorescence (Looking Southwest)

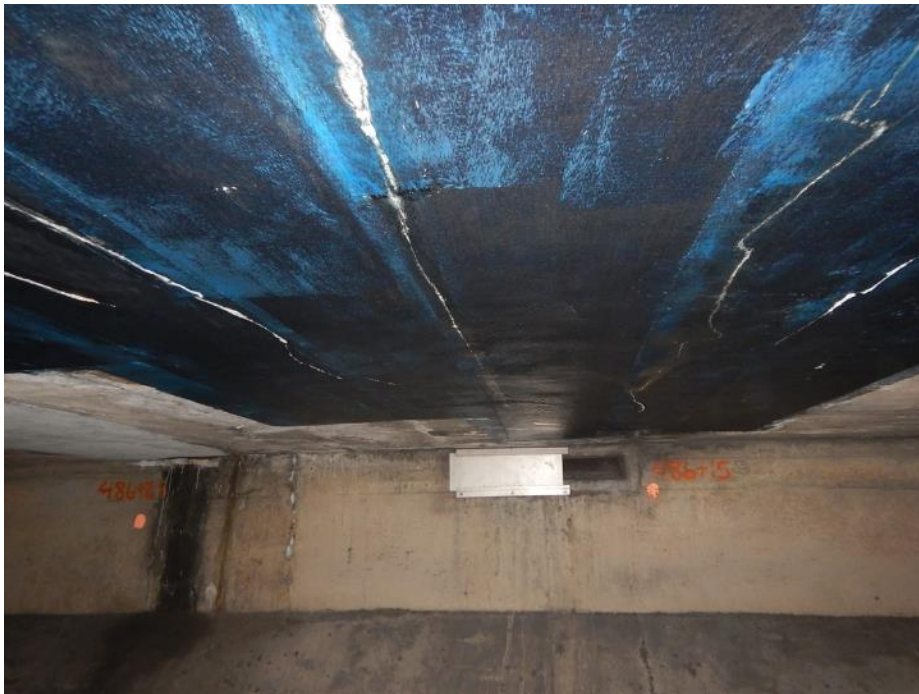
Photo 8.14-24: Invert Slab at STA 486+15 - Cracks with Efflorescence in FRP Repair on Underside

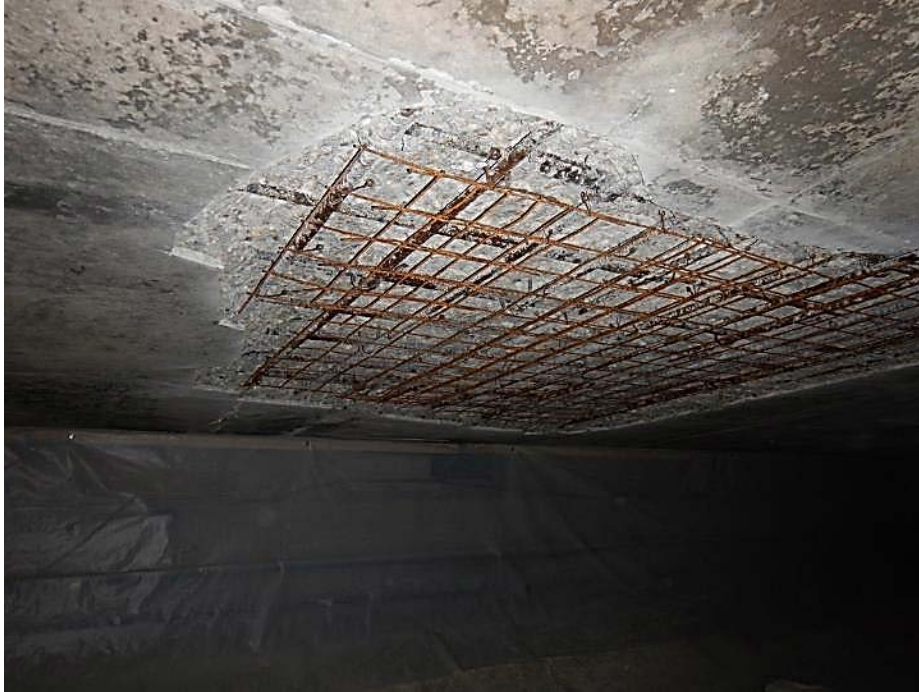
Photo 8.14-25: Invert Slab at STA 508+75 - Typical Condition of Invert Slab Prior to Shotcrete Repair (Little to No Section Loss of Existing Reinforcement)

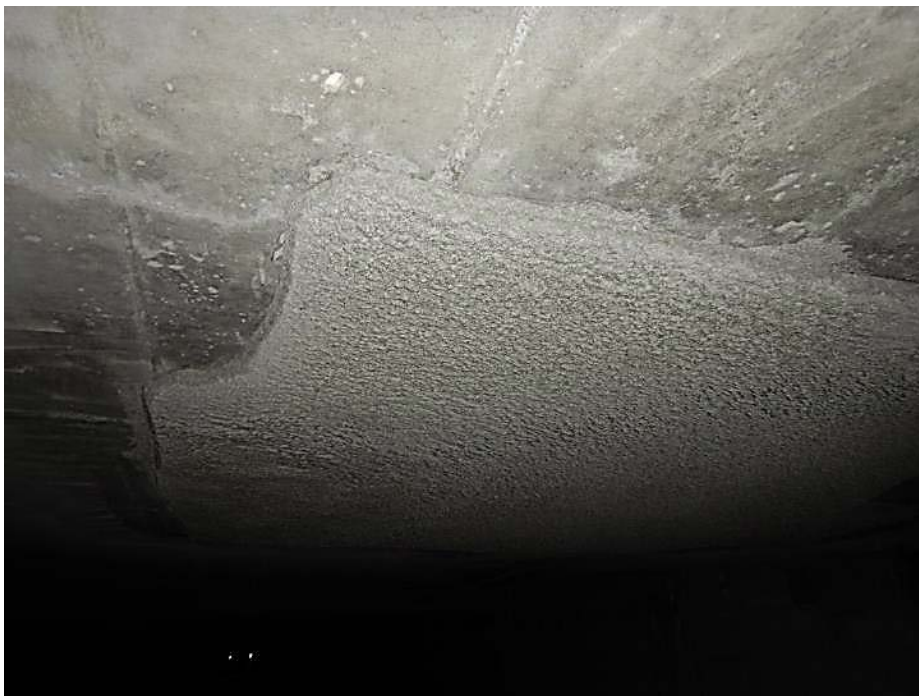
Photo 8.14-26: Invert Slab at STA 514+30 - Typical Condition of Invert Slab After Shotcrete Repair

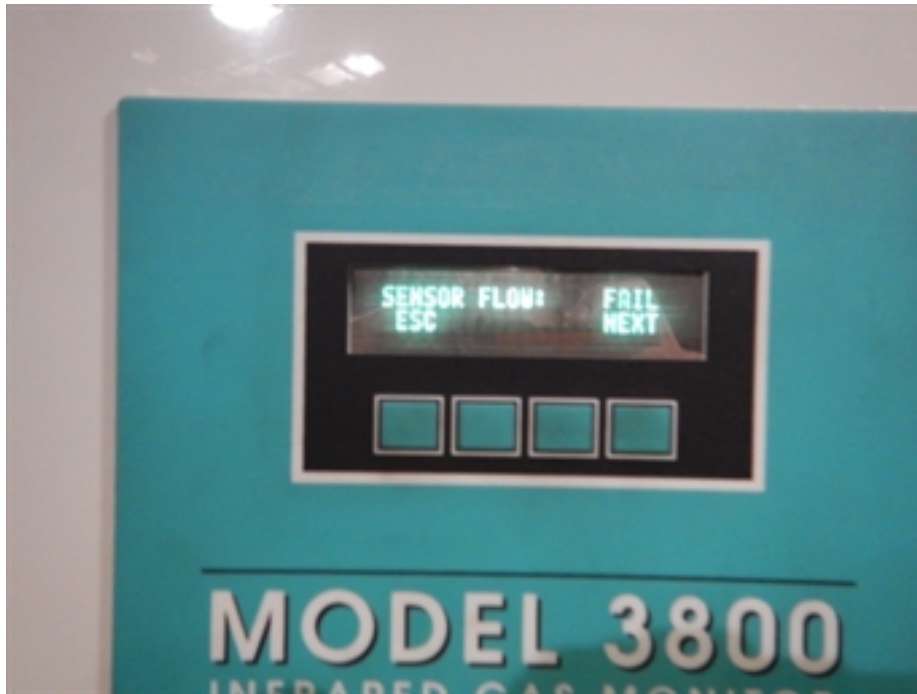
Photo 8.14-27: Ventilation System - Portal Island #4 Exhaust Duct CO Monitor Device Had an Error Reading "Sensor Flow - Fail" (Possibly Due to Moisture)

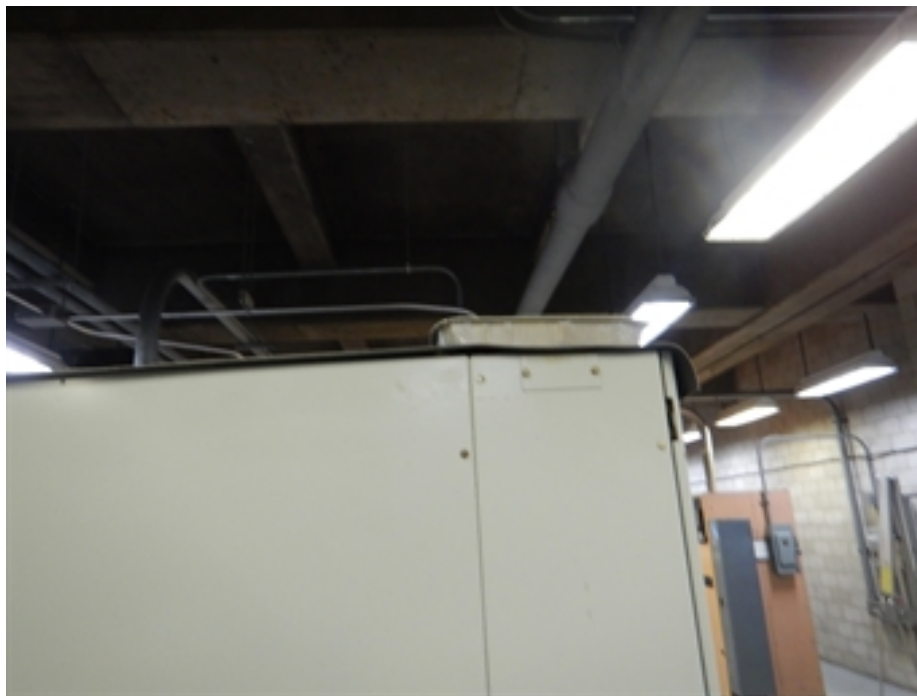
Photo 8.14-28: Emergency Generator System - Portal Island #3 Switchgear Does Not Have a Watertight Seal, and does not have NEC Acceptable Drip Pan at Locations Where Water is Ponding

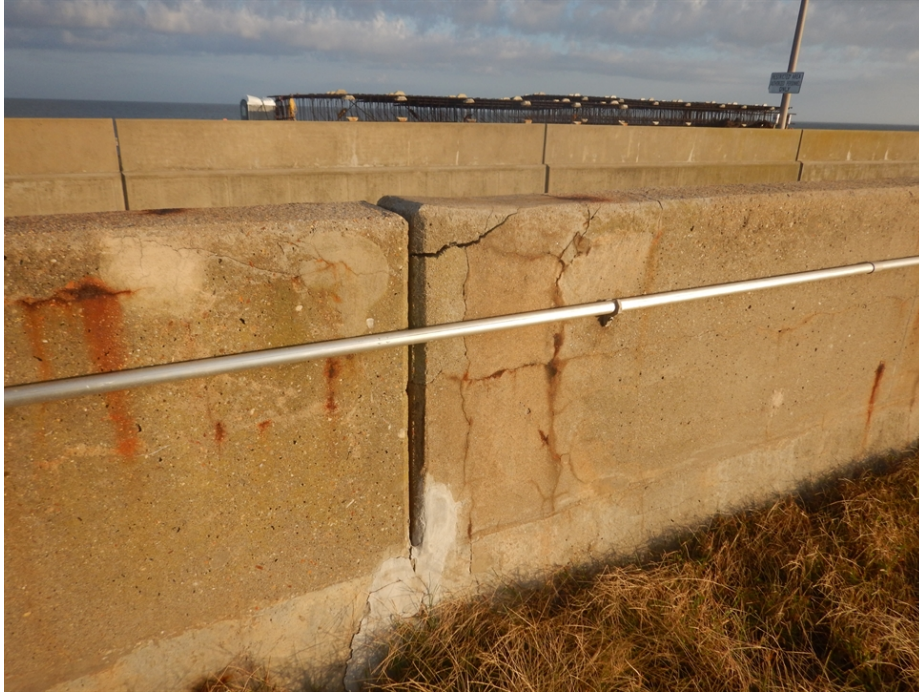
Photo 8.15-1: Portal Island 3 – Spalling on top of East Approach Wall Approximately 200' from South (Looking Northwest)

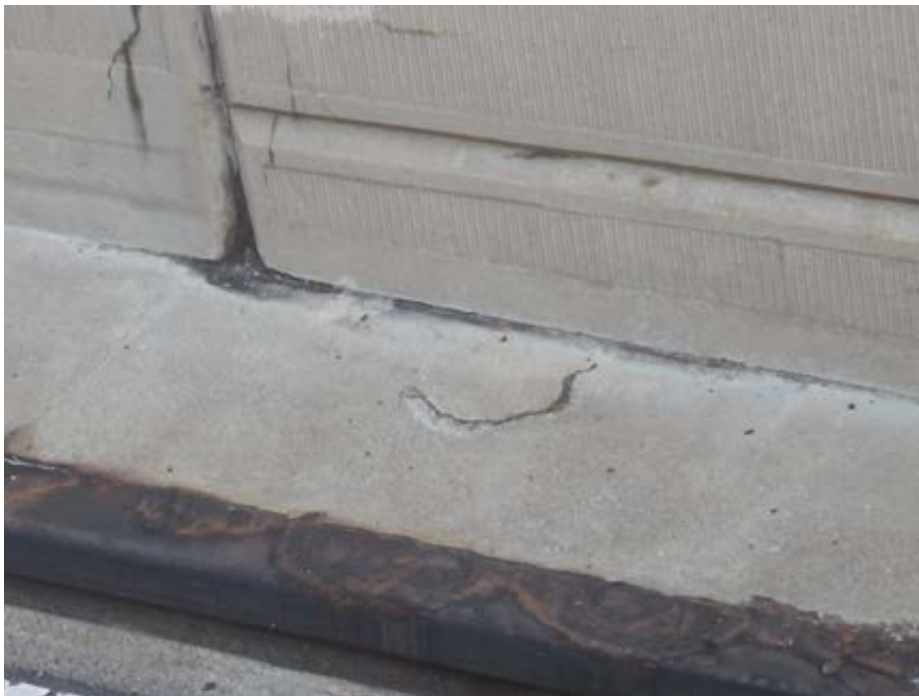
Photo 8.15-2: Portal Island 3 – Cracking/Delamination on West Sidewalk Approximately 600' from South (Looking Southwest)

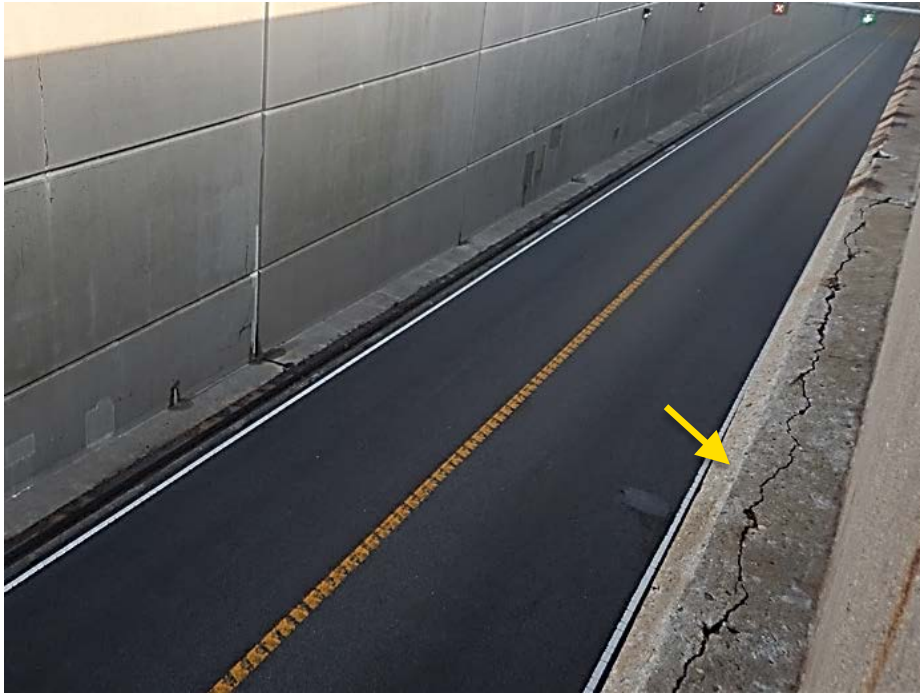
Photo 8.15-3: Portal Island 3 – Cracking/Delamination on East Approach Wall Approximately 700’ from South (Looking Northwest)

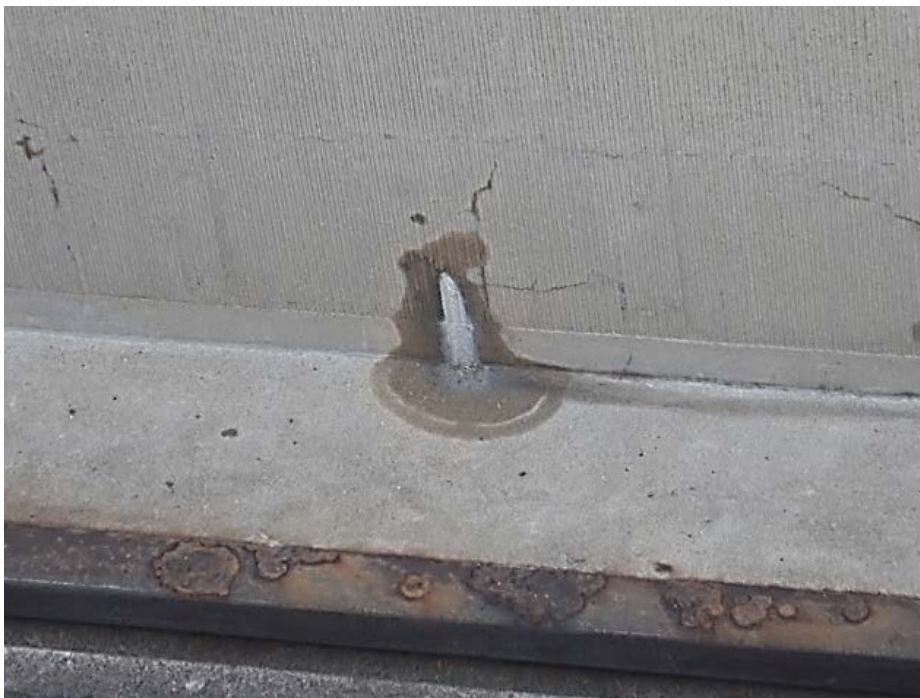
Photo 8.15-4: Portal Island 3 – Cracking with Efflorescence on West Approach Wall Approximately 700’ from South (Looking West)

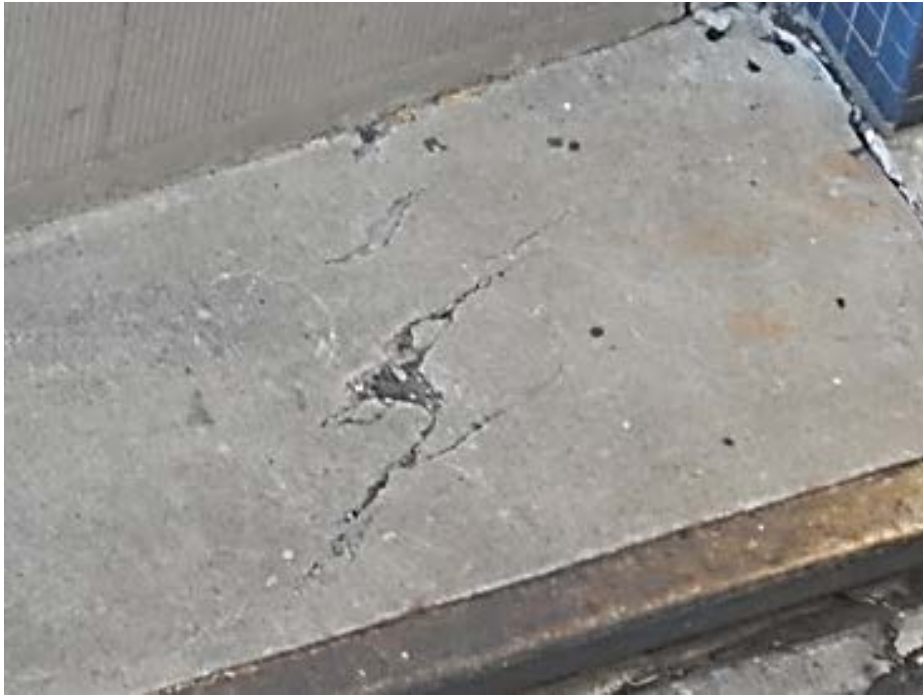
Photo 8.15-5: Portal Island 3 – Cracking/Delamination on West Sidewalk at Tunnel Portal (Looking Northwest)

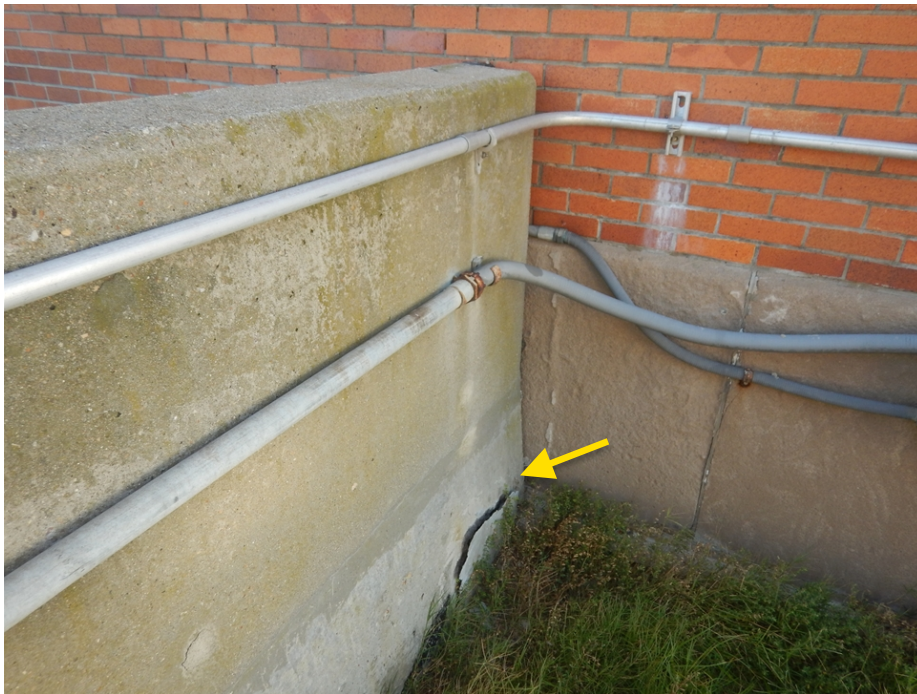
Photo 8.15-6: Portal Island 3 – Failed Concrete Repair on East Approach Wall at Ventilation Building (Looking Northwest)

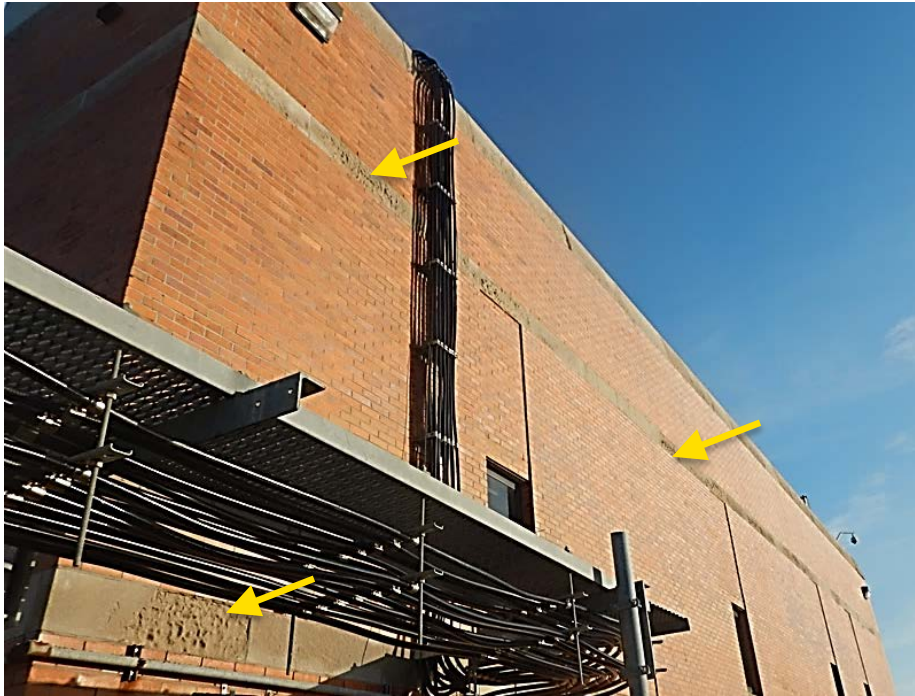
Photo 8.15-7: Portal Island 3 – Ventilation Building, Typical Erosion of Sandstone (Looking Northwest)

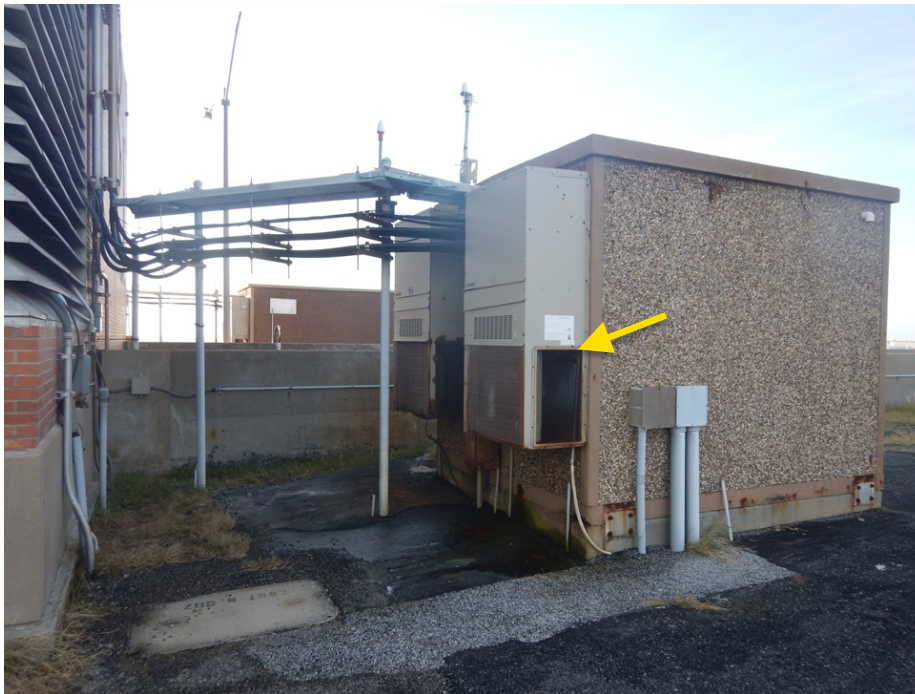
Photo 8.15-8: Portal Island 3 Utility Structure – Corroded Enclosures on Air Handling Unit (Looking East)

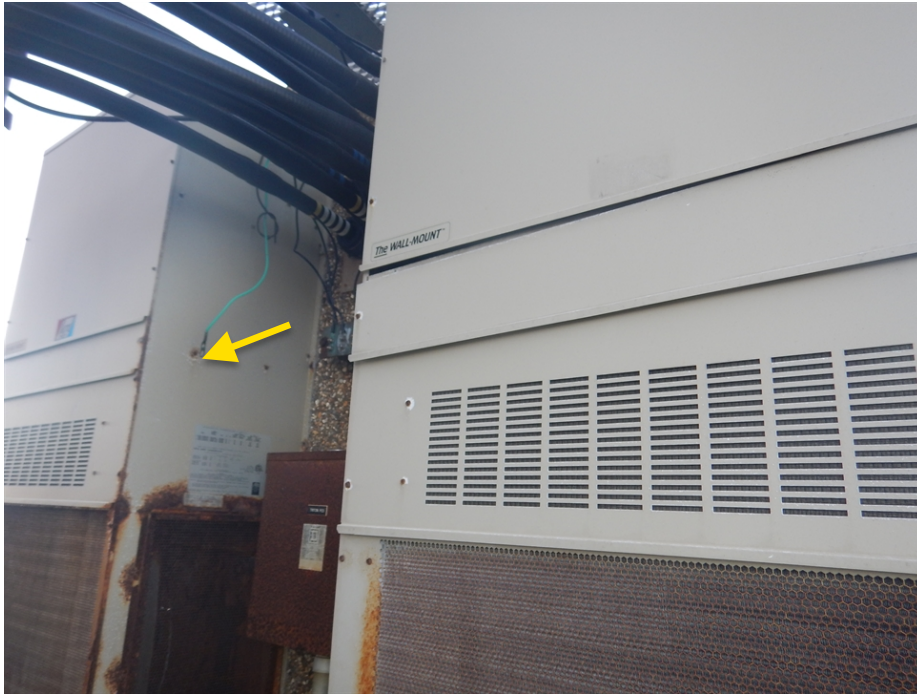
Photo 8.15-9: Portal Island 3 Utility Structure – Disconnected Grounding Cable (Looking Southeast)
