FY2019 Annual Inspection and Underwater Inspection, Trestle A'NB, ANB, & ASB

Chesapeake Bay Bridge and Tunnel District

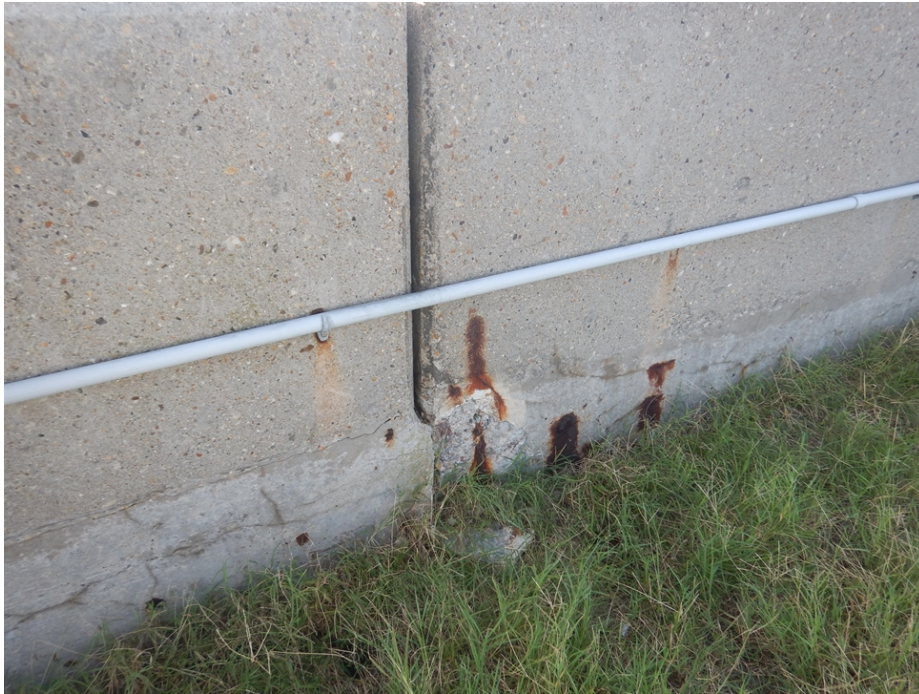
Photo 8.15-11: Portal Island 3 – Spalling on West Approach Wall Approximately 70' from North (Looking Southeast)

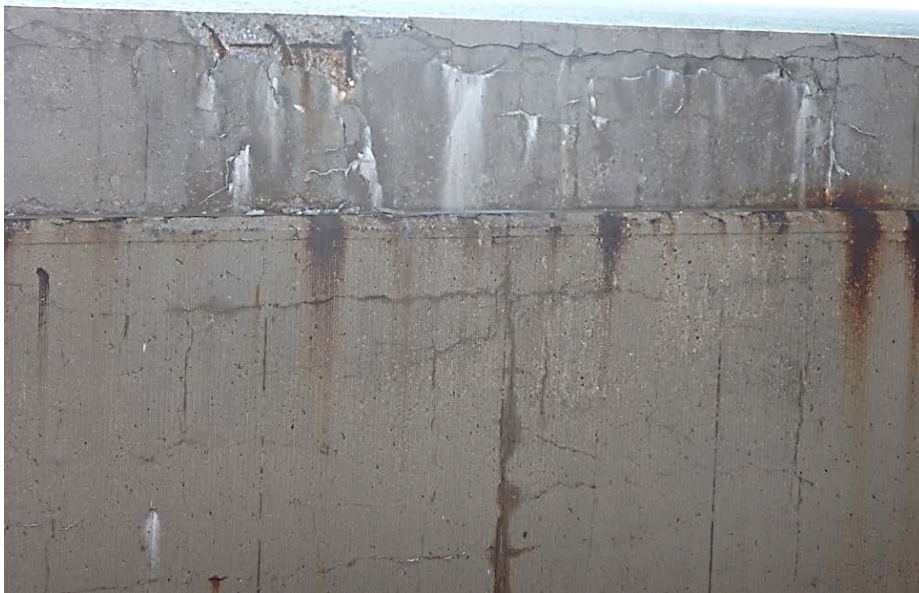
Photo 8.15-12: Portal Island 3 – Spalling with Exposed Reinforcement on top of East Approach Wall Approximately 500' from South (Looking Southeast)

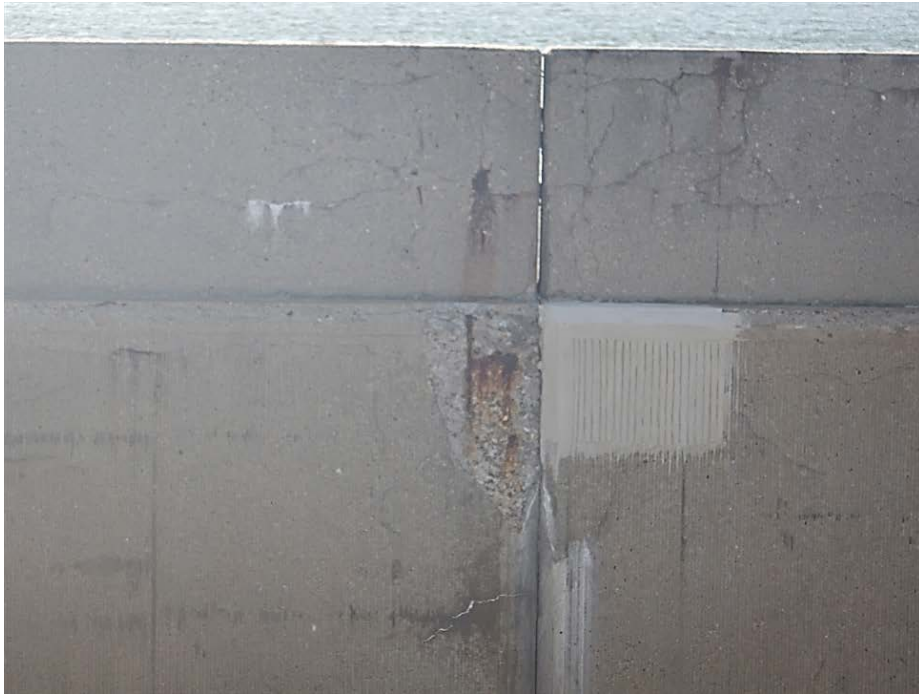
Photo 8.15-13: Portal Island 3 – Spalling with Exposed Reinforcement on East Approach Wall Approximately 100' from South (Looking East)

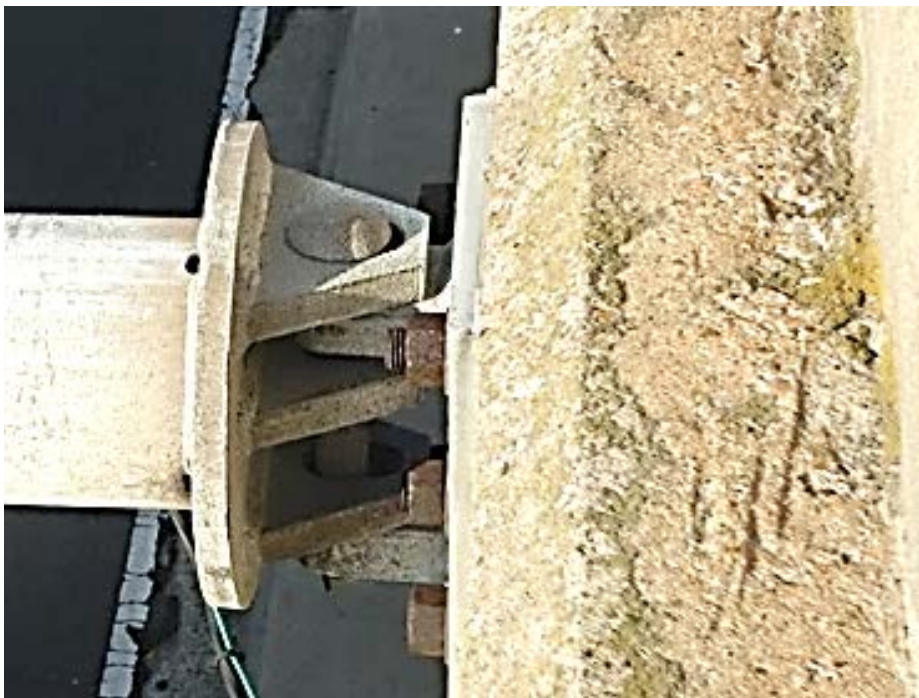
Photo 8.15-14: Portal Island 3 – Typical Overhead Signal Support Structure Condition with Surface Rust and Little to No Section Loss of Anchor Bolts (Looking South)

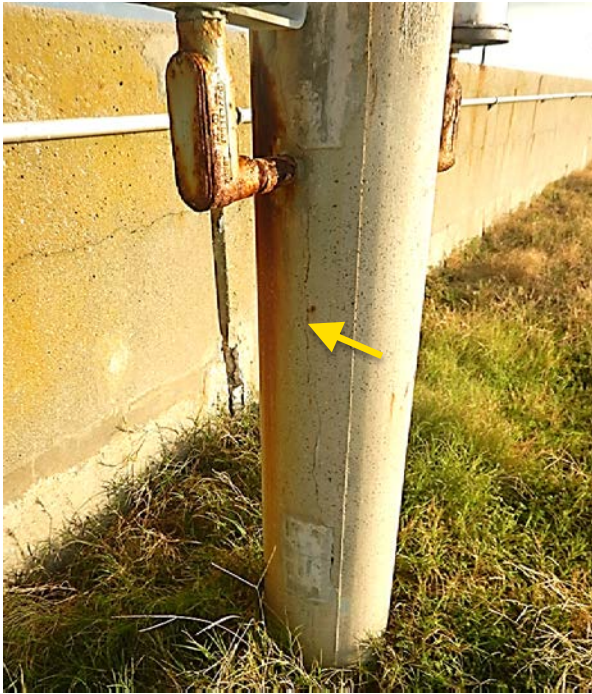
Photo 8.15-15: Portal Island 3 – 3rd Light Pole from Southeast Cracking at Base (Looking Northeast)

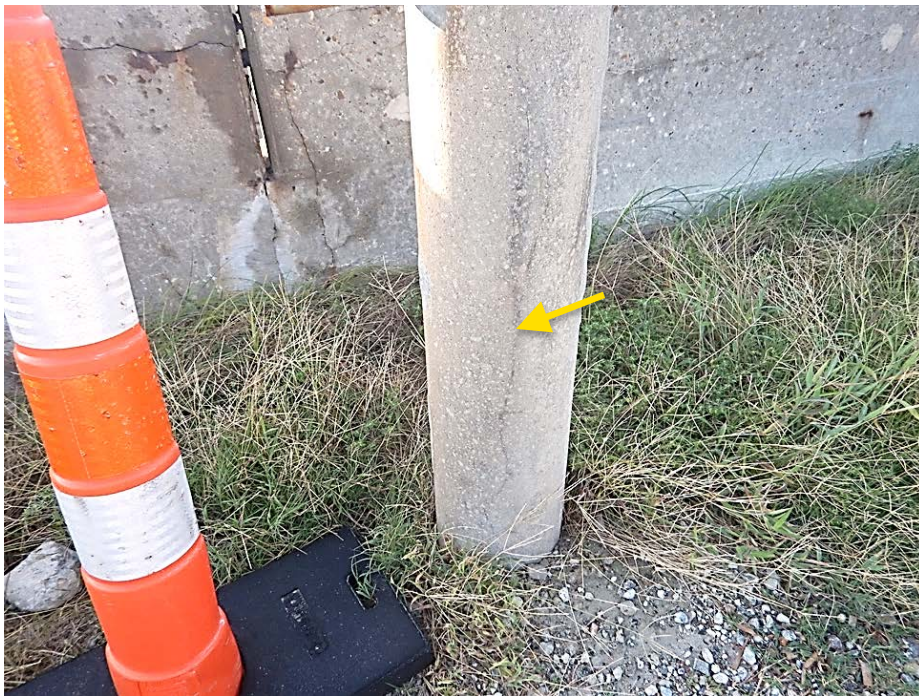
Photo 8.15-16: Portal Island 3 – 3rd Light Pole from Southwest Cracking at Base (Looking Northeast)

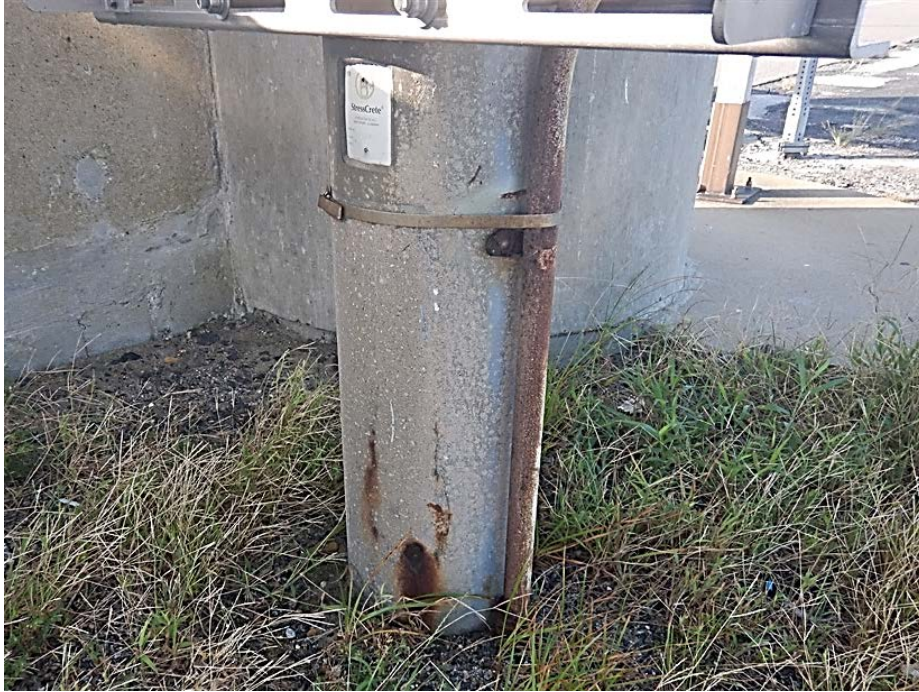
Photo 8.15-17: Portal Island 3 – Southwest Light Pole Cracking at Base (Looking Northeast)

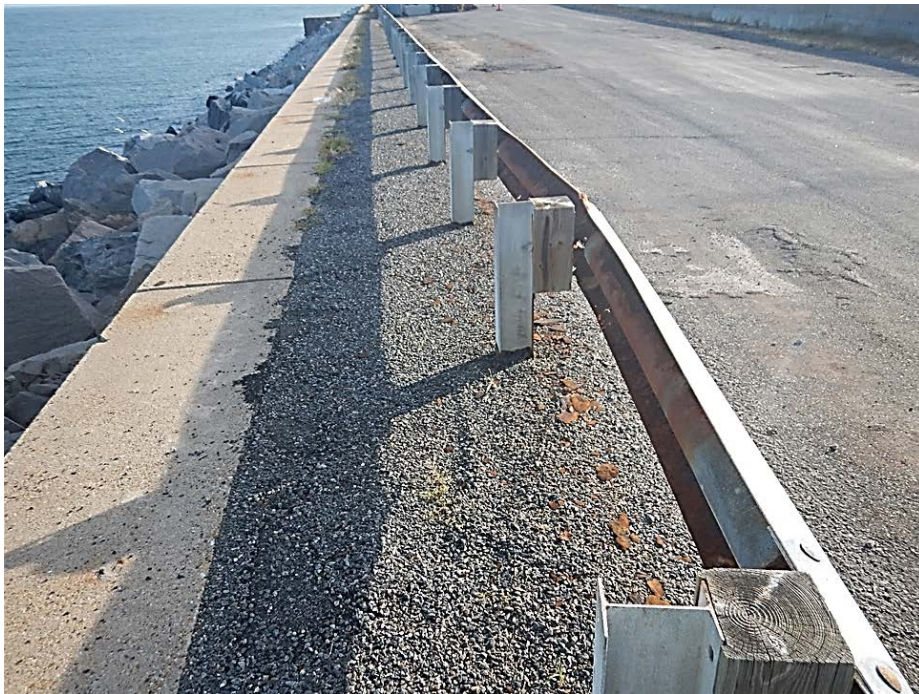
Photo 8.15-18: Portal Island 3 – Southwest Guardrail with Impact Damage and Corrosion with Isolated Areas of Complete Section Loss (Looking North)

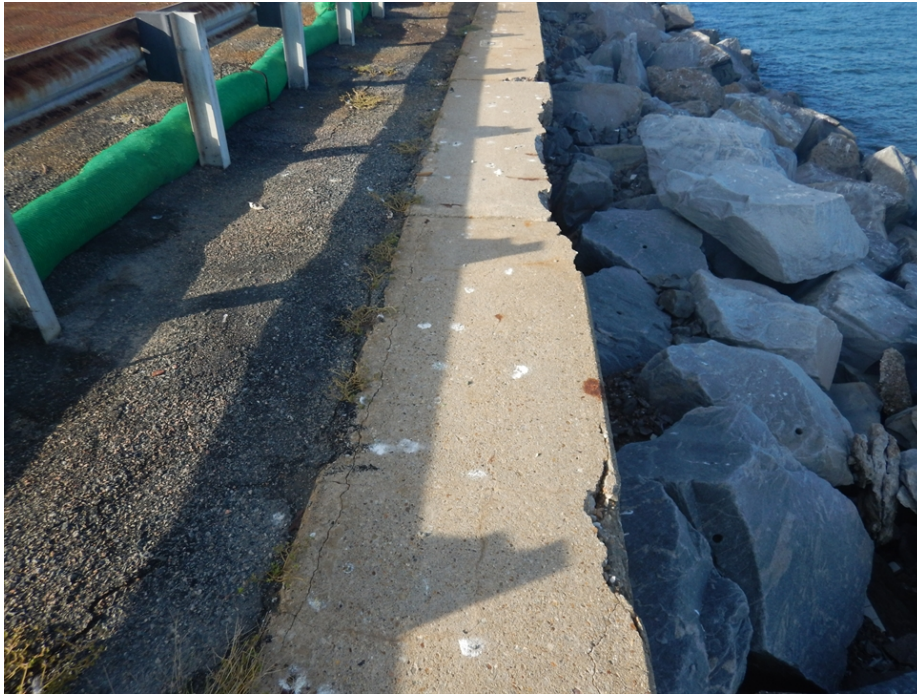
Photo 8.15-19: Portal Island 3 – Splash Wall Blocks 90-92, Typical Spalling along Splash Wall with Exposed Reinforcement (Looking South)

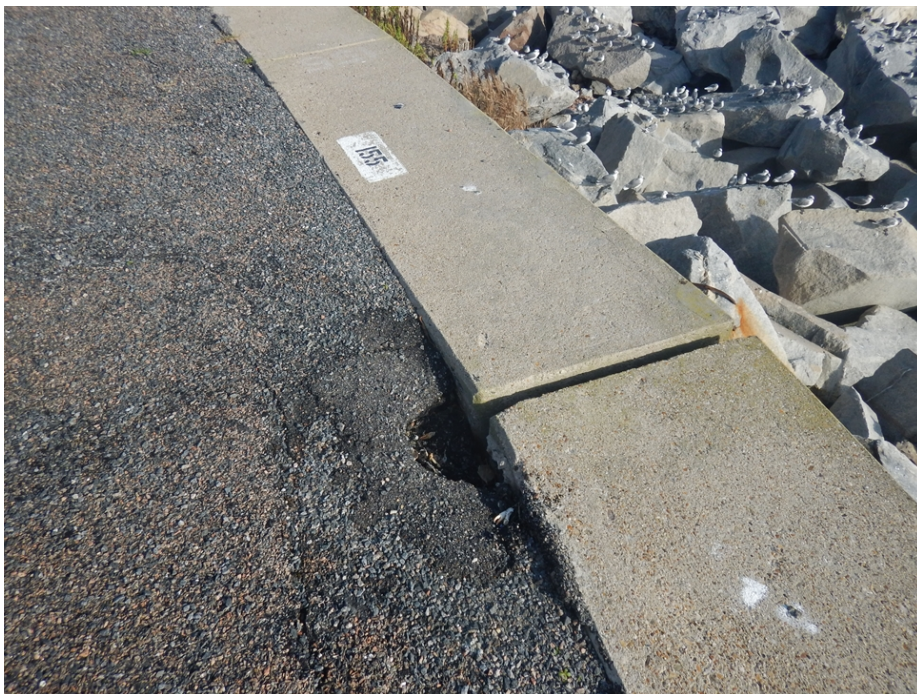
Photo 8.15-20: Portal Island 3 – Splash Wall Blocks 155-156, Typical Isolated Areas of Settlement and Erosion at Splash Wall Joints (Looking North)

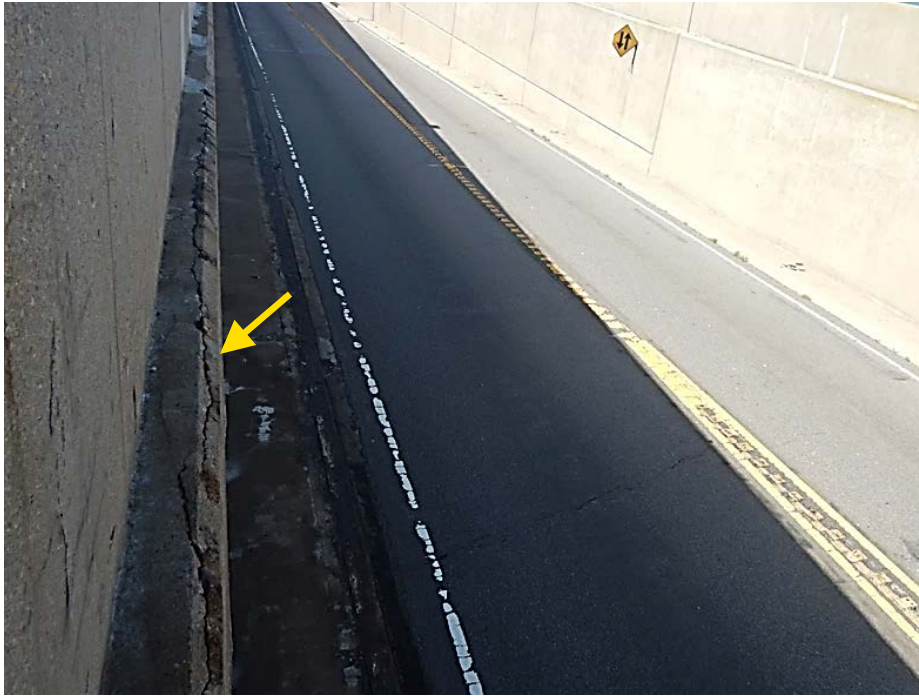
Photo 8.15-21: Portal Island 4 – Cracking/Delamination on East Approach Wall Approximately 150' from North (Looking South)

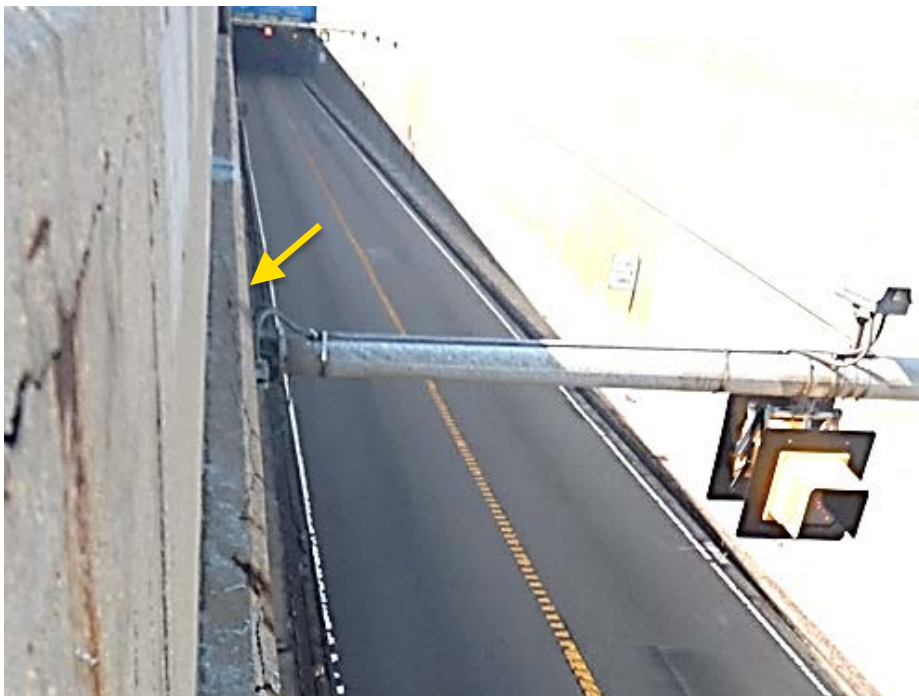
Photo 8.15-22: Portal Island 4 – Cracking/Delamination on East Approach Wall at Overhead Signal Anchorage Approximately 530' from North (Looking South)

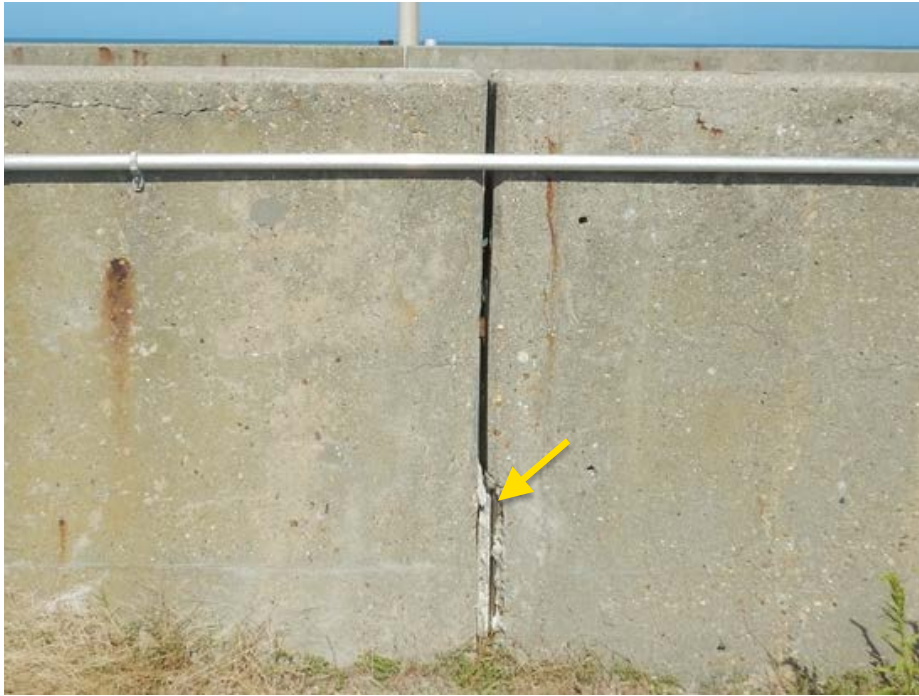
Photo 8.15-23: Portal Island 4 – Spalling at Location of Grounding Rod on East Approach Wall Approximately 600' from North (Looking West)

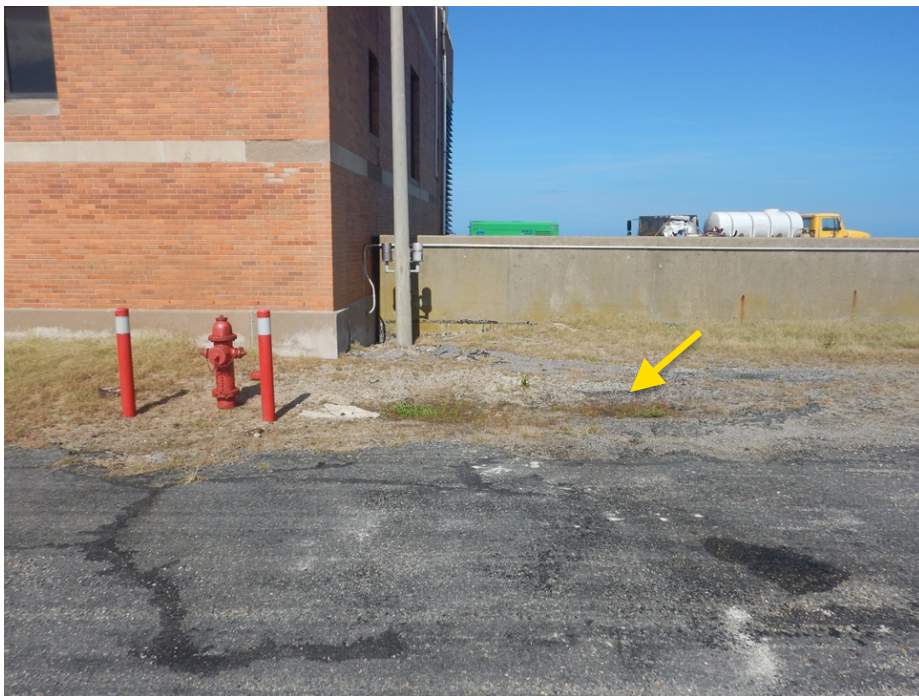
Photo 8.15-24: Portal Island 4 – Depression in Ground near Ventilation Building (Looking West)

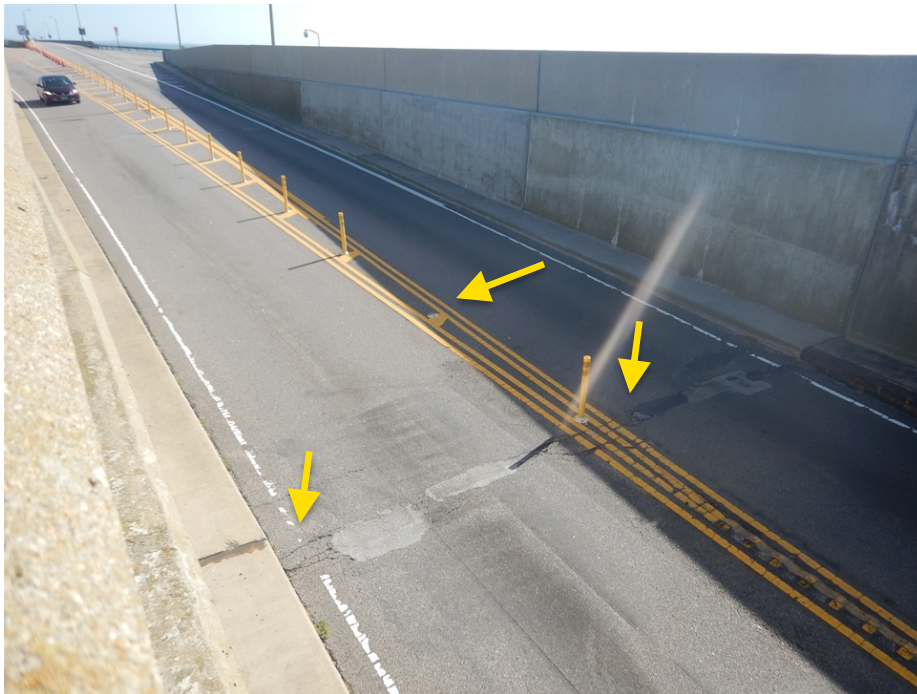
Photo 8.15-26: Portal Island 4 – Missing Delineator Post and Asphalt Cracking and Surface Spalling

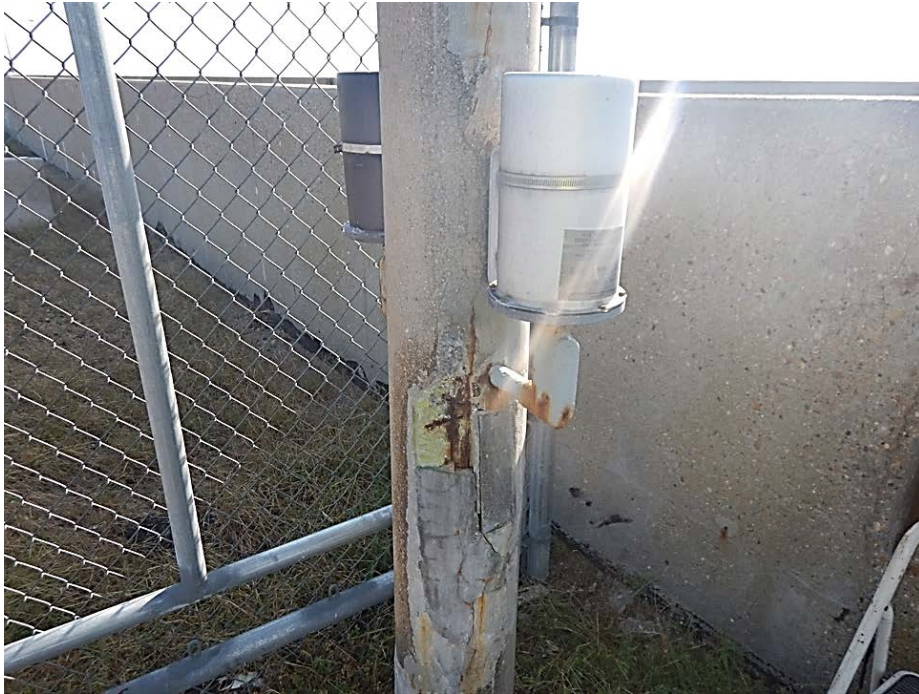
Photo 8.15-27: Portal Island 4 – Southwest Light Pole with Spalling with Exposed Reinforcement and Cracking extending towards the Base (Looking Northeast)

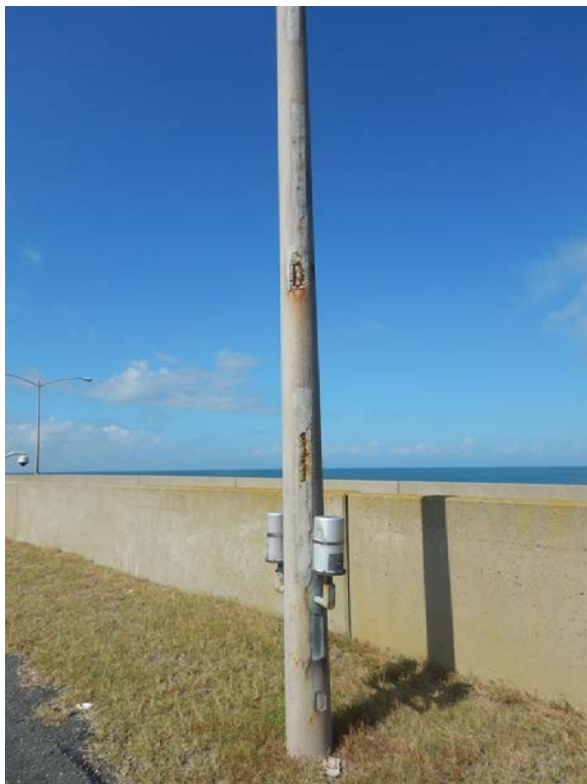
Photo 8.15-28: Portal Island 4 – 2nd Light Pole from Northeast with Failed Repairs and Cracking extending towards the Base (Looking Southwest)

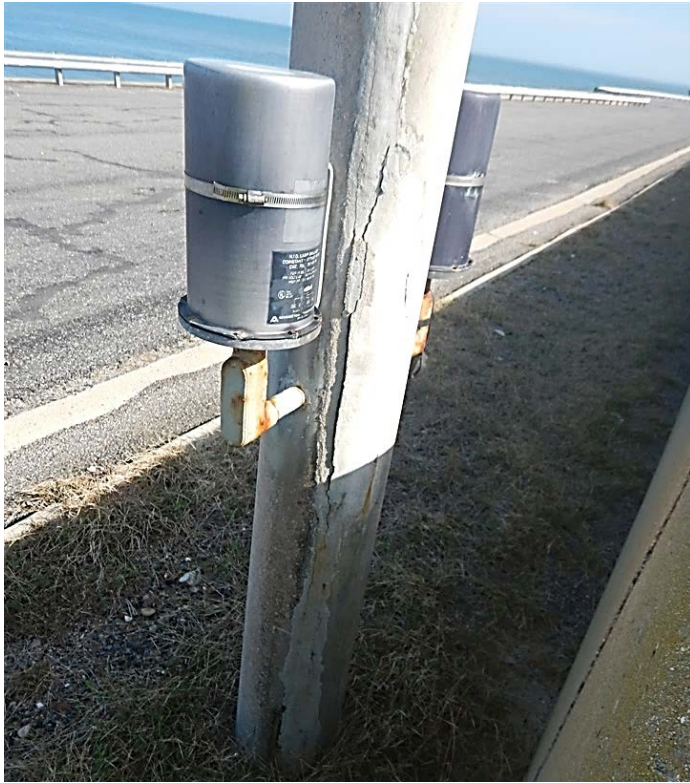
Photo 8.15-29: Portal Island 4 – 2nd Light Pole from Northwest with Delamination and Cracking extending towards the Base (Looking Northwest)

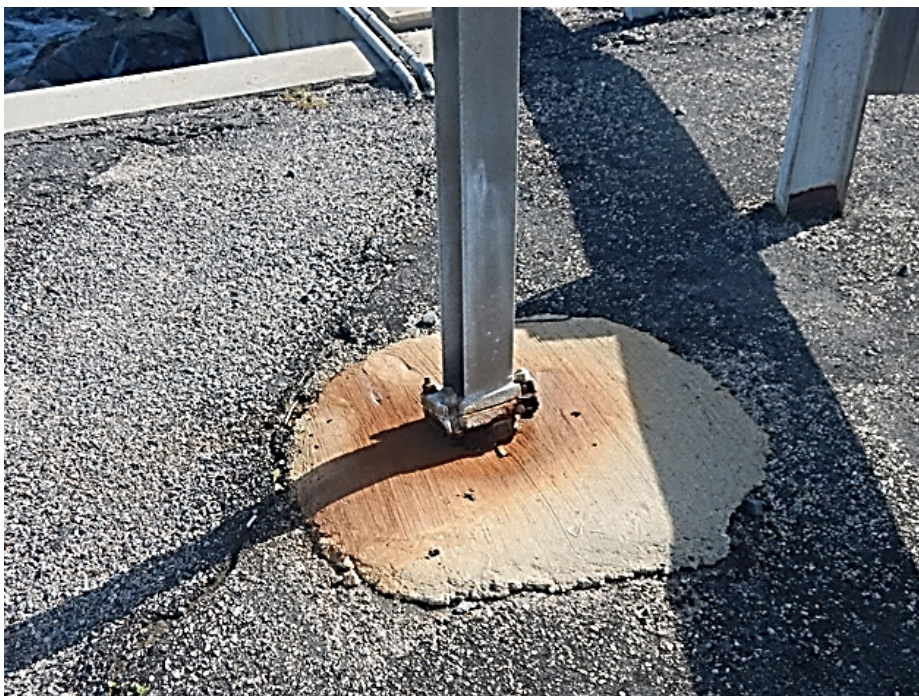
Photo 8.15-30: Portal Island 4 – Northwest Approach “Authorized Vehicles Only” Sign with Corroded Baseplate and Hardware (Looking Northeast)

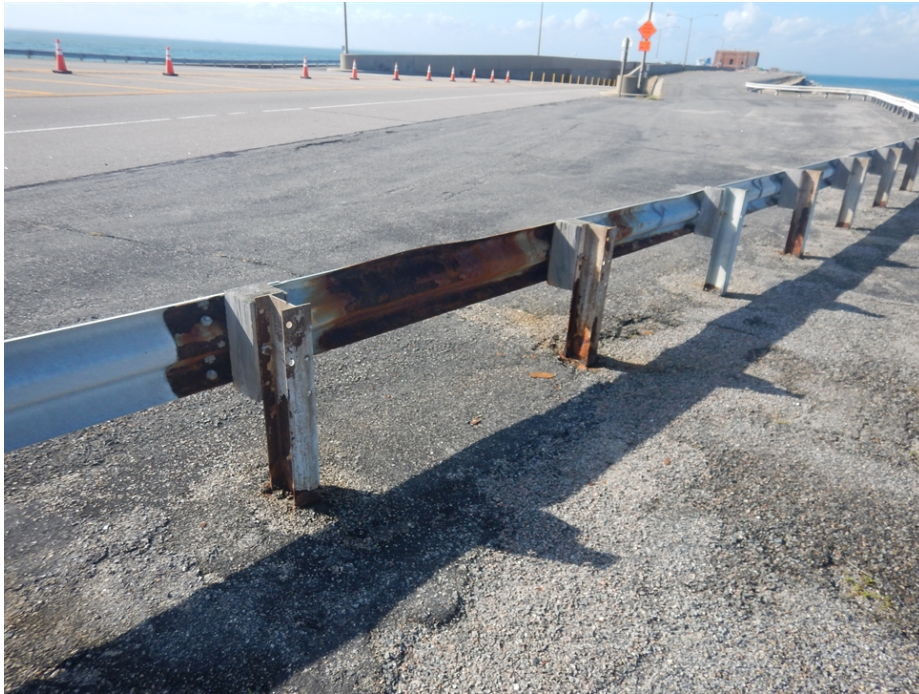
Photo 8.15-31: Portal Island 4 – Northwest Guardrail with Impact Damage and Corrosion with Isolated Areas of Significant Section Loss (Looking Southeast)

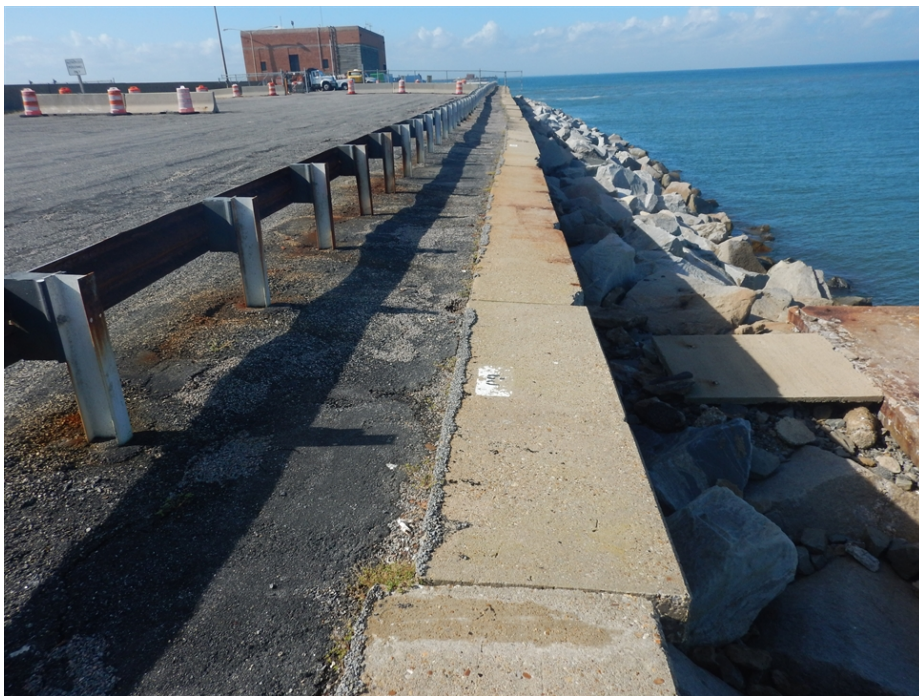
Photo 8.15-32: Portal Island 4 – Splash Walls Rotated Outward with Spalling (Looking South from Splash Wall 60)
