# **MIP** MATERIALS PERFORMANCE

JANUARY 2008

## **Corrosion of a Marine Bridge-Tunnel** *Cathodic Protection to the Rescue*

# Jackets Wrap Bridge Piles with Cathodic Protection

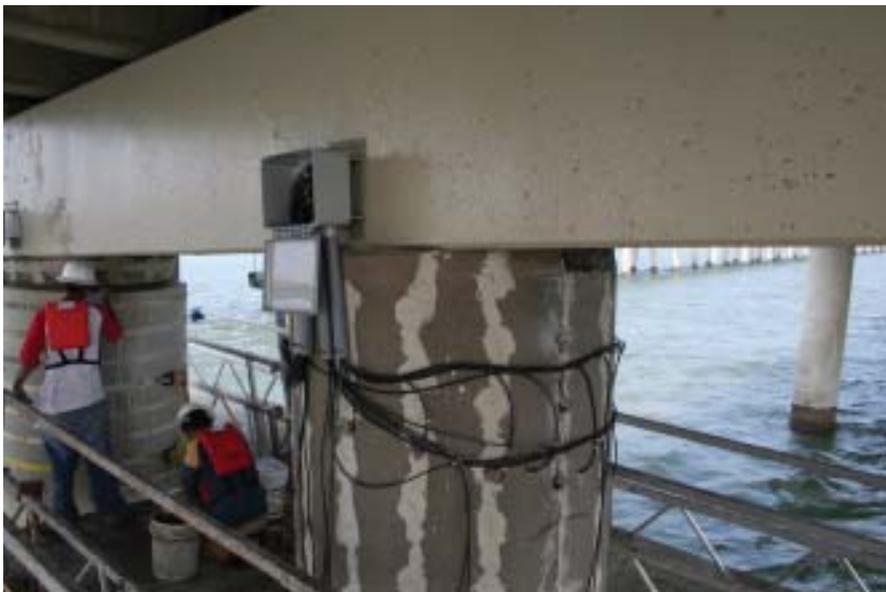
Each piece of reinforcing steel in the pile section is brazed to a lead wire and connected to a junction box on the pile cap. Photo courtesy of Precon Construction Co.

To do this, installers drill from the face of the pile into the concrete to expose a portion of the reinforcing steel, including the spiral wire and each prestressing strand, and then braze an American Wire Gauge (AWG) no. 10 copper wire onto the steel. Epoxy is applied at the connection point and the drill hole is plugged with grout material. “The piles have a unique reinforcement configuration because the reinforcing spiral wire in each segment is independent rather than continuous. So the spiral wire in each pile segment under the jacket must be connected,” Leng says. “Consequently, we use as many as 60 wires per pile for a single jacket system to ensure that all the steel is protected.”

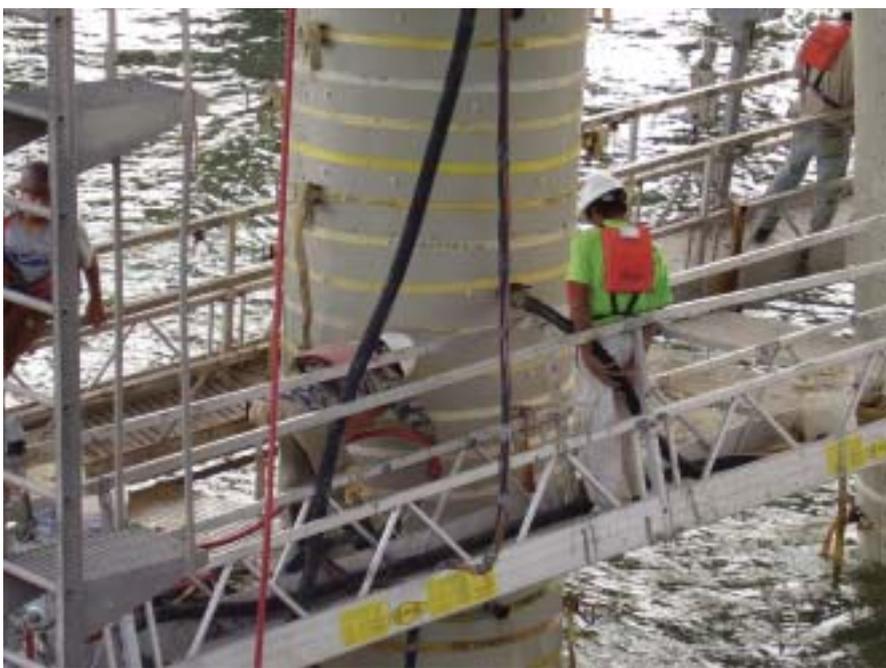
Installers fill the CP jacket with cementitious material to form a single monolithic fill about 2 in. thick. Photo courtesy of Douglas Leng, Corrosion Restoration Technologies.

Each fiberglass jacket is installed in four sections, and grout comprised of Portland cement and sand is pumped from the bottom of the jacket to the top from alternate pumping ports to create a single monolithic fill about 2 in. (51 mm) thick. The CP jackets, some of the largest the company has ever fabricated, were designed to withstand the high waves and swells resulting from the harsh Atlantic Ocean weather as well as maritime activities in the nearby shipping lanes. The jackets extend about 2 ft (0.6 m) below the mean low tide line up to ~ 1 ft (0.3 m) below the pile cap, for a total length of about 23 ft (7 m) with an inside diameter of 58 in. (147 cm).

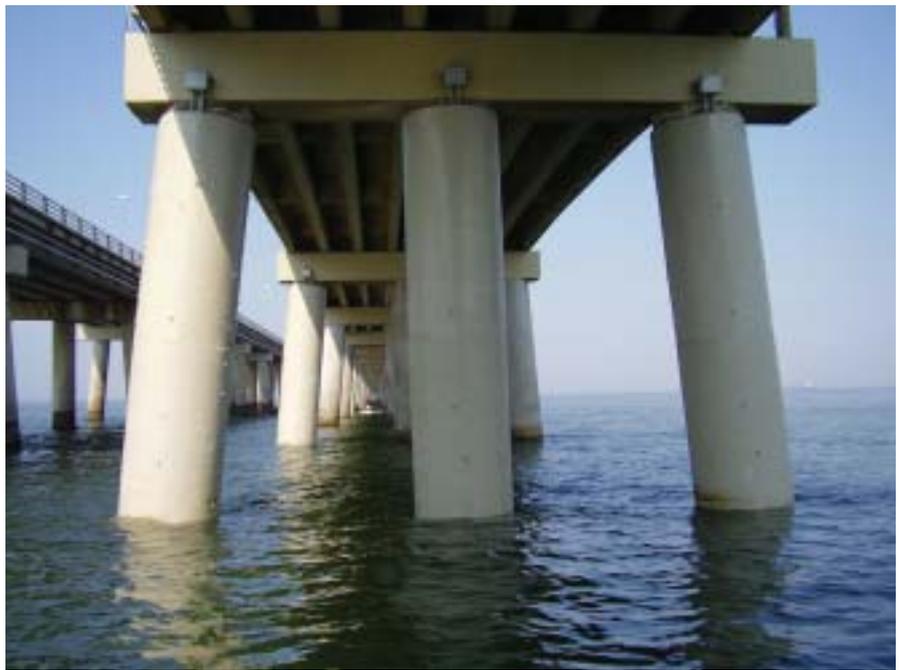
Bridge piles with installed galvanic CP jackets. Photo courtesy of Douglas Leng, Corrosion Restoration Technologies.

The CP jacket system is being installed on 215 of the structure’s piles. Not only does the jacket utilize galvanic CP to mitigate corrosion of the piles’ reinforcing steel, but it also creates a barrier against chlorides, moisture, and oxygen, explains Mather. To form the galvanic cell, the pile’s reinforcing steel is accessed and cathode lead wires from the steel are routed to a junction box bolted on the pile cap. The anode lead wires are also routed to the junction box as the jacket is being installed. “The majority of the anode material, about 600 lb (272 kg) of zinc, is inside the jacket,” Mather adds.
