| | | <p style="text-align: center;"> <b>CBRT NB NORTH CHANNEL</b><br/> <b>BRIDGE REPAIRS</b><br/> <b>REPAIR TYPE I - I</b> </p> | |

| <p align="center"> <b>CBBT NB NORTH CHANNEL</b><br/> <b>BRIDGE REPAIRS</b><br/> <b>REPAIR TYPE I - II</b> </p> | | | |

COMMONWEALTH OF VIRGINIA  
DEPARTMENT OF TRANSPORTATION  
STRUCTURE AND BRIDGE DIVISION  
**CBBT NB NORTH CHANNEL  
BRIDGE REPAIRS  
REPAIR TYPE 3 - 1**

| PROJECT: STEEL BRIDGE REPAIRS | | | |

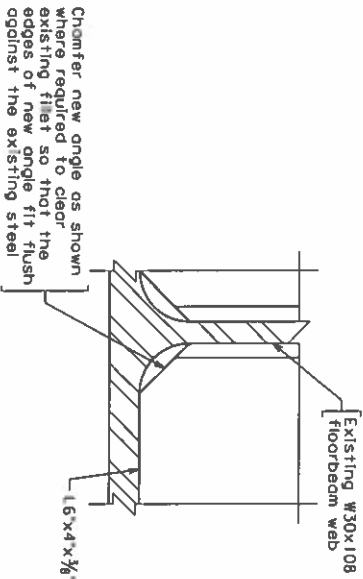
**DETAIL B**  
Scale: 3/16" = 1'

- Near top flange, locate fillet weld crack along bearing stiffener and grind out affected weld flush to base metal. Base metal shall not be removed during grinding. Check weld area with dye penetrant or magnetic particle testing to ensure the crack has been removed. All ground out weld areas are to be the same length on both sides of the stiffener.

- If the crack has propagated into the base metal, locate the ends of the crack(s) using some non-destructive testing methods and arrest the crack tip as shown in Detail A. Clean and grind corroded areas as required.

- Achieve tight fit condition for two opposing fill plates and mill to bear condition for the first angle and temporarily clamp all in place. Ensure alignment of the clamped shop drilled holes as a template, field drill through the fill plates and the floorbeam web. Achieve a mill to bear condition for the second angle on this same side of the floorbeam web. Also align with the field drilled holes in the fill plate. Repeat process for the opposite side of the floorbeam web. With all four angles clamped in place and using the shop drilled holes as a template, field drill through the floorbeam web and the opposite side angle.
