CHESAPEAKE BAY BRIDGE AND TUNNEL DISTRICT
			RMF 5044.5122 - STEEL BRIDGE PAINTING PROJECT
PROJECT NOTES			
No.	Description	Date	Designed: JSE Drawn: BSB Checked: AHC
			12/18/2025
	Revision		1 OF 45

CHESAPEAKE BAY BRIDGE AND TUNNEL DISTRICT	
			RMF 5044.5122 - STEEL BRIDGE PAINTING PROJECT	
NORTH CHANNEL BRIDGE NB GENERAL PLAN AND ELEVATION				
No.	Description	Date	Designed: JSE Drawn: BSB Checked: AHC	Date Plan No. Sheet No.
	Revision			12/18/2025 3 OF 45

CHESAPEAKE BAY BRIDGE AND TUNNEL DISTRICT							
			RMF 5044.5122 - STEEL BRIDGE PAINTING PROJECT							
NORTH CHANNEL BRIDGE NB STRINGER AND FLOORBEAM PLATING REPAIRS										
No. Description Date Designed: JSE Drawn: JSE Checked: AHC 12/18/2025 9 OF 45										
	Revision

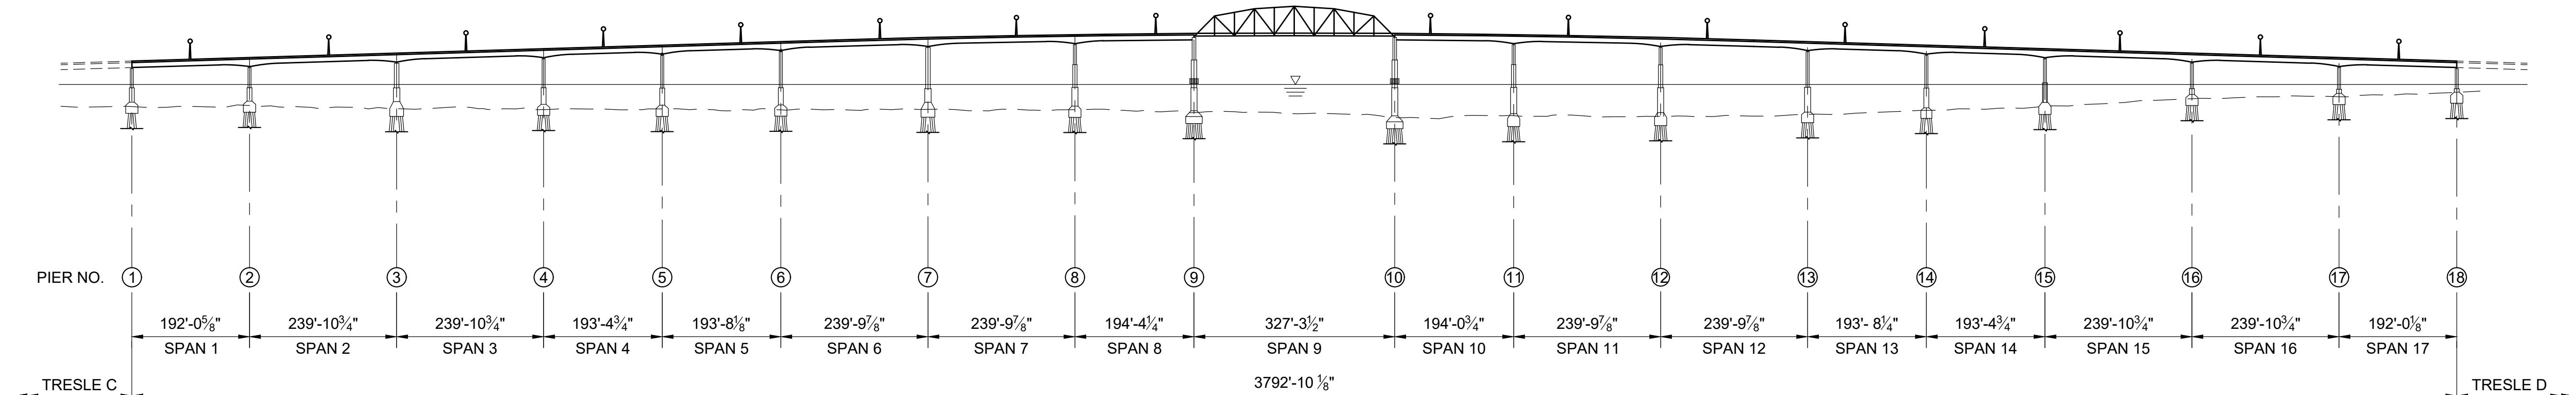
PLAN

THIS SIDE OF STRUCTURE IS REFERRED TO IN THE REPAIR DETAILS AS "EAST" IN CONJUNCTION WITH "NORTHBOUND" TERMINOLOGY

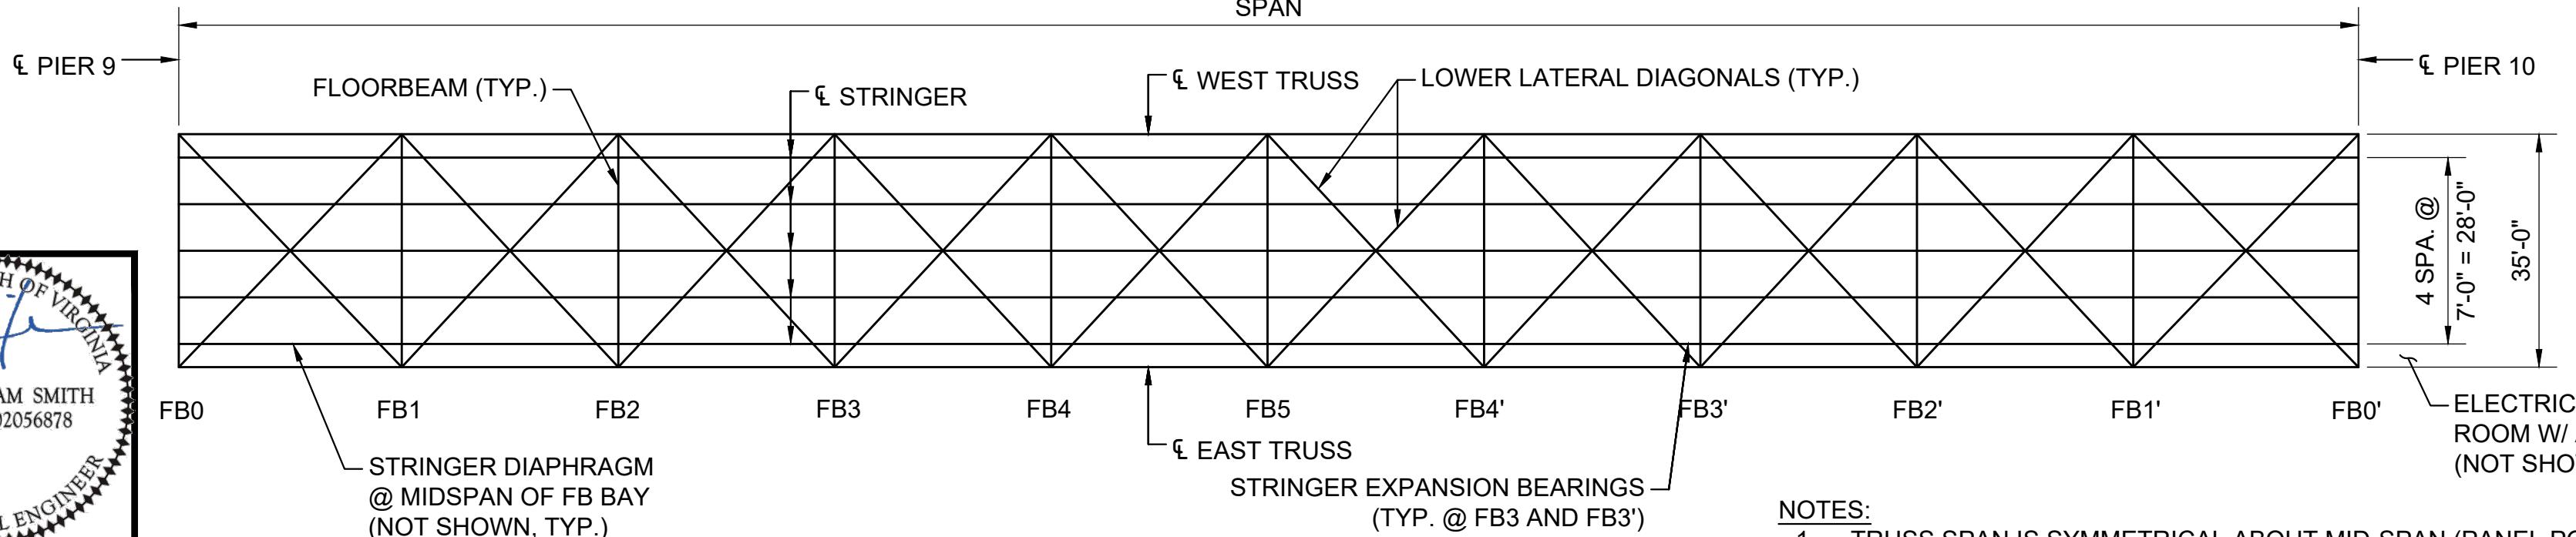
FRAMING PLAN TRUSS SPAN

1. TRUSS SPAN IS SYMMETRICAL ABOUT MID-SPAN (PANEL POINT 5). UNLESS OTHERWISE NOTED, REFERENCES IN REPAIR DETAILS TO PANEL POINTS 0 THROUGH 4 ALSO APPLY TO PANEL POINTS 4' THROUGH 0.
2. SPANS 1 - 8 AND 10 - 17 ARE TWO-GIRDER.

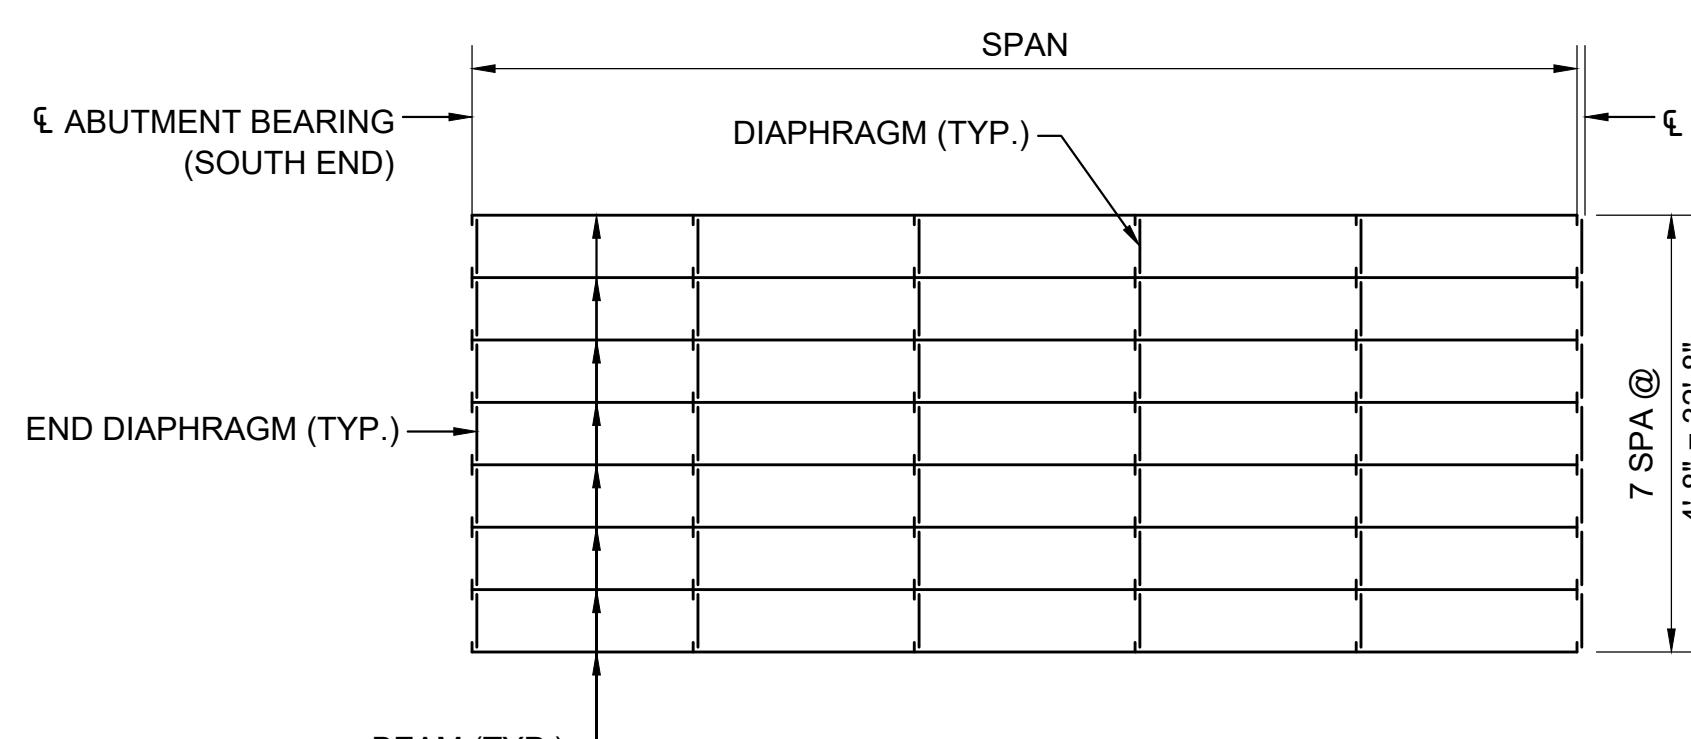
FRAMING PLAN
SPANS BSB1 AND CSB1

SPAN	SPAN LENGTH "A"
ASB1	73'-1"
ASB204	115'-1 1/4"
BNB1-2	107'-1 1/2"
BSB1	107'-10 11/16"
BSB202	114'-0 1/8"
CSB1	112'-11"

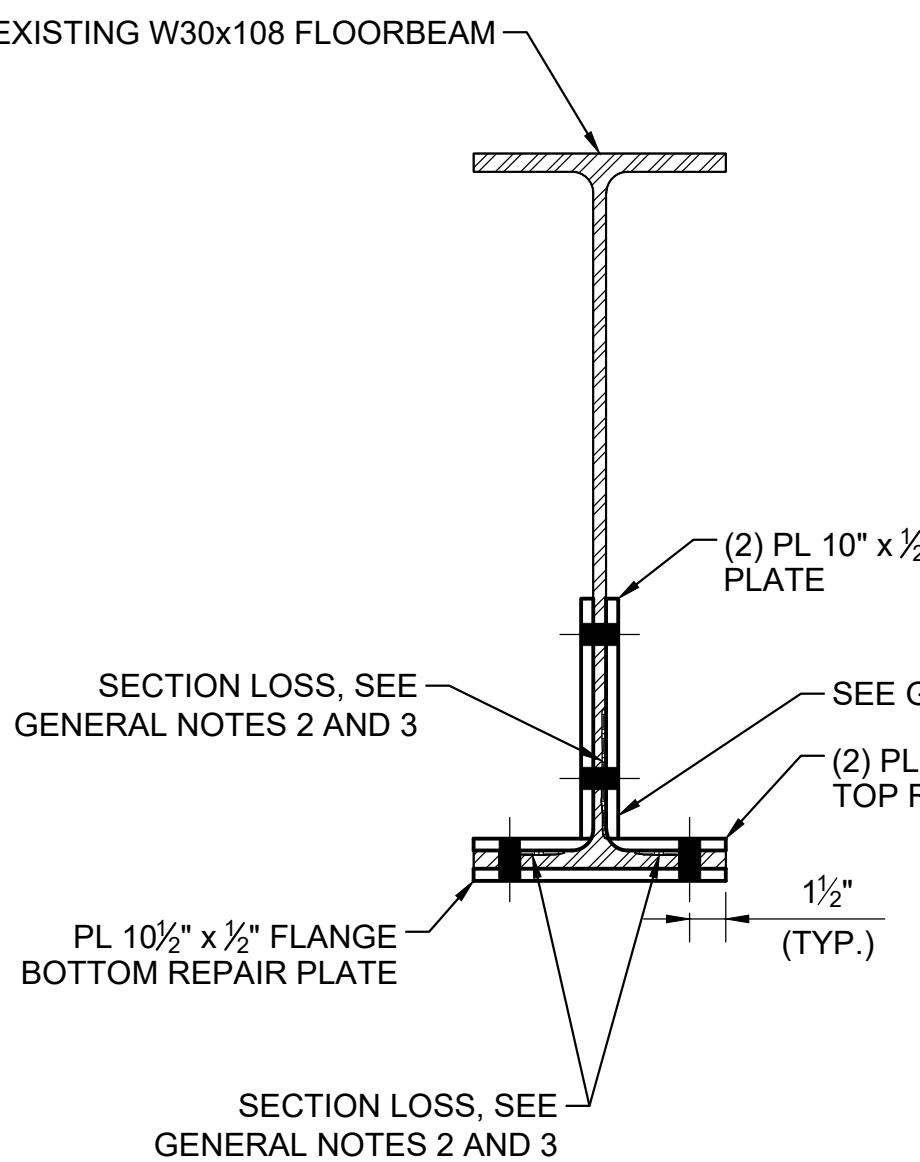
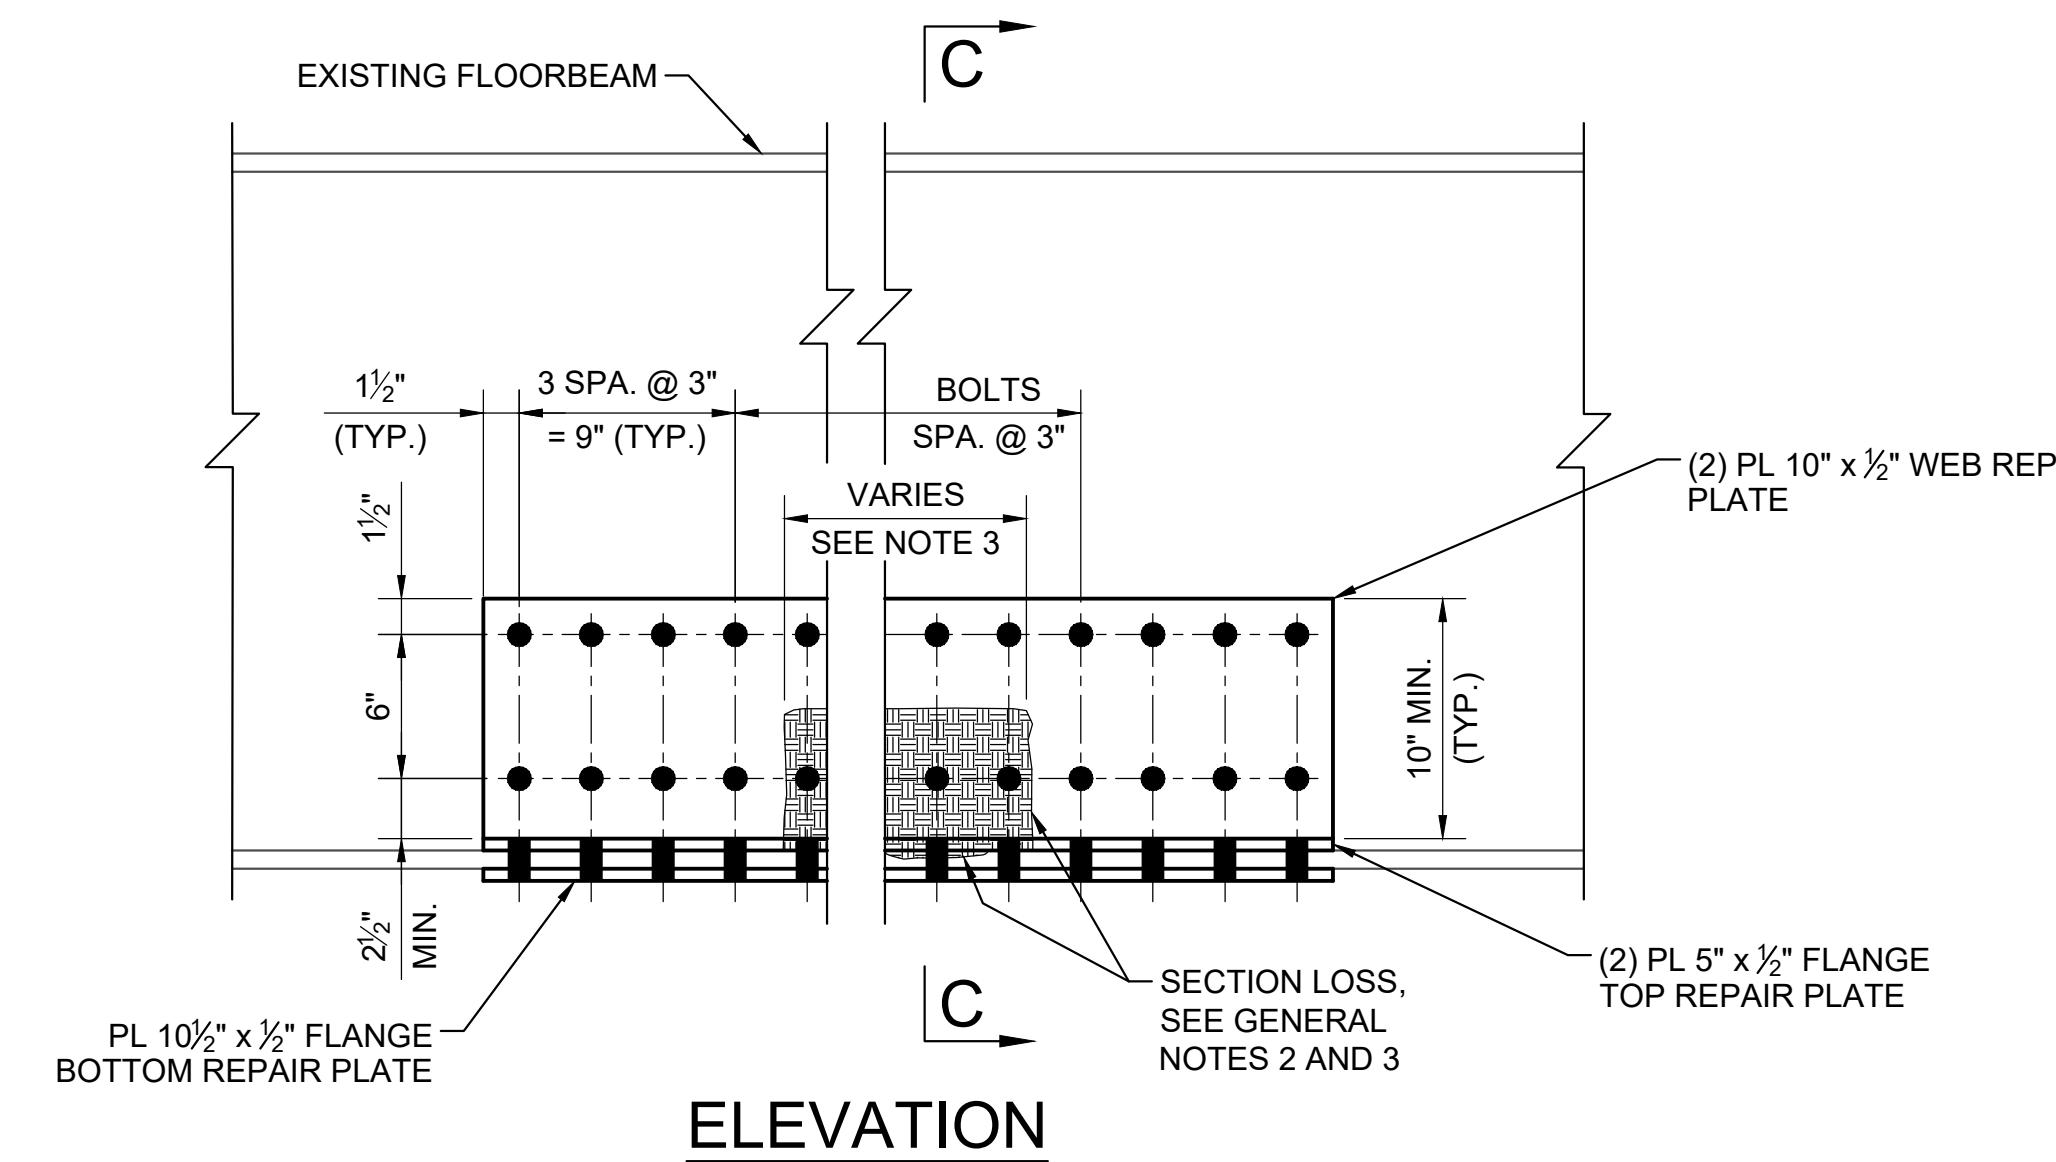
NCB-NB FLOORBEAM REPAIR TYPE

1. PERFORM THIS REPAIR IN NCB-NB SPANS 1-8 AND 10-17 FOR FLOORBEAMS WITH BOTTOM FLANGE CORROSION TOTAL SECTION LOSS EXCEEDING 10% OF THE ORIGINAL CROSS-SECTIONAL AREA OF THE FLANGE (APPROX. 0.76" THICK x 10.5" W) AS APPROVED BY THE DISTRICT.
2. IF FLANGE SECTION LOSS EXCEEDS 50% OF THE ORIGINAL FLANGE SECTION OR IF WEB SECTION LOSS EXCEEDS $\frac{1}{4}$ " DEEP AND EXTENDS FURTHER THAN 6" FROM THE BOTTOM FLANGE, CONTACT THE DISTRICT FOR DIRECTION.
3. TOTAL LENGTH OF REPAIR FOR THIS DETAIL IS EXPECTED TO VARY FROM APPROX. 4' TO APPROX. 12', WITH A TYPICAL AVERAGE OF 8'.

1. DETAILS ARE SHOWN AND ANNOTATED ASSUMING REPAIR PLATES ARE ASSEMBLED ACCORDING TO DETAIL 'A'. THE CONTRACTOR MAY SUBSTITUTE ASSEMBLY IN ACCORDANCE WITH DETAIL 'B' AT NO ADDITIONAL COST TO THE DISTRICT.
2. GRIND ALL CORROSION TO SMOOTH BARE METAL.
3. FILL ALL GAPS WITH STEEL-FILLED EPOXY PUTTY.
4. ADJUST PLATING PER BEAM END ALTERNATE DETAIL ON NEXT SHEET IF SECTION LOSS OCCURS AT END OF STRINGER OR FLOORBEAM. MAINTAIN FASTENER AND PLATE DETAILS BETWEEN SECTION LOSS AND CENTER OF STRINGER OR FLOORBEAM SPAN PER STRUCTURE SPECIFIC DETAILS.

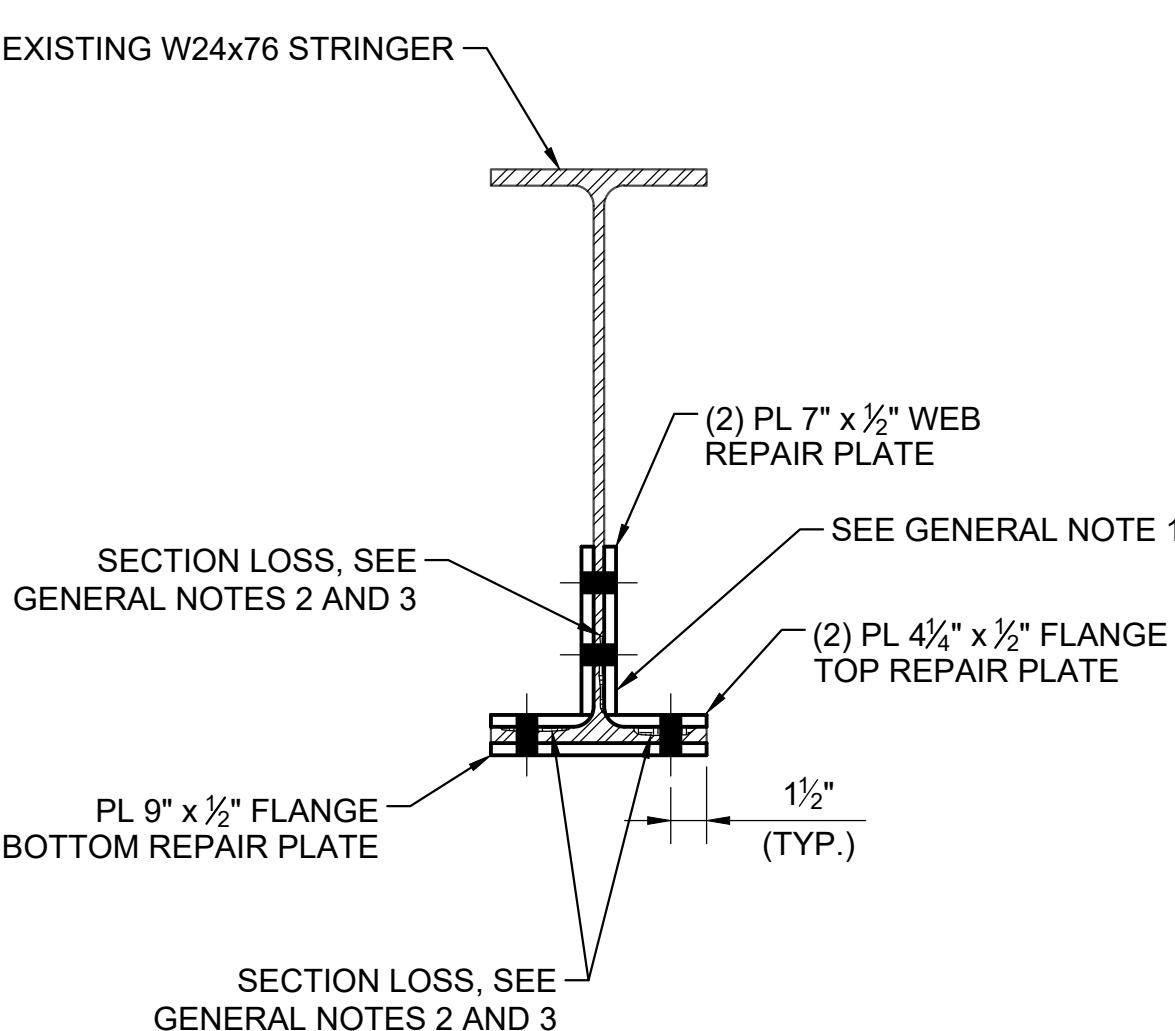
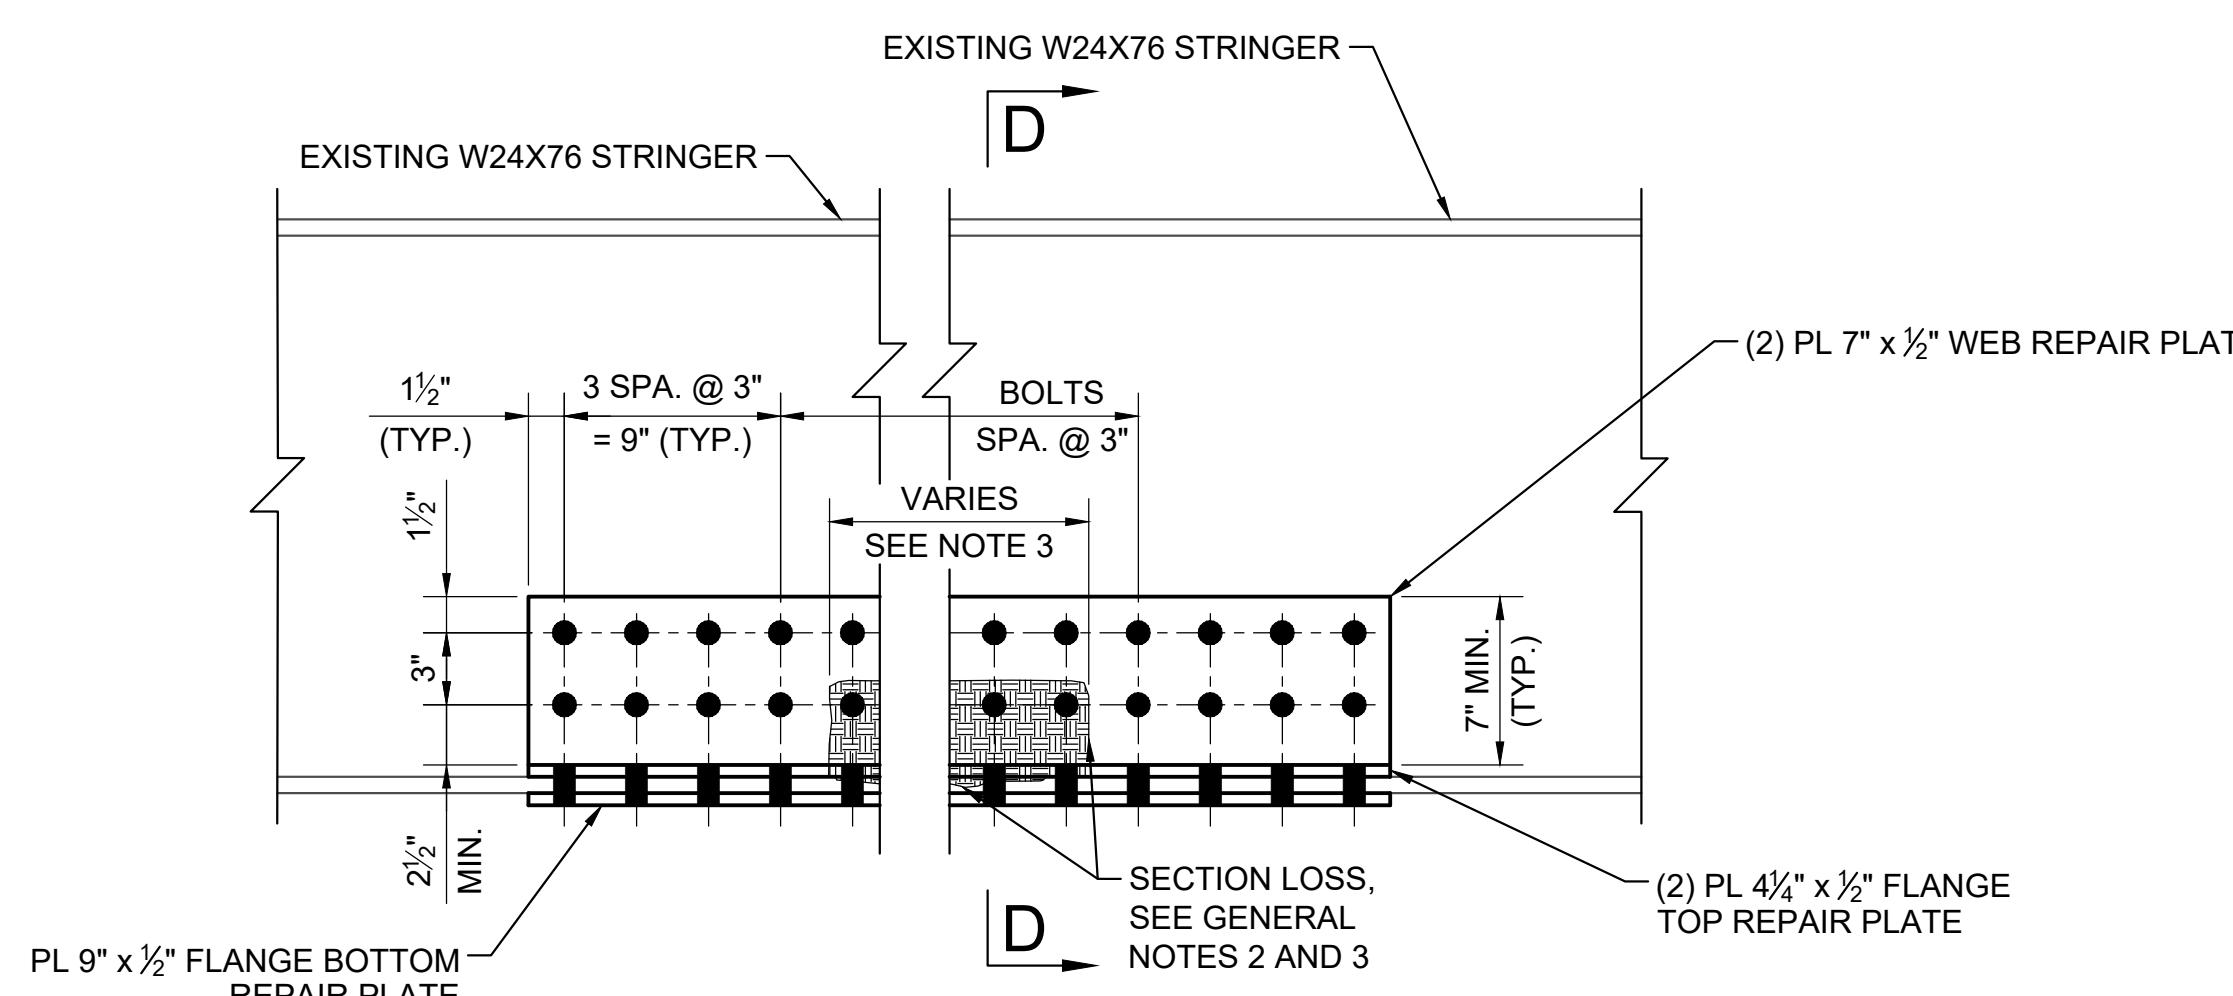
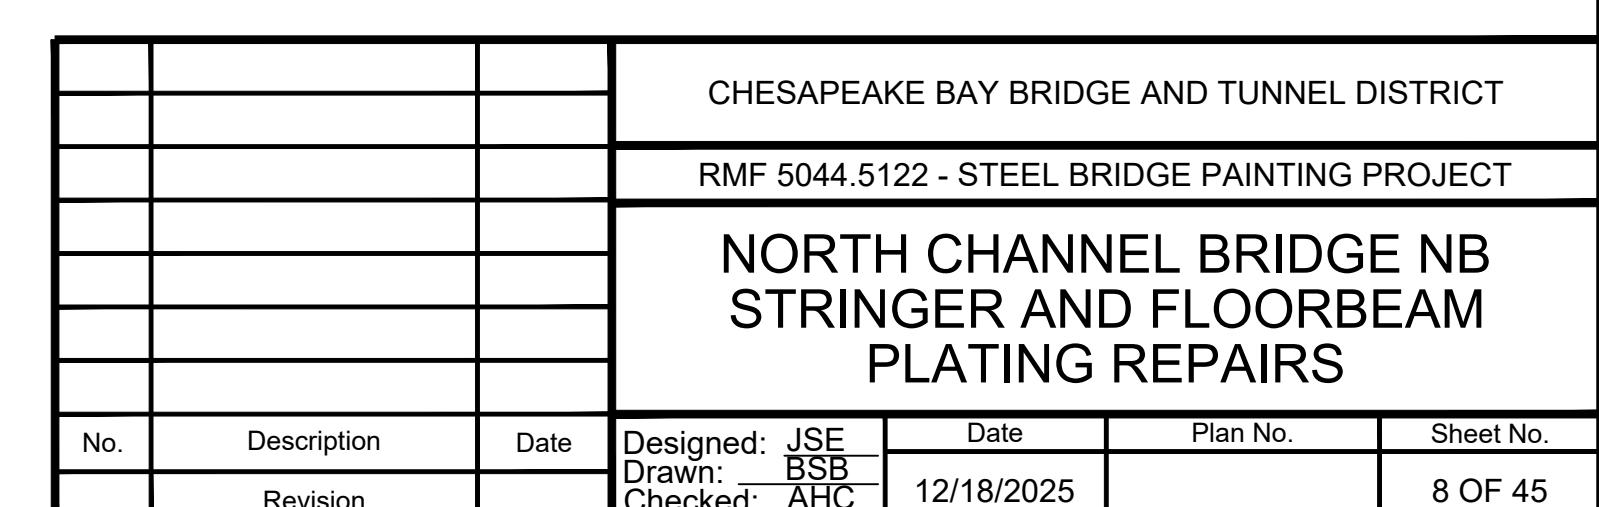
NCB-NB STRINGER REPAIR TYPE

1. PERFORM THIS REPAIR IN NCB-NB SPANS 1-8 AND 10-17 FOR STRINGERS WITH BOTTOM FLANGE CORROSION TOTAL SECTION LOSS EXCEEDING 10% OF THE ORIGINAL CROSS-SECTIONAL AREA OF THE FLANGE (APPROX. 0.68" THICK x 9.0" W) AS APPROVED BY THE DISTRICT.
2. IF FLANGE SECTION LOSS EXCEEDS 50% OF THE ORIGINAL FLANGE SECTION OR IF WEB SECTION LOSS EXCEEDS $\frac{1}{4}$ " DEEP AND EXTENDS FURTHER THAN 4" FROM THE BOTTOM FLANGE, CONTACT THE DISTRICT FOR DIRECTION.
3. TOTAL LENGTH OF REPAIR FOR THIS DETAIL IS EXPECTED TO VARY FROM APPROX. 4' TO APPROX. 12', WITH A TYPICAL AVERAGE OF 8'.

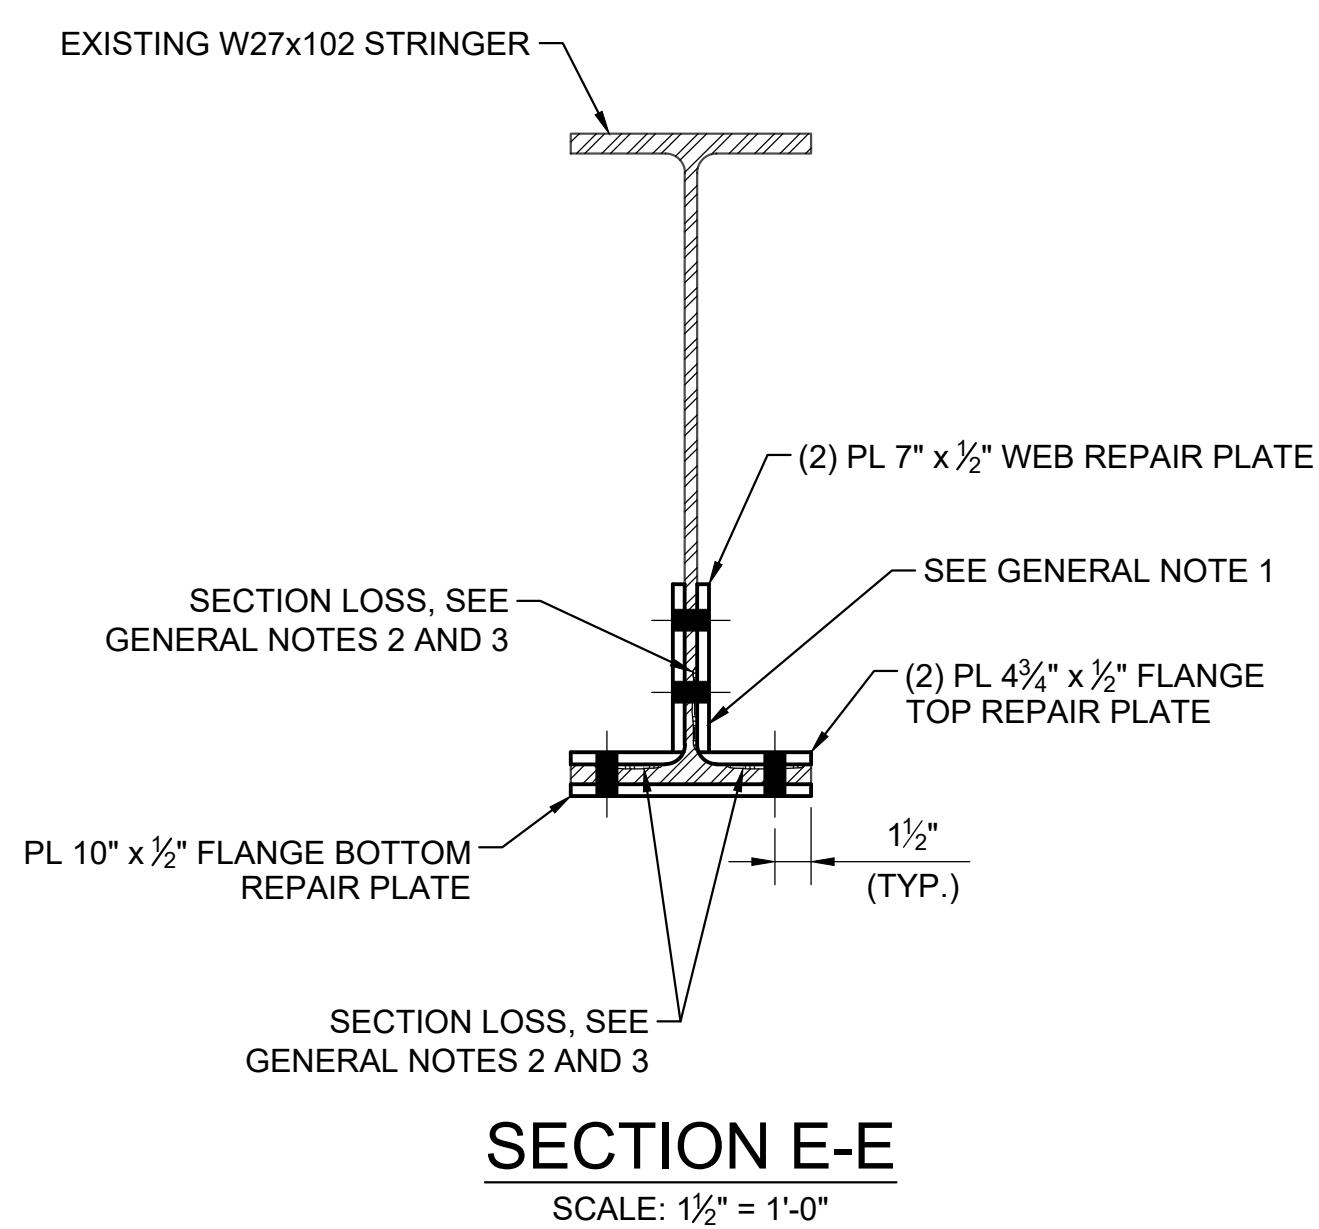
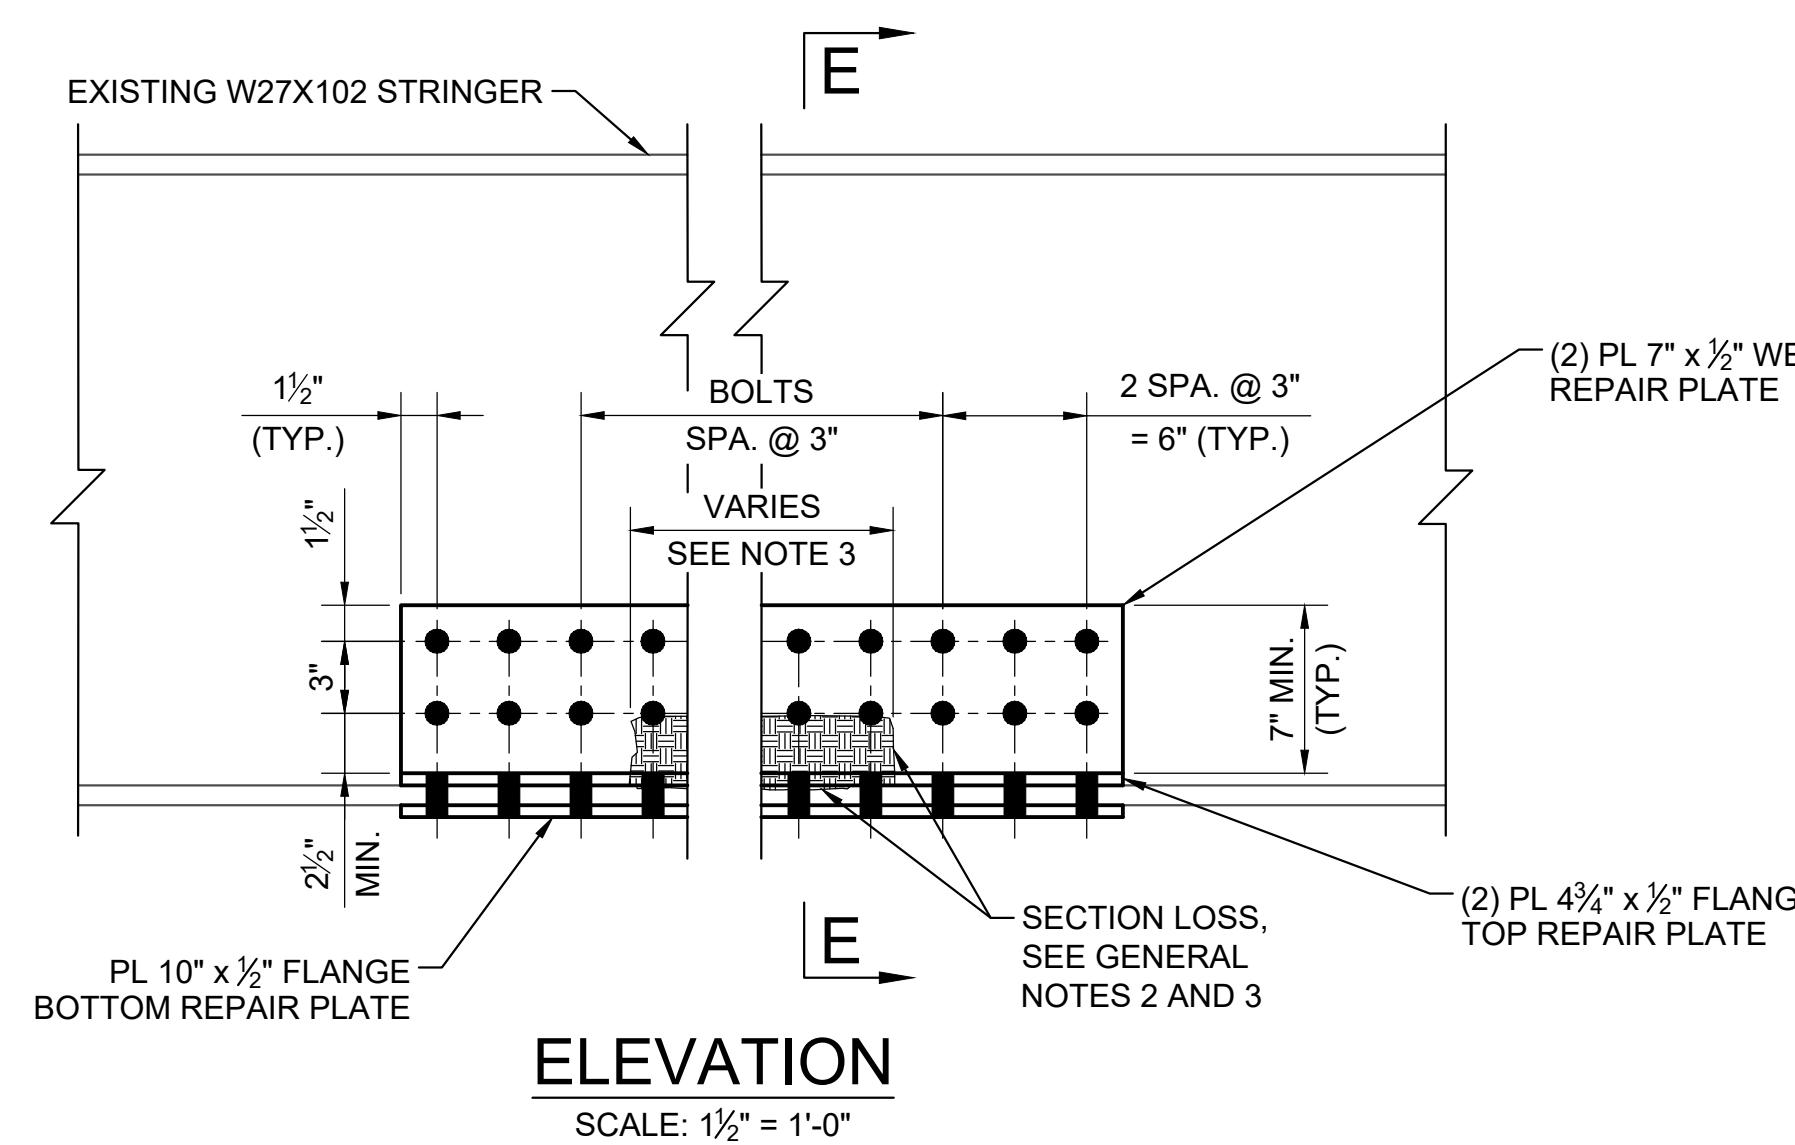
NCB-NB TRUSS STRINGER REPAIR TYPE 1

1. PERFORM THIS REPAIR FOR NCB-NB SPAN 9 (TRUSS SPAN) STRINGERS WITH BOTTOM FLANGE CORROSION TOTAL SECTION LOSS EXCEEDING 10% OF THE ORIGINAL CROSS-SECTIONAL AREA OF THE FLANGE (APPROX. 0.83" THICK X 10.0" W) AS APPROVED BY THE DISTRICT.
2. IF FLANGE SECTION LOSS EXCEEDS 50% OF THE ORIGINAL FLANGE SECTION OR IF WEB SECTION LOSS EXCEEDS $\frac{1}{4}$ " DEEP AND EXTENDS FURTHER THAN 3" FROM THE BOTTOM FLANGE, CONTACT THE DISTRICT FOR DIRECTION.
3. TOTAL REPAIR LENGTH FOR THIS DETAIL IS EXPECTED TO AVERAGE APPROXIMATELY 3'.
4. IF SECTION LOSS OCCURS AT OR NEAR A MIDSPAN DIAPHRAGM CONNECTION PLATE, ADJUST PLATING AS SHOWN IN DETAIL F. MAINTAIN MINIMUM OF (6) FASTENERS THRU FLANGE AND (6) FASTENERS THRU WEB ON EACH SIDE OF EXISTING SECTION LOSS.

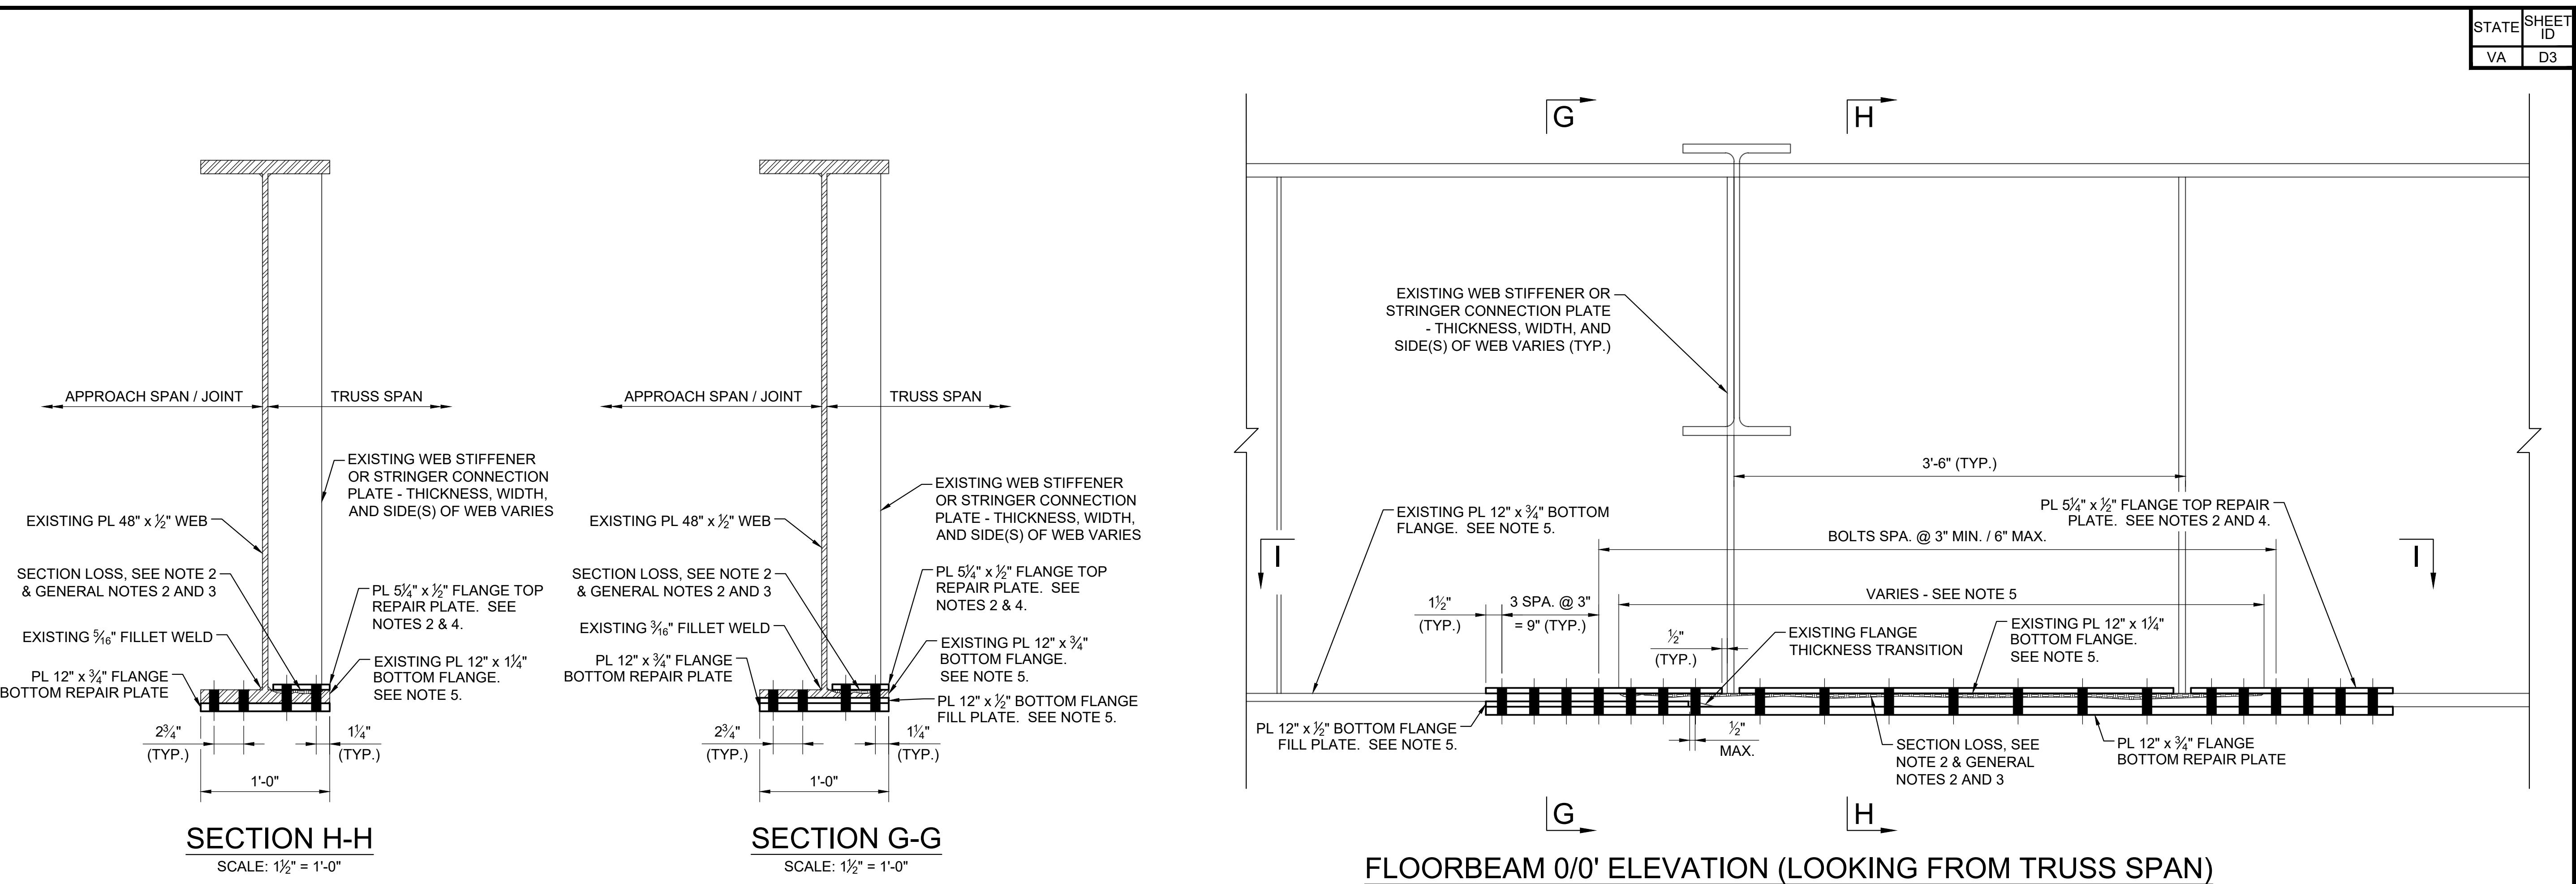
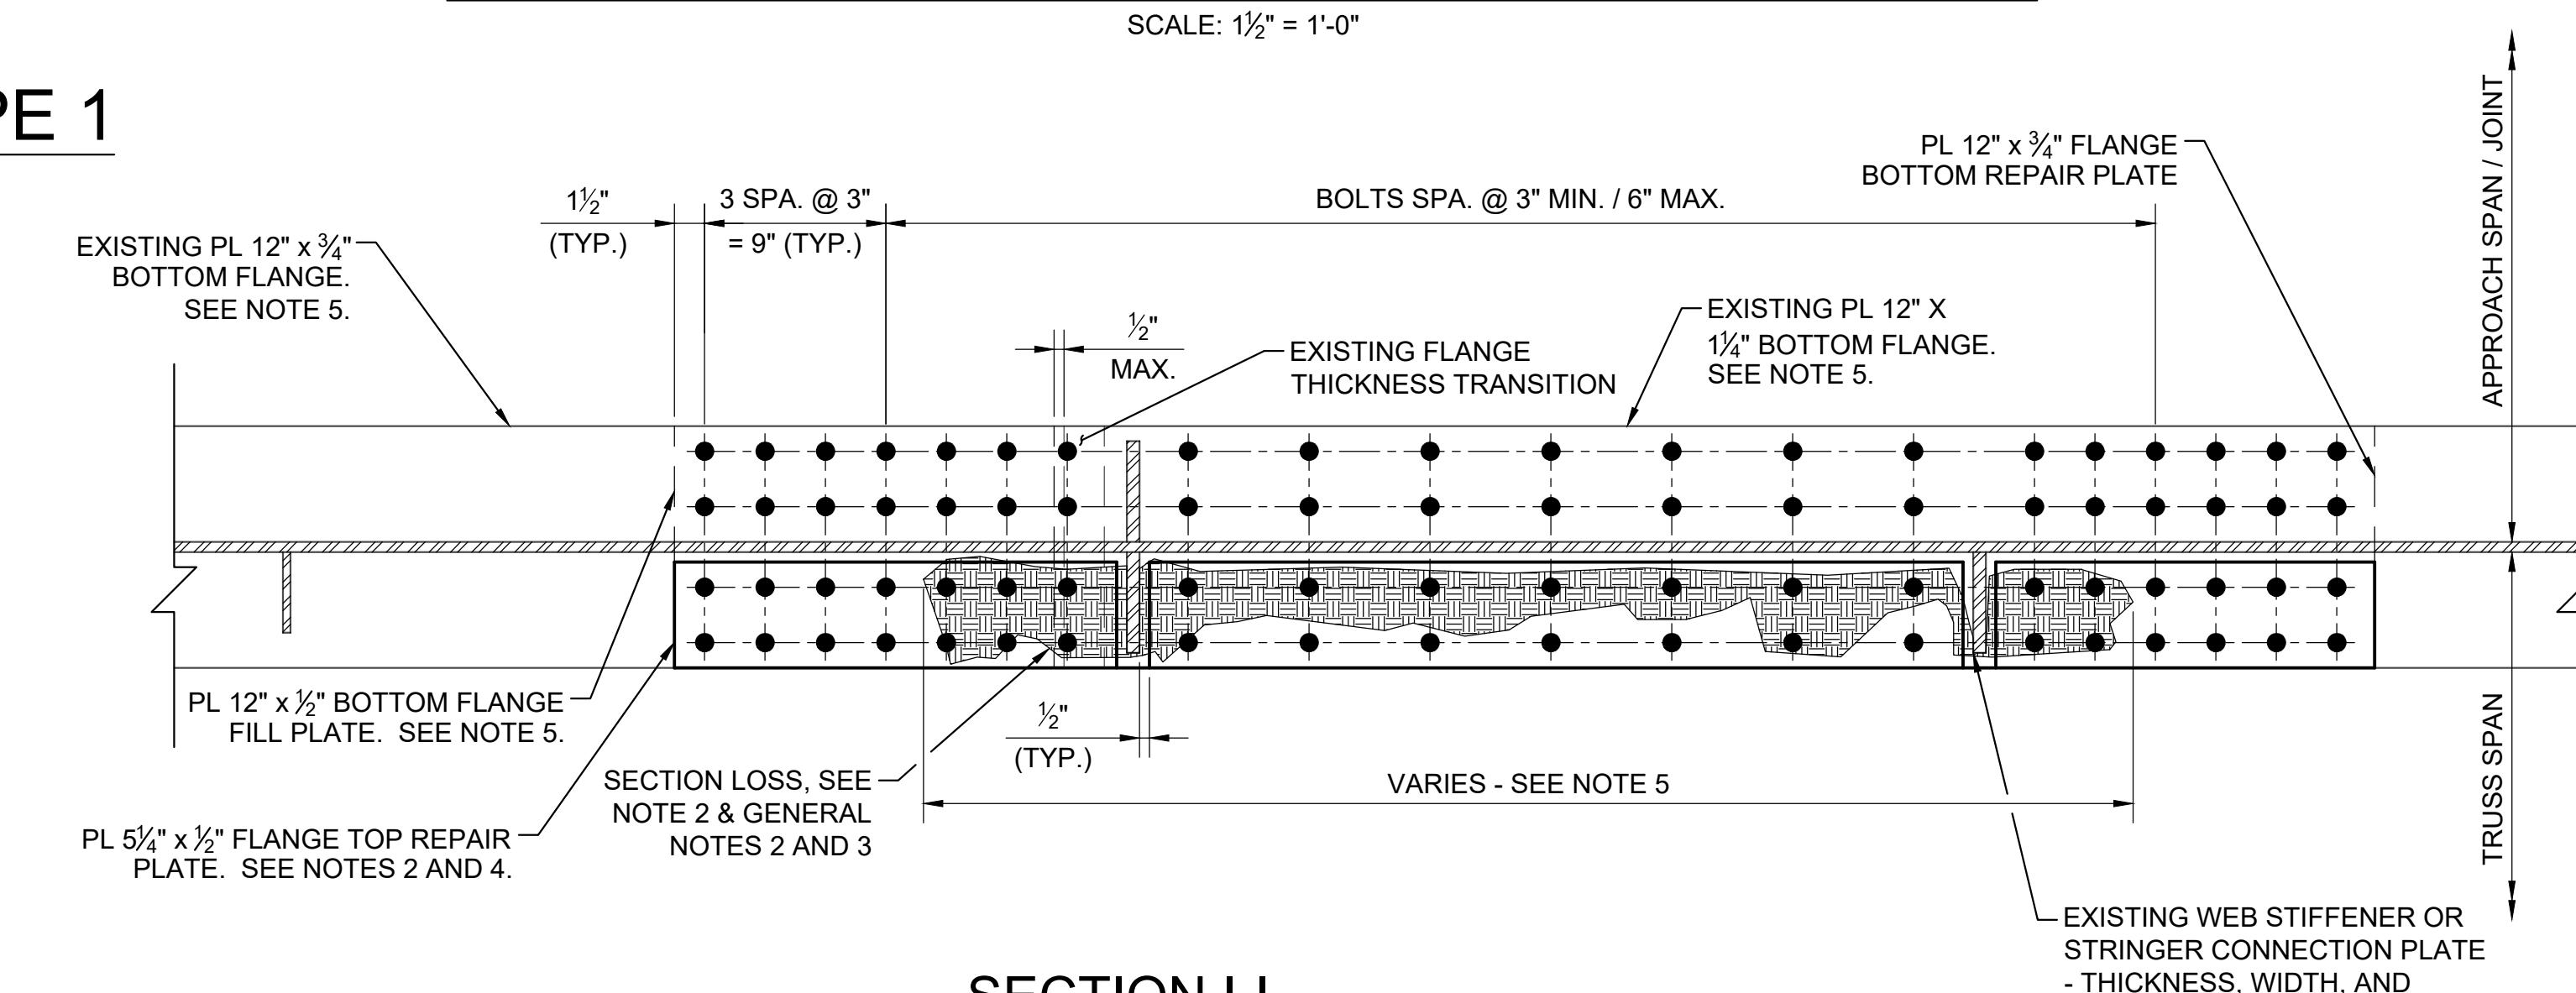
NCB-NB TRUSS FLOORBEAM TYPE 1

1. PERFORM THIS REPAIR FOR NCB-NB SPAN 9 (TRUSS SPAN) FLOORBEAMS 0 AND 0' FOR LOCATIONS WITH BOTTOM FLANGE TOP SURFACE CORROSION SECTION LOSS EXCEEDING 10% OF THE ORIGINAL CROSS-SECTIONAL AREA OF THE FLANGE AS APPROVED BY THE DISTRICT. IF SECTION LOSS EXCEEDS 50% OF THE ORIGINAL FLANGE CROSS-SECTIONAL AREA CONTACT THE DISTRICT FOR DIRECTION.

2. ALL CORROSION SECTION LOSS OF $\frac{1}{4}$ " OR DEEPER IS EXPECTED TO BE ON THE TRUSS-SPAN-SIDE TOP SURFACE OF THE BOTTOM FLANGE. IF CORROSION SECTION LOSS OF $\frac{1}{4}$ " OR DEEPER x 3" WIDE FOR GREATER THAN 2" LONG IS EXHIBITED ON THE APPROACH-SPAN/JOINT-SIDE OF THE BOTTOM FLANGE, PLACE AN ADDITIONAL FLANGE TOP REPAIR PLATE, SIZE AS NOTED IN DETAIL, ON THAT SIDE OF THE FLANGE.

3. IF WEB SECTION LOSS EXCEEDS $\frac{1}{8}$ " DEEP FOR AN AREA LARGER THAN 4" DIAMETER, CONTACT THE DISTRICT FOR DIRECTION.
4. CUT FLANGE TOP REPAIR PLATE FULL-WIDTH AT STIFFENERS AND CONNECTION PLATES TO LEAVE $\frac{1}{2}$ " GAP TO STIFFENER OR CONNECTION PLATE. ADJUST BOLT SPACING ALONG LENGTH OF FLOORBEAM AS NEEDED TO SATISFY THE FOLLOWING REQUIREMENTS:

5. EXISTING BOTTOM FLANGE THICKNESS IS $\frac{3}{4}$ " FOR $10\pm$ AT EACH END AND $1\frac{1}{4}$ " ELSEWHERE. BOTTOM FLANGE FILL PLATE IS ONLY NEEDED IF REPAIR SPANS AN EXISTING BOTTOM FLANGE THICKNESS TRANSITION. OMIT OTHERWISE.

6. TOTAL LENGTH OF REPAIR FOR THIS DETAIL IS EXPECTED TO AVERAGE APPROXIMATELY 7'.
