CHESAPEAKE BAY BRIDGE AND TUNNEL DISTRICT
			RMF 5044.5122 - STEEL BRIDGE PAINTING PROJECT
PROJECT NOTES			
No.	Description	Date	Designed: JSE Drawn: BSB Checked: AHC
			12/18/2025
	Revision		1 OF 45

CHESAPEAKE BAY BRIDGE AND TUNNEL DISTRICT	
			RMF 5044.5122 - STEEL BRIDGE PAINTING PROJECT	
NORTH CHANNEL BRIDGE NB GENERAL PLAN AND ELEVATION				
No.	Description	Date	Designed: JSE Drawn: BSB Checked: AHC	Date Plan No. Sheet No.
	Revision			12/18/2025 3 OF 45

CHESAPEAKE BAY BRIDGE AND TUNNEL DISTRICT							
			RMF 5044.5122 - STEEL BRIDGE PAINTING PROJECT							
NORTH CHANNEL BRIDGE NB STRINGER AND FLOORBEAM PLATING REPAIRS										
No. Description Date Designed: JSE Drawn: JSE Checked: AHC 12/18/2025 9 OF 45										
	Revision

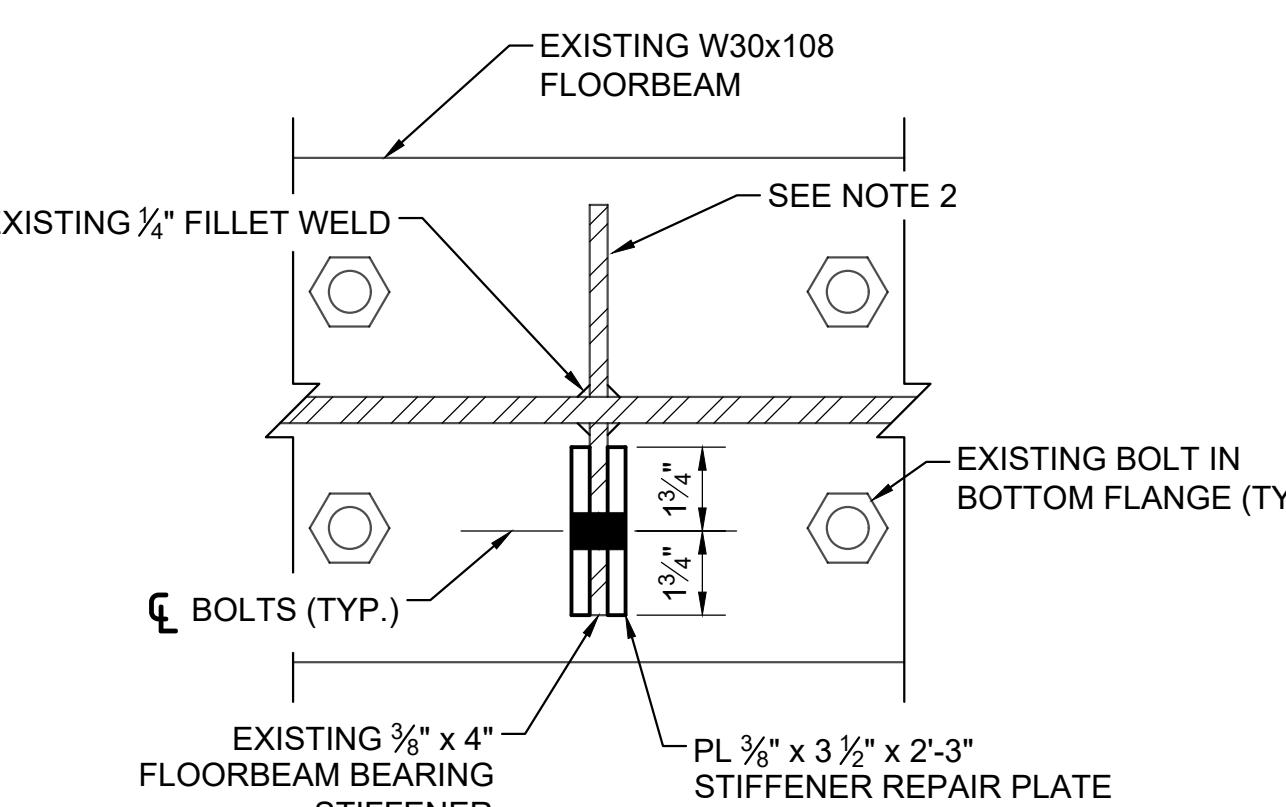
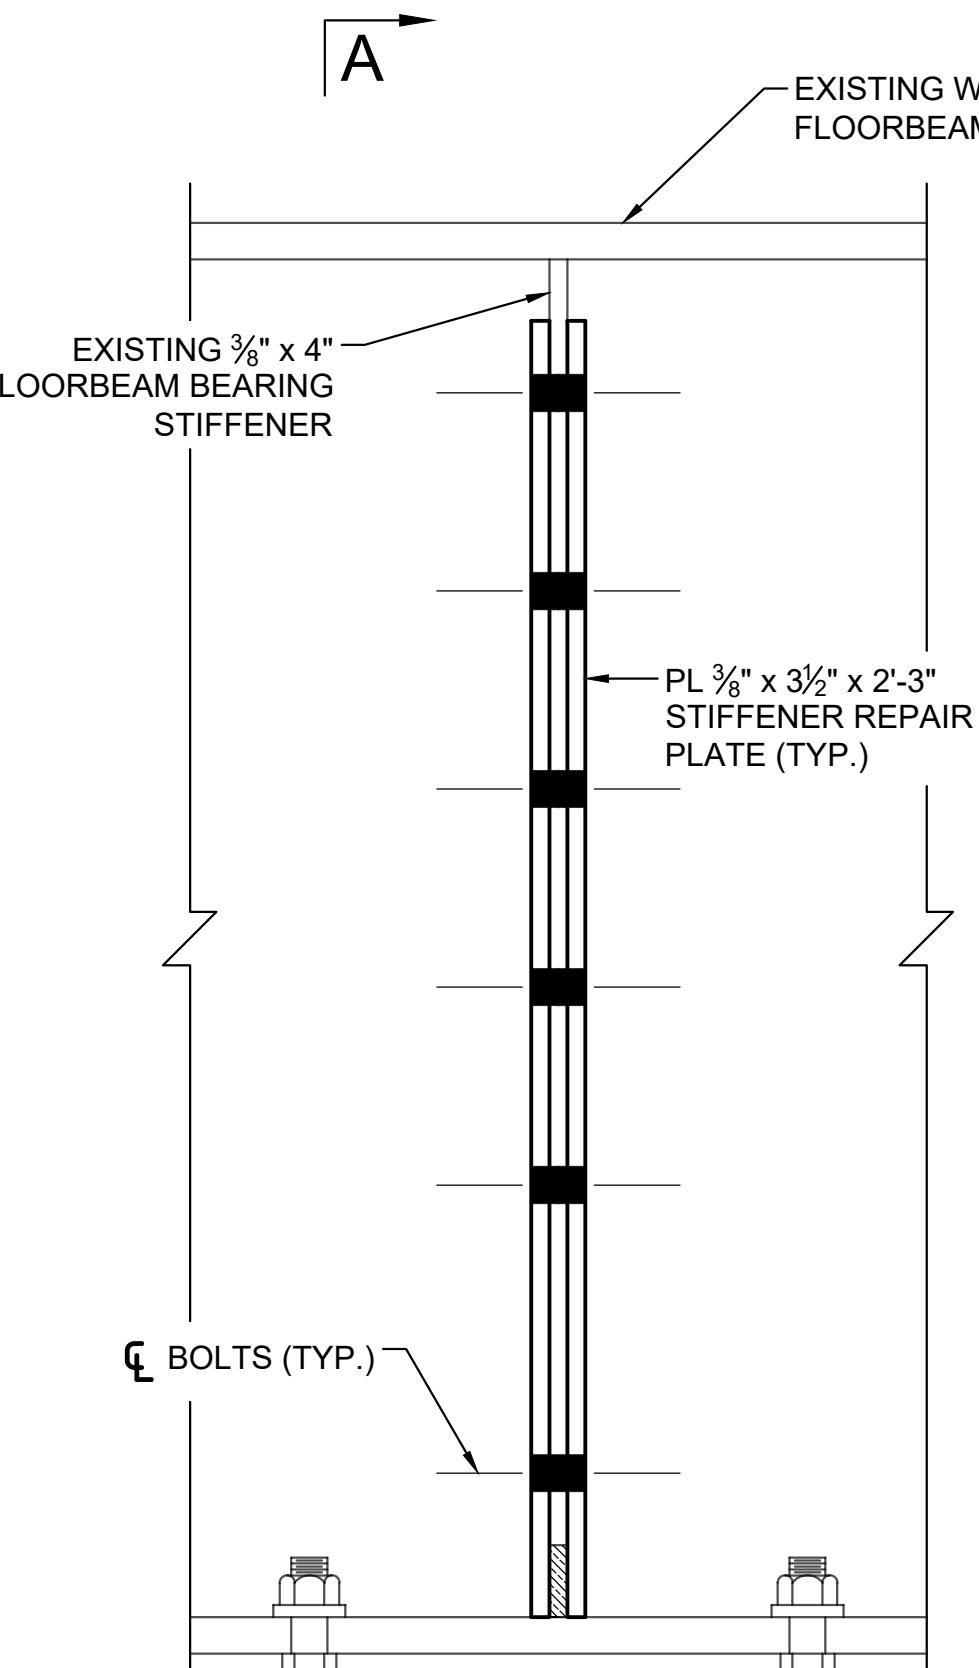
NCB-NB FLOORBEAM REPAIR TYPE 4

1. PERFORM THIS REPAIR IN NCB-NB SPANS 1-8 AND 10-17 FOR FLOORBEAM BEARING STIFFENERS (ABOVE THE GIRDERS) EXHIBITING CORROSION AT OR NEAR THE TOP OR BOTTOM END WITH LESS THAN 1/4" REMAINING OVER 3" OR MORE OF THE STIFFENER WIDTH AS APPROVED BY THE DISTRICT.

2. BACK TO BACK REPAIR CONDITIONS (EITHER SIDE OF FLOORBEAM) WILL EXIST.
3. RESTORE MILL TO BEAR CONTACT, LOST DUE TO CORROSION OF EXISTING BEARING STIFFENER, IN PROPOSED STIFFENER REPAIR PLATES.

4. DIMENSION 'X' IS THE HEIGHT OF CORROSION AT THE BOTTOM END OF THE BEARING STIFFENER.
 - 4.1. WHEN DIMENSION 'X' IS 1 1/2" OR LESS, PERFORM THE REPAIR AS SHOWN IN SECTION A-A.

- 4.2. WHEN DIMENSION 'X' > 1 1/2" AND < 6", ADJUST THE REPAIR AS SHOWN IN DETAIL B.
5. IF ONE OR MORE CORROSION HOLES ARE PRESENT NEAR THE TOP EDGE OF THE BEARING STIFFENER, EXTEND STIFFENER REPAIR PLATES TO ACHIEVE TIGHT FIT CONDITION WITH TOP FLANGE AND ADJUST THE REPAIR AS SHOWN IN DETAIL C.

8. PL 1/2" x 3 1/2" x 2'-3" IS AN ACCEPTABLE SUBSTITUTE FOR STIFFENER REPAIR PLATE.

- A. CLEAN AND GRIND CORRODED AREAS PER PROJECT NOTES AS REQUIRED. AS PART OF CLEANING AND PREPARING THE TOP OF THE BOTTOM FLANGE, BOTTOM FLANGE SECTION LOSS UP TO 1/8" DEEP IS ACCEPTABLE. IF BOTTOM FLANGE SECTION LOSS EXCEEDS 1/8" DEEP, NOTIFY THE DISTRICT PRIOR TO PROCEEDING WITH THE REPAIR. DETERMINE IF SECTION A-A OR DETAIL B IS APPLICABLE (SEE NOTE 4).

- B. VISUALLY INSPECT TOP AND BOTTOM OF FLOORBEAM WEB AT BEARING STIFFENER FOR CRACKS. IF CRACKS ARE APPARENT, PERFORM DYE PENETRANT TESTING AND NOTIFY THE DISTRICT OF FINDINGS. IF NDT INDICATES CRACKS, PERFORM NCB-NB FLOORBEAM REPAIR TYPE 5.

- C. ACHIEVE MILL TO BEAR CONDITION (BOTTOM) AND/OR TIGHT FIT CONDITION (TOP) FOR THE REPAIR PLATES AND TEMPORARILY CLAMP THEM IN PLACE. ENSURE ALIGNMENT OF THE CLAMPED POSITION WILL PROVIDE EDGE DISTANCE (1 1/2") FOR THE NEW HOLES. INSERT FILL PLATE IF REQUIRED.

- D. REMOVE THE TEMPORARILY CLAMPED REPAIR AND FILL PLATES. APPLY STEEL-FILLED EPOXY PUTTY TO ALL MATING SURFACES AND TO FILL ALL GAPS, SMOOTHED TO MATCH EXISTING SURFACE. BOLT THE REPAIR AND FILL PLATES TO BOTH SIDES OF THE FLOORBEAM STIFFENER.

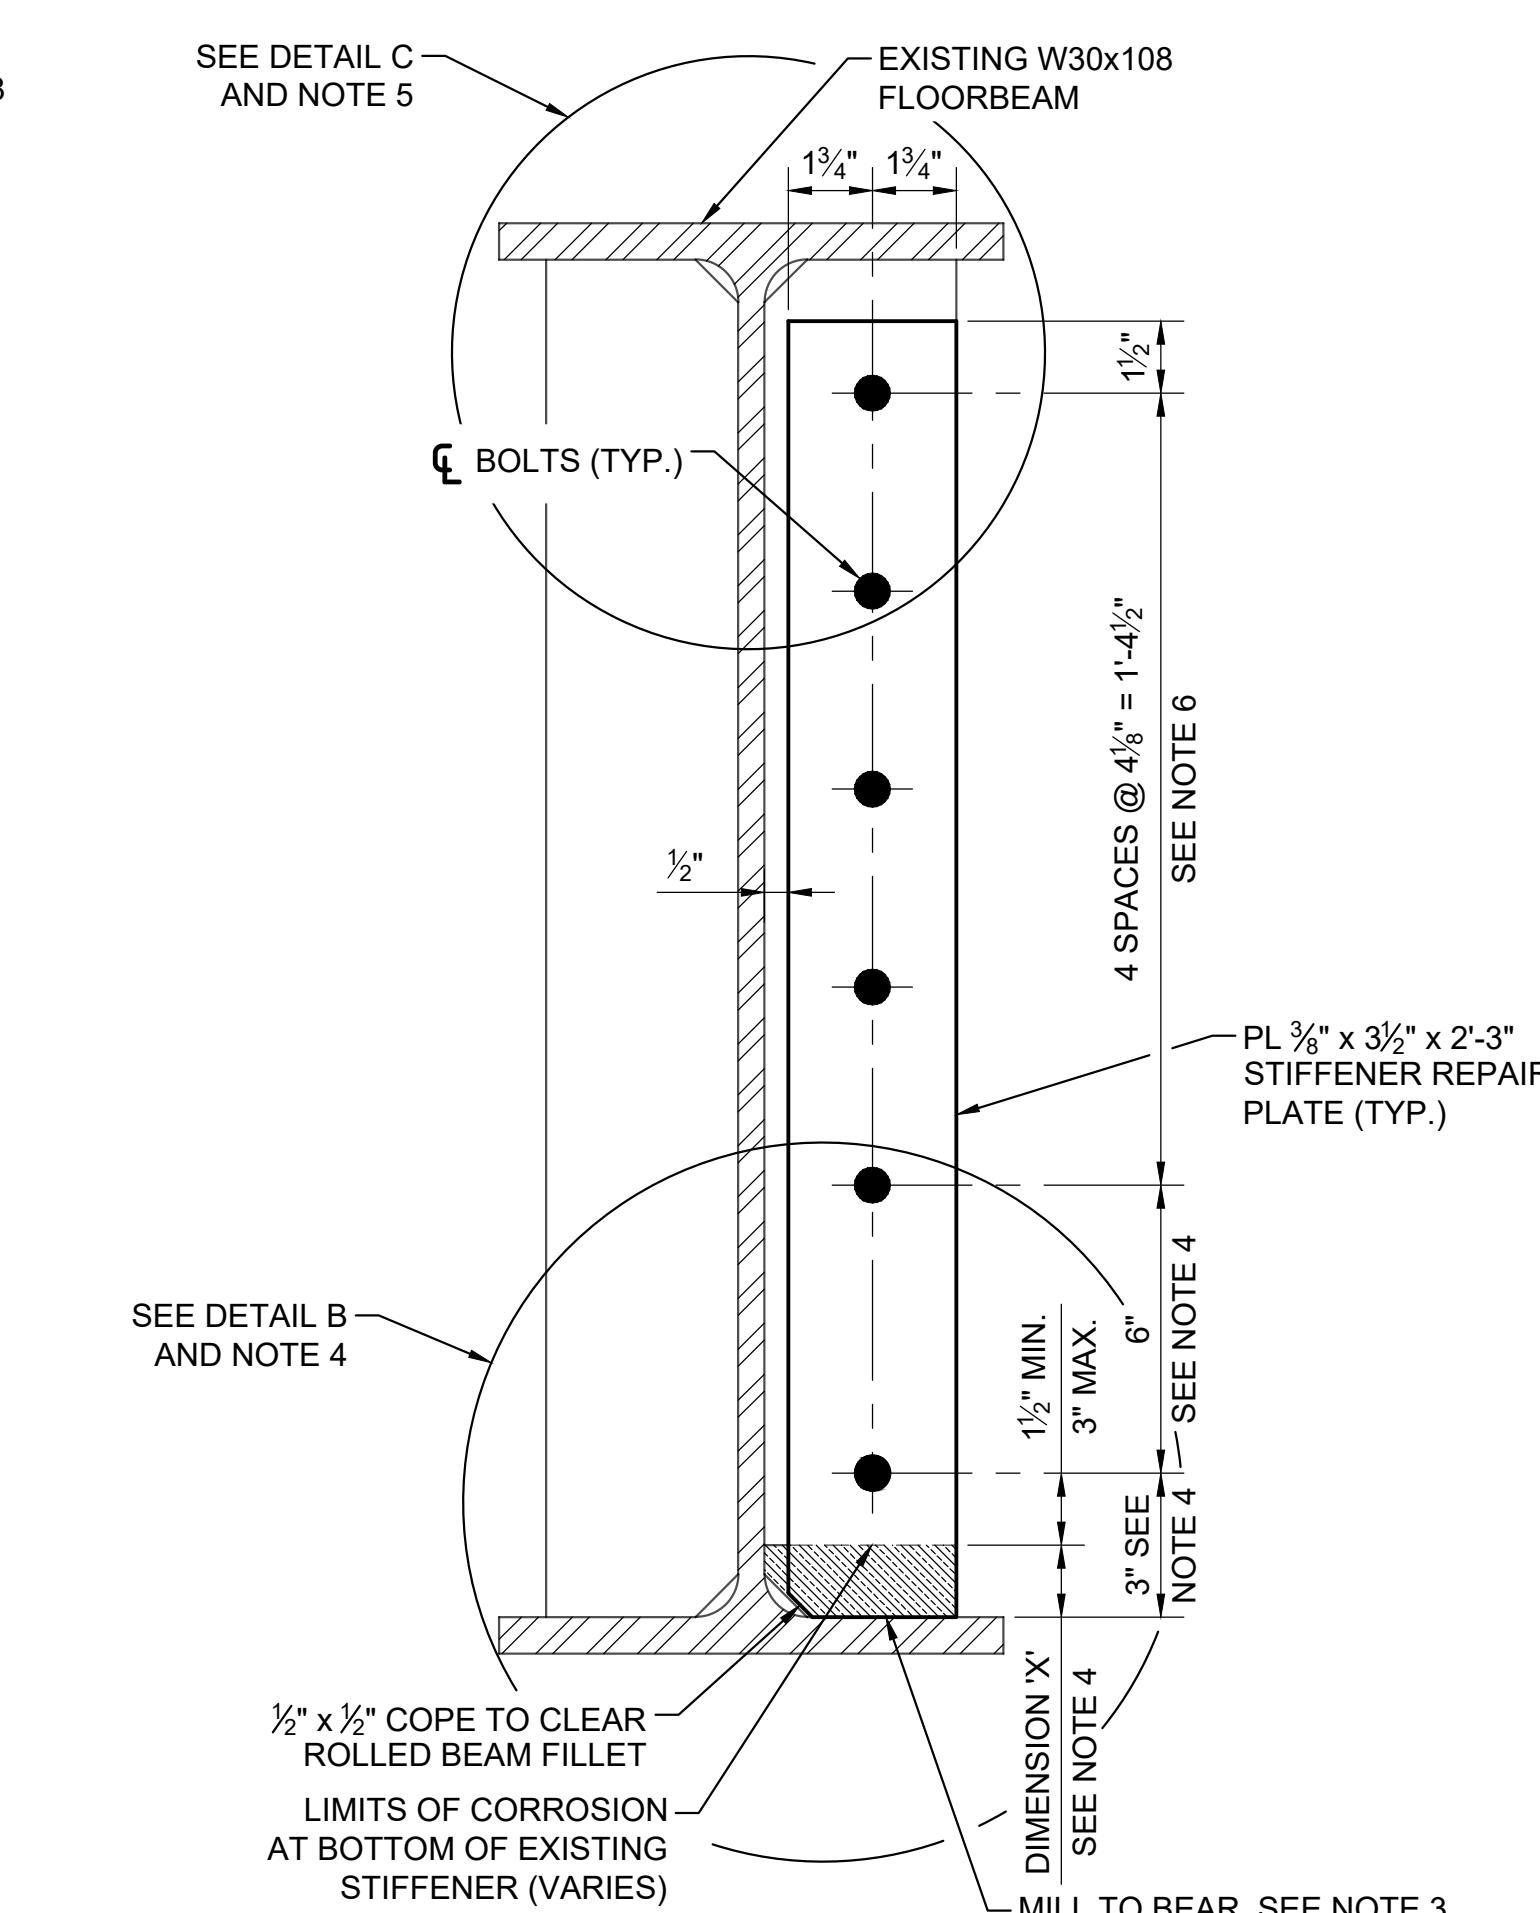
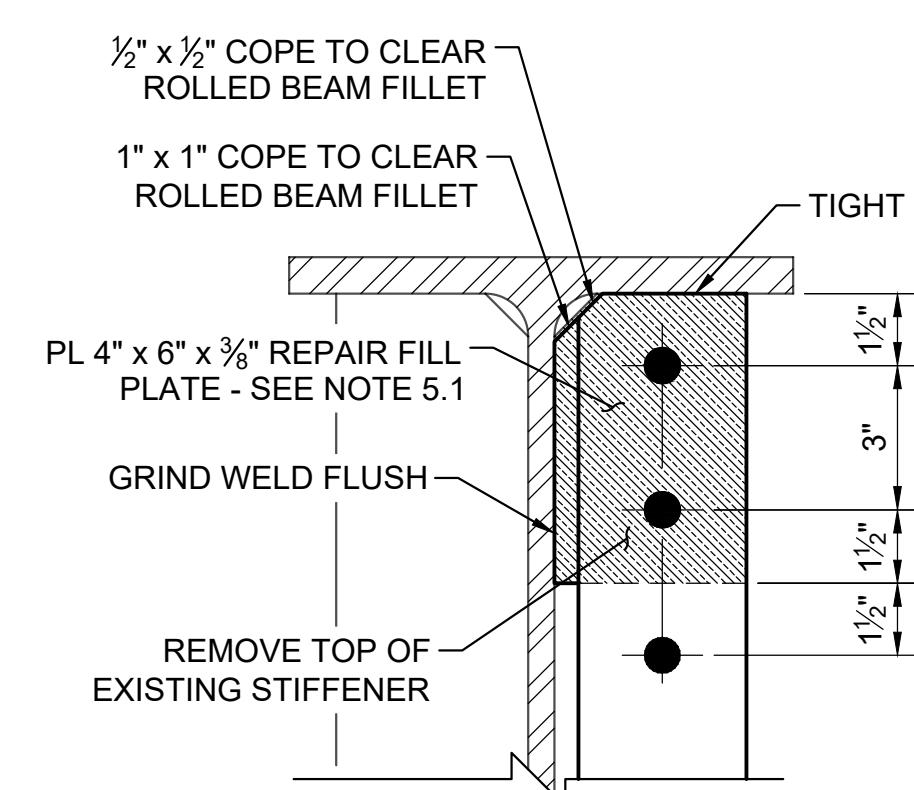
SECTION A-A

DETAIL B

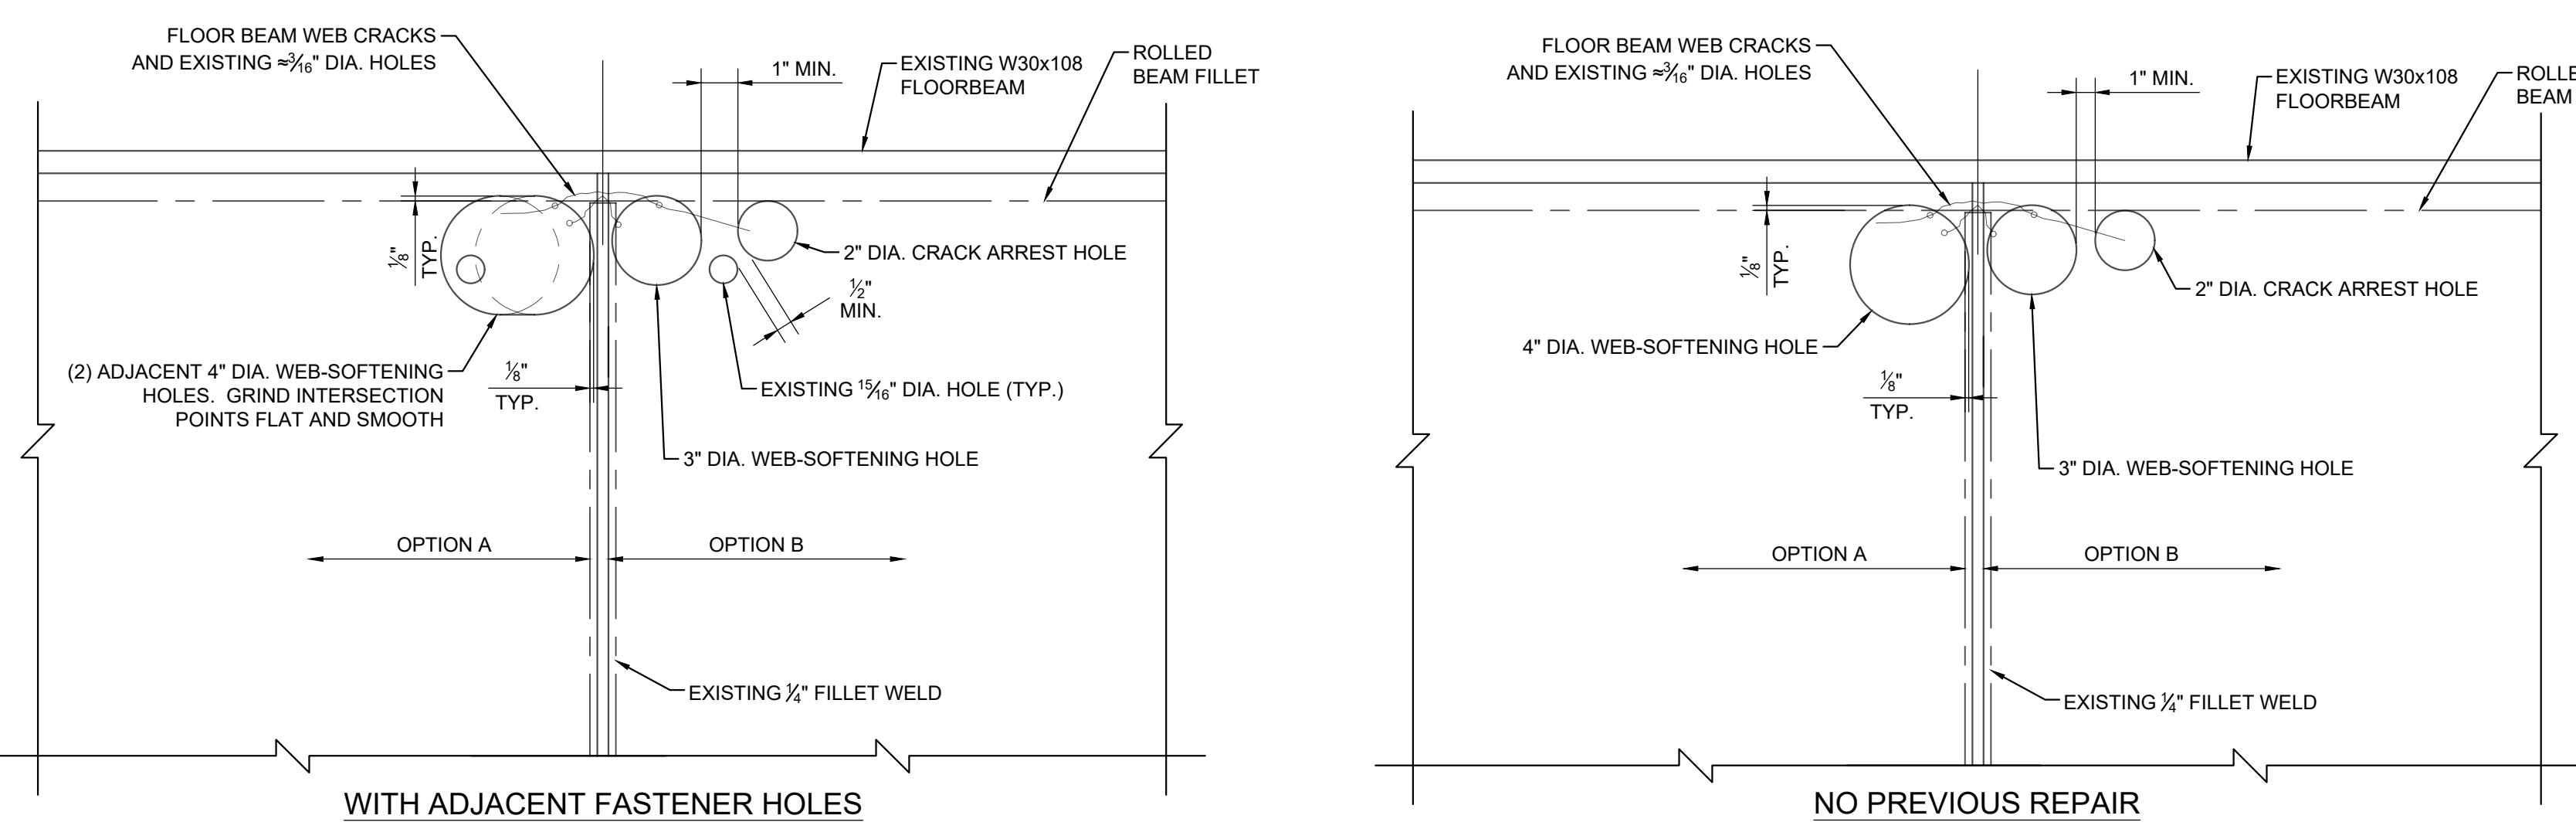
NCB-NB FLOORBEAM REPAIR TYPE 5 EXISTING CONDITION

1. PERFORM THIS REPAIR IN NCB-NB SPANS 1-8 AND 10-17 FOR FLOORBEAM WEBS EXHIBITING CRACKS ADJACENT TO THE TOP OF THE BEARING STIFFENER (ABOVE THE GIRDERS) AS APPROVED BY THE DISTRICT.

2. VISUALLY INSPECT TOP AND BOTTOM OF FLOORBEAM WEB AT BEARING STIFFENER (ABOVE THE GIRDERS) FOR CRACKS AFTER PAINT REMOVAL. IF CRACKS ARE APPARENT, PERFORM DYE PENETRANT TESTING TO DETERMINE THE EXTENT OF CRACKING, NOTIFY THE DISTRICT OF FINDINGS, AND PROCEED WITH REPAIR ONCE APPROVED BY THE DISTRICT. LOCATIONS WITH KNOWN CRACK DEFECTS INCLUDE BUT ARE NOT LIMITED TO

- 2.1. SPAN 13 FLOORBEAM 8 ABOVE EAST GIRDER
 - 2.2. SPAN 17 FLOORBEAM 6 ABOVE EAST GIRDER
3. EXISTING CONDITIONS:
 - 3.1. DIMENSIONS AND LAYOUT OF EXISTING CRACK AND PREVIOUS REPAIR HOLES/ELEMENTS ARE ESTIMATED. ADJUST REPAIR AS NEEDED TO SUIT CONDITIONS. MAINTAIN MIN. 1/2" FASTENER EDGE DISTANCE AND 3" MIN. / 5/8" MAX. FASTENER SPACING FOR ALL FASTENERS.

- 3.2. SOME STIFFENER LOCATIONS CONTAIN EXISTING PARTIALLY-REMOVED KNEE-BRACE ANGLE (AS SHOWN THIS SHEET), WHICH IS TO BE REMOVED IF PRESENT FOR LOCATIONS SUBJECT TO THIS REPAIR DETAIL (AS SHOWN NEXT SHEET).

- 3.3. SOME STIFFENER LOCATIONS CONTAIN EXISTING REPAIR ELEMENTS (AS SHOWN THIS SHEET), WHICH ARE TO BE REMOVED AND REPLACED WITH PROPOSED REPAIR ELEMENTS FOR LOCATIONS SUBJECT TO THIS REPAIR DETAIL (AS SHOWN NEXT SHEET). IF NO PREVIOUS REPAIR ELEMENTS ARE PRESENT AT A GIVEN LOCATION, DRILL CRACK ARREST AND/OR WEB SOFTENING HOLES BUT OMIT PROPOSED REPAIR ELEMENTS.

4. TWO ACCEPTABLE OPTIONS ARE PROVIDED FOR WEB SOFTENING AND CRACK ARREST HOLES, AS SHOWN. DRILL HOLES USING A MAG DRILL AND ANNULAR CUTTER BITS. NOTE THAT THE ADJACENT SIP FORM AND CONCRETE DECK SOFFIT MAY REQUIRE LOW PROFILE BITS.

- 4.1. OPTION A: (1) OR (2) 4" DIA. WEB SOFTENING HOLES.
 - 4.1.1. HOLE(S) SHALL FULLY CAPTURE CRACK TIP(S).
 - 4.1.2. HOLE(S) SHALL EITHER FULLY OVERLAP EXISTING FASTENER HOLE (IF PRESENT) OR MAINTAIN 1/2" MIN. CLEAR DISTANCE TO IT.

- 4.1.5. IF POSSIBLE WHILE ALSO SATISFYING PRECEDING REQUIREMENTS, HOLE ADJACENT TO STIFFENER SHOULD OVERLAP STIFFENER-WEB WELD BY 1/8".
 - 4.2. OPTION B: (1) 3" DIA. WEB SOFTENING HOLE AND (1) 2" DIA. CRACK ARREST HOLE.

- 4.2.1. CRACK ARREST HOLE SHALL FULLY CAPTURE CRACK TIP(S).
 - 4.2.2. HOLES SHALL MAINTAIN 1/2" MIN. CLEAR DISTANCE TO EXISTING FASTENER HOLE (IF PRESENT) AND 1" MIN. CLEAR DISTANCE BETWEEN EACH OTHER.

5. 1/8" THICK REPAIR ELEMENTS, WITH OTHER DIMENSIONS AS NOTED IN THE DETAIL, ARE ACCEPTABLE ALTERNATES TO 3/8" THICK ELEMENTS SPECIFIED.

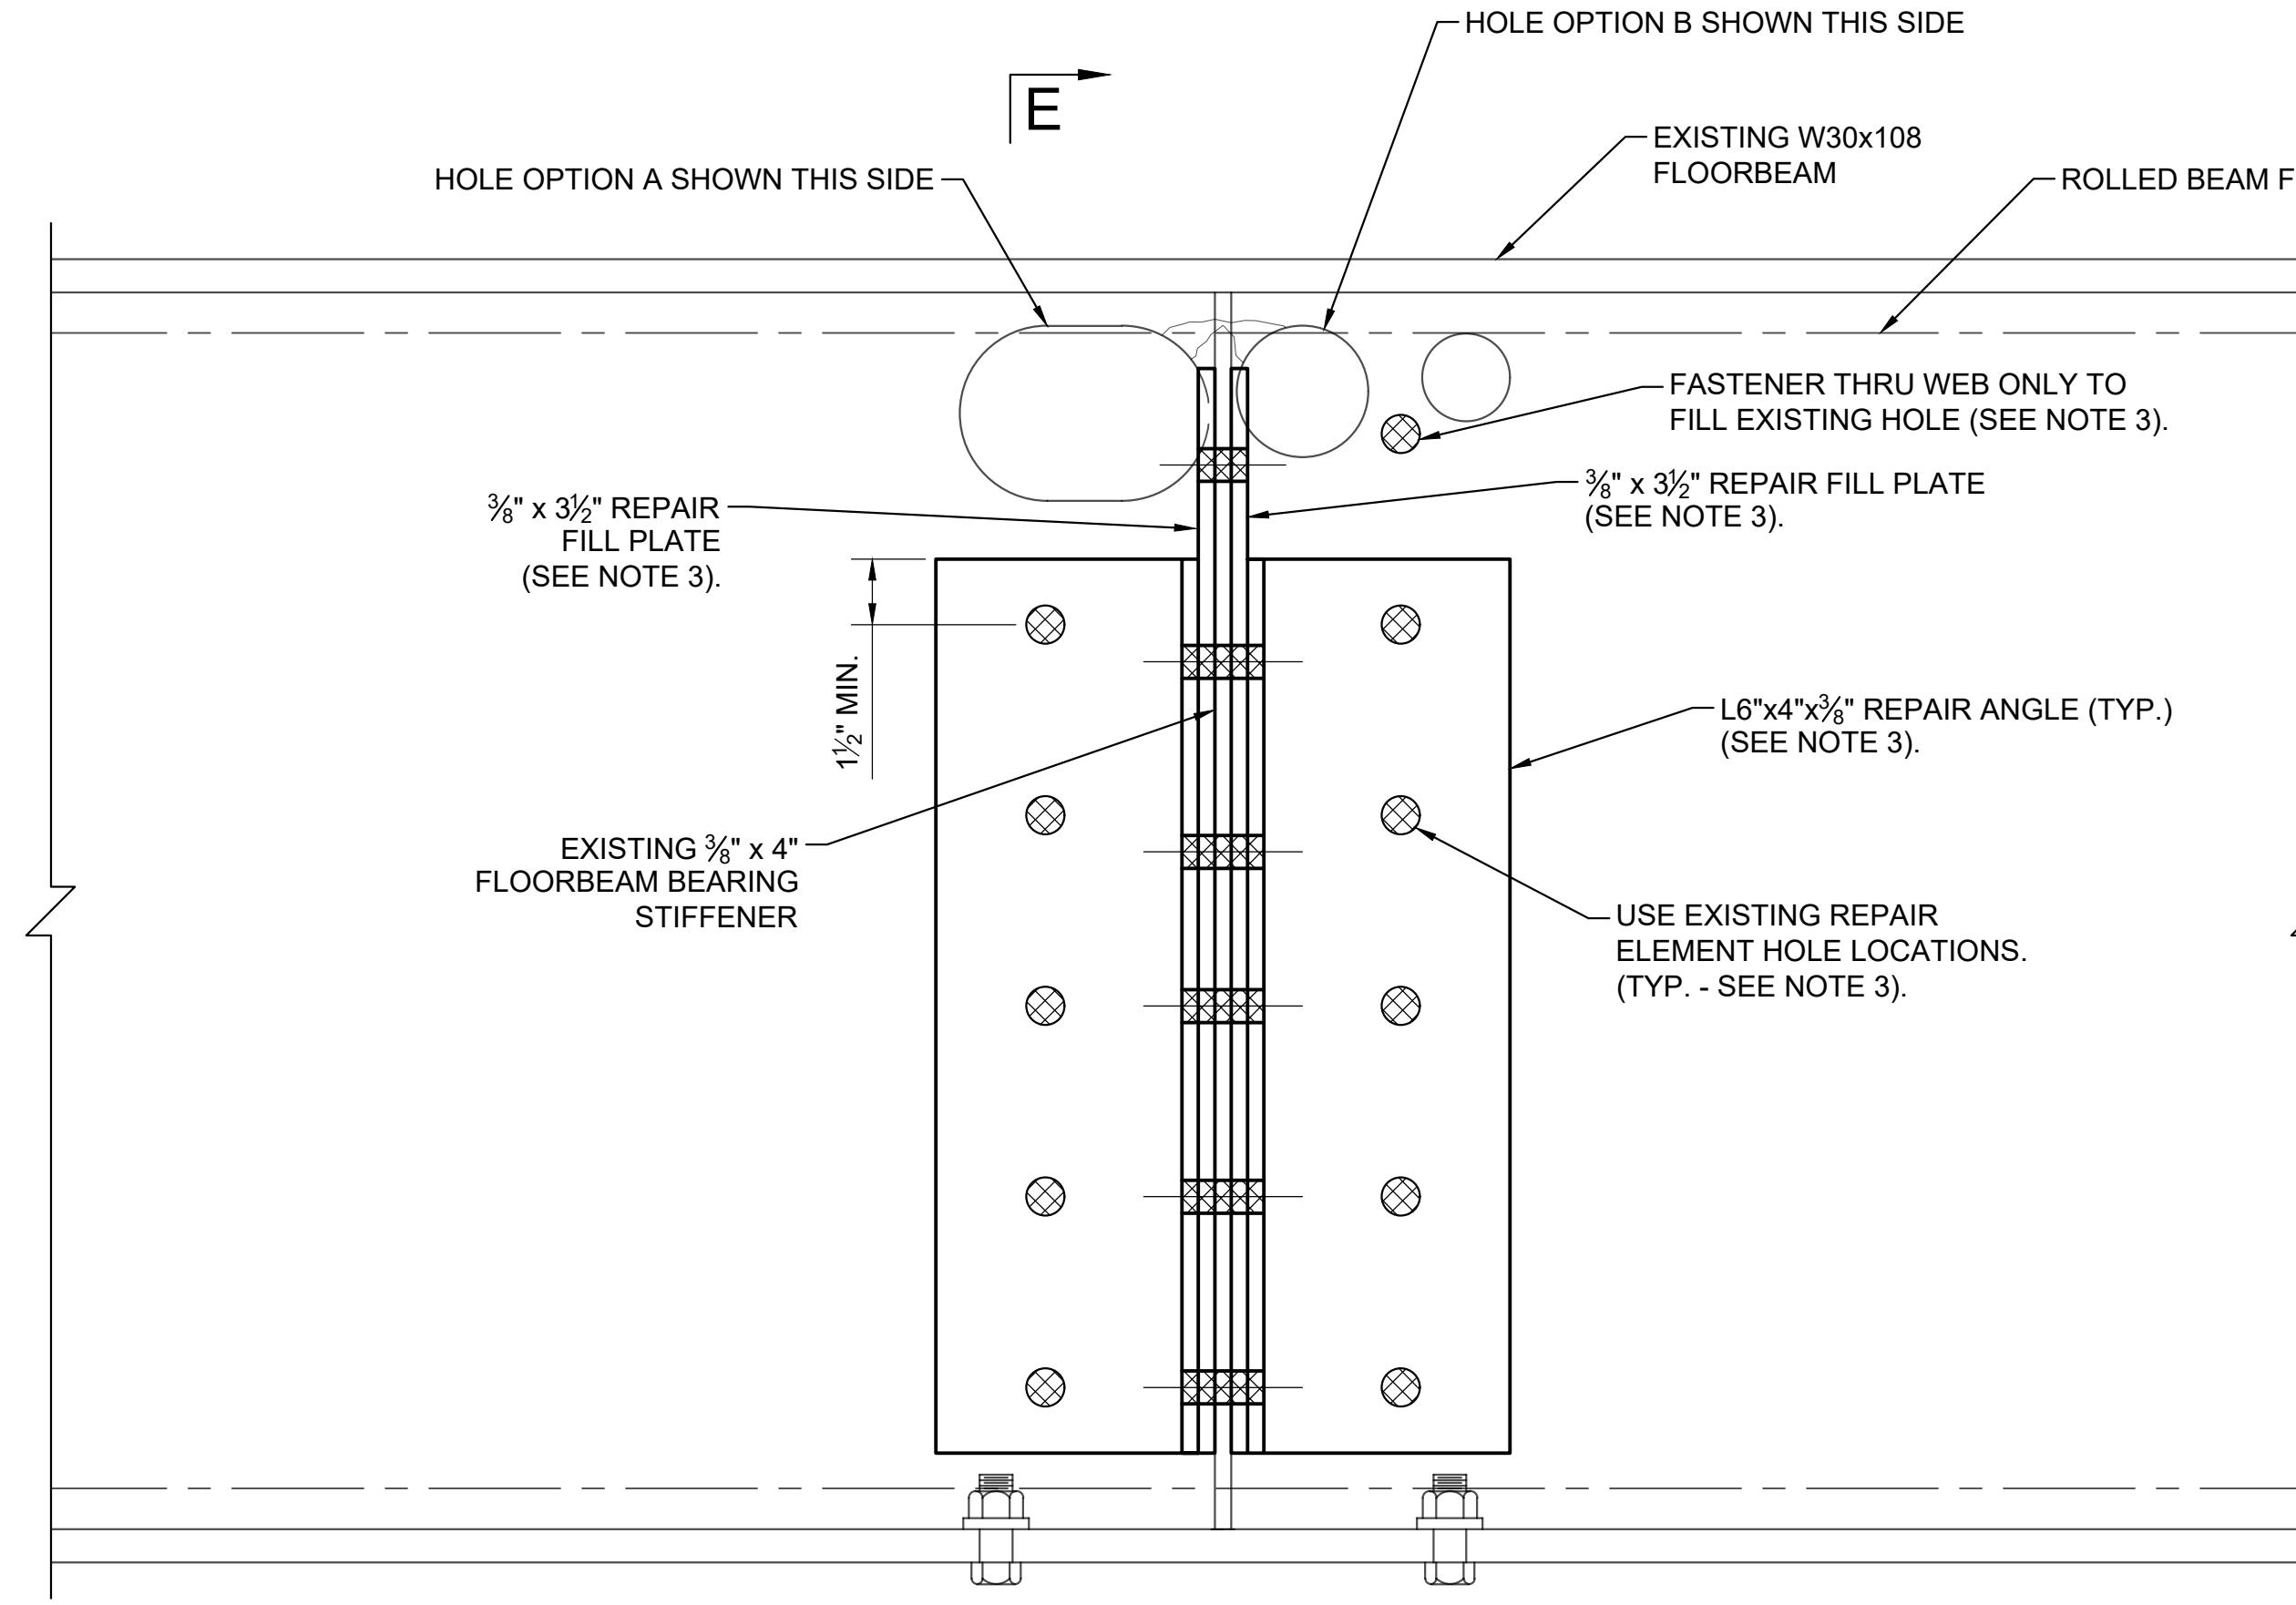
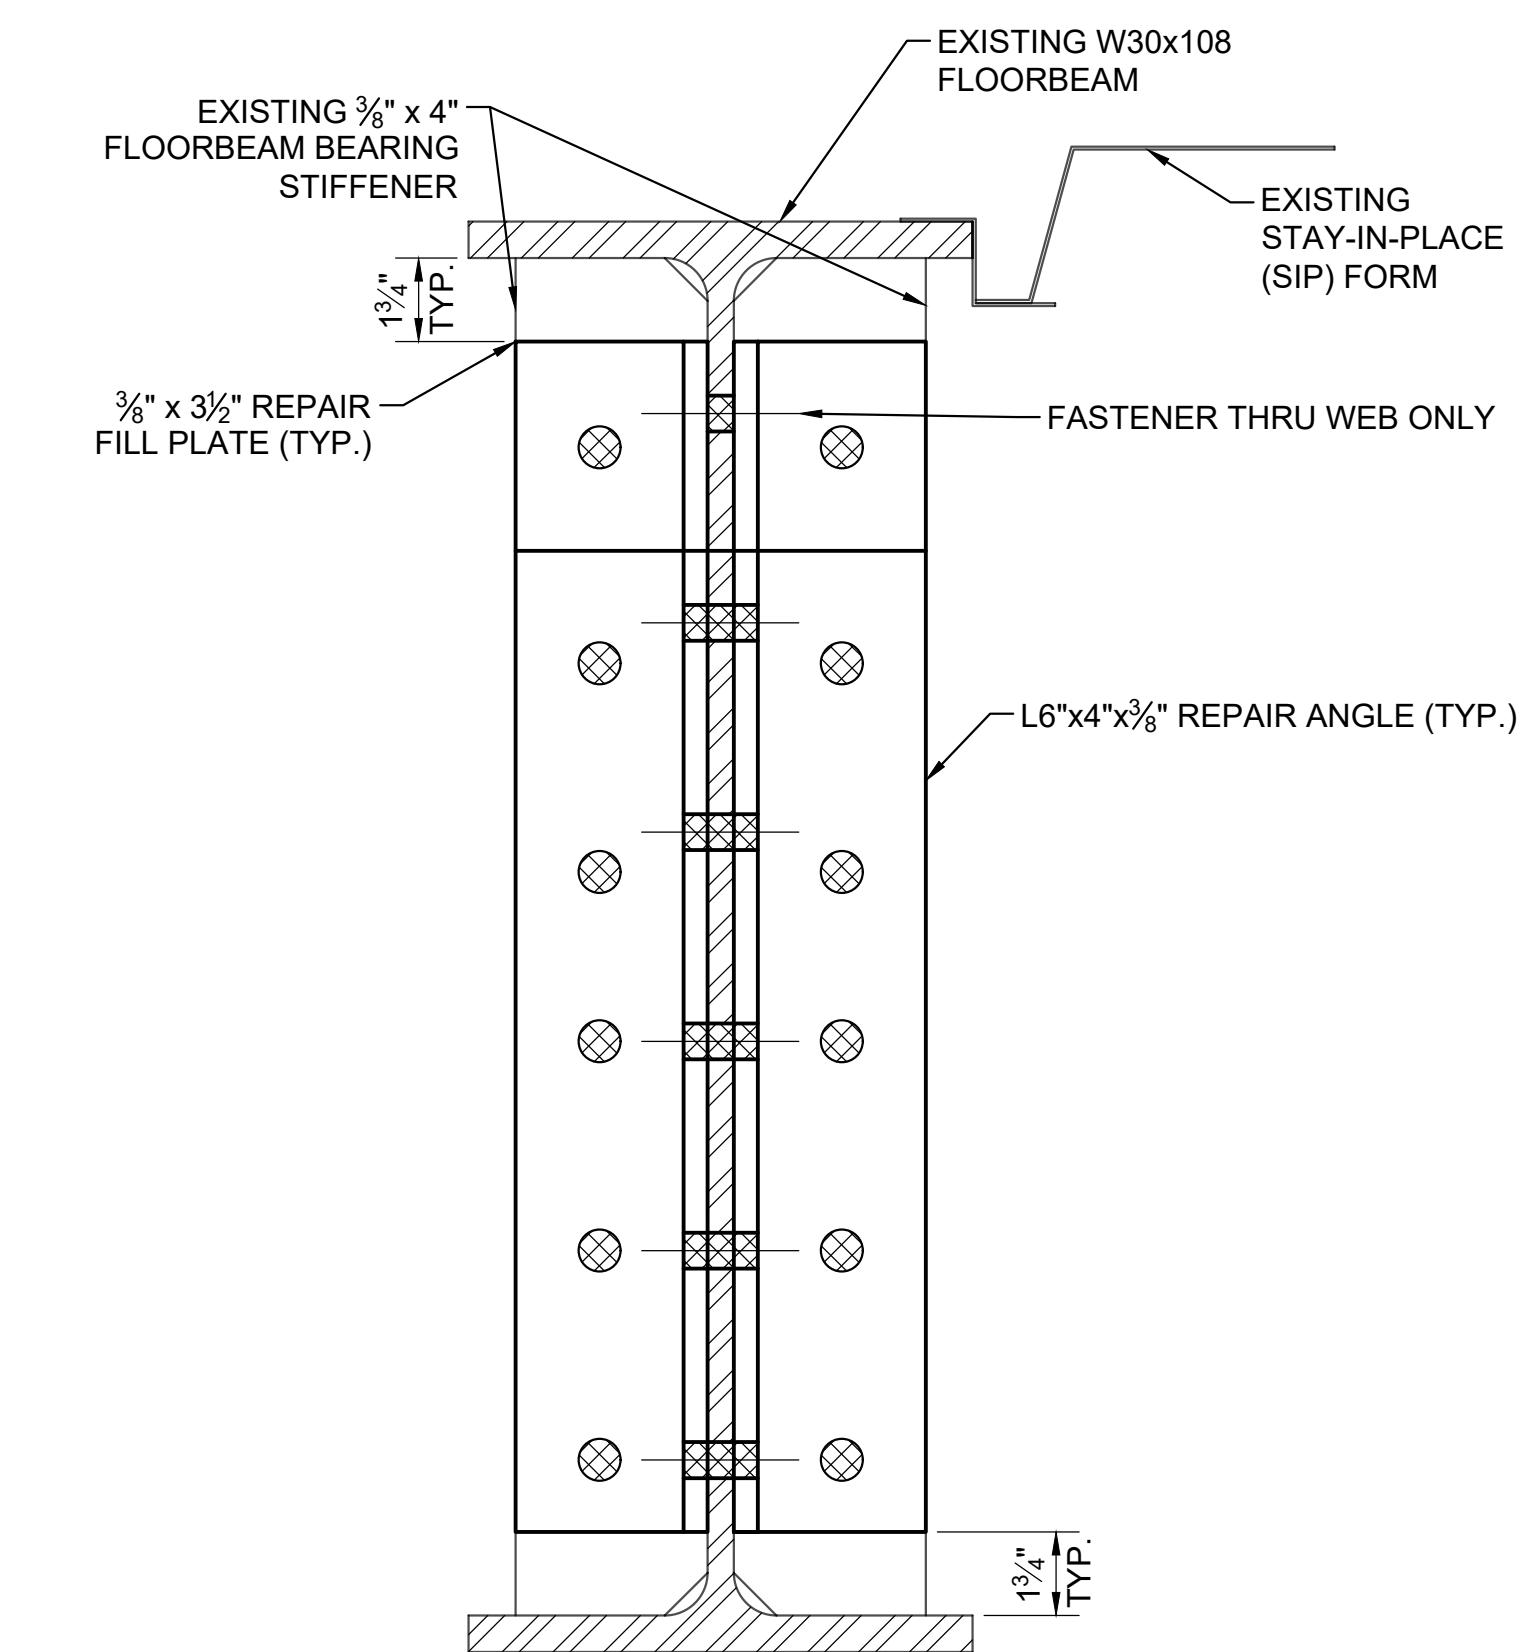
NCB-NB FLOORBEAM REPAIR TYPE 5
REPAIRED CONDITION

ELEVATION

SECTION E-E

- IF EXISTING REPAIR ELEMENTS ARE PRESENT, REMOVE BOLTS AND EXISTING REPAIR ELEMENTS. CLEAN AND GRIND CORRODED AREAS AS REQUIRED. PERFORM DYE PENETRANT TESTING TO IDENTIFY LOCATION OF CRACK TIP(S).
- LAY OUT WEB SOFTENING AND/OR CRACK ARREST HOLES. ENSURE THAT CONDITIONS SPECIFIED IN DETAIL-SPECIFIC NOTES WILL BE MET PRIOR TO DRILLING HOLES. DRILL HOLE(S).
- OMIT THIS STEP IF NO EXISTING REPAIR ELEMENTS ARE PRESENT:

IF EXISTING REPAIR ELEMENTS ARE PRESENT, USE AS A TEMPLATE TO DRILL THROUGH PROPOSED REPAIR ELEMENTS. APPLY STEEL-FILLED EPOXY PUTTY TO ALL MATING SURFACES AND TO FILL ALL GAPS, SMOOTHED TO MATCH EXISTING SURFACE. DO NOT FILL WEB SOFTENING OR CRACK ARREST HOLES WITH EPOXY. BOLT THE REPAIR AND FILL PLATES AND ANGLES TO BOTH SIDES OF THE FLOORBEAM STIFFENER. PLACE BOLT(S) THROUGH THE FLOOR BEAM WEB AT UPPER FASTENER HOLE(S).
