CHESAPEAKE BAY BRIDGE AND TUNNEL DISTRICT
			RMF 5044.5122 - STEEL BRIDGE PAINTING PROJECT
PROJECT NOTES			
No.	Description	Date	Designed: JSE Drawn: BSB Checked: AHC
			12/18/2025
	Revision		1 OF 45

CHESAPEAKE BAY BRIDGE AND TUNNEL DISTRICT	
			RMF 5044.5122 - STEEL BRIDGE PAINTING PROJECT	
NORTH CHANNEL BRIDGE NB GENERAL PLAN AND ELEVATION				
No.	Description	Date	Designed: JSE Drawn: BSB Checked: AHC	Date Plan No. Sheet No.
	Revision			12/18/2025 3 OF 45

CHESAPEAKE BAY BRIDGE AND TUNNEL DISTRICT							
			RMF 5044.5122 - STEEL BRIDGE PAINTING PROJECT							
NORTH CHANNEL BRIDGE NB STRINGER AND FLOORBEAM PLATING REPAIRS										
No. Description Date Designed: JSE Drawn: JSE Checked: AHC 12/18/2025 9 OF 45										
	Revision

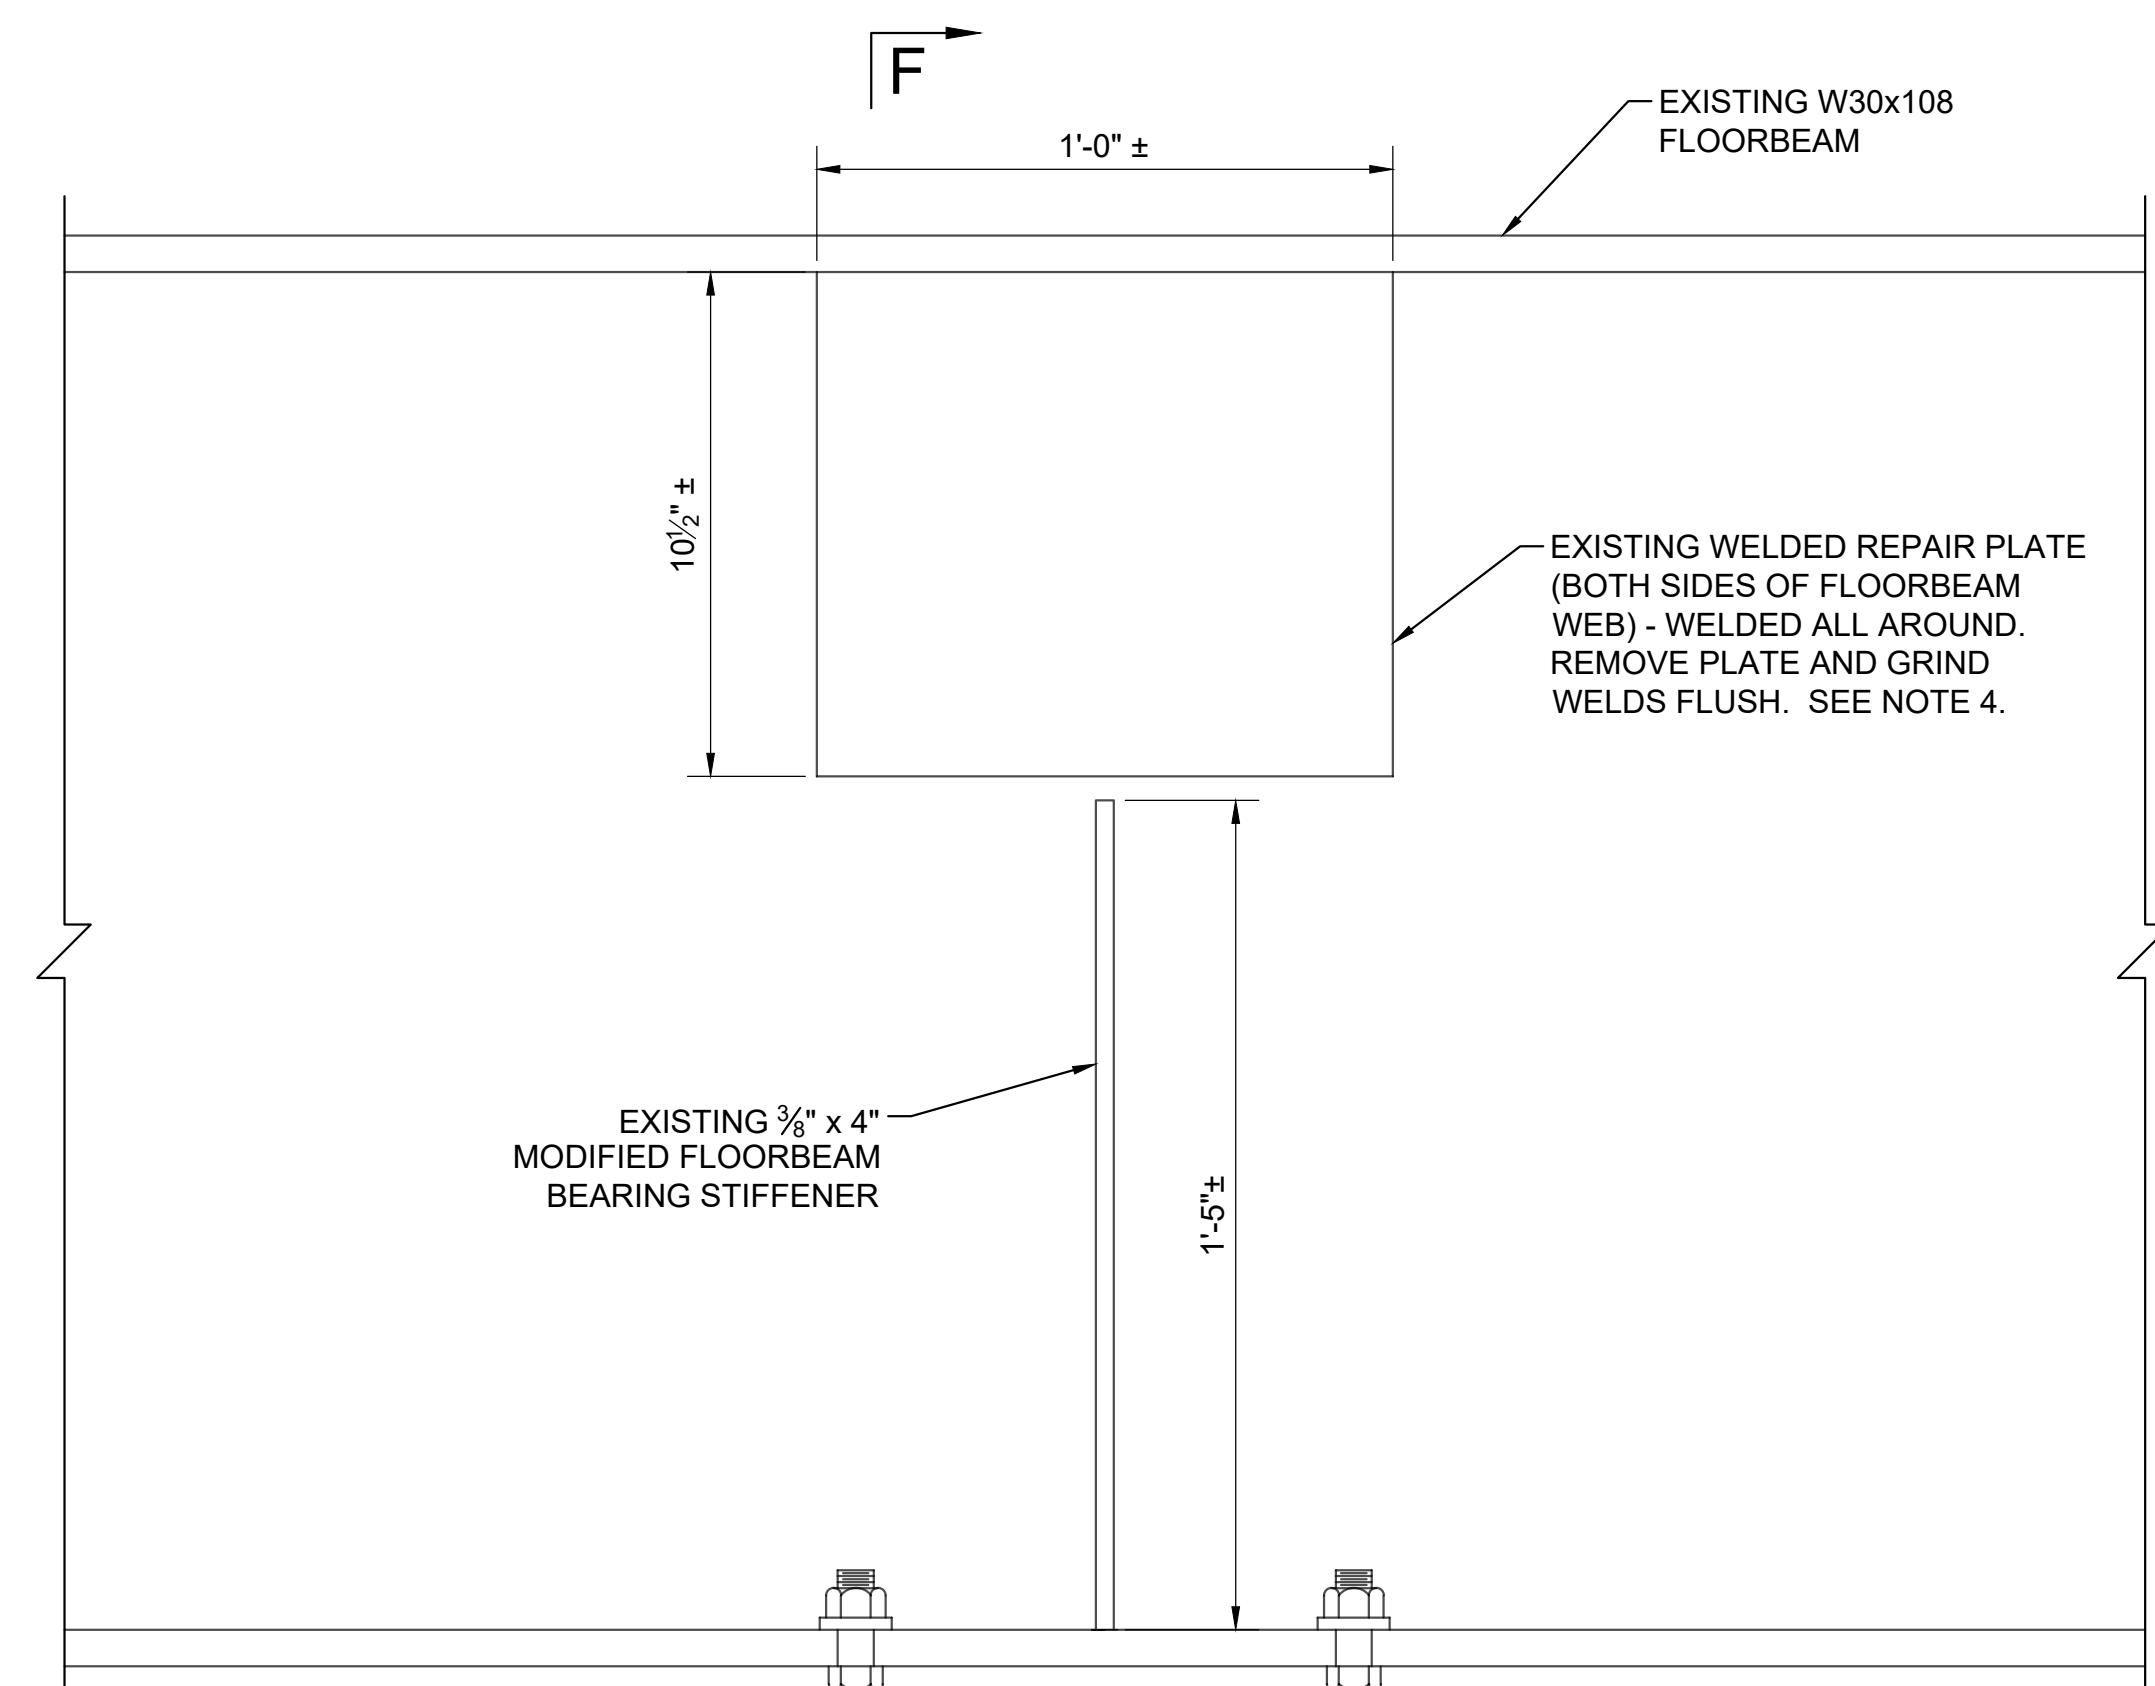
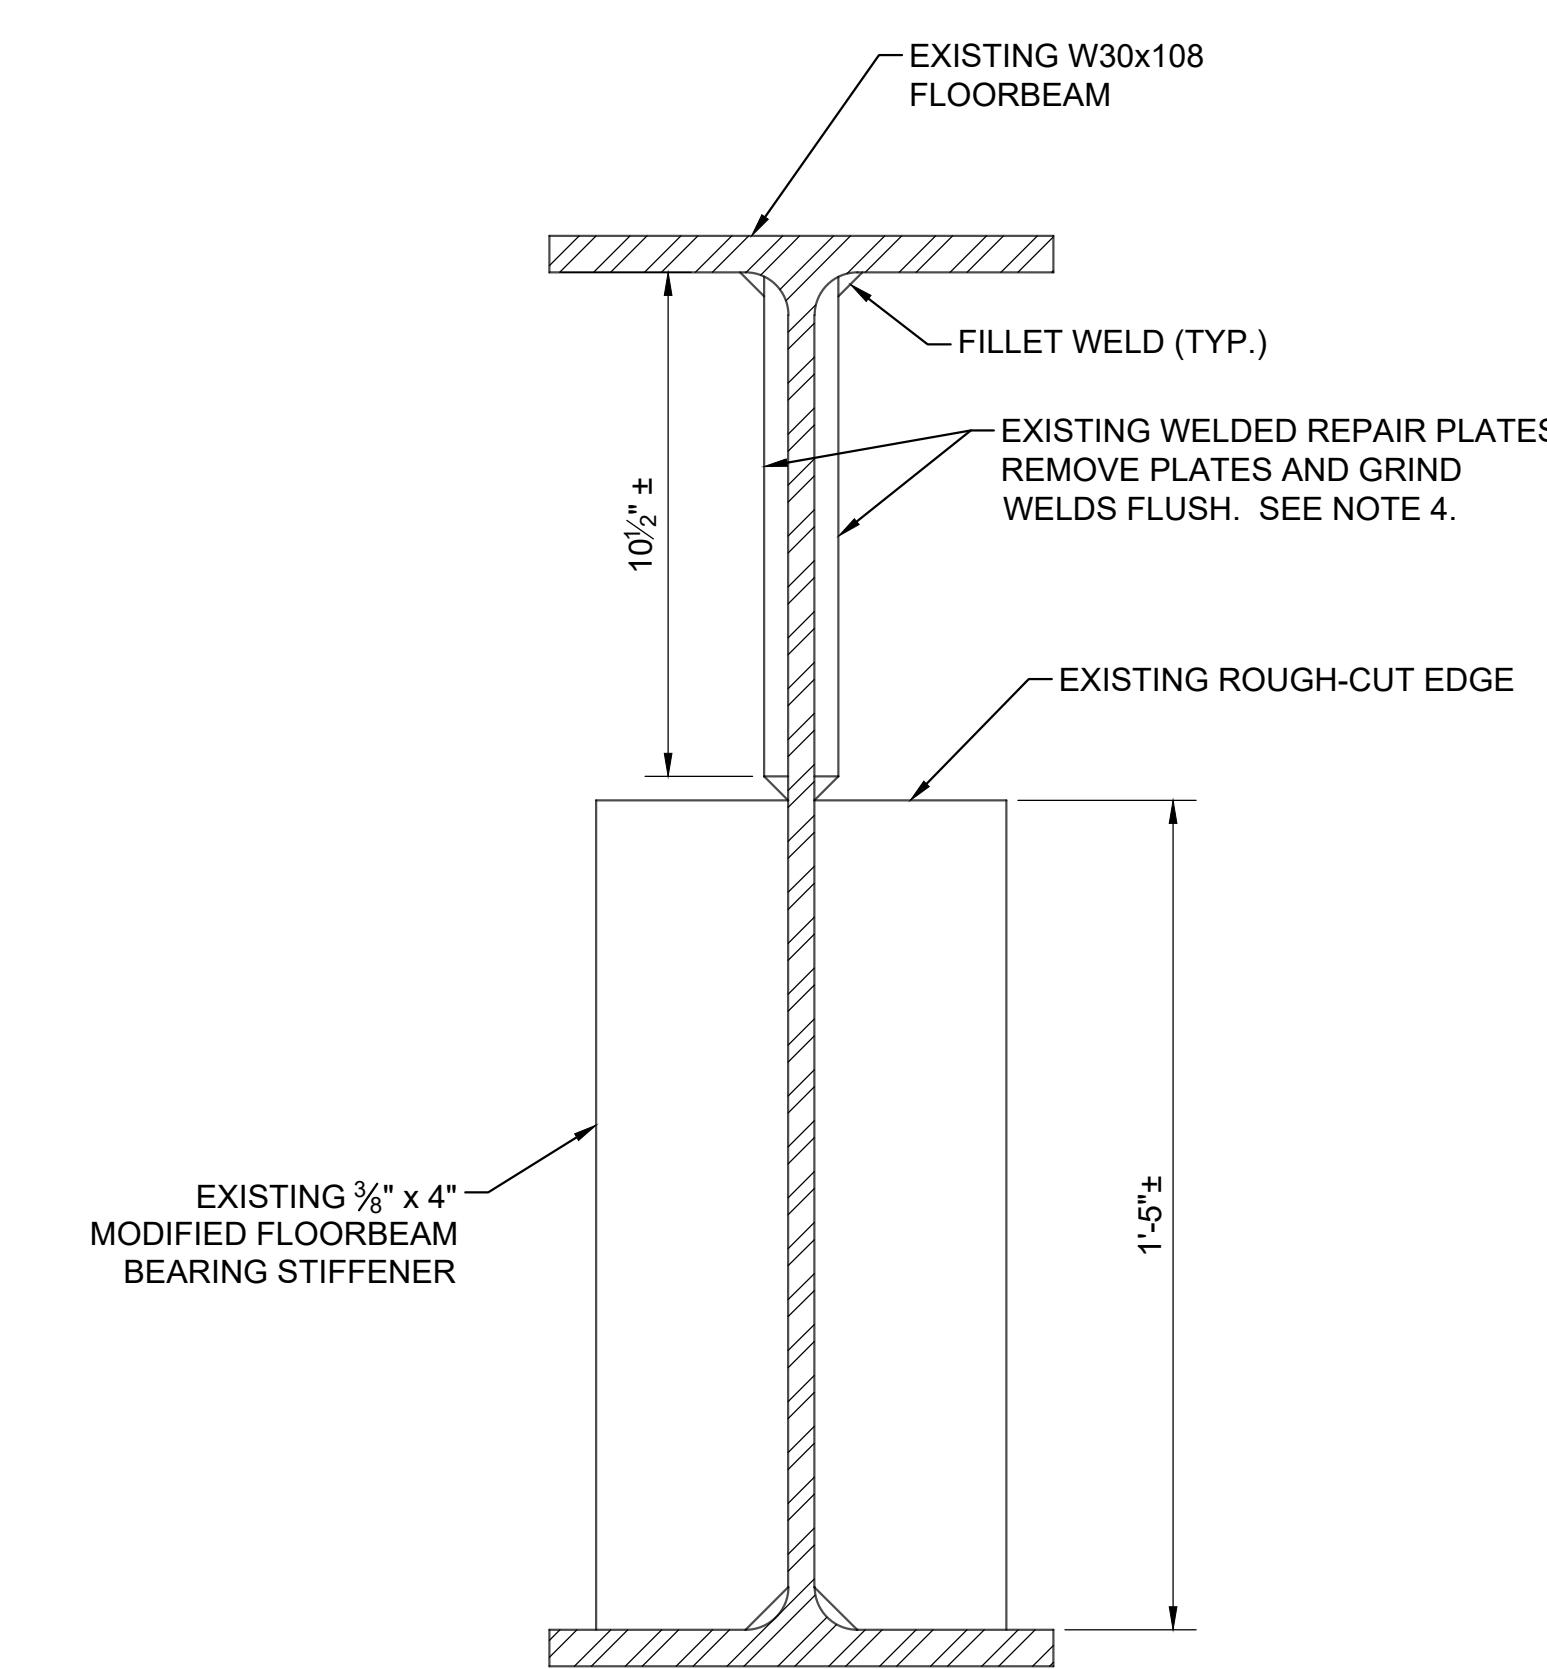
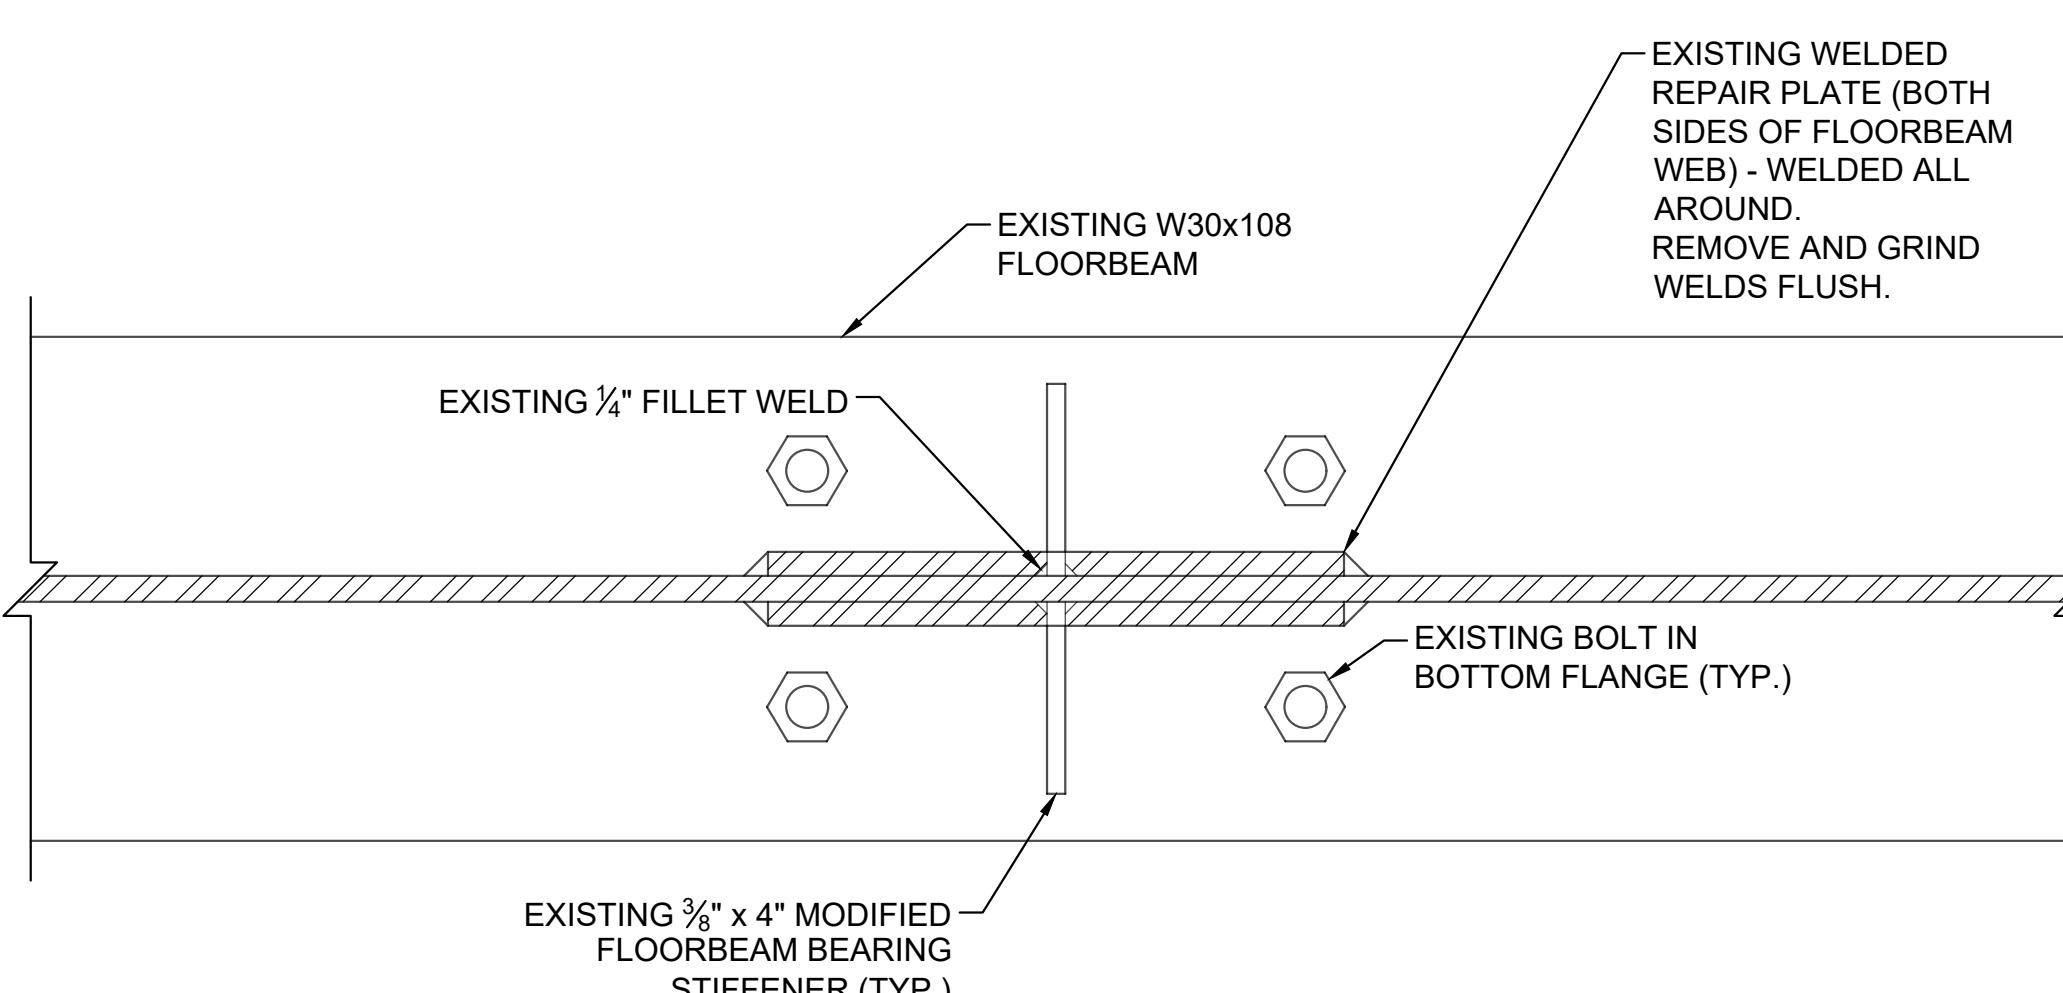
NCB-NB FLOORBEAM REPAIR TYPE 6

EXISTING CONDITION

SECTION F-F

PLAN VIEW

1. PERFORM THIS REPAIR AT THE NCB-NB SPAN 14 FLOORBEAM 2 BEARING STIFFENERS ABOVE THE EAST GIRDER.
2. EXISTING CONDITION OF WEB WITHIN FOOTPRINT OF EXISTING WELDED REPAIR PLATE IS UNKNOWN. THE (12) FASTENERS SHOWN WITHIN FOOTPRINT ARE TO BE FIELD-LOCATED AND DRILLED, AND LOCATIONS ARE ASSUMED. AFTER EXISTING WELDED REPAIR PLATE IS REMOVED, INSPECT AND CONTACT THE DISTRICT WITH INFORMATION ON EXISTING WEB CONDITION. THE DISTRICT WILL PROVIDE GUIDANCE ON FINAL FASTENER LAYOUT AND/OR CRACK ARREST HOLES REQUIRED PRIOR TO PROCEEDING.

3. MATCH DRILL OPPOSING STIFFENER SPLICE PLATES AND WEB REPAIR PLATES IN THE SHOP.
4. USE CAUTION TO AVOID DAMAGE TO FLOORBEAM WEB OR TOP FLANGE WHEN REMOVING EXISTING WELDED REPAIR PLATE. FLAME CUTTING IS PROHIBITED AS A METHOD FOR REMOVAL FOR THIS DETAIL. IF DAMAGE OCCURS, CONTRACTOR IS RESPONSIBLE FOR REPAIRING IT TO THE SATISFACTION OF THE DISTRICT AT NO COST TO THE DISTRICT.

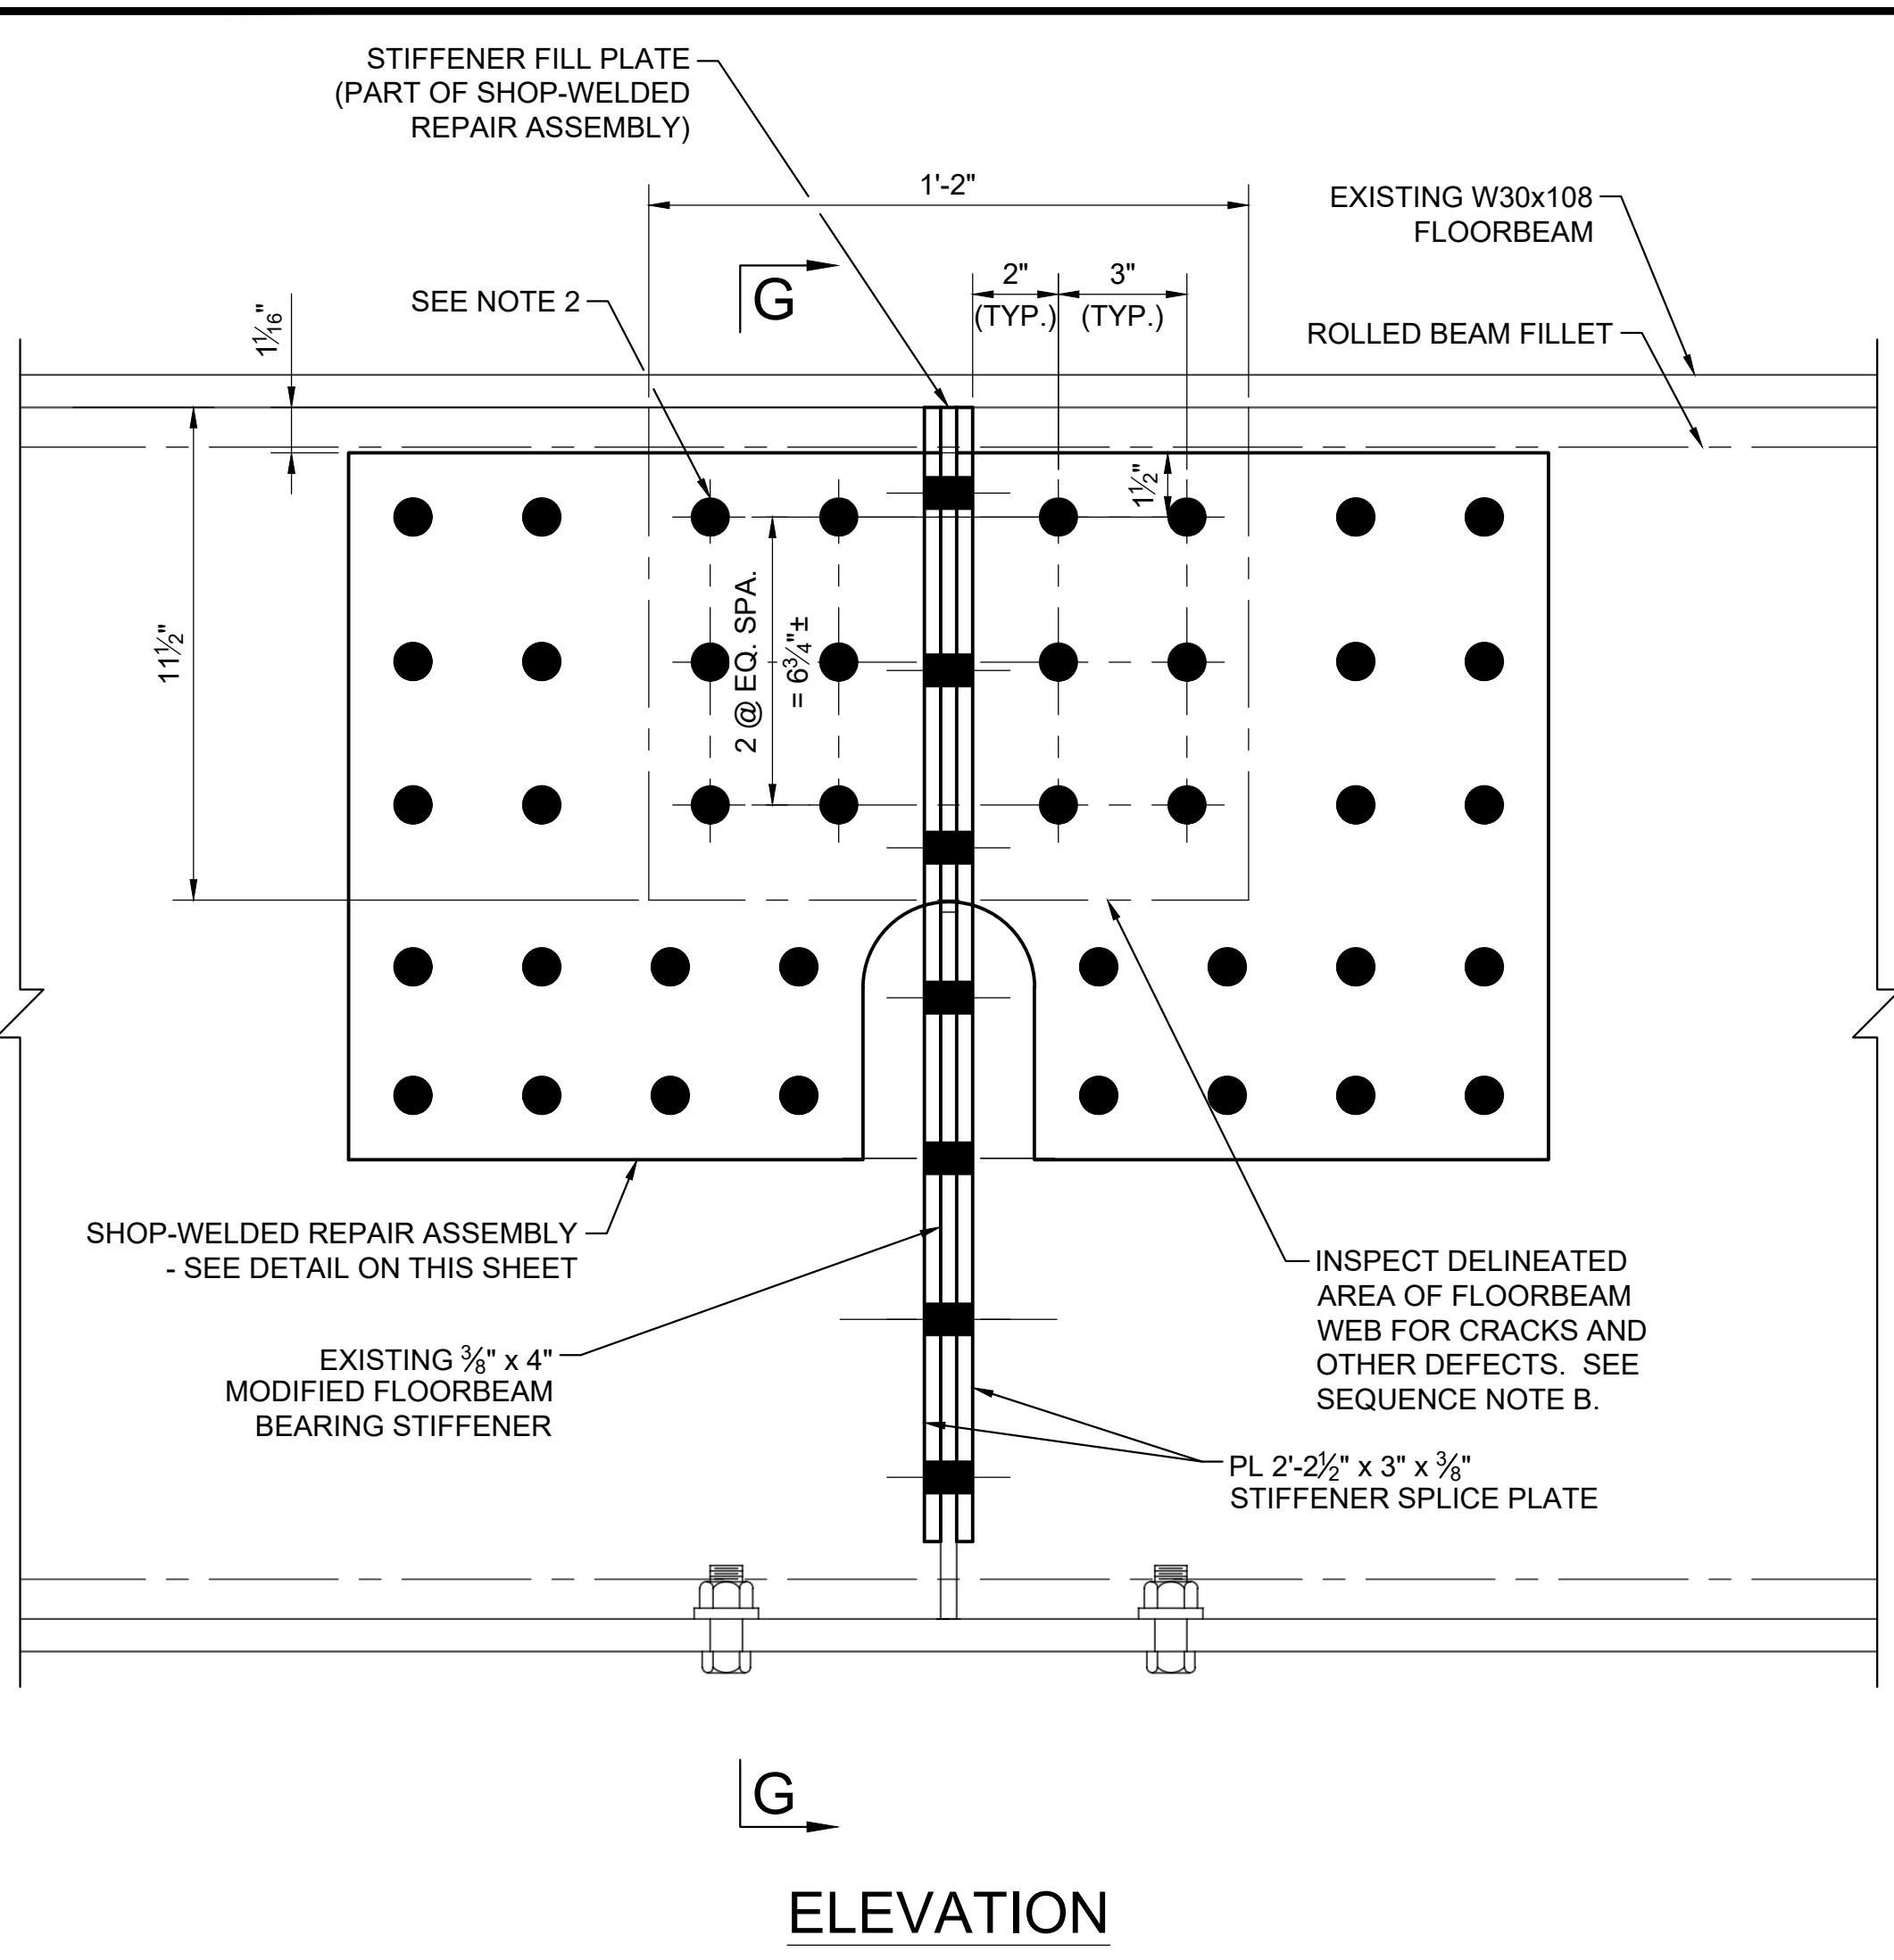
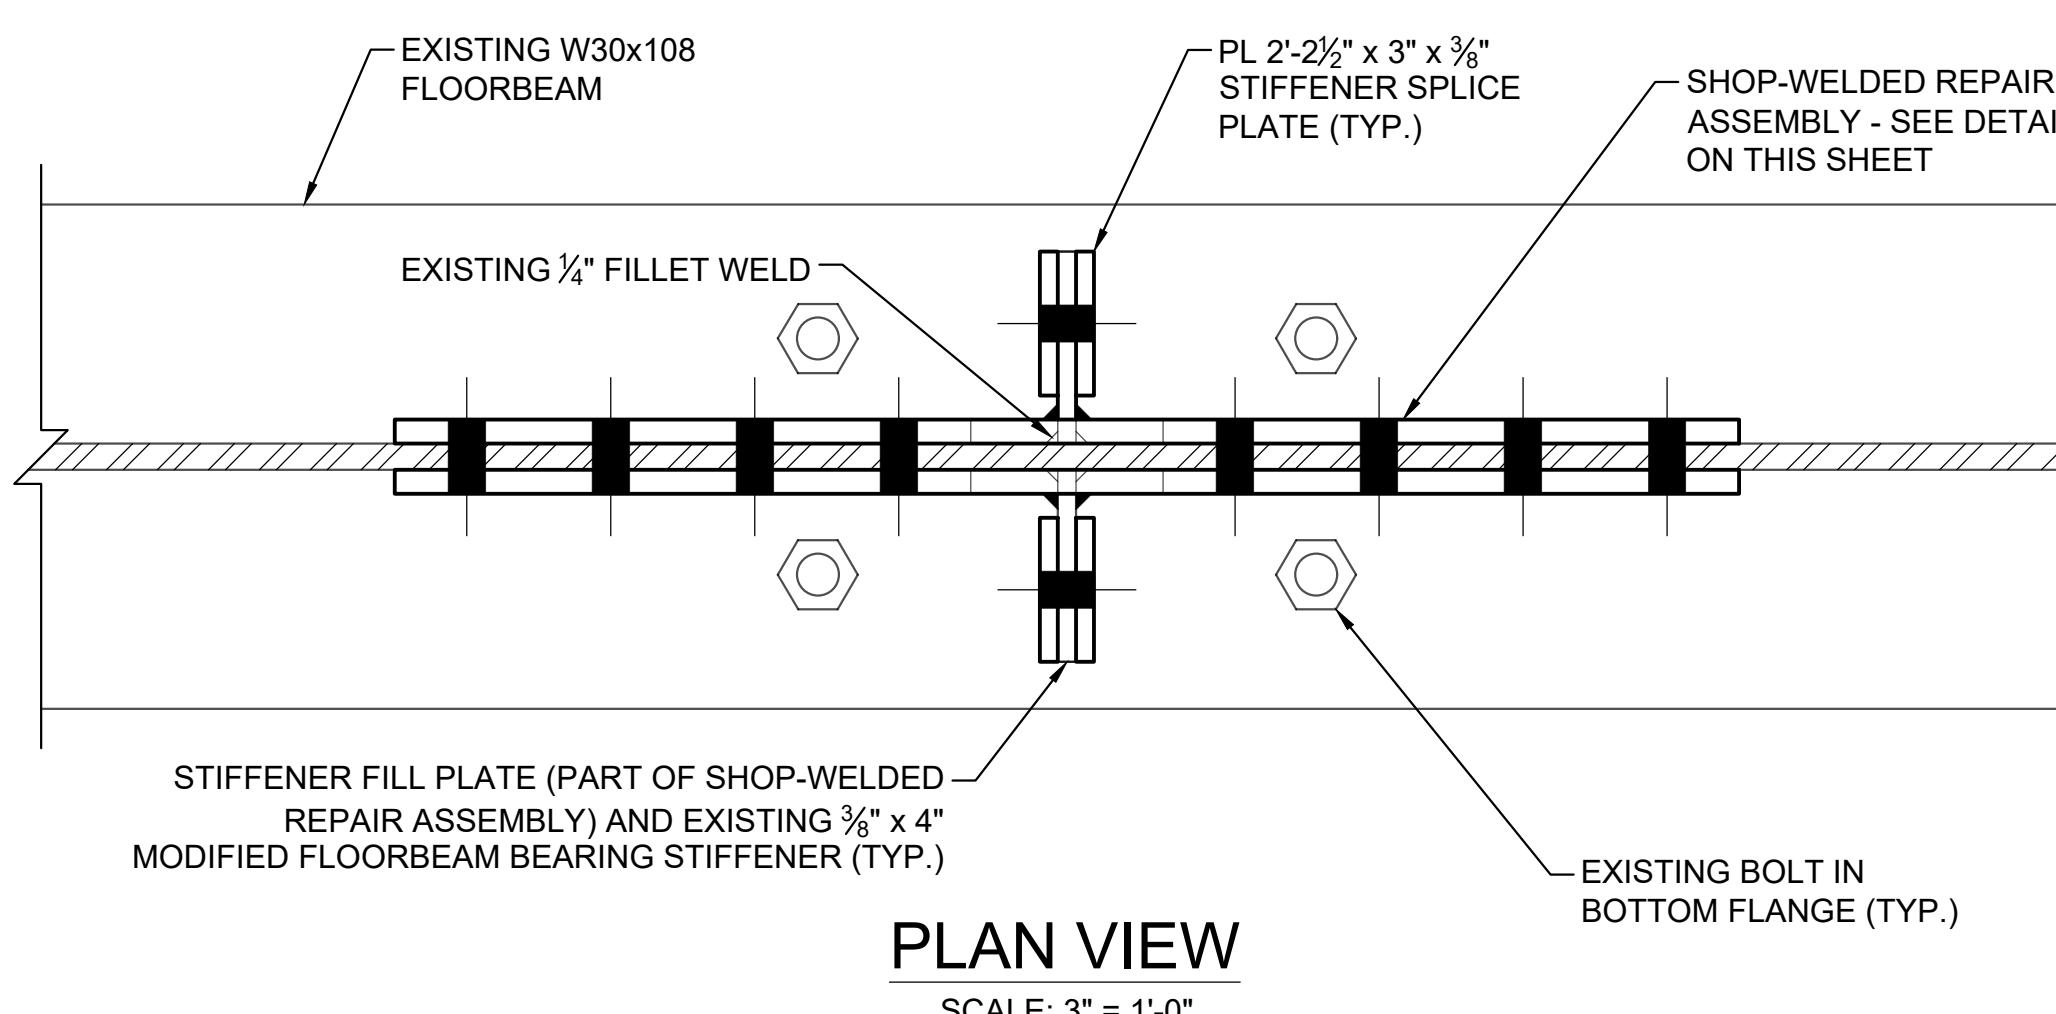
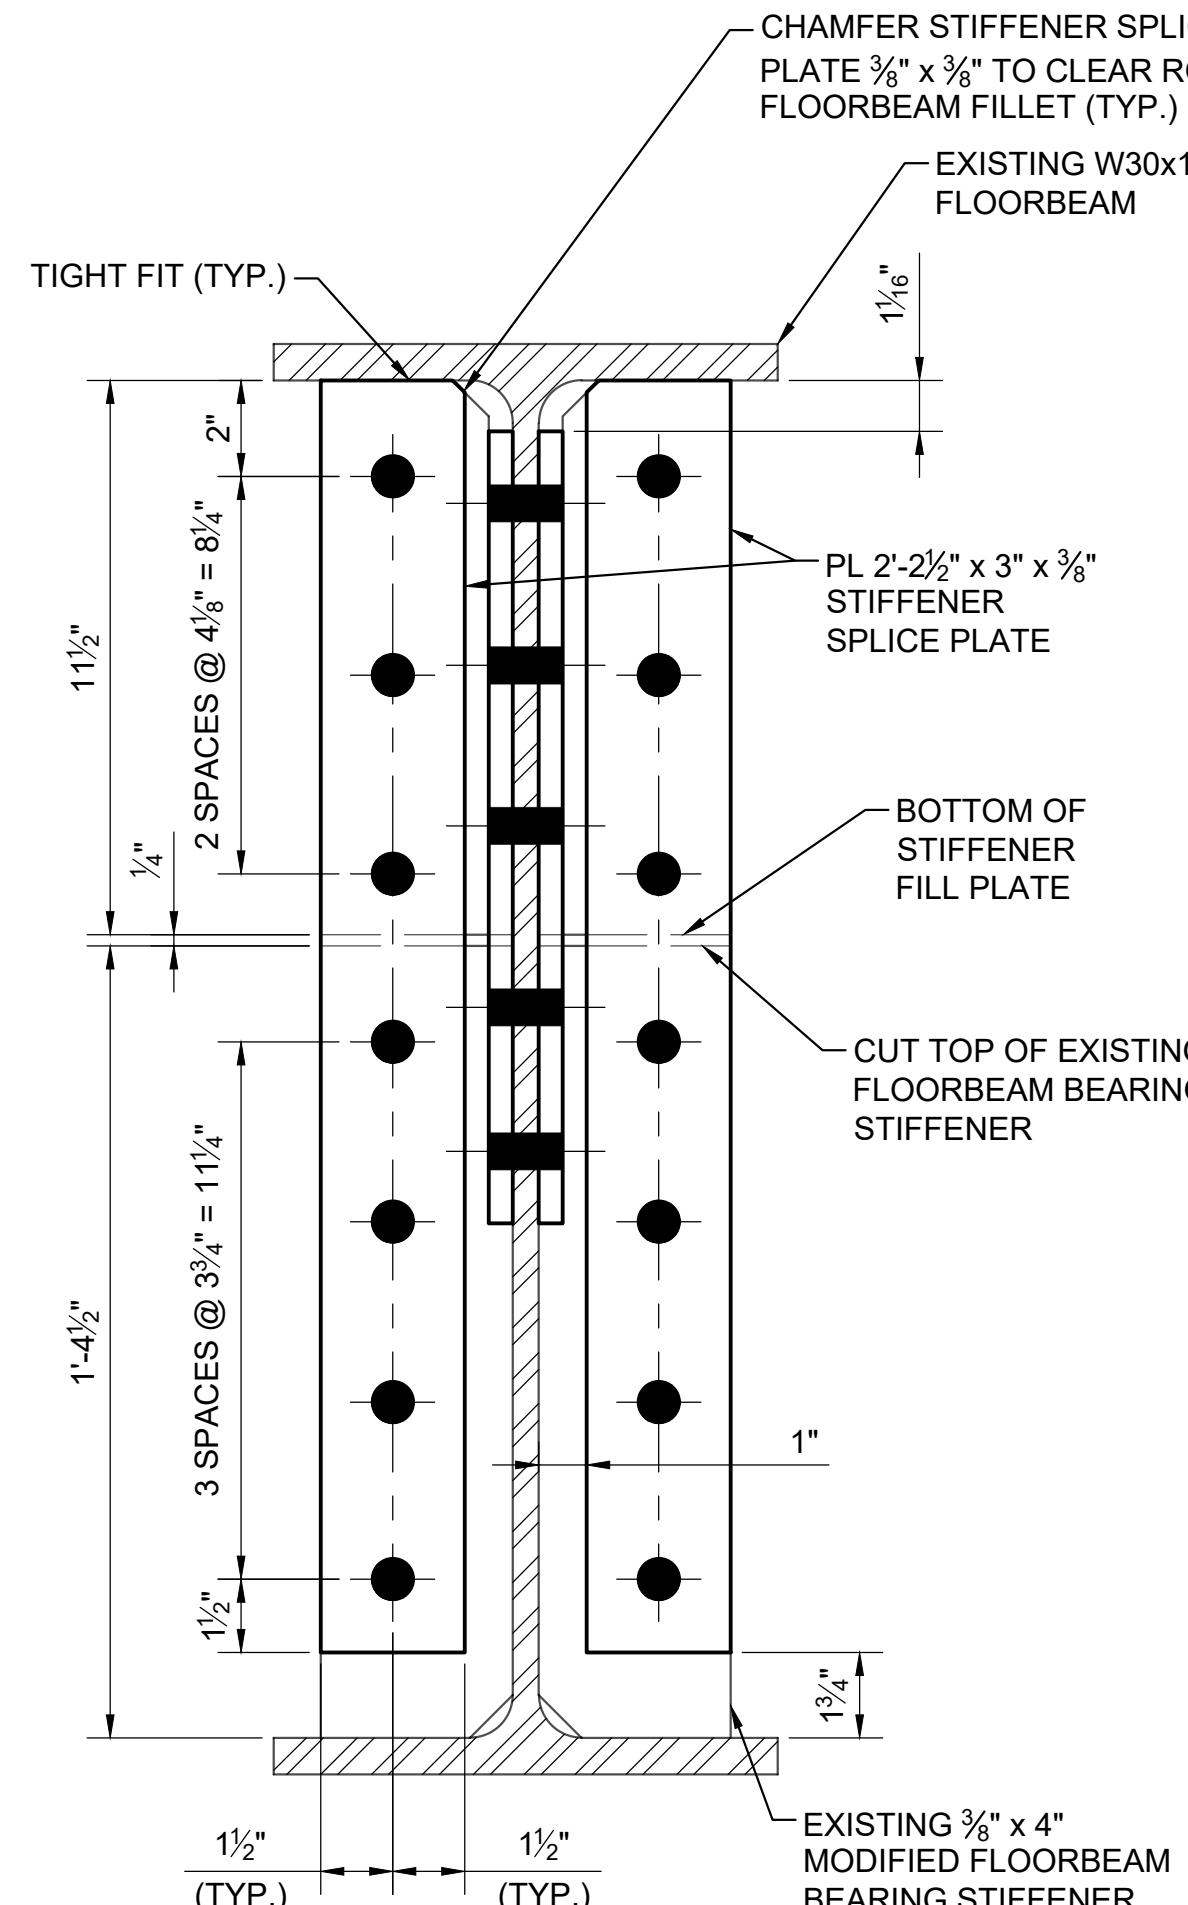
NCB-NB FLOORBEAM REPAIR TYPE 6

REPAIRED CONDITION

SECTION G-

SHOP-WELDED REPAIR ASSEMBLY

- A. REMOVE EXISTING REPAIR PLATE ON EACH SIDE OF THE WEB AND GRIND WELDS FLUSH AND ALL CORRODED AREAS. CUT EXISTING FLOORBEAM STIFFENERS TO HEIGHT INDICATED.

- B. VISUALLY INSPECT FLOORBEAM WEB FOR CRACKS. IF APPARENT, PERFORM DYE PENETRANT INSPECTION. PROVIDE WEB CONDITION INFORMATION TO THE DISTRICT FOR EVALUATION, FINAL FASTENER LAYOUT, AND DETAILS FOR ANY CRACK ARREST HOLES REQUIRED.

- C. ACHIEVE TIGHT FIT CONDITION FOR THE SHOP-WELDED REPAIR ASSEMBLY ON ONE SIDE OF WEB, ENSURING ALIGNMENT OF THE STIFFENER FILL PLATE WITH THE EXISTING STIFFENER, AND CLAMP ASSEMBLY IN PLACE. TRANSFER REQUIRED FASTENER HOLES TO THE WEB. LOCATE REPAIR ASSEMBLY ON OPPOSITE SIDE OF WEB AND CLAMP IN PLACE.

- D. ACHIEVE TIGHT FIT CONDITION FOR STIFFENER SPLICE PLATES, CLAMP IN PLACE, AND TRANSFER REQUIRED FASTENER HOLES THROUGH THE STIFFENER FILL PLATE AND EXISTING STIFFENER.

- E. LOCATE AND FIELD-DRILL REMAINING FASTENER HOLES THROUGH THE WEB REPAIR PLATE AND WEB, ADJUSTING AS NECESSARY PER DETAIL-SPECIFIC NOTE 2.
- F. REMOVE THE TEMPORARILY CLAMPED PLATES. APPLY STEEL-FILLED EPOXY PUTTY TO ALL MATING SURFACES AND TO FILL ALL GAPS, SMOOTHED TO MATCH EXISTING SURFACE. BOLT THE REPAIR PLATES TO BOTH SIDES OF THE FLOORBEAM STIFFENER.
