CHESAPEAKE BAY BRIDGE AND TUNNEL DISTRICT
			RMF 5044.5122 - STEEL BRIDGE PAINTING PROJECT
PROJECT NOTES			
No.	Description	Date	Designed: JSE Drawn: BSB Checked: AHC
			12/18/2025
	Revision		1 OF 45

CHESAPEAKE BAY BRIDGE AND TUNNEL DISTRICT	
			RMF 5044.5122 - STEEL BRIDGE PAINTING PROJECT	
NORTH CHANNEL BRIDGE NB GENERAL PLAN AND ELEVATION				
No.	Description	Date	Designed: JSE Drawn: BSB Checked: AHC	Date Plan No. Sheet No.
	Revision			12/18/2025 3 OF 45

CHESAPEAKE BAY BRIDGE AND TUNNEL DISTRICT							
			RMF 5044.5122 - STEEL BRIDGE PAINTING PROJECT							
NORTH CHANNEL BRIDGE NB STRINGER AND FLOORBEAM PLATING REPAIRS										
No. Description Date Designed: JSE Drawn: JSE Checked: AHC 12/18/2025 9 OF 45										
	Revision

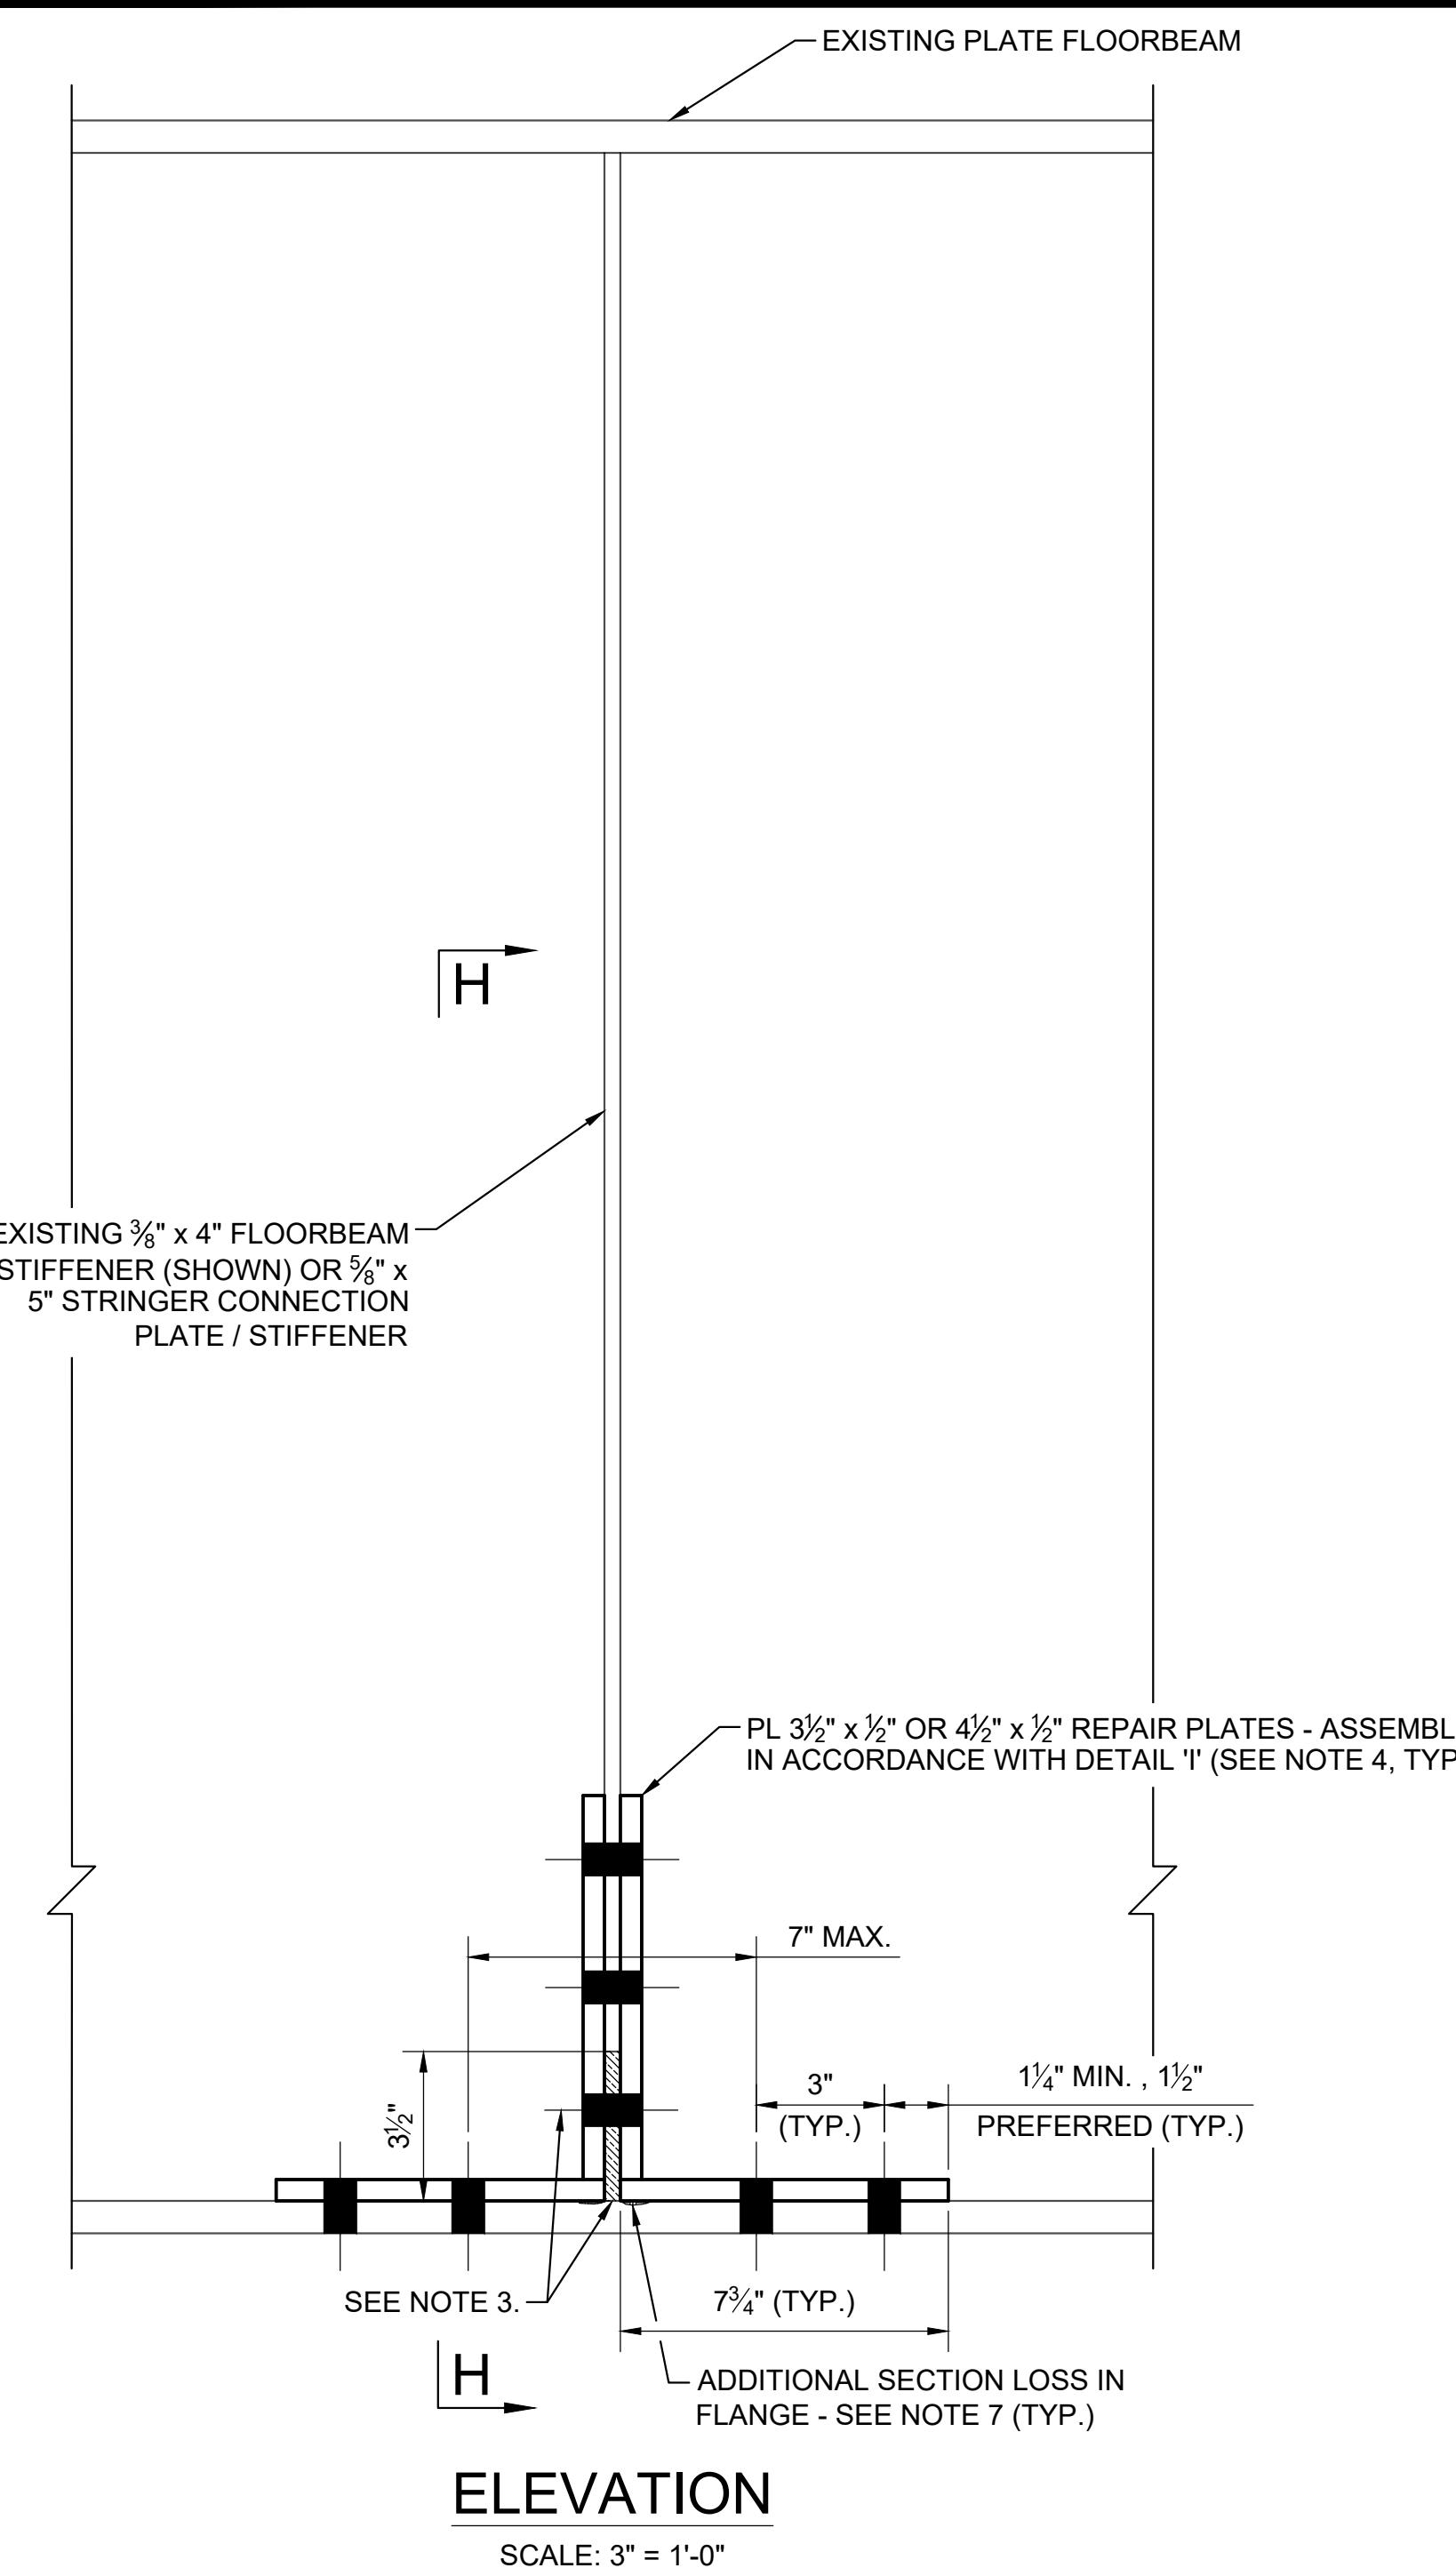
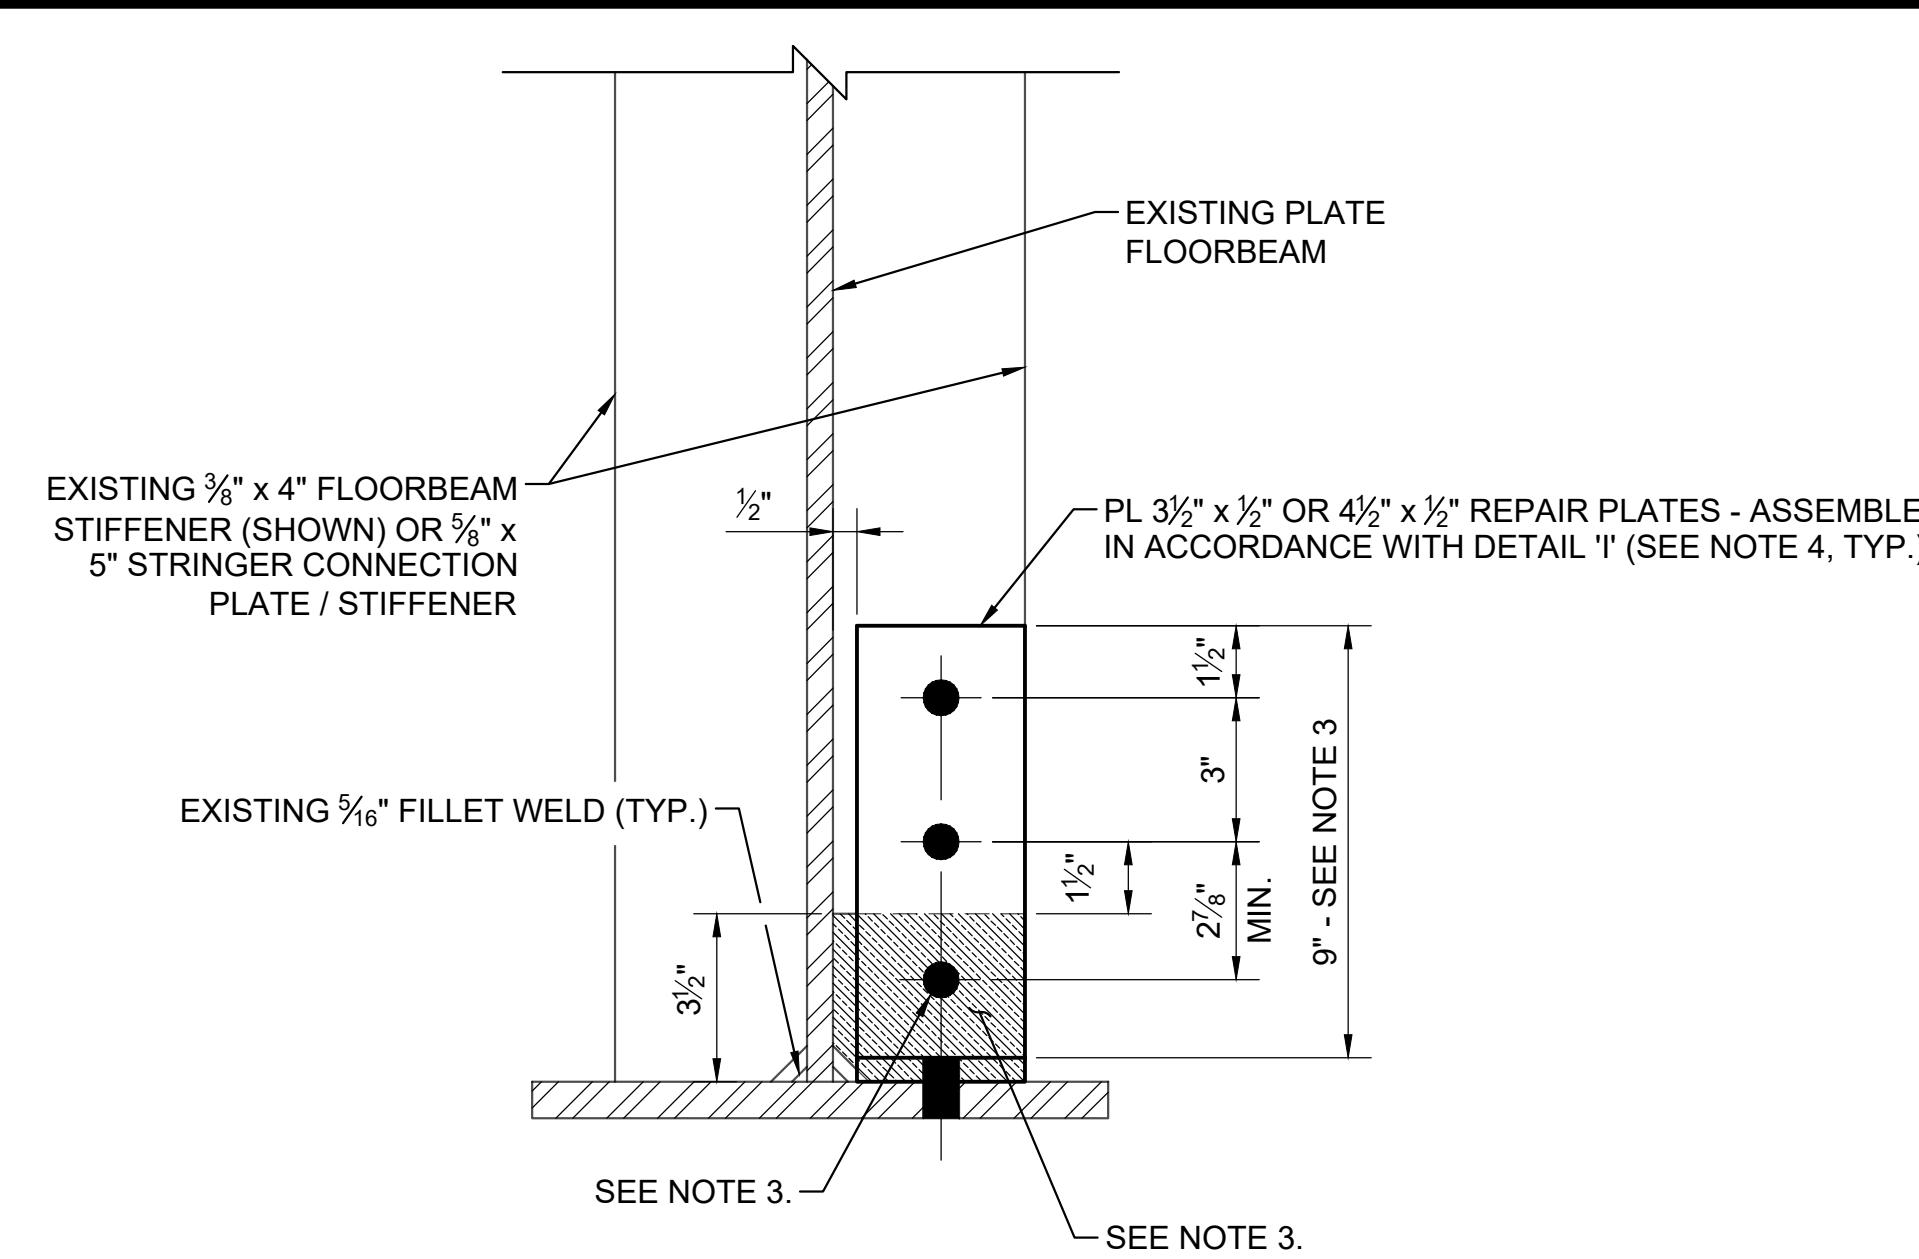
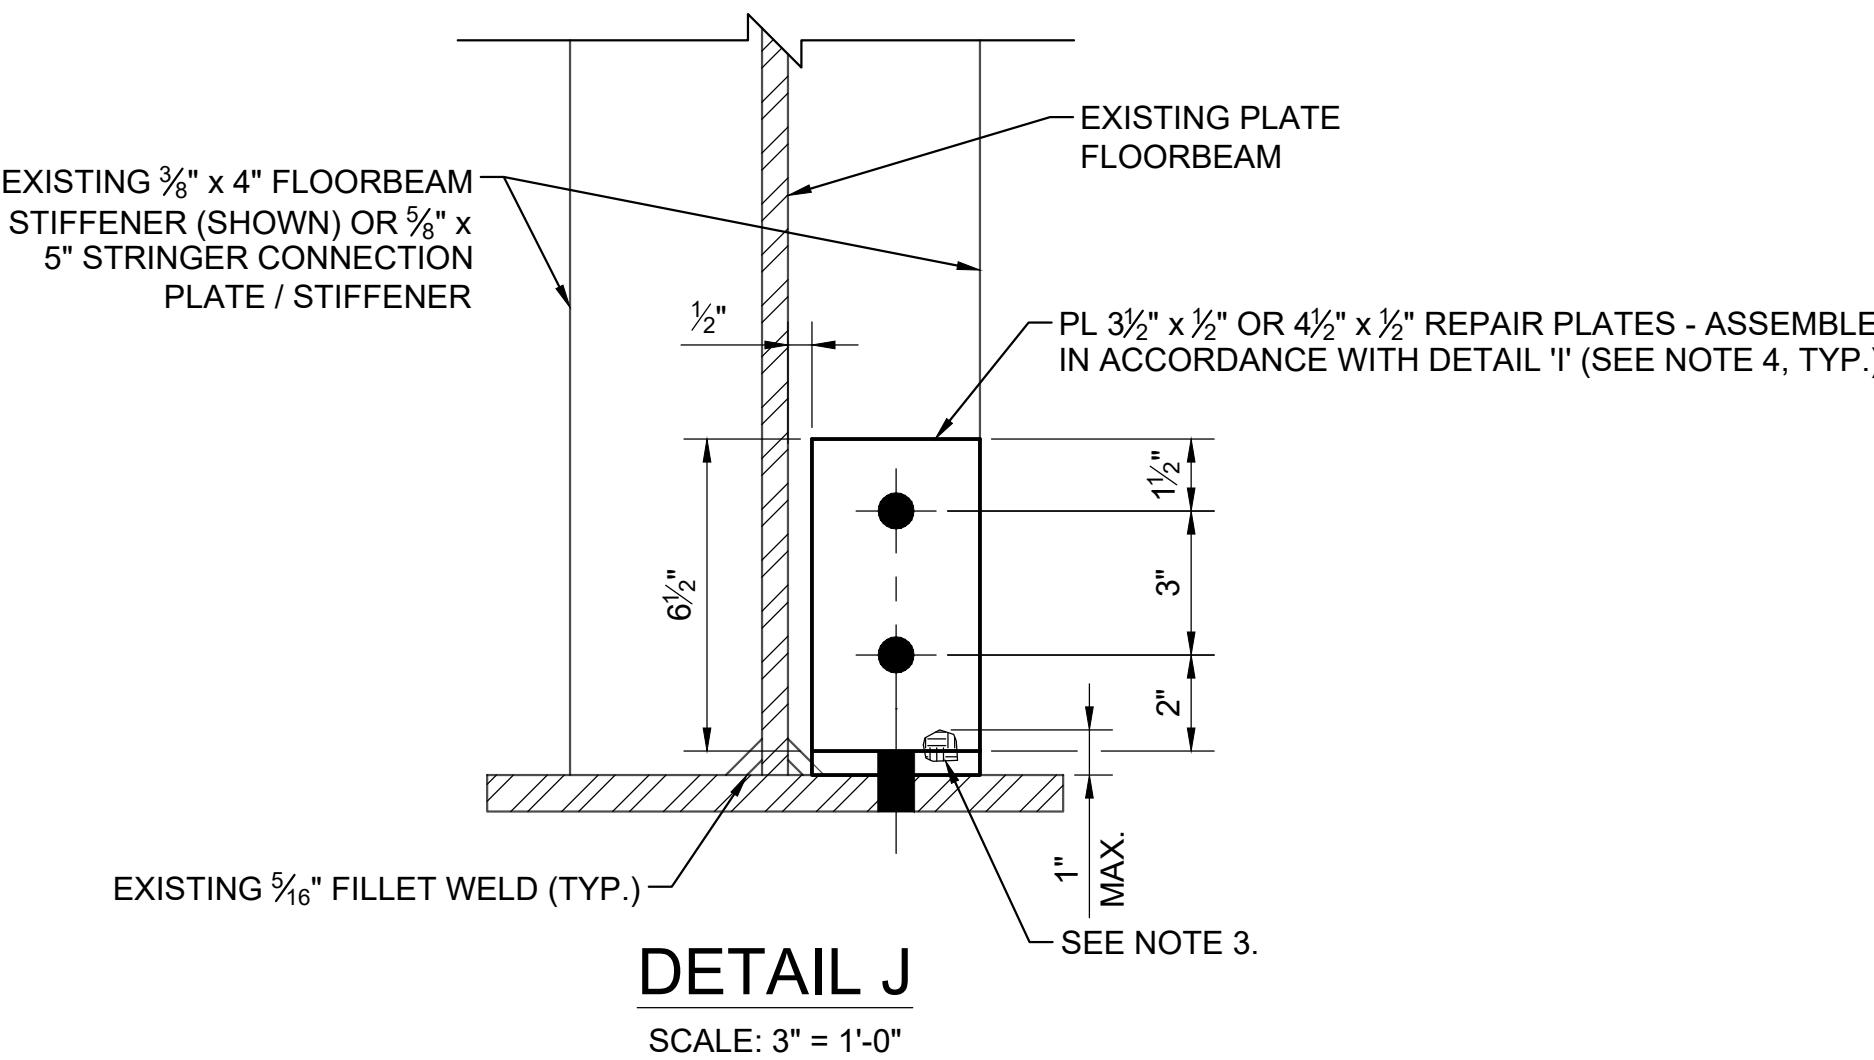
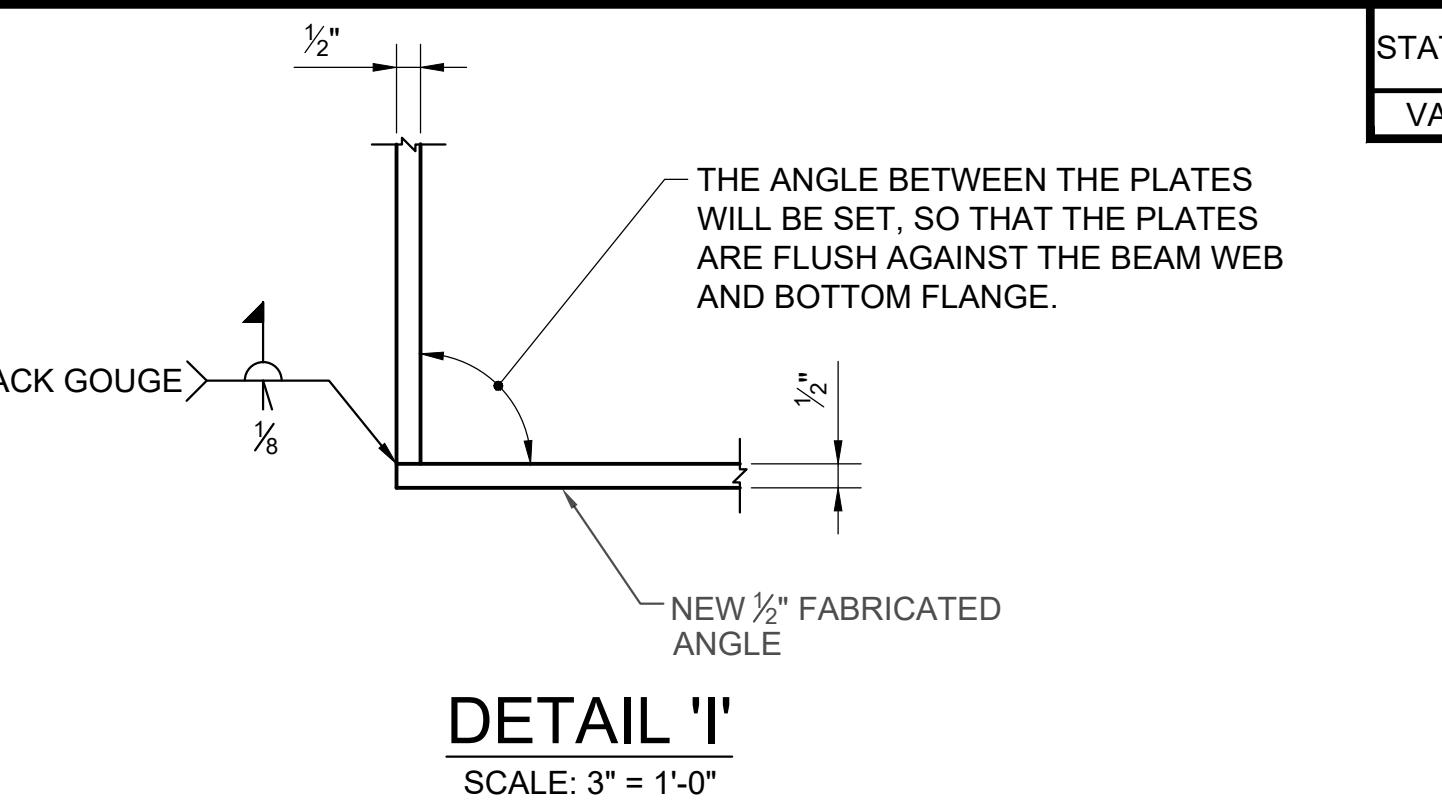
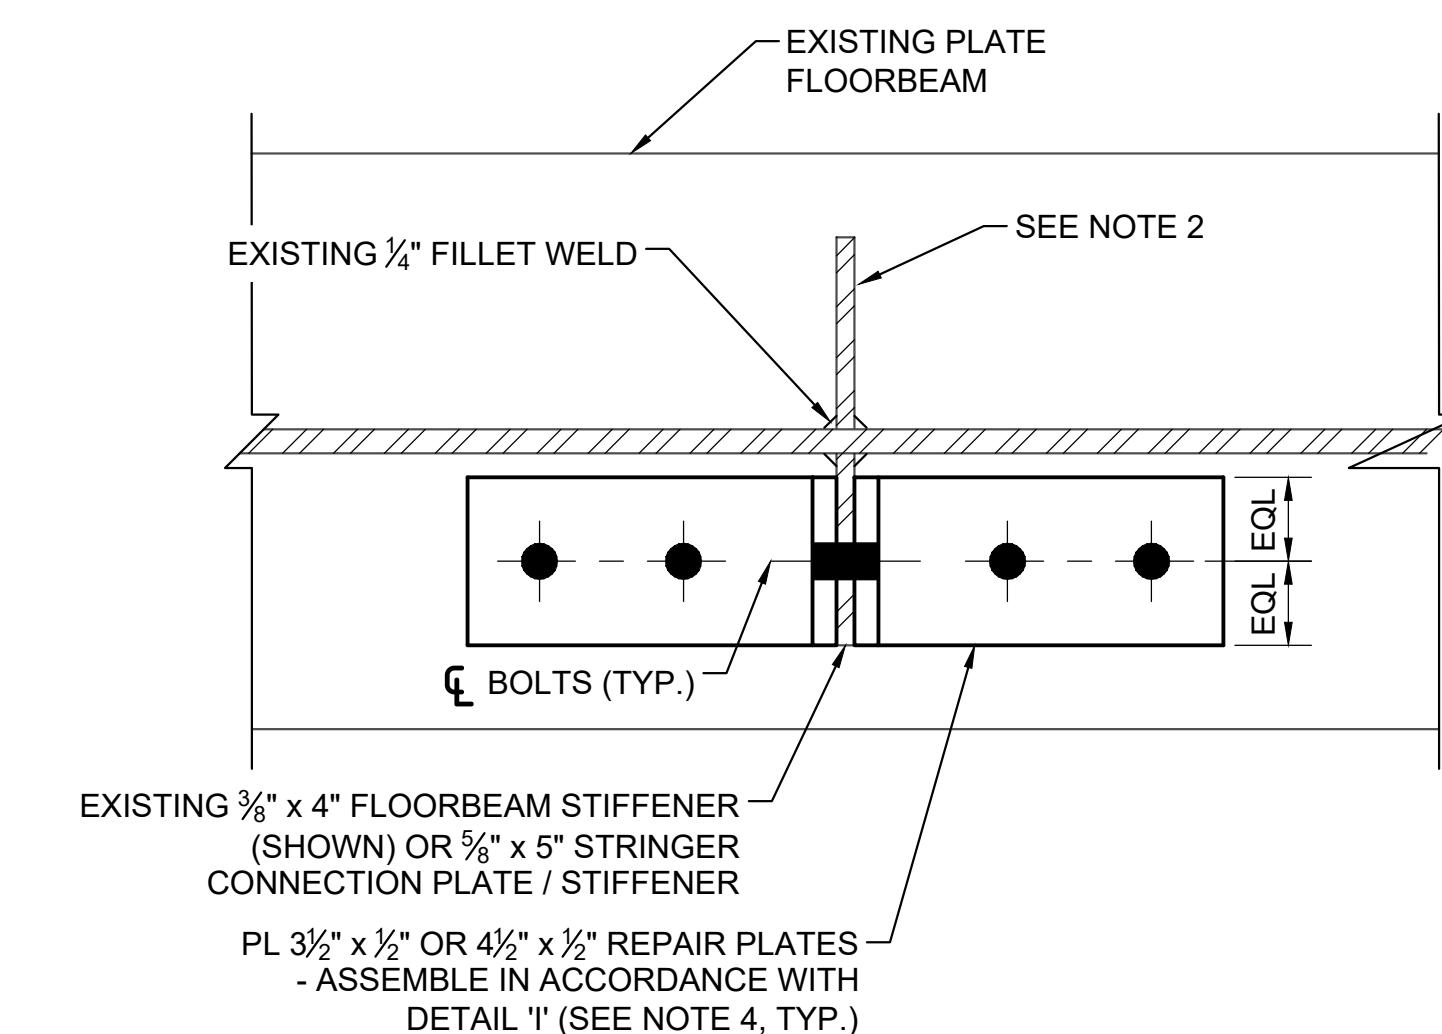
NCB-NB TRUSS FLOORBEAM REPAIR TYPE 2

1. PERFORM THIS REPAIR FOR NCB-NB SPAN 9 (TRUSS SPAN) FLOORBEAM STIFFENERS AND STRINGER CONNECTION PLATES EXHIBITING CORROSION AT BOTTOM END WITH LESS THAN 1/4" REMAINING THICKNESS OVER 3" OR MORE OF THE STIFFENER WIDTH AS APPROVED BY THE DISTRICT.

2. BACK TO BACK REPAIR CONDITIONS (EITHER SIDE OF FLOORBEAM) WILL EXIST.
3. CORROSION ANTICIPATED AT THE BOTTOM END OF THE BEARING STIFFENER IS UP TO APPROXIMATELY 3 1/2" HIGH x UP TO FULL WIDTH x UP TO FULL THICKNESS (CORROSION HOLE).

- 3.1. IF CORROSION IS LESS THAN 1" WIDE OR 1" HIGH, GRIND CORROSION SMOOTH, FILL GAP WITH EPOXY PUTTY, AND ADJUST REPAIR AS SHOWN IN DETAIL J.
 - 3.2. IF CORROSION IS > 1 1/2" AND < 3 1/2" HIGH, CUT-OUT BOTTOM OF STIFFENER 3 1/2" ABOVE BOTTOM FLANGE ACROSS FULL WIDTH AND PLACE 3/8" x 4" OR 5/8" x 5" FILL PLATE (TO MATCH EXISTING STIFFENER) AS SHOWN IN SECTION H-H.

- 3.3. IF CORROSION EXCEEDS 3 1/2" HIGH, CONTACT THE DISTRICT FOR DIRECTION.
4. USE 3 1/2" WIDE REPAIR PLATES WHEN REPAIRING 4" WIDE STIFFENERS. USE 4 1/2" WIDE REPAIR PLATES WHEN REPAIRING 5" WIDE STRINGER CONNECTION PLATES.

5. MATCH DRILL OPPOSING REPAIR PLATE ASSEMBLIES IN THE SHOP.
6. IT IS ACCEPTABLE TO SUBSTITUTE ROLLED ANGLE SECTIONS WITH EQUIVALENT FLANGE LENGTH AND THICKNESS IN PLACE OF THE WELDED REPAIR PLATE ASSEMBLIES DEPICTED AT NO ADDITIONAL COST TO THE DISTRICT.

7. GRIND ALL CORROSION TO SMOOTH BARE METAL.
8. FILL ALL GAPS WITH STEEL-FILLED EPOXY PUTTY.

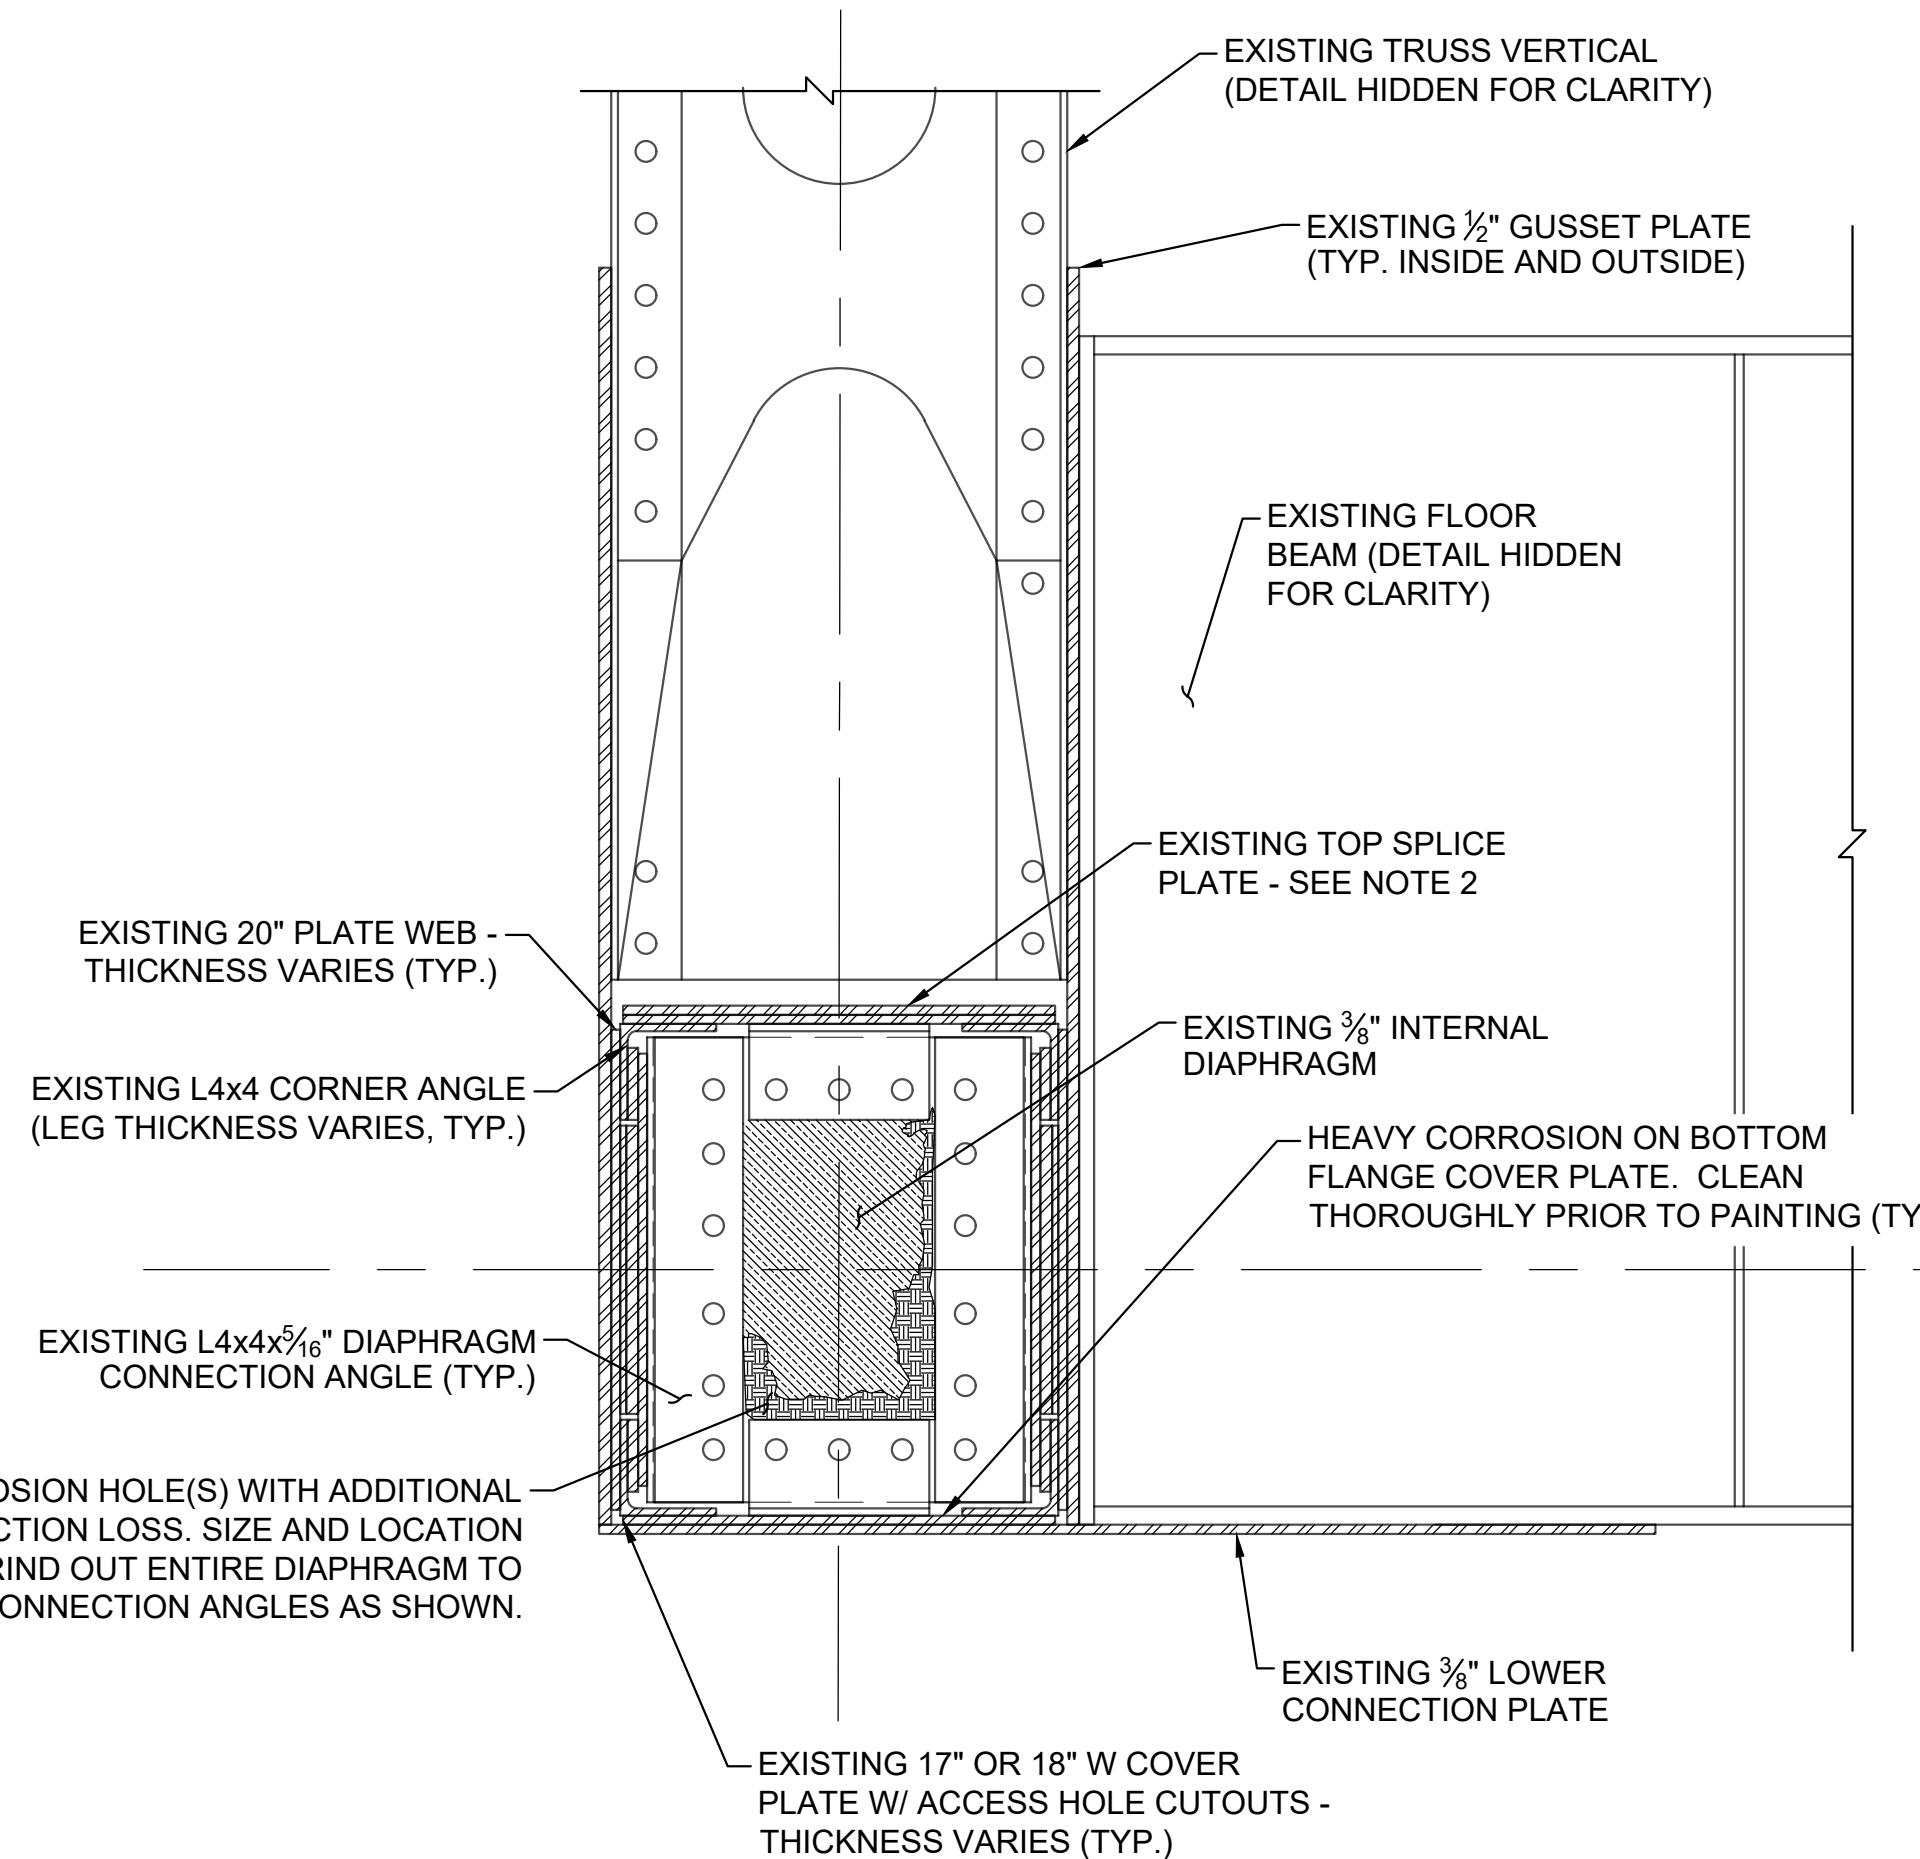
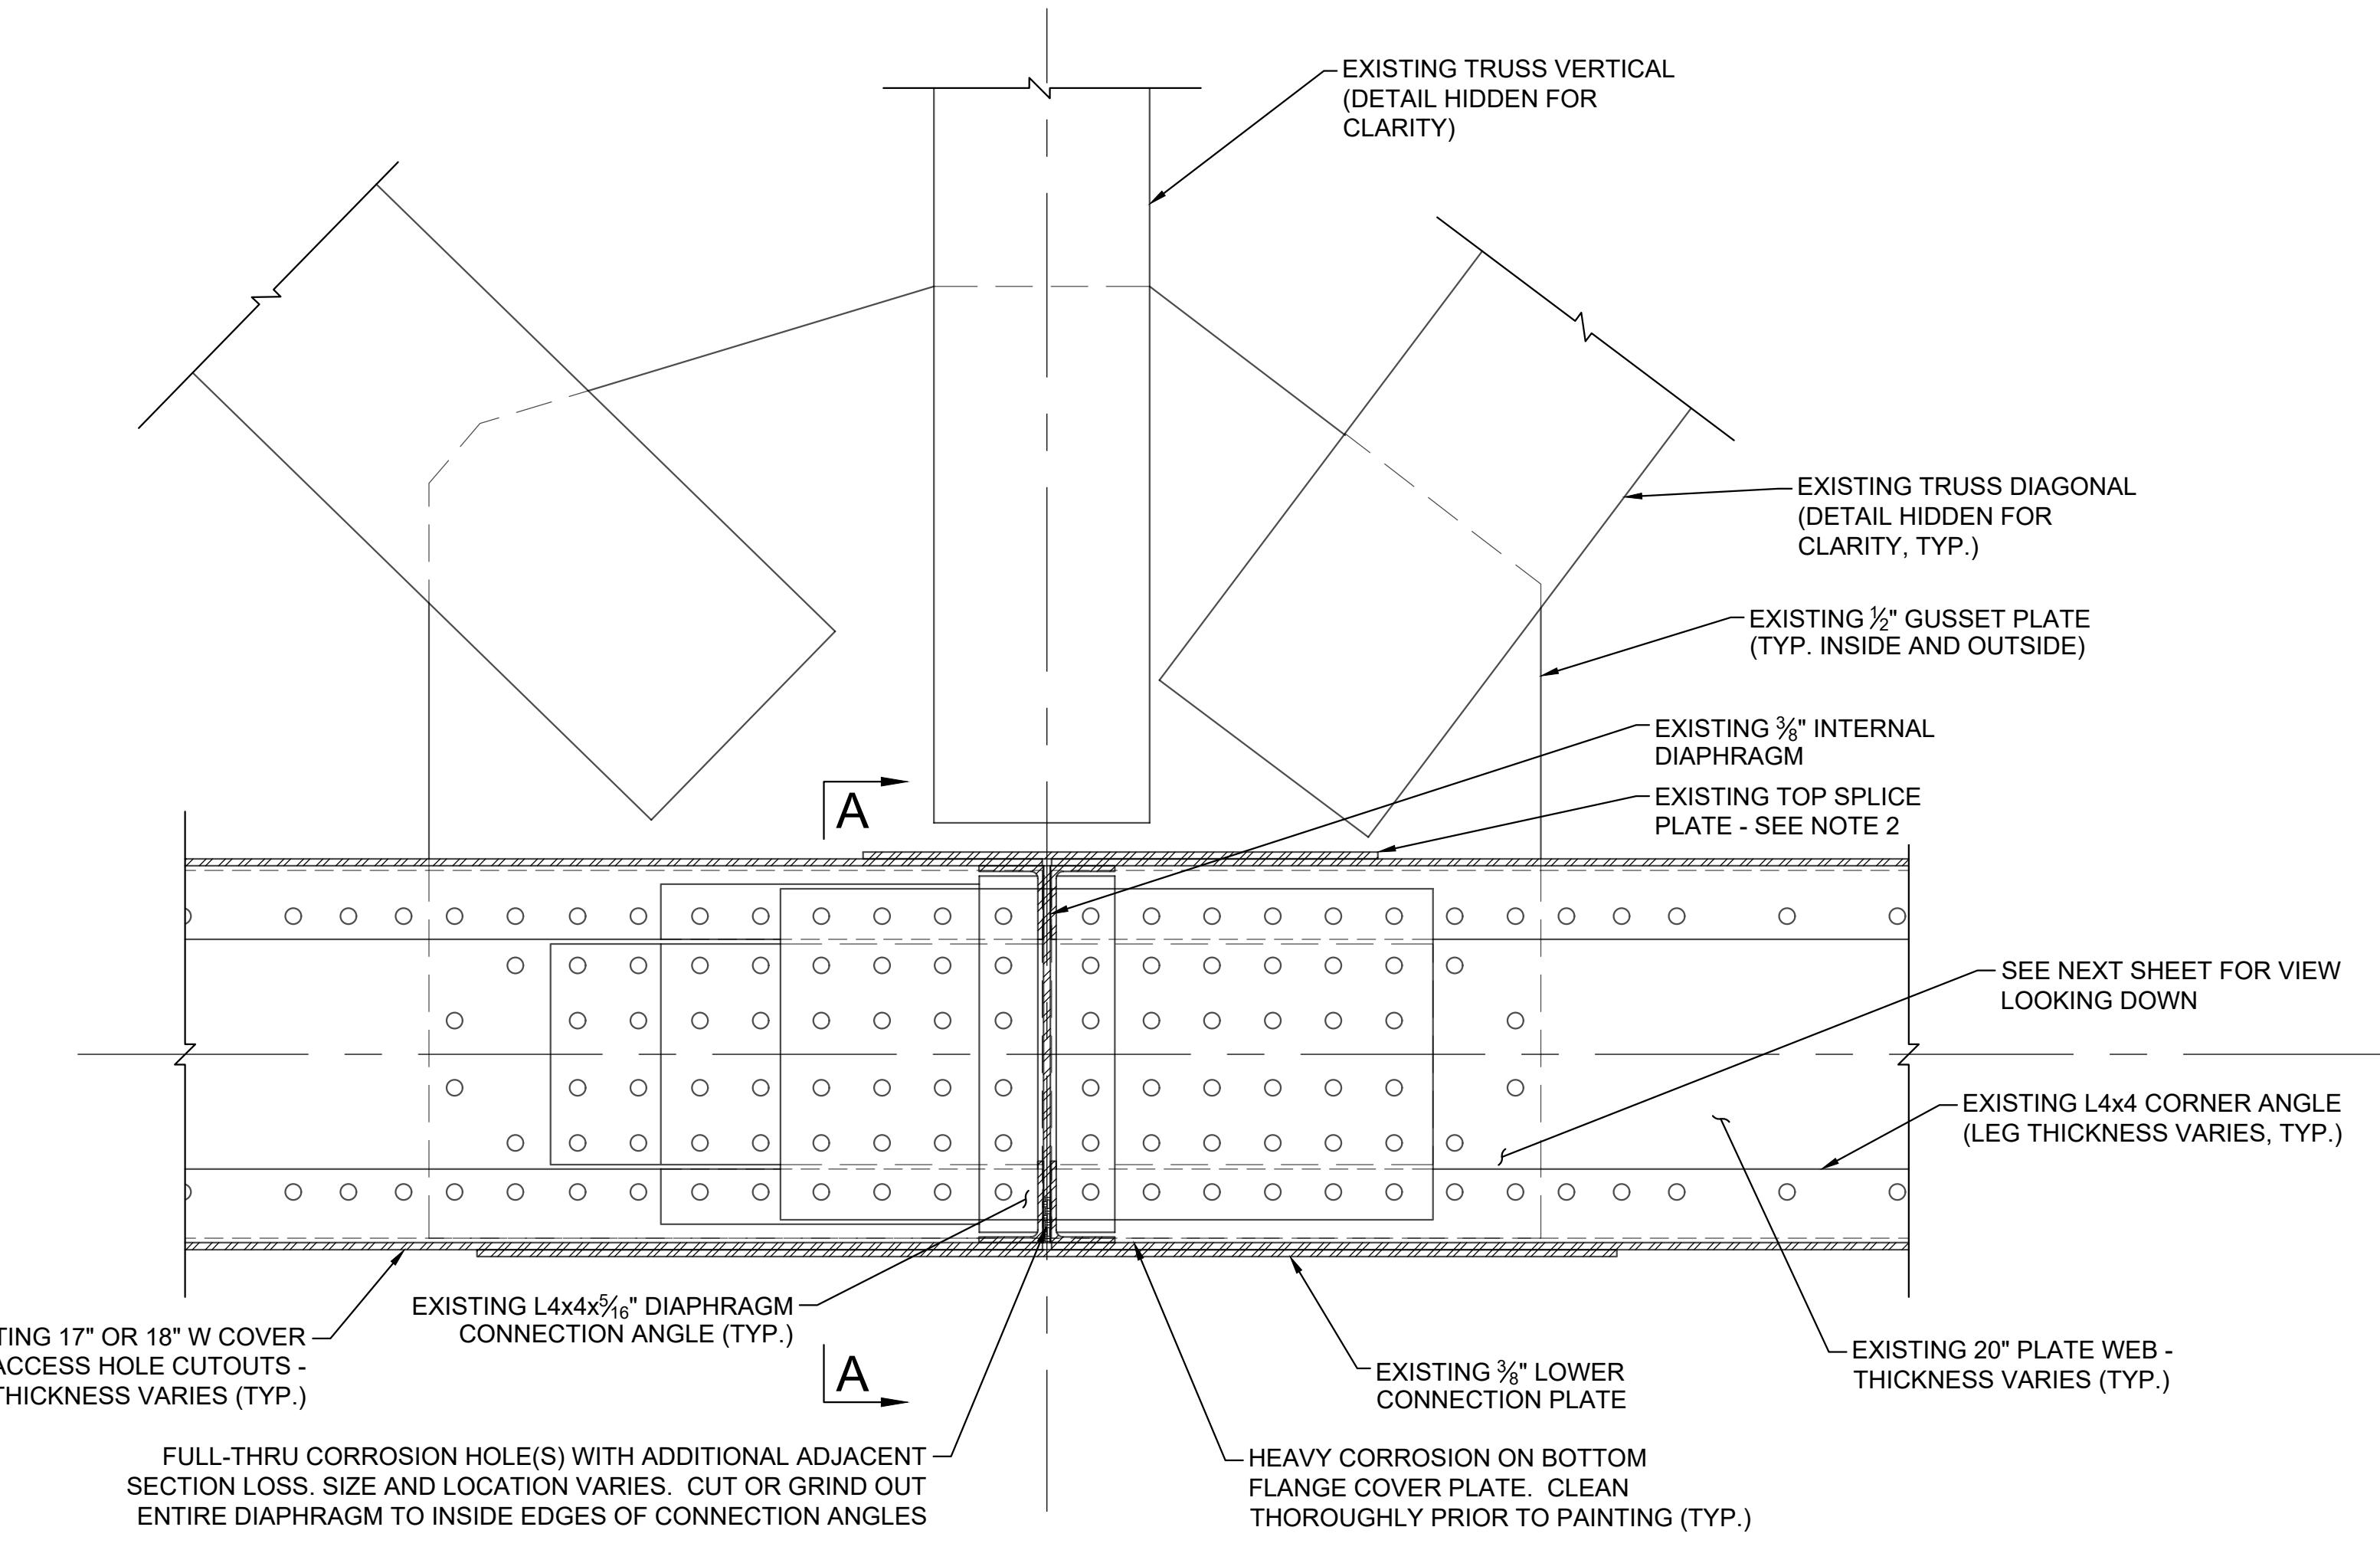
NCB-NB TRUSS REPAIR TYPE 1

SECTION A-A

INSIDE VIEW LOOKING OUT

1. PERFORM THIS REPAIR TO NCB-NB SPAN 9 (TRUSS SPAN) TRUSS LOWER CHORD MEMBERS AT PANEL POINTS FOR INTERNAL DIAPHRAGMS WITH CORROSION HOLES AS APPROVED BY THE DISTRICT.
2. TOP SPICE PLATE (THICKNESS VARIES) $\frac{7}{16}$ " BOTTOM SPICE PLATE (NOT SHOWN), AND INDICATED ASSOCIATED FASTENERS ON THE BOTTOM COVER PLATE ARE PRESENT AT PANEL POINTS L2 & L4 ONLY.
3. USE CAUTION TO AVOID DAMAGE TO TRUSS MEMBER WEBS, COVER PLATES, CORNER ANGLES, GUSSET PLATES, AND ALL OTHER ADJACENT STRUCTURE. FLAME CUTTING IS PROHIBITED AS A METHOD FOR REMOVAL FOR THE CORRODED AREAS DEPICTED IN THIS DETAIL. IF DAMAGE OCCURS, CONTRACTOR IS RESPONSIBLE FOR REPAIRING IT TO THE SATISFACTION OF THE DISTRICT AT NO COST TO THE DISTRICT.
4. GRIND ALL CORROSION TO SMOOTH BARE METAL.

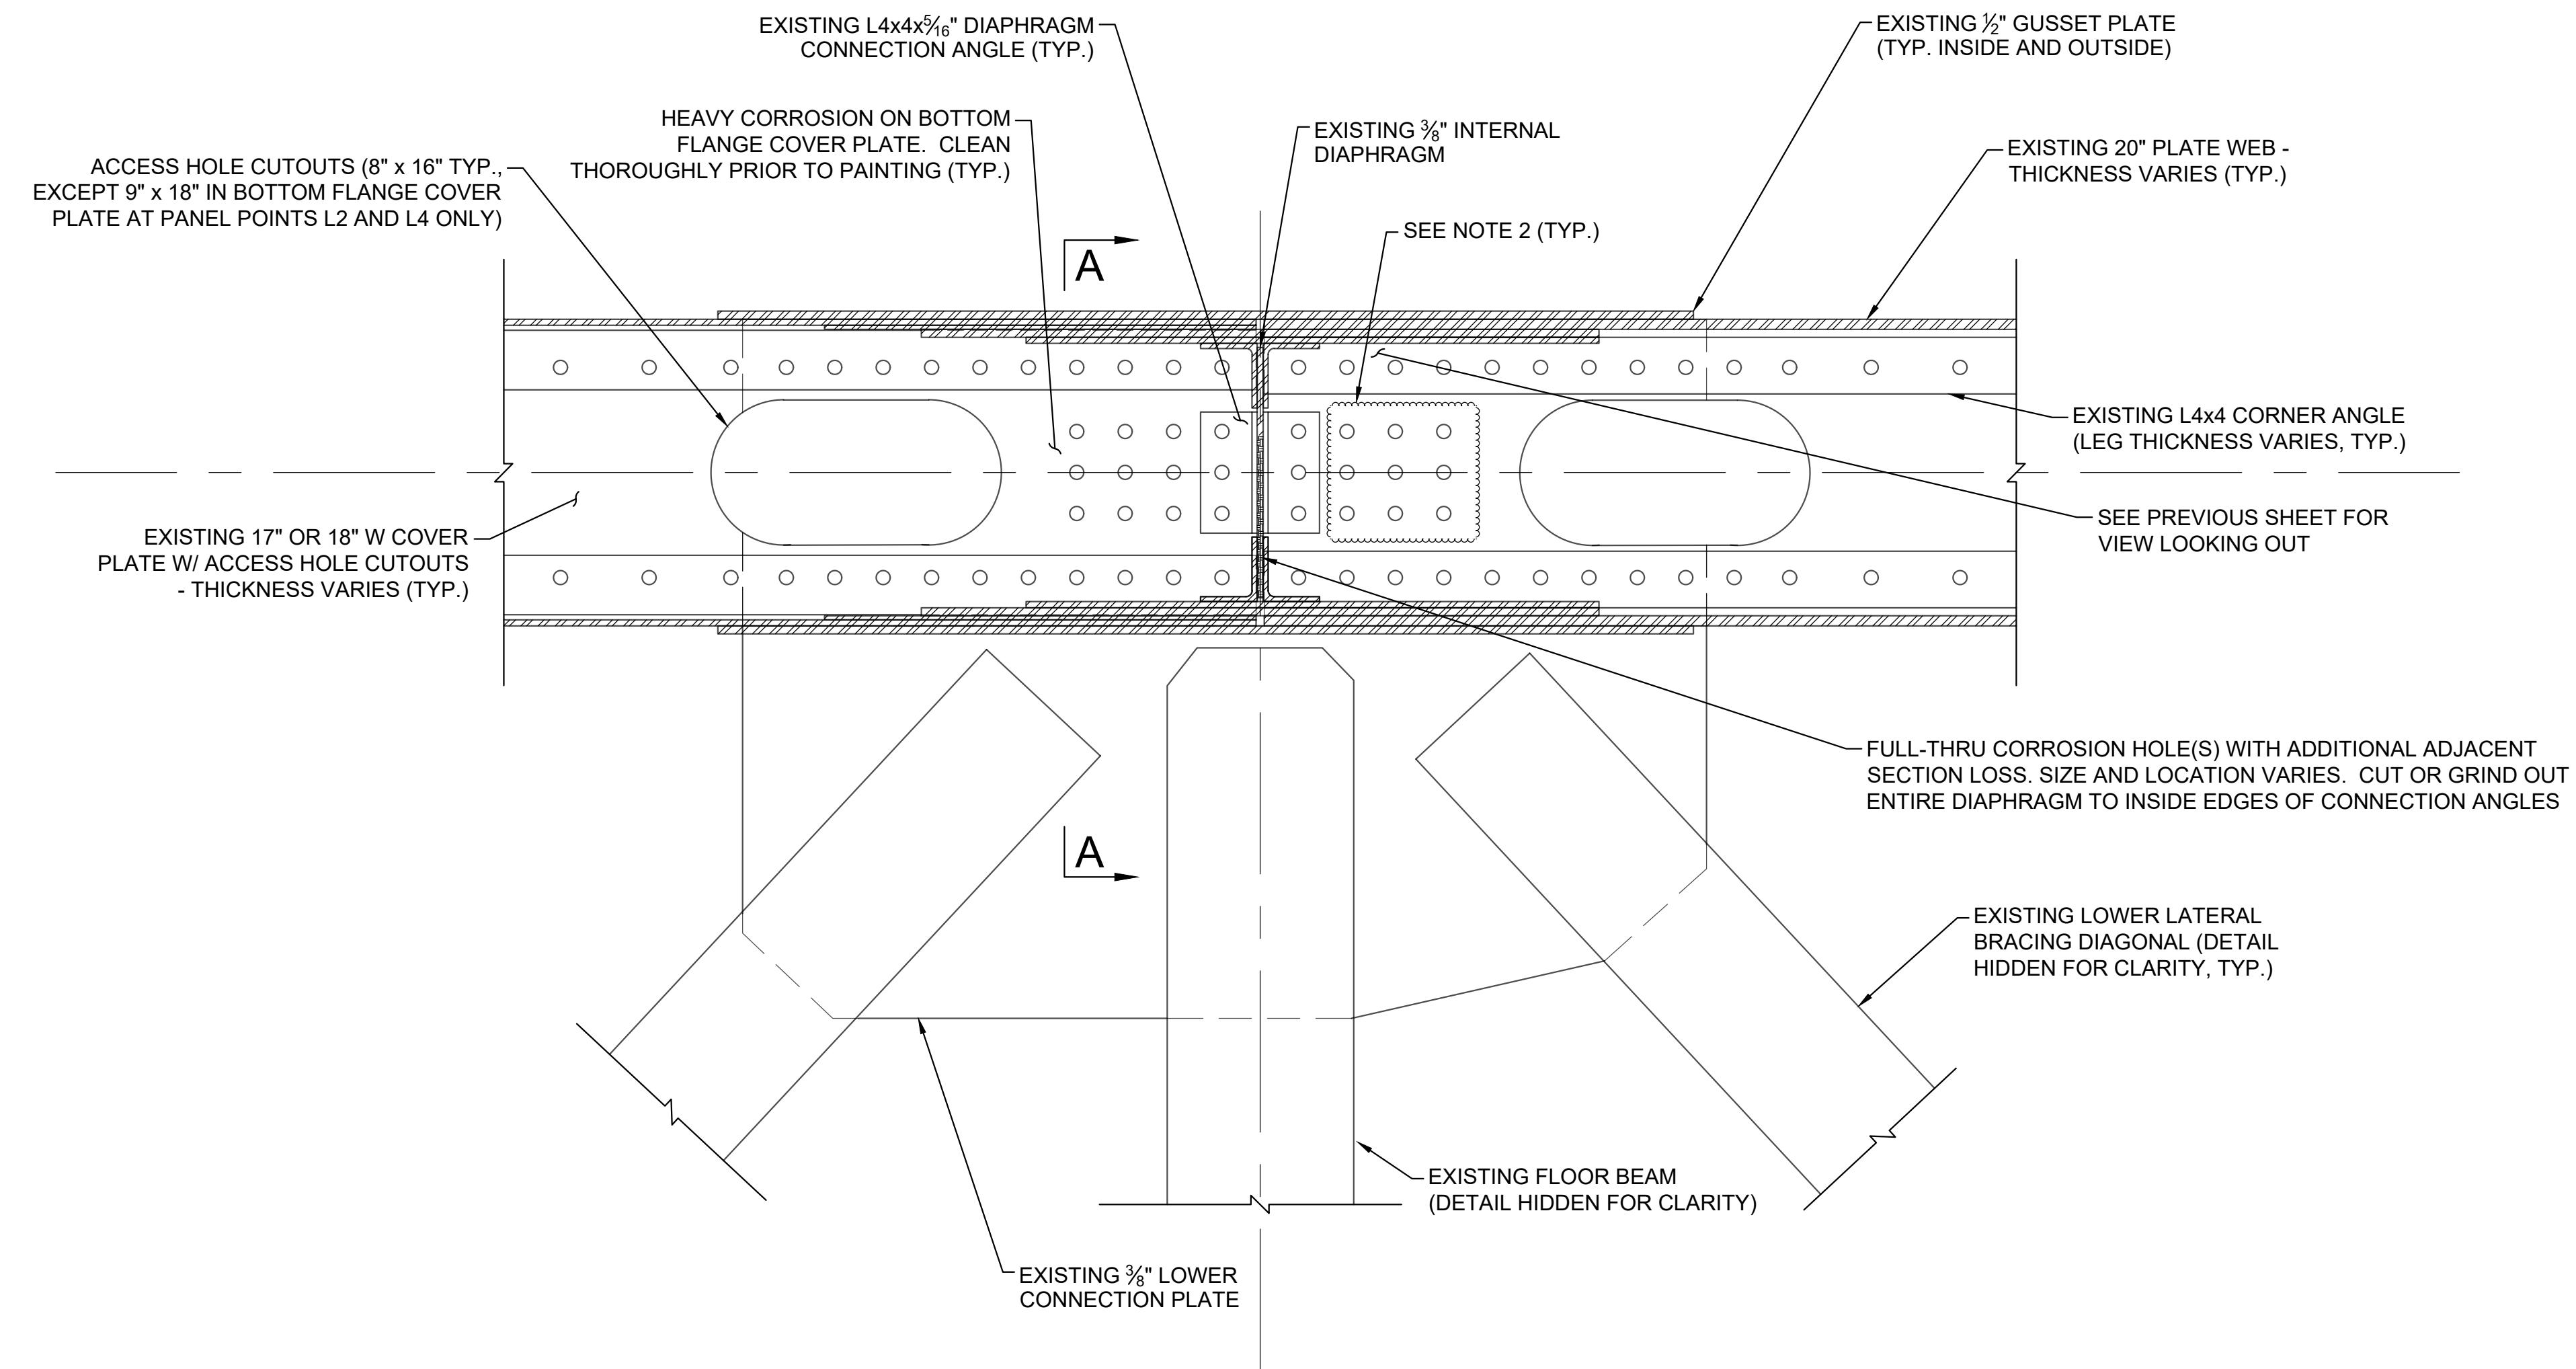
NCB-NB TRUSS REPAIR TYPE 1

INSIDE VIEW LOOKING DOWN
