CHESAPEAKE BAY BRIDGE AND TUNNEL DISTRICT
			RMF 5044.5122 - STEEL BRIDGE PAINTING PROJECT
PROJECT NOTES			
No.	Description	Date	Designed: JSE Drawn: BSB Checked: AHC
			12/18/2025
	Revision		1 OF 45

CHESAPEAKE BAY BRIDGE AND TUNNEL DISTRICT	
			RMF 5044.5122 - STEEL BRIDGE PAINTING PROJECT	
NORTH CHANNEL BRIDGE NB GENERAL PLAN AND ELEVATION				
No.	Description	Date	Designed: JSE Drawn: BSB Checked: AHC	Date Plan No. Sheet No.
	Revision			12/18/2025 3 OF 45

CHESAPEAKE BAY BRIDGE AND TUNNEL DISTRICT							
			RMF 5044.5122 - STEEL BRIDGE PAINTING PROJECT							
NORTH CHANNEL BRIDGE NB STRINGER AND FLOORBEAM PLATING REPAIRS										
No. Description Date Designed: JSE Drawn: JSE Checked: AHC 12/18/2025 9 OF 45										
	Revision

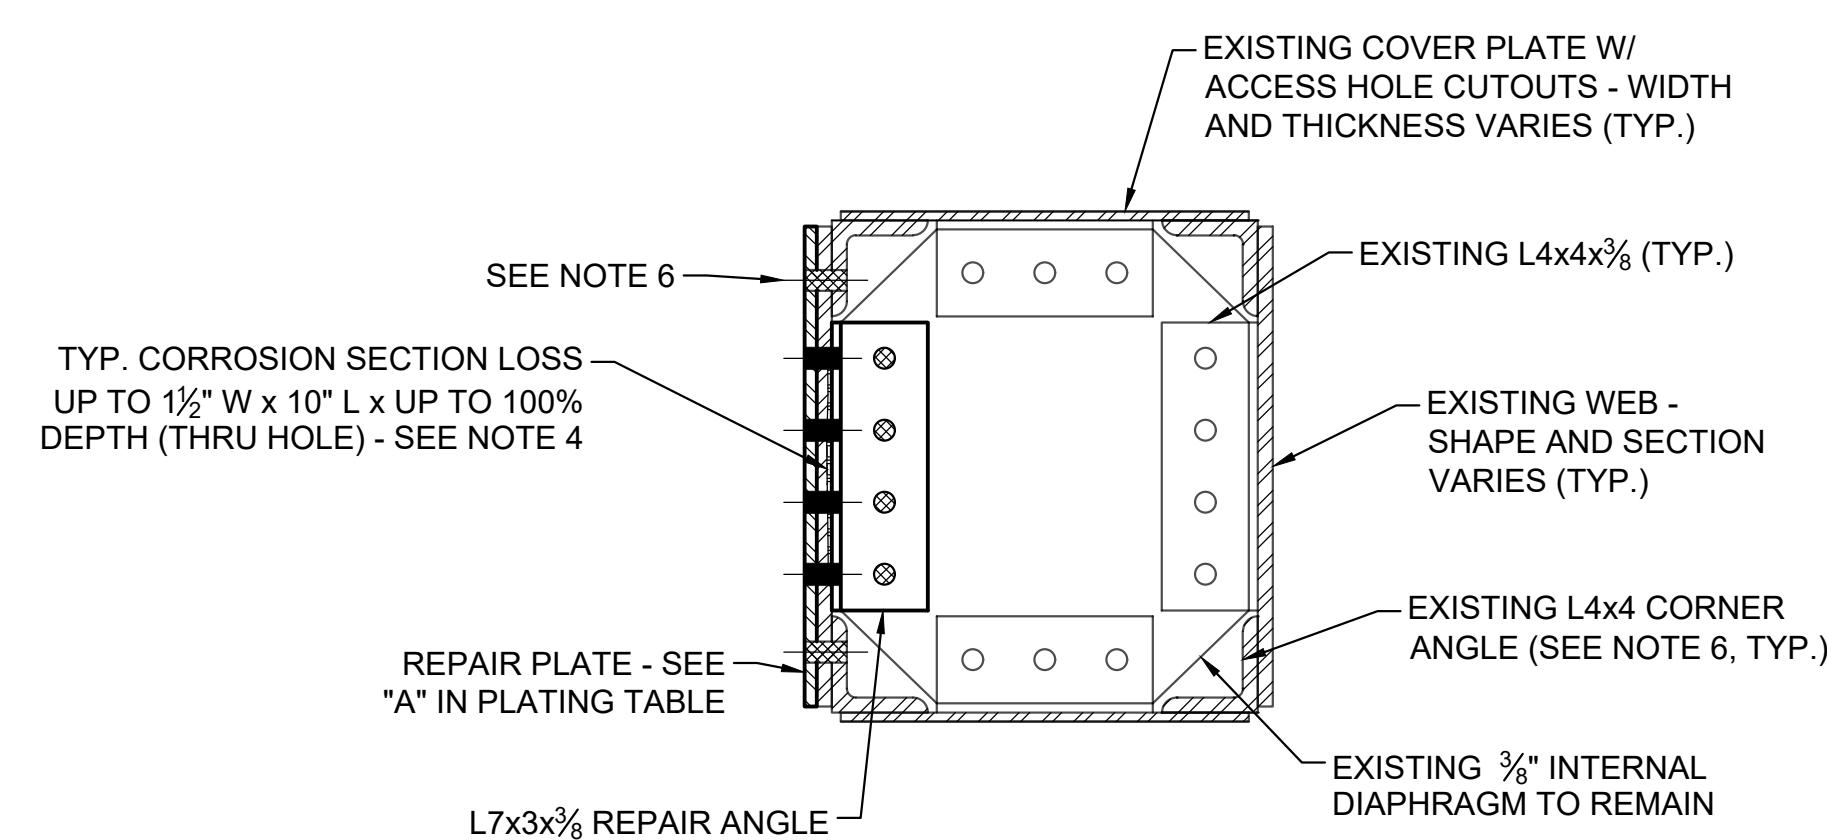
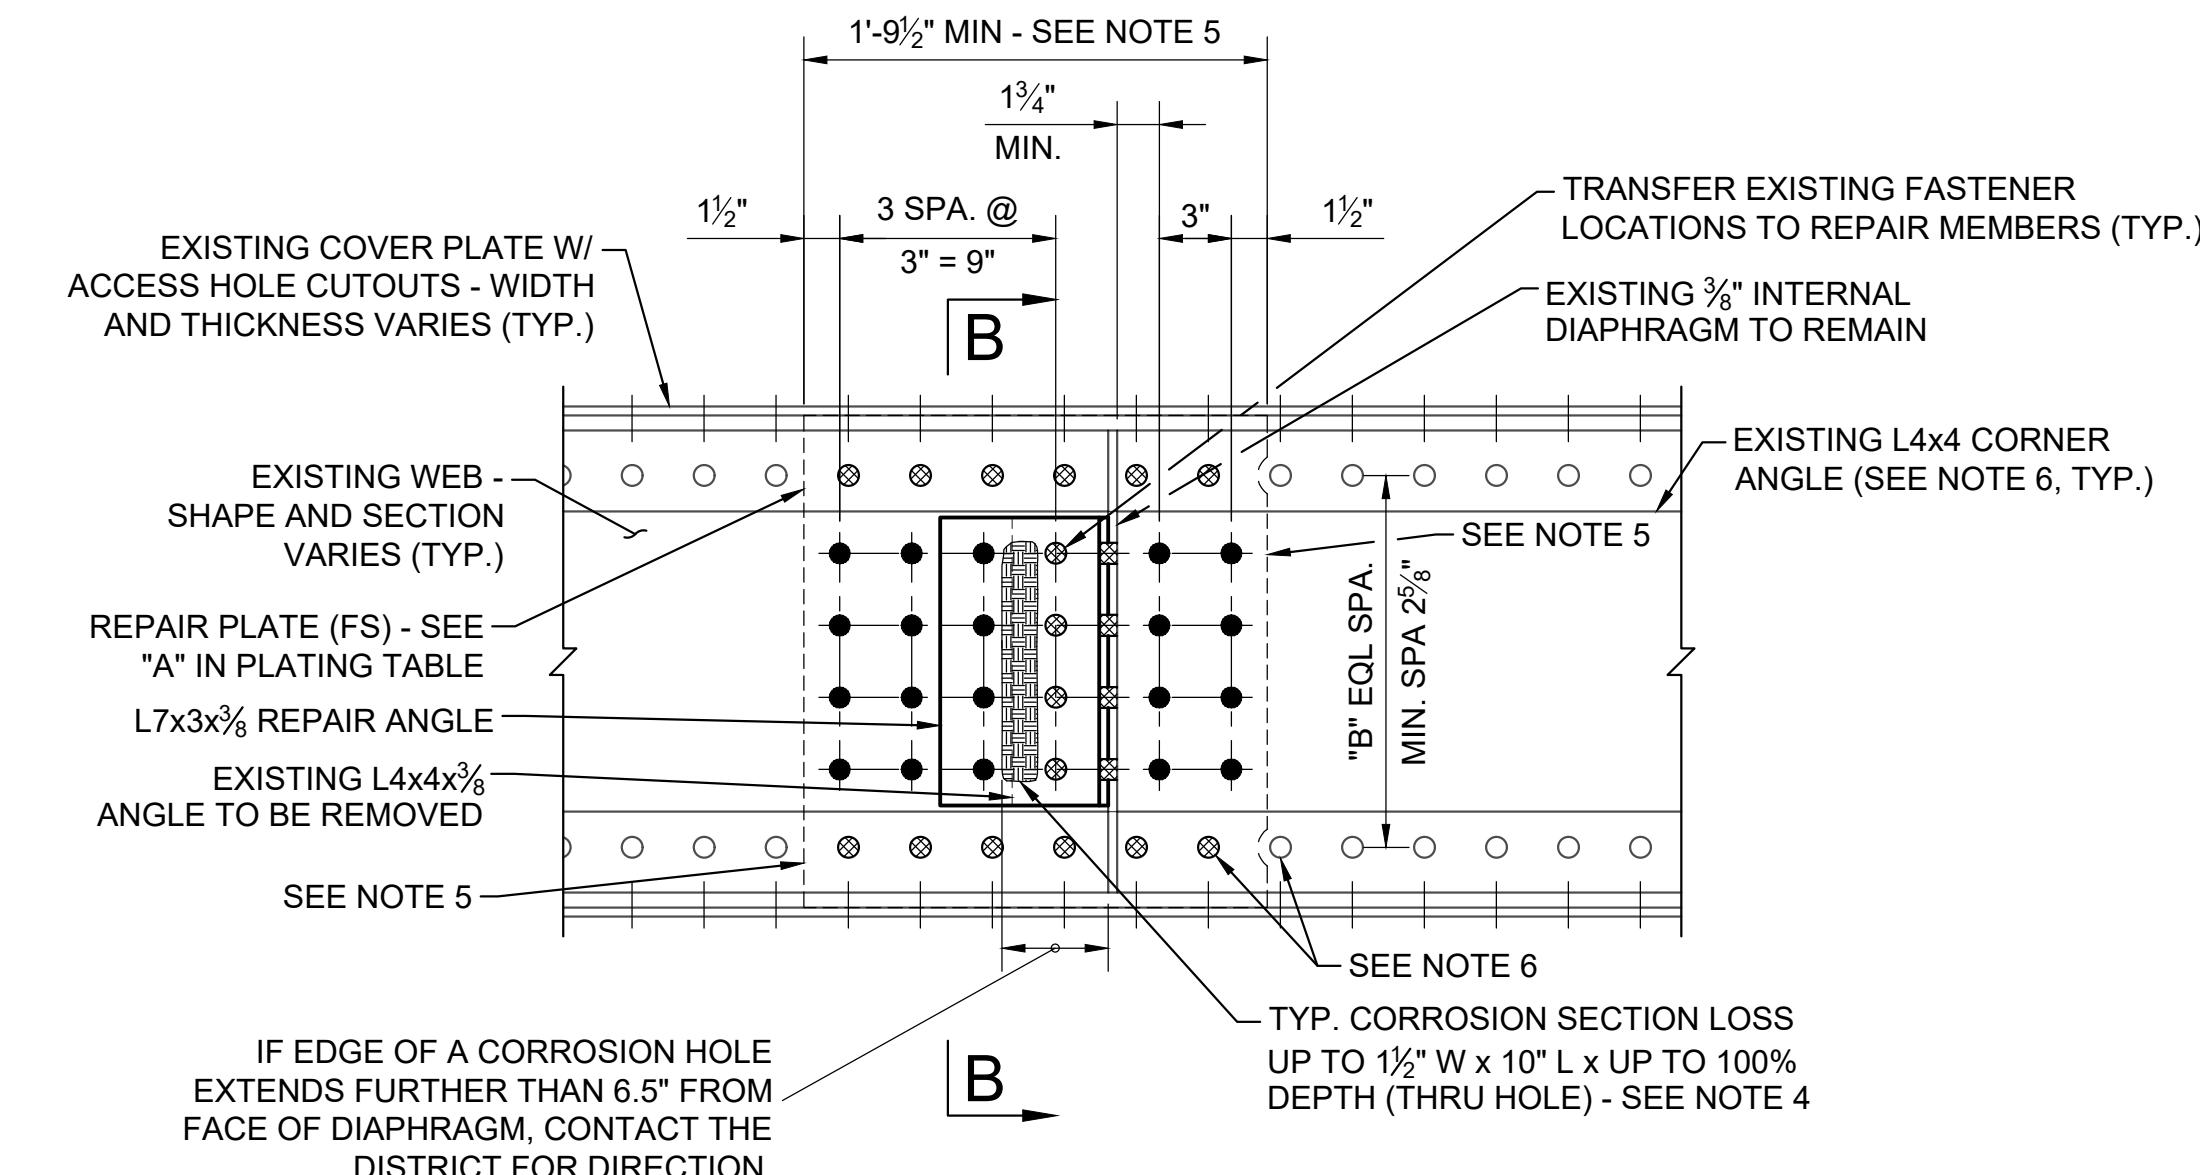
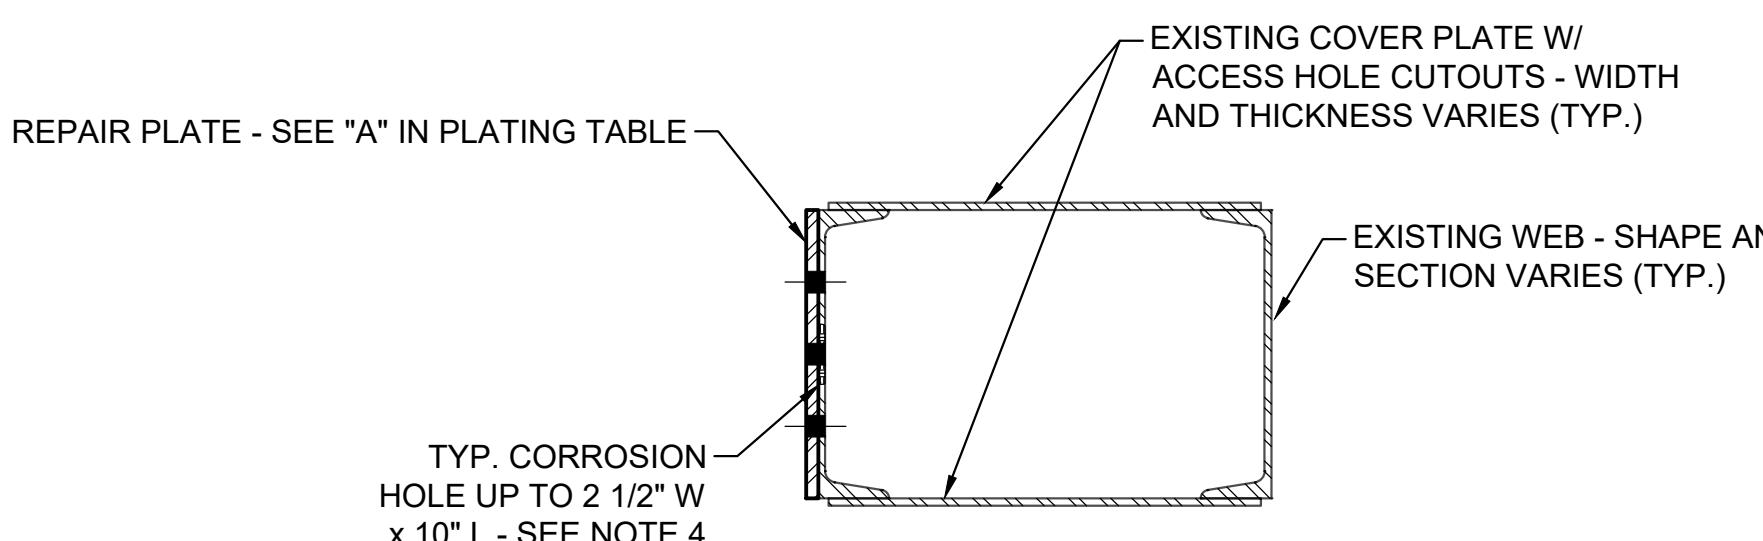
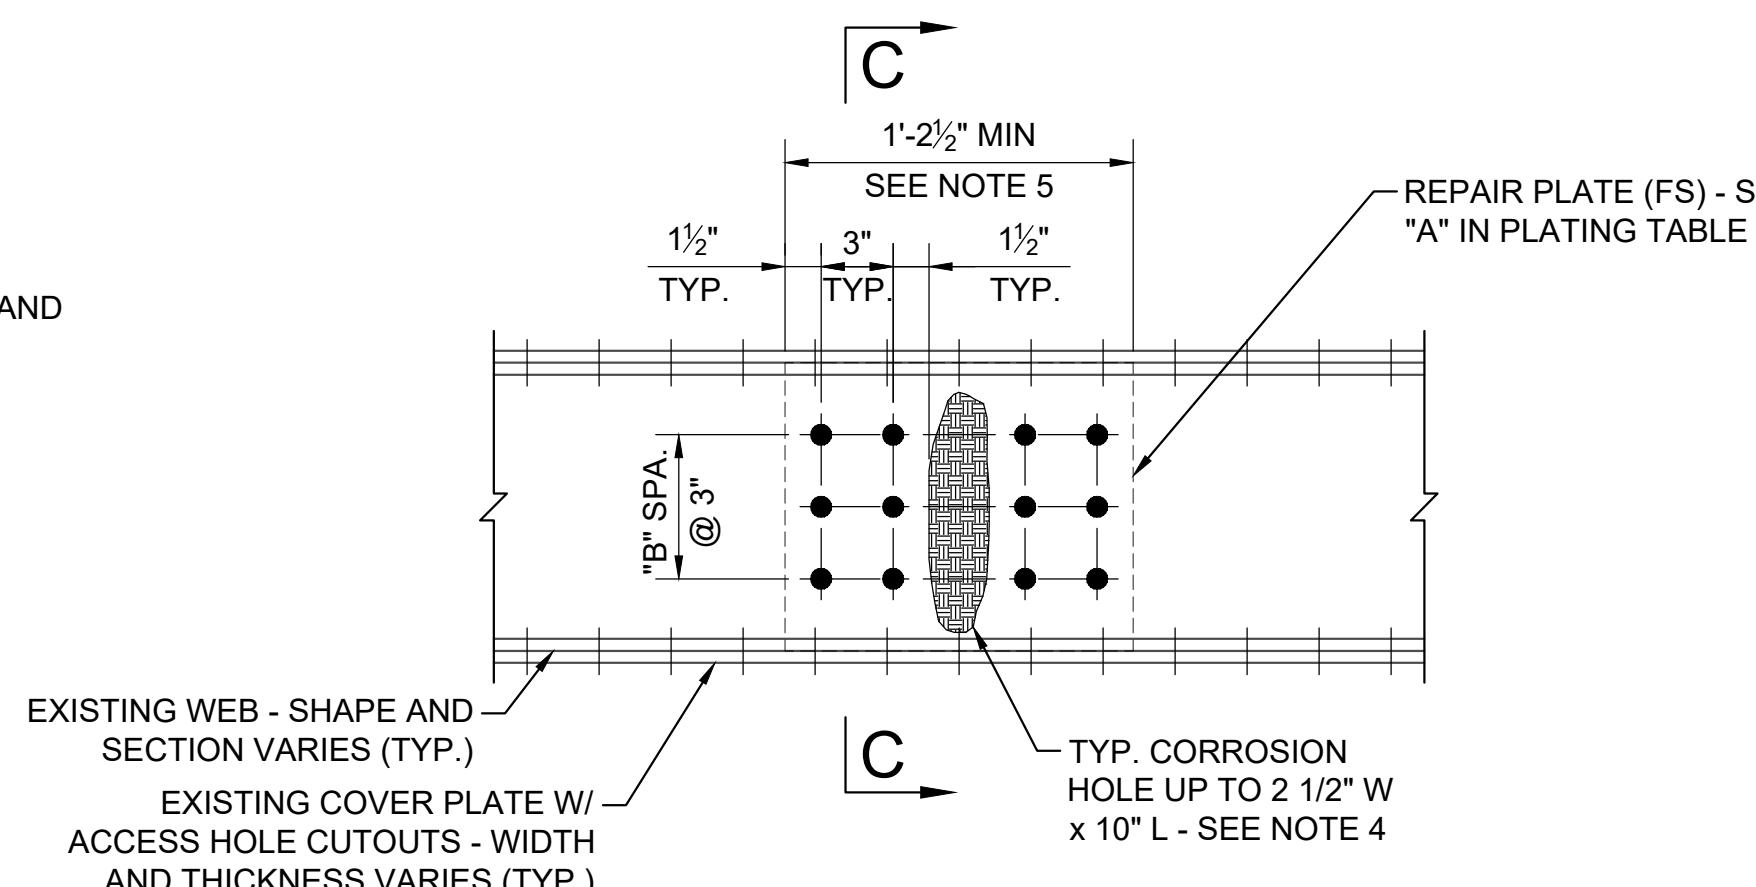
NCB-NB TRUSS REPAIR TYPE 2

SECTION B-B

INSIDE VIEW LOOKING OUT

CASE 1

SECTION C-C

1. PERFORM THIS REPAIR TO NCB-NB SPAN 9 (TRUSS SPAN) TRUSS MEMBERS FOR CORROSION HOLES TO ANY ELEMENT (WEB OR COVER PLATE) OR FOR TOTAL CORROSION SECTION LOSS OF EITHER WEB EXCEEDING 20% AT A GIVEN CROSS SECTION AS APPROVED BY THE DISTRICT. TWO DIFFERENT DEFECT/REPAIR LOCATION CASES ARE NOTED:

- CASE 1: CORROSION OCCURRING AT AN INTERNAL DIAPHRAGM
 - CASE 2: CORROSION OCCURRING ELSEWHERE
 NOTE THAT ONE OR BOTH "COVER PLATES" CONTAIN 8" x 16" ACCESS HOLES SPACED AT APPROX. 3'-6". WEB PLATE OF U1-L1, U3-L3, AND U5-L5 CONTAIN 6" x 12" HOLES SPACED AT APPROX. 3'-6".

2. DEFECT AND CORRESPONDING REPAIRS ARE SHOWN ON ONE SIDE ONLY FOR EACH CASE SUB-DETAIL. REPEAT AS NEEDED IF QUALIFYING CORROSION OCCURS ON MULTIPLE FACES AT A GIVEN SECTION. REPAIR ONE SIDE AT A TIME AT ANY GIVEN SECTION.

3. GRIND CORROSION SMOOTH AND FILL WITH METAL-FILLED EPOXY. IF CORROSION HOLE EXCEEDS 2 1/4" DIA., INSTALL FILL PLATE (THICKNESS TO MATCH EXISTING PLATE) TO FILL VOID, WITH AT LEAST ONE (1) FASTENER INSTALLED THRU FILL PLATE.

4. IF CORROSION HOLES OCCUR IN COVER PLATES, CUT REPAIR PLATING TO MATCH ACCESS HOLES. ADJUST OR OMIT FASTENER LOCATIONS THAT DO NOT MAINTAIN 1 1/2" EDGE DISTANCE FROM ACCESS HOLES, SUBJECT TO THE FASTENER SPACING AND END DISTANCE RESTRICTIONS PROVIDED IN THE PLATING TABLE ON THIS SHEET. NOTCH OUTER REPAIR PLATE AROUND EXISTING FASTENERS IF 1 1/2" EDGE DISTANCE CAN'T BE MAINTAINED.

5. FOR REPAIRS TO LO-U1 WEB PLATES ONLY, ADD AN ADDITIONAL ROW OF FASTENERS AT EACH LONGITUDINAL END OF THE REPAIR PLATING AND EXTEND REPAIR PLATE LENGTH ACCORDINGLY.

6. L4x4 CORNER ANGLE IS ONLY PRESENT FOR TRUSS MEMBERS WITH PLATE WEBS (AS OPPOSED TO C-CHANNEL WEBS). LEG THICKNESS VARIES. IF PRESENT, MATCH EXISTING FASTENER LOCATIONS ON REPAIR PLATE. IF NOT PRESENT, ADD ROW OF FASTENERS (ADJACENT TO COVER PLATE, AS SHOWN) SUBJECT TO THE FASTENER SPACING AND END DISTANCE RESTRICTIONS PROVIDED IN THE PLATING TABLE ON THIS SHEET. NOTCH OUTER REPAIR PLATE AROUND EXISTING FASTENERS IF 1 1/2" EDGE DISTANCE CAN'T BE MAINTAINED.

7. GRIND ALL CORROSION TO SMOOTH BARE METAL.
8. FILL ALL GAPS WITH STEEL-FILLED EPOXY PUTTY.

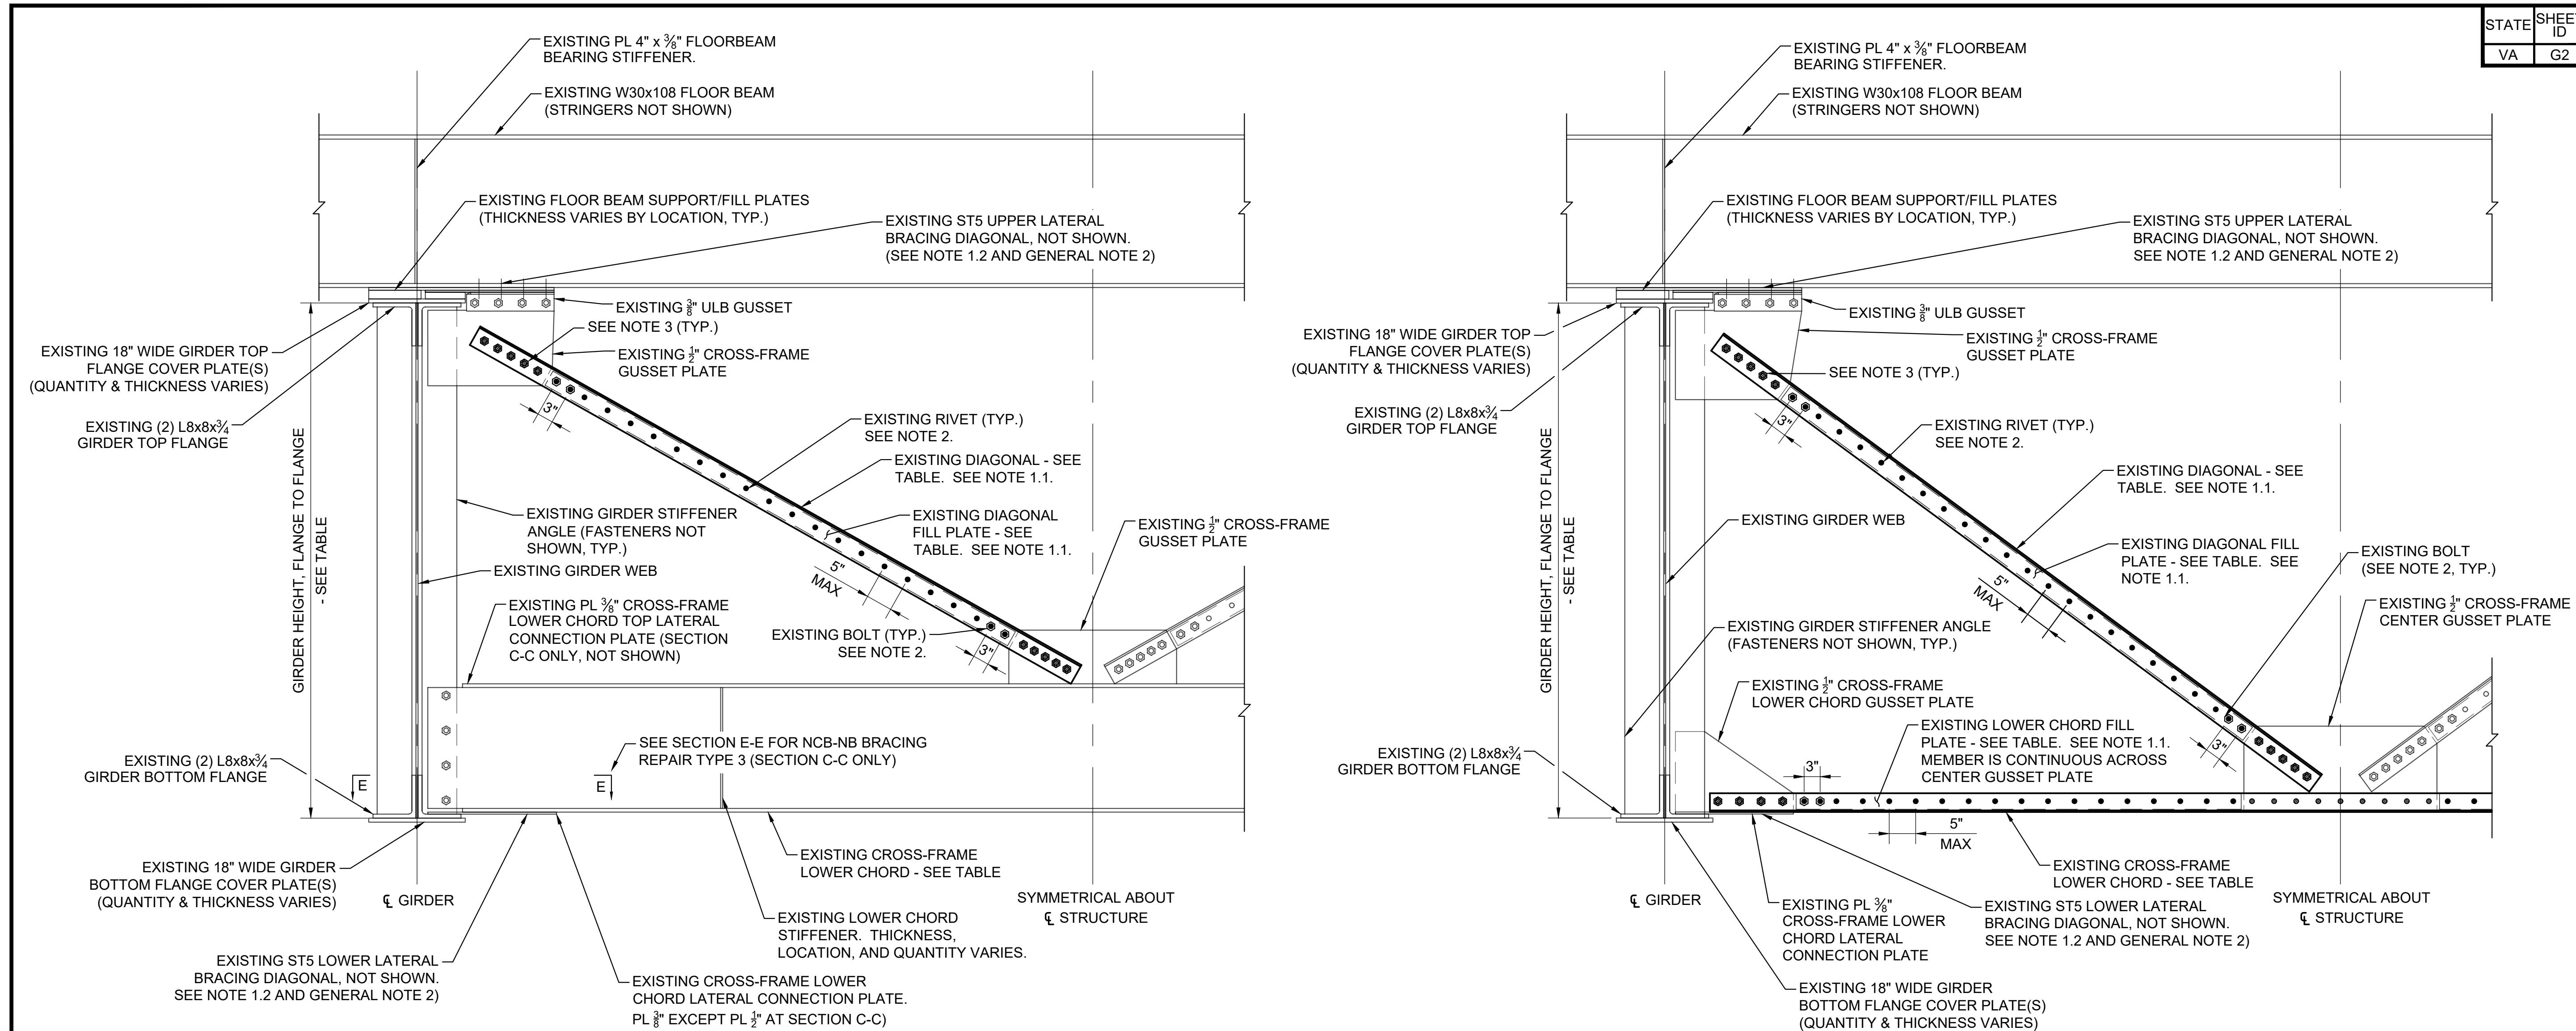
NCB-NB BRACING REPAIR TYPE 1 NCB-NB BRACING REPAIR TYPE 3

DETAIL-SPECIFIC NOTES (NCB-NB BRACING REPAIR TYPE 1)

1. NCB NB BRACING REPAIR TYPE 1 IS APPLICABLE FOR NCB-NB SPANS 1-8 AND 10-17 FOR UPPER AND LOWER LATERAL BRACING MEMBERS AND CROSS FRAME MEMBERS, AS DEPICTED IN THE NOTED VIEWS, WITH FULL-THRU CORROSION HOLES AT ANY LOCATION ALONG LENGTH OF MEMBER AS APPROVED BY THE DISTRICT.

- 1.1. FOR BUILT-UP TEE SECTION CROSS-FRAME MEMBERS (BACK-TO-BACK ANGLES WITH FILLER PLATE) WITH A CORROSION HOLE, REPLACE ENTIRE MEMBER IN-KIND.
 - 1.2. FOR ROLLED TEE SECTION UPPER AND LOWER LATERAL BRACING MEMBERS WITH A CORROSION HOLE, REPLACE ENTIRE MEMBER IN-KIND.

- 1.3. FOR A CORROSION HOLE LOCATED ON A WIDE-FLANGE SECTION CROSS-FRAME MEMBER, CONTACT THE DISTRICT FOR DIRECTION.
 - 1.4. FOR SECTION LOSS NOT MEETING THIS CRITERIA, GRIND CORROSION SMOOTH.

2. WHEN FABRICATING REPLACEMENT BUILT-UP TEE SECTION MEMBERS, STITCH MEMBERS TOGETHER WITH BOLTS AT SPACING NOT TO EXCEED 5" SPACING. SPACE FIRST PAIR OF STITCH BOLTS ADJACENT TO GUSSET PLATES AT 3". FOR INTERIOR SUPPORT LOCATIONS, STAGGER FASTENERS TO MATCH EXISTING.

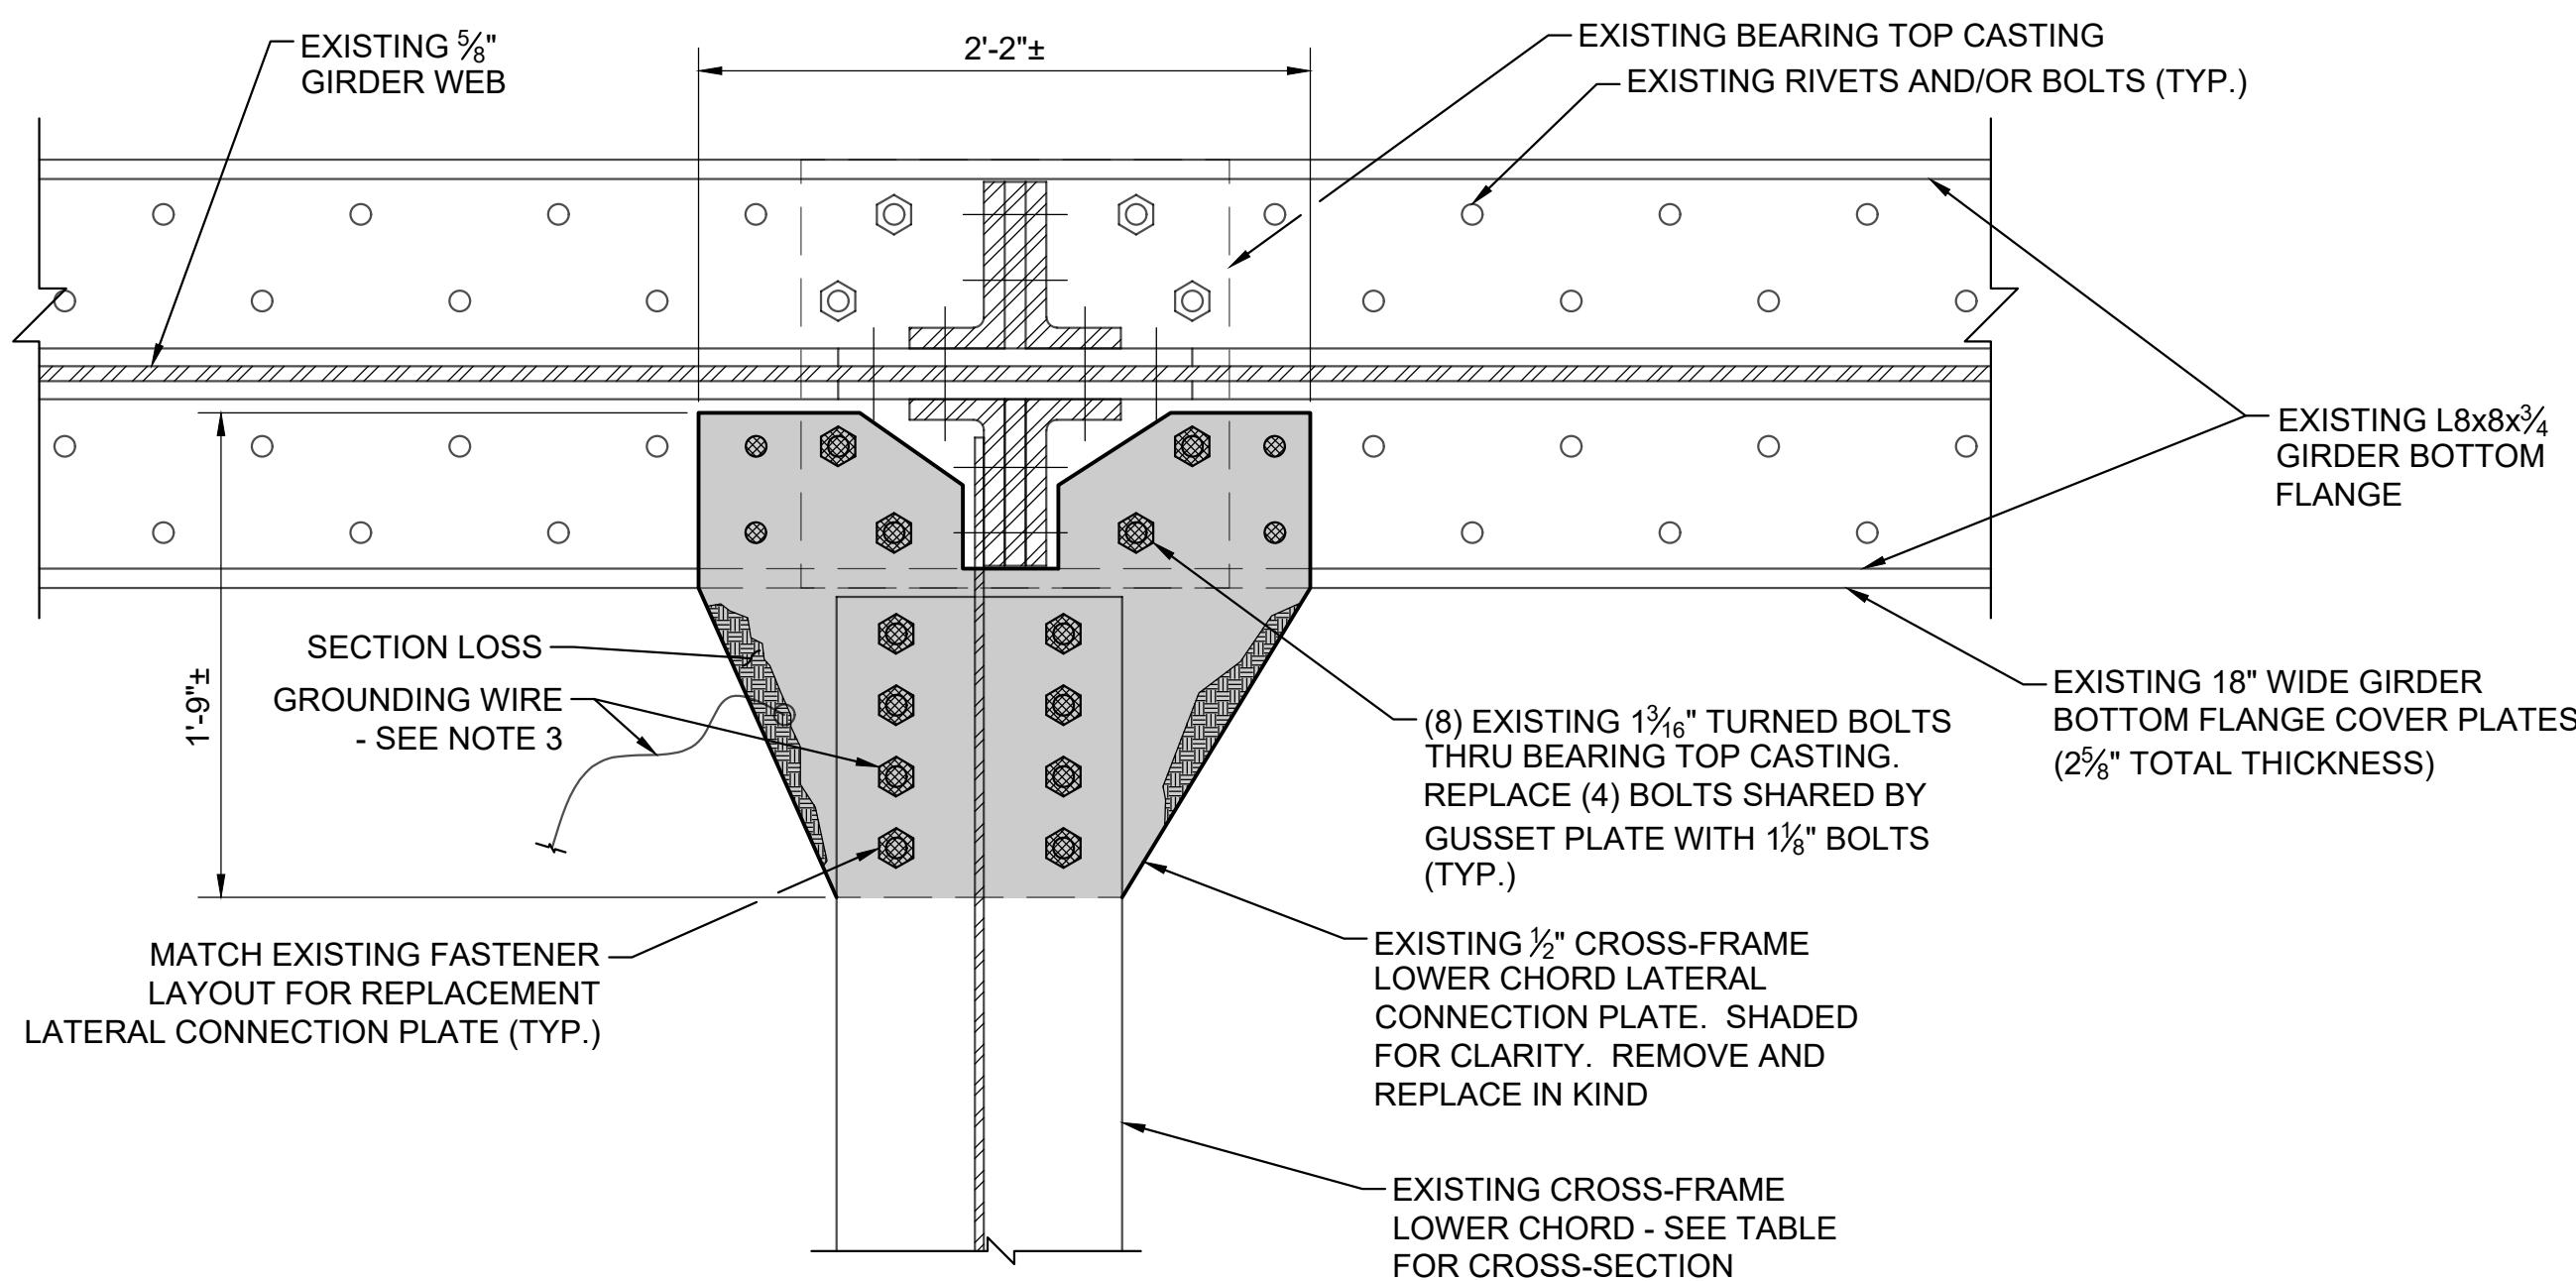
NCB-NB BRACING REPAIR TYPE 3

SECTION E-E

DETAIL-SPECIFIC NOTES (NCB-NB BRACING REPAIR TYPE 3)

1. NCB NB BRACING REPAIR TYPE 3 IS APPLICABLE FOR NCB-NB SPANS 1-8 AND 10-17 FOR CROSS-FRAME LOWER CHORD LATERAL CONNECTION PLATES LOCATED AT INTERIOR PIERS WITH SECTION LOSS EXCEEDING $\frac{1}{4}$ " DEEP FOR AN AREA GREATER THAN 1" WIDE x 2" LONG AS APPROVED BY THE DISTRICT. IF DAMAGE IS BELOW LIMITS, GRIND SMOOTH PER PROJECT NOTES.
2. USE EXISTING LATERAL CONNECTION PLATE AS TEMPLATE FOR SHAPE AND SIZE OF REPLACEMENT LATERAL CONNECTION PLATE.
3. SOME LATERAL CONNECTION PLATES CONTAIN GROUNDING WIRES ATTACHED APPROXIMATELY AS SHOWN. IF LATERAL CONNECTION PLATE IS REPLACED, RE-ATTACH EXISTING GROUND WIRE TO LOWER CHORD BOTTOM FLANGE HARDWARE AND REPAIR PAINT SYSTEM.
4. WHEN REPLACING MEMBERS, MATCH EXISTING FASTENER LOCATIONS AT LATERAL CONNECTION PLATES, ETC.

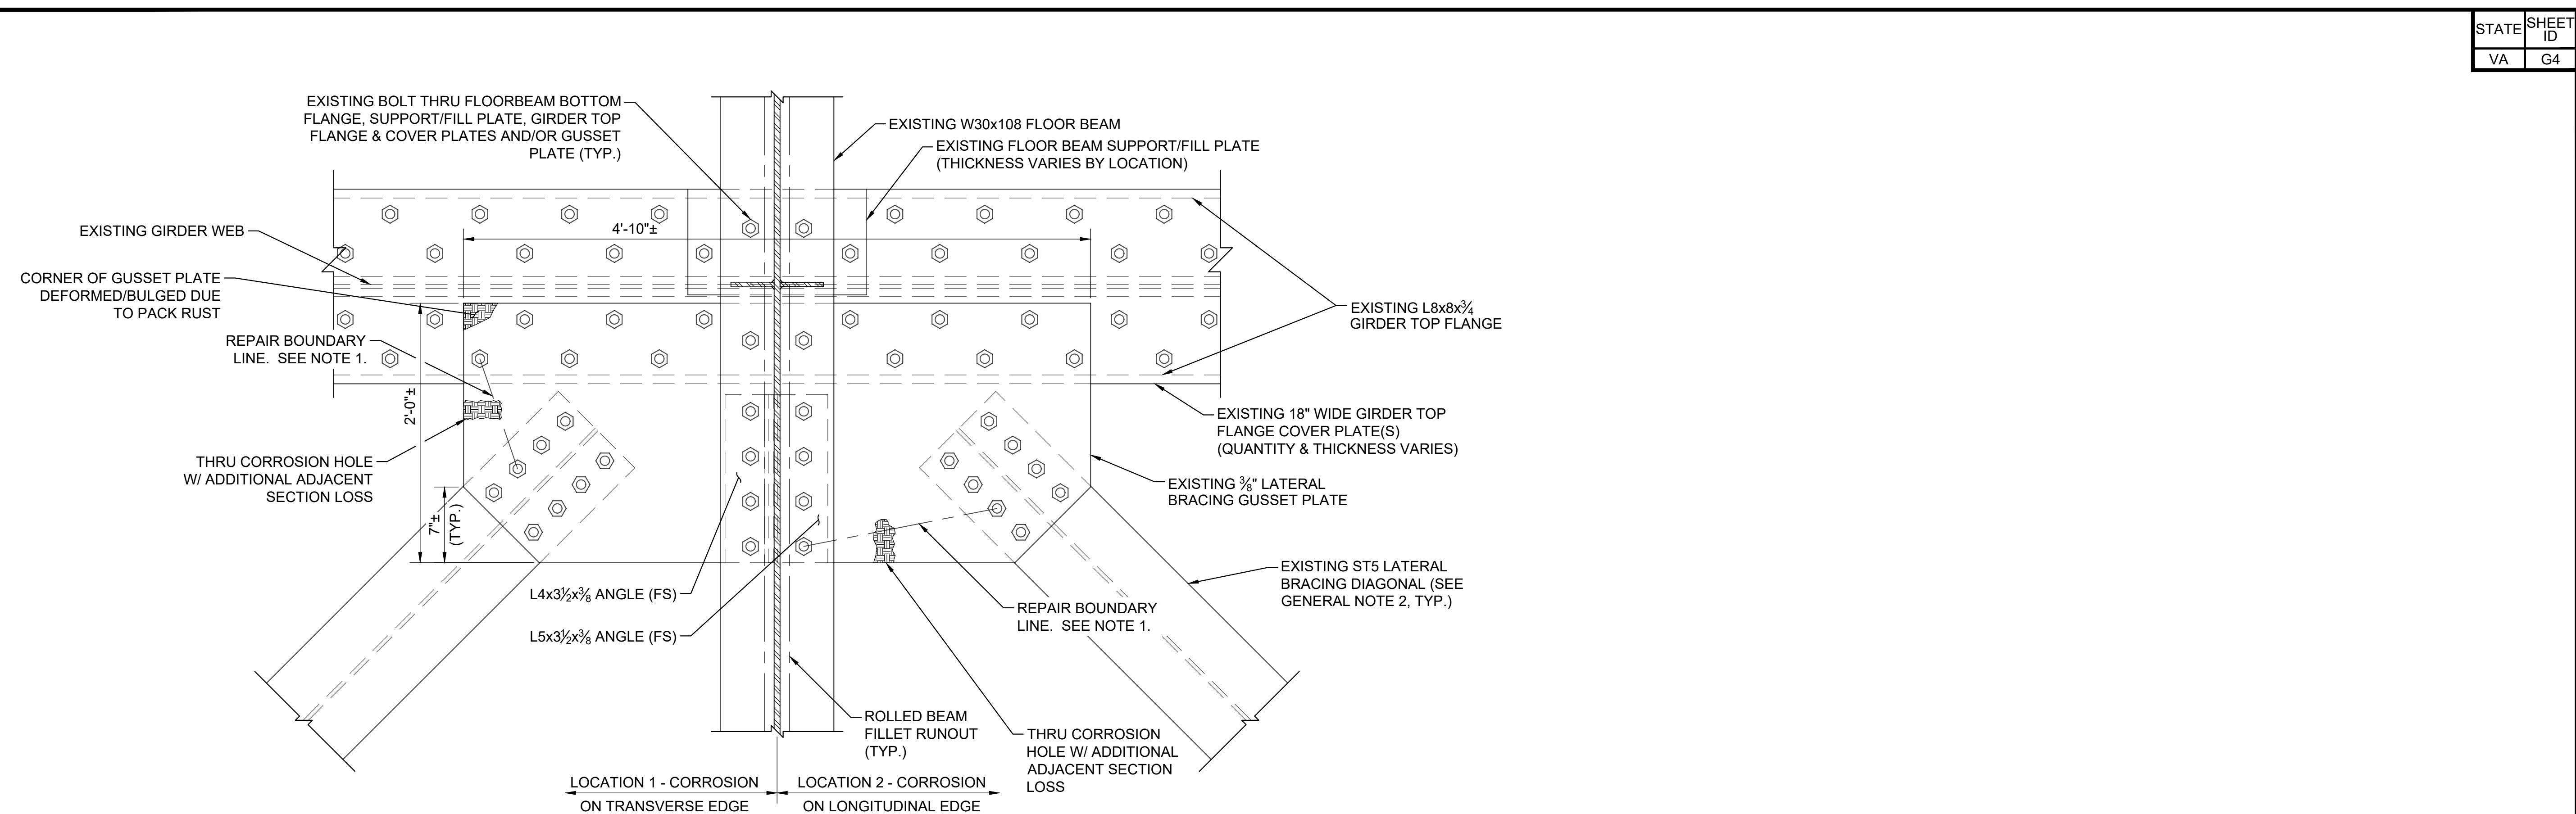
NCB-NB BRACING REPAIR TYPE 2

PLAN VIEW

EXISTING CONDITION AND REPAIR CRITERIA

1. THIS REPAIR IS APPLICABLE FOR NCB-NB SPANS 1-8 AND 10-17 FOR UPPER AND LOWER LATERAL BRACING GUSSET PLATES AT GIRDERS. PERFORM PRESCRIBED REPAIR IF FULL-THRU CORROSION HOLE AT GUSSET PLATE EDGE EXTENDS BEYOND INDICATED BOUNDARY LINE AS APPROVED BY THE DISTRICT. IF DAMAGE DOES NOT EXTEND BEYOND INDICATED BOUNDARY LINE, GRIND SMOOTH PER PROJECT NOTES.

2. THIS DETAIL IS APPLICABLE FOR EITHER OF THE TWO REPRESENTATIVE CORROSION DAMAGE LOCATIONS SHOWN (RESPECTIVELY ALONG THE TRANSVERSE OR LONGITUDINAL EDGES), AT ANY LATERAL BRACING GUSSET PLATE. DETAIL IS SHOWN AT INTERMEDIATE FLOORBEAM UPPER LATERAL BRACING LOCATION. ADJUST AS NEEDED FOR OTHER GUSSET LOCATIONS AND FOR LOWER LATERAL BRACING. IF A SINGLE GUSSET PLATE CONTAINS QUALIFYING CORROSION DAMAGE ON MULTIPLE EDGES REQUIRING REPAIR, REPAIR EACH EDGE'S CORROSION ONE AT A TIME.

3. QUANTITY AND THICKNESS OF EXISTING TOP FLANGE COVER PLATES, AND CORRESPONDING THICKNESSES OF EXISTING FILL PLATES, VARIES BY LOCATION. ADJUST THICKNESS OF INDICATED REPAIR FILL PLATES ACCORDINGLY. IT IS PERMISSIBLE TO REPLACE WITH MULTIPLE PLATES, MINIMUM THICKNESS OF ANY INDIVIDUAL PLATE TO BE $\frac{3}{8}$ ".

6. GRIND ALL CORROSION TO SMOOTH BARE METAL.
7. FILL ALL GAPS WITH STEEL-FILLED EPOXY PUTTY.

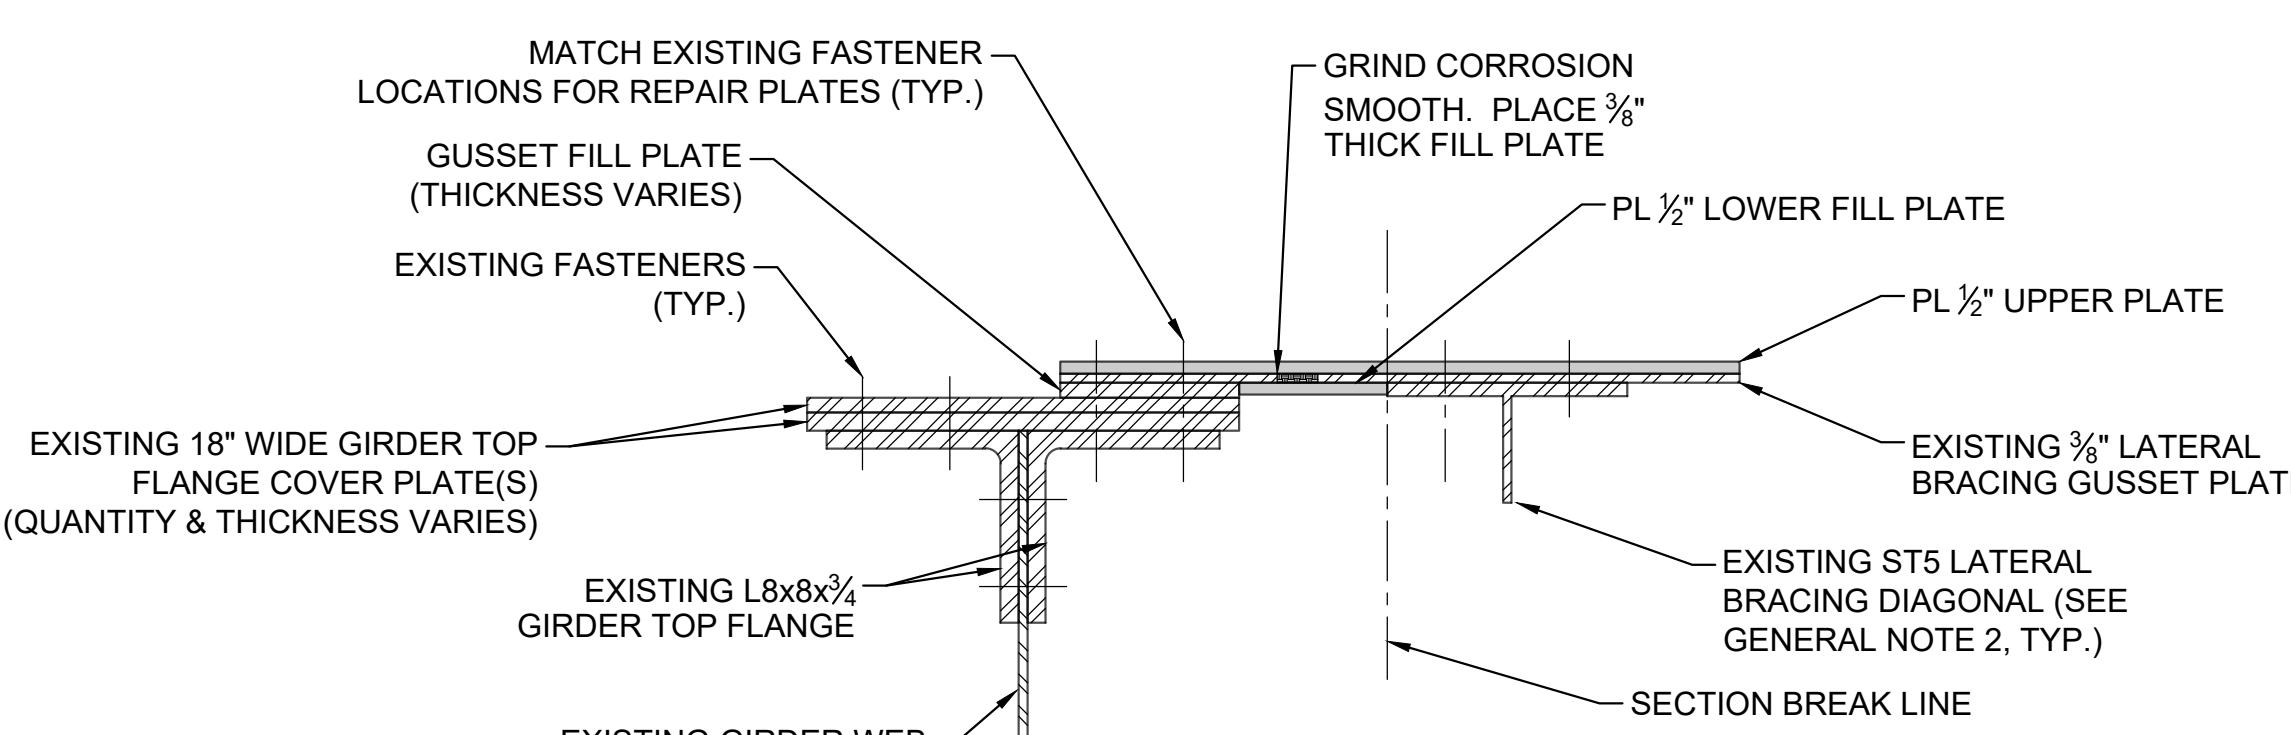
NCB-NB BRACING REPAIR TYPE 2 REPAIRED CONDITION

4. PLACE ADDITIONAL FASTENERS THROUGH REPAIR PLATES. FASTENER SPACING MUST SATISFY THE FOLLOWING REQUIREMENTS:
 - 4.1. MIN. CENTER SPACING: $2\frac{1}{8}$ "

- 4.2. MAX. CENTER SPACING ALONG EDGE: $5\frac{1}{2}$ "
 - 4.3. MIN. END DISTANCE: $1\frac{1}{8}$ "
 - 4.4. MAX. END DISTANCE: 3"
5. CUT OFF AND REMOVE DEFORMED/BULGED PORTION OF EXISTING GUSSET. DO NOT EXTEND REMOVAL BEYOND EDGE OF REPAIR PLATE. CONTACT THE DISTRICT FOR DIRECTION IF THE DEFORMATION INTERFERES WITH REPAIR PLATE INSTALLATION AND EXTENDS PAST THESE LIMITS. USE CAUTION TO AVOID DAMAGE TO GIRDER TOP FLANGE AND TOP FLANGE COVER PLATES AND ALL OTHER STRUCTURE. FLAME CUTTING IS PROHIBITED AS A METHOD FOR REMOVAL FOR THIS DETAIL. IF DAMAGE OCCURS, CONTRACTOR IS RESPONSIBLE FOR REPAIRING IT TO THE SATISFACTION OF THE DISTRICT AT NO COST TO THE DISTRICT.

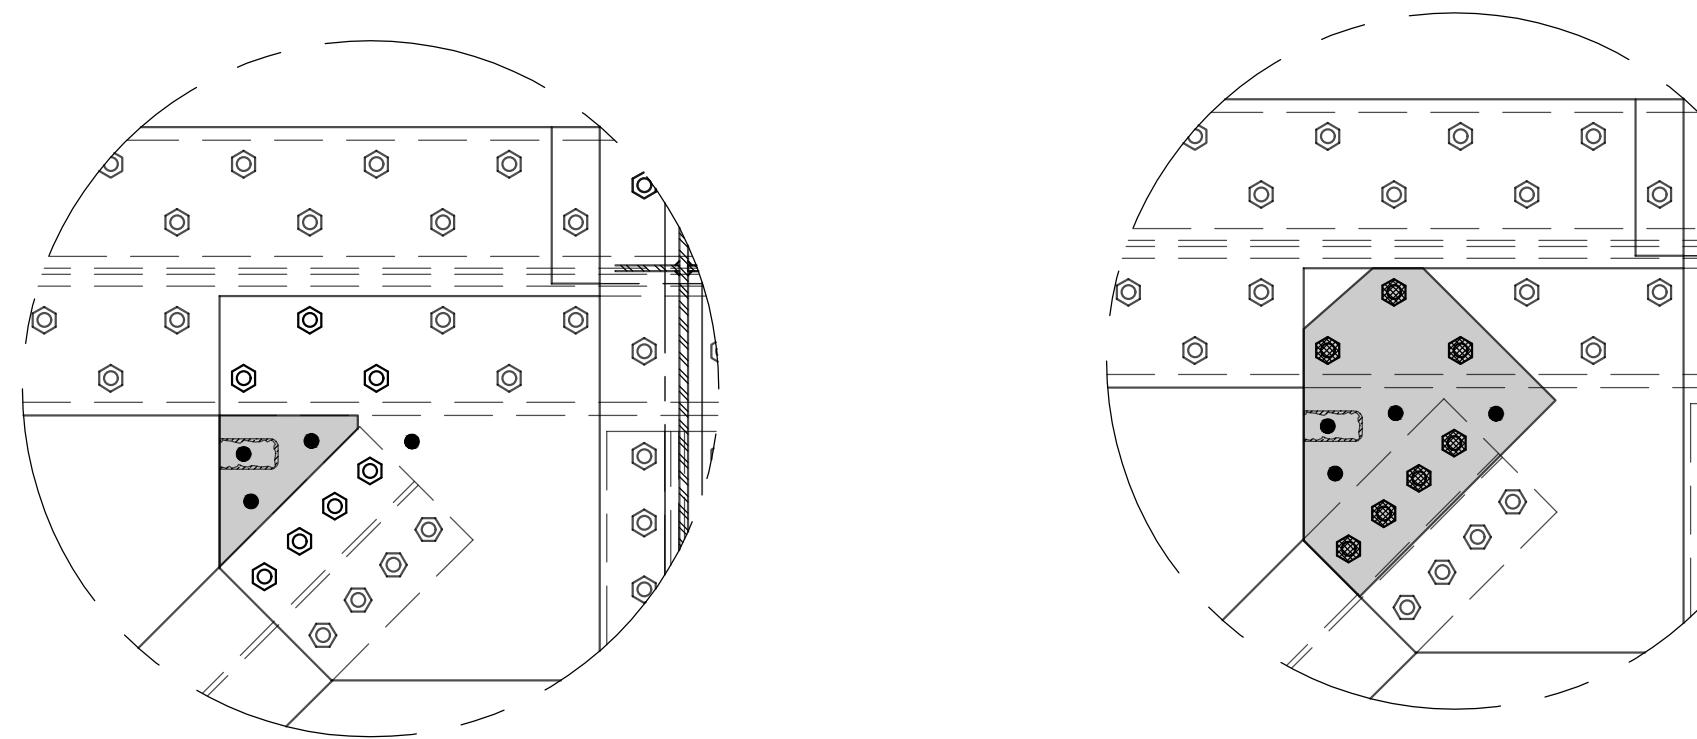
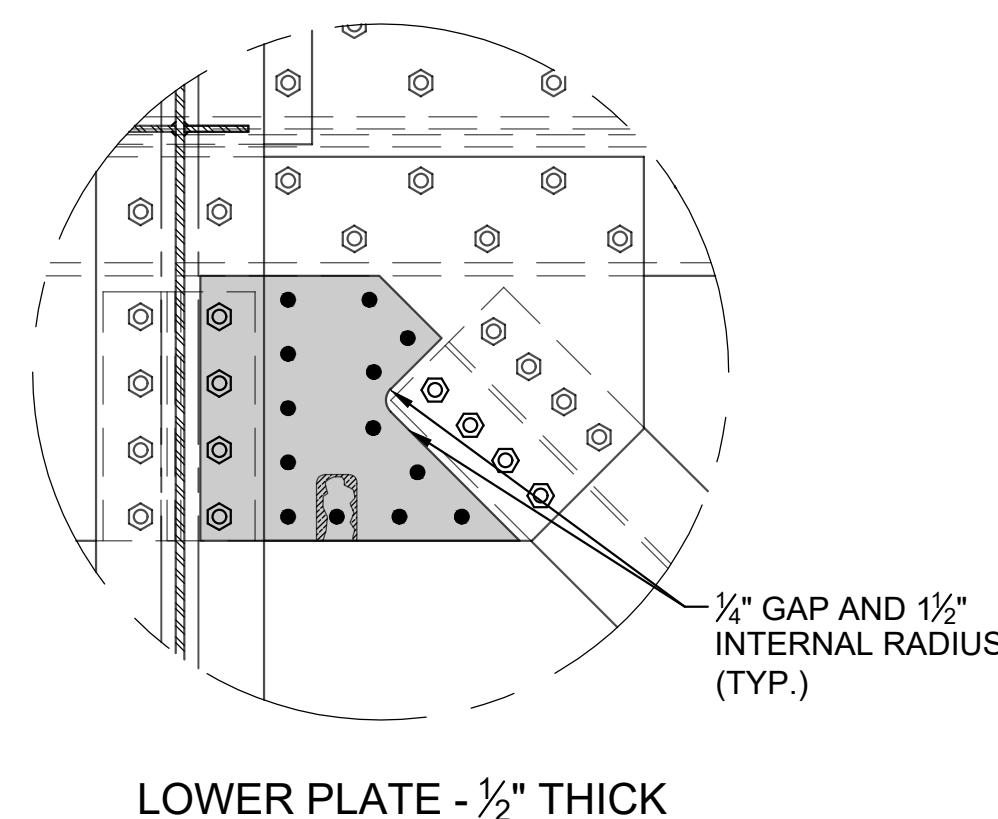
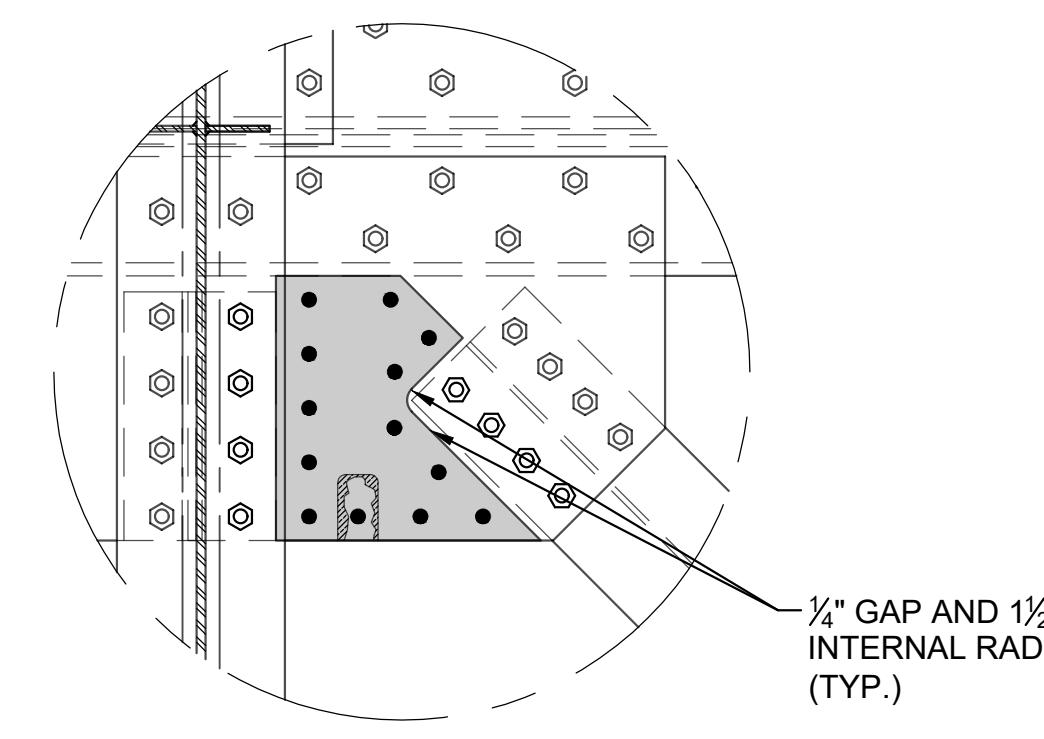
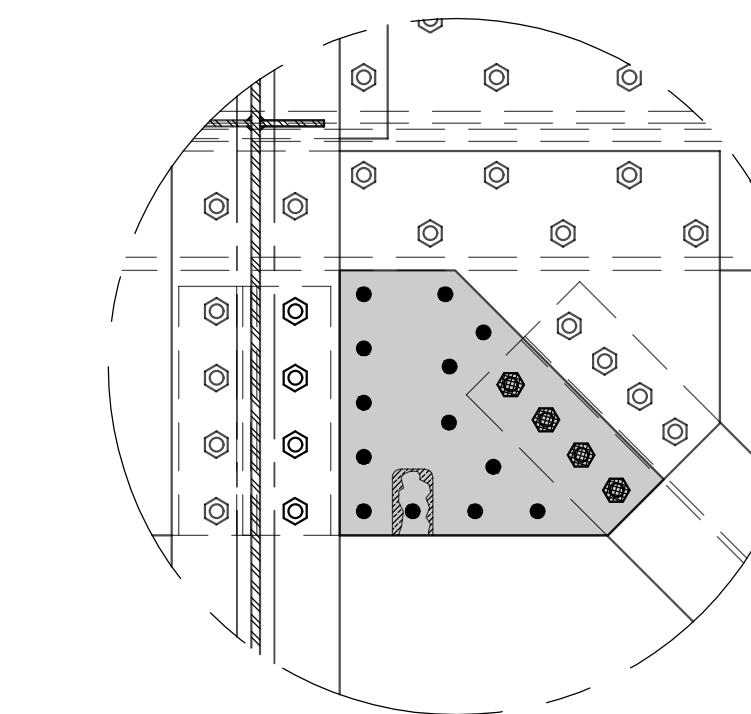
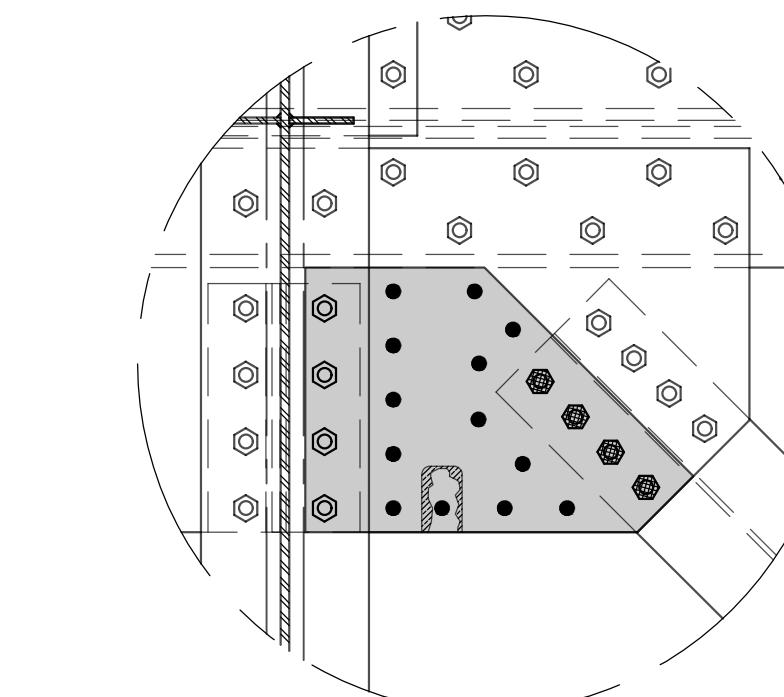
LOCATION 1 PLATING SHAPE DETAIL VIEWS

LOWER FILL PLATE - $\frac{1}{2}$ " THICK UPPER PLATE - $\frac{1}{2}$ " THICK

LOWER PLATE - $\frac{1}{2}$ " THICK

LOWER FILL PLATE - $\frac{3}{8}$ " THICK

UPPER FILL PLATE - SEE NOTE 3

UPPER PLATE - $\frac{1}{2}$ " THICK
