CHESAPEAKE BAY BRIDGE AND TUNNEL DISTRICT
			RMF 5044.5122 - STEEL BRIDGE PAINTING PROJECT
PROJECT NOTES			
No.	Description	Date	Designed: JSE Drawn: BSB Checked: AHC
			12/18/2025
	Revision		1 OF 45

CHESAPEAKE BAY BRIDGE AND TUNNEL DISTRICT	
			RMF 5044.5122 - STEEL BRIDGE PAINTING PROJECT	
NORTH CHANNEL BRIDGE NB GENERAL PLAN AND ELEVATION				
No.	Description	Date	Designed: JSE Drawn: BSB Checked: AHC	Date Plan No. Sheet No.
	Revision			12/18/2025 3 OF 45

CHESAPEAKE BAY BRIDGE AND TUNNEL DISTRICT							
			RMF 5044.5122 - STEEL BRIDGE PAINTING PROJECT							
NORTH CHANNEL BRIDGE NB STRINGER AND FLOORBEAM PLATING REPAIRS										
No. Description Date Designed: JSE Drawn: JSE Checked: AHC 12/18/2025 9 OF 45										
	Revision

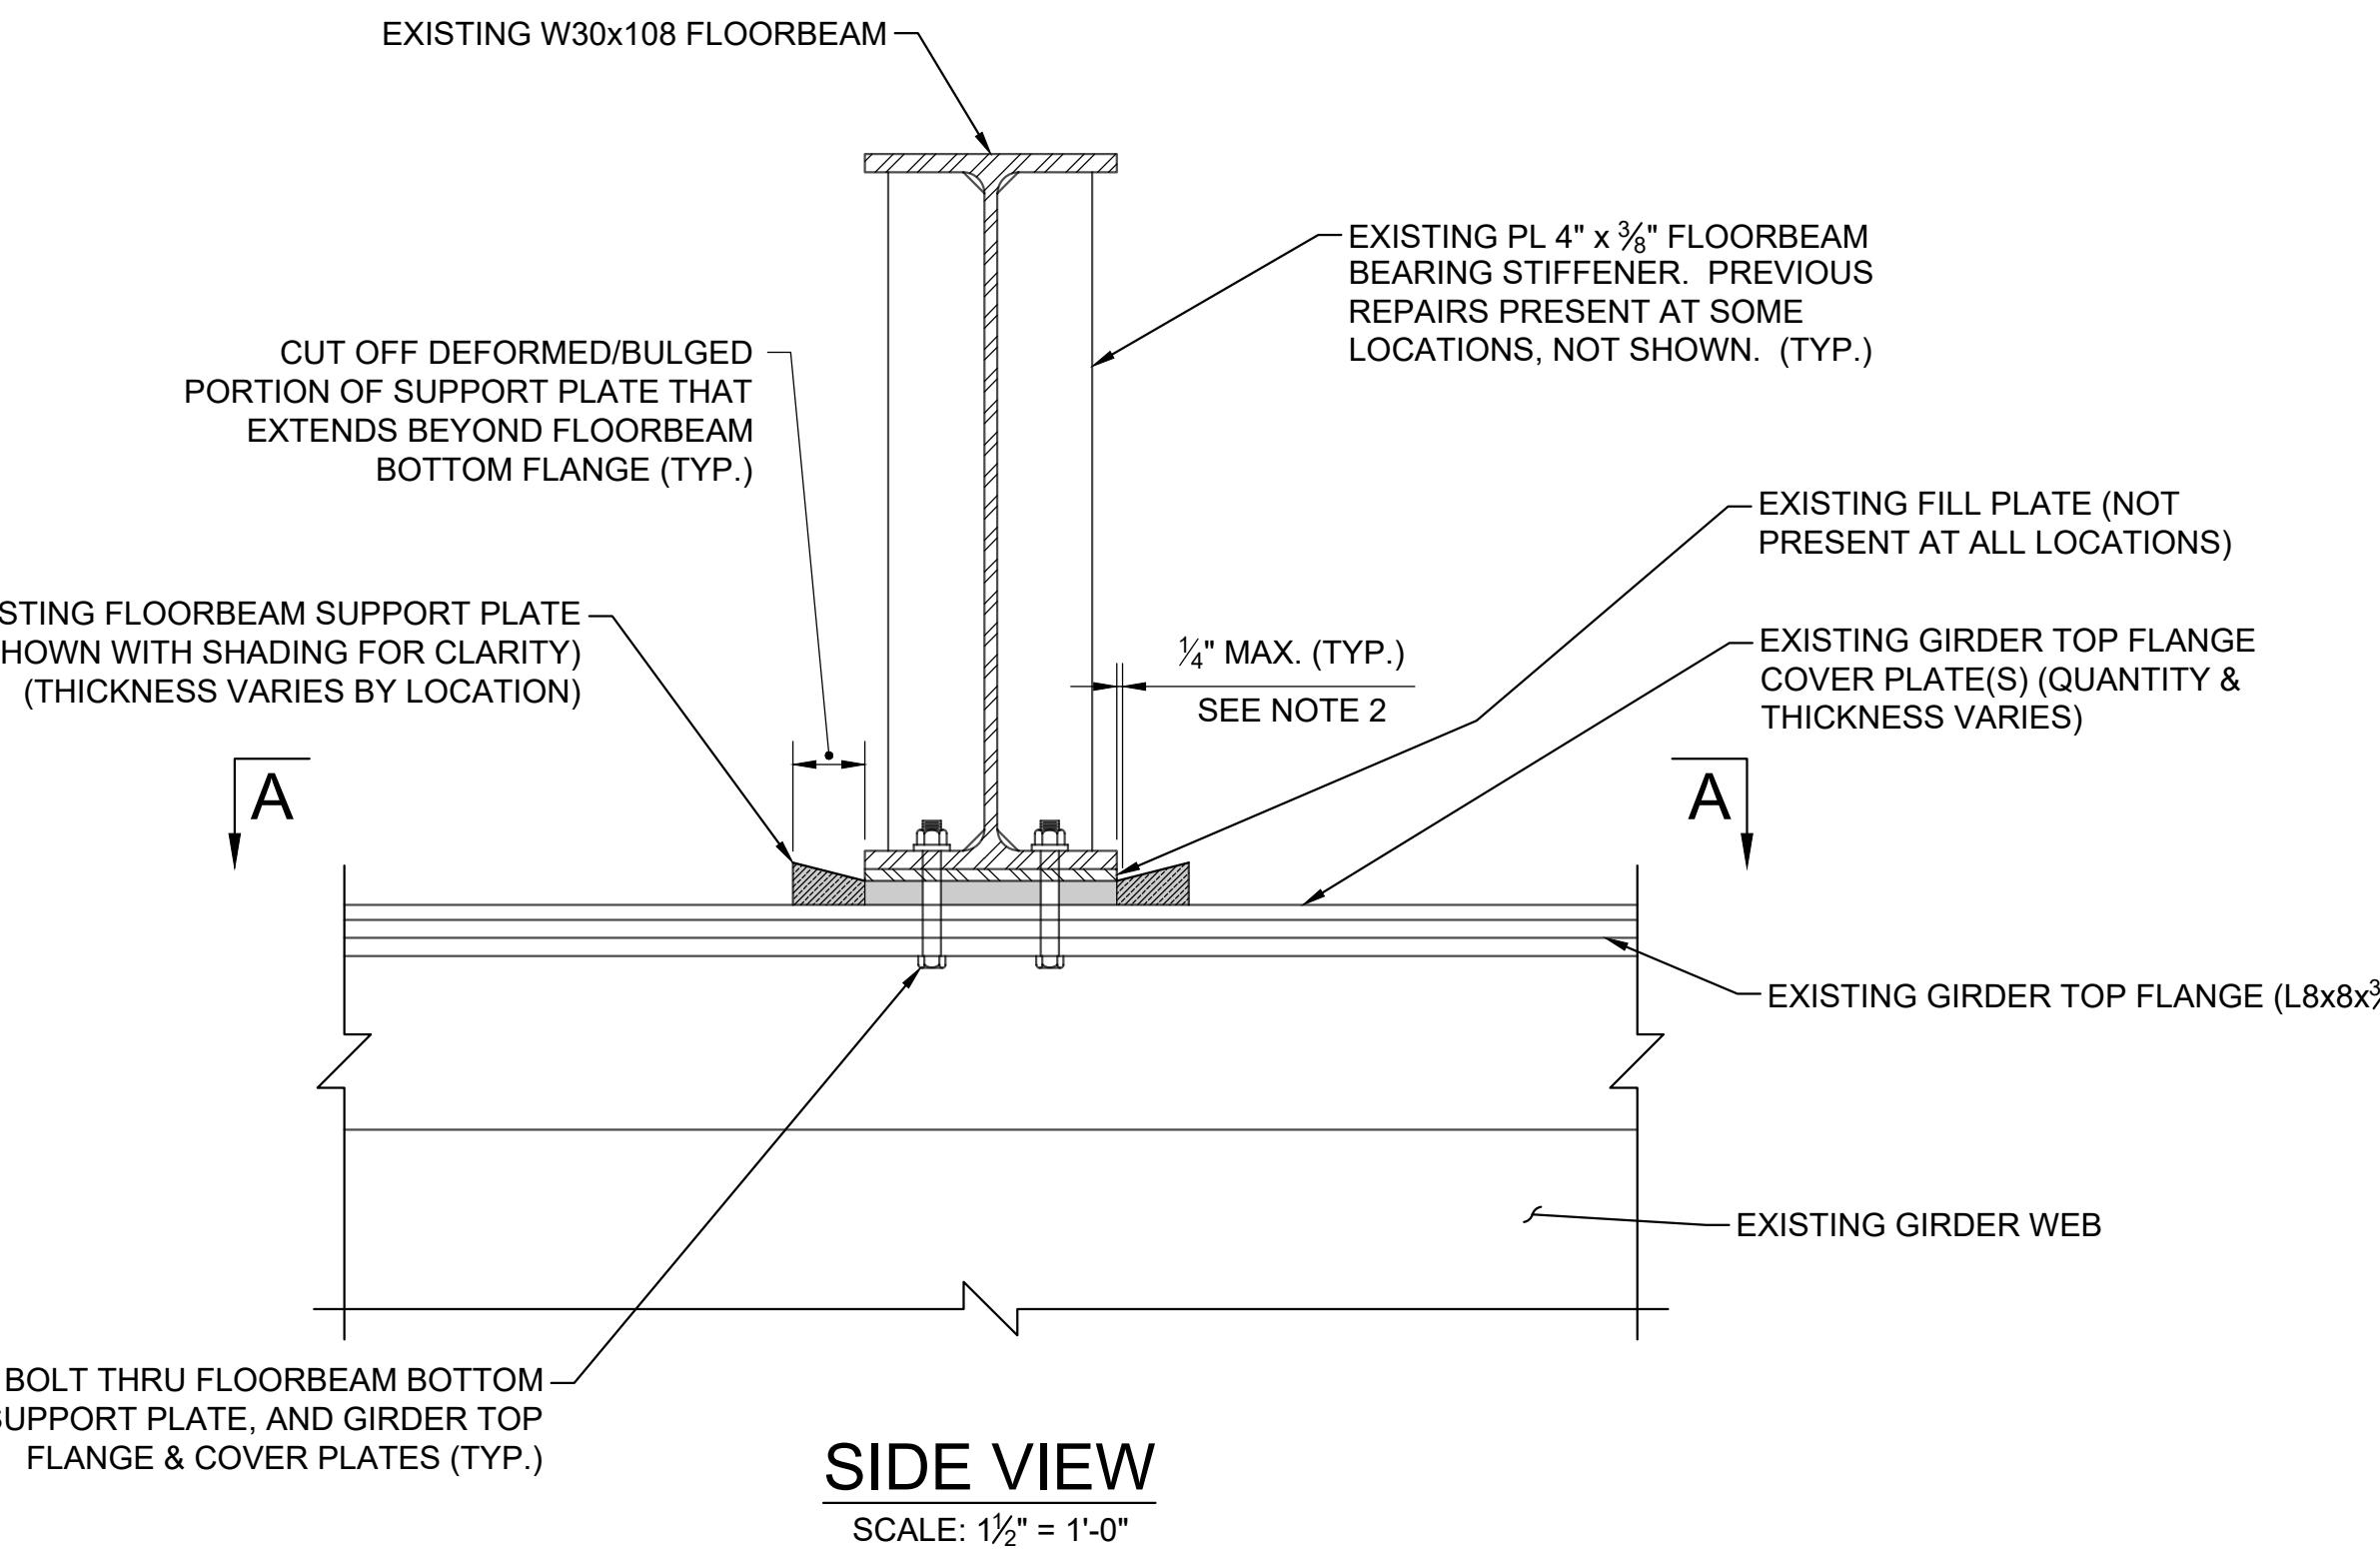
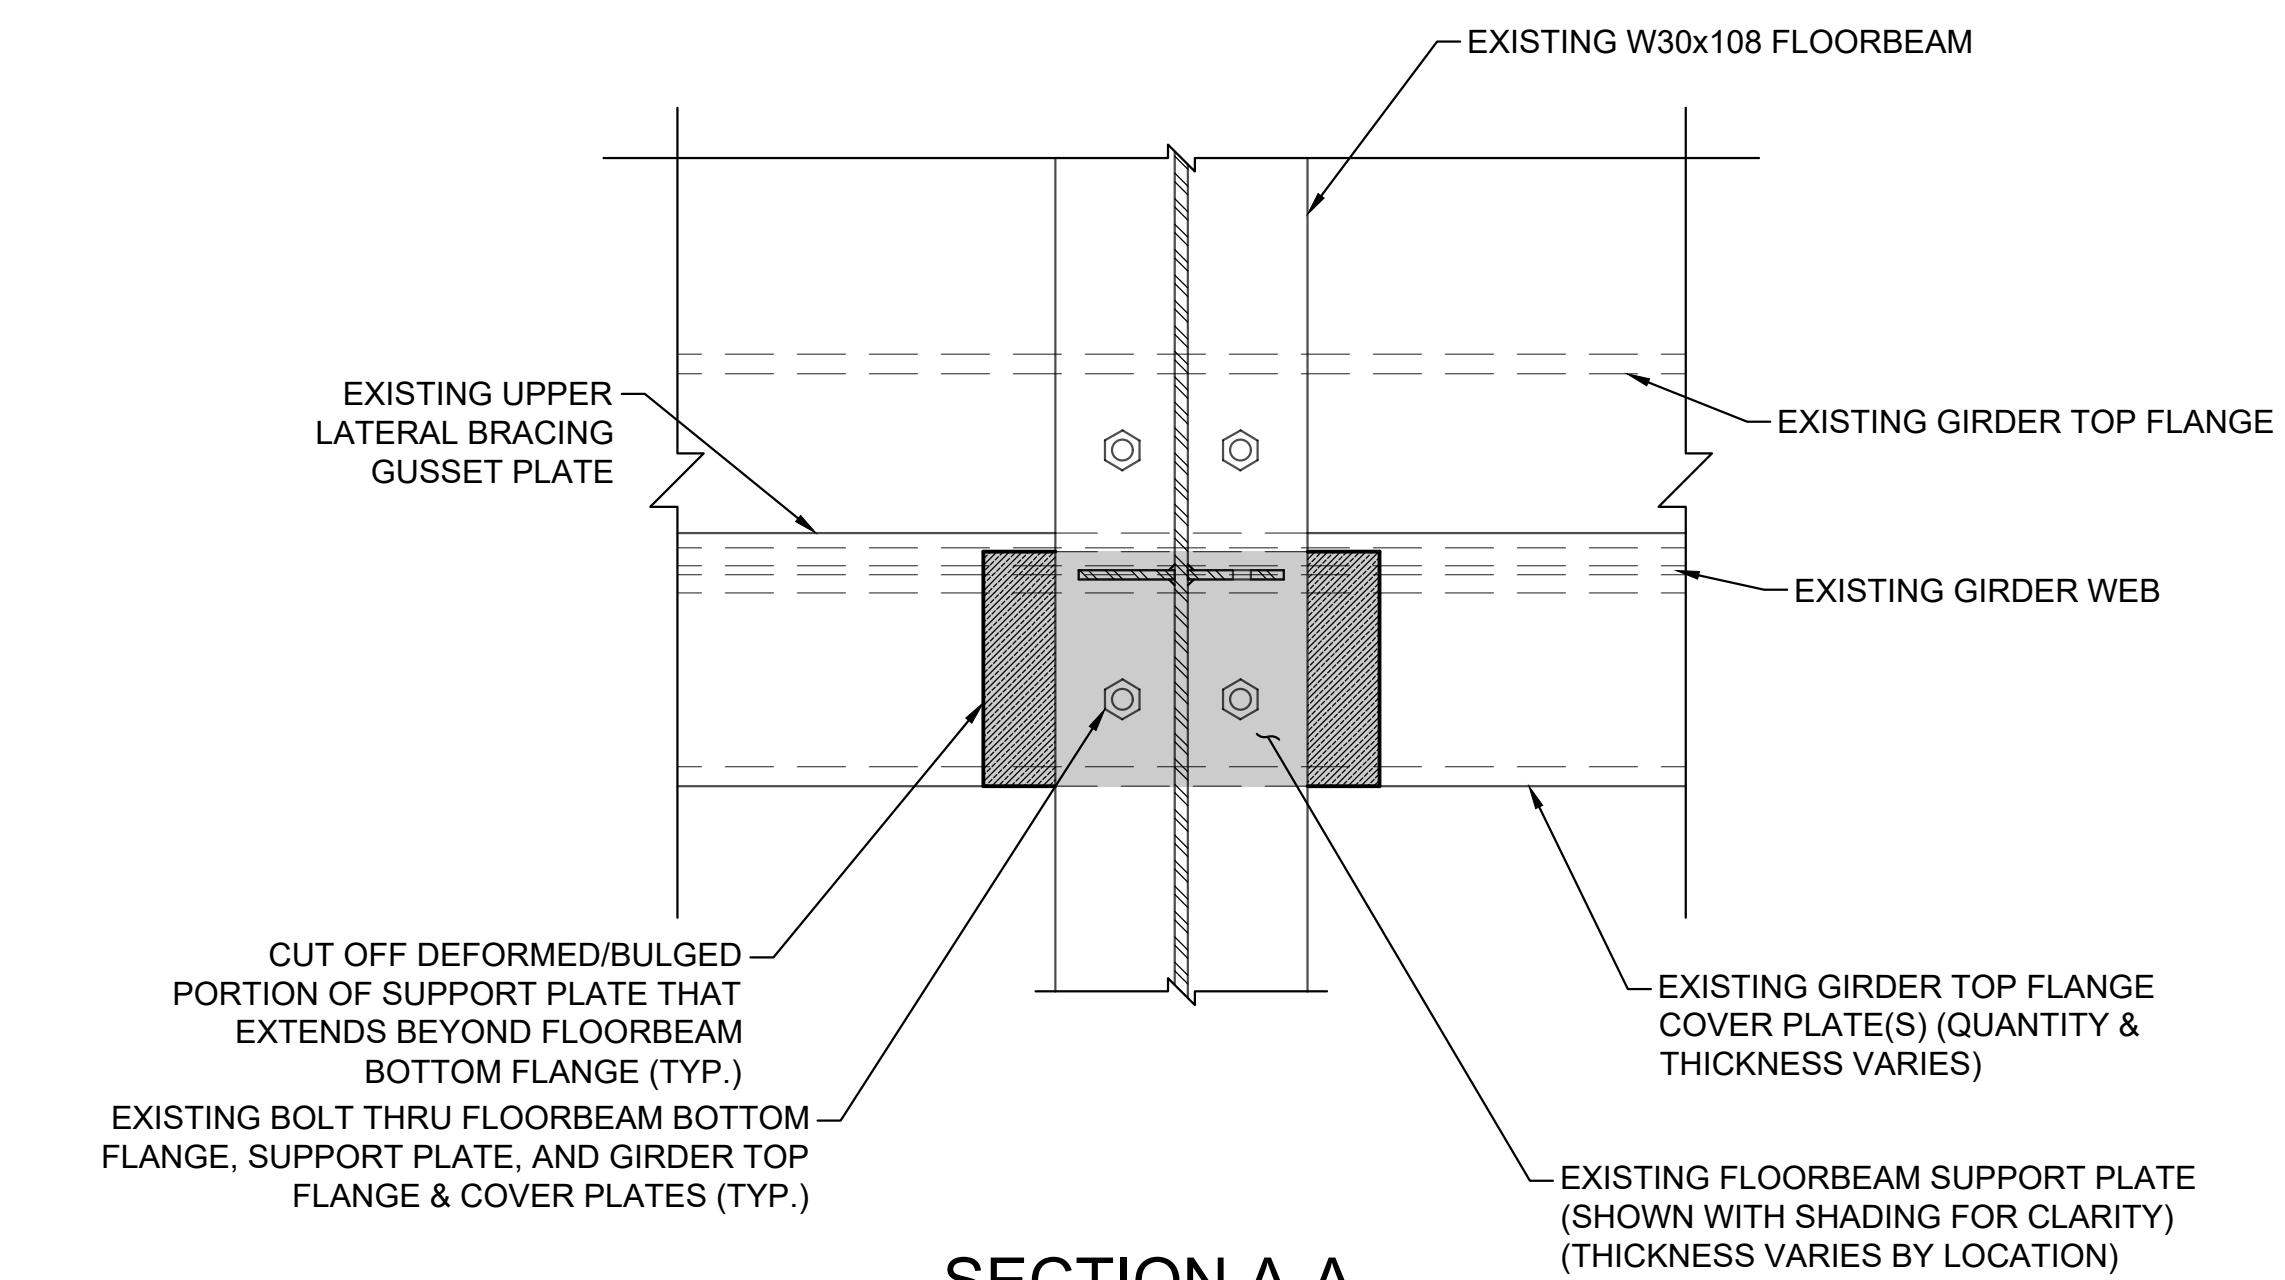
NCB-NB FLOORBEAM REPAIR TYPE 1

1. PERFORM THIS REPAIR IN NCB-NB SPANS 1-8 AND 10-17 FOR FLOORBEAM SUPPORT PLATES DEFORMED AND/OR BULGED (BEYOND THE EDGE OF THE FLOORBEAM BOTTOM FLANGE) AT LEAST $\frac{1}{2}$ " THICKER THAN ORIGINAL THICKNESS AS APPROVED BY THE DISTRICT.
2. CUT OFF OR OTHERWISE REMOVE DEFORMED AND/OR BULGED PORTION OF FLOORBEAM SUPPORT PLATE TO WITHIN $\frac{1}{4}$ " OF BOTTOM FLANGE EDGE FACE.
3. USE CAUTION TO AVOID DAMAGE TO GIRDERS TOP FLANGE AND TOP FLANGE COVER PLATES, FLOORBEAM, UPPER LATERAL BRACING GUSSET PLATES, AND ALL OTHER STRUCTURE. FLAME CUTTING IS PROHIBITED AS A METHOD FOR REMOVAL FOR THIS DETAIL. IF DAMAGE OCCURS, CONTRACTOR IS RESPONSIBLE FOR REPAIRING IT TO THE SATISFACTION OF THE DISTRICT AT NO COST TO THE DISTRICT.

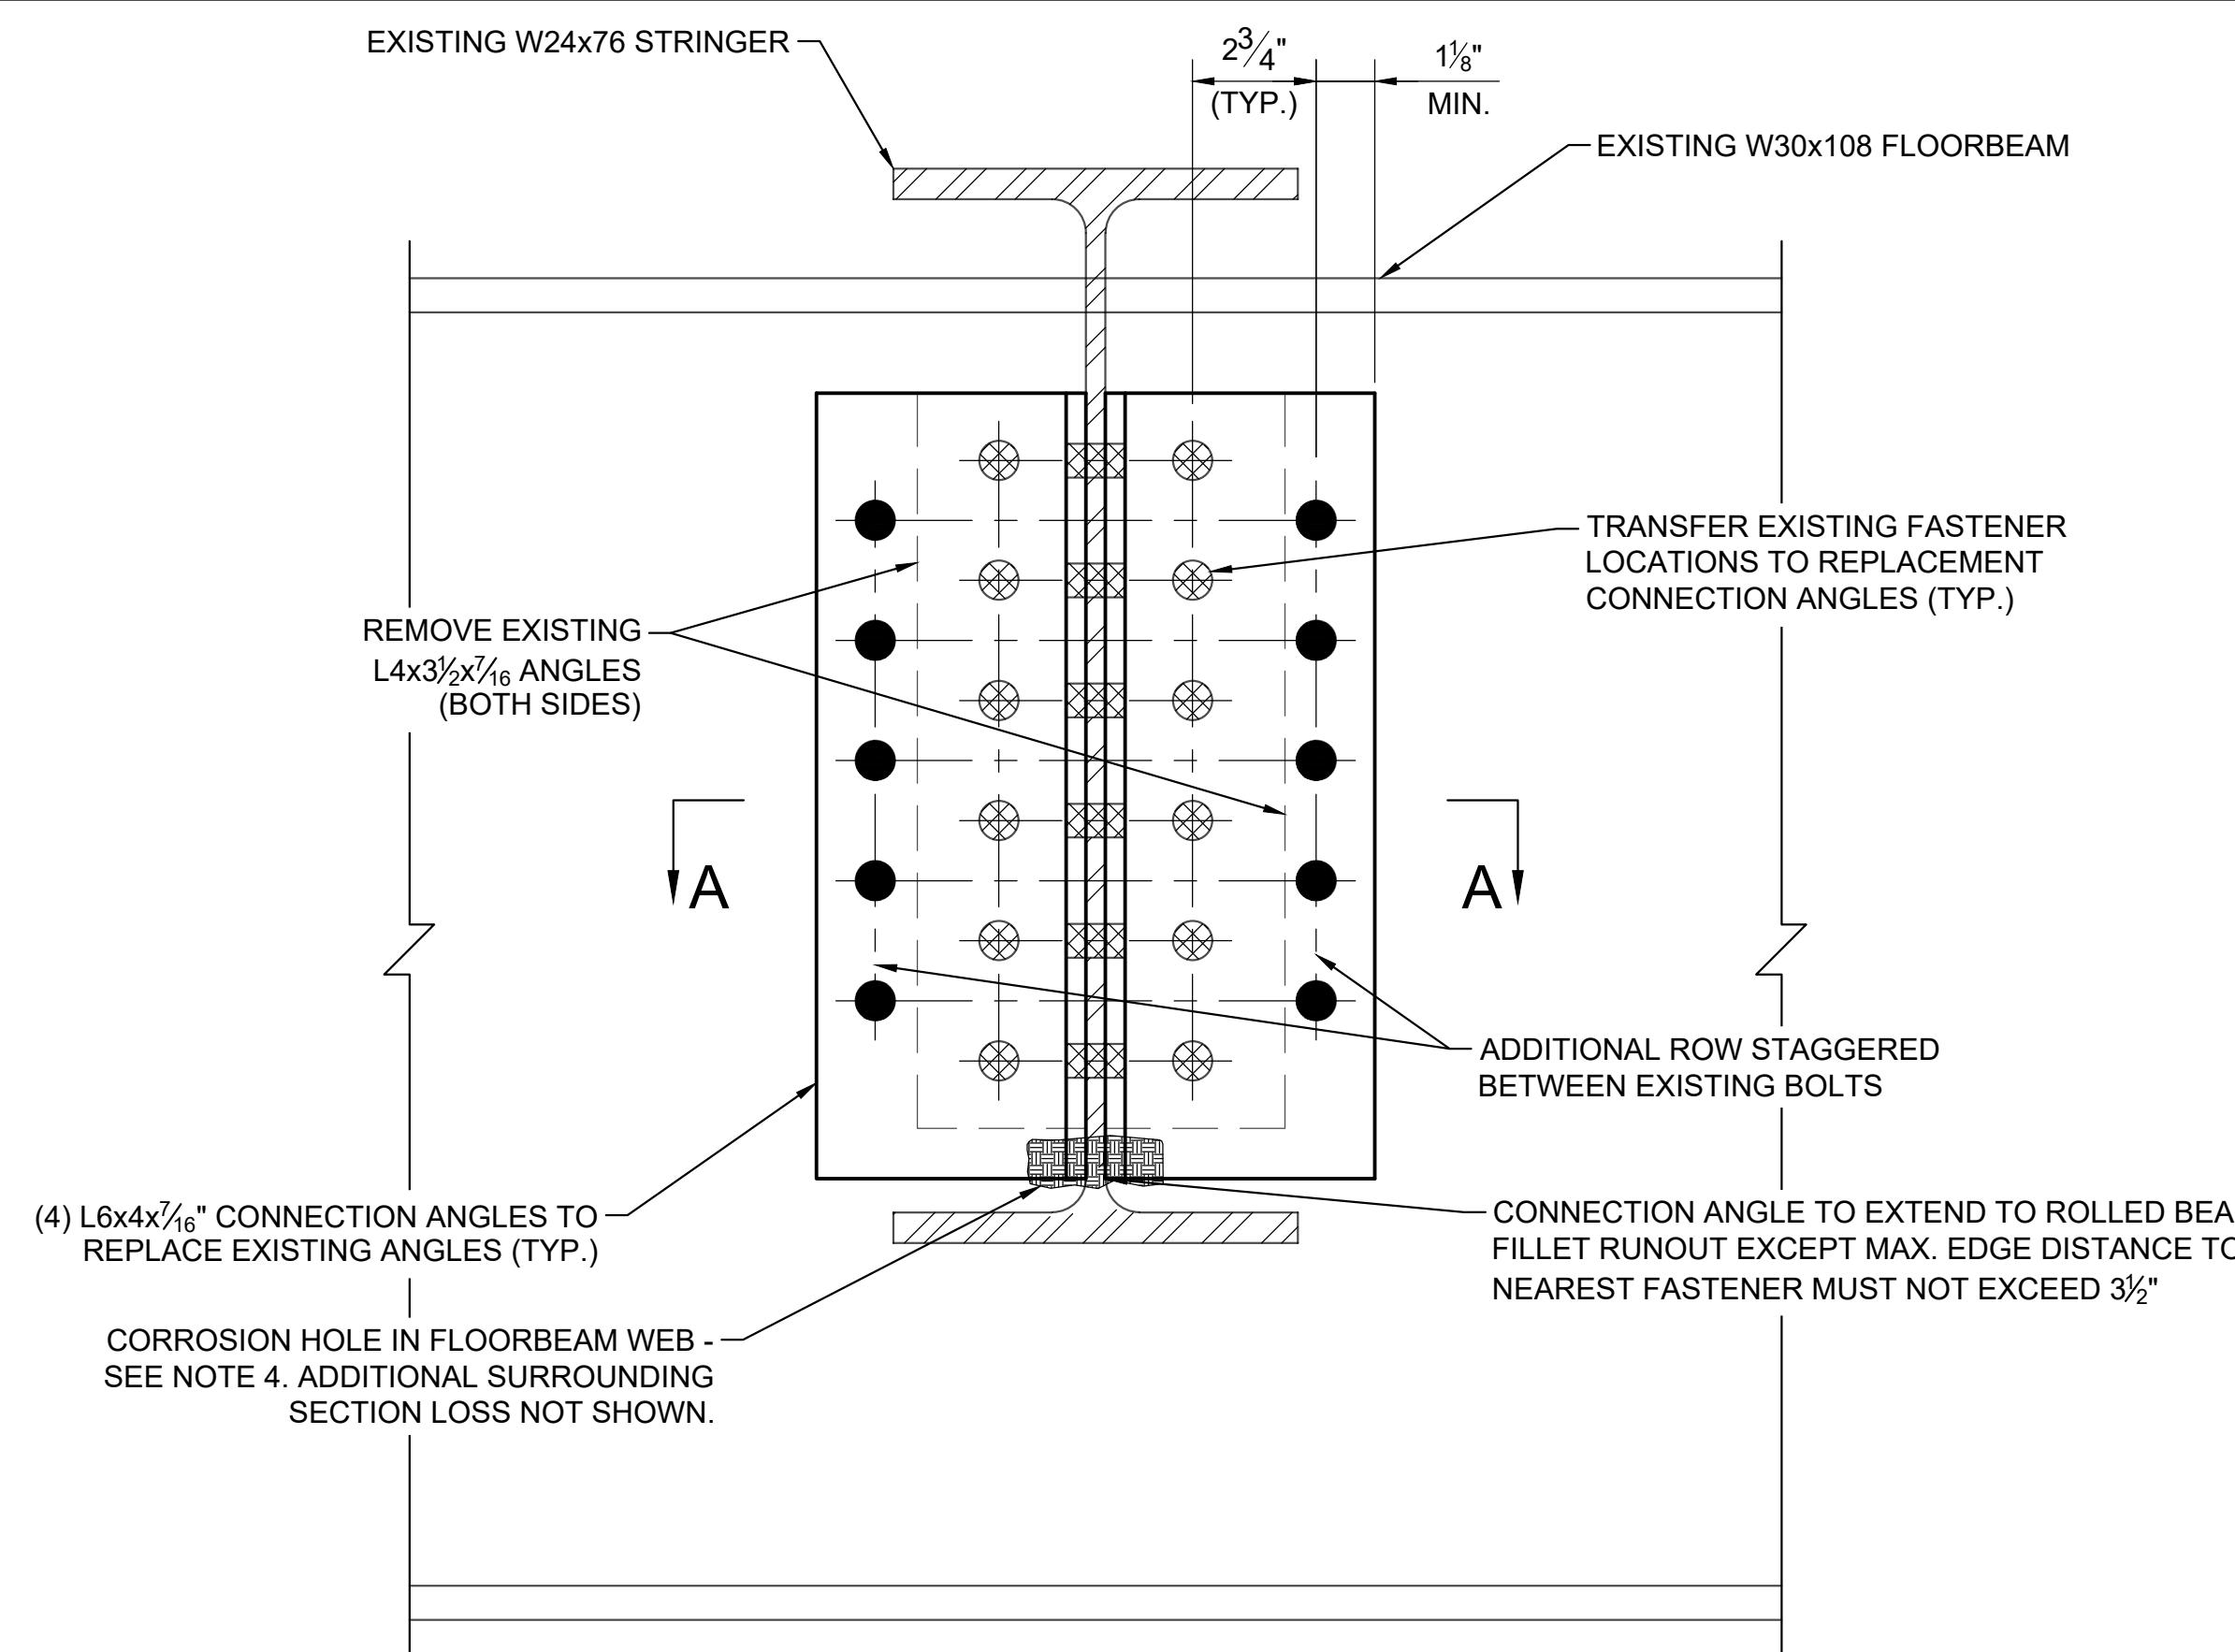
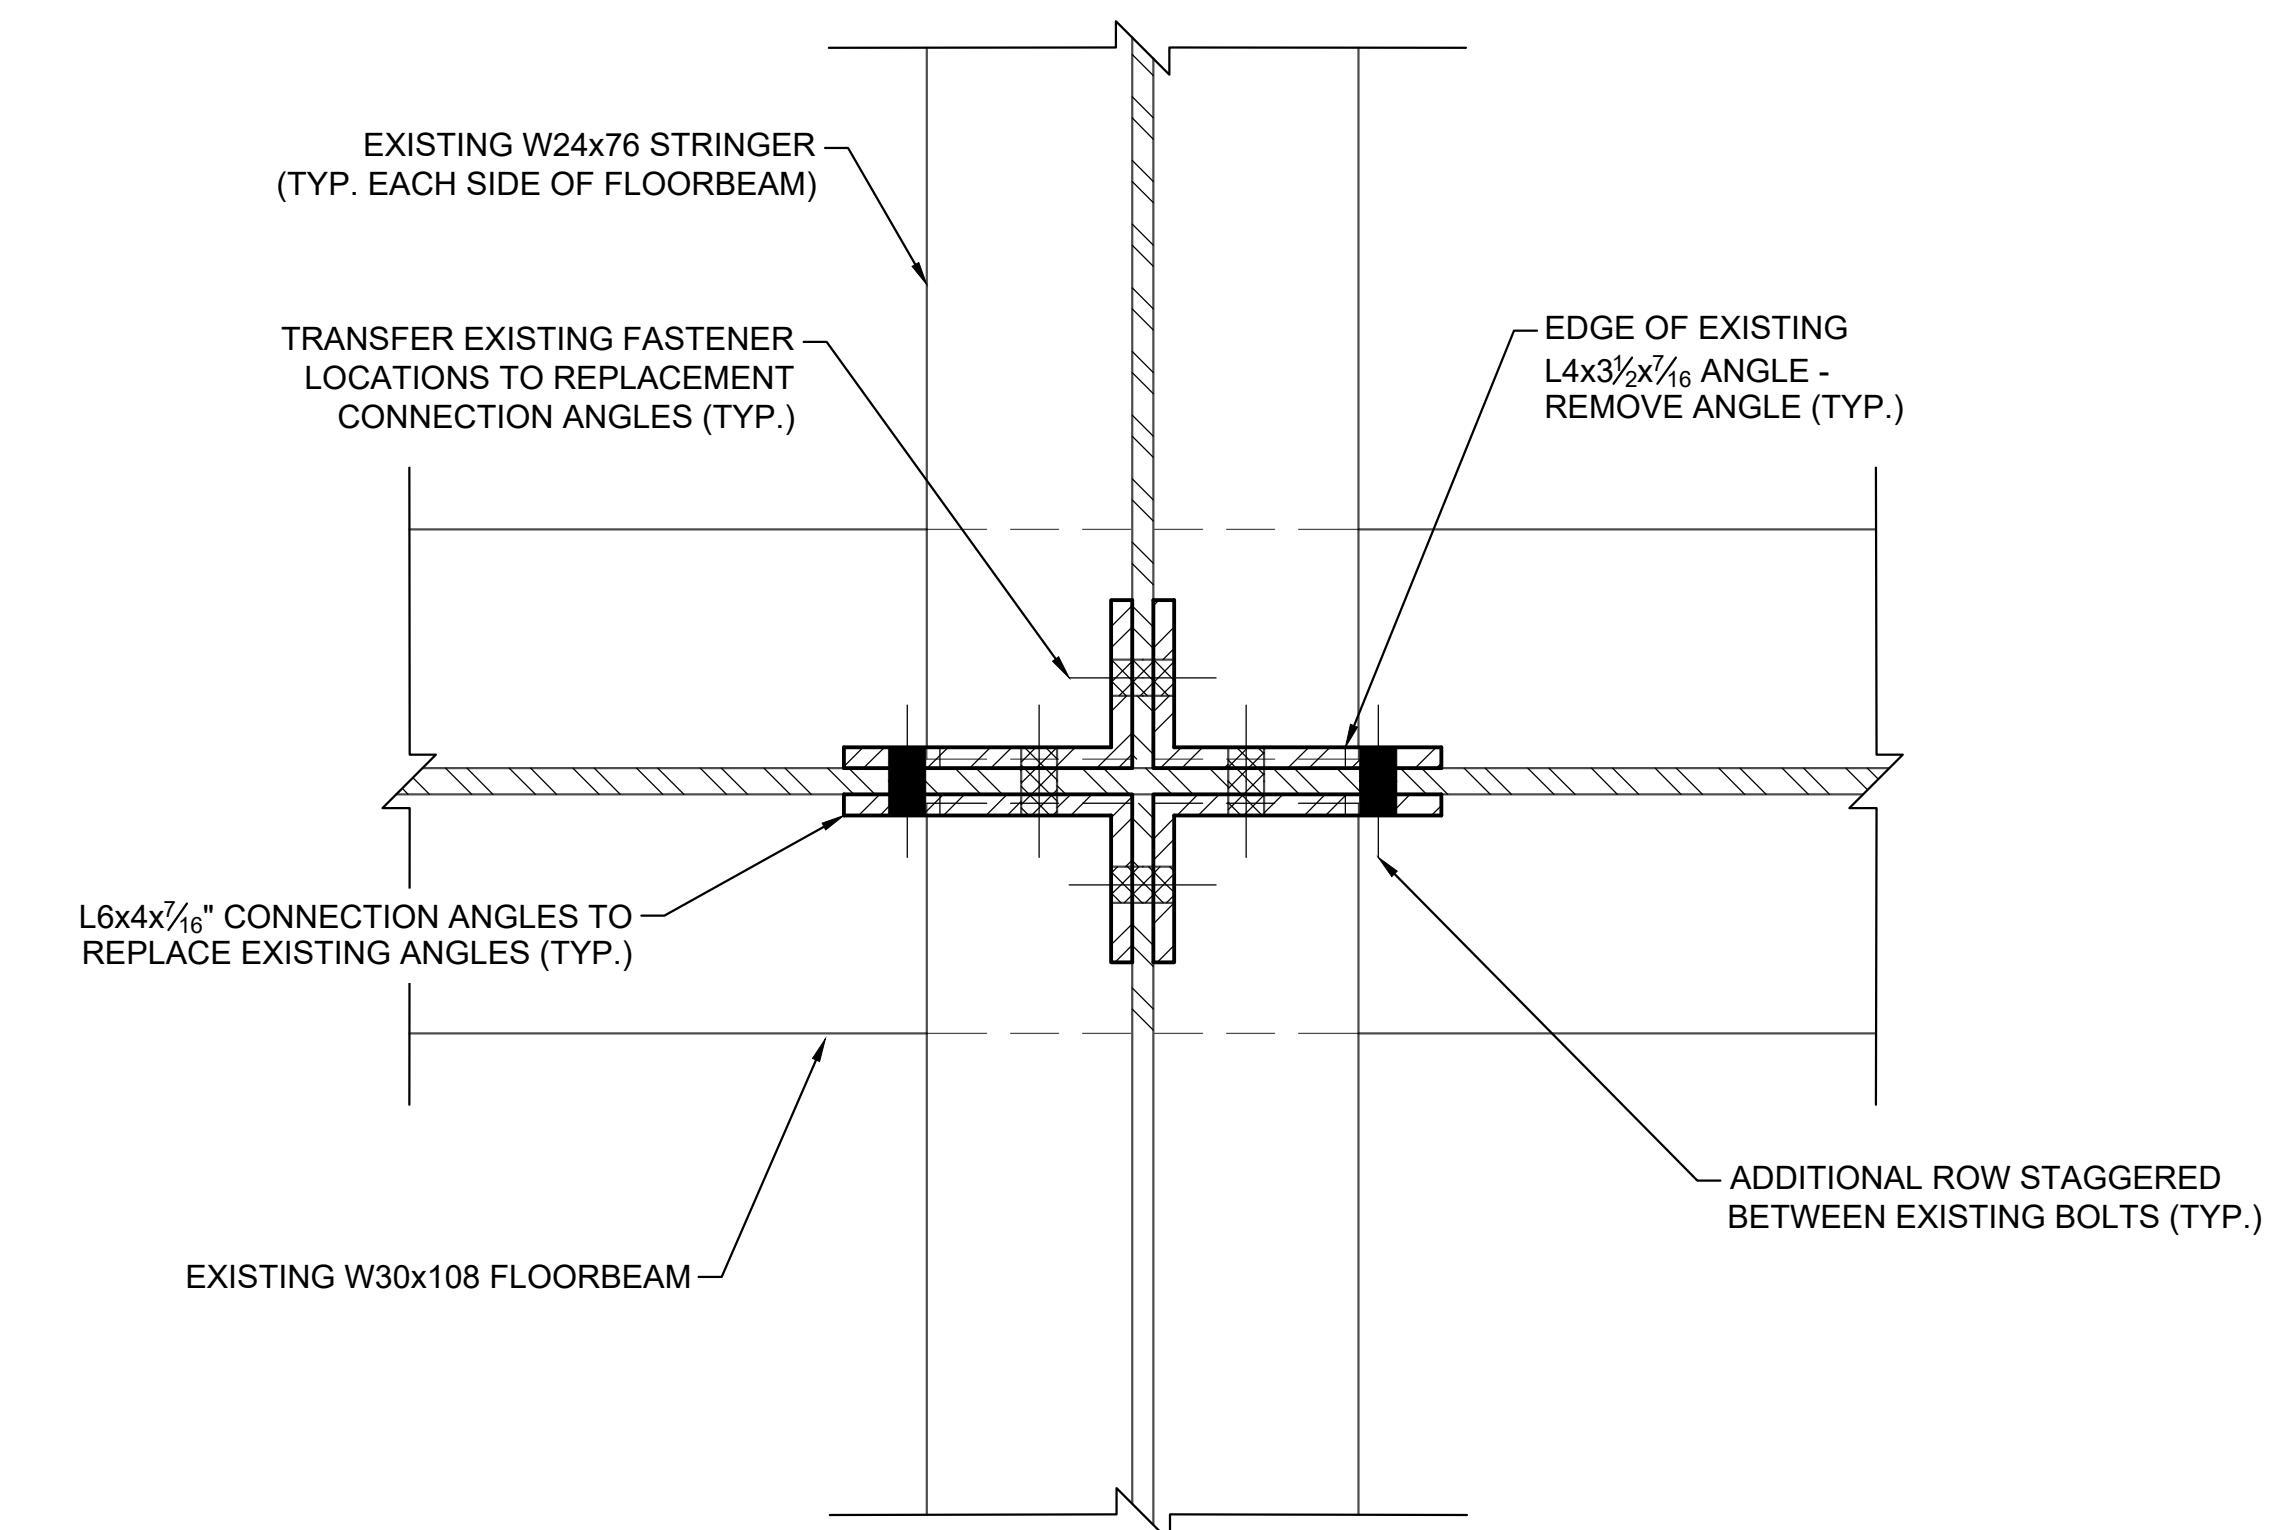
SECTION A-A

1. PERFORM EACH INSTANCE OF THIS REPAIR TYPE ONE AT A TIME.
2. INSTALL TEMPORARY SUPPORT SYSTEM FOR STRINGERS ON BOTH SIDES OF FLOORBEAM TO BE REPAIRED.
3. REMOVE CONNECTION ANGLES.
4. CLEAN AND GRIND CORRODED AREAS AS REQUIRED.
5. CLAMP REPAIR CONNECTION ANGLES IN PLACE WITH EACH STRINGER AND TRANSFER EXISTING HOLES IN FLOORBEAM AND STRINGER WEBS TO EACH ANGLE.
6. FIELD DRILL ADDITIONAL STAGGERED FASTENERS THRU FLOORBEAM WEB AND CONNECTION ANGLE.
7. REMOVE CLAMPS AND APPLY EPOXY FILLER TO CLEANED AND PAINTED CORROSION ZONE IN FLOOR BEAMS WEB AS NEEDED. ENSURE FINISH IS SMOOTH AND FLUSH.
8. INSTALL CONNECTION ANGLES AND BOLTS. REMOVE TEMPORARY SUPPORT SYSTEM FOR STRINGERS.

1. PERFORM THIS REPAIR IN NCB-NB SPANS 1-8 AND 10-17 FOR FLOORBEAM - STRINGER CONNECTIONS WITH ONE OR MORE CORROSION HOLES IN THE FLOORBEAM WEB AND/OR REMAINING WEB THICKNESS LESS THAN $\frac{1}{8}$ " FOR A 1" DIA. AREA AS APPROVED BY THE DISTRICT.
2. FILL ALL GAPS WITH STEEL-FILLED EPOXY PUTTY.
3. GRIND ALL CORROSION TO SMOOTH BARE METAL.
4. APPROXIMATE TYPICAL CORROSION HOLE SIZE IS UP TO 3" W x 1" H. ASSUME MAXIMUM CORROSION HOLE SIZE TO BE 4" H x 1 1/2" W AFTER BLASTING. CONTACT THE DISTRICT FOR DIRECTION IF CORROSION HOLE EXTENDS MORE THAN 5 1/2" FROM STRINGER WEB.

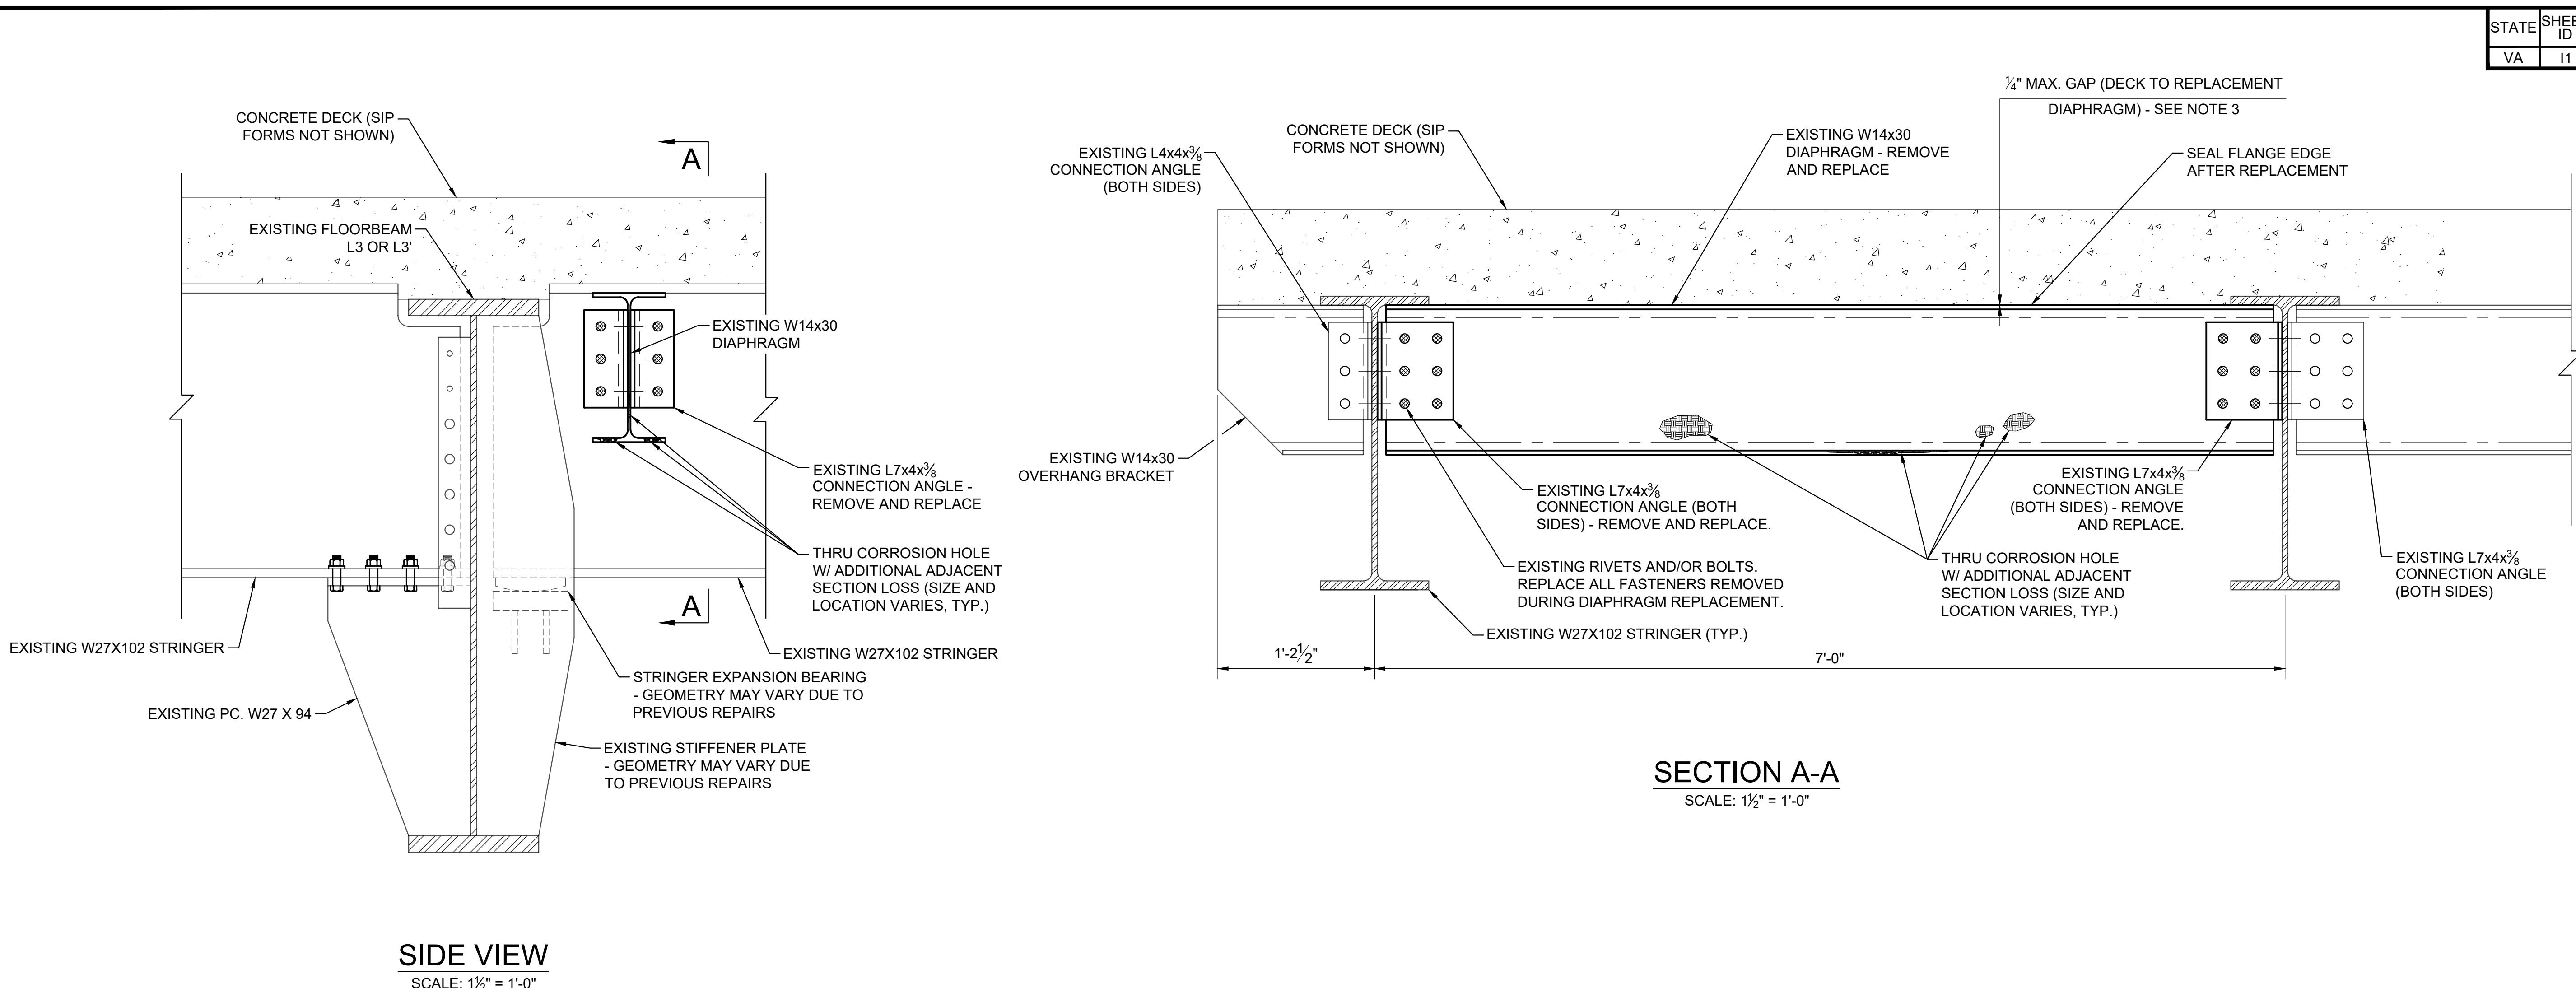
NCB-NB TRUSS STRINGER REPAIR TYPE 3

1. PERFORM THIS REPAIR FOR NCB-NB SPAN 9 (TRUSS SPAN) STRINGER BAY END DIAPHRAGMS ADJACENT TO FLOOR BEAMS 3 AND 3' EXHIBITING FULL-THRU CORROSION HOLES AS APPROVED BY THE DISTRICT. REPAIR CONSISTS OF FULL REMOVAL AND REPLACEMENT OF DIAPHRAGM AND (4) L7x4x $\frac{3}{8}$ CONNECTION ANGLES [(2) AT EACH END]. PERFORM EACH DIAPHRAGM REPLACEMENT ONE AT A TIME. SUPPORT OVERHANG BRACKET AND/OR DIAPHRAGM(S) IN THE ADJACENT BAY(S) WHILE PERFORMING REPLACEMENT.

2. EXISTING DECK IS POURED AGAINST EXISTING DIAPHRAGM TOP FLANGE BUT IS NOT COMPOSITE WITH FLANGE. USE CAUTION TO ENSURE THAT DECK AND SOFFIT ARE NOT DAMAGED IN ANY WAY WHEN REMOVING EXISTING DIAPHRAGM. IF DAMAGE OCCURS, CONTRACTOR IS RESPONSIBLE FOR REPAIRING IT TO THE SATISFACTION OF THE DISTRICT AT NO COST TO THE DISTRICT. CAREFULLY REMOVE INTERFERING PORTIONS OF SIP FORMS AS NECESSARY TO REMOVE DIAPHRAGM. IF SIP FORM AND/OR ASSOCIATED BRACKET(S) ARE CUT, ENSURE FINAL CUT EDGE IS STRAIGHT.

3. SEAL EDGES OF DIAPHRAGM TOP FLANGE TO DECK SOFFIT USING CAULK FOR PAINT SYSTEM DESCRIBED IN SECTION 411.

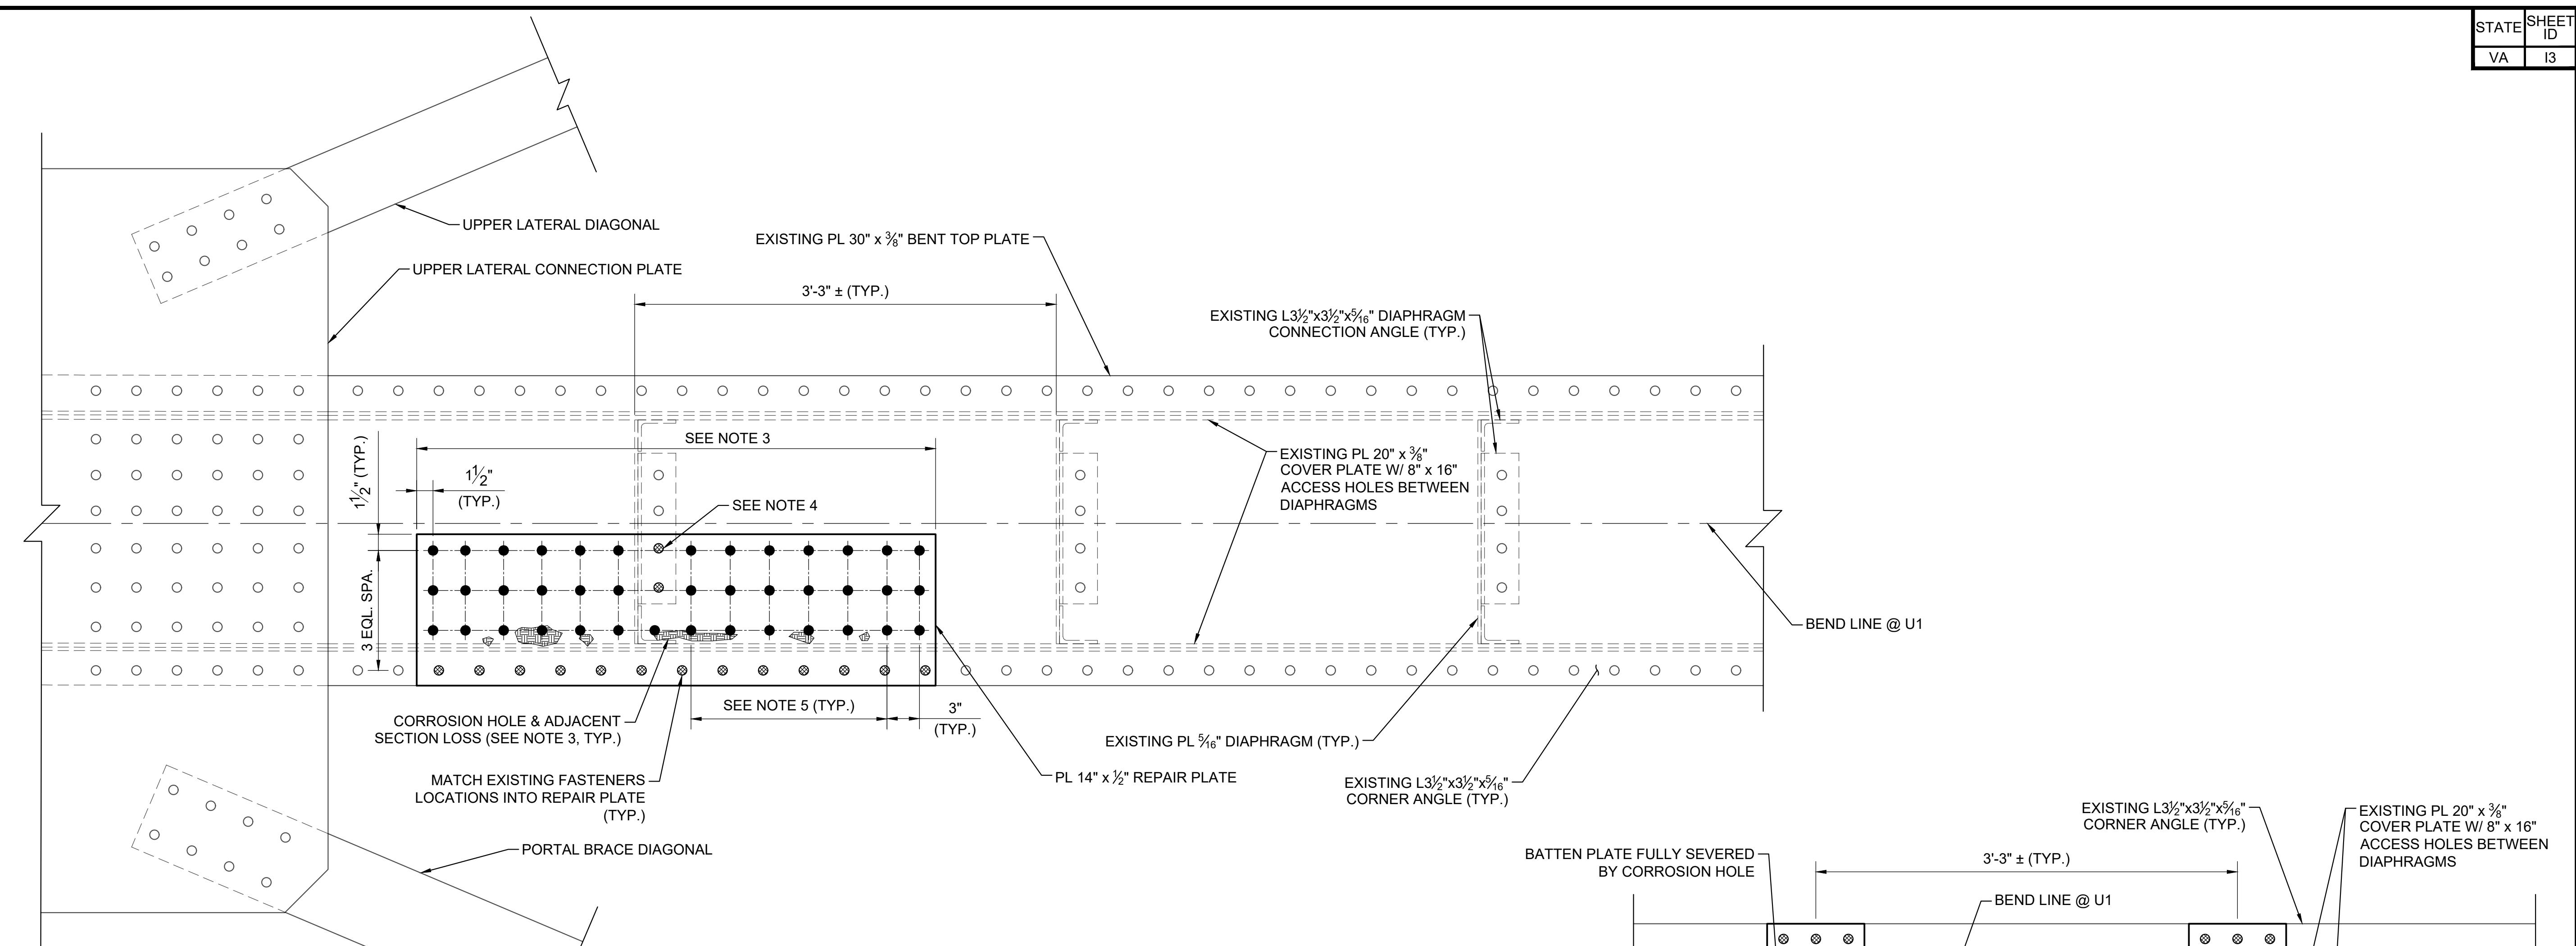
VIEW C-C
SCALE: 1 1/2" = 1'-0"

NCB-NB TRUSS PORTAL REPAIR TYPE 1

1. PERFORM THIS REPAIR FOR NCB-NB SPAN 9 (TRUSS SPAN) PORTAL BRACING TOP STRUT (PANEL POINT U1) FOR TOP PLATE FULL-THRU CORROSION HOLES AS APPROVED BY THE DISTRICT.
2. TOP PLATE IS SYMMETRIC ABOUT BEND LINE. ADJACENT REPAIRS ON OPPOSITE SIDES OF THE BEND LINE MAY OCCUR. TREAT SUCH ADJACENT REPAIRS INDEPENDENTLY.
3. SIZE, LOCATION, AND SEVERITY OF CORROSION VARIES. TYPICAL MAXIMUM LENGTH OF CONTIGUOUS DAMAGE IS APPROXIMATELY 3'-0" (TOTAL REPAIR LENGTH APPROX. 4'-0")
4. INCREASE WIDTH OF REPAIR PLATE AS NECESSARY TO ENSURE MINIMUM EDGE DISTANCE OF 1 1/8" FOR DIAPHRAGM CONNECTION ANGLE FASTENERS.
5. SPACE FASTENERS ALONG AXIS OF BEND LINE AT 3" MIN. / 5 1/2" MAX. MAXIMUM SPACING BETWEEN FASTENERS MAY NOT EXCEED 5 1/2".
6. GRIND ALL CORROSION TO SMOOTH BARE METAL.
7. FILL ALL GAPS WITH STEEL-FILLED EPOXY PUTTY.

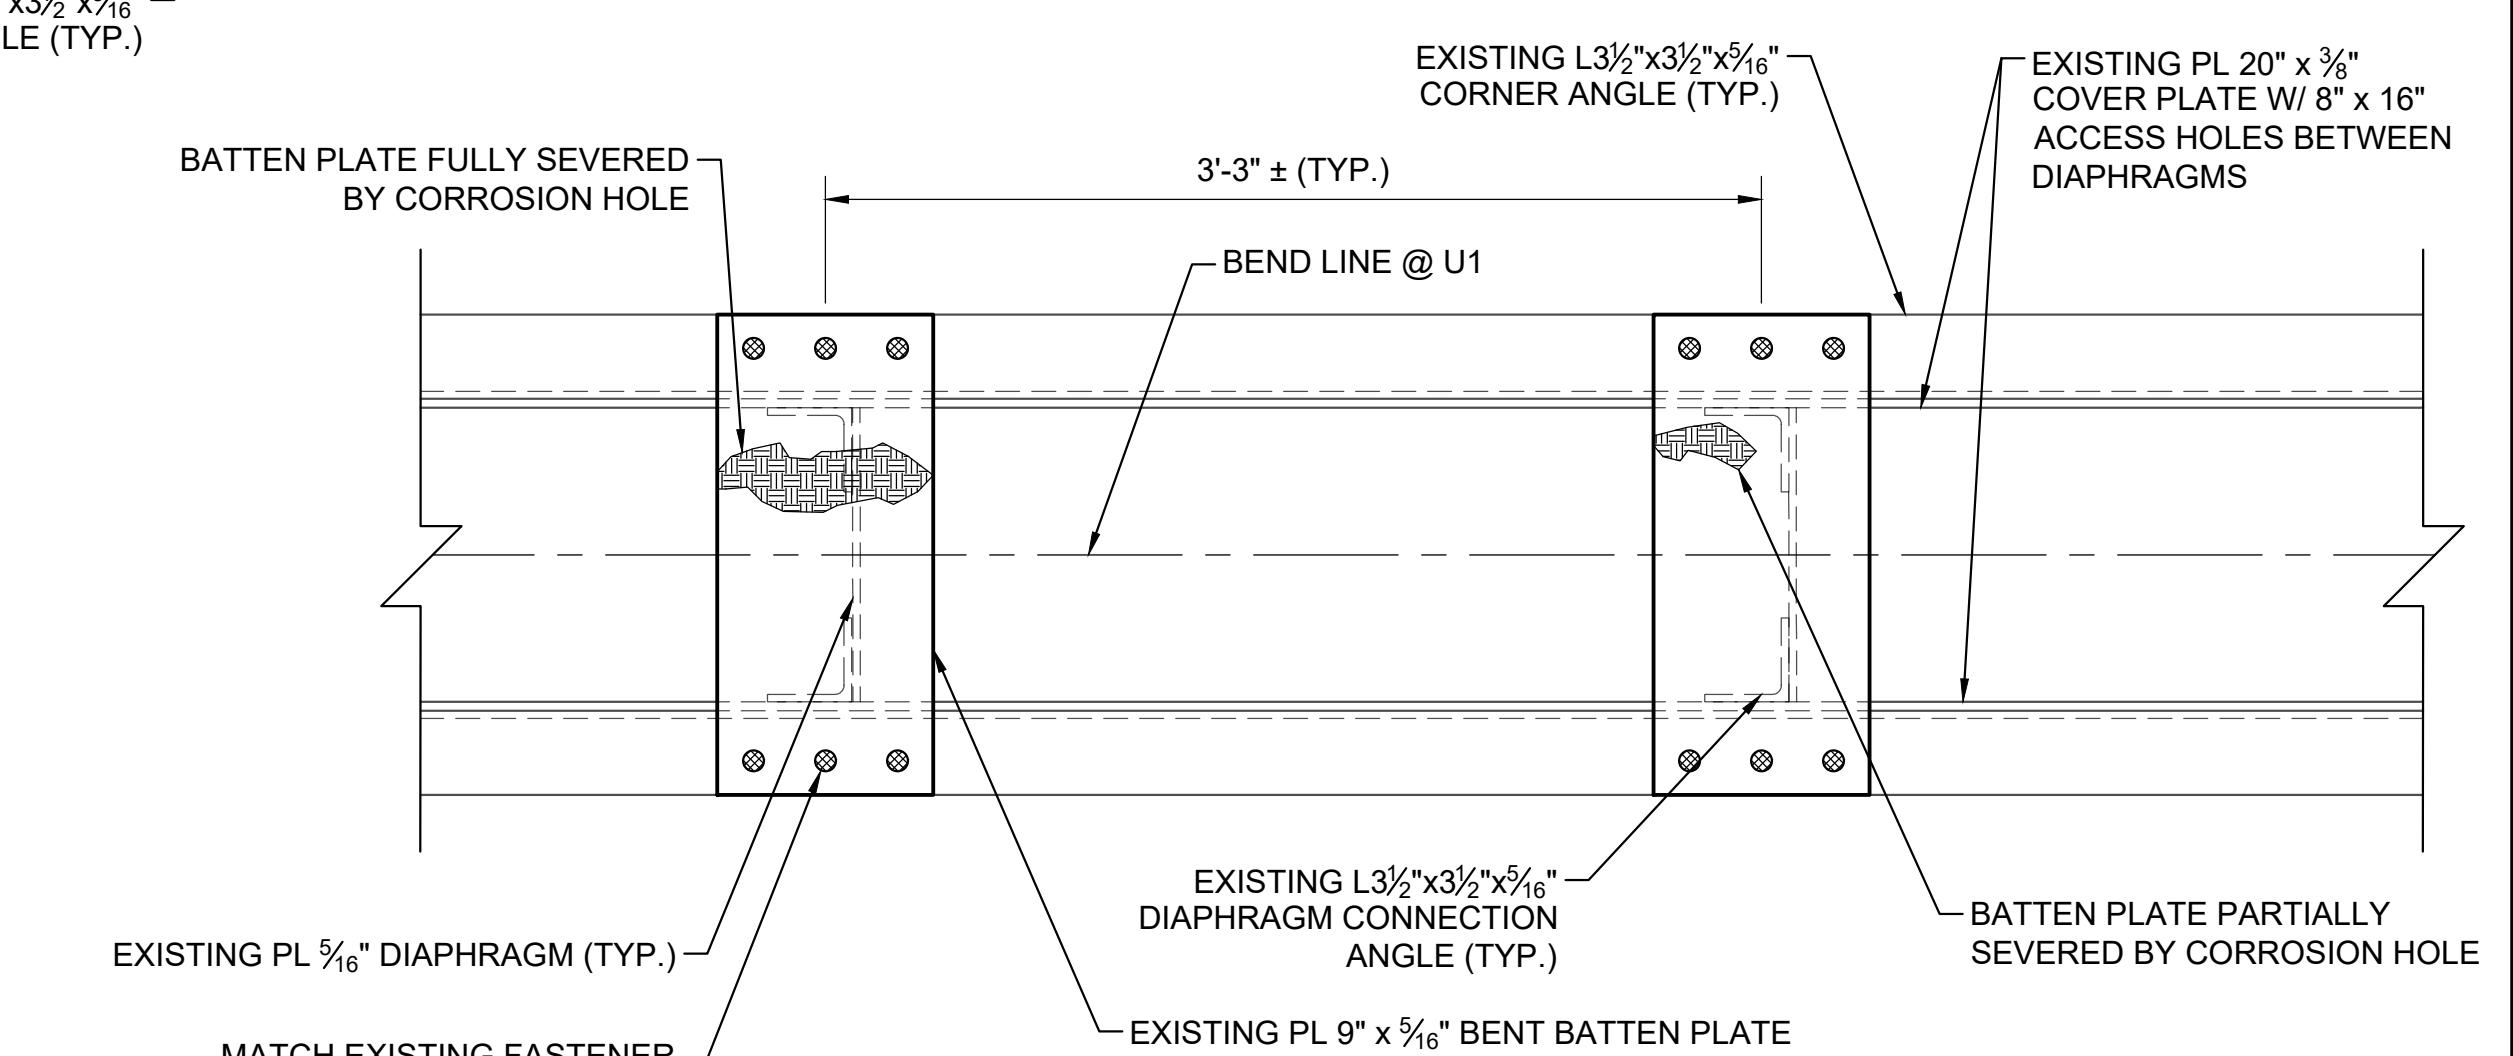
VIEW D-D
SCALE: 1 1/2" = 1'-0"

NCB-NB TRUSS PORTAL REPAIR TYPE 2

1. PERFORM THIS REPAIR FOR NCB-NB SPAN 9 (TRUSS SPAN) PORTAL BRACING TOP STRUT (PANEL POINT U1) FOR BOTTOM BATTEN PLATES MISSING OR PARTIALLY OR FULLY SEVERED DUE TO CORROSION HOLES AS APPROVED BY THE DISTRICT.
2. IT IS PERMISSIBLE TO SUBSTITUTE 5/8" OR 1/2" THICK PLATE WHEN REPLACING EXISTING 5/16" THICK BATTEN PLATES.
