CHESAPEAKE BAY BRIDGE AND TUNNEL DISTRICT
			RMF 5044.5122 - STEEL BRIDGE PAINTING PROJECT
PROJECT NOTES			
No.	Description	Date	Designed: JSE Drawn: BSB Checked: AHC
			12/18/2025
	Revision		1 OF 45

CHESAPEAKE BAY BRIDGE AND TUNNEL DISTRICT	
			RMF 5044.5122 - STEEL BRIDGE PAINTING PROJECT	
NORTH CHANNEL BRIDGE NB GENERAL PLAN AND ELEVATION				
No.	Description	Date	Designed: JSE Drawn: BSB Checked: AHC	Date Plan No. Sheet No.
	Revision			12/18/2025 3 OF 45

CHESAPEAKE BAY BRIDGE AND TUNNEL DISTRICT							
			RMF 5044.5122 - STEEL BRIDGE PAINTING PROJECT							
NORTH CHANNEL BRIDGE NB STRINGER AND FLOORBEAM PLATING REPAIRS										
No. Description Date Designed: JSE Drawn: JSE Checked: AHC 12/18/2025 9 OF 45										
	Revision

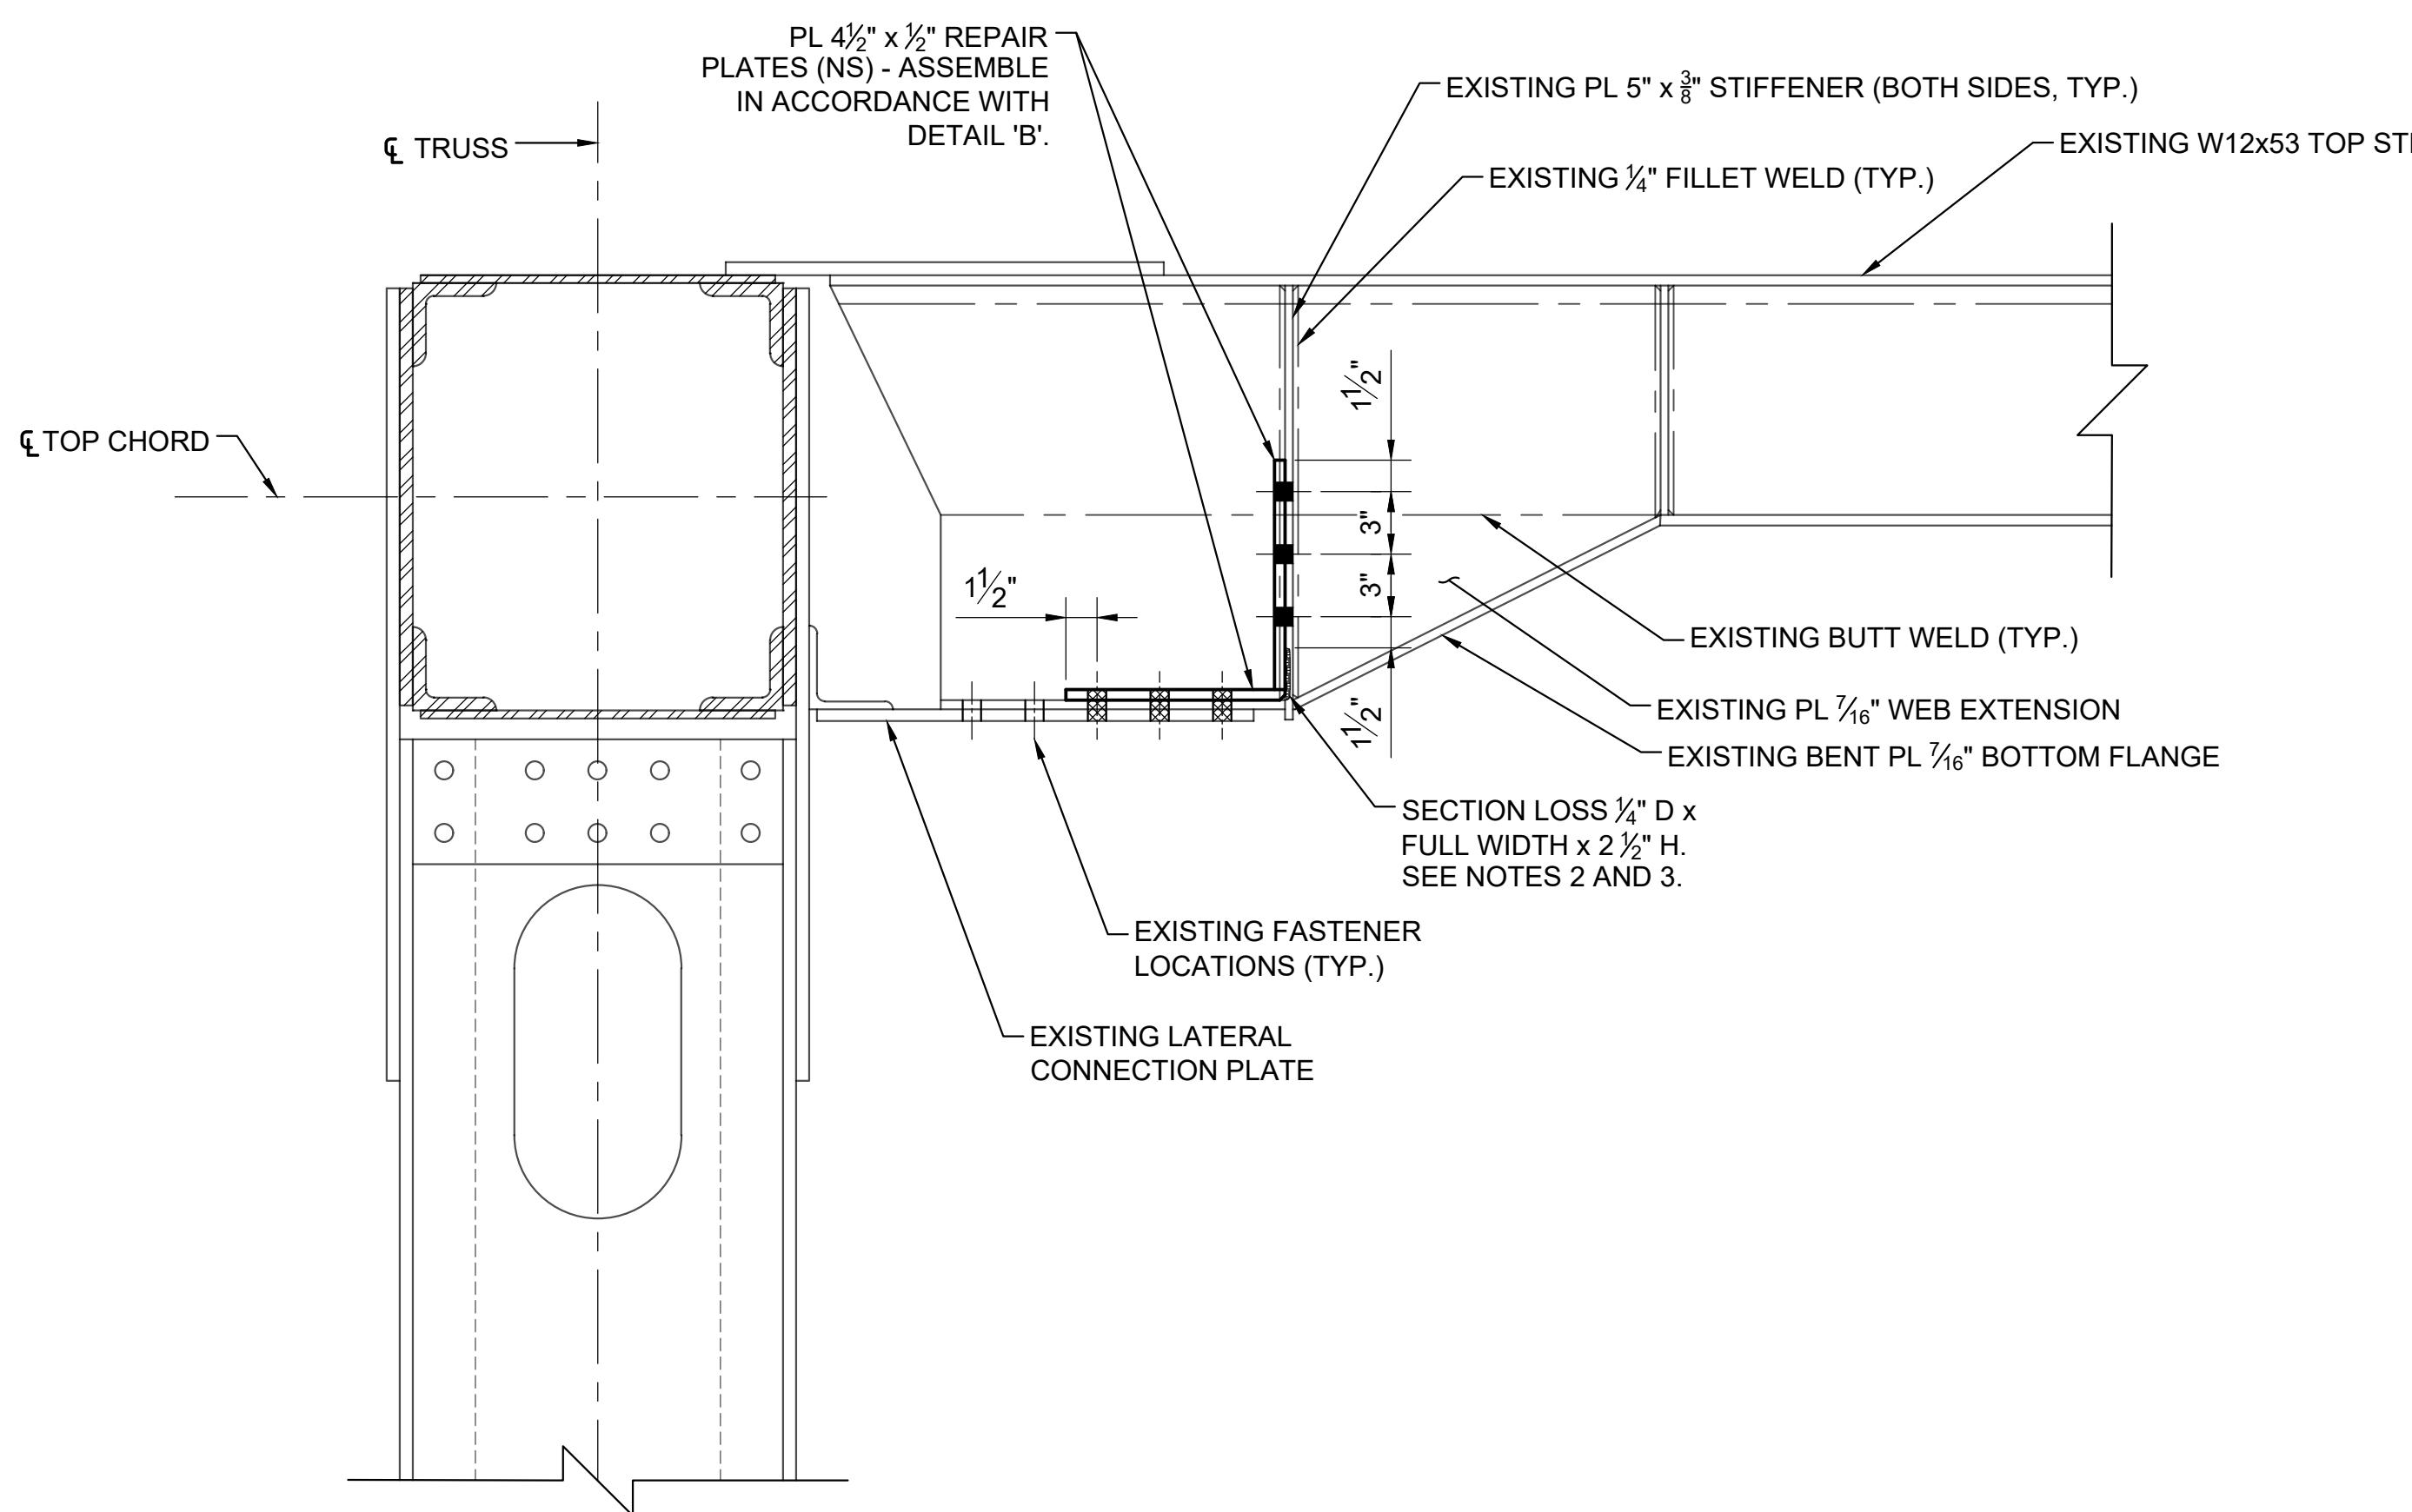
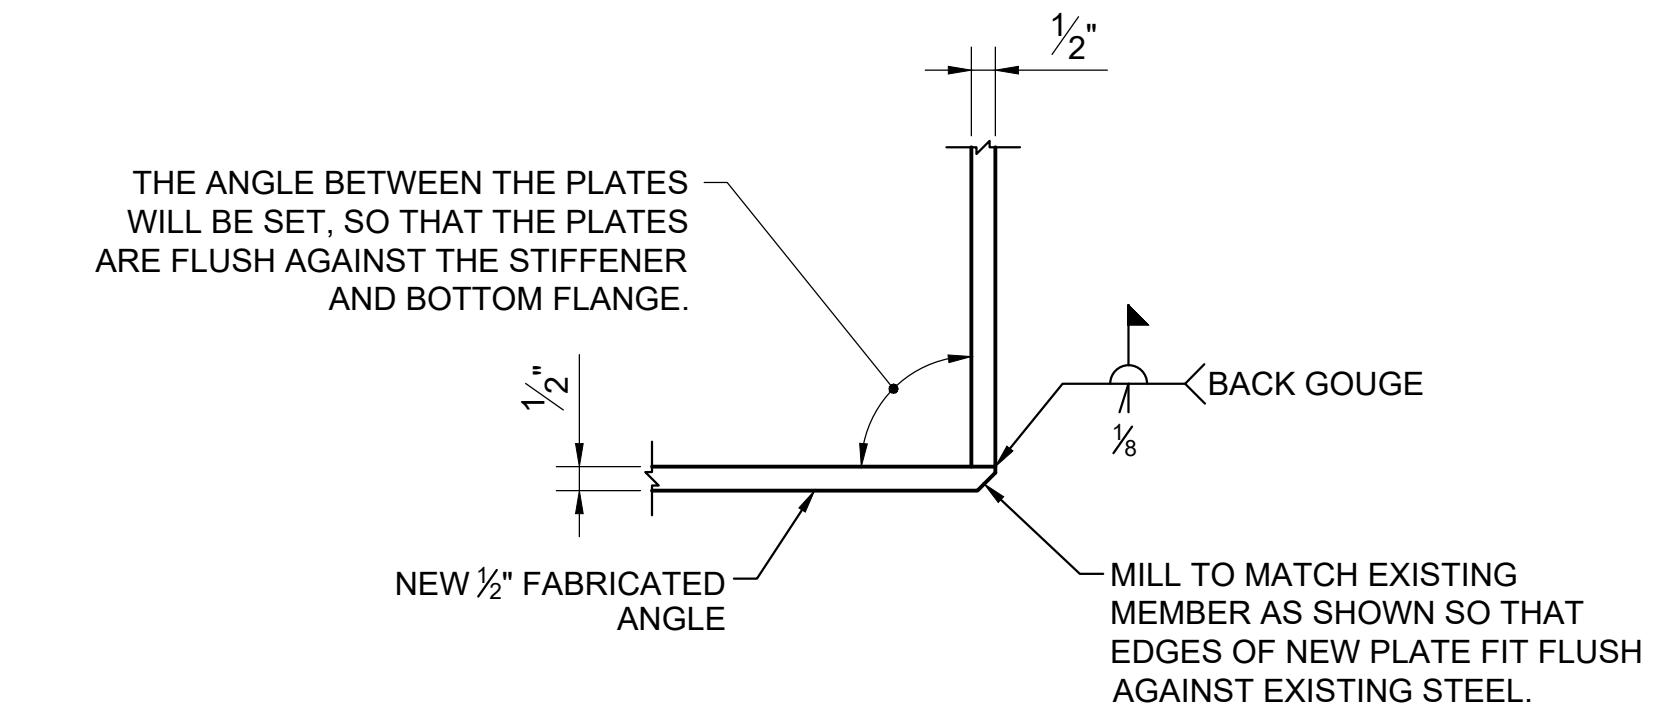
NCB-NB TRUSS LATERAL REPAIR TYPE 1

ELEVATION

DETAIL 'B'

1. PERFORM THIS REPAIR FOR NCB-NB SPAN 9 (TRUSS SPAN) TOP LATERAL STRUT DEPTH-TRANSITION STIFFENERS EXHIBITING CORROSION WITH LESS THAN 1/4" REMAINING OVER 3" OR MORE OF THE STIFFENER WIDTH AS APPROVED BY THE DISTRICT. PERFORM ON EACH SIDE OF THE STRUT AS NEEDED.
2. GRIND ALL CORROSION TO SMOOTH BARE METAL.
3. FILL ALL GAPS WITH STEEL-FILLED EPOXY PUTTY.

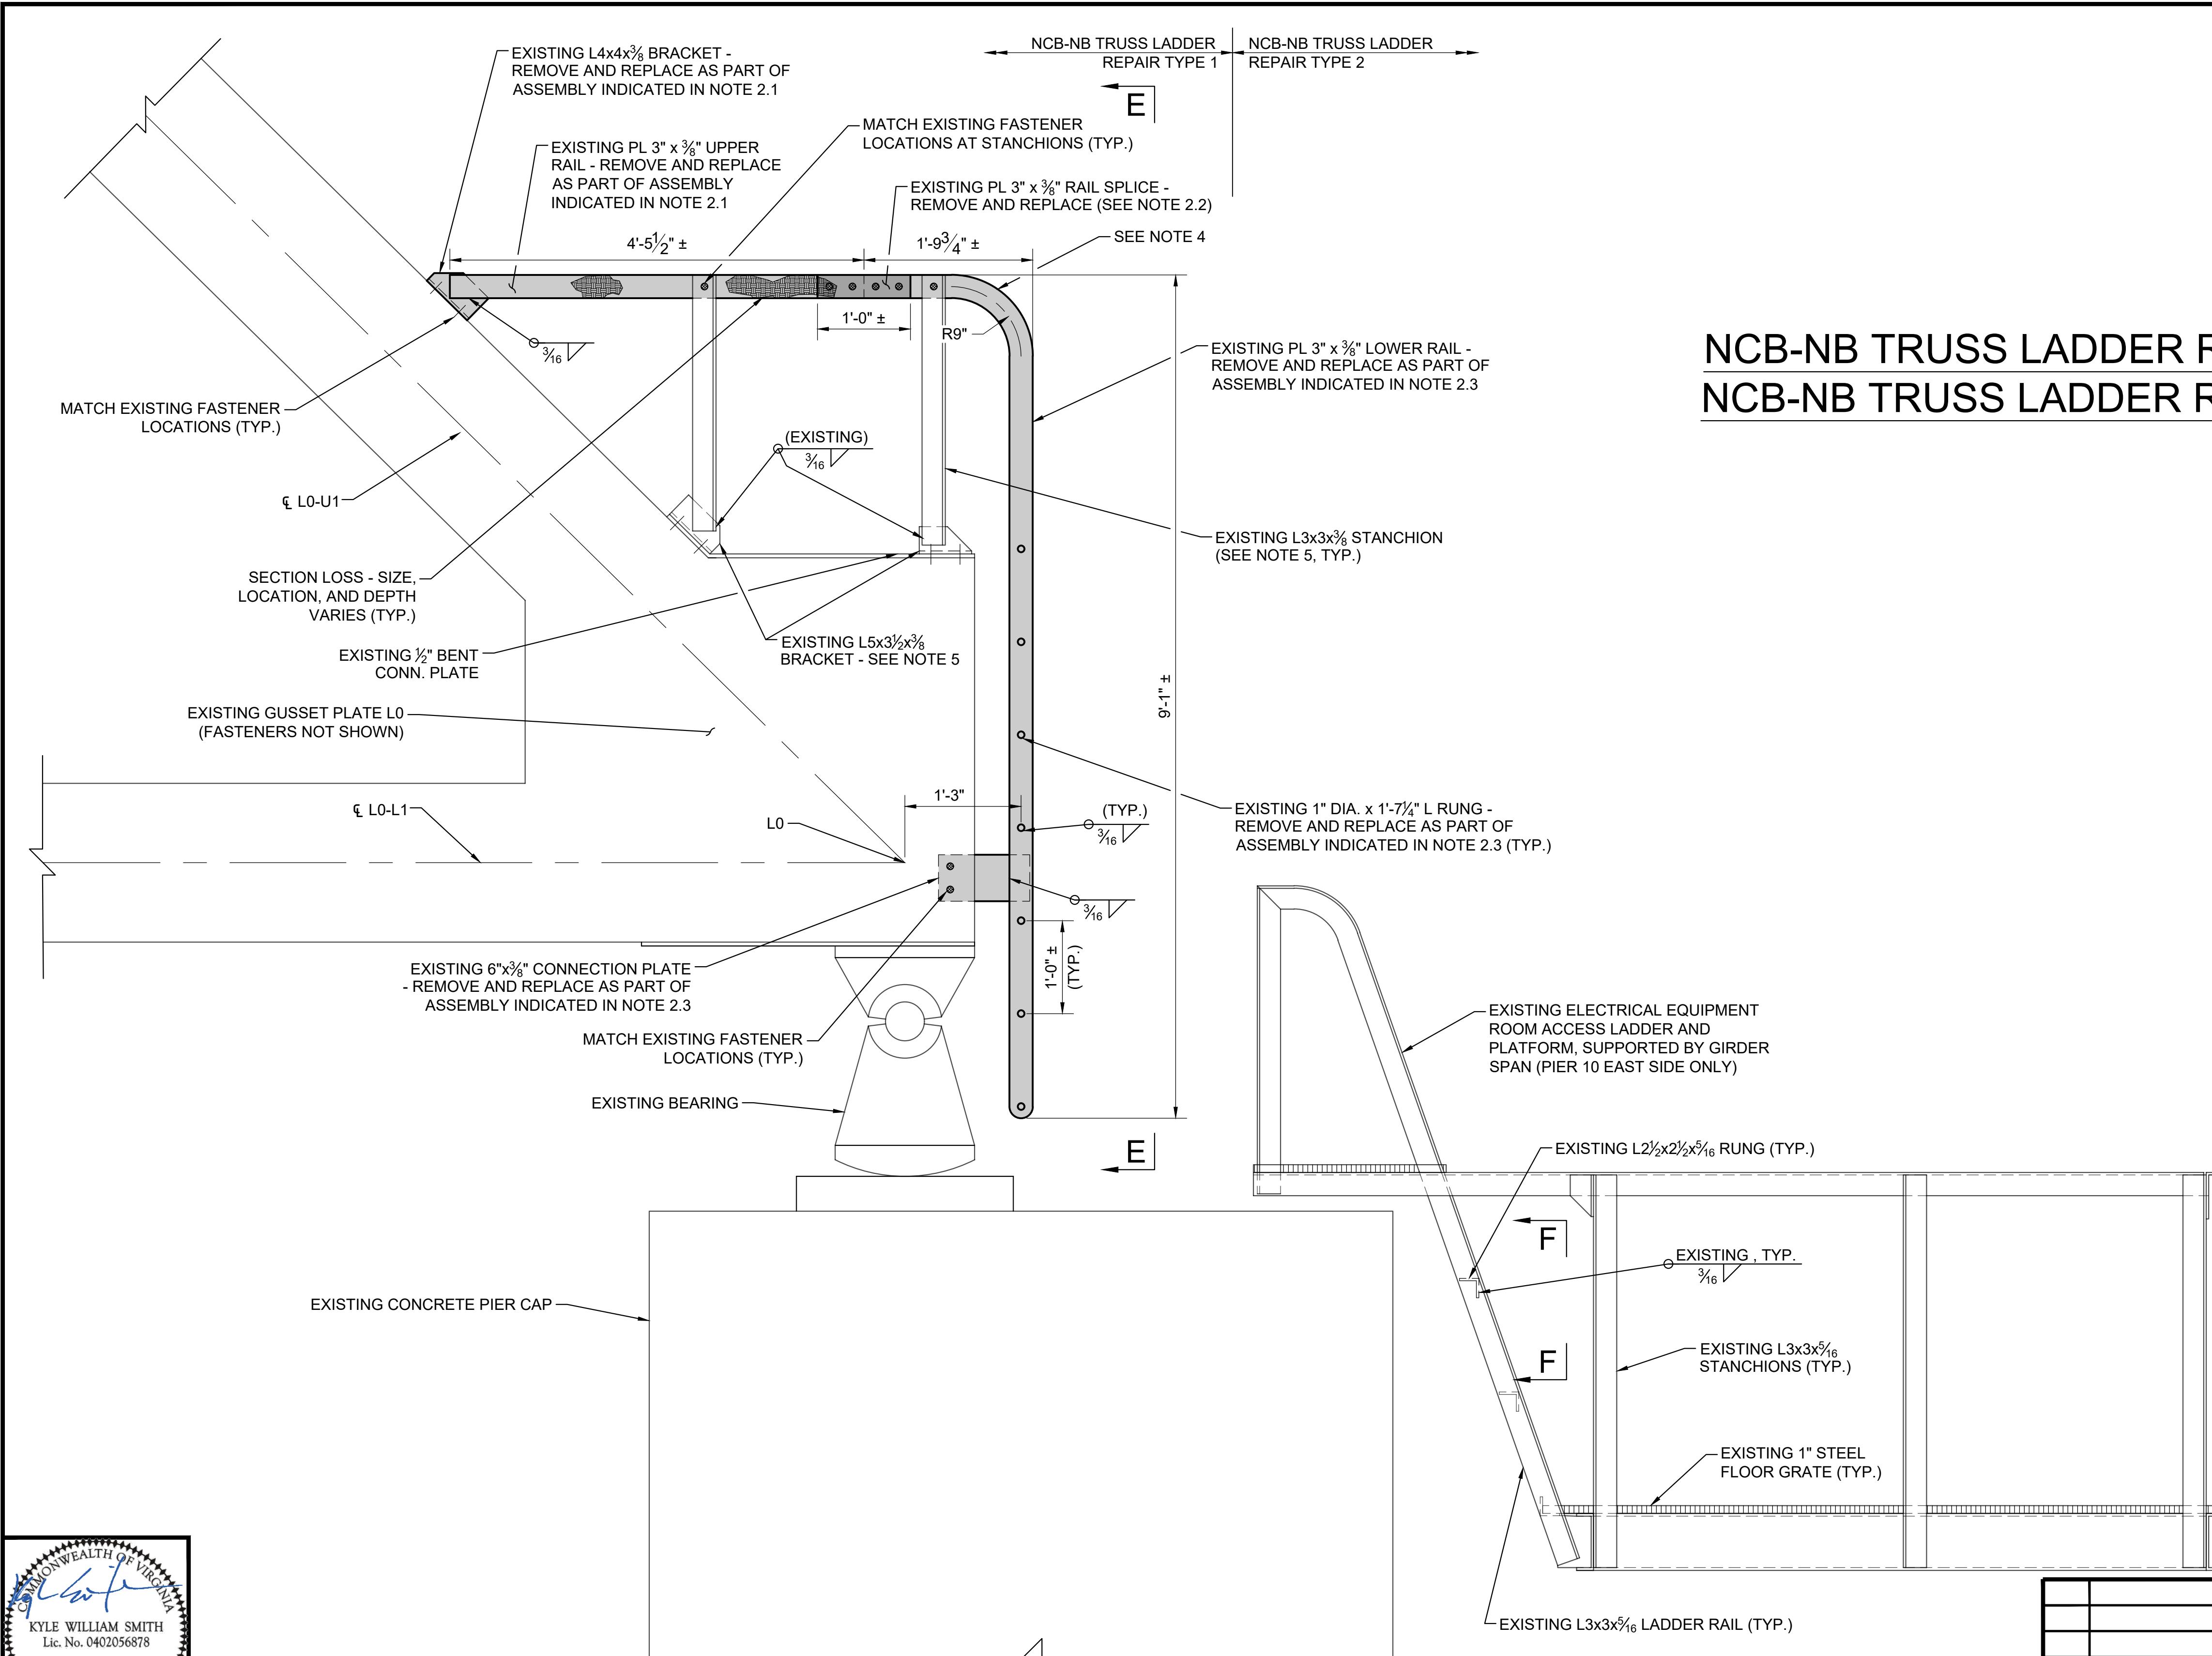
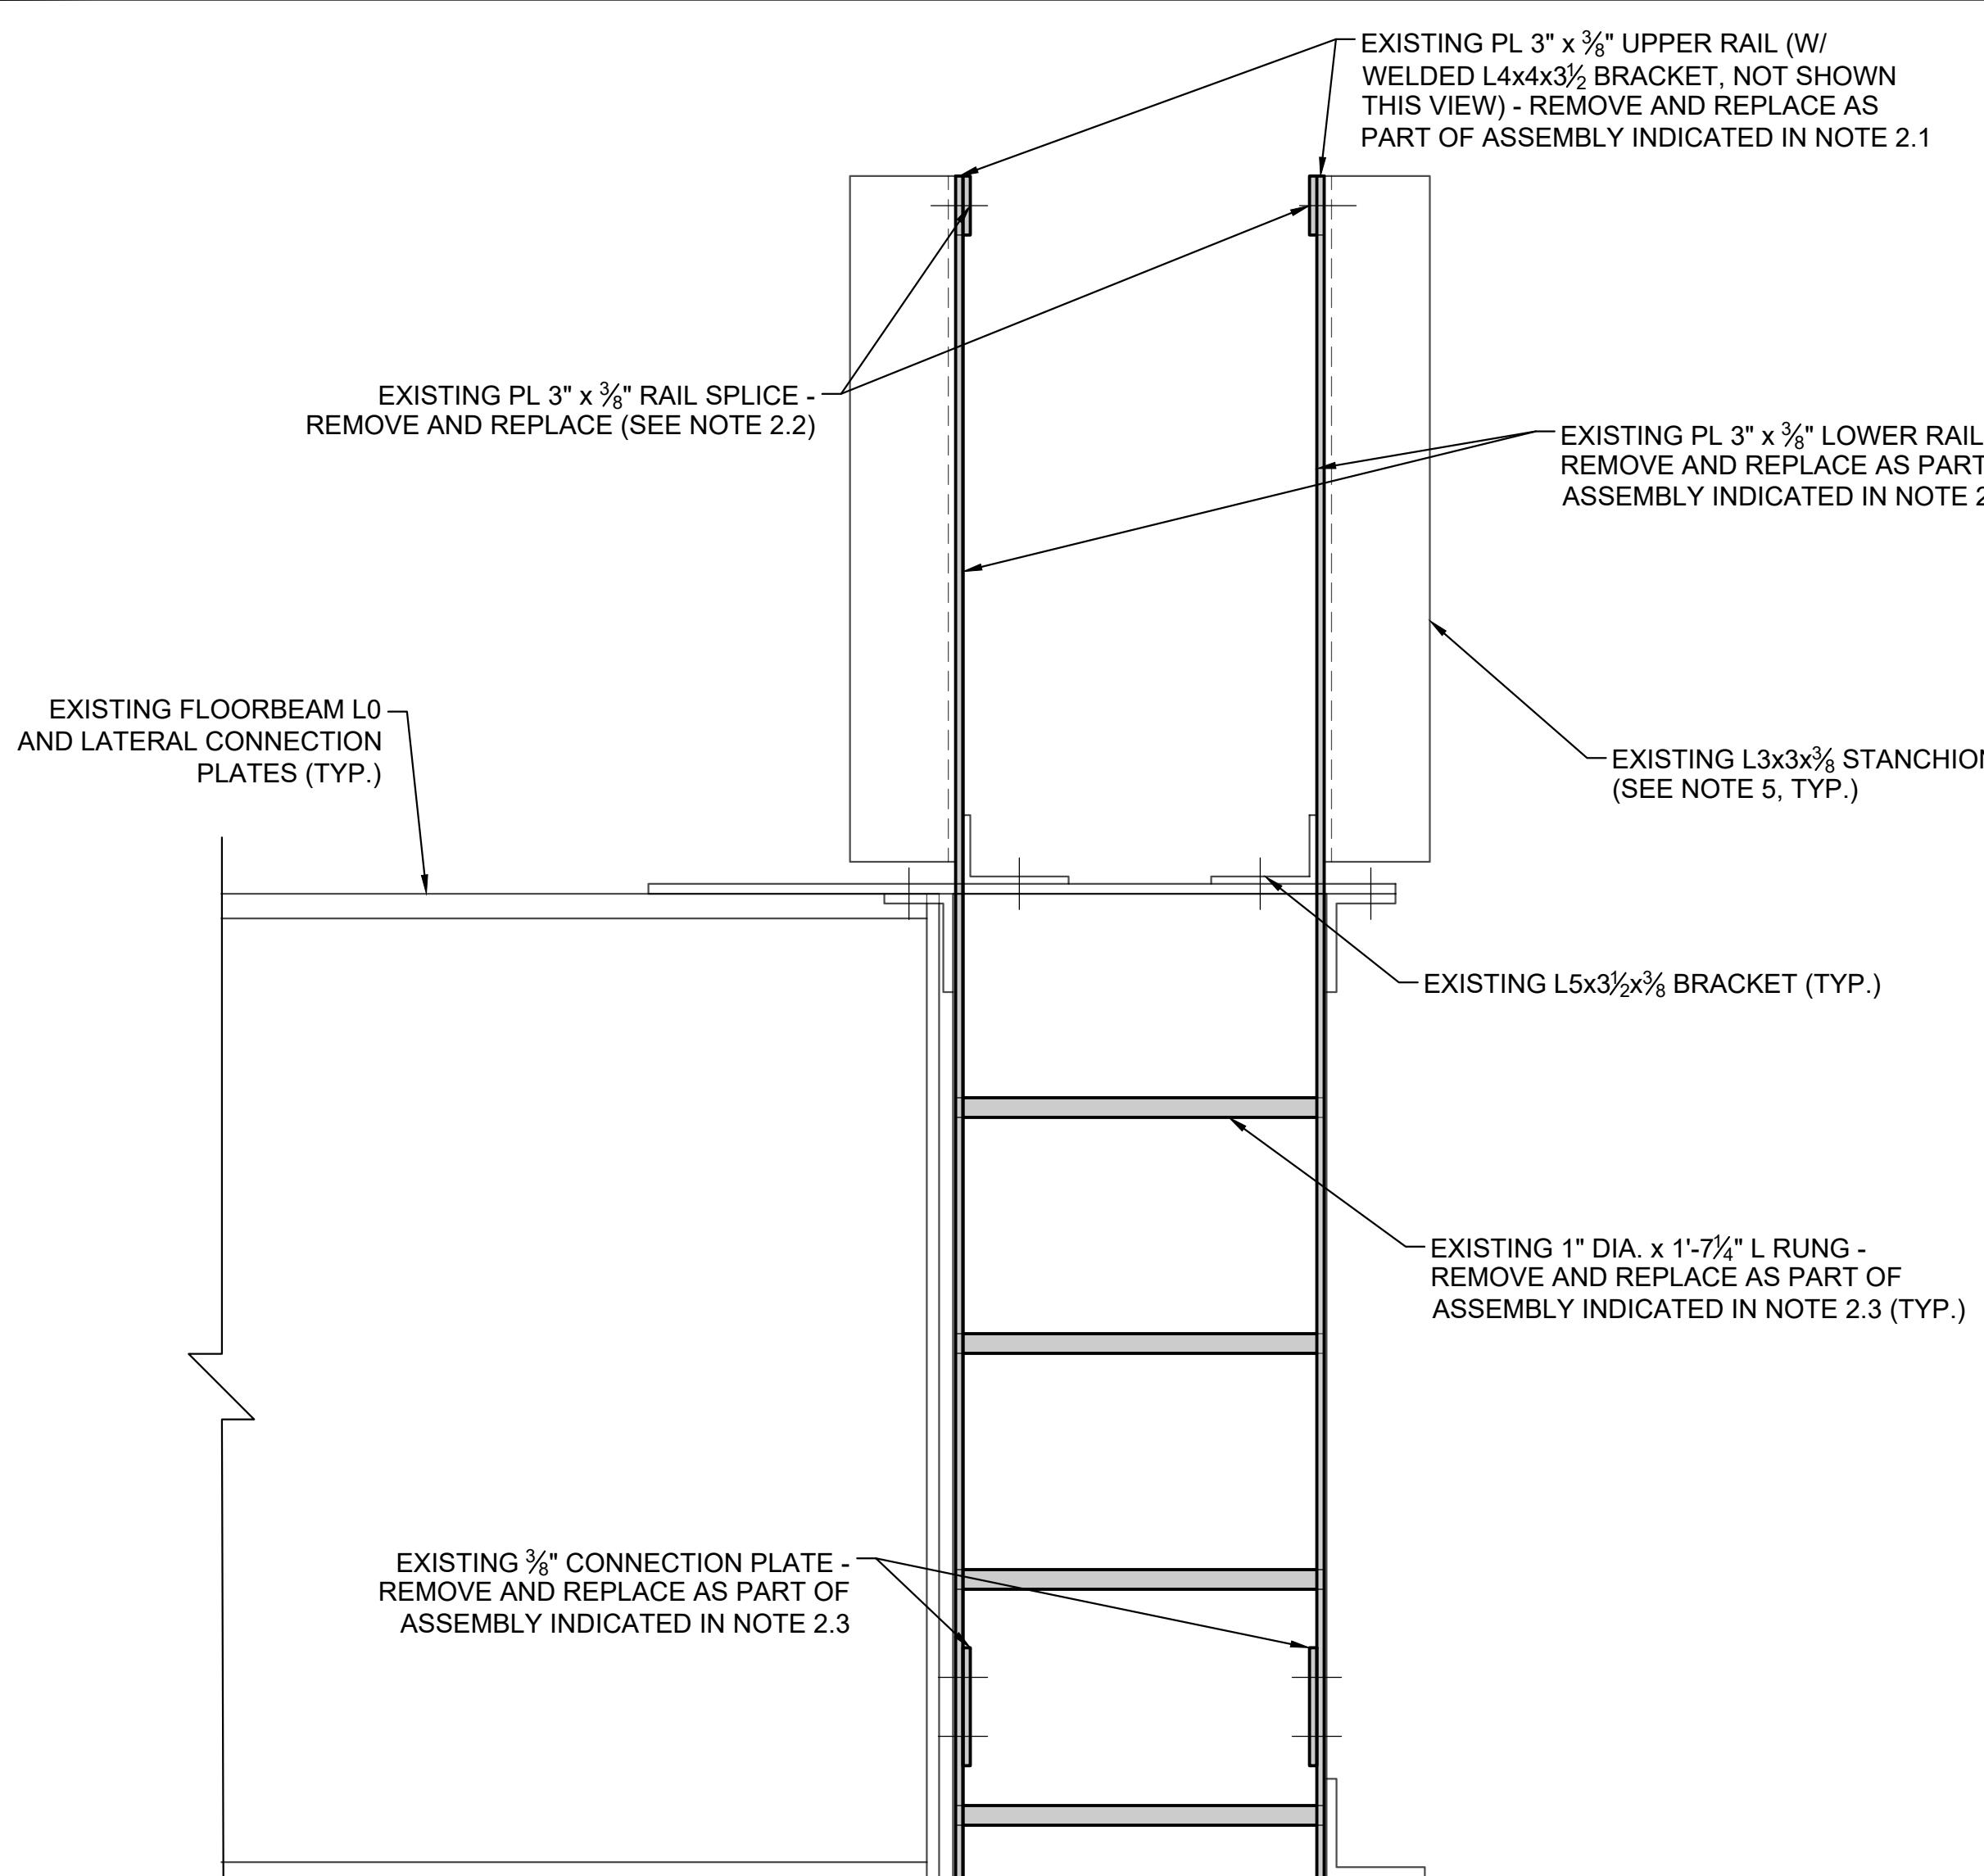
NCB-NB TRUSS LADDER REPAIR TYPE 1

VIEW E-E

1. PERFORM THIS REPAIR FOR NCB-NB SPAN 9 (TRUSS SPAN) PIER CAP ACCESS LADDERS (LOCATED AT PIERS 9 AND 10, BOTH SIDES OF TRUSS) AS APPROVED BY THE DISTRICT.

2. REPLACE EXISTING ACCESS LADDER STRUCTURE. MATCH EXISTING GEOMETRY, WELDING DETAILS, AND ASSEMBLY AS SHOWN, EXCEPT AS NOTED BELOW. THE EXISTING LADDER COMPONENTS TO BE REPLACED ARE SHOWN SHADED AND CONSIST OF THE FOLLOWING PIECES AND/OR WELDED ASSEMBLIES:

3. FIELD-VERIFY ALL DIMENSIONS AND ADJUST AS NECESSARY PRIOR TO FABRICATING REPLACEMENT ELEMENTS.
4. ONE (1) OR MORE OF THE FOUR (4) TOTAL LADDER LOCATIONS MAY HAVE ALTERNATE BEND GEOMETRY DUE TO A PREVIOUS RETROFIT. FABRICATE REPLACEMENT TO MATCH GEOMETRY DEPICTED ABOVE.

5. CONTACT THE DISTRICT FOR DIRECTION IF SECTION LOSS EXCEEDING 3/16" DEEP x FULL WIDTH OF EITHER FLANGE OF AN L3x3x3/16 STANCHION ELEMENT OR 3/16" DEEP x FULL LENGTH OF AN L5x3 1/2x3/8 BRACKET IS OBSERVED.

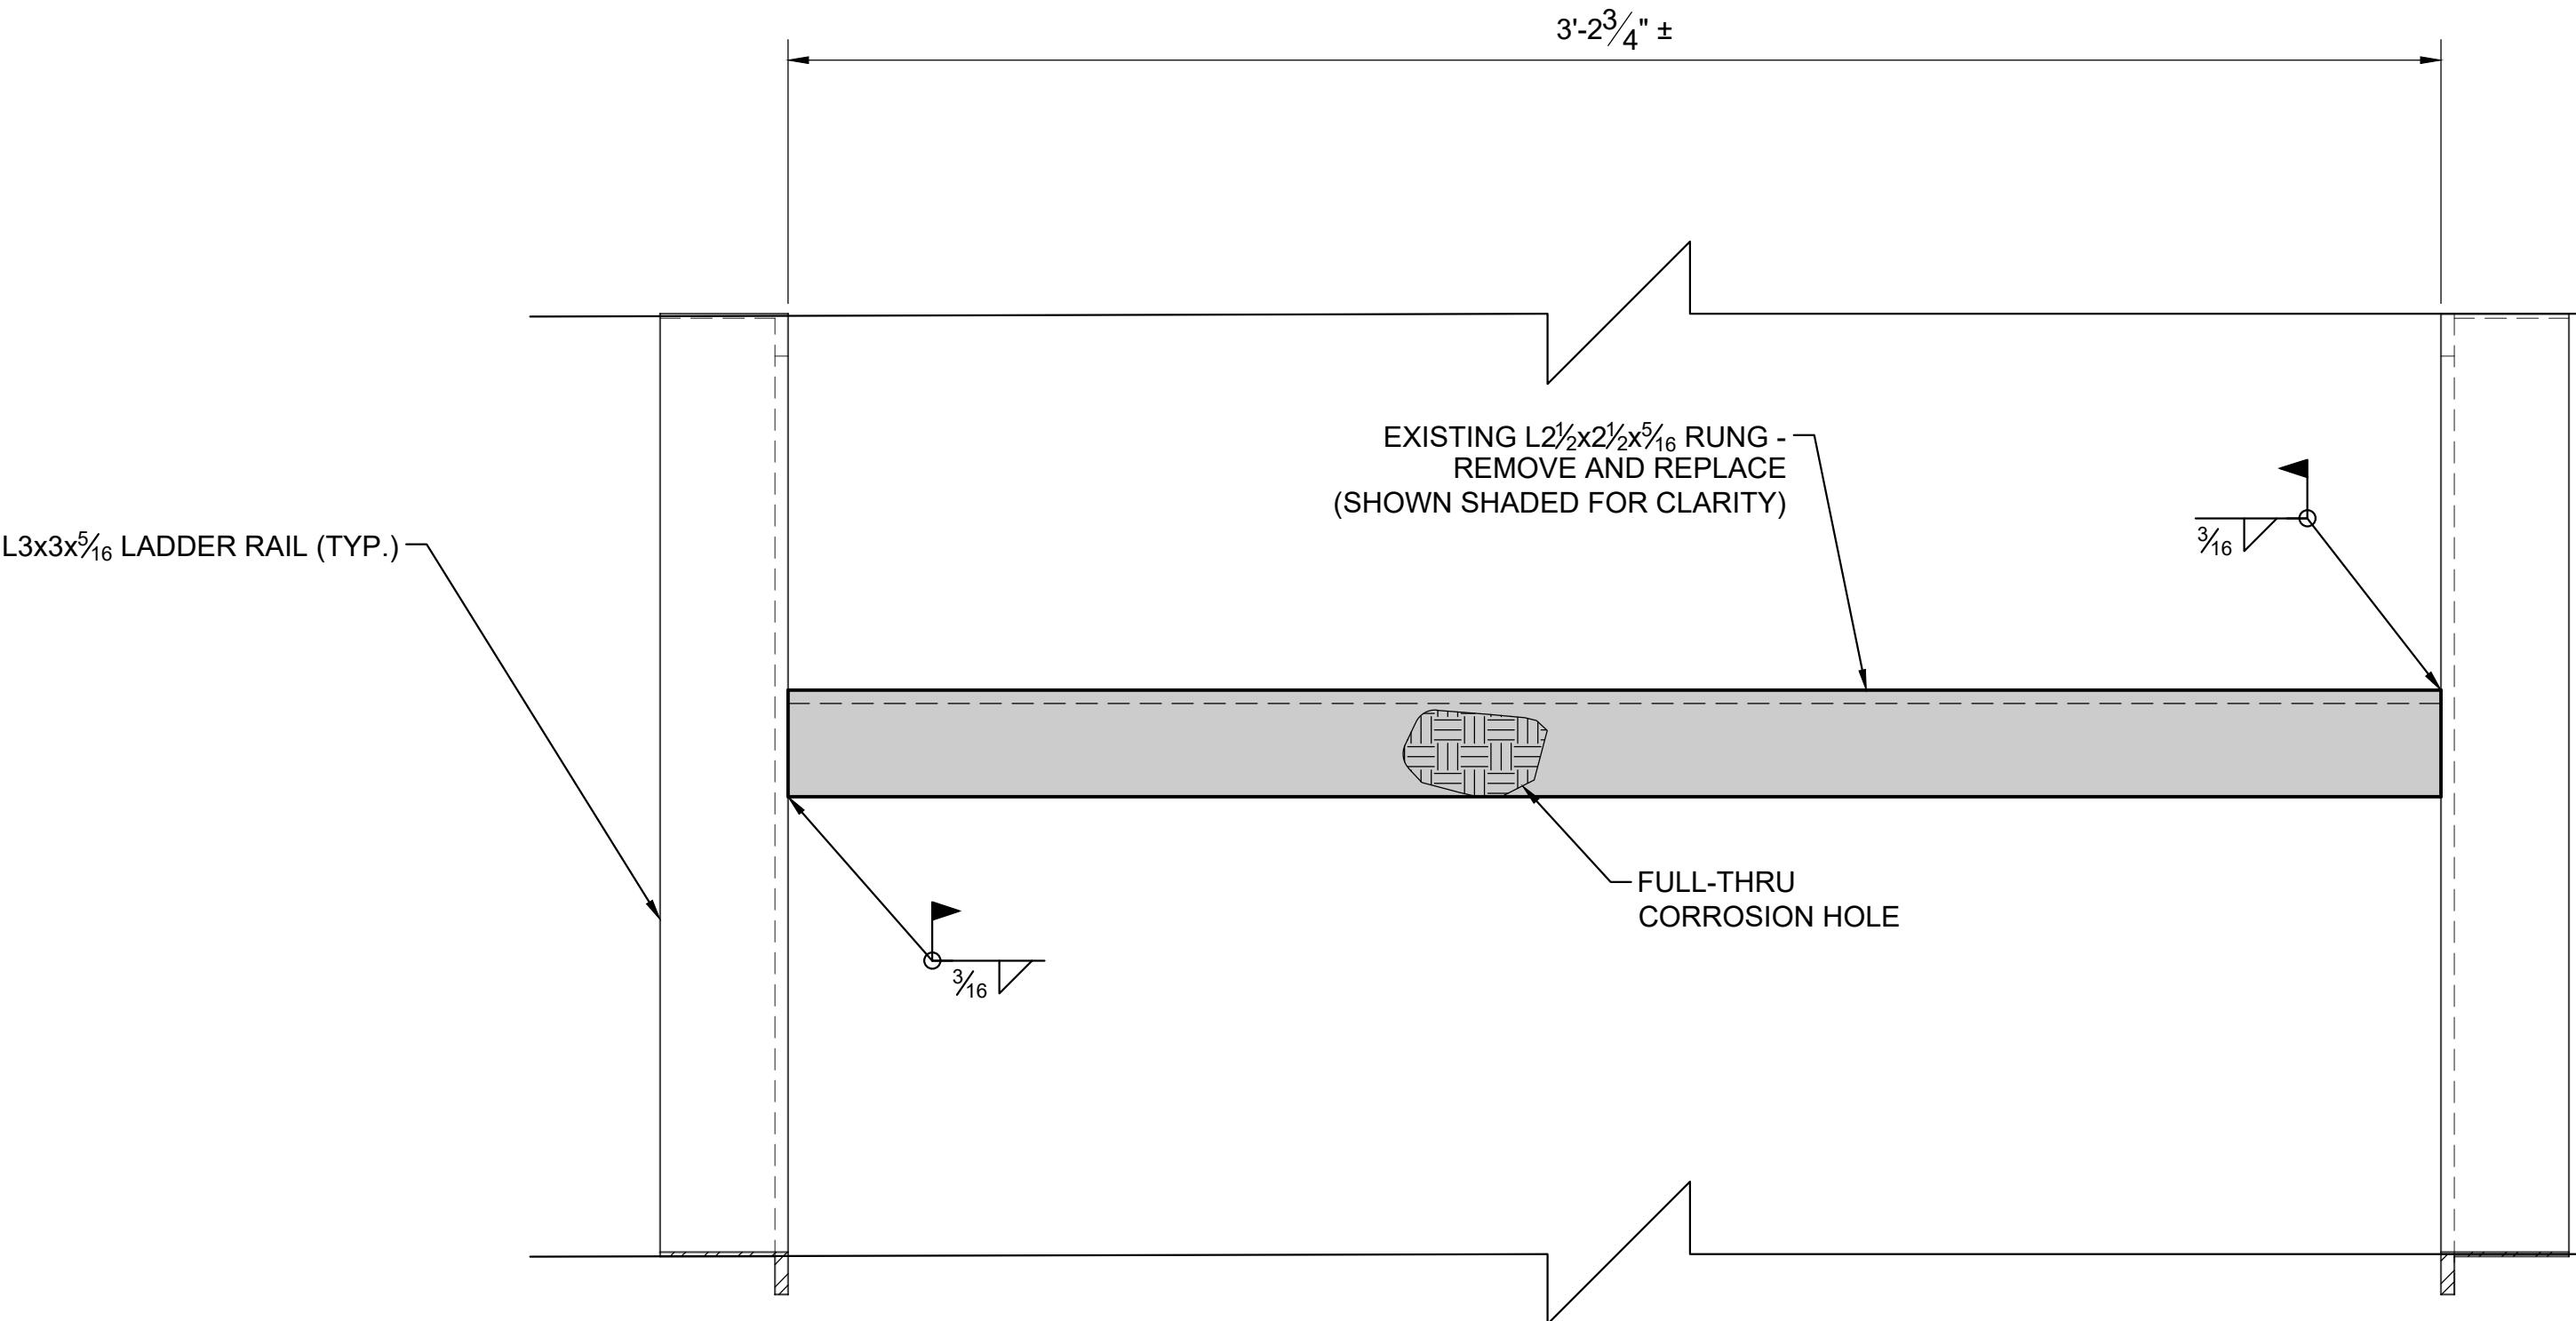
VIEW F-F

1. PERFORM THIS REPAIR FOR NCB-NB ELECTRICAL EQUIPMENT ROOM ACCESS LADDER (LOCATED AT PIER 10, EAST SIDE OF TRUSS ONLY).

NCB-NB TRUSS LADDER REPAIR TYPE 2

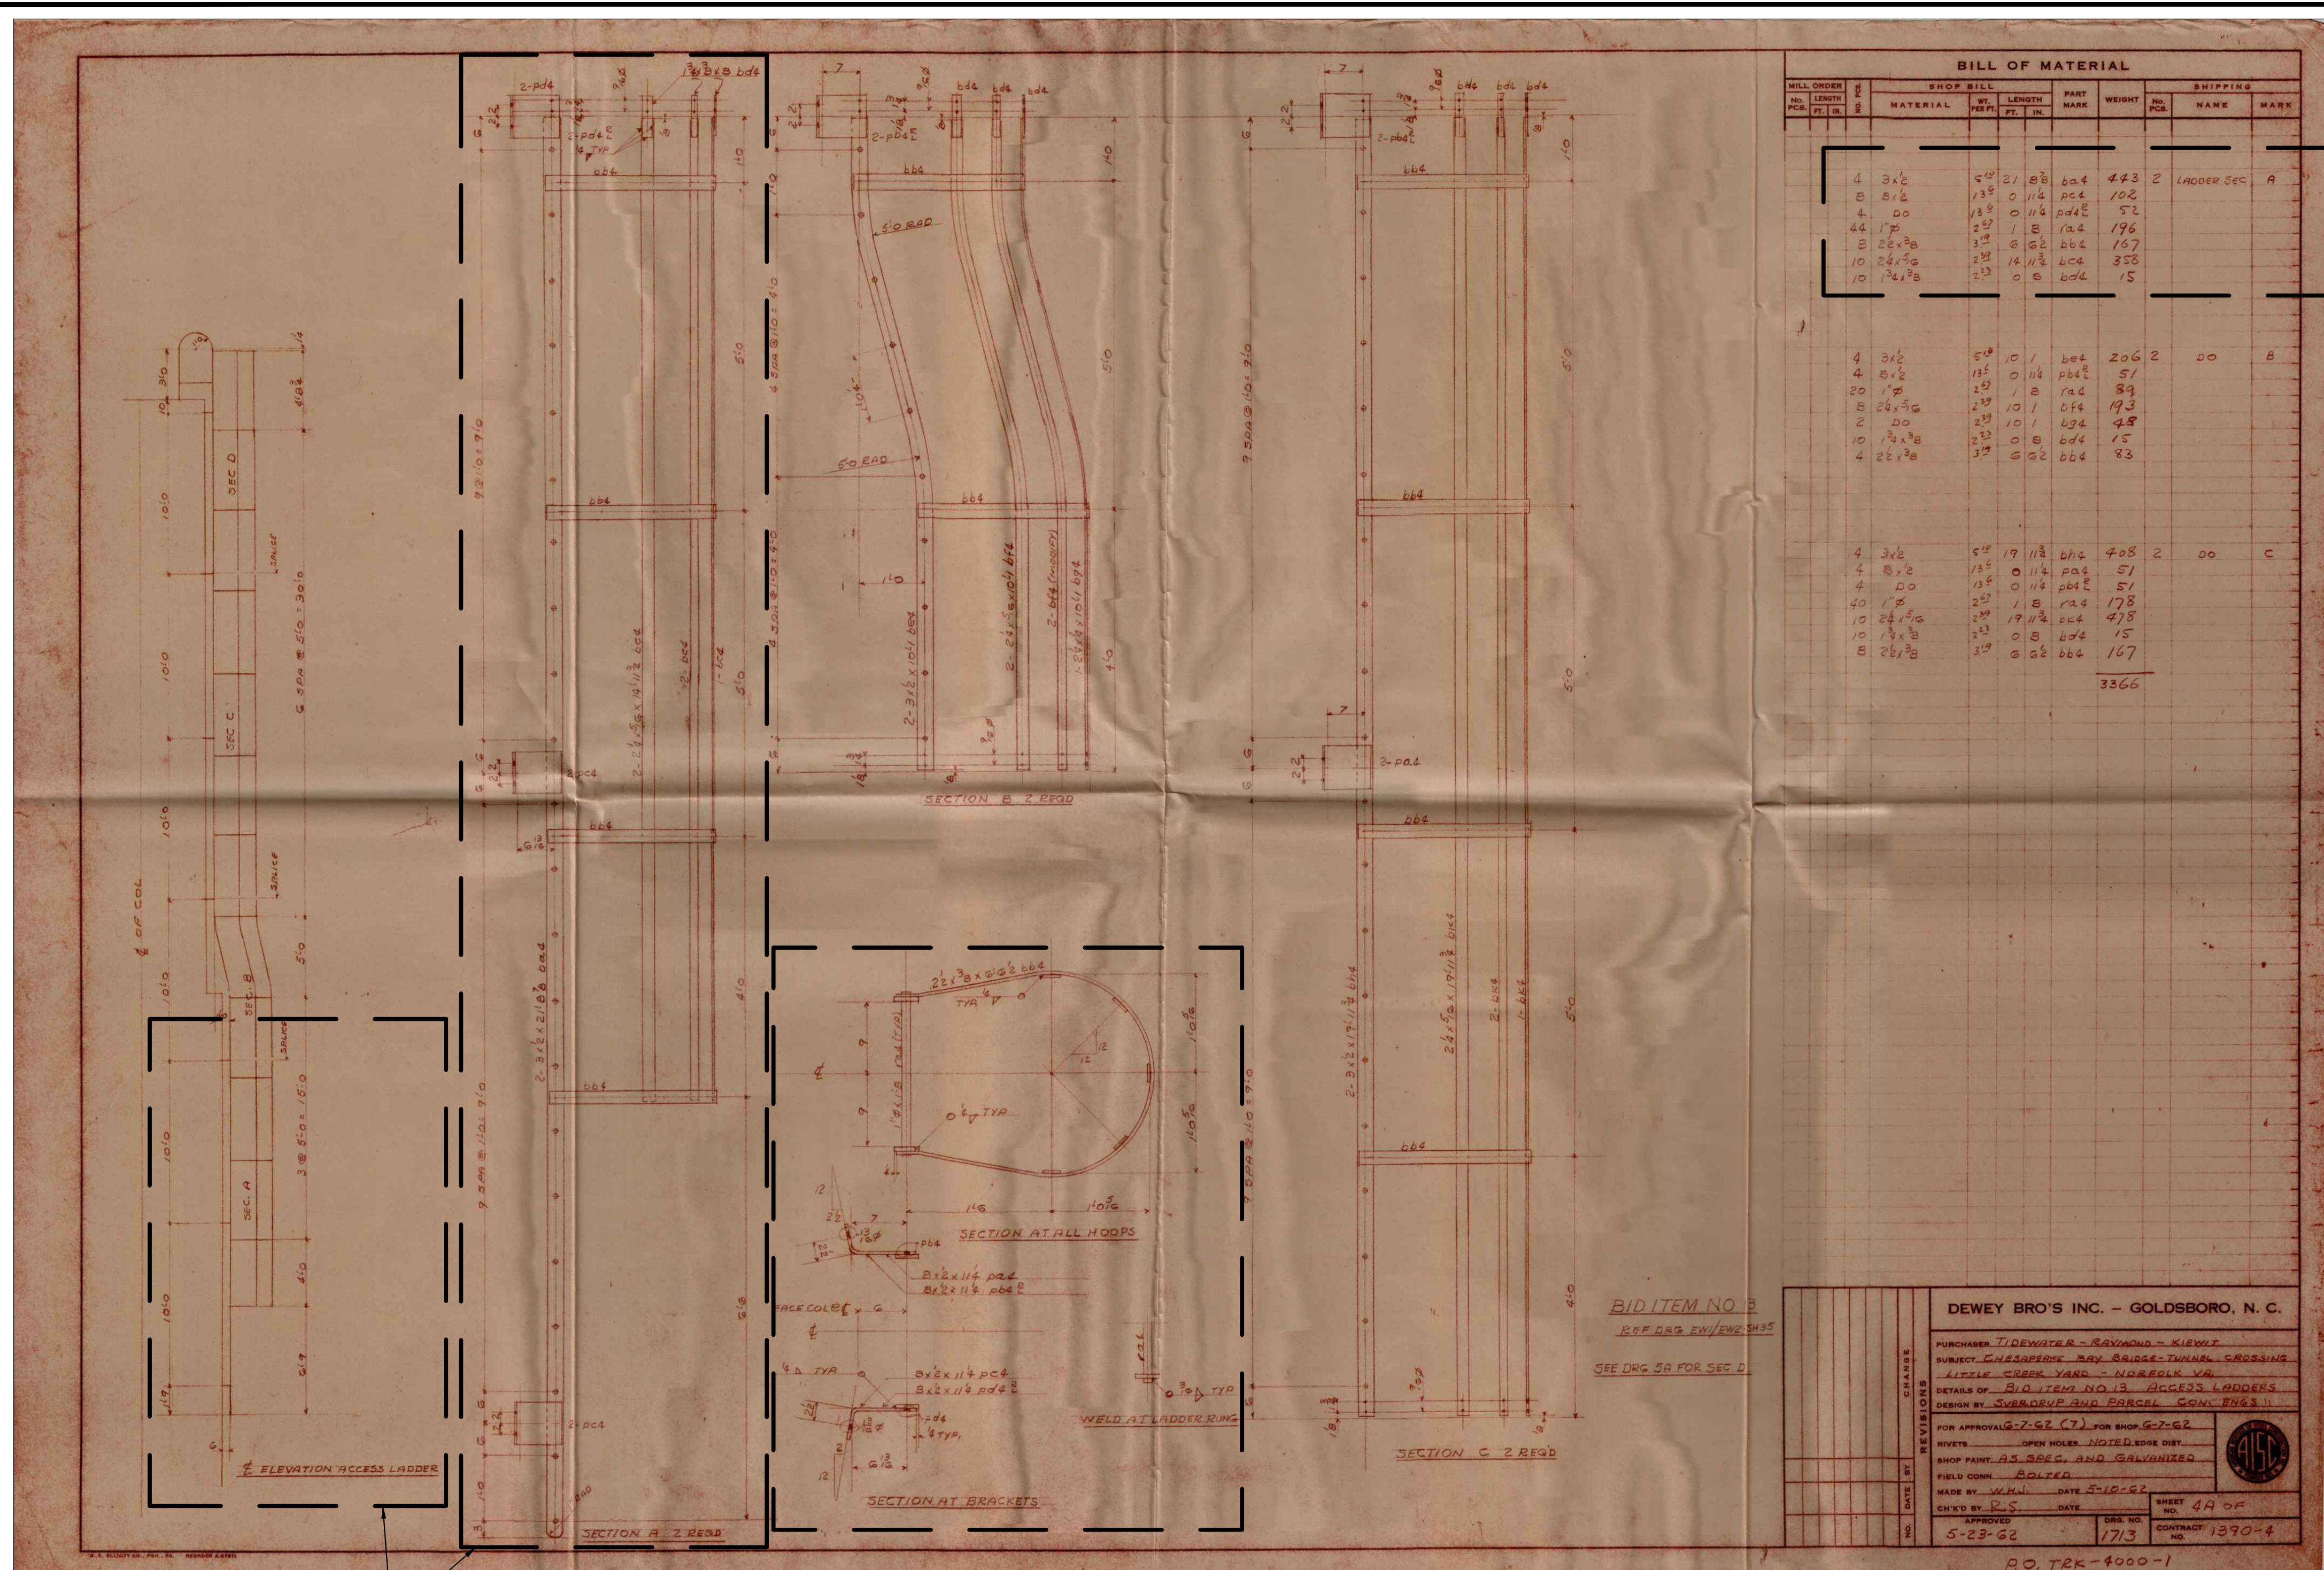
NCB-NB TRUSS LADDER REPAIR TYPE 3

REPLACE SECTION "A".
SEE NOTE 2.

1. PERFORM THIS REPAIR FOR NCB-NB SPAN 9 (TRUSS SPAN) PIER FENDER ACCESS LADDERS (LOCATED AT PIERS 9 AND 10, EAST PIER COLUMN ONLY) AS APPROVED BY THE DISTRICT.
2. AS-BUILT DRAWING DETAILS ARE PROVIDED ON THIS SHEET TO REFLECT THE EXISTING ACCESS LADDER STRUCTURE. REPLACE EXISTING ACCESS LADDER SECTION "A" IN KIND. MATCH EXISTING GEOMETRY, WELDING DETAILS, AND ASSEMBLY AS SHOWN, EXCEPT AS NOTED BELOW. AS-BUILT DRAWING DETAILS ARE NOT TO SCALE.
3. FIELD-VERIFY ALL DIMENSIONS AND ADJUST AS NECESSARY PRIOR TO FABRICATING REPLACEMENT ELEMENTS.
4. HOT-DIP GALVANIZE REPLACEMENT LADDER SECTION COMPONENTS.
5. REPLACEMENT LADDER SECTIONS SHALL BE OSHA-COMPLIANT.
6. SUBMIT WORKING DRAWINGS IN ACCORDANCE WITH VDOT SPECIFICATION 105.10(C) AND SIGNED AND SEALED BY A PROFESSIONAL ENGINEER HOLDING A VALID CURRENT LICENSE TO PRACTICE ENGINEERING IN THE COMMONWEALTH OF VIRGINIA.
