CHESAPEAKE BAY BRIDGE AND TUNNEL DISTRICT
			RMF 5044.5122 - STEEL BRIDGE PAINTING PROJECT
PROJECT NOTES			
No.	Description	Date	Designed: JSE Drawn: BSB Checked: AHC
			12/18/2025
	Revision		1 OF 45

CHESAPEAKE BAY BRIDGE AND TUNNEL DISTRICT	
			RMF 5044.5122 - STEEL BRIDGE PAINTING PROJECT	
NORTH CHANNEL BRIDGE NB GENERAL PLAN AND ELEVATION				
No.	Description	Date	Designed: JSE Drawn: BSB Checked: AHC	Date Plan No. Sheet No.
	Revision			12/18/2025 3 OF 45

CHESAPEAKE BAY BRIDGE AND TUNNEL DISTRICT							
			RMF 5044.5122 - STEEL BRIDGE PAINTING PROJECT							
NORTH CHANNEL BRIDGE NB STRINGER AND FLOORBEAM PLATING REPAIRS										
No. Description Date Designed: JSE Drawn: JSE Checked: AHC 12/18/2025 9 OF 45										
	Revision

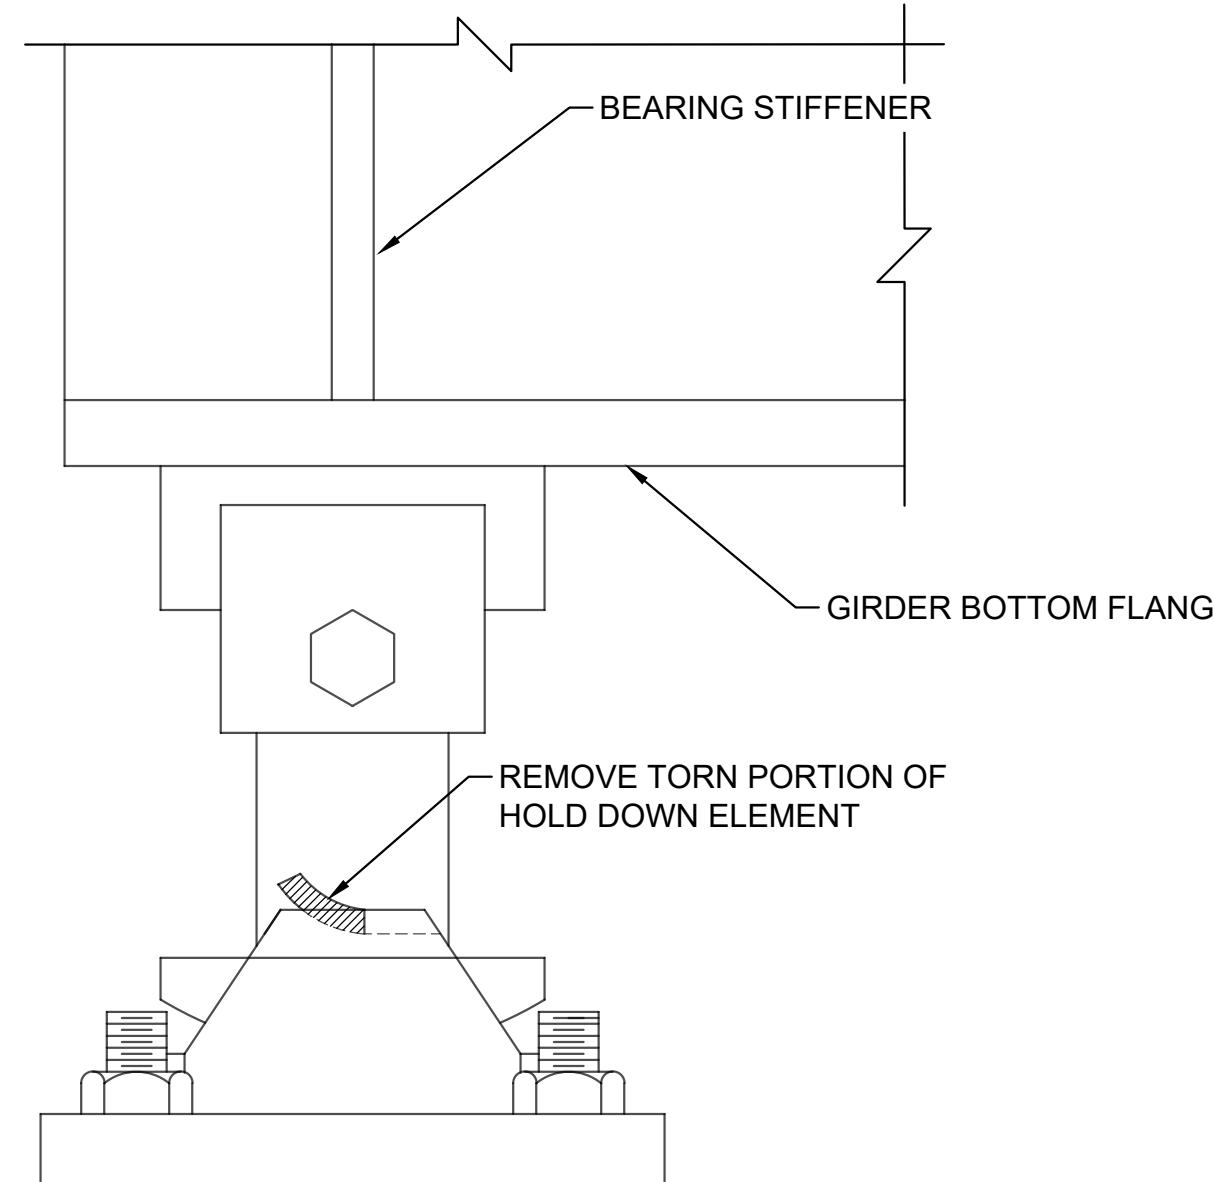
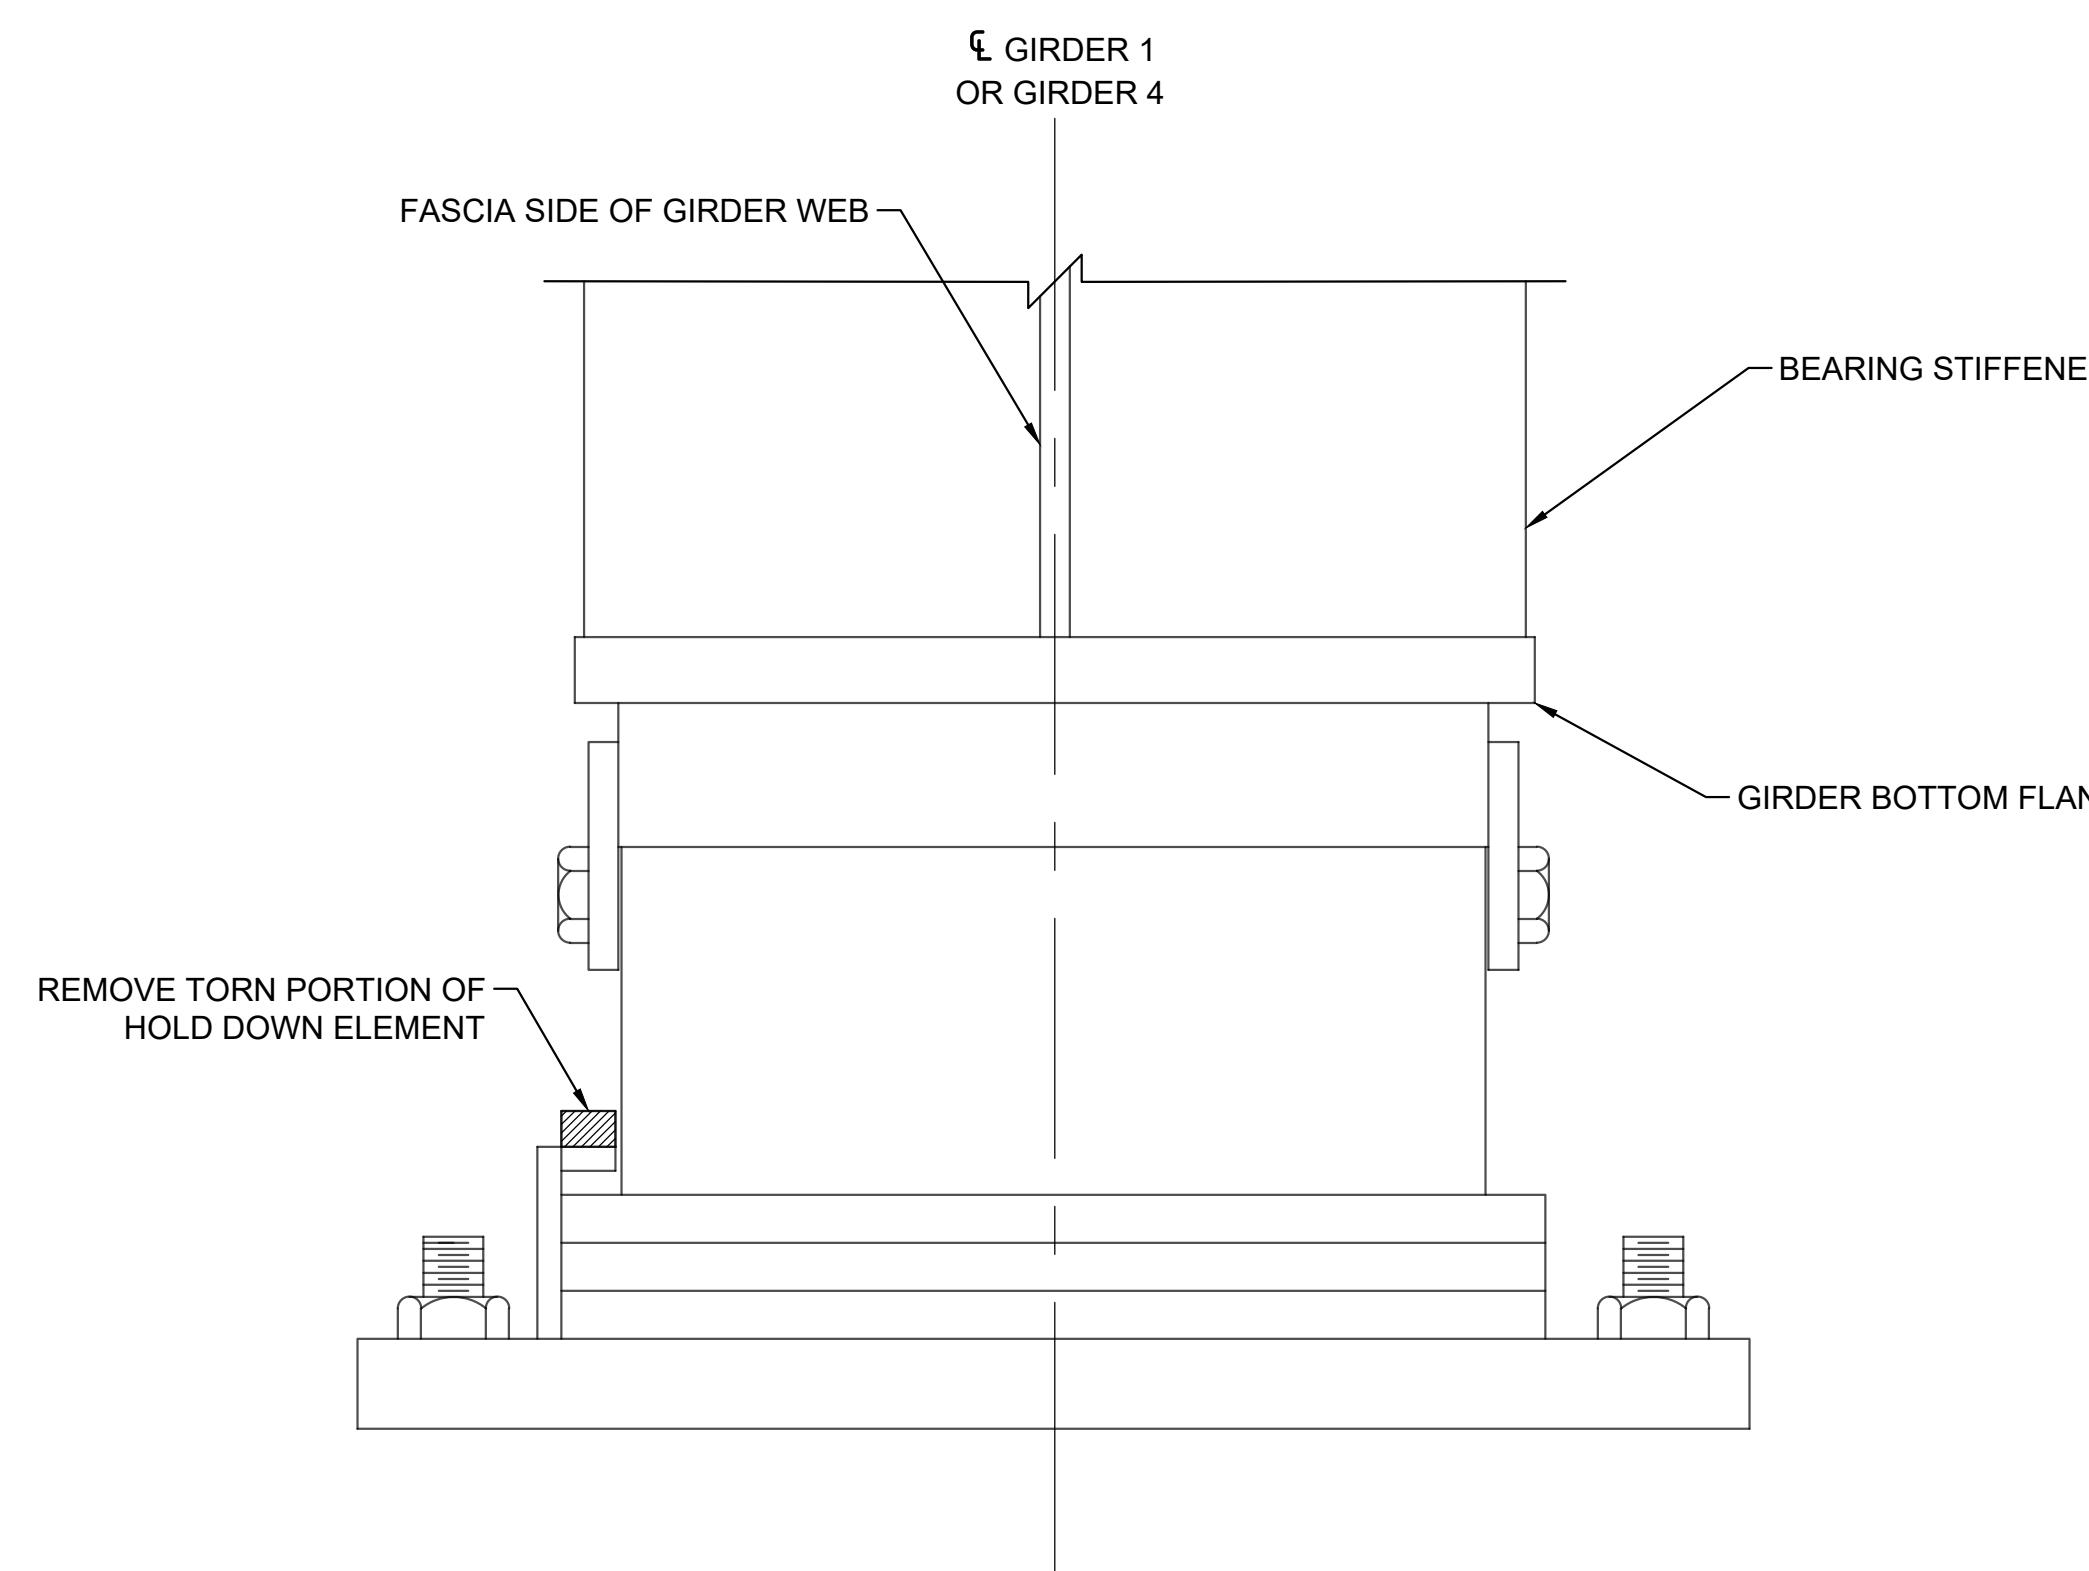
NCB-SB REPAIR TYPE 1

EXPANSION BEARING SIDE VIEW

EXPANSION BEARING ELEVATION

1. PERFORM THIS REPAIR FOR NCB-SB AND FIB-NB EXPANSION BEARINGS WITH A TORN AND BENT HOLD DOWN ELEMENT AS APPROVED BY THE DISTRICT. NOTE THAT HOLD DOWN ELEMENT IS ONLY PRESENT ON FASCIA GIRDER BEARINGS. KNOWN LOCATIONS WITH THIS DEFECT INCLUDE BUT ARE NOT LIMITED TO:
 - 1.1. NCB-SB SPAN 7 GIRDER 1 @ PIER 8
 - 1.2. NCB-SB SPAN 7 GIRDER 4 @ PIER 8
2. CUT OFF OR OTHERWISE REMOVE TORN AND BENT PORTION OF HOLD DOWN ELEMENT TO EXTENT OF TEAR AND SQUARE OFF TO INTACT PORTION OF HOLD DOWN ELEMENT AS SHOWN ON SIDE VIEW ON THIS SHEET.
3. USE CAUTION TO AVOID DAMAGE TO ALL OTHER ELEMENTS OF BEARING AND GIRDER. FLAME CUTTING IS PROHIBITED AS A METHOD FOR REMOVAL FOR THIS DETAIL. IF DAMAGE OCCURS, CONTRACTOR IS RESPONSIBLE FOR REPAIRING IT TO THE SATISFACTION OF THE DISTRICT AT NO COST TO THE DISTRICT.

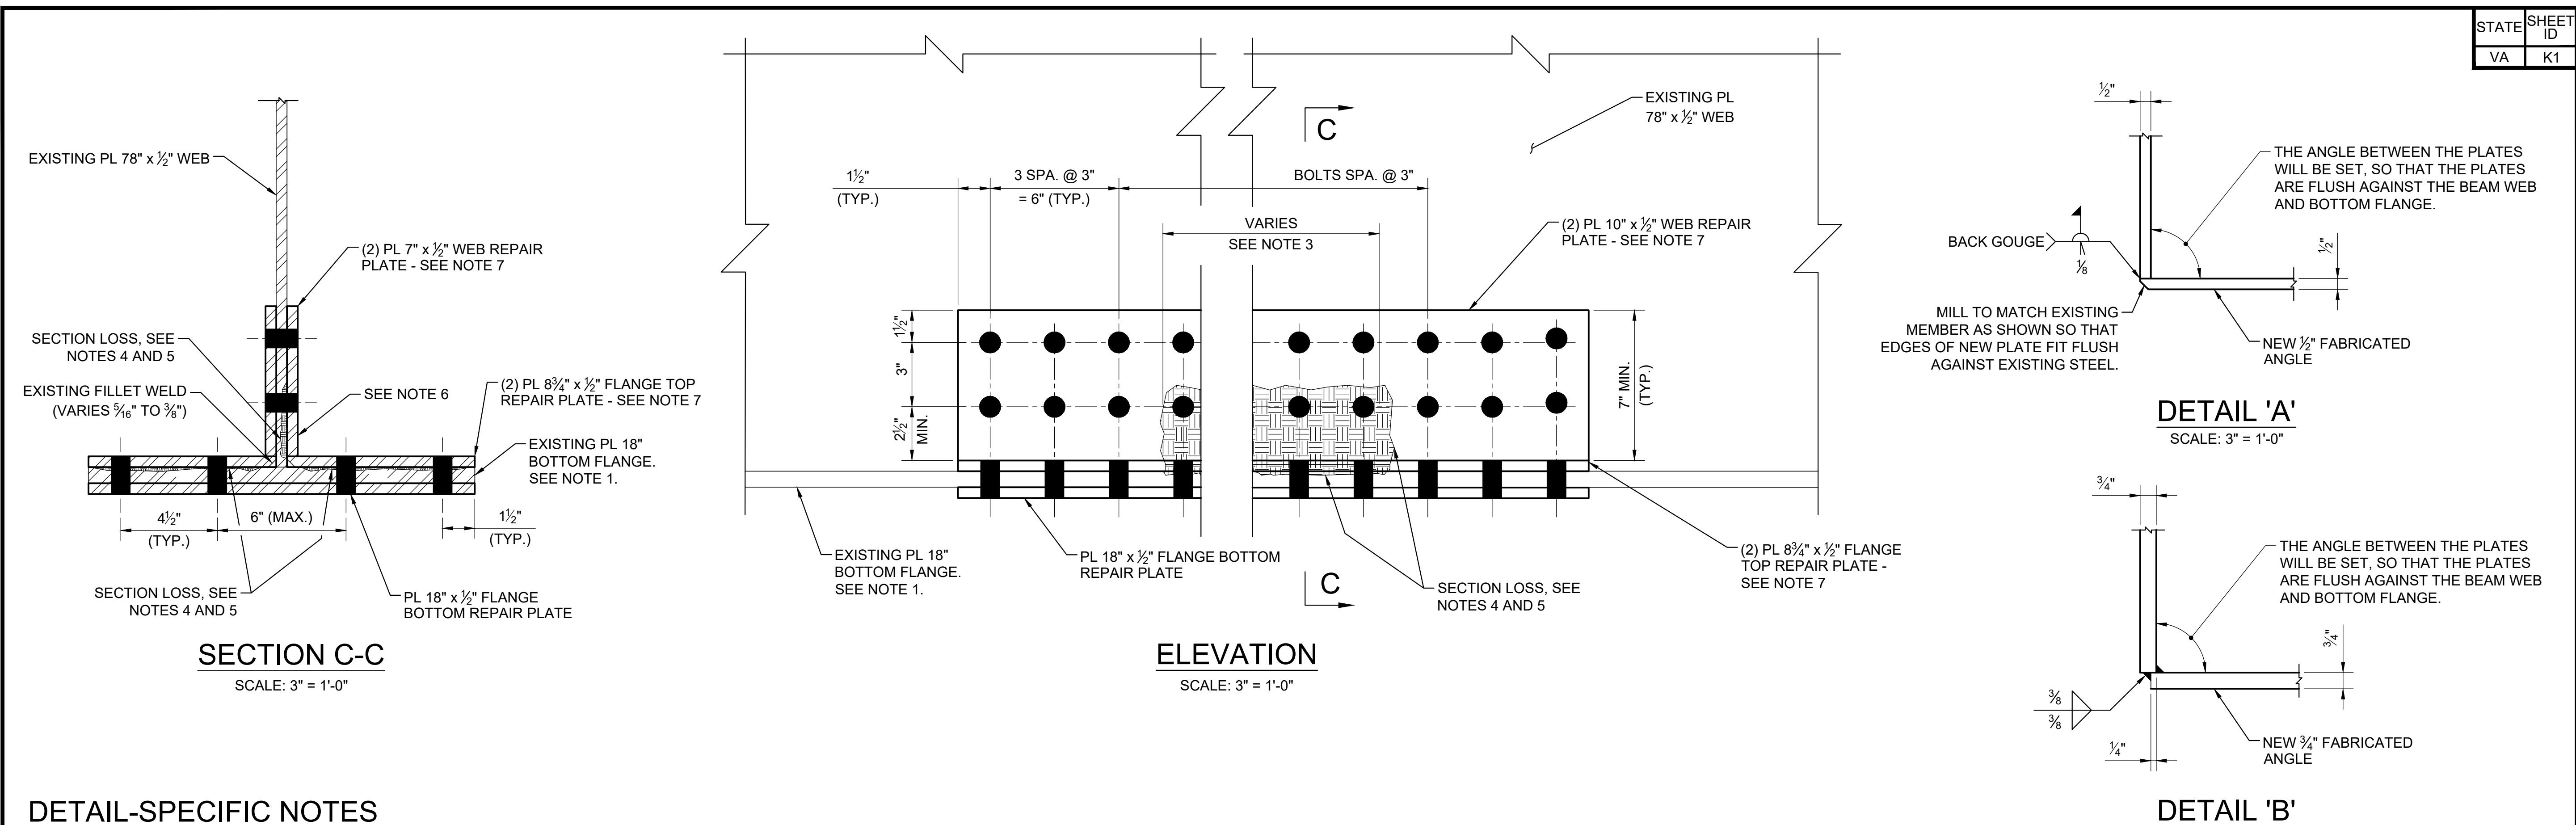
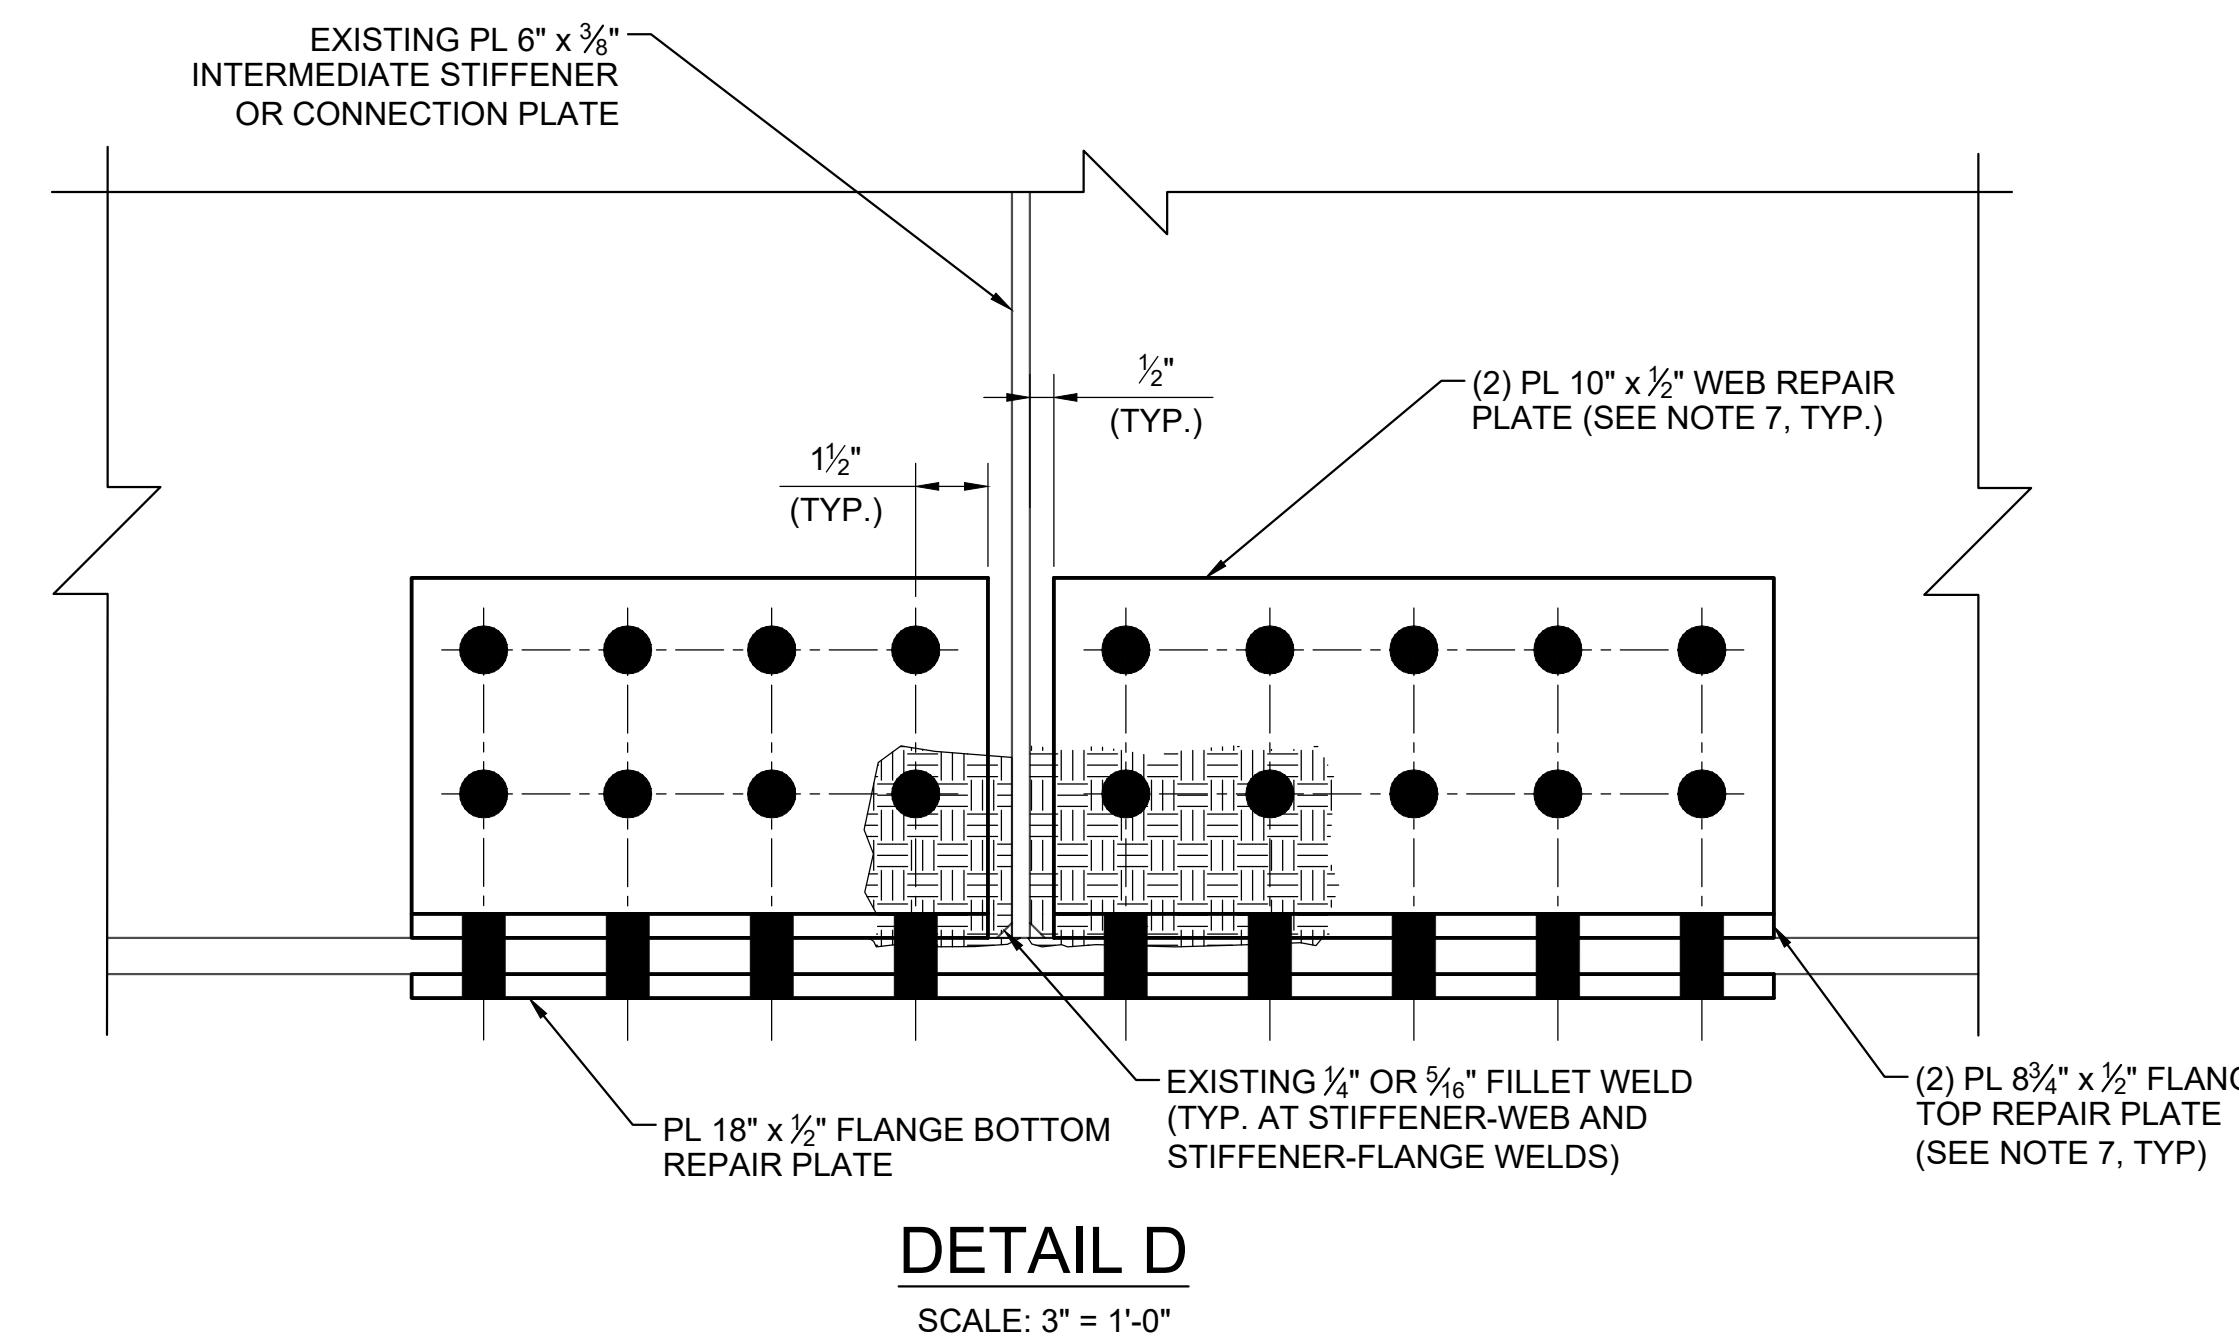
FIB-SB GIRDER REPAIR TYPE 1

1. PERFORM THIS REPAIR IN FIB-SB SPANS FOR GIRDERS WITH BOTTOM FLANGE CORROSION TOTAL SECTION LOSS EXCEEDING 10% OF THE ORIGINAL CROSS-SECTIONAL AREA OF THE FLANGE (18" W x THICKNESS VARYING FROM $\frac{3}{4}$ " TO $2\frac{1}{2}$ ") AS APPROVED BY THE DISTRICT. PLACE BOTTOM FLANGE FILL PLATE (18" W x THICKNESS AS REQUIRED) IF REPAIR SPANS AN EXISTING BOTTOM FLANGE THICKNESS TRANSITION.

- 2.2. WEB SECTION LOSS EXCEEDS $\frac{1}{4}$ " DEEP AND EXTENDS FURTHER THAN 4" HIGH FROM THE BOTTOM FLANGE
3. TOTAL LENGTH OF REPAIR FOR THIS DETAIL IS EXPECTED TO AVERAGE APPROXIMATELY 5'.

4. GRIND ALL CORROSION TO SMOOTH BARE METAL.
5. FILL ALL GAPS WITH STEEL-FILLED EPOXY PUTTY.
6. DETAILS ARE SHOWN AND ANNOTATED ASSUMING REPAIR PLATES ARE ASSEMBLED ACCORDING TO DETAIL 'A'. THE CONTRACTOR MAY SUBSTITUTE ASSEMBLY IN ACCORDANCE WITH DETAIL 'B' AT NO ADDITIONAL COST TO THE DISTRICT.

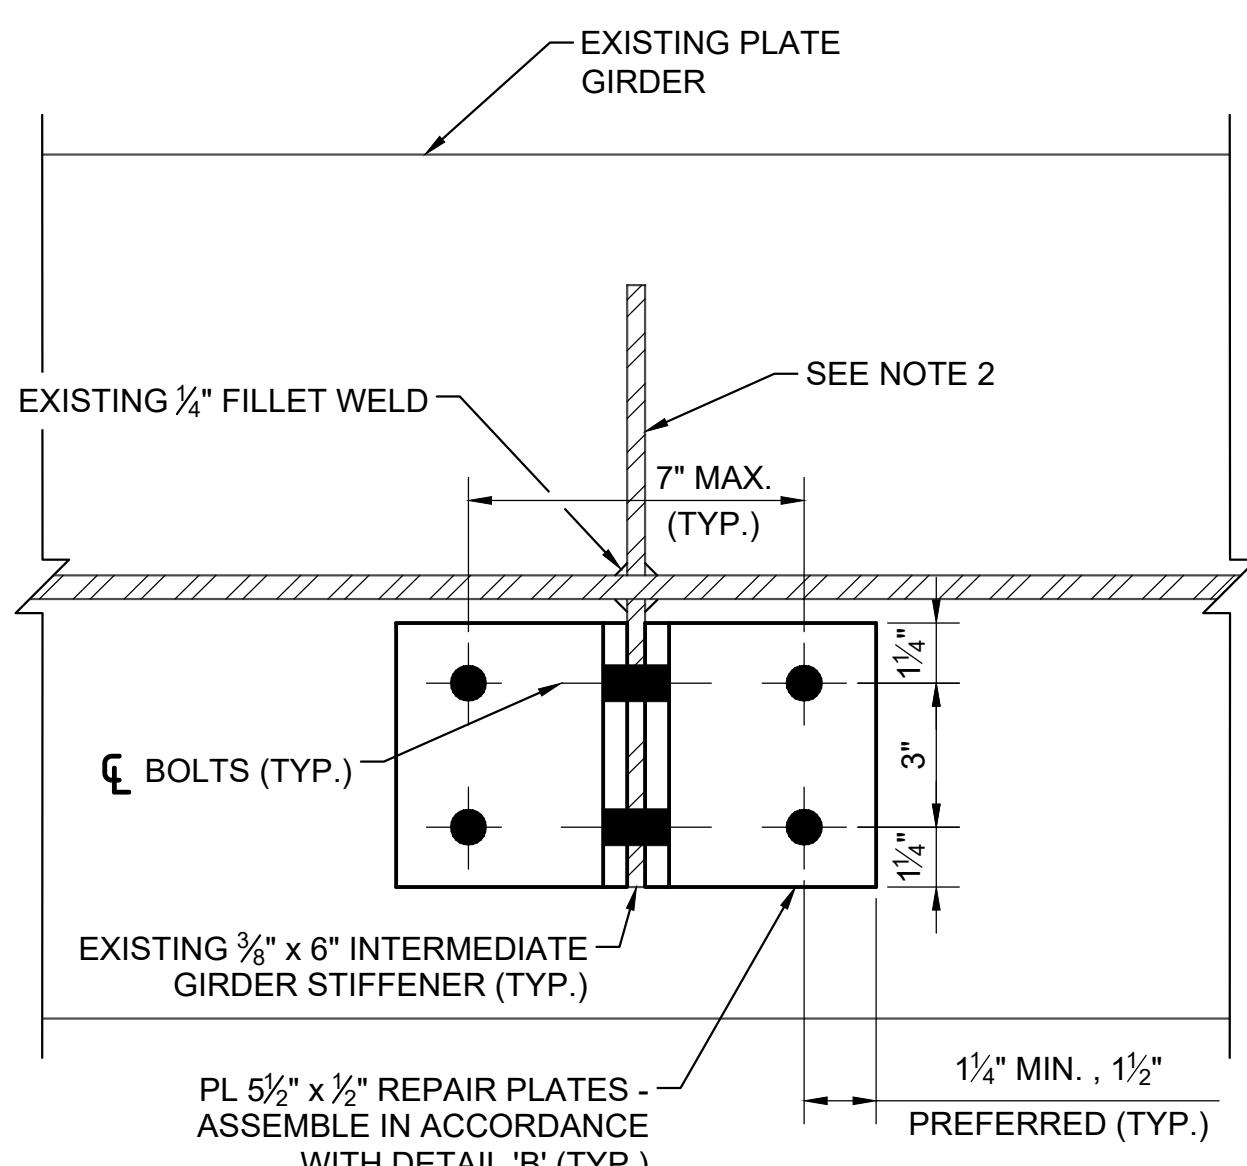
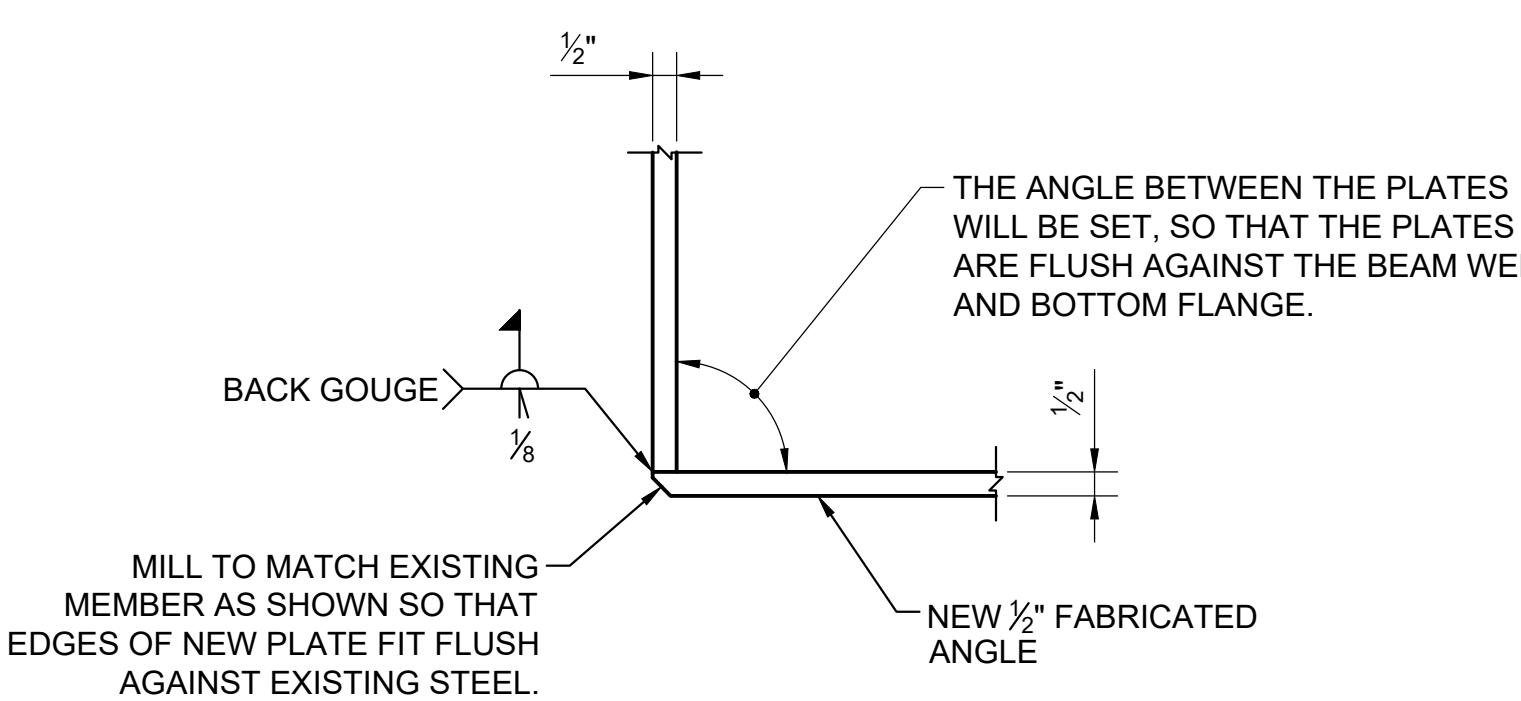
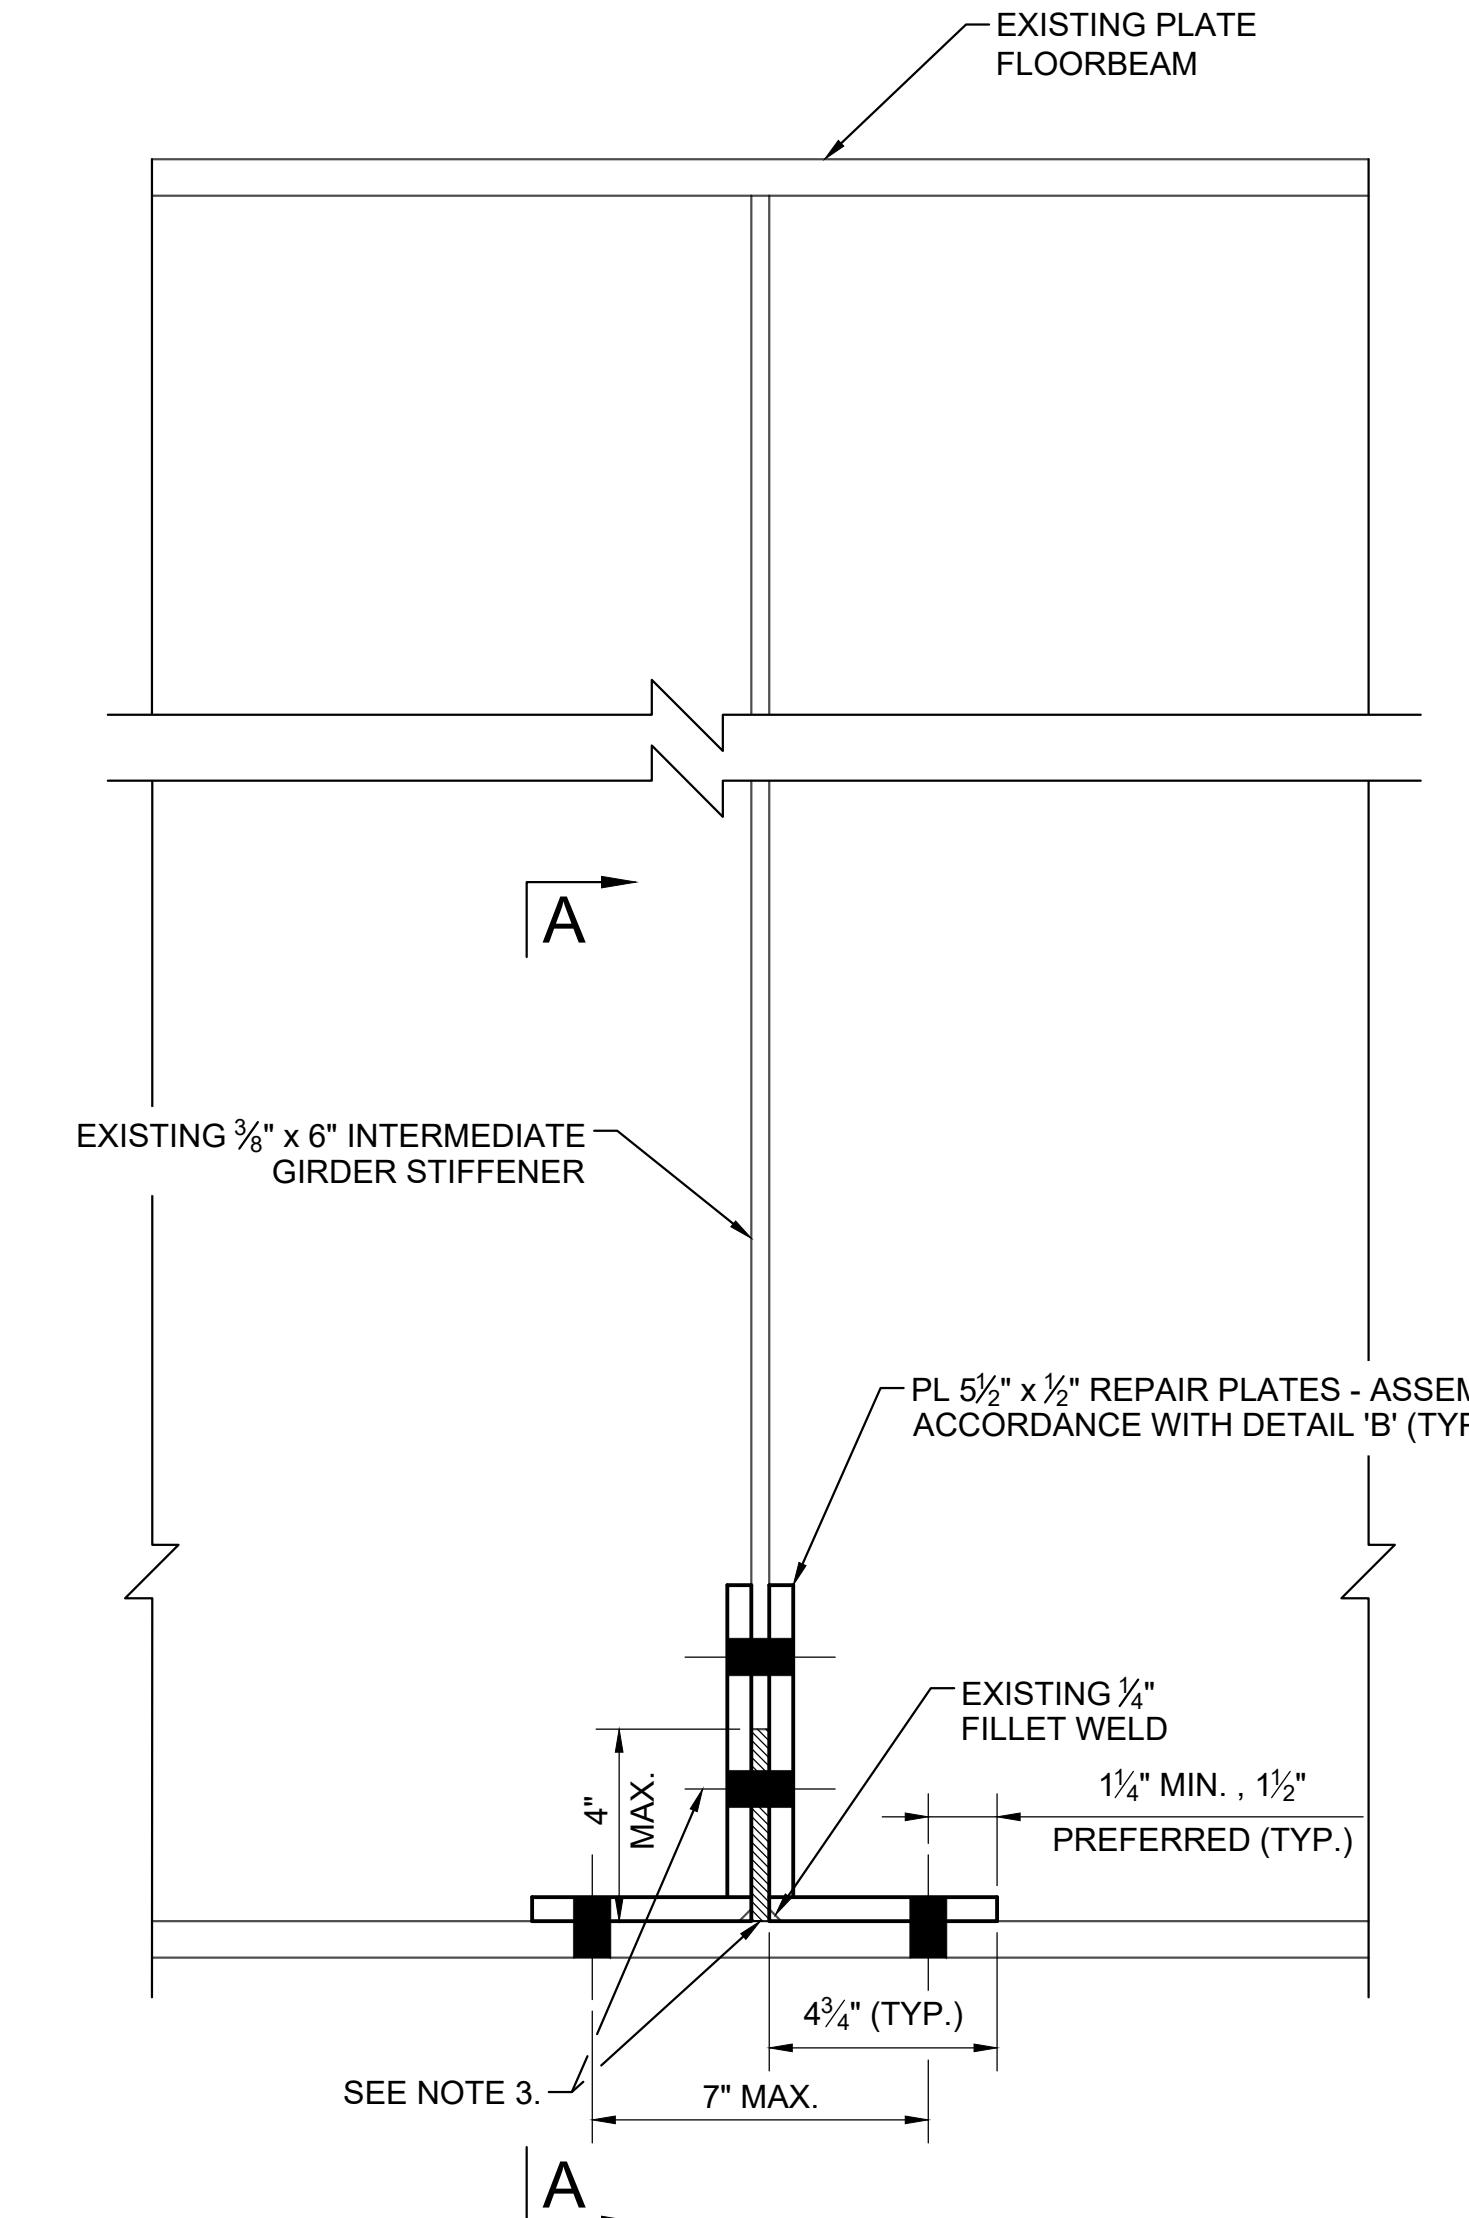
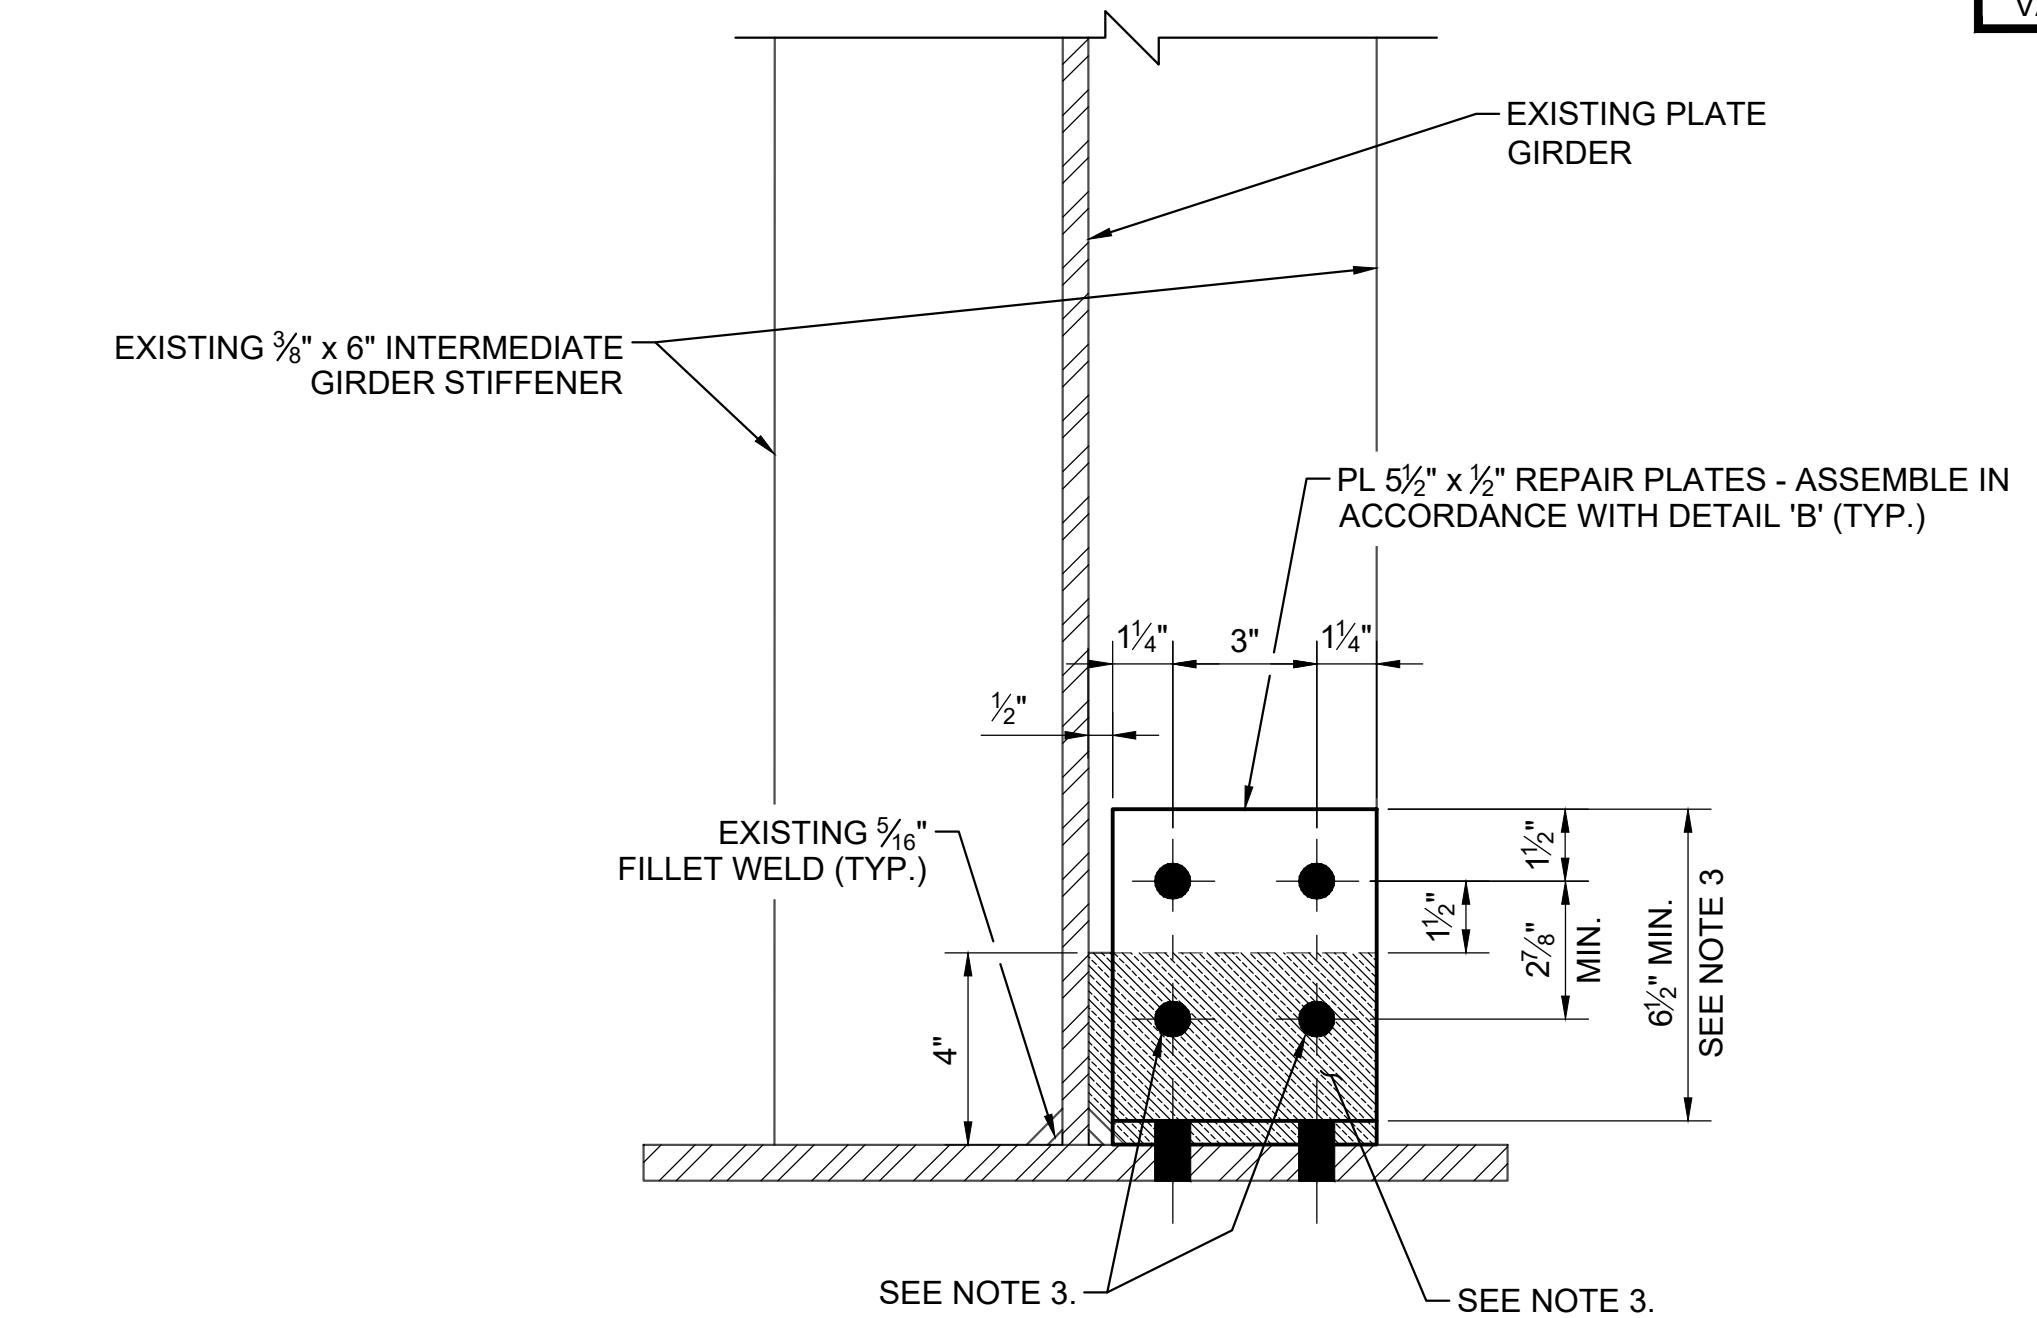
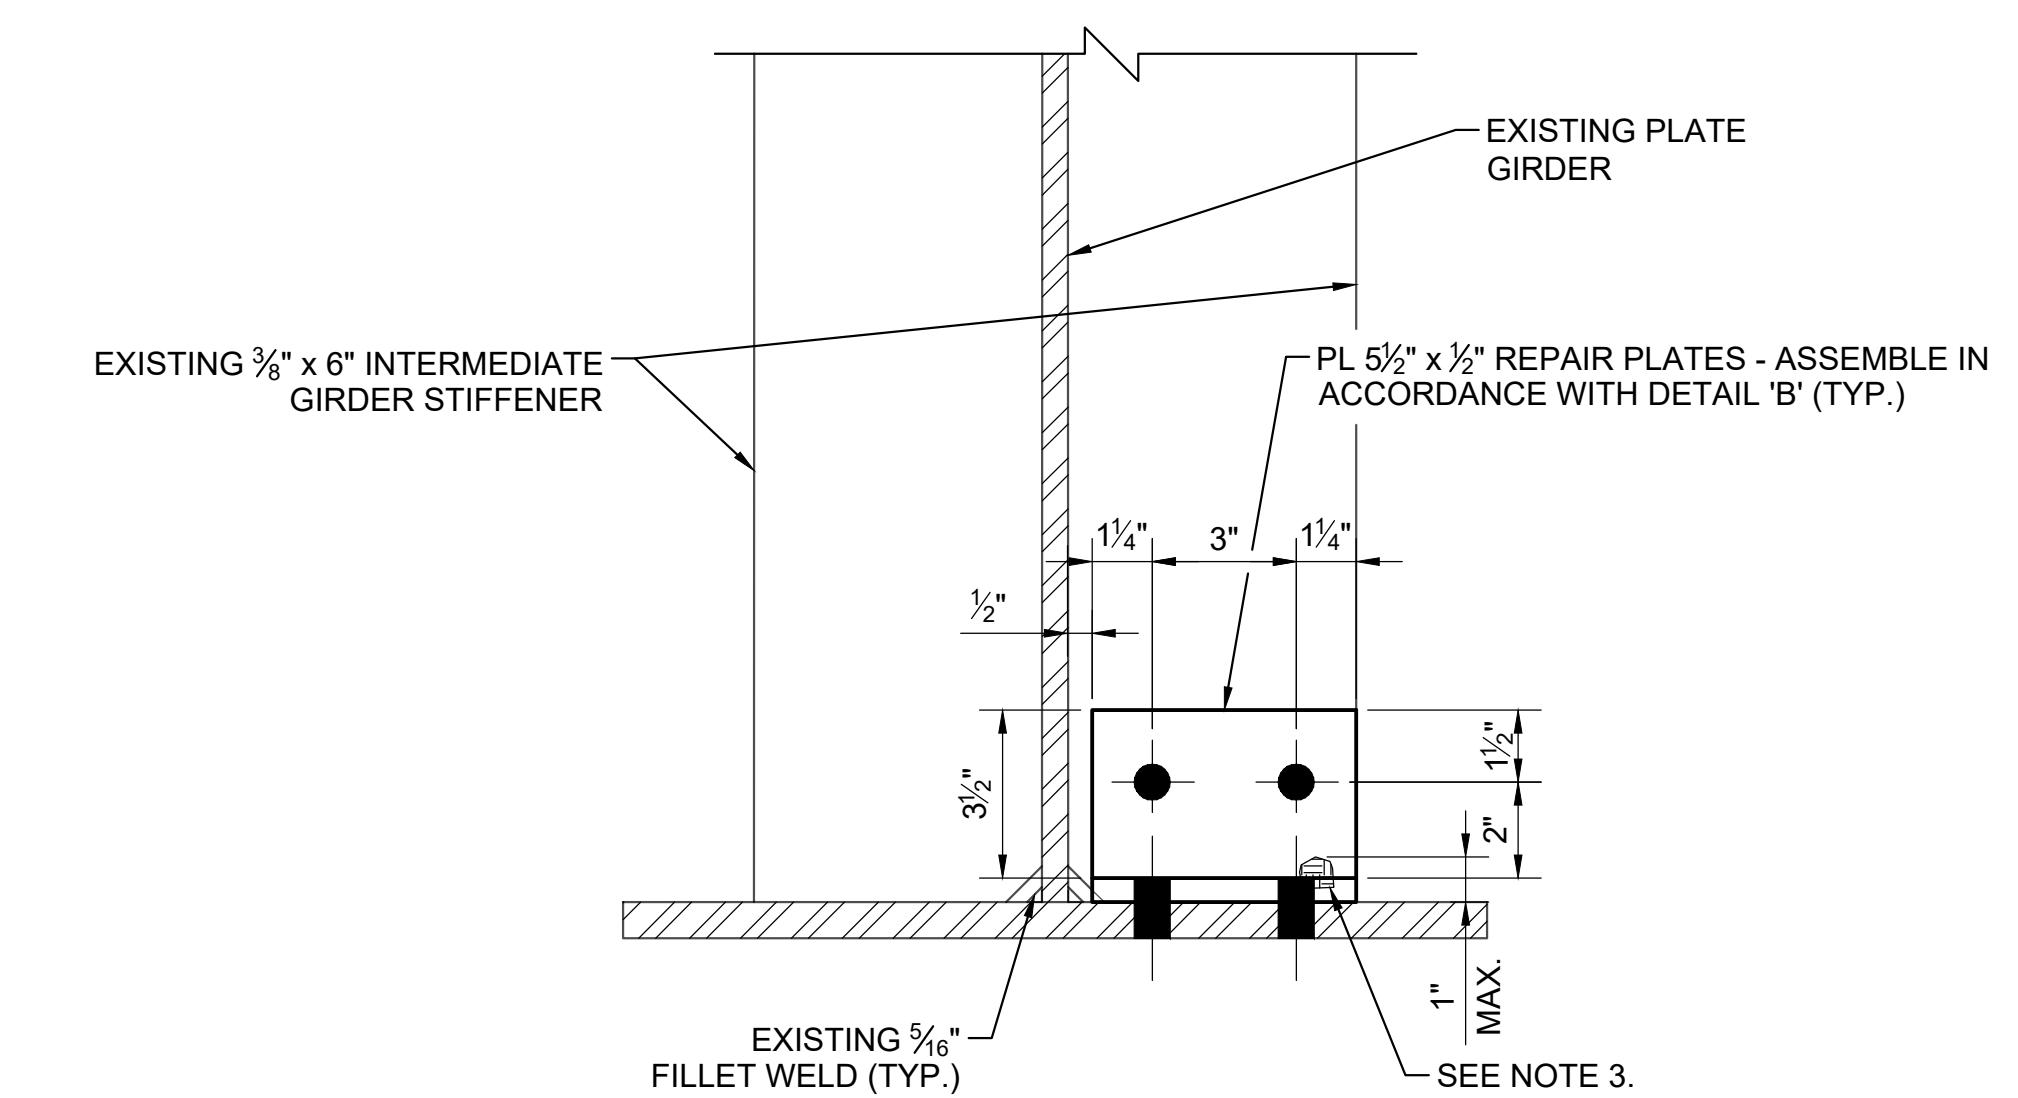
FIB-SB GIRDER REPAIR TYPE 2

PLAN VIEW

DETAIL 'B'

ELEVATION

1. PERFORM THIS REPAIR IN FIB-SB SPANS FOR INTERMEDIATE GIRDER STIFFENERS EXHIBITING CORROSION AT BOTTOM END WITH LESS THAN 1/4" REMAINING OVER 3" OR MORE OF THE STIFFENER WIDTH AS APPROVED BY THE DISTRICT.

2. BACK TO BACK REPAIR CONDITIONS (EITHER SIDE OF GIRDER) MAY EXIST.
3. CORROSION ANTICIPATED AT THE BOTTOM END OF THE BEARING STIFFENER IS UP TO 4" HIGH x UP TO FULL WIDTH x UP TO 3/16" TOTAL DEPTH.

- 3.1. IF CORROSION IS LESS THAN 1" WIDE OR 1" HIGH, GRIND CORROSION SMOOTH, FILL GAP WITH EPOXY PUTTY, AND ADJUST REPAIR AS SHOWN IN DETAIL C.
 - 3.2. IF CORROSION IS > 1/2" AND < 4" HIGH, CUT-OUT BOTTOM OF STIFFENER 4" ABOVE BOTTOM FLANGE ACROSS FULL WIDTH, GRIND WELDS ON BOTTOM FLANGE AND AFFECTED PORTION OF WEB FLUSH, AND PLACE 3/8" x 6" FILL PLATE AS SHOWN IN SECTION A-A.

- 3.3. IF CORROSION EXCEEDS 4" HIGH, CONTACT THE DISTRICT FOR DIRECTION.
4. MATCH DRILL OPPOSING REPAIR PLATE ASSEMBLIES IN THE SHOP.
5. IT IS ACCEPTABLE TO SUBSTITUTE ROLLED ANGLE SECTIONS WITH EQUIVALENT FLANGE LENGTH AND THICKNESS IN PLACE OF THE WELDED REPAIR PLATE ASSEMBLIES DEPICTED AT NO ADDITIONAL COST TO THE DISTRICT.

SECTION A-A

DETAIL C
