CHESAPEAKE BAY BRIDGE AND TUNNEL DISTRICT
			RMF 5044.5122 - STEEL BRIDGE PAINTING PROJECT
PROJECT NOTES			
No.	Description	Date	Designed: JSE Drawn: BSB Checked: AHC
			12/18/2025
	Revision		1 OF 45

CHESAPEAKE BAY BRIDGE AND TUNNEL DISTRICT	
			RMF 5044.5122 - STEEL BRIDGE PAINTING PROJECT	
NORTH CHANNEL BRIDGE NB GENERAL PLAN AND ELEVATION				
No.	Description	Date	Designed: JSE Drawn: BSB Checked: AHC	Date Plan No. Sheet No.
	Revision			12/18/2025 3 OF 45

CHESAPEAKE BAY BRIDGE AND TUNNEL DISTRICT							
			RMF 5044.5122 - STEEL BRIDGE PAINTING PROJECT							
NORTH CHANNEL BRIDGE NB STRINGER AND FLOORBEAM PLATING REPAIRS										
No. Description Date Designed: JSE Drawn: JSE Checked: AHC 12/18/2025 9 OF 45										
	Revision

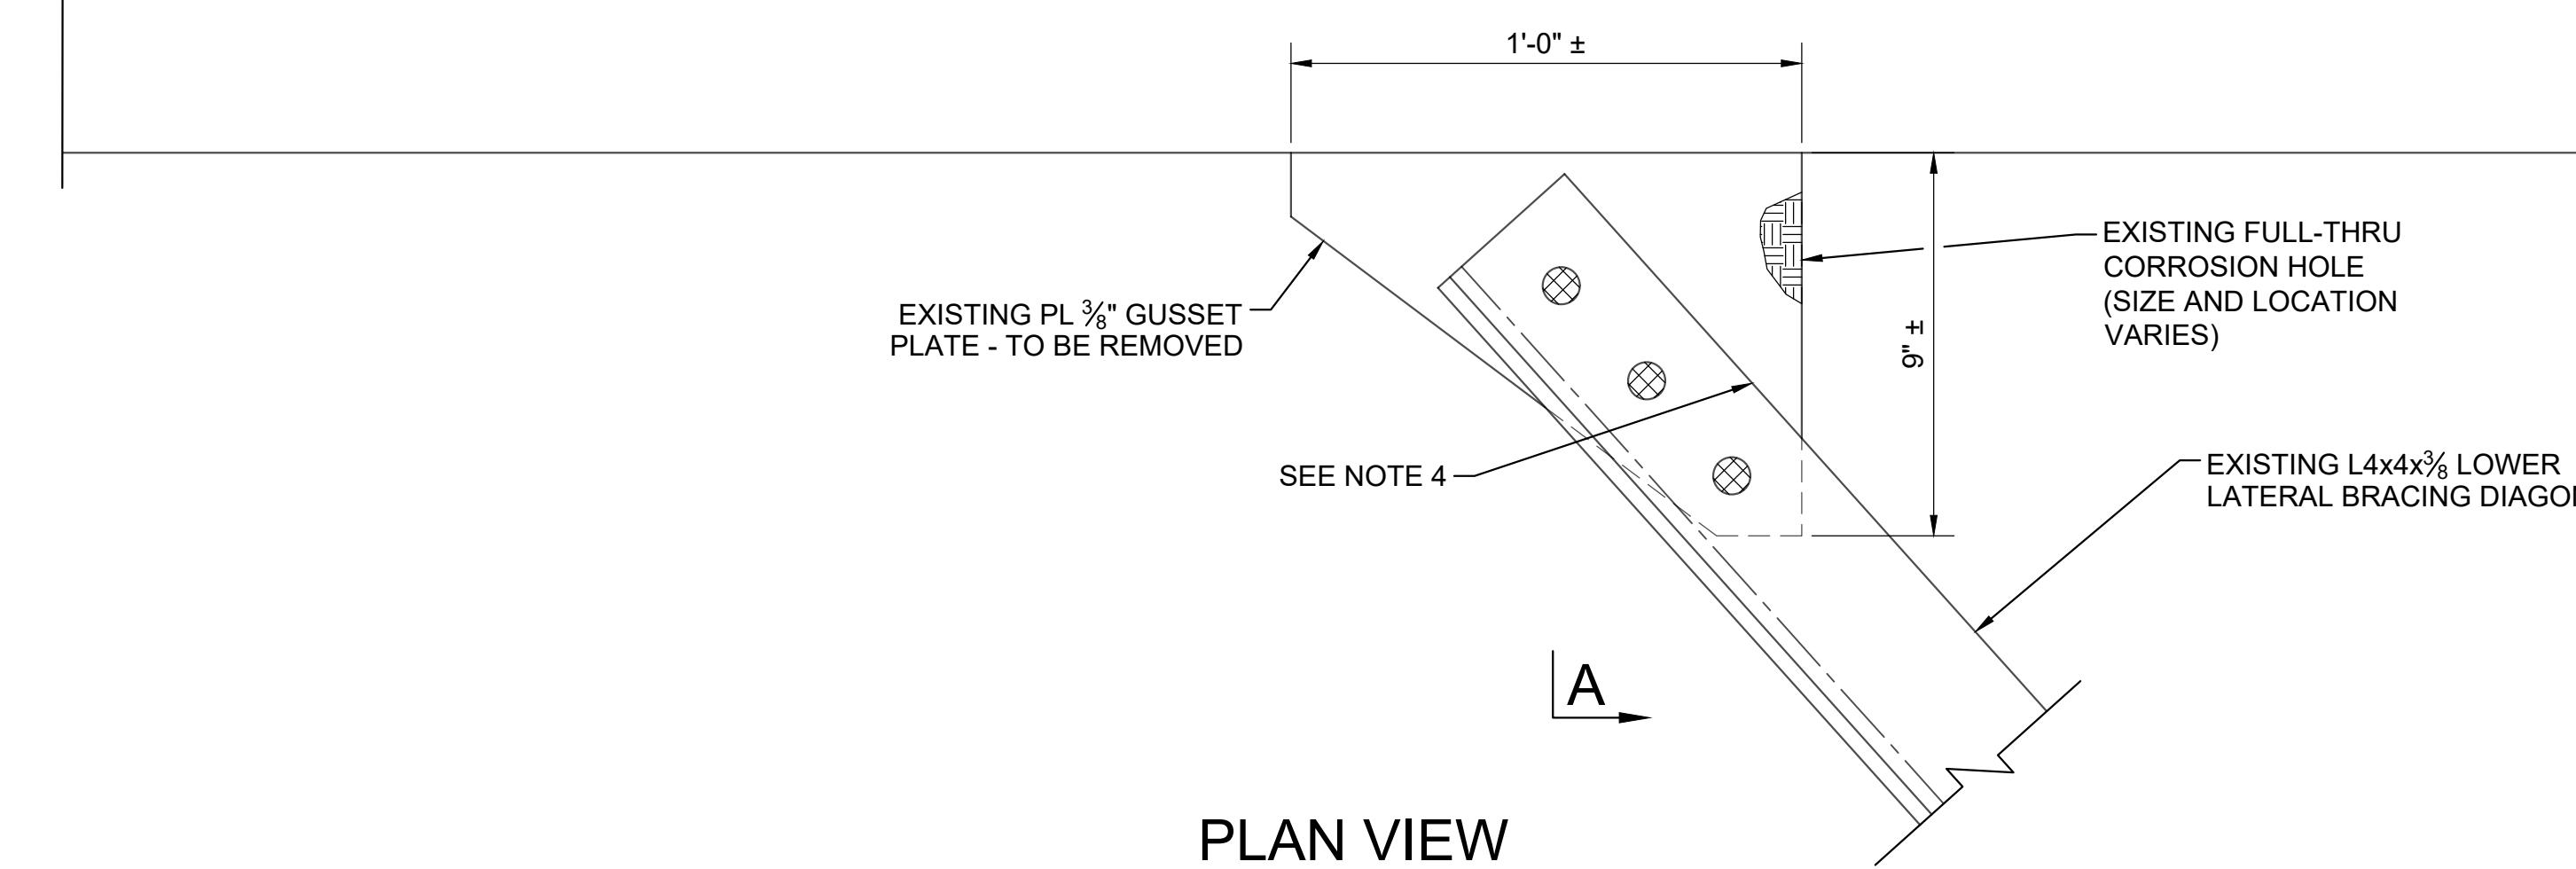
FIB-SB BRACING REPAIR TYPE 1
EXISTING CONDITION

PLAN VIEW

1. PERFORM THIS REPAIR FOR FIB-SB LOWER LATERAL BRACING GUSSET PLATES AT INTERIOR GIRDERS WITH FULL-THRU EDGE CORROSION HOLES EXTENDING FURTHER THAN 1" FROM THE GUSSET EDGE AS APPROVED BY THE DISTRICT. FOR CORROSION HOLES EXTENDING LESS THAN 1" FROM THE GUSSET EDGE, GRIND CORRODED EDGES SMOOTH PRIOR TO PAINTING.
2. SUPPORT ANY LATERAL BRACING MEMBERS DISCONNECTED WHILE PERFORMING REPAIR PER THIS DETAIL.
3. PROPOSED REPAIR ELEMENTS ARE SHOWN SHADED FOR CLARITY.
4. CONTACT THE DISTRICT FOR DIRECTION IF THE LOWER LATERAL BRACING DIAGONAL HORIZONTAL FLANGE EXHIBITS SECTION LOSS GREATER THAN 20% AT ANY CROSS-SECTION.

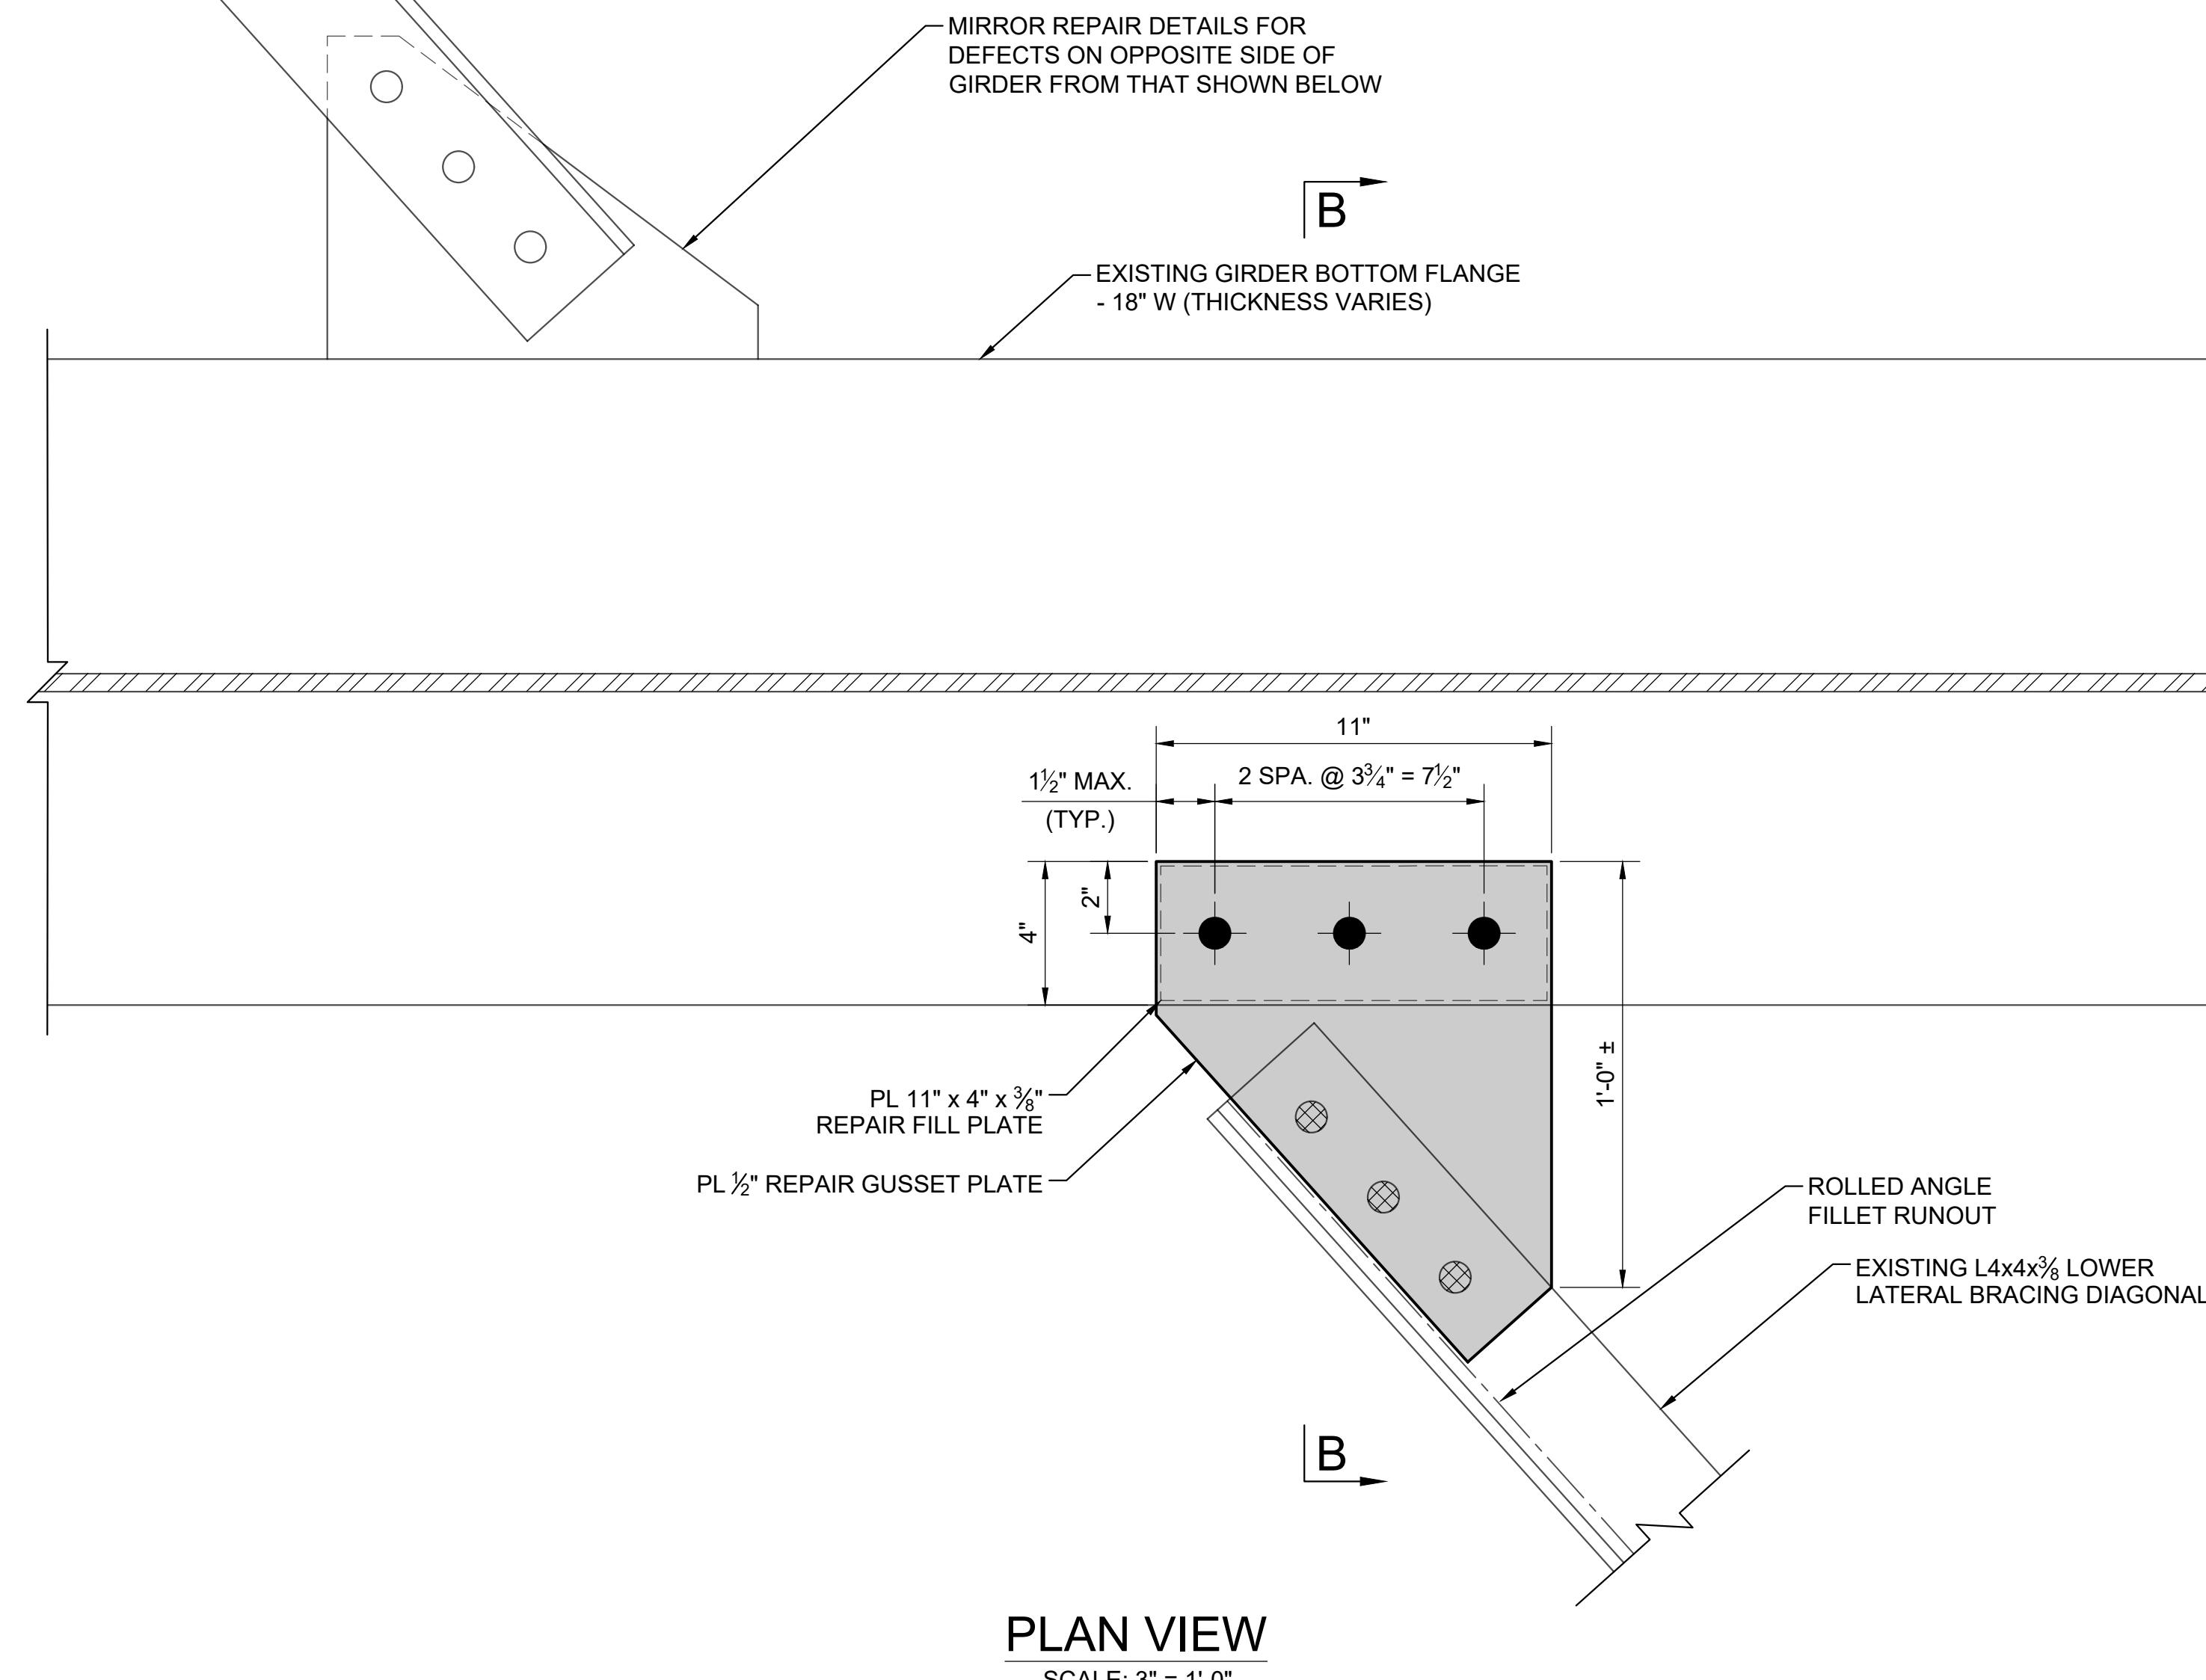
FIB-SB BRACING REPAIR TYPE 1
REPAIRED CONDITION

PLAN VIEW
SCALE: 3" = 1'-0"

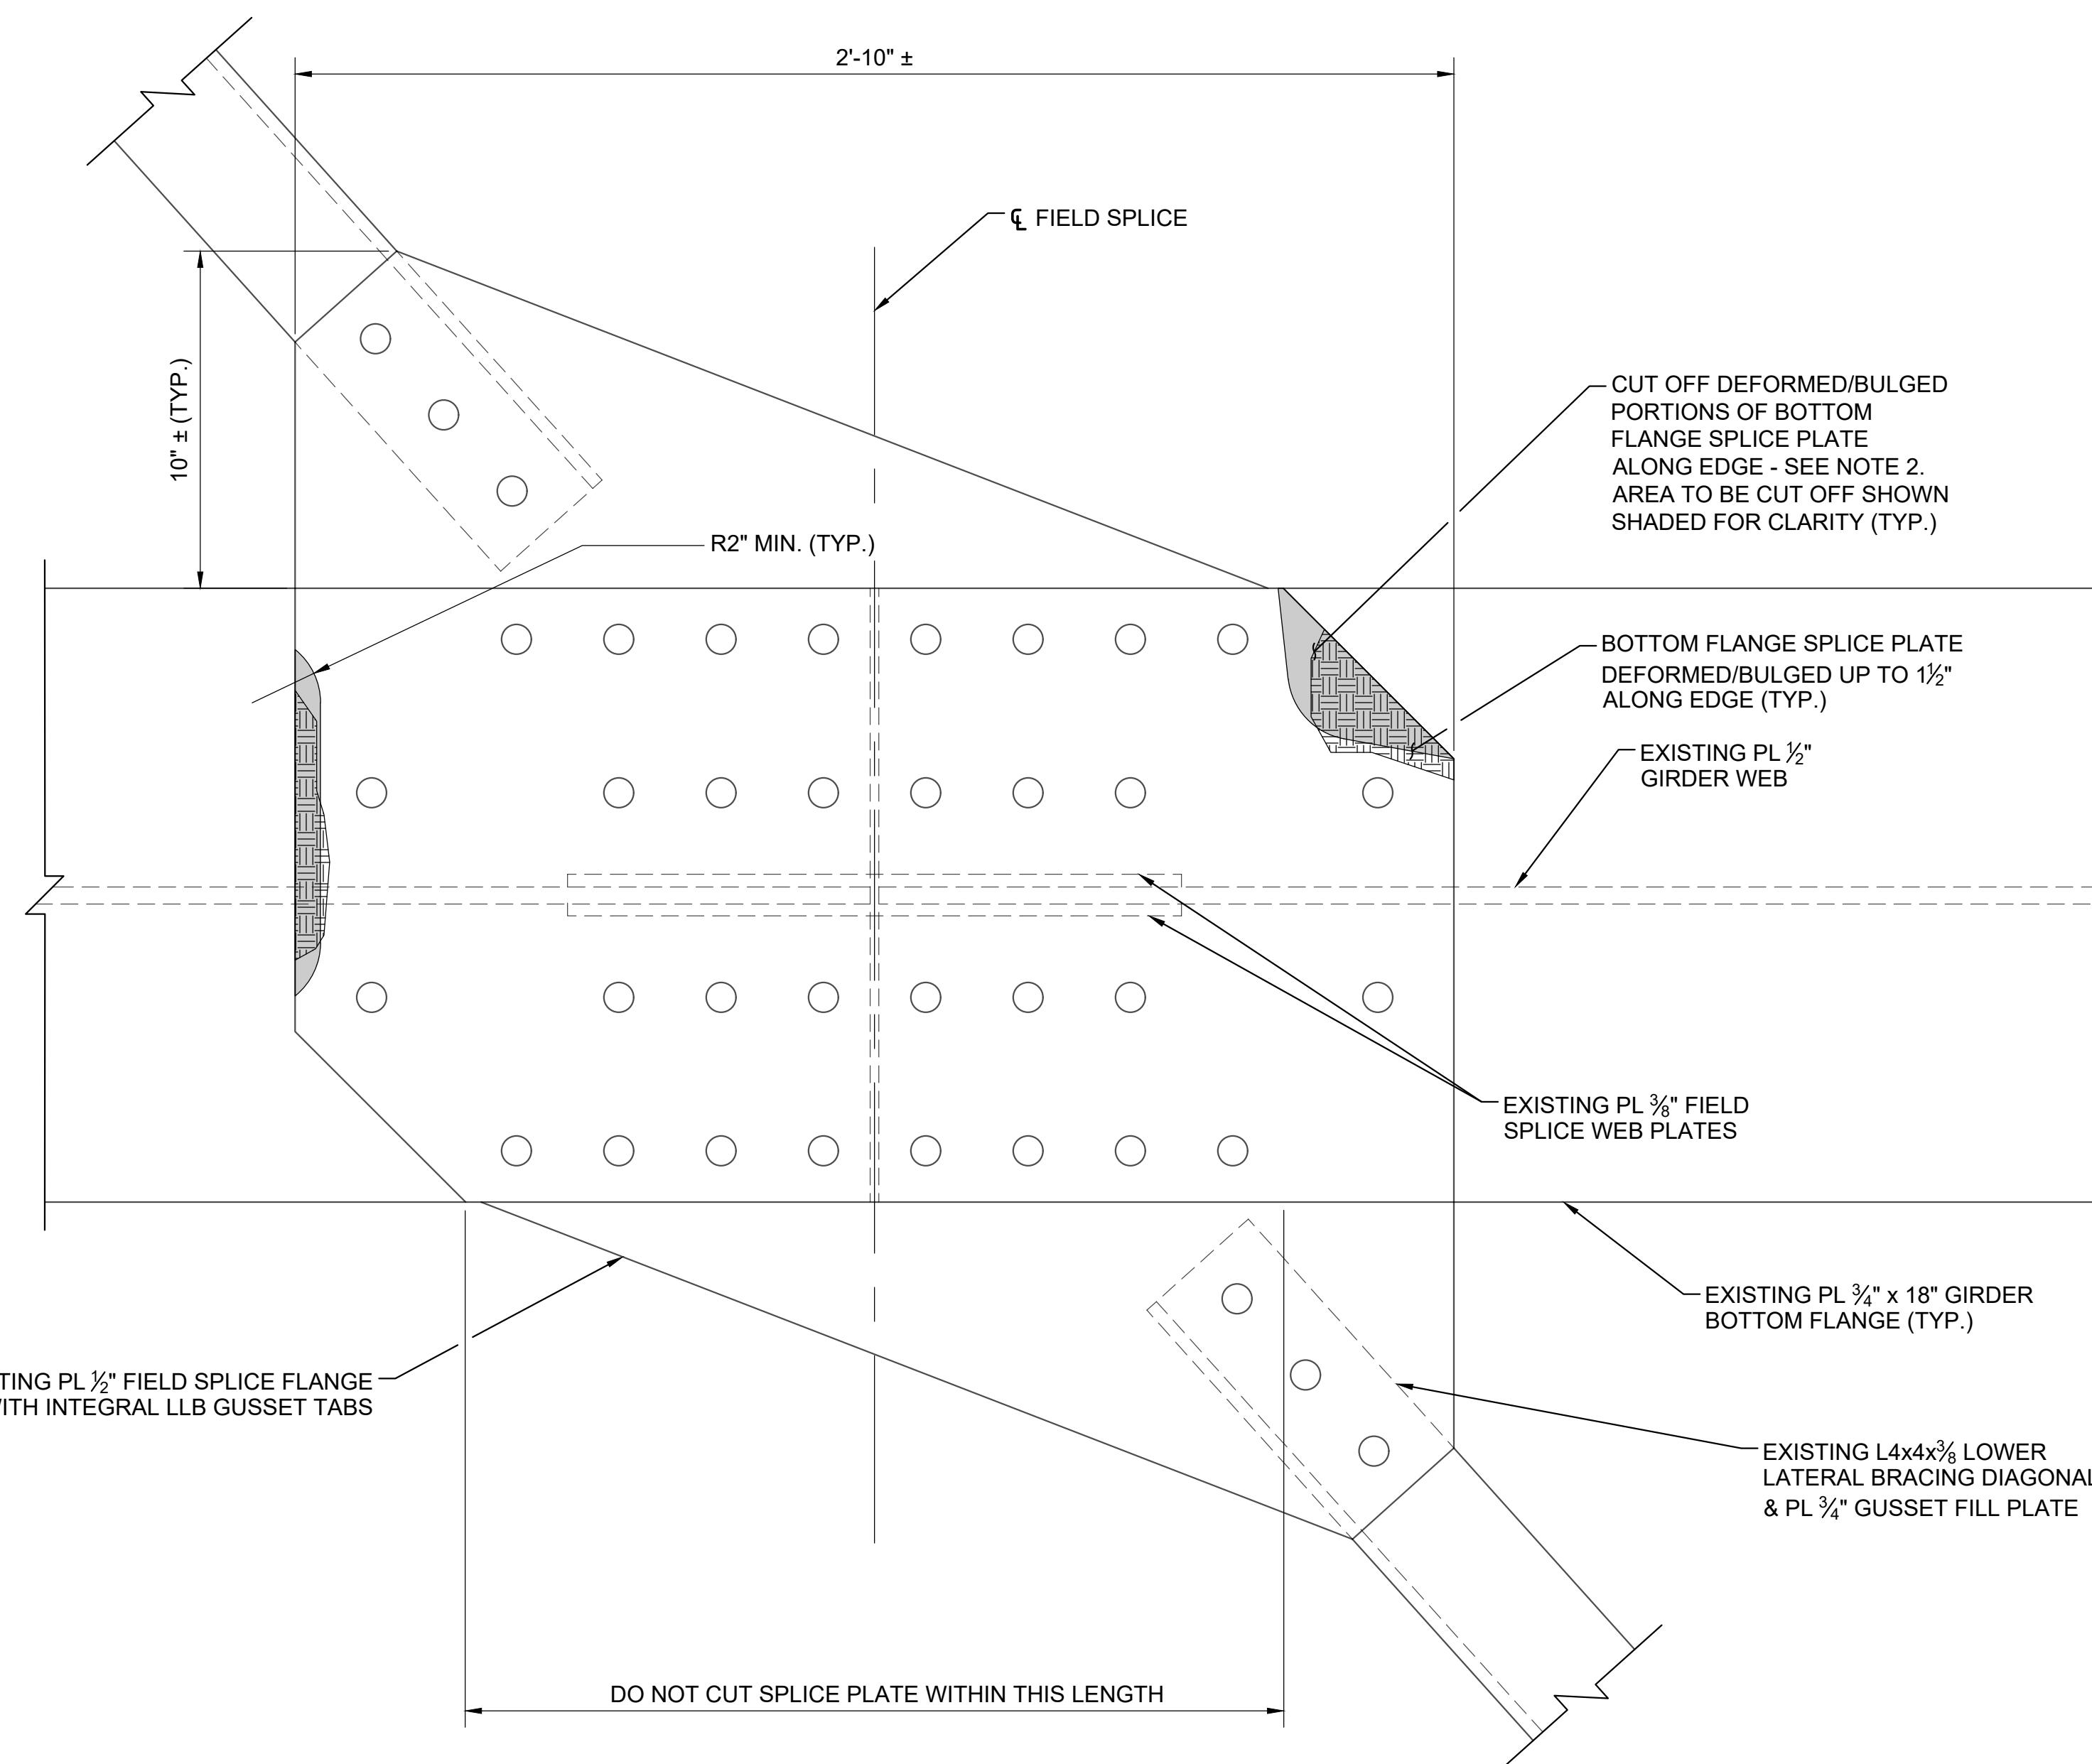
FIB-SB BRACING REPAIR TYPE 2

VIEW LOOKING UP

1. PERFORM THIS REPAIR FOR FIB-SB SPAN 2 FIELD SPLICE BOTTOM FLANGE PLATES WITH INTEGRAL LOWER LATERAL BRACING GUSSET TABS DEFORMED AND/OR BULGED AROUND THEIR PERIPHERY AT LEAST $\frac{1}{2}$ " THICKER THAN ORIGINAL THICKNESS OF $\frac{1}{2}$ " AS APPROVED BY THE DISTRICT.

3. USE CAUTION TO AVOID DAMAGE TO GIRDER BOTTOM FLANGE, LOWER LATERAL BRACING MEMBERS, AND ALL OTHER STRUCTURE. FLAME CUTTING IS PROHIBITED AS A METHOD FOR REMOVAL FOR THIS DETAIL. IF DAMAGE OCCURS, CONTRACTOR IS RESPONSIBLE FOR REPAIRING IT TO THE SATISFACTION OF THE DISTRICT AT NO COST TO THE DISTRICT.

4. SHAPE AND DIMENSIONS OF EXISTING BOTTOM FLANGE SPLICE PLATE WITH INTEGRAL GUSSET TABS ARE APPROXIMATE.

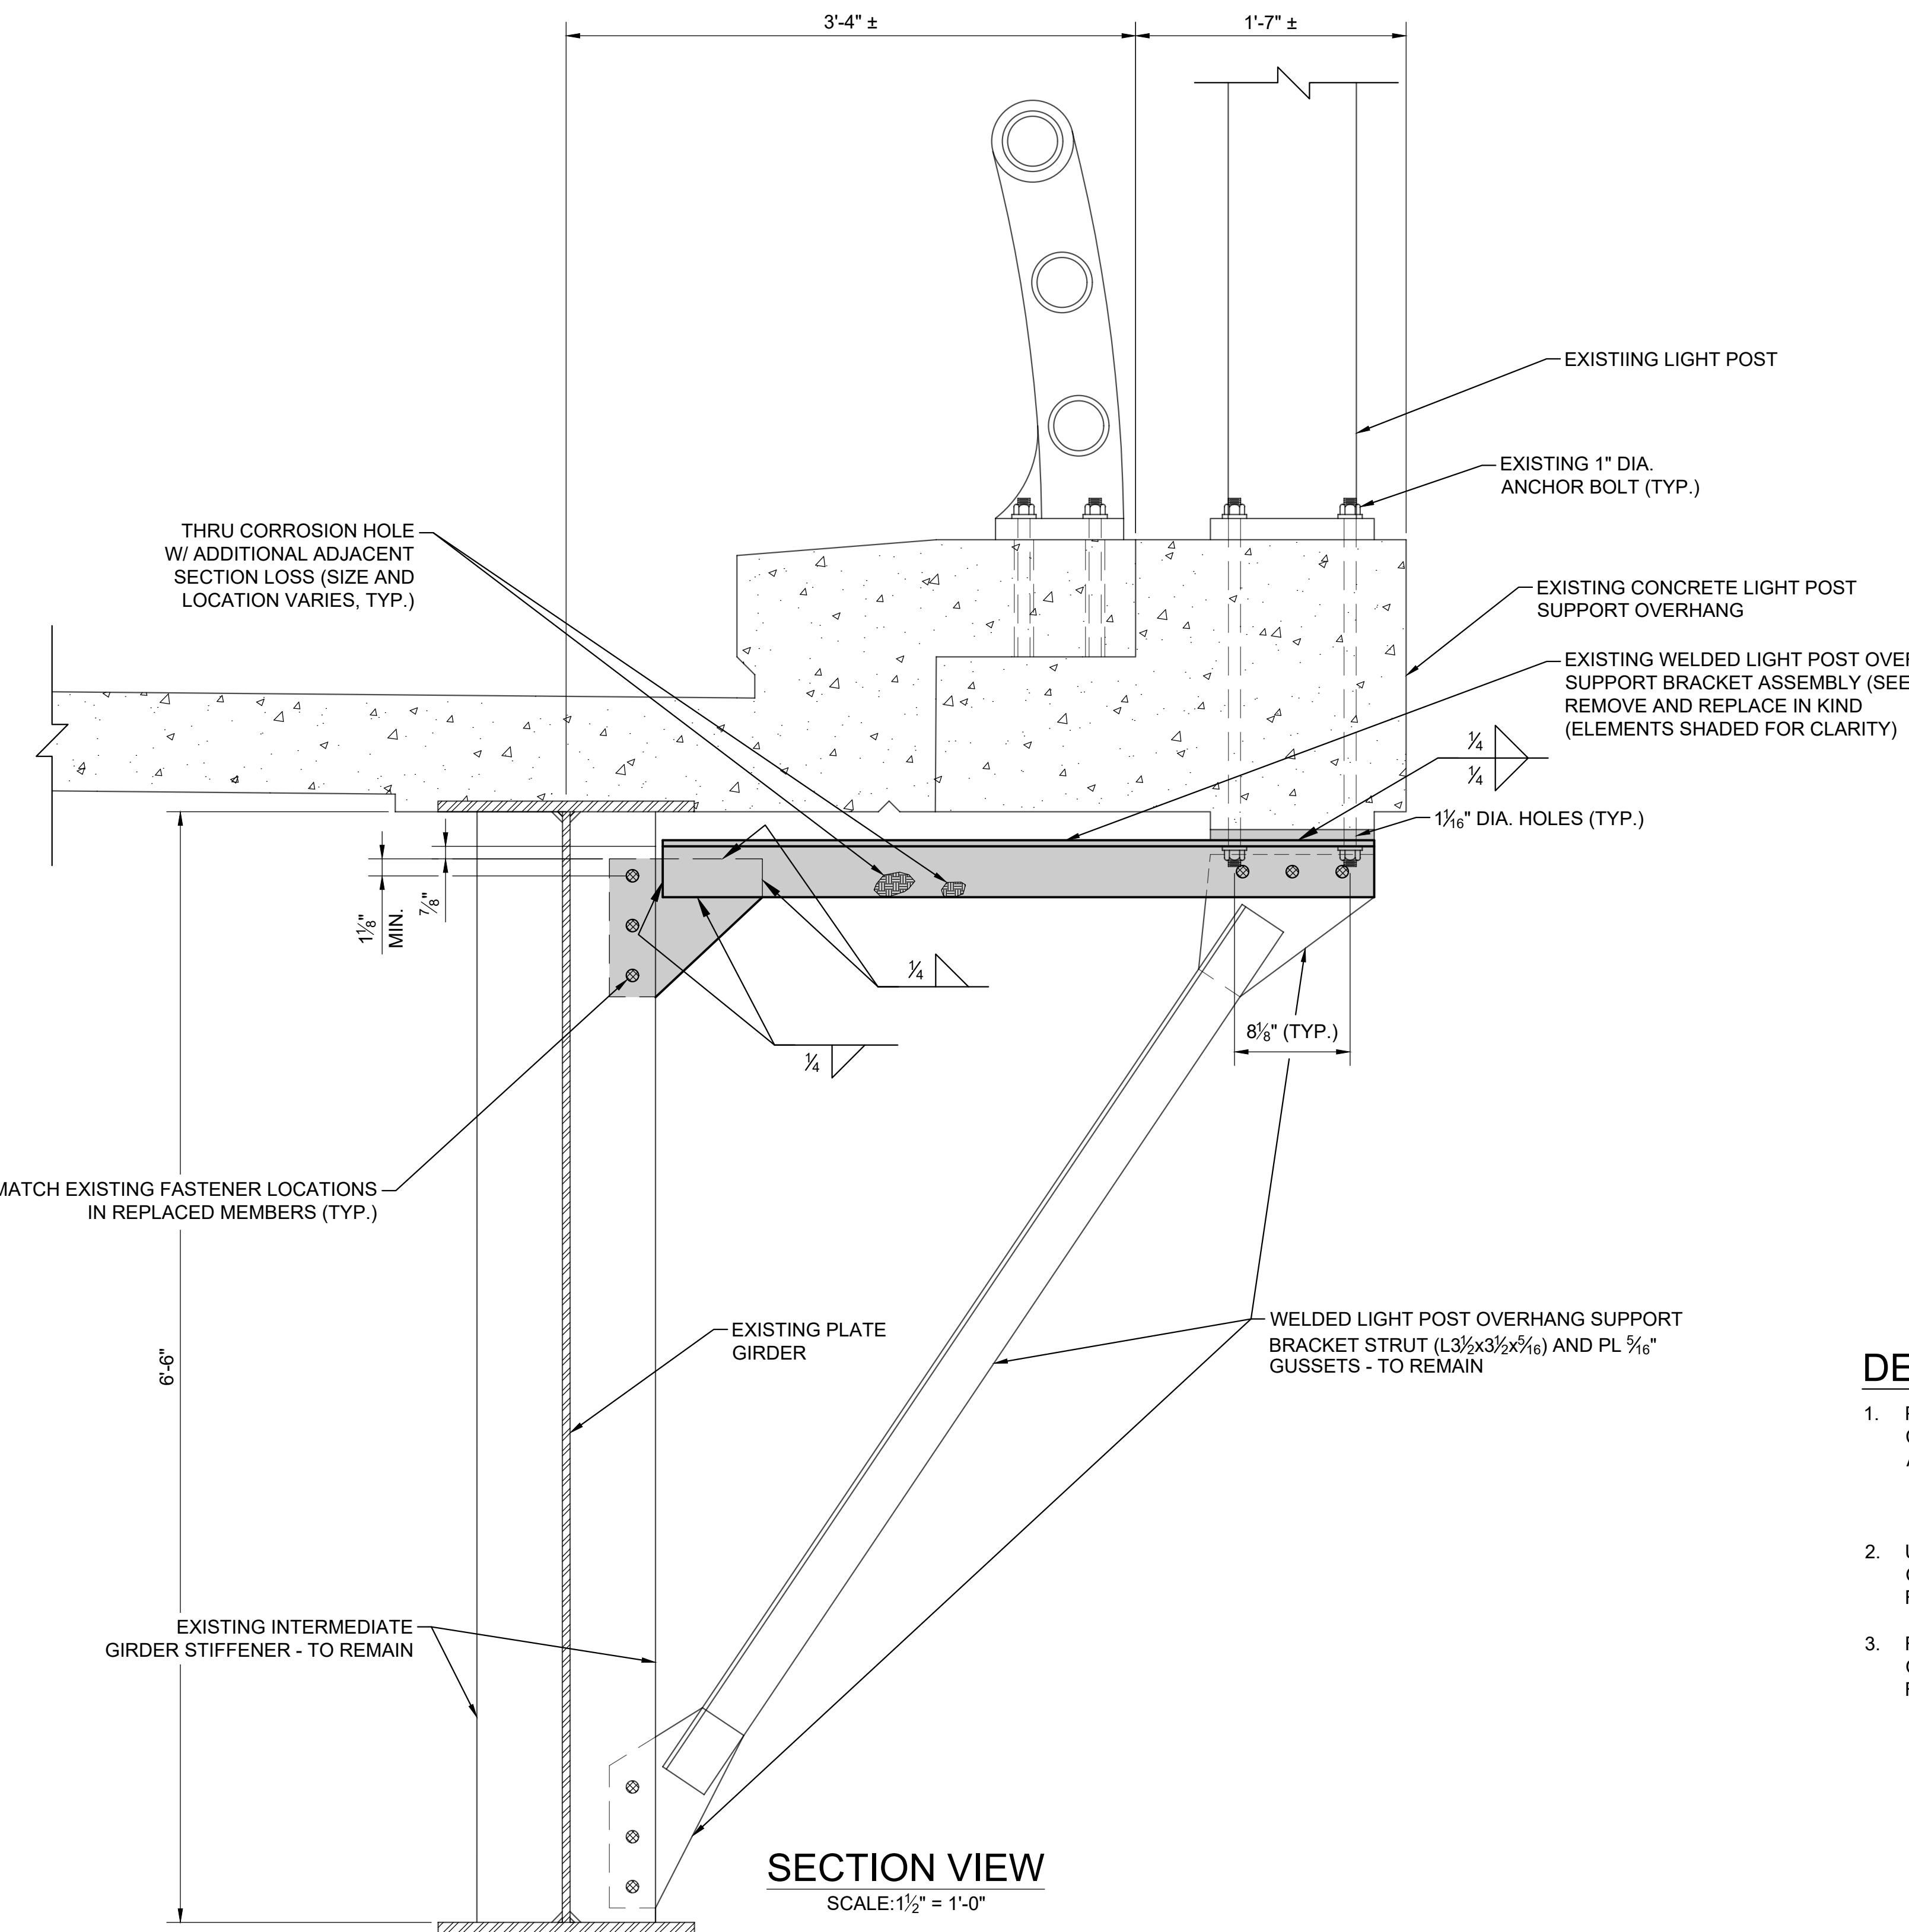
1. PERFORM THIS REPAIR FOR FIB-SB EXISTING LIGHT POST OVERHANG SUPPORT BRACKETS WITH FULL-THRU CORROSION HOLES AS APPROVED BY THE DISTRICT. THE LIGHT POST OVERHANG SUPPORT BRACKETS ARE LOCATED AS FOLLOWS:

- SPAN 1 EAST FASCIA ADJACENT TO PIER 2
 - SPAN 3 WEST FASCIA ADJACENT TO PIER 3
2. USE CAUTION TO ENSURE THAT CONCRETE LIGHT POST SUPPORT OVERHANG, SUPPORT BRACKETS TO REMAIN, GIRDER, AND ALL OTHER COMPONENTS ARE NOT DAMAGED IN ANY WAY. IF DAMAGE OCCURS, CONTRACTOR IS RESPONSIBLE FOR REPAIRING IT TO THE SATISFACTION OF THE DISTRICT AT NO COST TO THE DISTRICT.

3. REMOVE AND REPLACE EXISTING WELDED LIGHT POST OVERHANG SUPPORT BRACKET ASSEMBLY, WHICH CONSISTS OF THE FOLLOWING, IN KIND. FIELD-VERIFY ALL DIMENSIONS AND ADJUST AS NECESSARY PRIOR TO FABRICATING REPLACEMENT ELEMENTS.

- 3.1. (1) SUPPORT BRACKET TOP CHORD (ST4x11.5)
 - 3.2. (1) PL 5/16" GUSSET
 - 3.3. (1) PL 11 1/2" x 11 1/2" x 3/4" ADAPTER PLATE

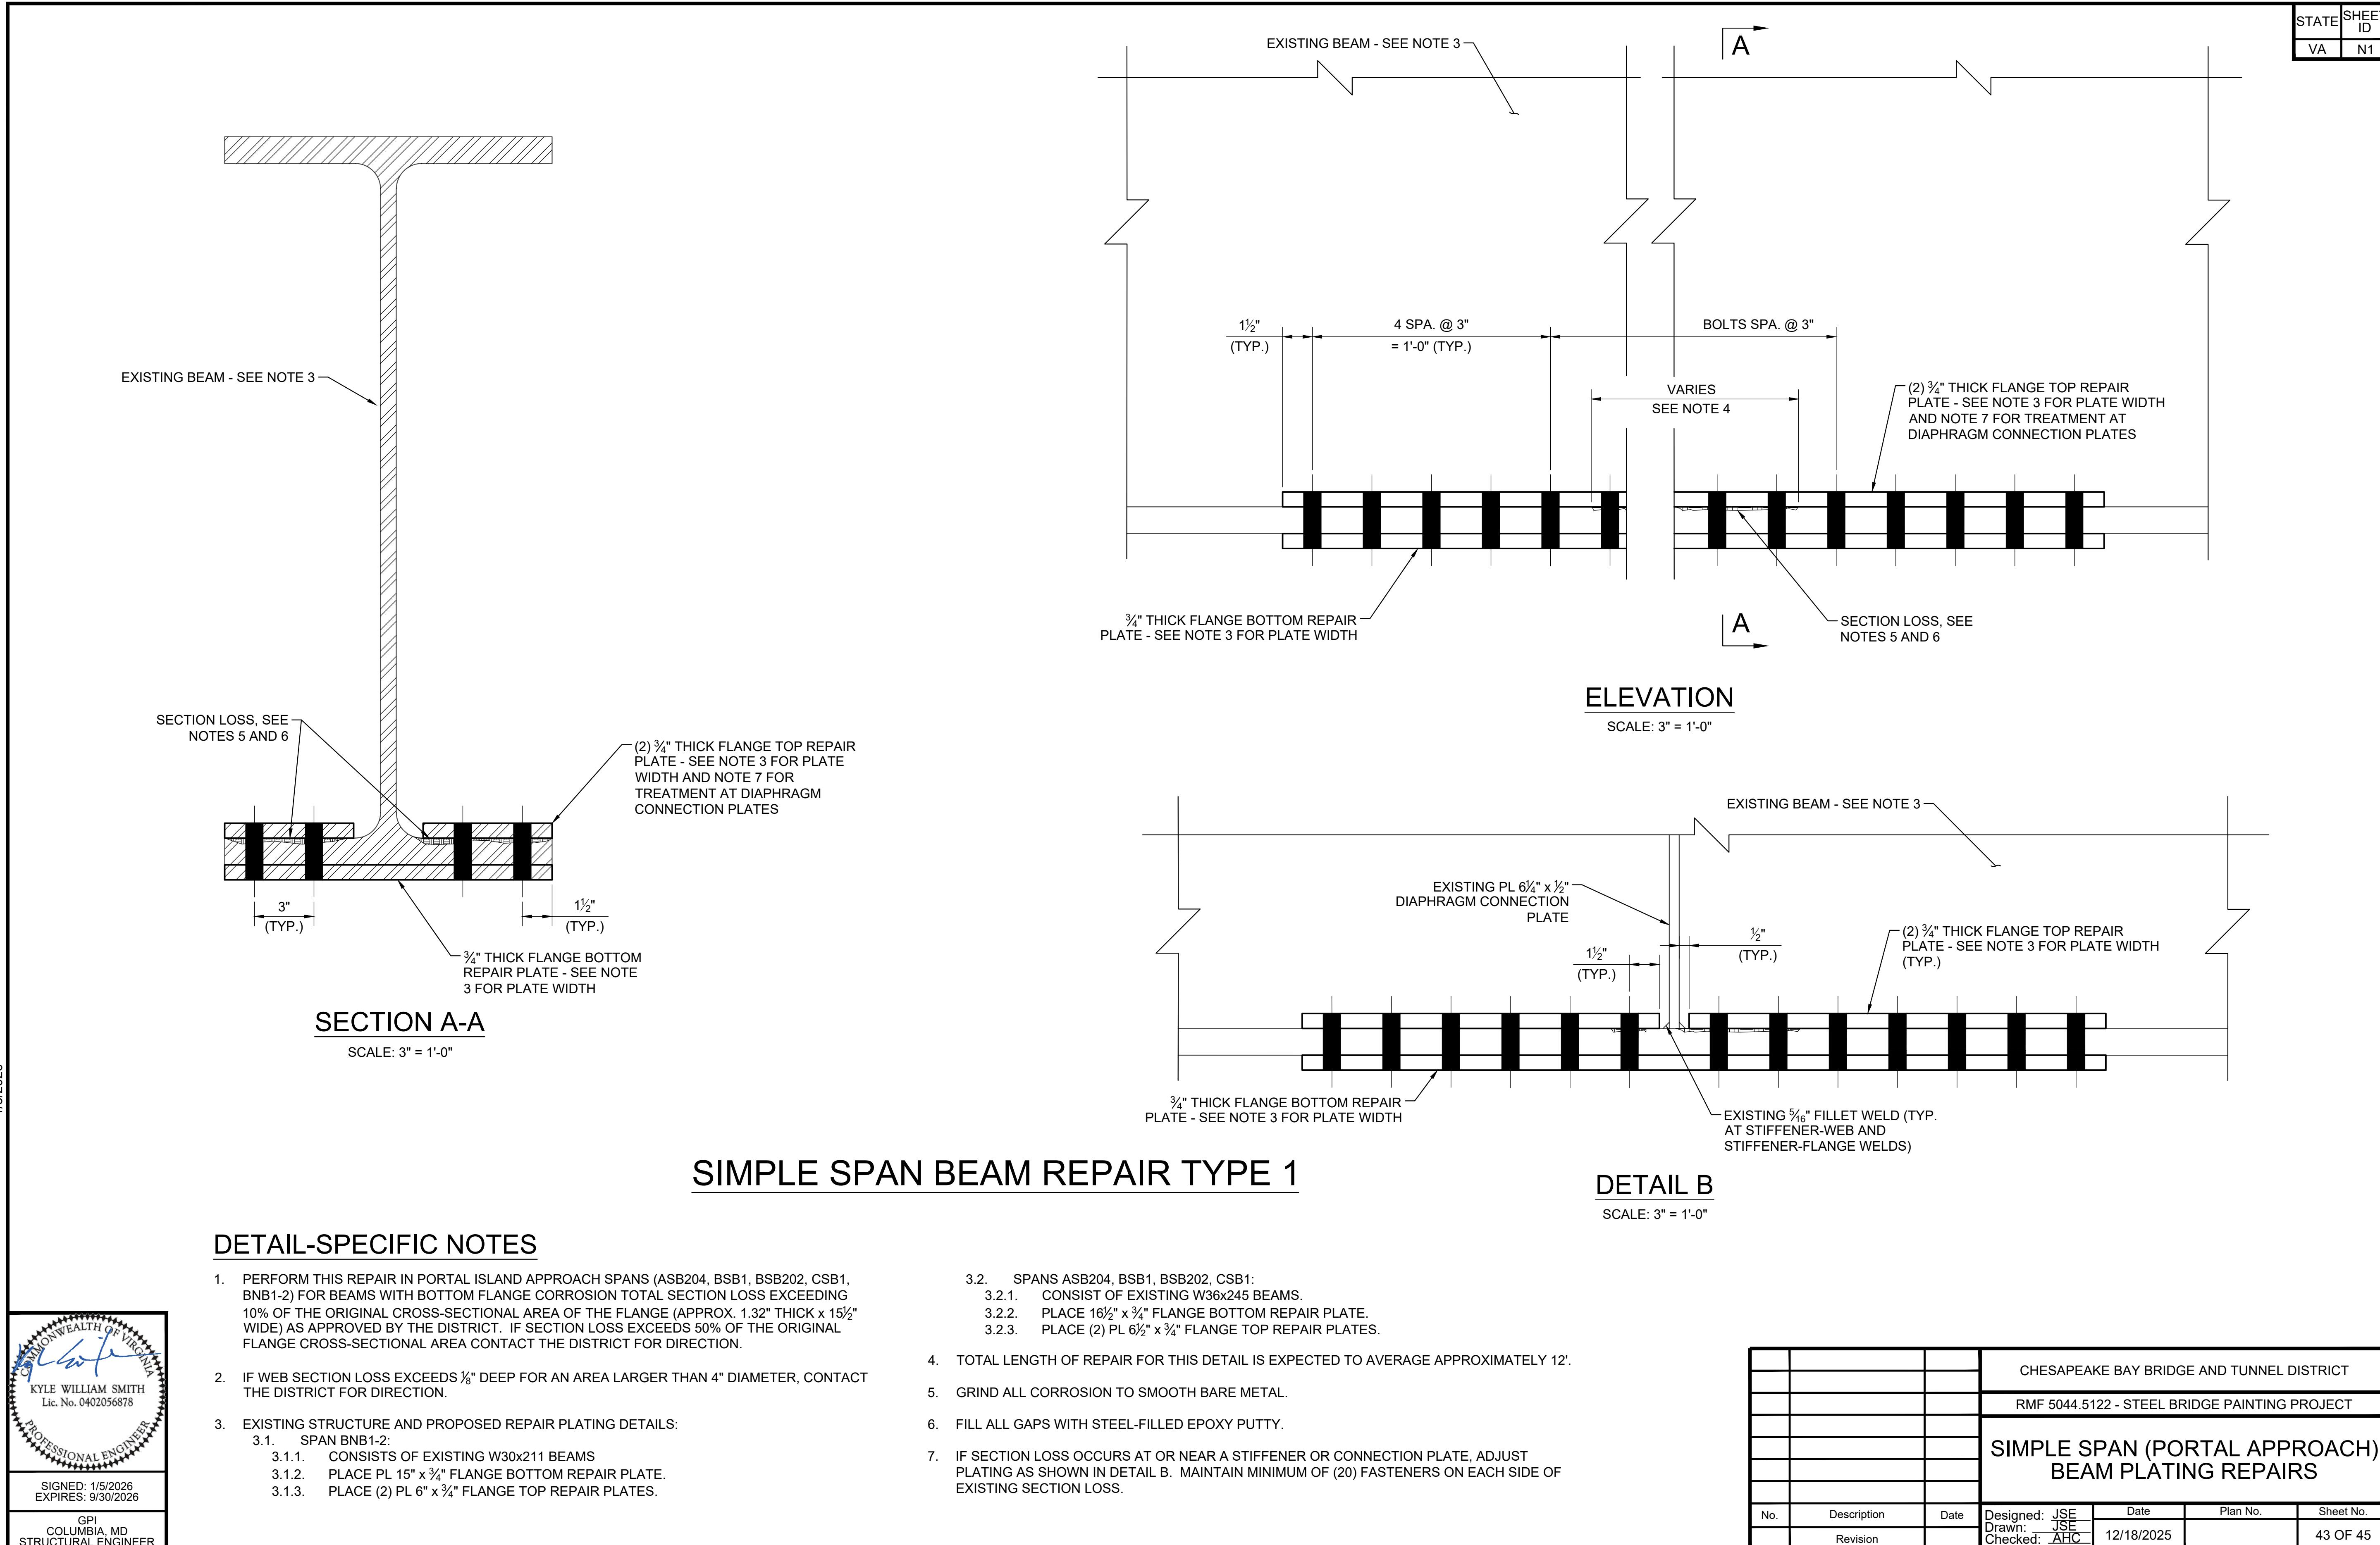
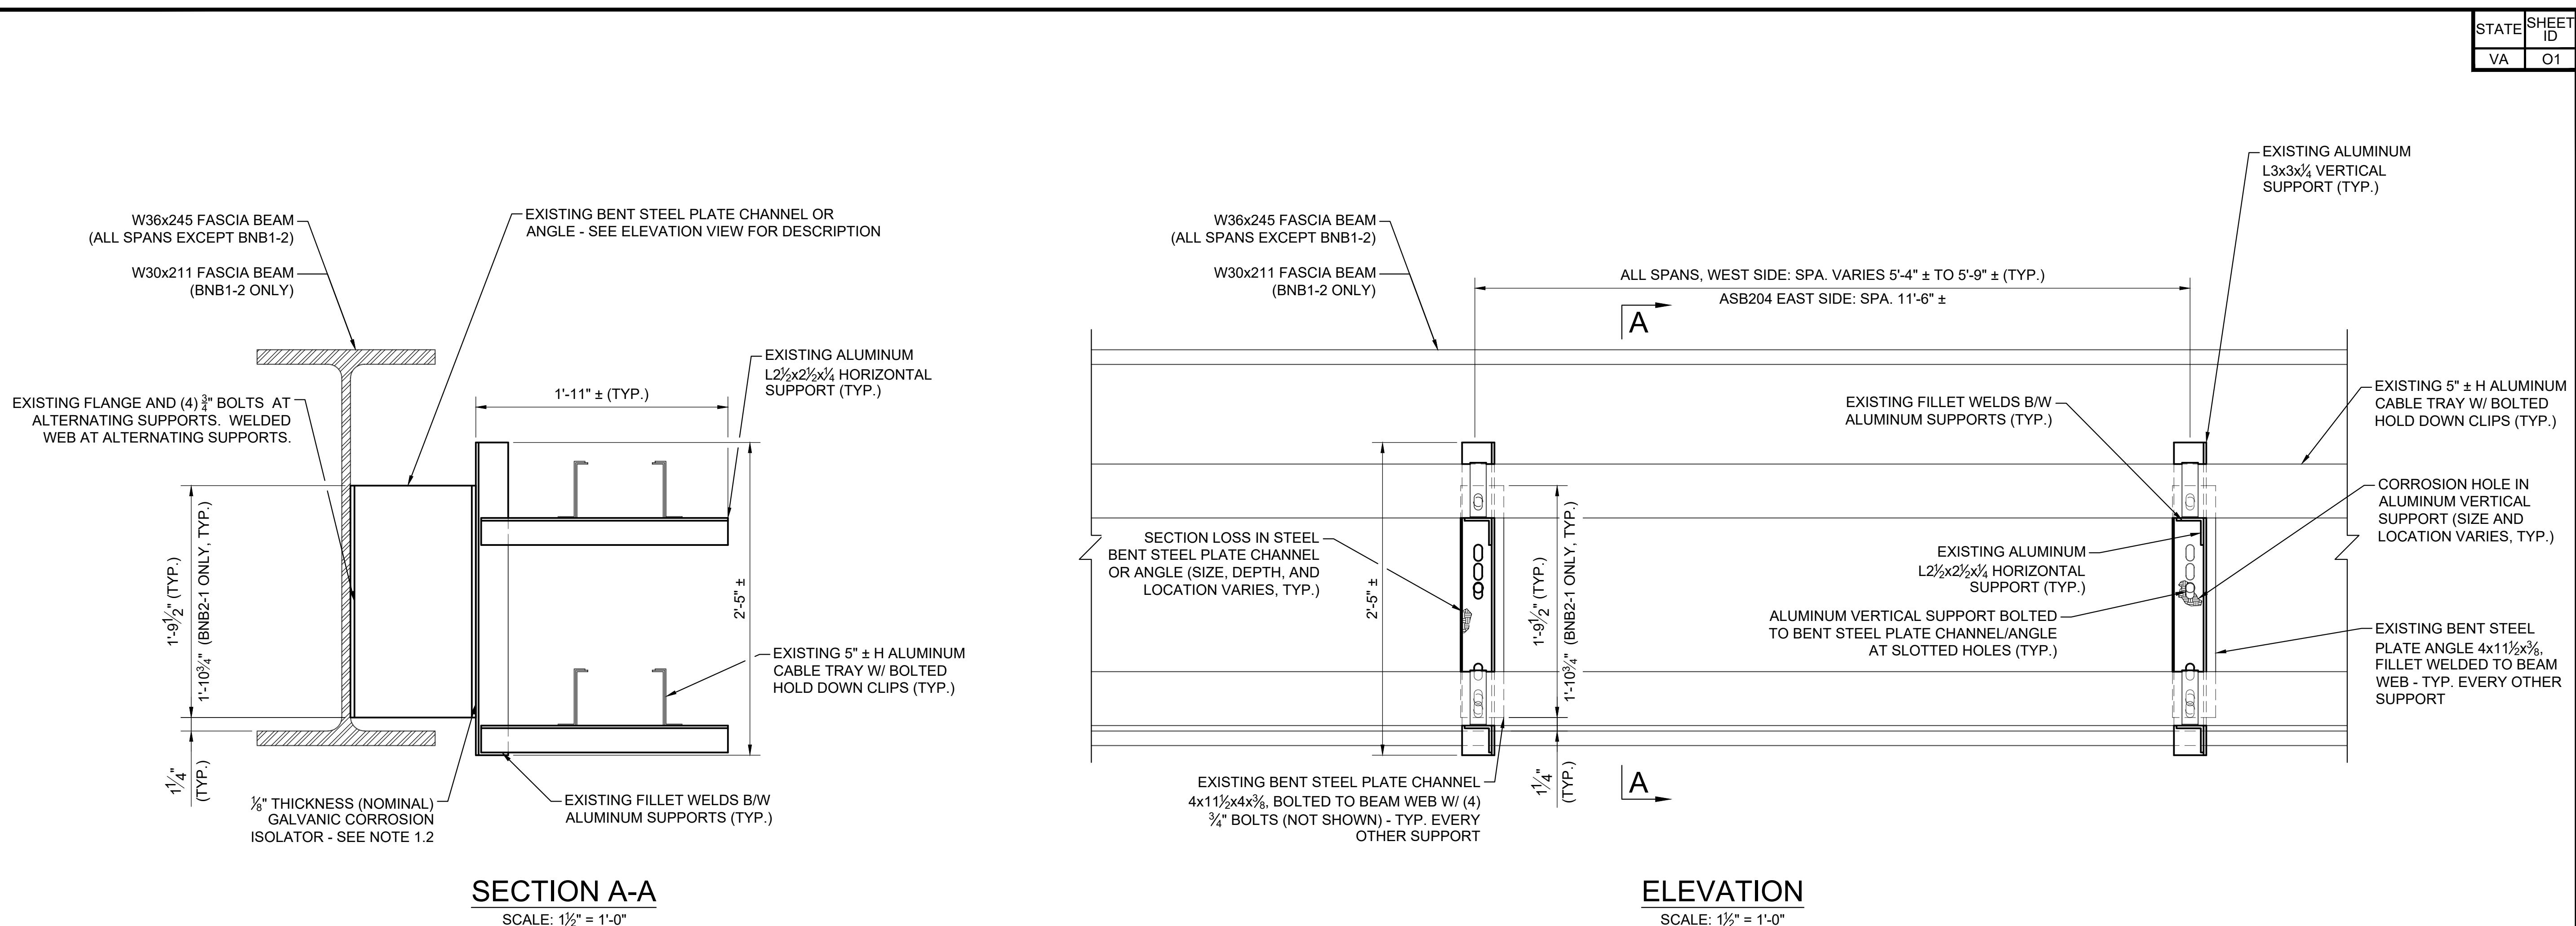
SIMPLE SPAN UTILITY REPAIR TYPES 1 & 1A

1. PERFORM SIMPLE SPAN UTILITY REPAIR TYPE 1 ON PORTAL ISLAND APPROACH SPANS (ASB204, BSB1, BSB202, CSB1, BNB1-2) FOR ALUMINUM UTILITY SUPPORT BRACKET ASSEMBLIES EXHIBITING AT LEAST ONE FULL-THROUGH CORROSION HOLE 1" DIA. OR LARGER. REPAIR CONSISTS OF:

- 1.1. IN-KIND REPLACEMENT OF WELDED ALUMINUM BRACKET ASSEMBLY, EACH OF WHICH CONSISTS OF:
 - 1.1.1. (1) L3x3x1/4 VERTICAL SUPPORT, AND
 - 1.1.2. (2) L2 1/2x2 1/2x1/4 HORIZONTAL SUPPORTS

- 1.2. PLACEMENT OF AN 1/8" NOMINAL THICKNESS GALVANIC CORROSION ISOLATOR BETWEEN ALUMINUM AND STEEL MATING SURFACES. THE DISTRICT WILL VISUALLY VERIFY GALVANIC ISOLATOR INSTALLATION.

- 1.3. INSTALLATION WITH STAINLESS STEEL GRADE 316 BOLTS. USE INSULATING BOLT SLEEVES AND WASHERS TO GALVANICALLY ISOLATE THE FASTENERS USED FOR ATTACHMENT OF ALUMINUM SUPPORTS TO BRIDGE-MOUNTED STEEL SUPPORTS. THE DISTRICT WILL VERIFY ELECTRICAL ISOLATION OF INSTALLED FASTENERS.

- 1.4. CLEAN AND PAINT ALL Affected CARBON STEEL WITH THE ZINC - 2 COAT PAINT SYSTEM.
2. ADDITIONALLY, PERFORM SIMPLE SPAN UTILITY REPAIR TYPE 1A ON PORTAL ISLAND APPROACH SPANS (ASB204, BSB1, BSB202, CSB1, BNB1-2) FOR BENT STEEL PLATE UTILITY SUPPORT ANGLES OR CHANNELS (BRACKETS) EXHIBITING AT LEAST ONE FULL-THROUGH CORROSION HOLE 1" DIA. OR LARGER. REPAIR CONSISTS OF:

- 2.1. REPLACEMENT USING A BENT STEEL 3/8" PLATE CHANNEL WITH 4" W FLANGES AND AN 11 1/2" W WEB (TO MATCH EXISTING CHANNEL LOCATED AT ALTERNATING LOCATIONS).

- 2.2. ATTACHMENT USING (4) 3/4" BOLTS.
 - 2.2.1. AT EXISTING BOLTED CHANNEL LOCATIONS, MATCH EXISTING HOLES IN REPLACEMENT BRACKET.
 - 2.2.2. AT EXISTING WELDED ANGLE LOCATIONS, GRIND WELD FLUSH TO BEAM WEB.

3. USE CAUTION TO ENSURE THAT EXISTING BEAM IS NOT DAMAGED IN ANY WAY WHEN REMOVING EXISTING UTILITY SUPPORTS. IF DAMAGE OCCURS, CONTRACTOR IS RESPONSIBLE FOR REPAIRING IT TO THE SATISFACTION OF THE DISTRICT AT NO COST TO THE DISTRICT.

4. ALL UTILITY SUPPORT SECTION SIZES AND DIMENSIONS ARE APPROXIMATE. FIELD VERIFY PRIOR TO FABRICATING ELEMENTS.

FOR ALUMINUM SUPPORT BRACKET ASSEMBLIES TO REMAIN, GRIND ALL REMAINING CORROSION SMOOTH.
