CHESAPEAKE BAY BRIDGE AND TUNNEL DISTRICT
			RMF 5044.5122 - STEEL BRIDGE PAINTING PROJECT
PROJECT NOTES			
No.	Description	Date	Designed: JSE Drawn: BSB Checked: AHC
			12/18/2025
	Revision		1 OF 45

CHESAPEAKE BAY BRIDGE AND TUNNEL DISTRICT	
			RMF 5044.5122 - STEEL BRIDGE PAINTING PROJECT	
NORTH CHANNEL BRIDGE NB GENERAL PLAN AND ELEVATION				
No.	Description	Date	Designed: JSE Drawn: BSB Checked: AHC	Date Plan No. Sheet No.
	Revision			12/18/2025 3 OF 45

CHESAPEAKE BAY BRIDGE AND TUNNEL DISTRICT							
			RMF 5044.5122 - STEEL BRIDGE PAINTING PROJECT							
NORTH CHANNEL BRIDGE NB STRINGER AND FLOORBEAM PLATING REPAIRS										
No. Description Date Designed: JSE Drawn: JSE Checked: AHC 12/18/2025 9 OF 45										
	Revision

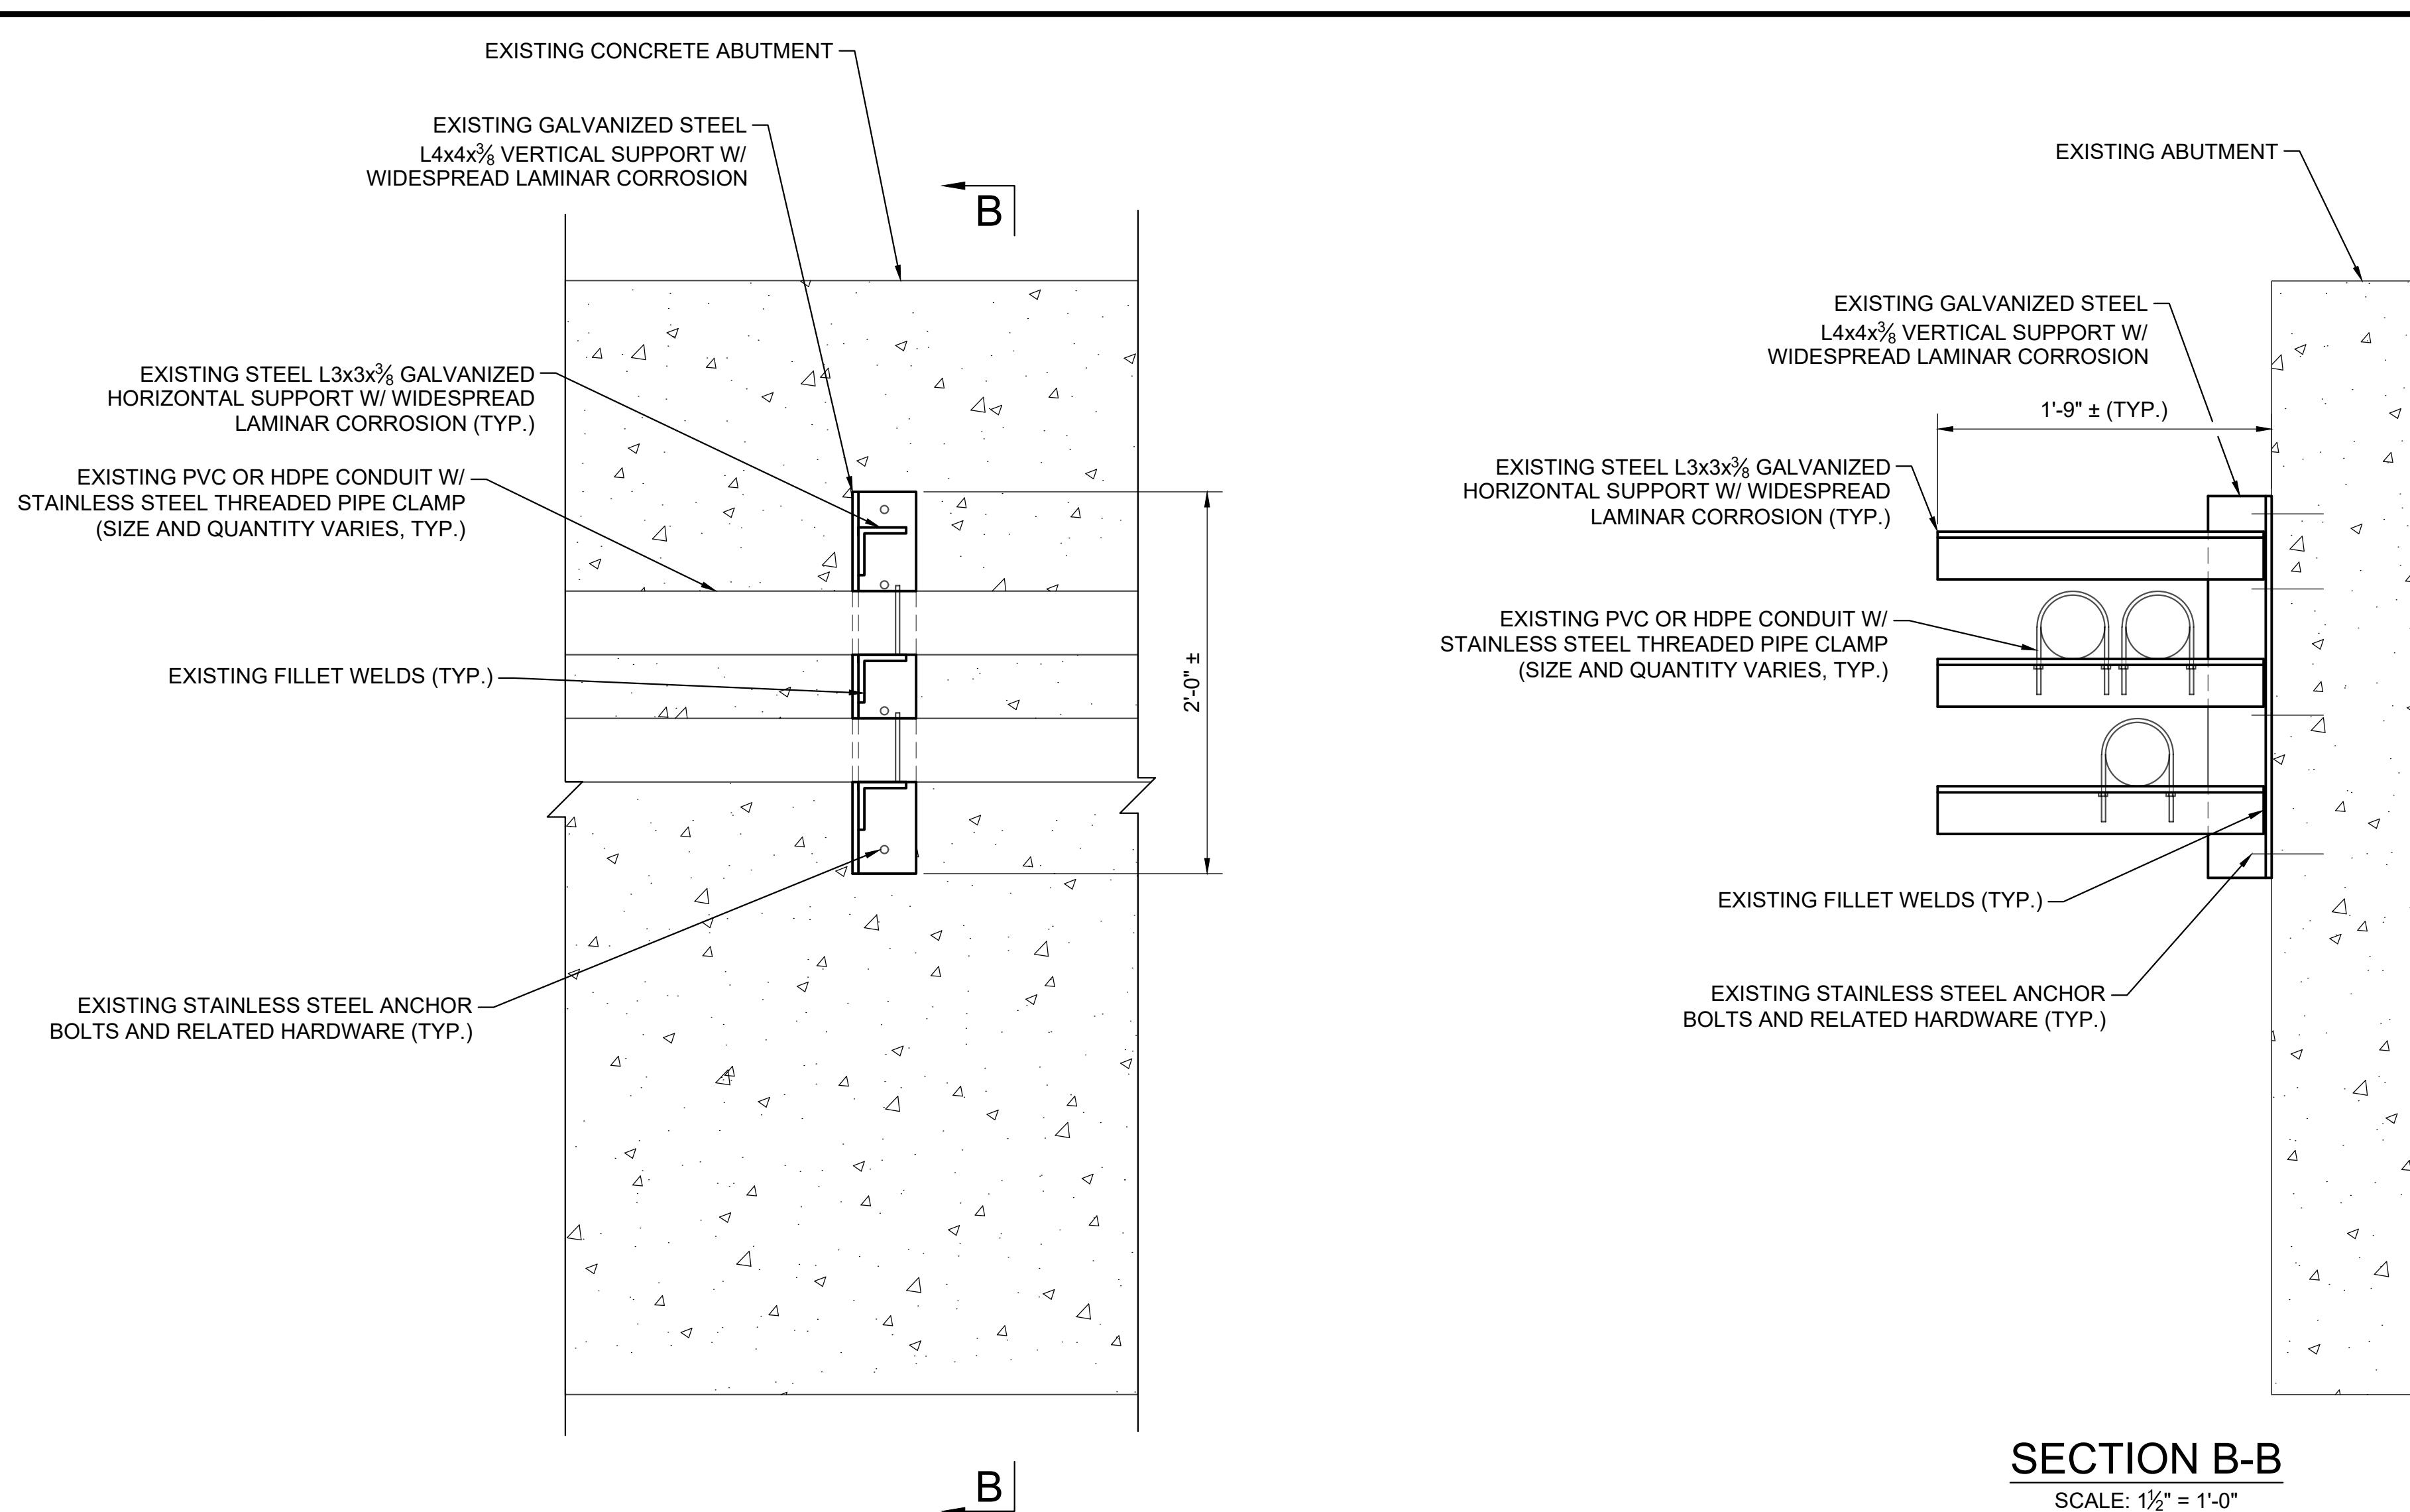
SECTION B-B

1. PERFORM SIMPLE SPAN UTILITY REPAIR TYPE 2 ON PORTAL ISLAND APPROACH SPAN (ASB204, BSB1, BSB202, CSB1, BNB1-2) ABUTMENTS FOR GALVANIZED STEEL UTILITY SUPPORT BRACKET ASSEMBLIES WITH TOTAL SECTION LOSS DUE TO CORROSION EXCEEDING 25% OF THE ORIGINAL CROSS-SECTIONAL AREA AT ANY CROSS-SECTION AS APPROVED BY THE DISTRICT. REPAIR CONSISTS OF:

- 1.3. REPLACE PIPE CLAMPS (USE STAINLESS STEEL GRADE 316).

2. ALL UTILITY SUPPORT SECTION SIZES AND DIMENSIONS ARE APPROXIMATE. FIELD VERIFY PRIOR TO FABRICATING ELEMENTS.
