## FY2023 Annual Inspection and Underwater Inspection, Trestle CSB

### FY2023 Facility Annual Inspection Report FINAL

December 30, 2022

Chesapeake Bay Bridge and Tunnel District

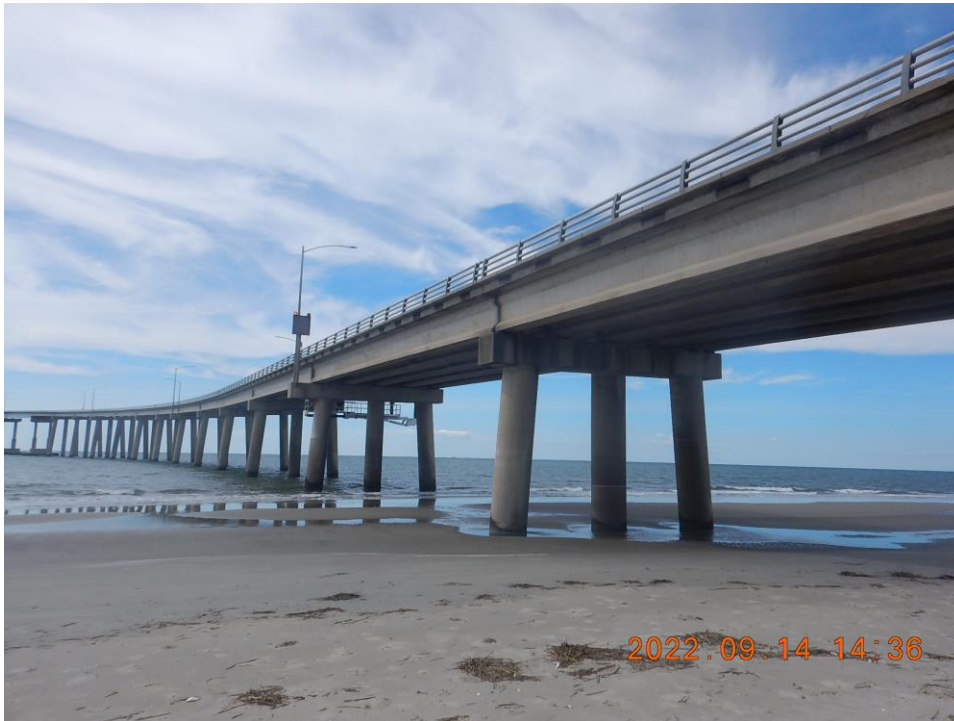
Photo 39 - East Elevation of Trestle DSB (Looking Southwest)

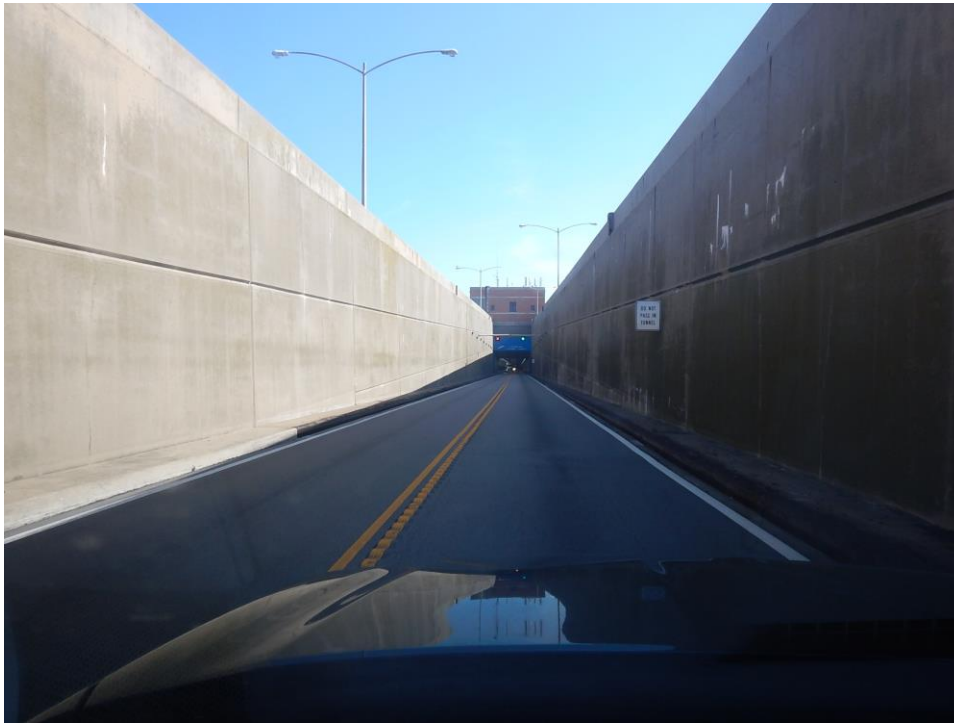
Photo 59 – Island 3 Open Approach Roadway (Looking North)

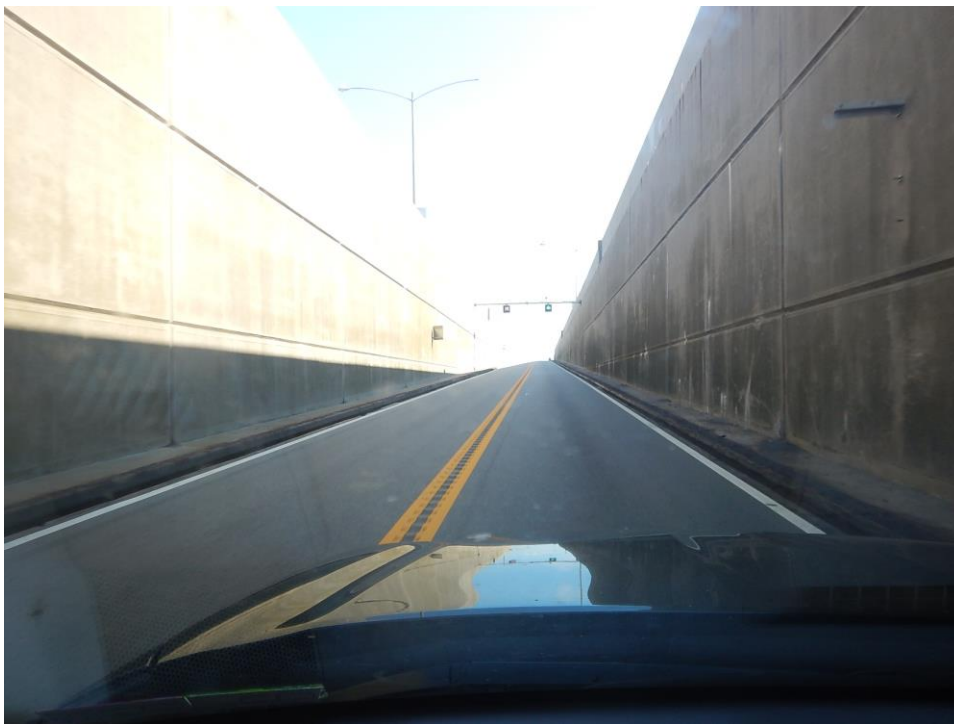
Photo 60 – Island 4 Open Approach Roadway (Looking North)

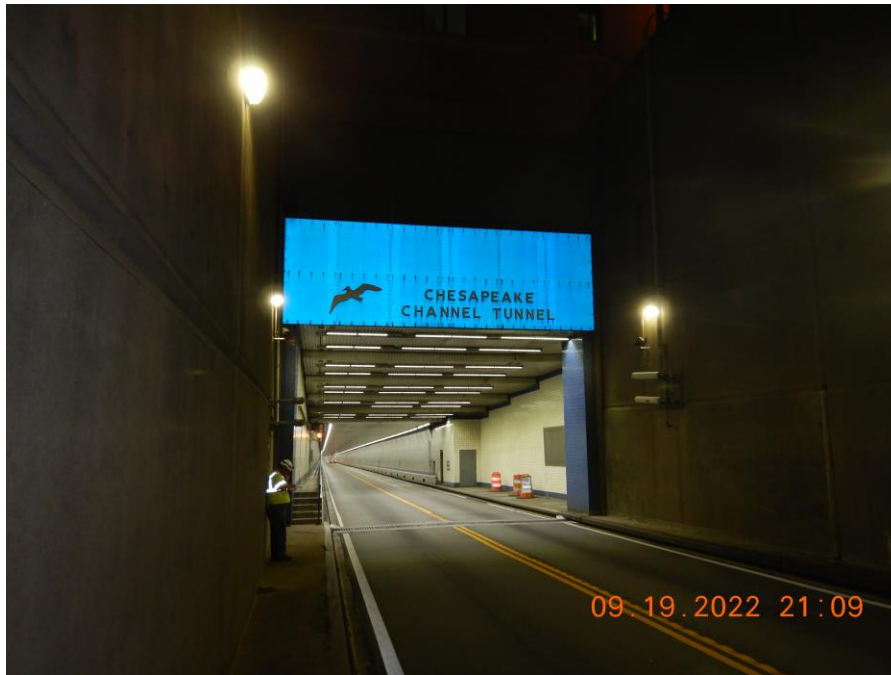
Photo 61: Tunnel Portal – General View of Island 3 Portal (Looking North)

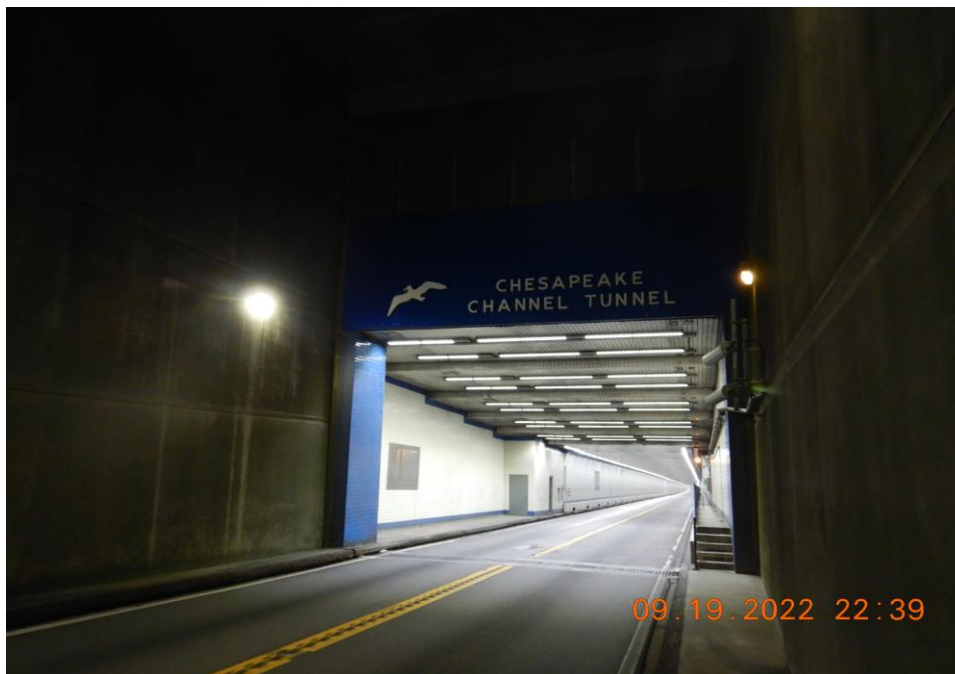
Photo 62: Tunnel Portal – General View of Island 4 Portal (Looking South)

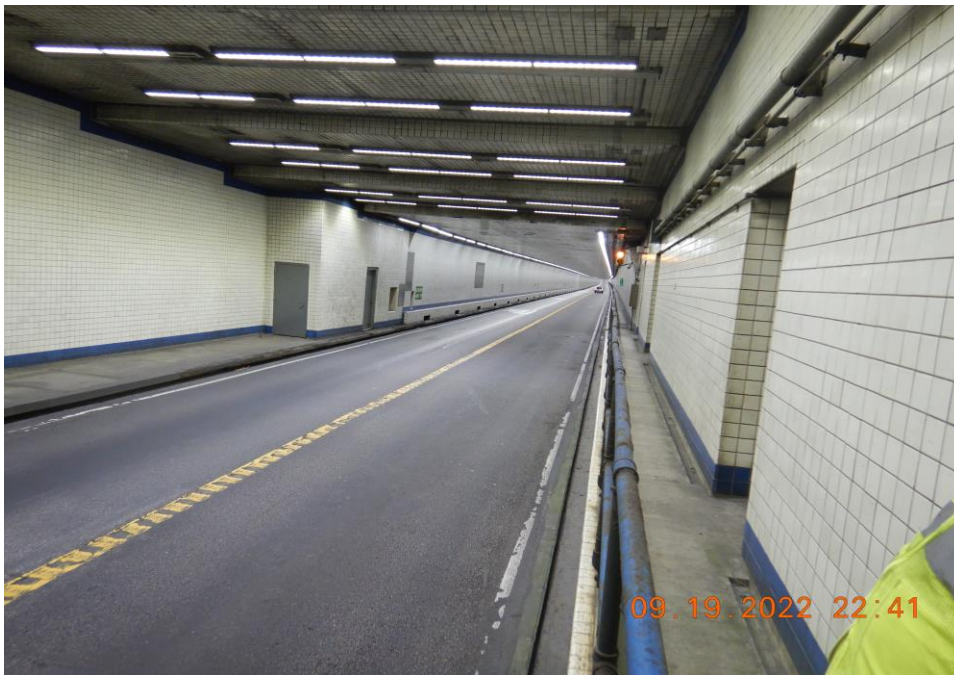
Photo 64: Tunnel Roadway – General View along Tunnel Roadway (Looking South)

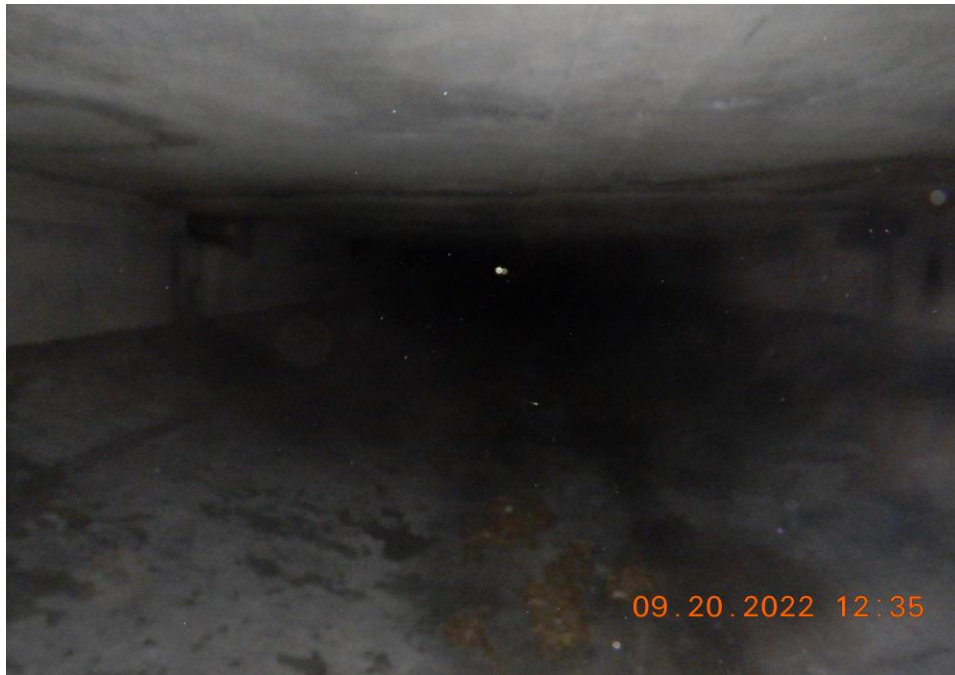
Photo 67: Fresh Air Duct – General View along Invert (Looking North)

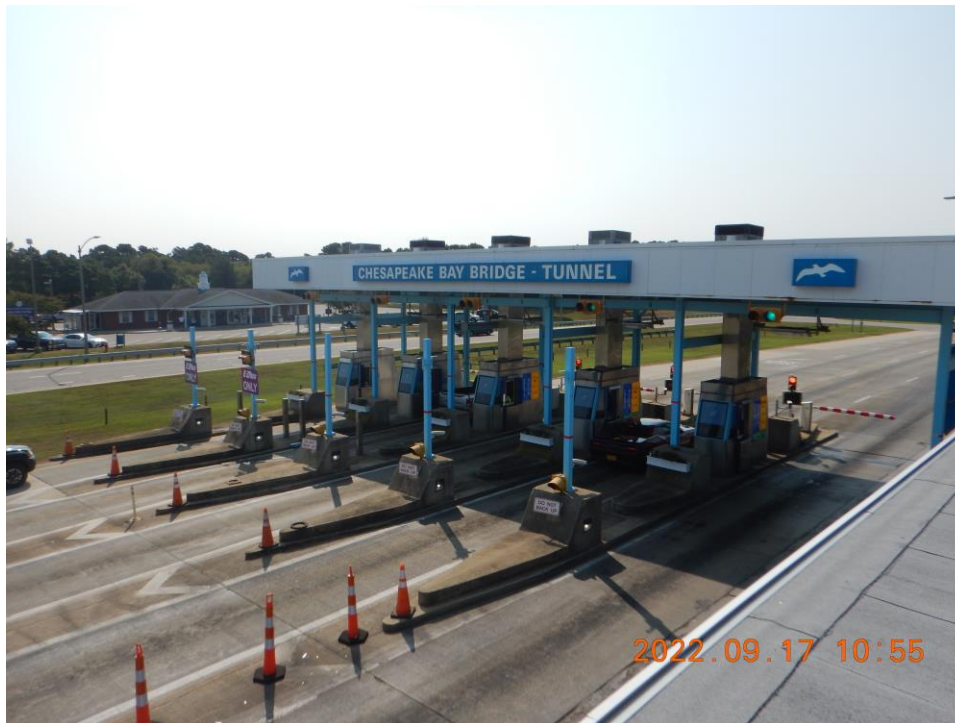
Photo 69: North Toll Plaza (Looking Southeast)

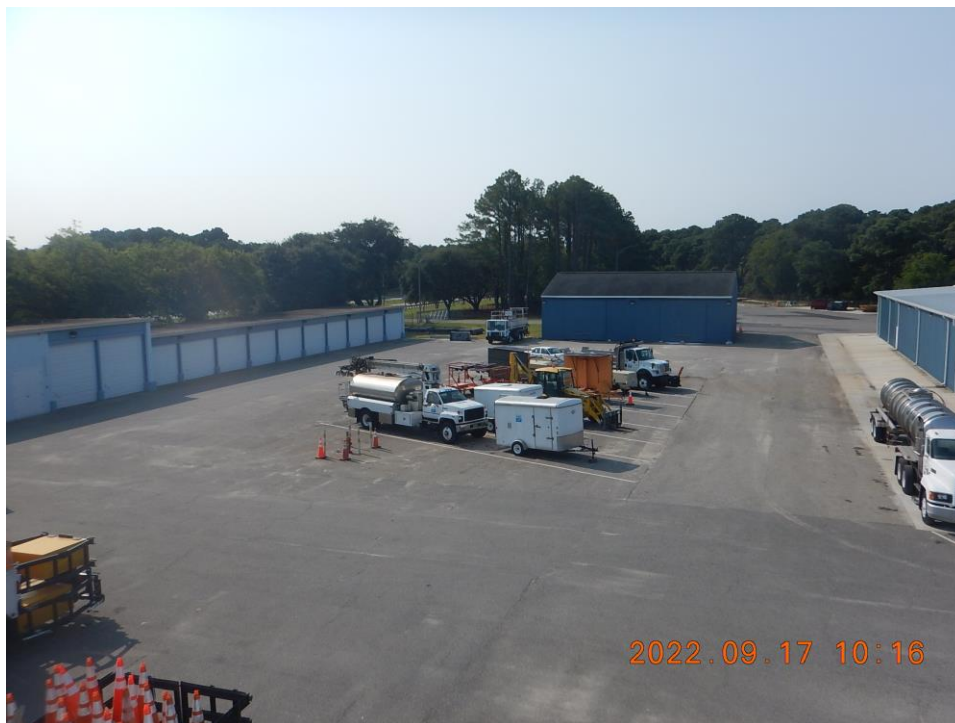
Photo 70: North Toll Plaza Maintenance Buildings (Looking South)

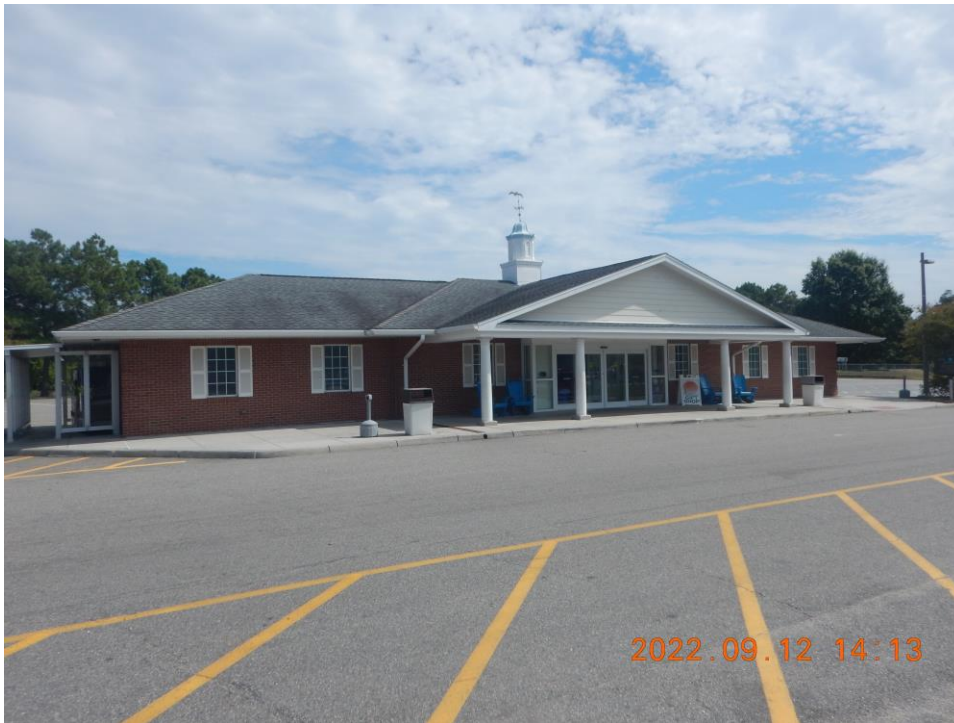
Photo 71: North Toll Plaza Rest Area Building (Looking Southeast)

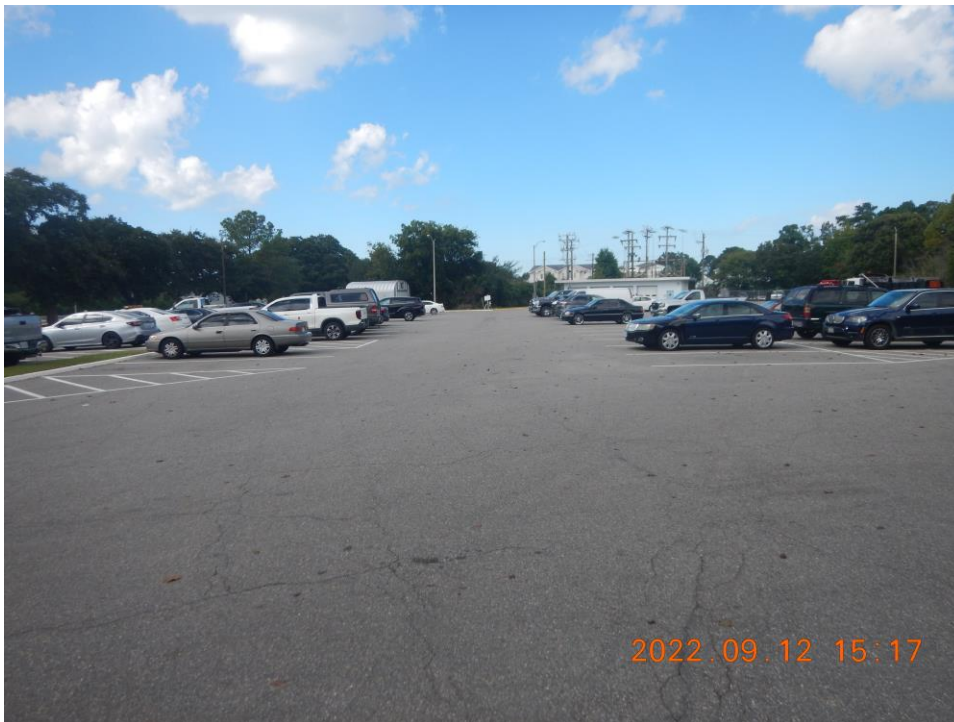
Photo 72: South Toll Plaza Parking Area (Looking North)
